Landusky Metals Total Maximum Daily Loads and Framework Water Quality Improvement Plan

March 2012

Water Quality Planning Bureau
Watershed Management Section

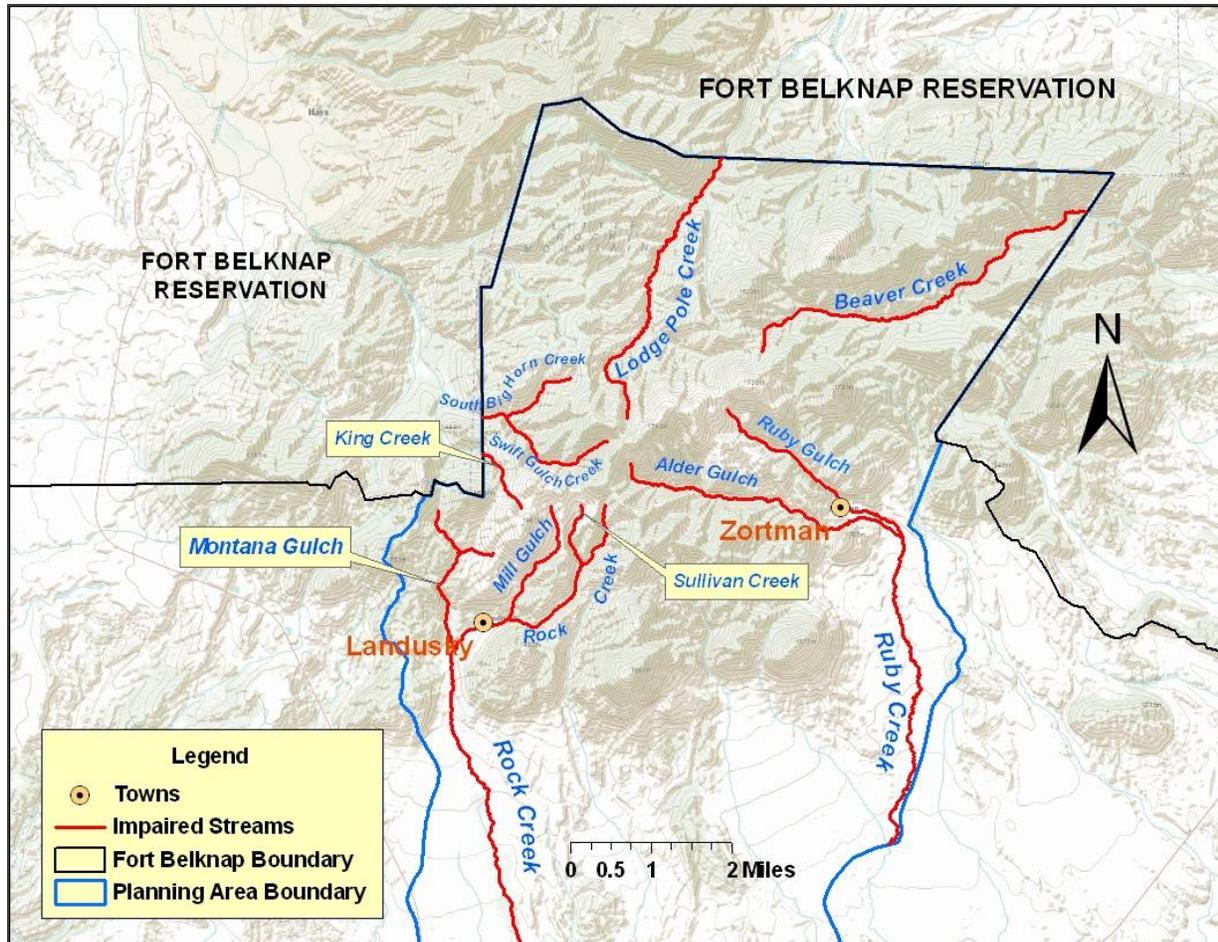
Figure 2-1. Map of the northern half of the Landusky TPA showing locations of impaired waters.

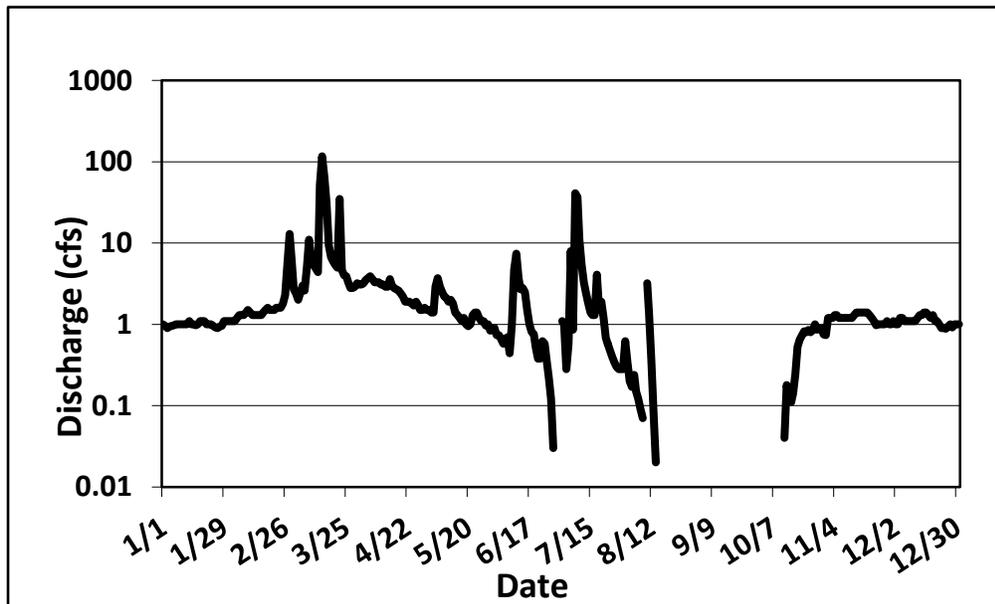
Figure 2-2. Mean daily discharge of Rock Creek at USGS Station 06115350 near Landusky, Montana

Stream flow data are based on records from the USGS stream gage on Rock Creek near Landusky described above, and are available via the Internet from the USGS NWIS site (United States Department of the Interior, 2008). Flows in Rock Creek vary considerably over a calendar year. A hydrograph summarizing mean daily discharge at this station is shown below in **Figure 2-2**

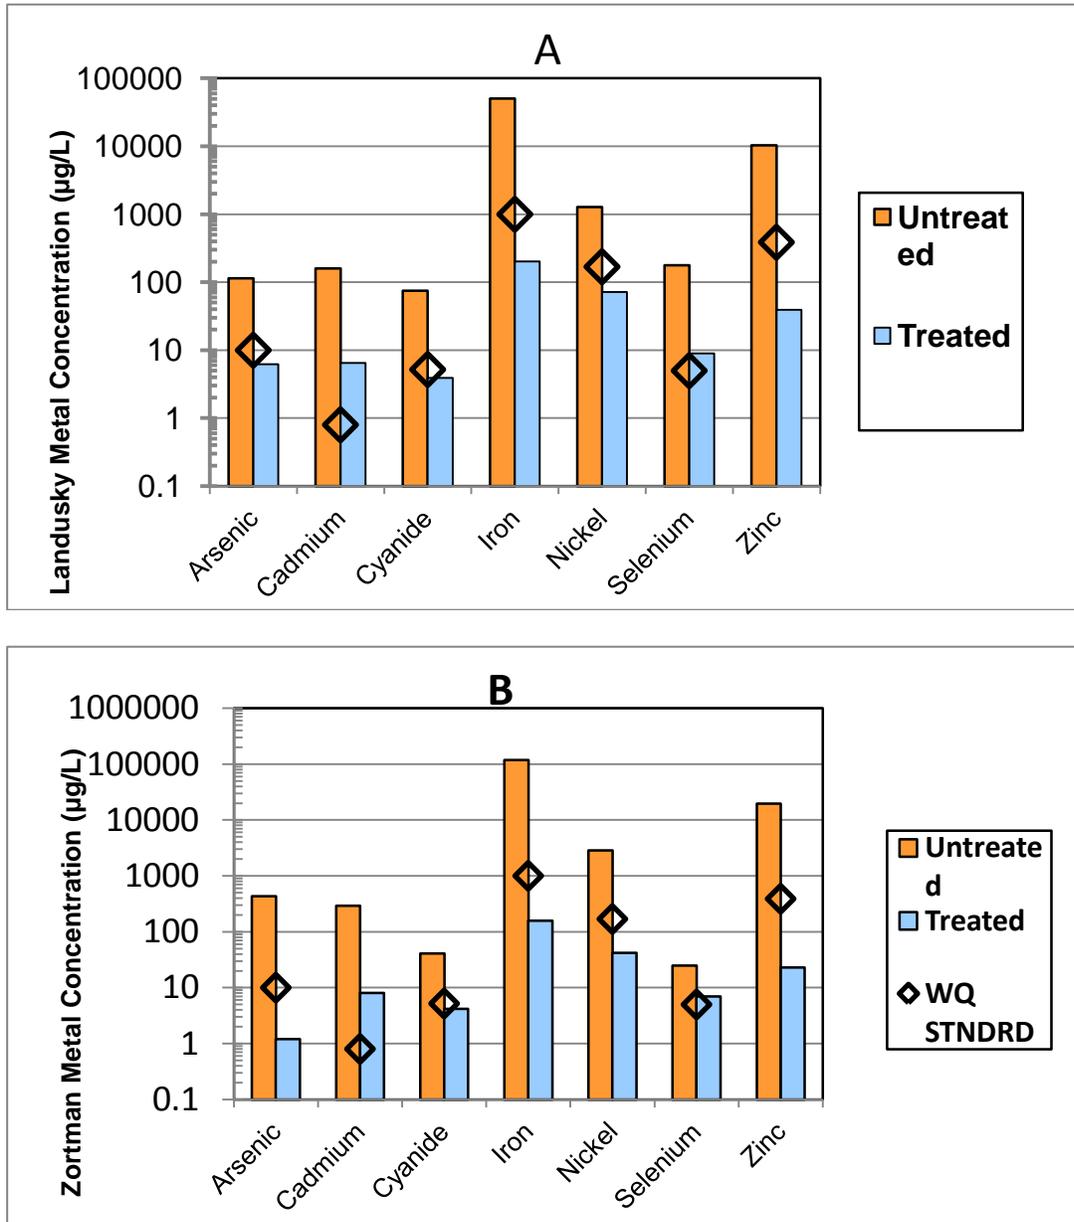
Figure 2-3. Metals and cyanide concentrations in untreated and treated wastewater at the Landusky (A) and Zortman (B) treatment plants

The metals concentrations in untreated water reporting to the Zortman and Landusky treatment plants are generally several orders of magnitude higher than the applicable water quality standards. Although the reduction in metal concentrations with treatment is substantial at both plants, the treated effluent commonly exceeds standards for several parameters. **Figure 2-3** illustrates the metal concentrations in influent and effluent from the plants since 2003, compared to water quality standards.

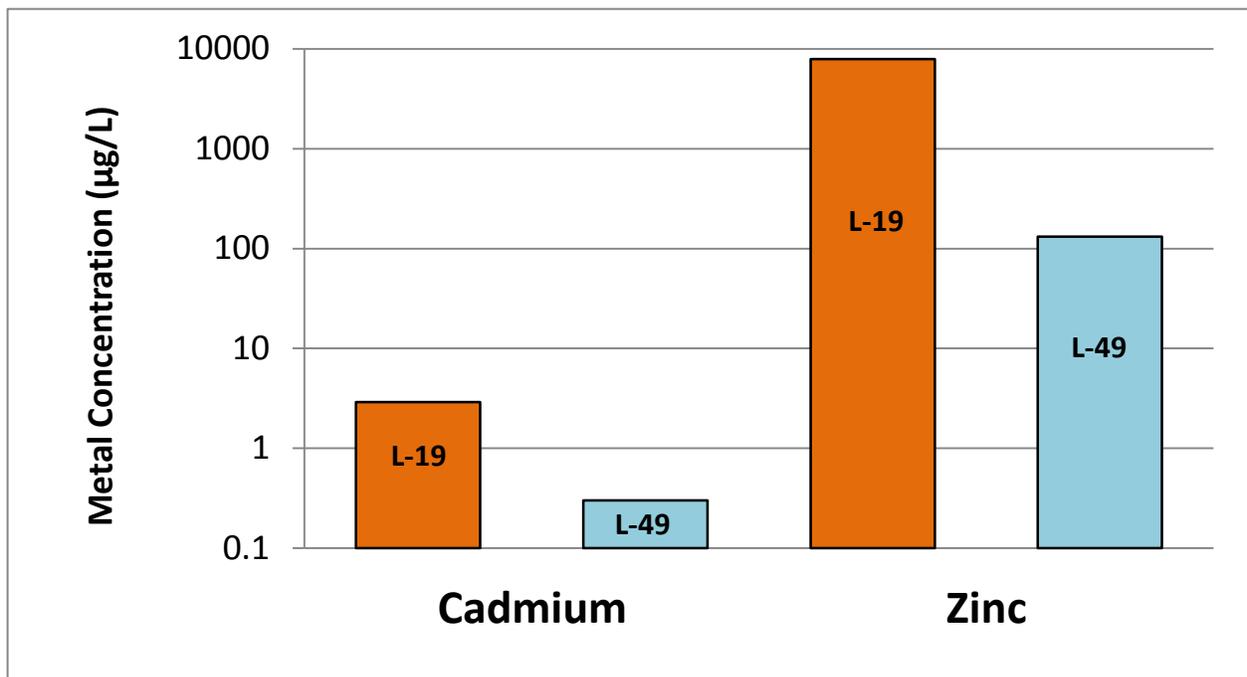
Figure 2-4. Median June through August cadmium and zinc concentrations in Swift Gulch Creek at sites upstream (L-19) and downstream (L-49) of the treatment plant during 2010.

The Swift Gulch Creek plant operated from June through November of 2010, treating water from two upstream capture systems. The plant capacity ranges from 50 to 100 gallons per minute. **Figure 2-4** contains bar graphs of cadmium and zinc concentrations in Swift Gulch Creek at site L-19, located upstream of the capture systems, and site L-49, located downstream of the treatment plant discharge.

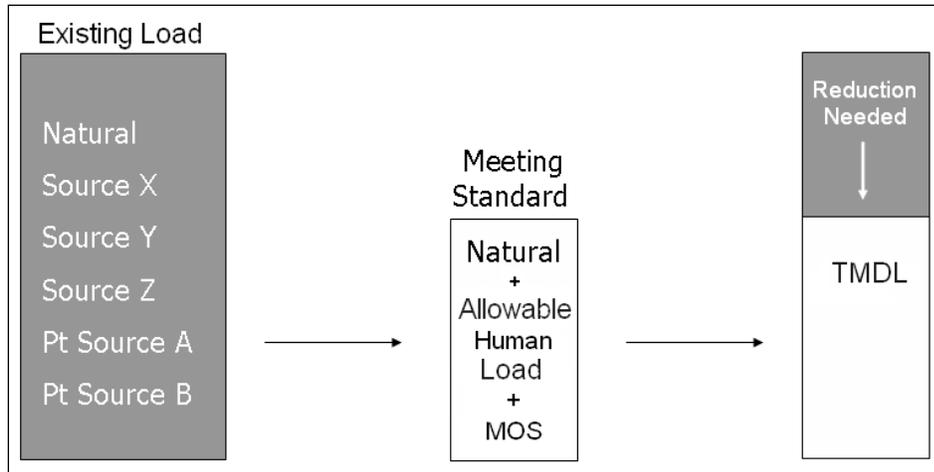
Figure 4-1. Schematic example of TMDL development

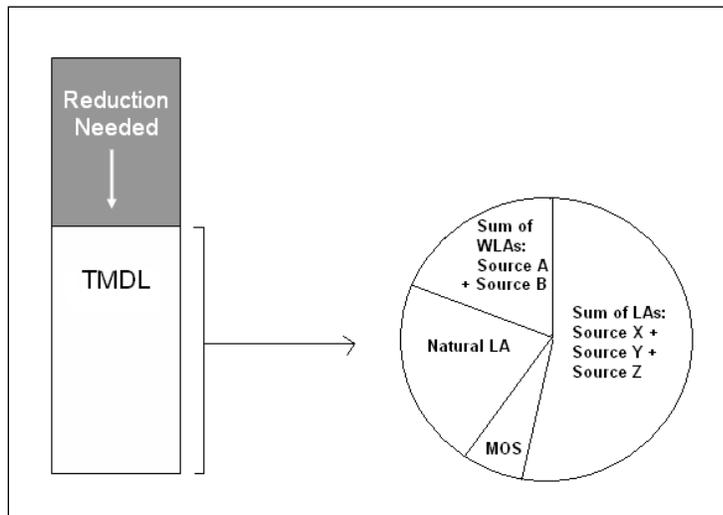
Figure 4-2. Schematic diagram of TMDL and allocations

Under the current regulatory framework for development of TMDLs, flexibility is allowed in the expression of allocations in that *“TMDLs can be expressed in terms of either mass per time, toxicity, or other appropriate measure.”* Allocations are typically expressed as a number, a percent reduction (from the current load), or as a surrogate measure, such as a percent increase in canopy density for temperature TMDLs.

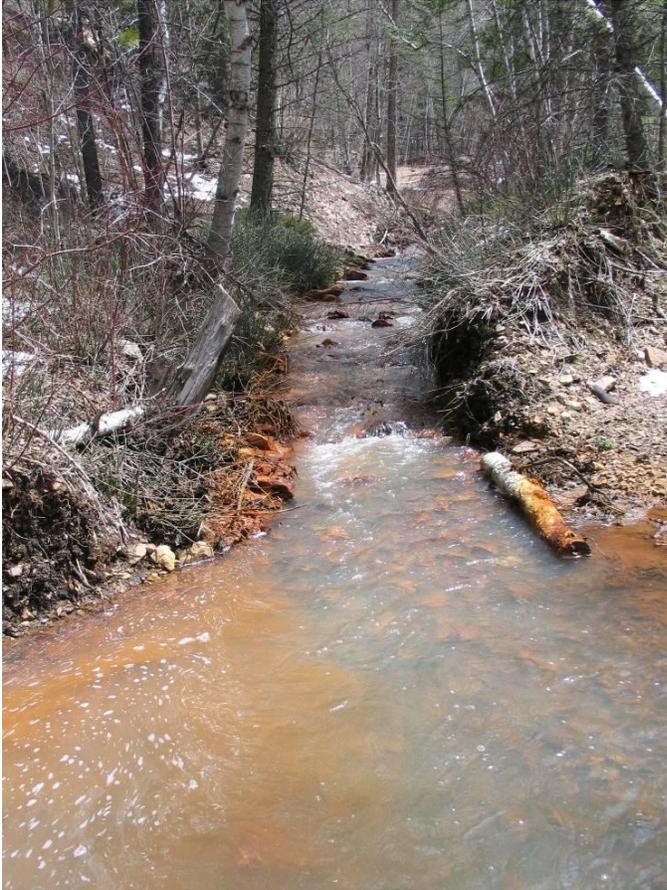
Figure 5-1. ARD-related iron oxide turbidity and substrate coating in Swift Gulch Creek

The increased surface water acidity associated with sulfide oxidation increases the solubility of other metals such as copper, lead, and arsenic. The acid generation and metal contamination caused by metal sulfide oxidation are commonly referred to as “acid rock drainage” or ARD. **Figure 5-1** shows the effects of ARD on water quality in Swift Gulch Creek.

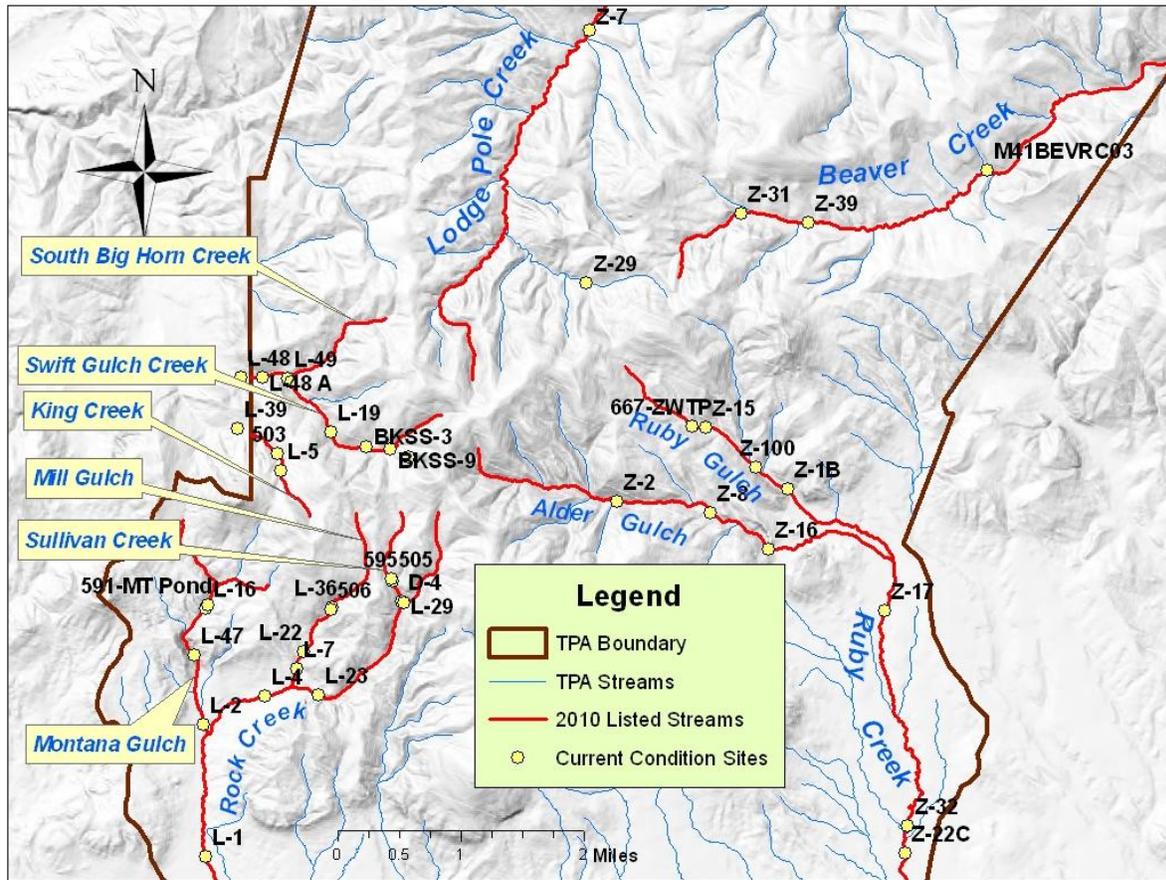
Figure 5-2. Monitoring sites selected as representing current water quality conditions

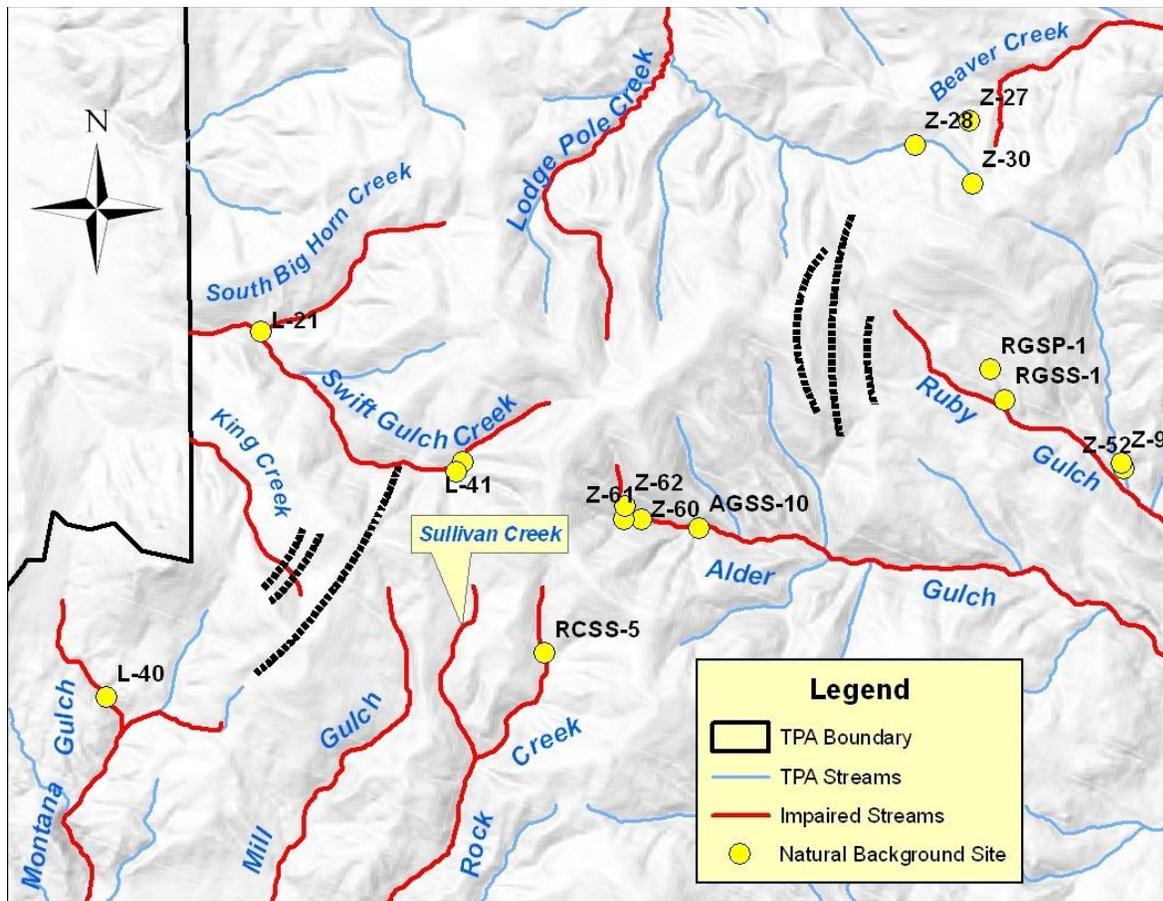
Figure 5-3. Locations of sites representing natural background water quality relative to bedrock shear zones in the Zortman (upper right) and Landusky (lower left) mine areas.

Figure 5-3 shows the location of the background sites in relation to the mineralized shear zones that were the focus of mining at Zortman and Landusky. The sites are generally in portions of the stream drainages more remote from mining disturbances. The **Table 5-3** sites which are included in the Zortman and Landusky mine water classification system developed by Osborne and Gallagher (2001), are classified as “Headwaters Background”, “Mineralized Syenite Background”, and “Non-Mineralized Syenite Background.” Although the shear zones shown in **Figure 5-3** are concentrated in headwater positions, other such zones occur throughout the core of the Little Rockies range. Thus, the metal sulfide mineralogy can potentially affect water quality at other locations and at lower elevations.

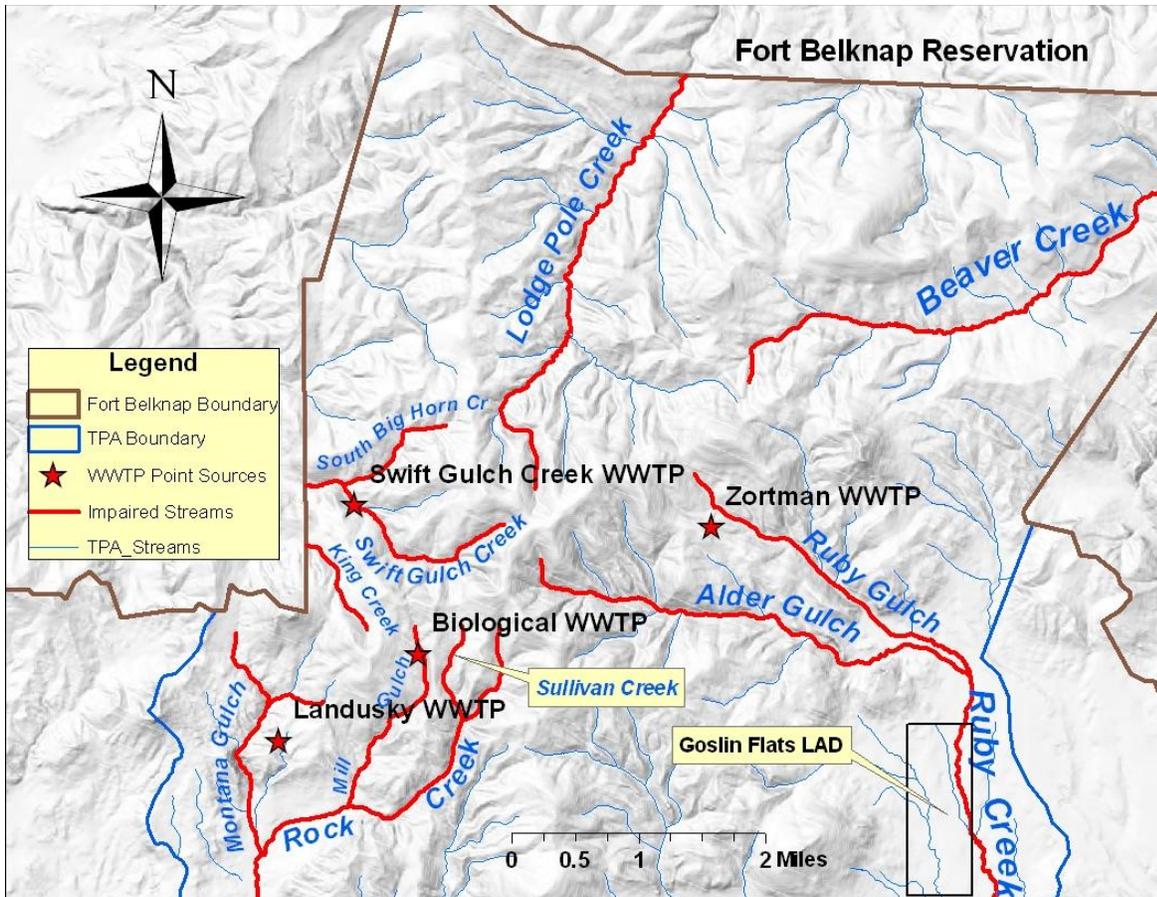
Figure 5-4. Wastewater treatment plant and Goslin LAD point source locations.

Four wastewater treatment plants operate as point sources under authority of the Comprehensive Environmental Response, Compensation and Liability Act (CERCLA) through the BLM. Treatment of ARD affected wastewater by pH adjustment with hydrated lime is occurring at three plants located at the Landusky Mine, Zortman Mine and in the Swift Gulch Creek drainage. The Zortman plant began operation on June 10th, 1994. It discharges treated water to surface water in Ruby Gulch. The Landusky plant, that began operation on October 1st, 1997, discharges to surface water into Montana Gulch. The Swift Gulch Creek plant began a seasonal (June through November) operations during 2010. Treated wastewater discharges to Swift Gulch Creek downstream of the plant. Since 2005, a fourth plant provides biological removal of cyanide, selenium and nitrates from leach pad drainage piped from both the Zortman and Landusky mines. Treated water is discharged either to surface water in Montana Gulch or to a 204-acre land disposal area located between Goslin Gulch and Ruby Creek about one mile south of the town of Zortman. **Figure 5-4** illustrates the locations of the treatment plant point sources and the Goslin Flats land disposal area.

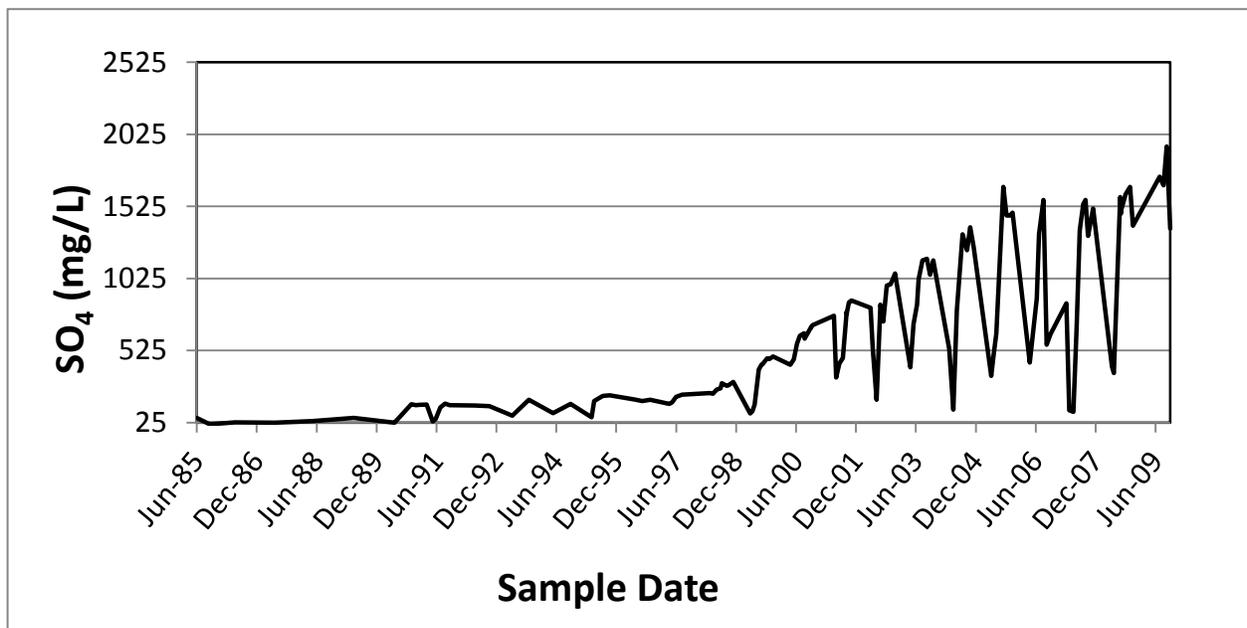
Figure 5-5. Surface water sulfate monitoring record for site L-19 in Swift Gulch Creek.

Natural background concentrations of sulfate are low in planning area surface waters compared with waters affected by mining. The median values for high and low flow condition sulfate concentration are 11 and 42 mg/L respectively (**Table 5-6**). Mining activity and associated sulfide oxidation have caused wide sulfate ranges in affected surface waters. The typical range is from the median values in **Table 5-6** to several thousand mg/L. **Figure 5-5** illustrates this range for water quality in Swift Gulch Creek that began to deteriorate during the early 1990s as local groundwater contaminated beneath the Landusky Mine pit entered the stream through a series of springs. The wide fluctuation in sulfate concentration after 2000 is the dilution effect of spring snowmelt and precipitation.

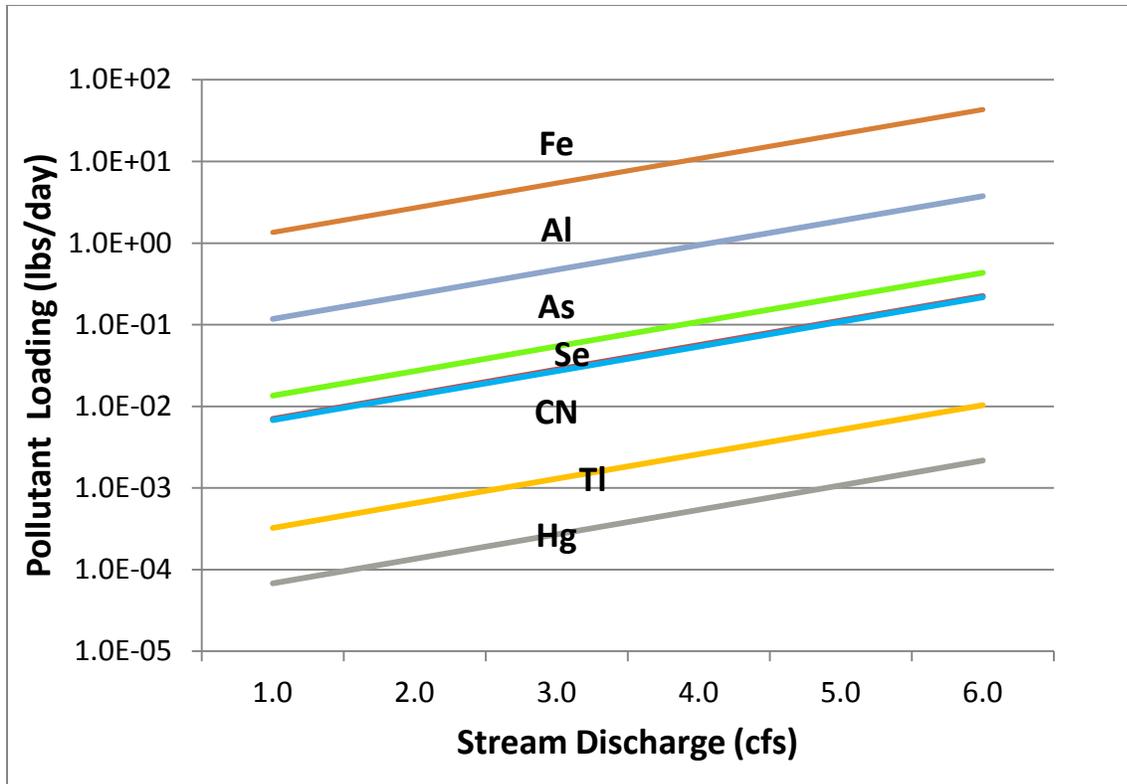
Figure 5-6. Graphs of TMDLs (lbs/day) for iron (Fe), aluminum (Al), arsenic (As), selenium (Se), cyanide (CN), thallium (TI), and Mercury (Hg) with increasing stream discharge

The toxicity of several metal elements and the cyanide are independent of water hardness. The TMDLS for these substances can be illustrated graphically using Equation 1 above with the most restrictive water quality criterion substituted for the value of "X", and stream discharge in cubic feet per second (cfs) substituted for the value of "Y". **Figure 5-6** shows the graphs of the TMDLs for Fe, As, Se, CN, Tl, and Hg based on the most restrictive water quality criterion for each parameter over a range of stream discharge common in the Landusky TPA. For C-3 classified waters where drinking water is not an established use, the loading graphs for arsenic and mercury would be based on the less restrictive aquatic life criteria, and appear higher on the vertical loading axis.

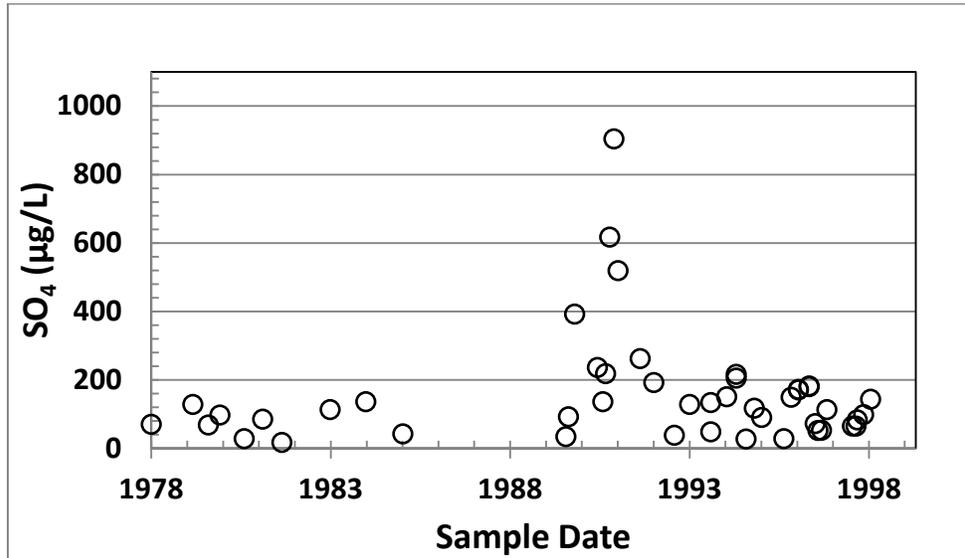
Figure 5-7. Sulfate concentration record at site Z-8 in Alder Gulch.

column SO_4 concentration. **Figure 5-7** shows the SO_4 monitoring record for site Z-8 in Alder Gulch and the corresponding concentration spike from 1990 to 1992.

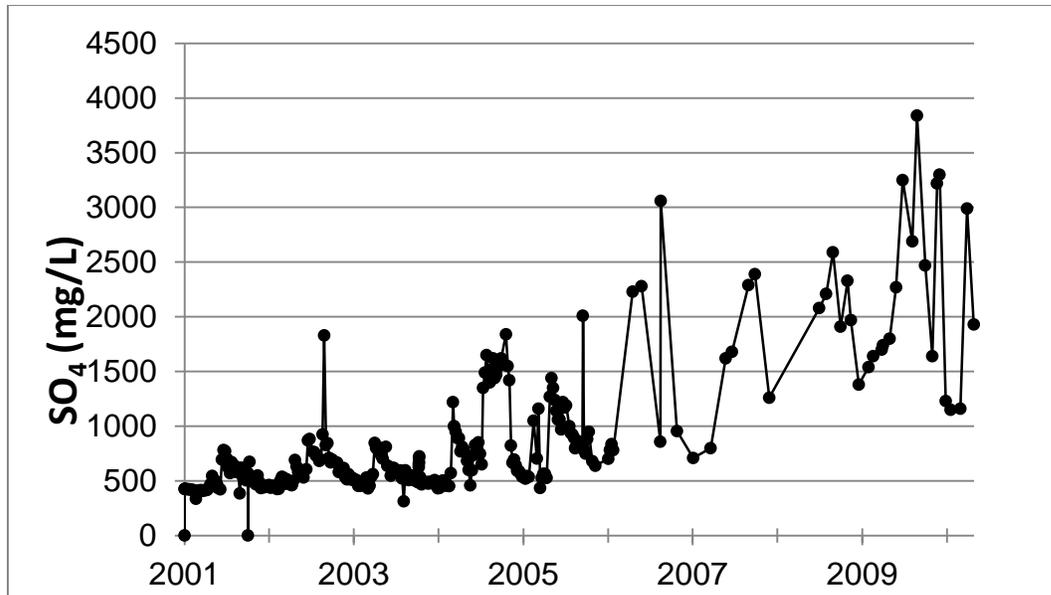
Figure 5-8. Graph of the sulfate concentration in the Montana Gulch pond discharge during the past 10 years.

The increasing trend in **Figure 5-8** for sulfate is similar to those for cadmium, cyanide, nickel, selenium, and zinc. Although the datasets for the three current condition sites downstream of site 591 are much smaller, they exhibit a similar trend of deteriorating water quality. **Figure 5-9** shows the sulfate data points for sites L-16, L-47 and L-2 from 2001 through 2009.

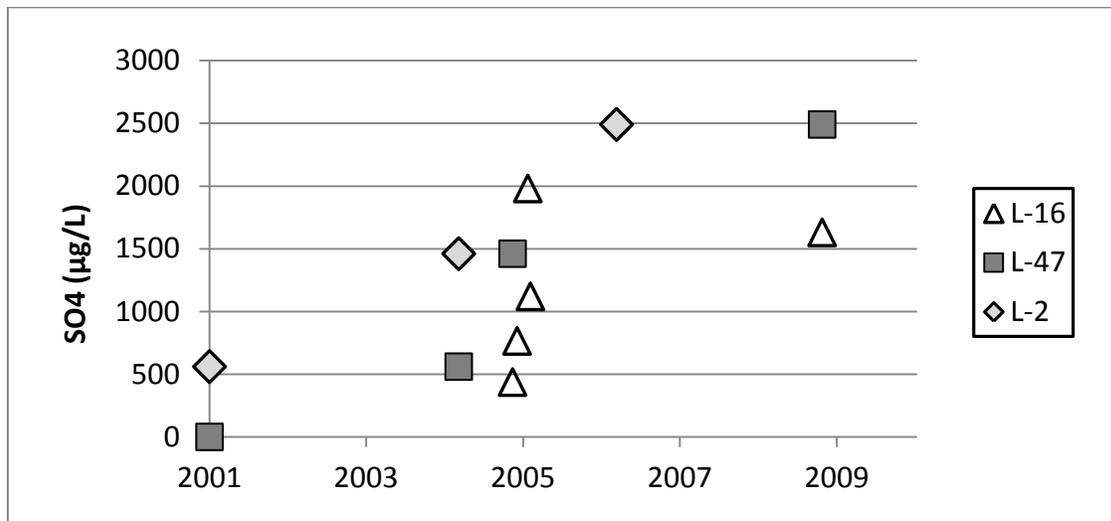
Figure 5-9. Graphs of surface water sulfate concentration at sites L-16, L-47, and L-2 during the past 10 years

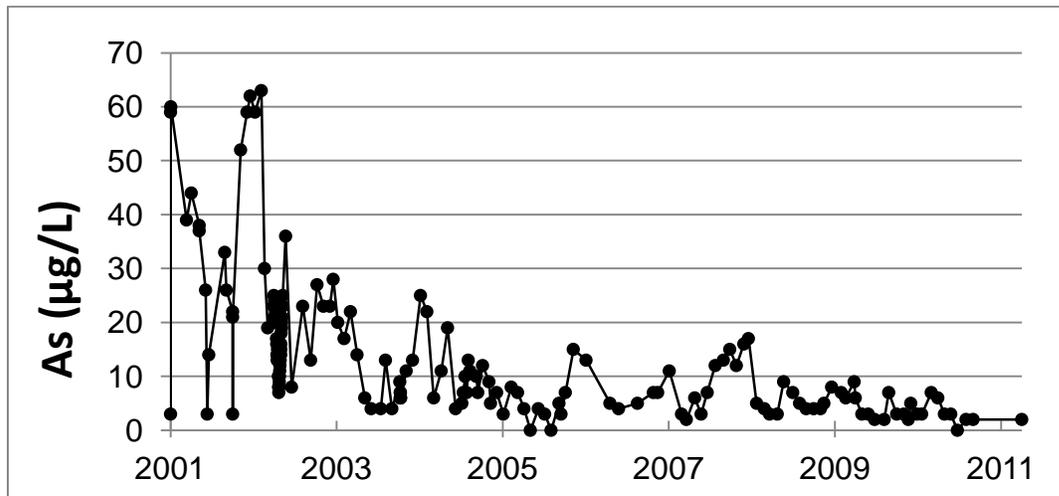
Figure 5-10. Graph of the arsenic concentration in the Montana Gulch pond discharge during the past 10 years.

Although the arsenic record contains 51 human health exceedances, arsenic has been on a decreasing trend since 2001. Arsenic concentrations have generally been an order of magnitude less than the CAL and AAL targets. **Figure 5-10** shows the trend in arsenic concentration at site 591 over the past decade. Although clearly on a decreasing trend, persistent arsenic exceedances during the most recent decade require development of an arsenic TMDL.

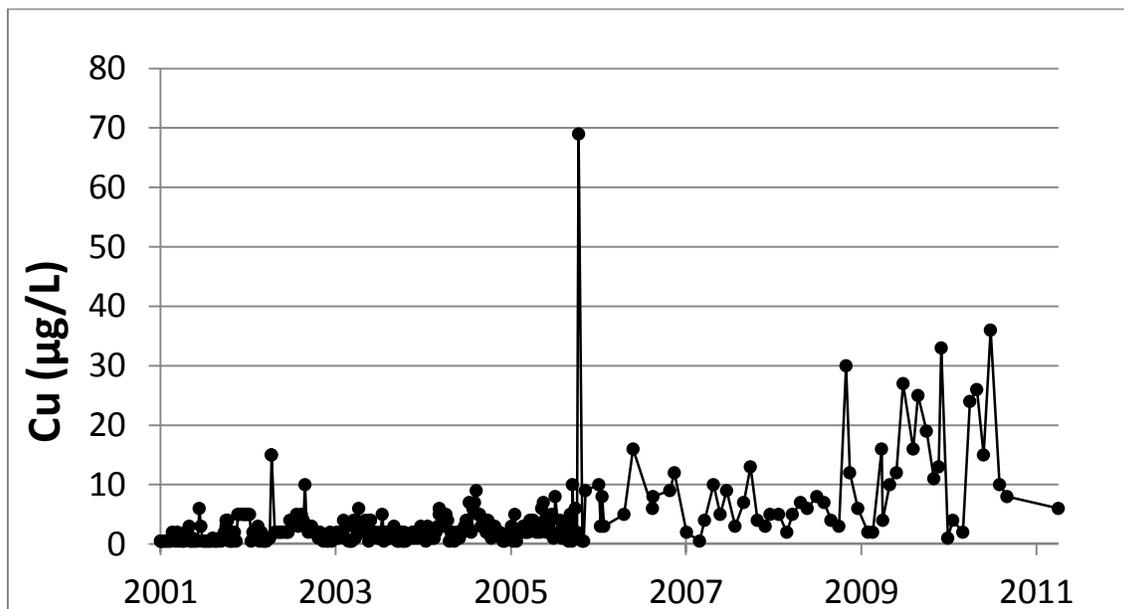
Figure 5-11. Graph of copper concentration in the Montana Gulch pond discharge during the past 10 years.

Although copper concentrations in Montana Gulch are increasing slightly, (Figure 5-11) the CAL and AAL exceedance rates over all flow conditions are about one percent. No TMDLs or allocations are proposed for copper in Montana Gulch.

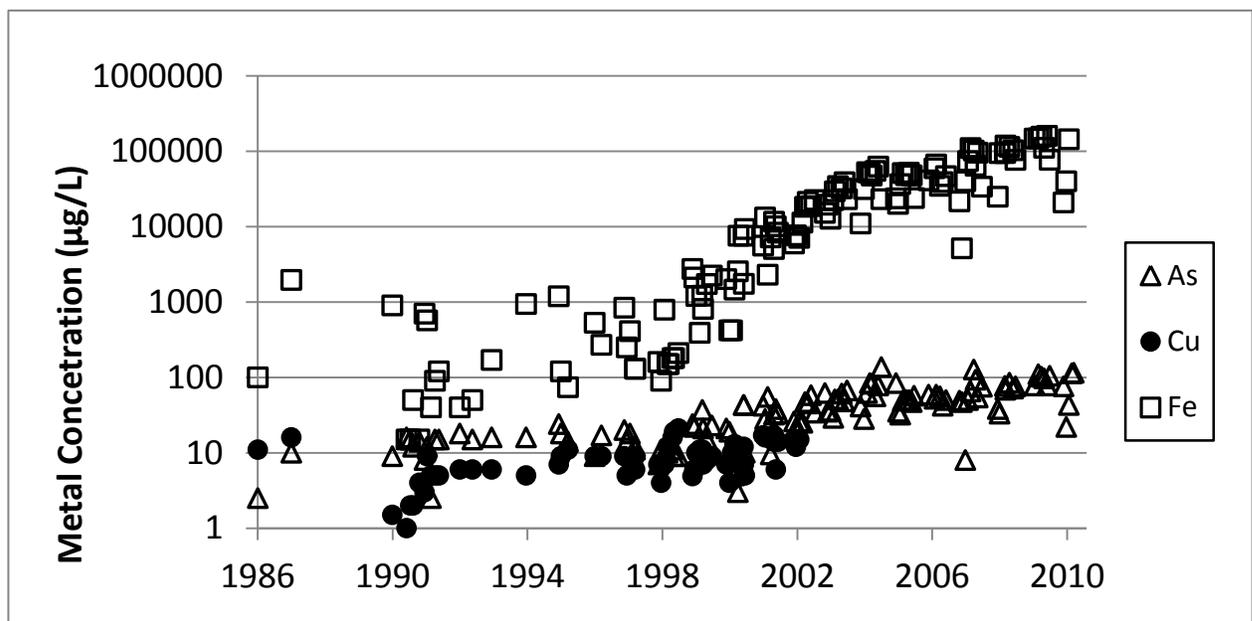
Figure 5-12. Graphs of arsenic, copper, and iron concentration at site L-19 in Swift Gulch Creek through 2010.

Swift Gulch Creek is a southern tributary to South Big Horn Creek. Approximately 540 acres of the reclaimed surface of the Landusky Mine drain north to Swift Gulch Creek. The main source of metals loading to Swift Gulch Creek from the mine is ARD from beneath the August-Little Ben-Surprise-Queen Rose pit complex at the Landusky mine. The pit complex is approximately parallel to subsurface bedrock shear zones where local mineralization has increased concentrations of sulfides, particularly pyrite (FeS_2). The shear zones control the volume and direction of local groundwater flow. The shear zone extends from beneath the pit complex, northeastward into the Swift Gulch Creek watershed (Spectrum Engineering, 2008). The intersection of the shears and the Swift Gulch Creek channel are expressed in a series of streambank springs. Mining within the shear zones at the Landusky Mine has lowered the local water table and exposed an increased volume of sulfide bedrock to weathering. Accelerated sulfide oxidation in the mined portion of the shear zones has acidified local groundwater that enters Swift Gulch Creek at the springs. Groundwater quality in Swift Gulch Creek has been deteriorating due to metals loading since the early 1990s; with a marked increased rate of metals loading beginning in 1998. This effect is illustrated in **Figure F-22**, a graph of the sulfate concentration in Swift Gulch Creek at site L-19. Sulfate is a product of sulfide mineral oxidation. **Figure 5-12** contains graphs of arsenic, copper, and iron concentrations in Swift Gulch Creek during the past two decades.

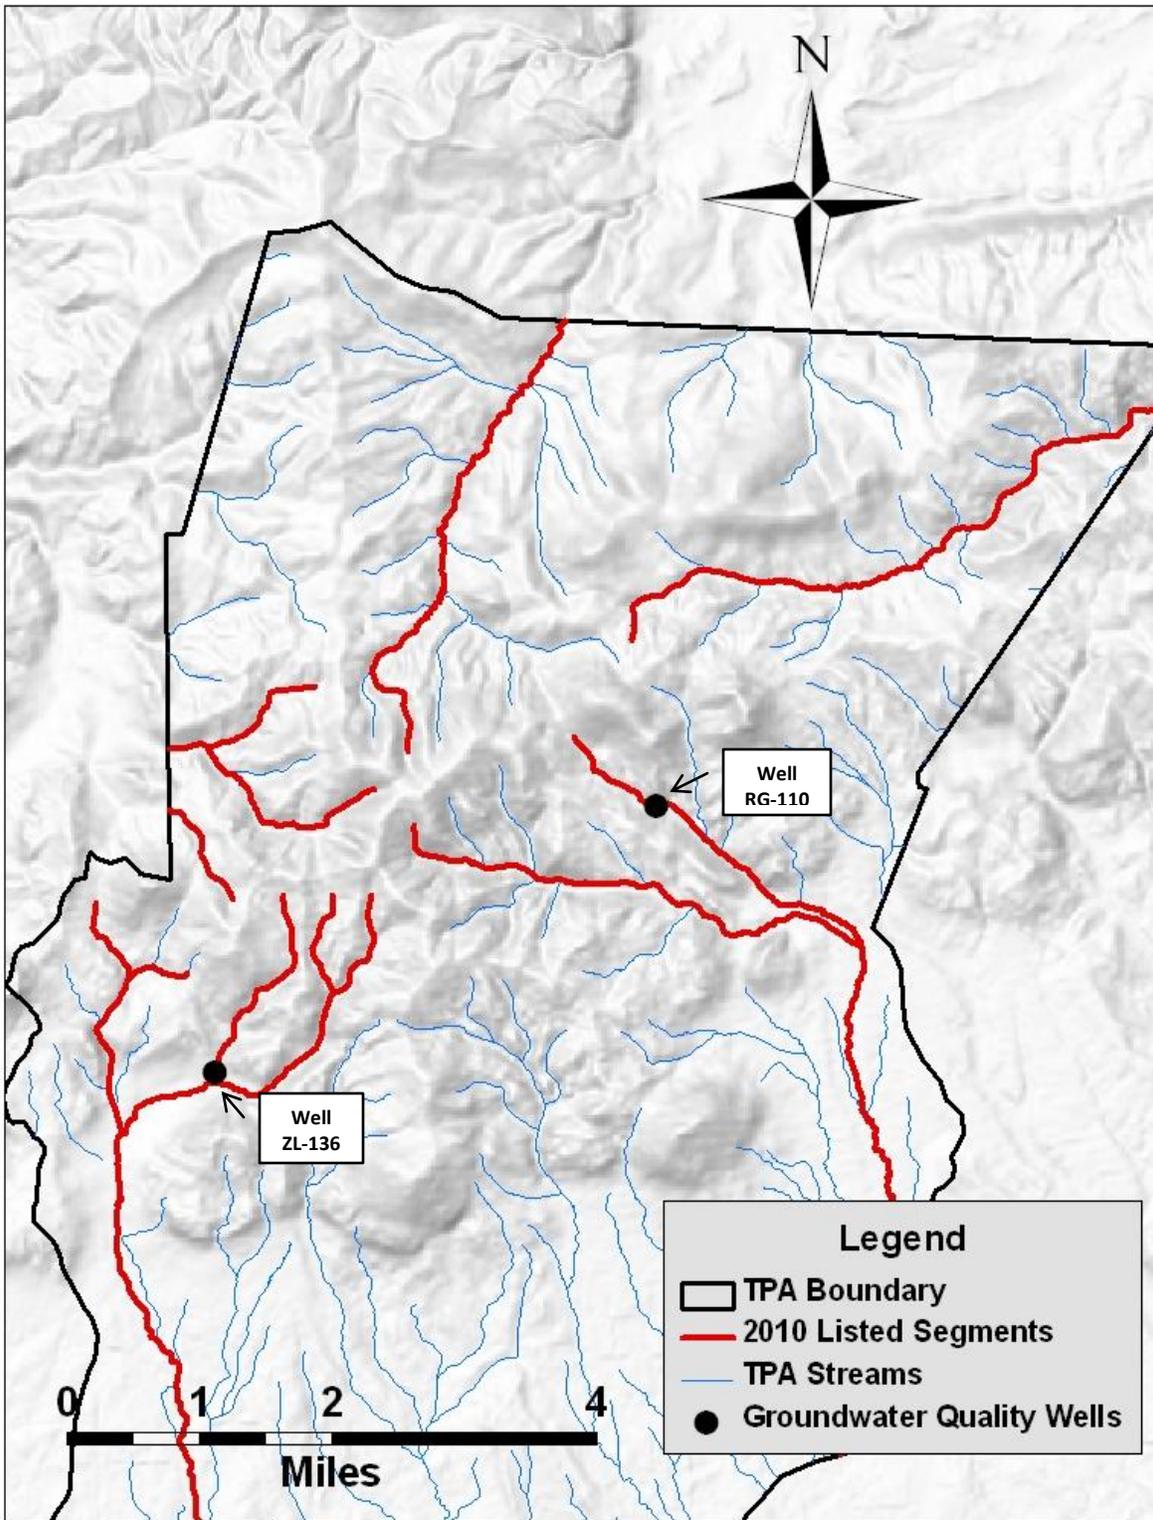
Figure A-8. Selected Ground Water Quality Well Sites

The Spectrum ACCESS database contains groundwater quality data from over 150 locations that include either wells or springs that were monitored at some point during mine operations. Because of the large datasets for individual sites, the chemistry of samples from wells RG-110 and ZL-136 is given in **Appendix D** to represent shallow aquifer conditions at the Zortman and Landusky mines respectively. The locations of these wells are shown in **Appendix A, Figure A-8**.

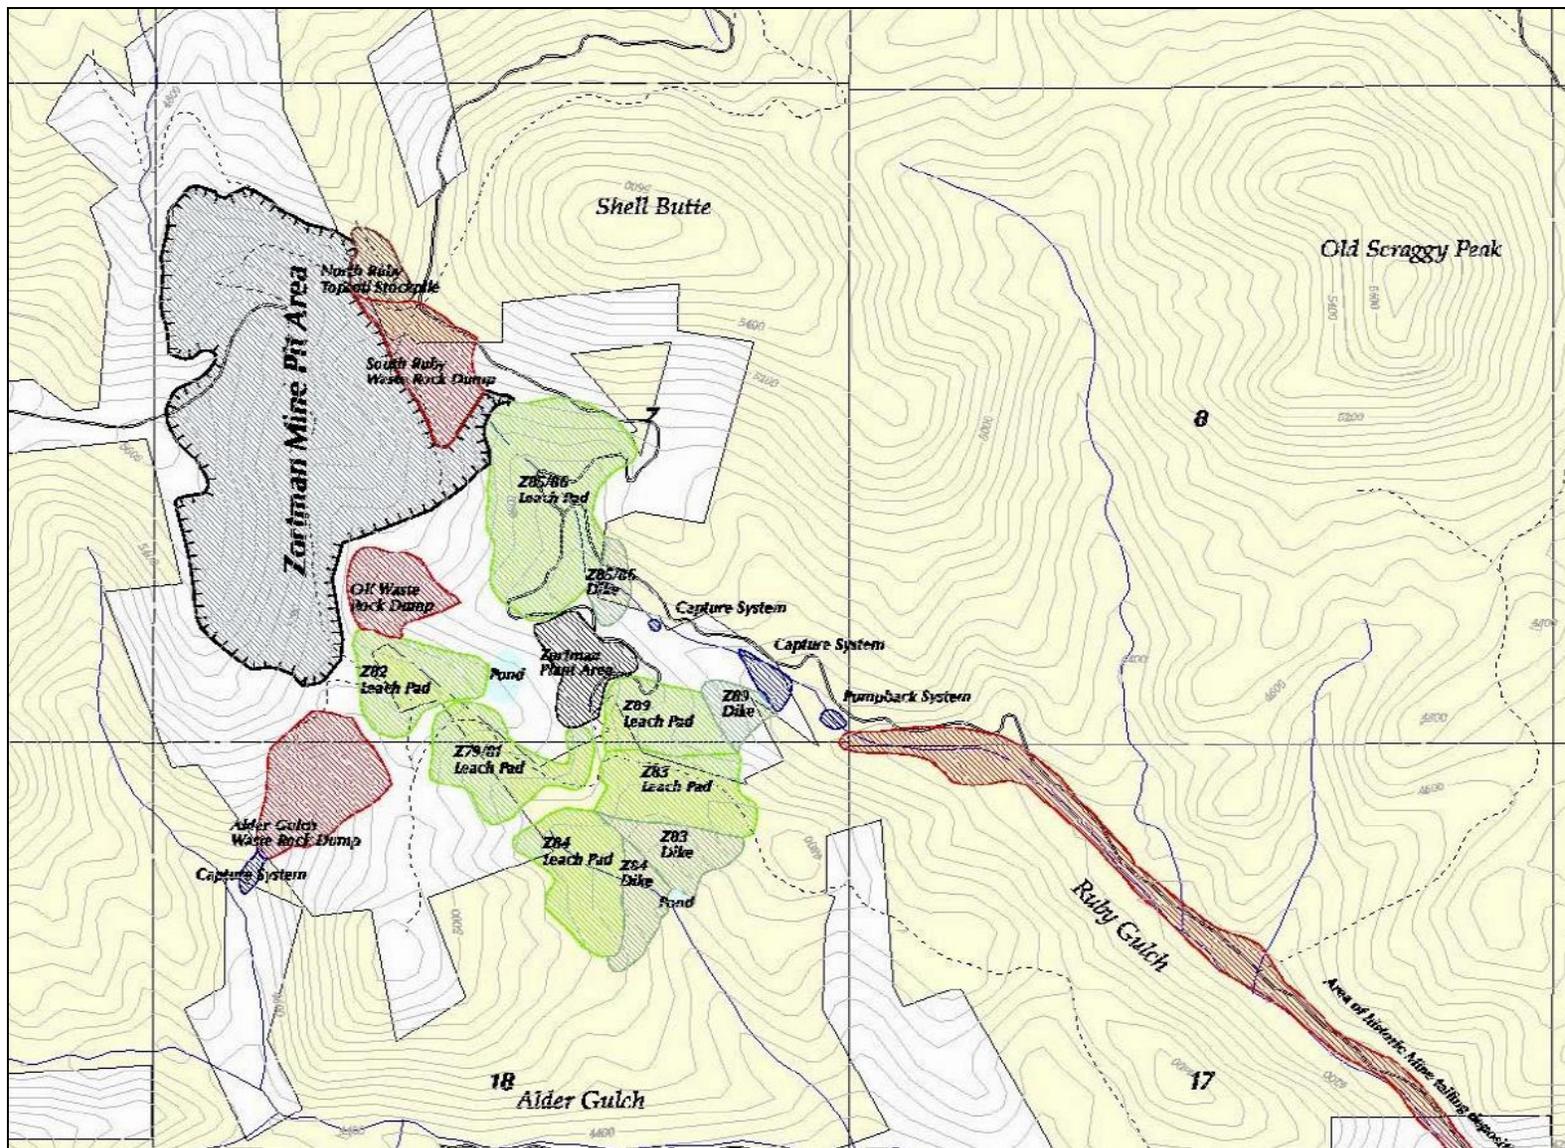
Figure A-16. Zortman Mine Facilities Map (Haight 2004).

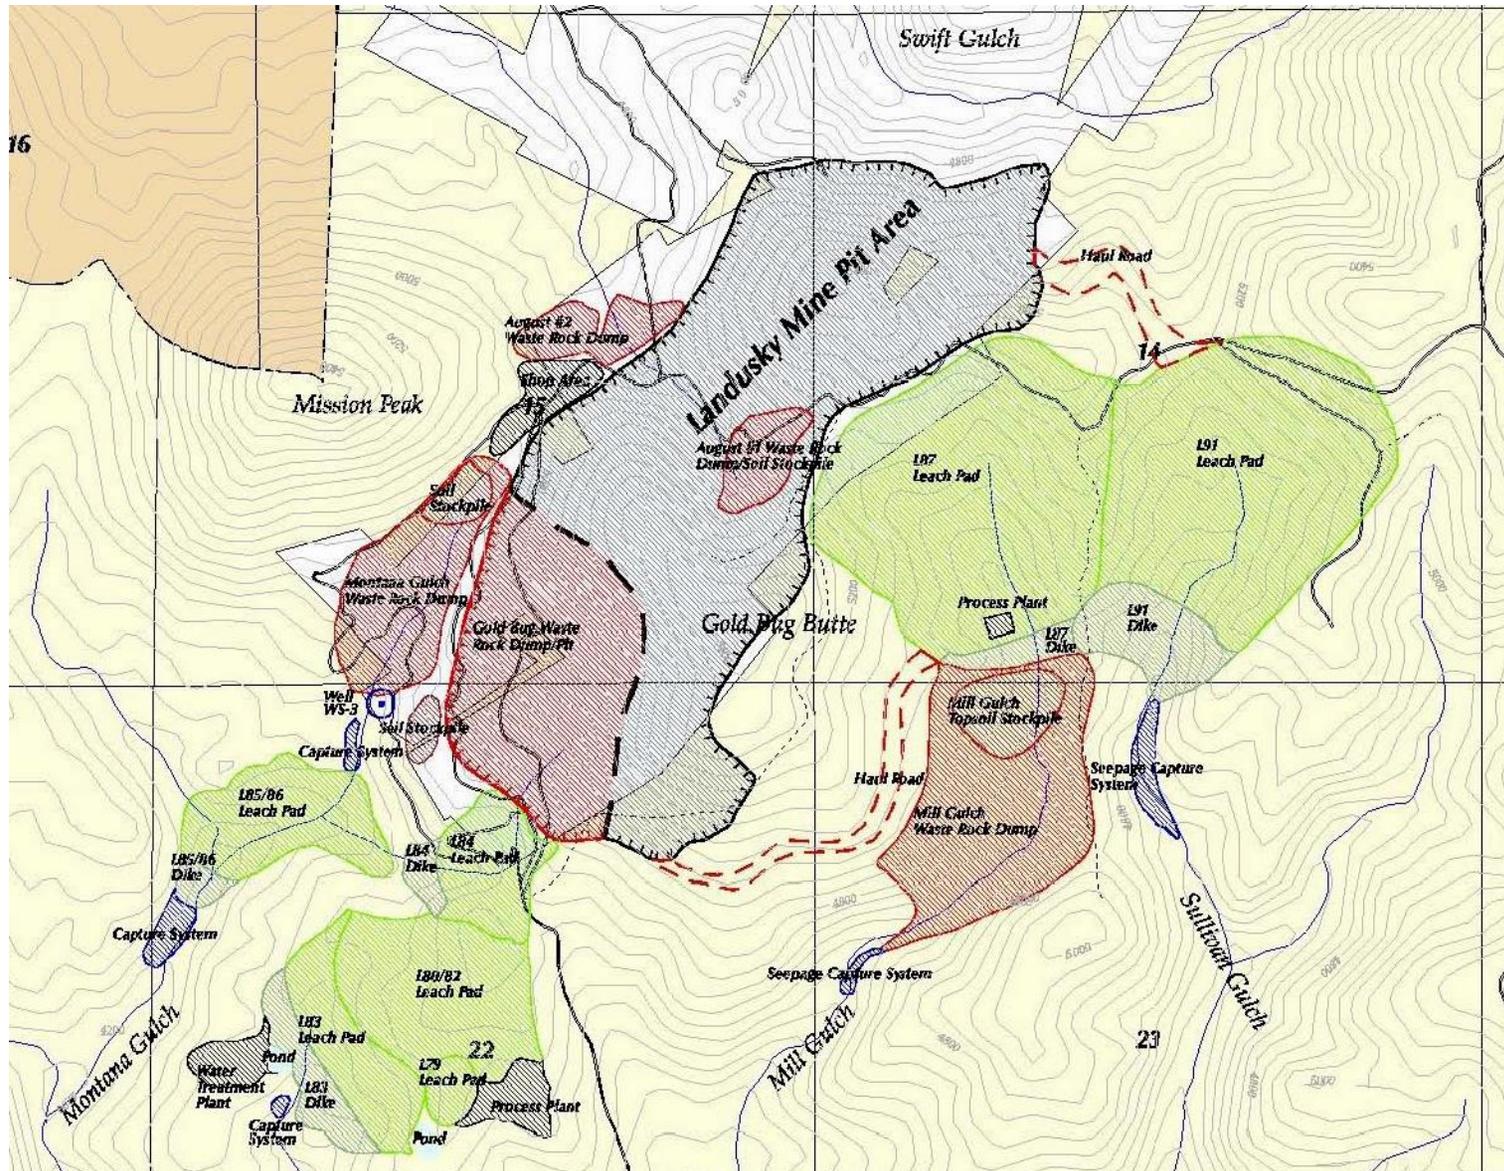
Figure A-17. Landusky Mine Facilities Map (Haight 2004).
