Landusky Metals Total Maximum Daily Loads and Framework Water Quality Improvement Plan

March 2012

Water Quality Planning Bureau
Watershed Management Section

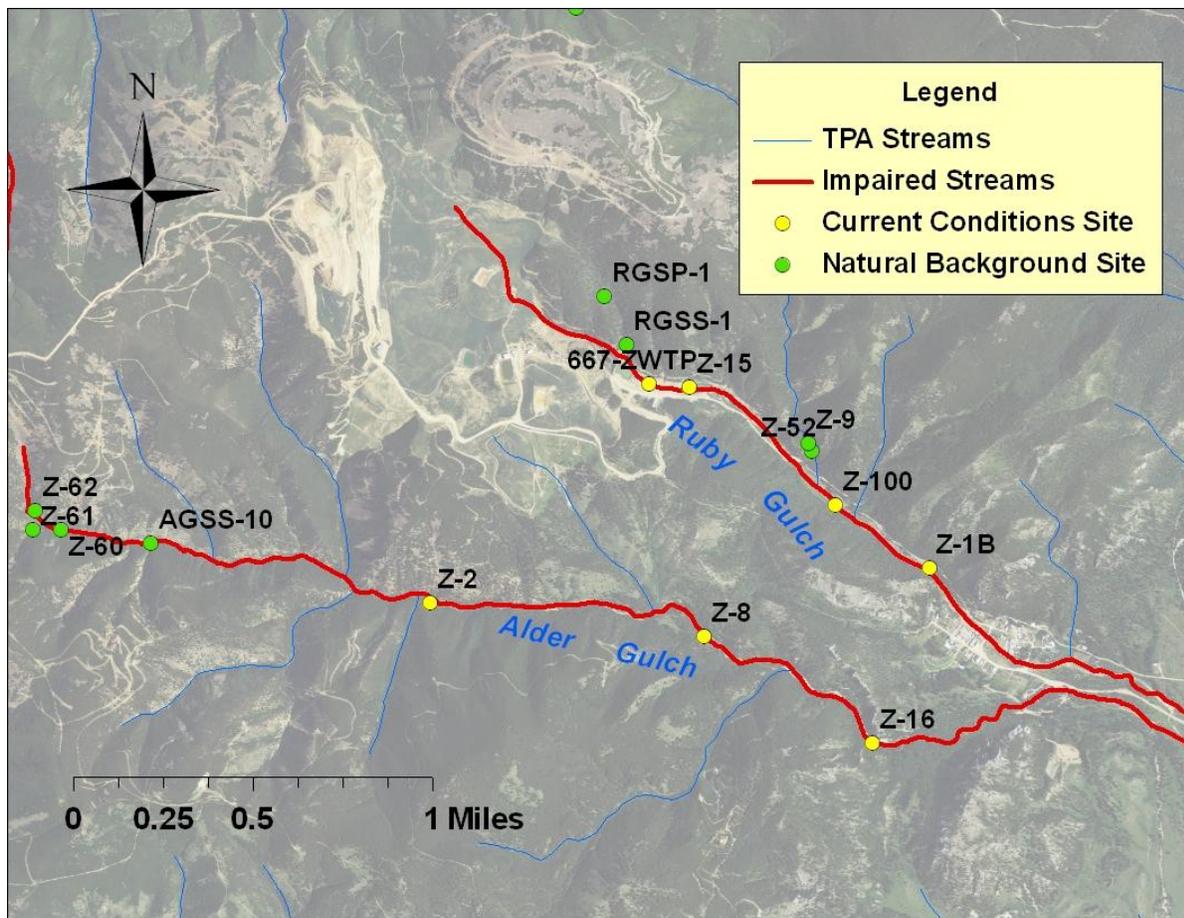
Figure F-1. Alder and Ruby gulches and locations of current condition and natural background sites.

Alder Gulch is listed as impaired in the 2010 Integrated Report (Montana Department of Environmental Quality, Water Quality Planning Bureau, 2010) for cadmium, copper, lead, mercury, selenium, zinc, and pH. The segment is classified as C-3 and extends for 4.04 miles from its headwaters to its confluence with Ruby Gulch. Current water quality conditions are represented by sites Z-2, Z-8, and Z-16 (**Figure F-1**.)

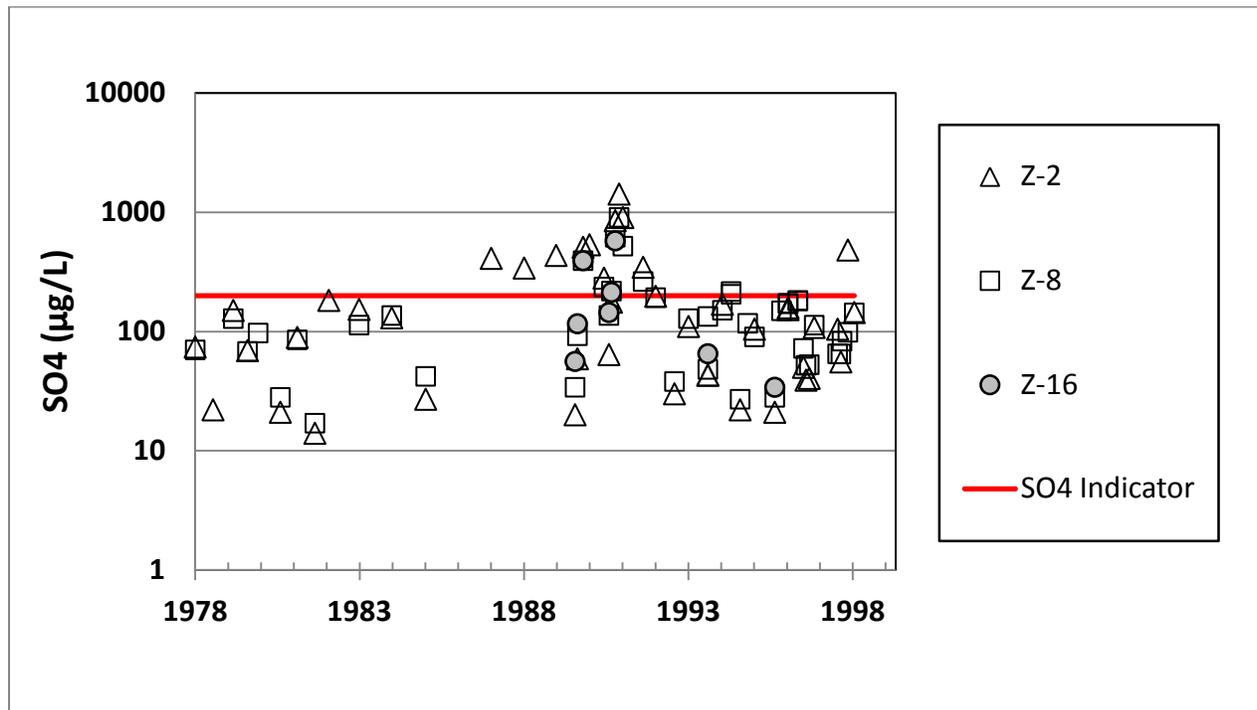
Figure F-2. Sulfate monitoring record for sites Z-2, Z-8, and Z-16 in Alder Gulch.

closer to the waste rock and leach pad sources. Sulfate concentrations in Alder Gulch indicate the effects of ARD.

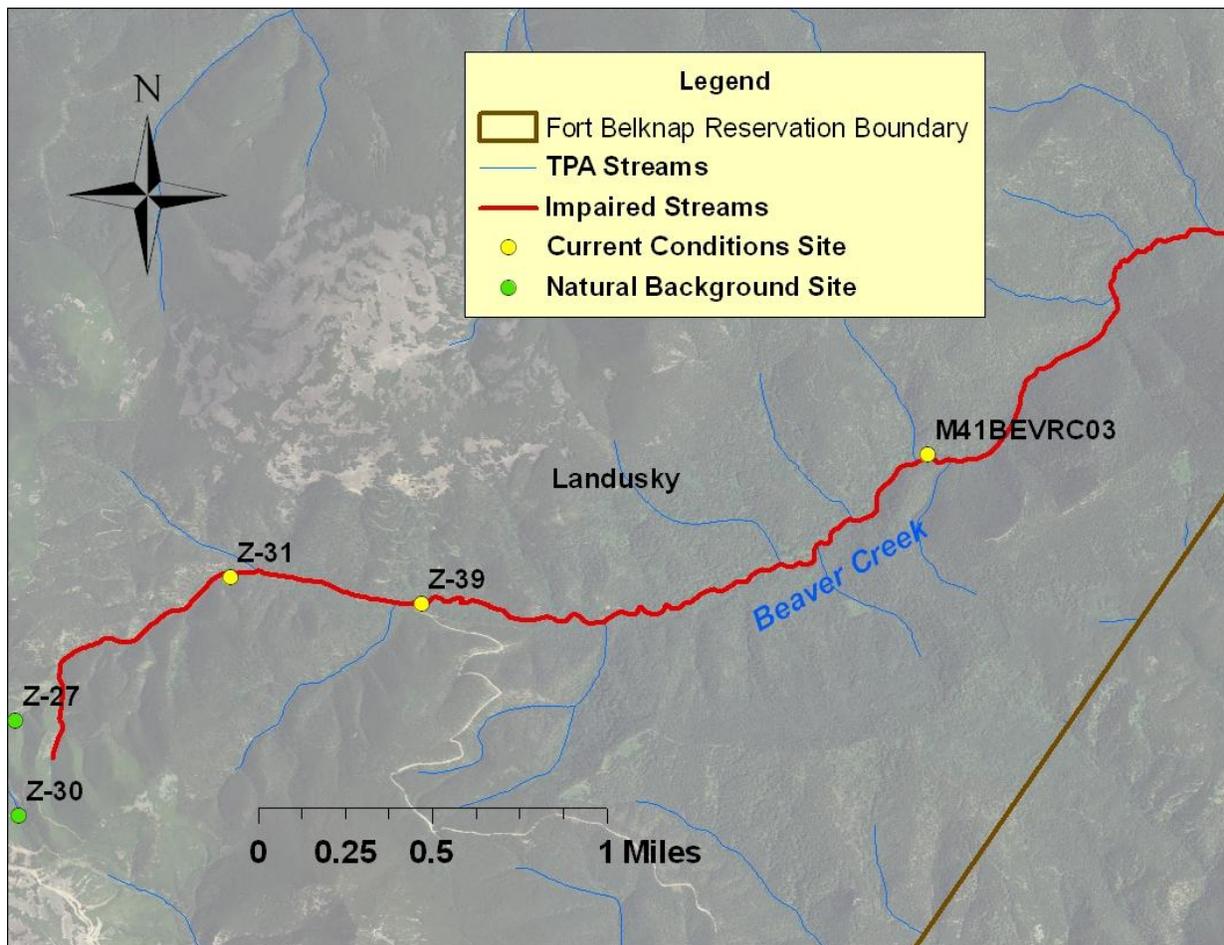
Figure F-3. Beaver Creek and the locations of current condition sites (Z-31, Z-39 and M41BVERC03) and natural background site Z-27

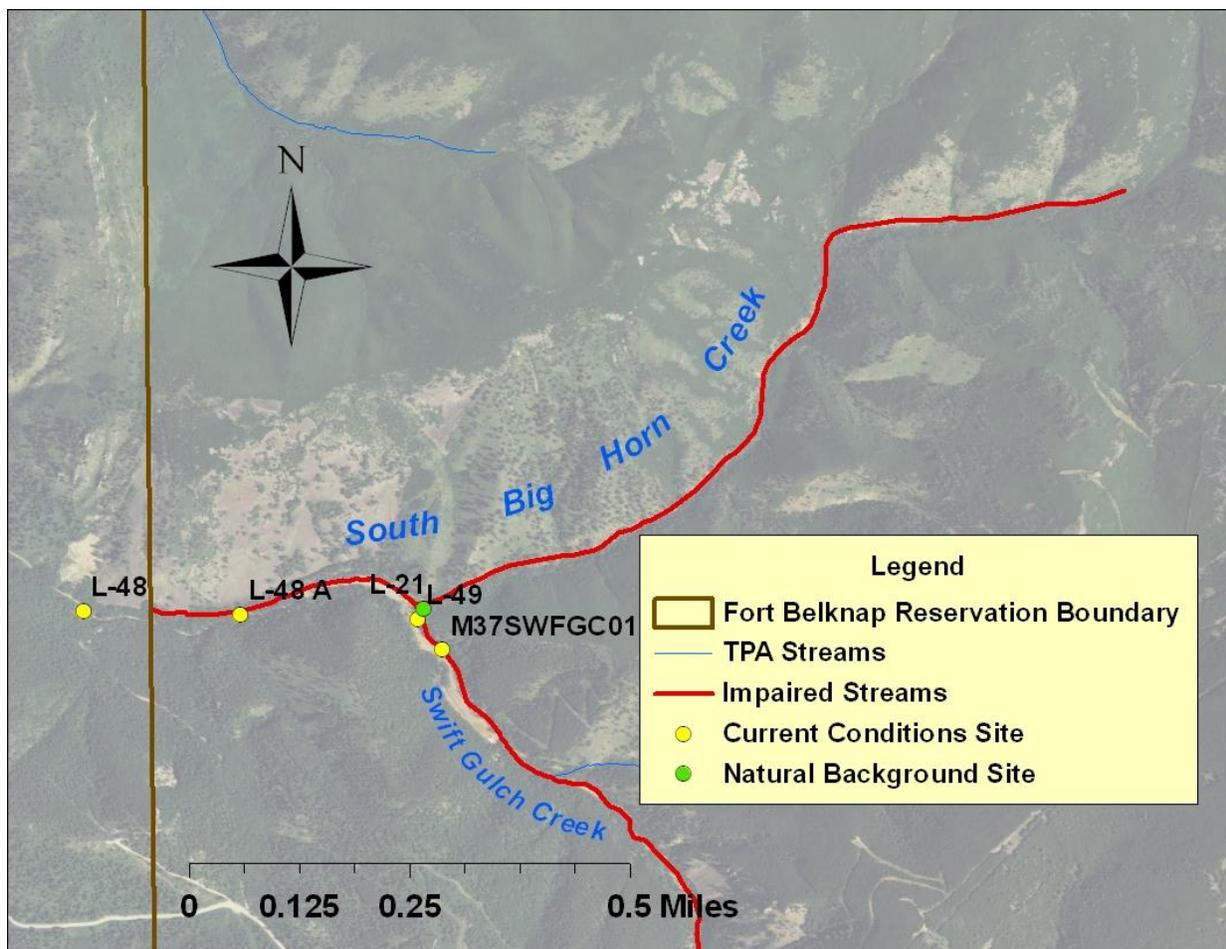
Figure F-4. South Big Horn Creek extending from the northeast, past the Swift Gulch Creek confluence, to the Fort Belknap Reservation boundary

South Big Horn Creek impairment causes in the 2010 Integrated Report included aluminum, arsenic, cadmium, nickel, and zinc. The segment is classified as B-1 and extends for 1.4 miles from its headwaters, westward to the Fort Belknap Reservation boundary. Current water quality conditions are represented by the records for sites L-48 and L-48A (**Figure F-4**). Site L-21 is located just upstream of the confluence with Swift Gulch Creek. Human-caused sources are not evident in the South Big Horn Creek drainage above the Swift Gulch Creek confluence. Therefore, site L-21 conceivably represents natural background conditions in South Big Horn Creek. Sites L-49 and M37SWFGC01 in **Figure F-4** are on Swift Gulch Creek.

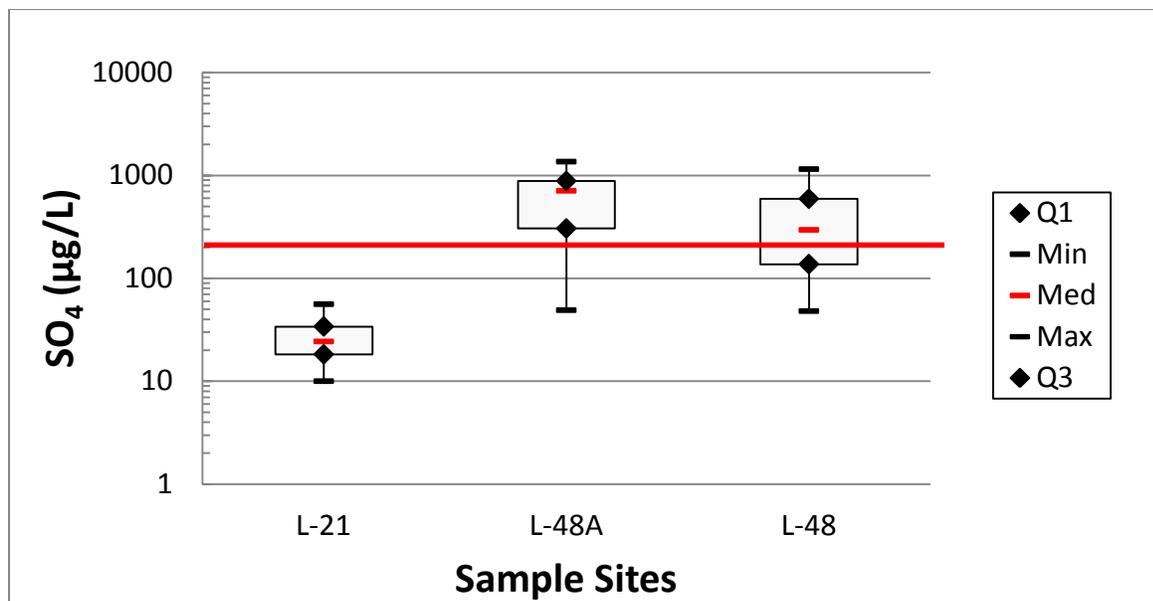
Figure F-5. Boxplot graph of sulfate data distributions for sites L-21 (background), L-48 and L-48A compared to the 200 $\mu\text{g/L}$ indicator value.

There are no macroinvertebrate metrics (MMI/RIVPACS) or sediment chemistry data available for South Big Horn Creek. **Figure F-5** shows the data distributions for sulfate at sites L-21, L-48, and L-48A.

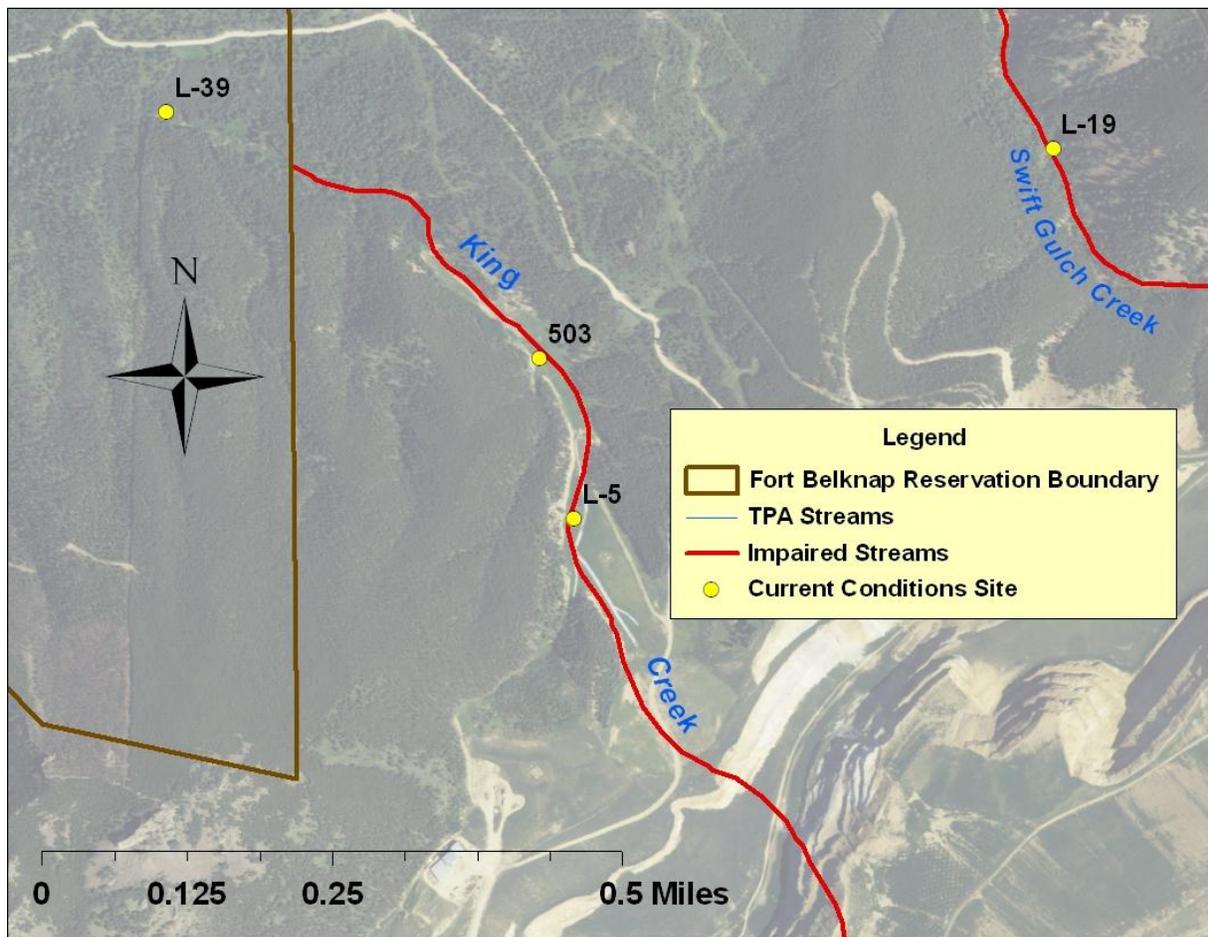
Figure F-6. King Creek and current condition sites extending from the August-Surprise-Queen Rose pit complex at the Landusky Mine to the Fort Belknap Reservation boundary

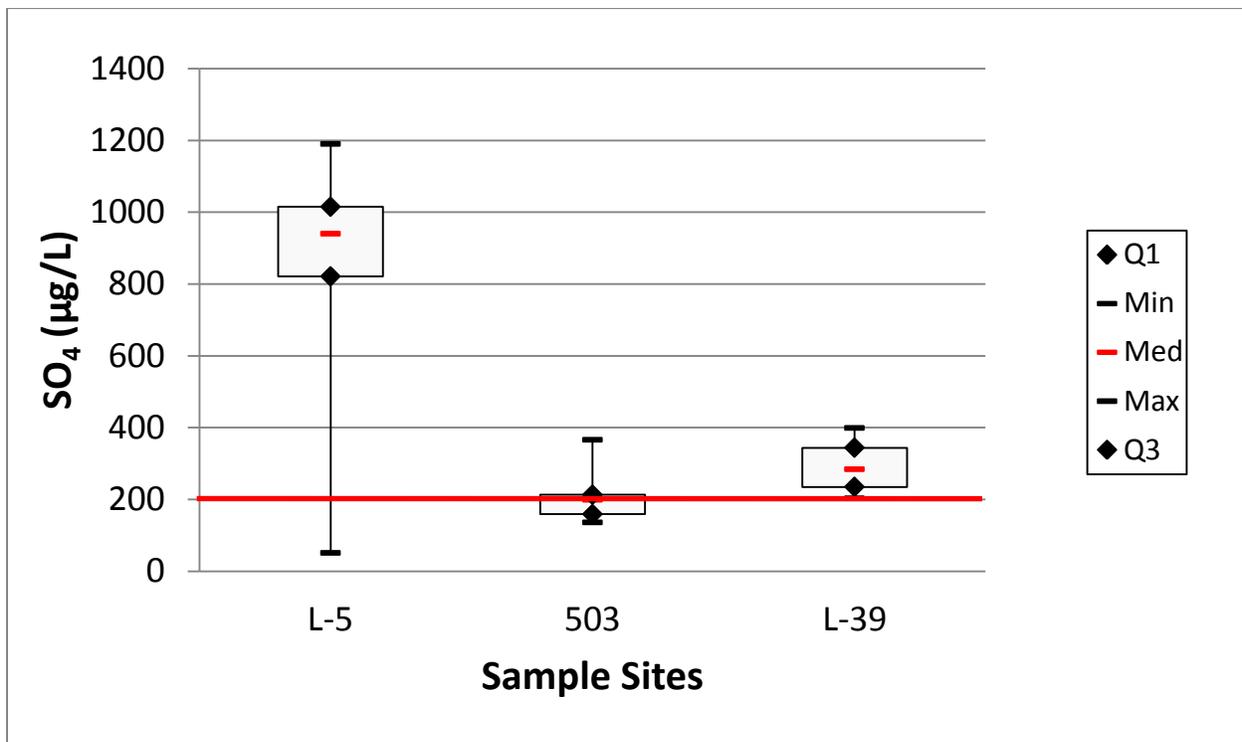
Figure F-7. Boxplot graph of sulfate data distributions at selected monitoring points compared to the 200 µg/L indicator value

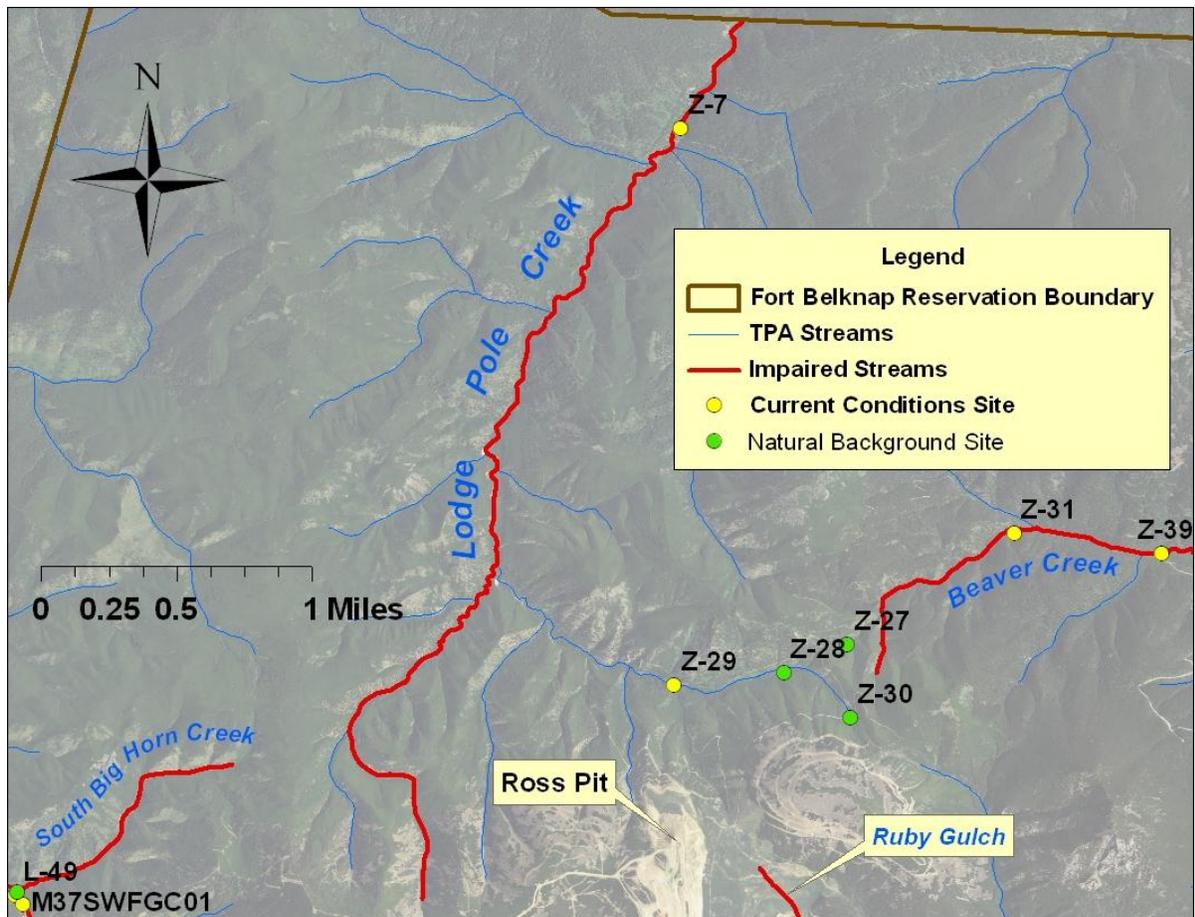
Figure F-8. Lodge Pole Creek extending from the northern edge of the Zortman Mine disturbance to the Fort Belknap Reservation boundary

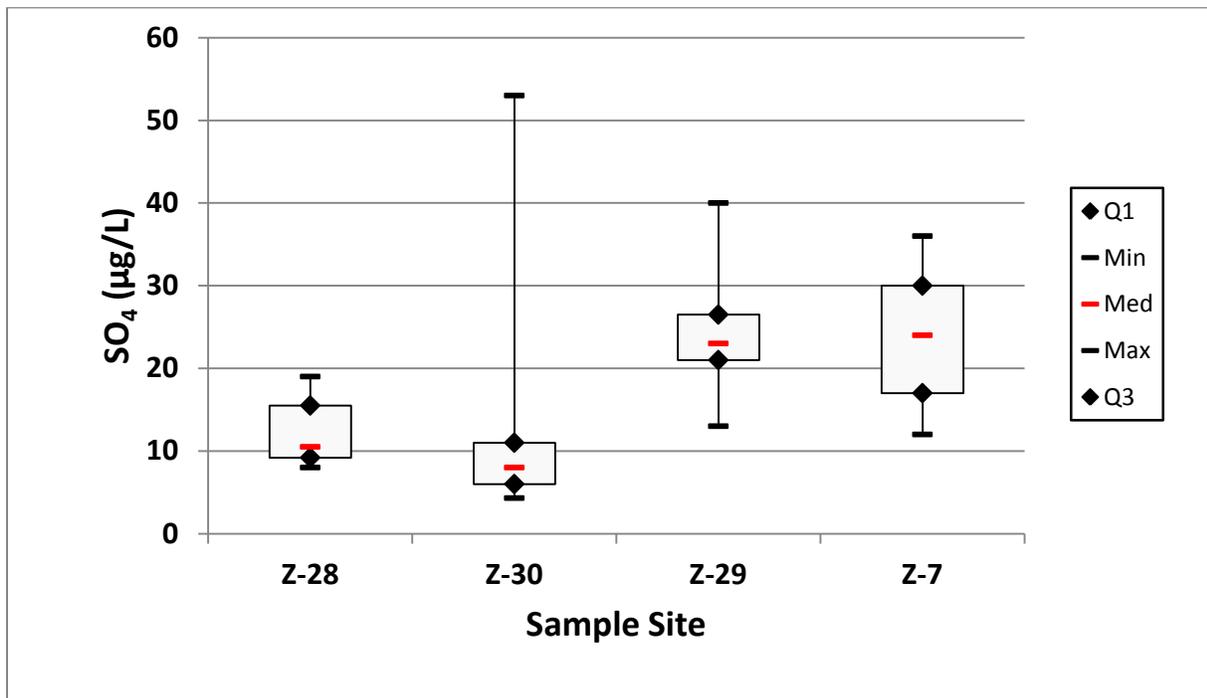
Figure F-9. Boxplot graph of sulfate data distributions at selected natural background sites (Z-28 & Z-30) and current condition sites (Z-29 & Z-7) on Lodge Pole Creek.

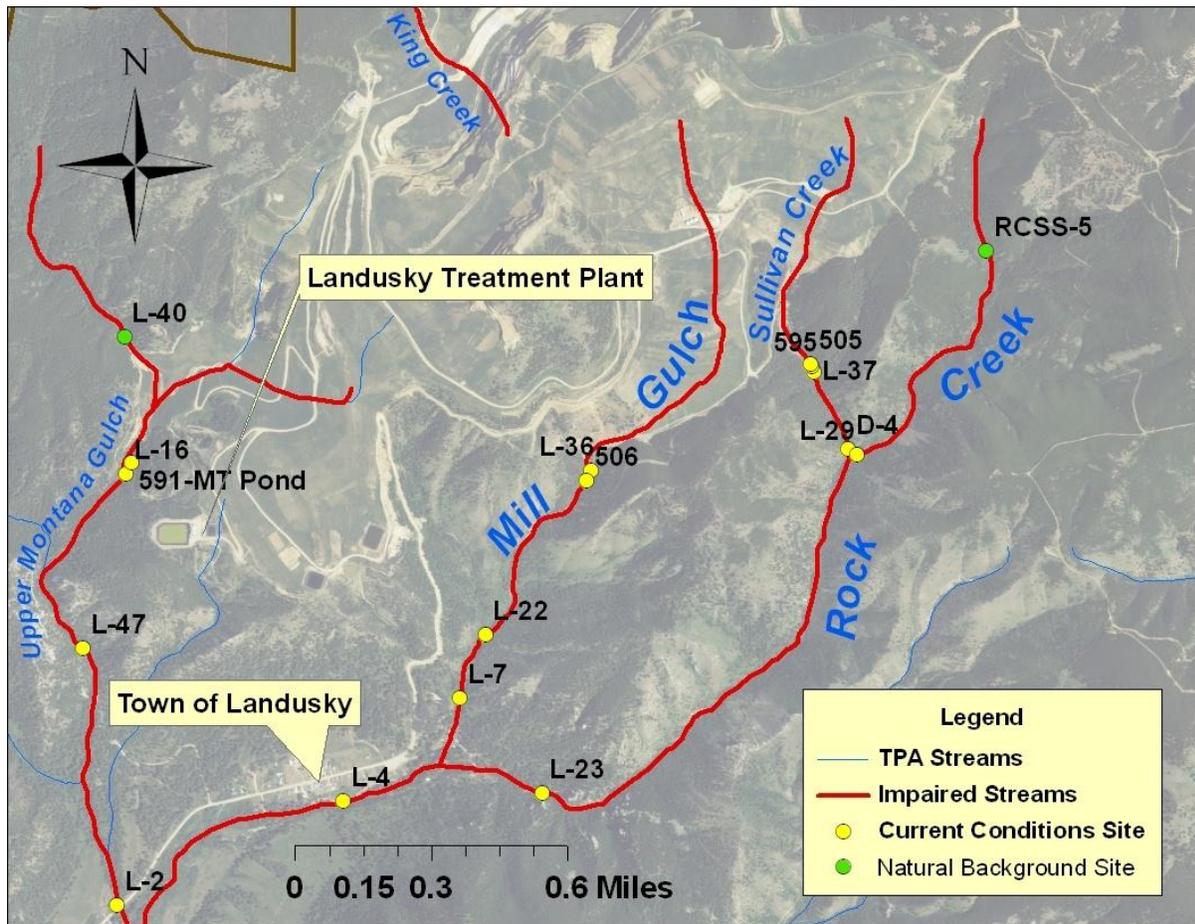
Figure F-10. Mill Gulch extending from the Landusky pit area, south, to its confluence with Rock Creek and existing condition sites L-36, 506, L-22, and L-7

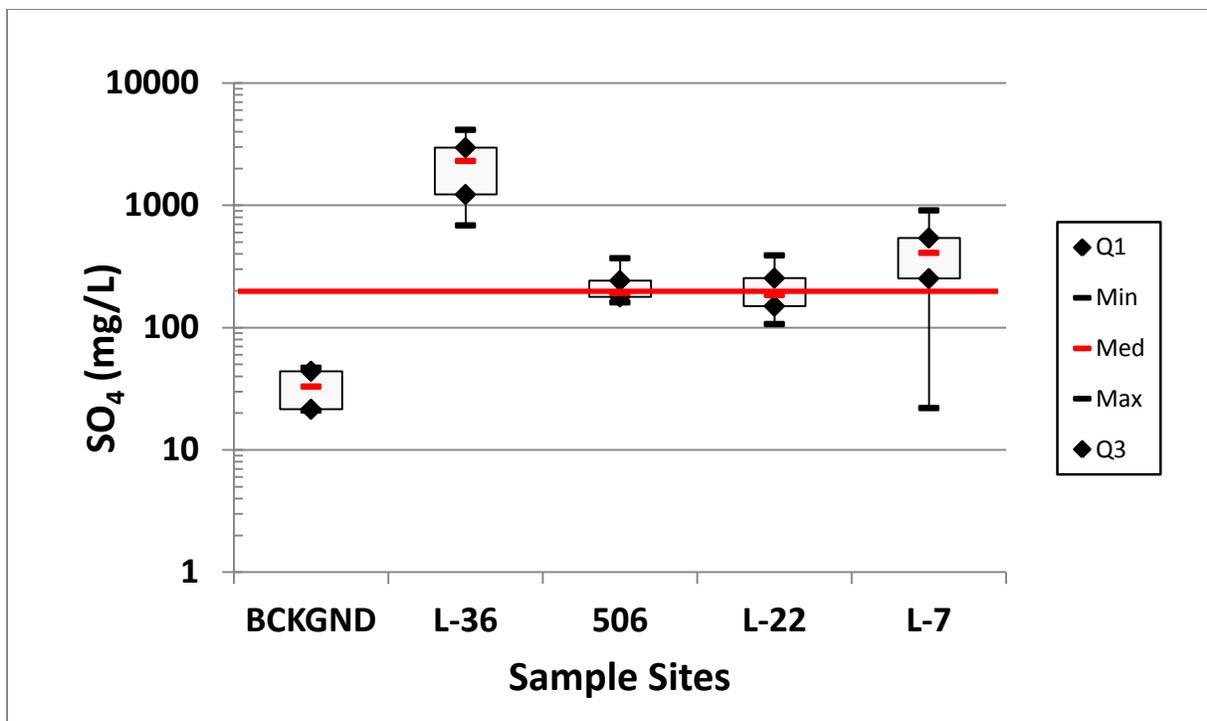
Figure 9-11. Boxplot graph of sulfate data distributions at selected natural background sites (L-40 & RCSS-5) and four current condition sites on Mill Gulch compared to the 200 mg/L indicator value.

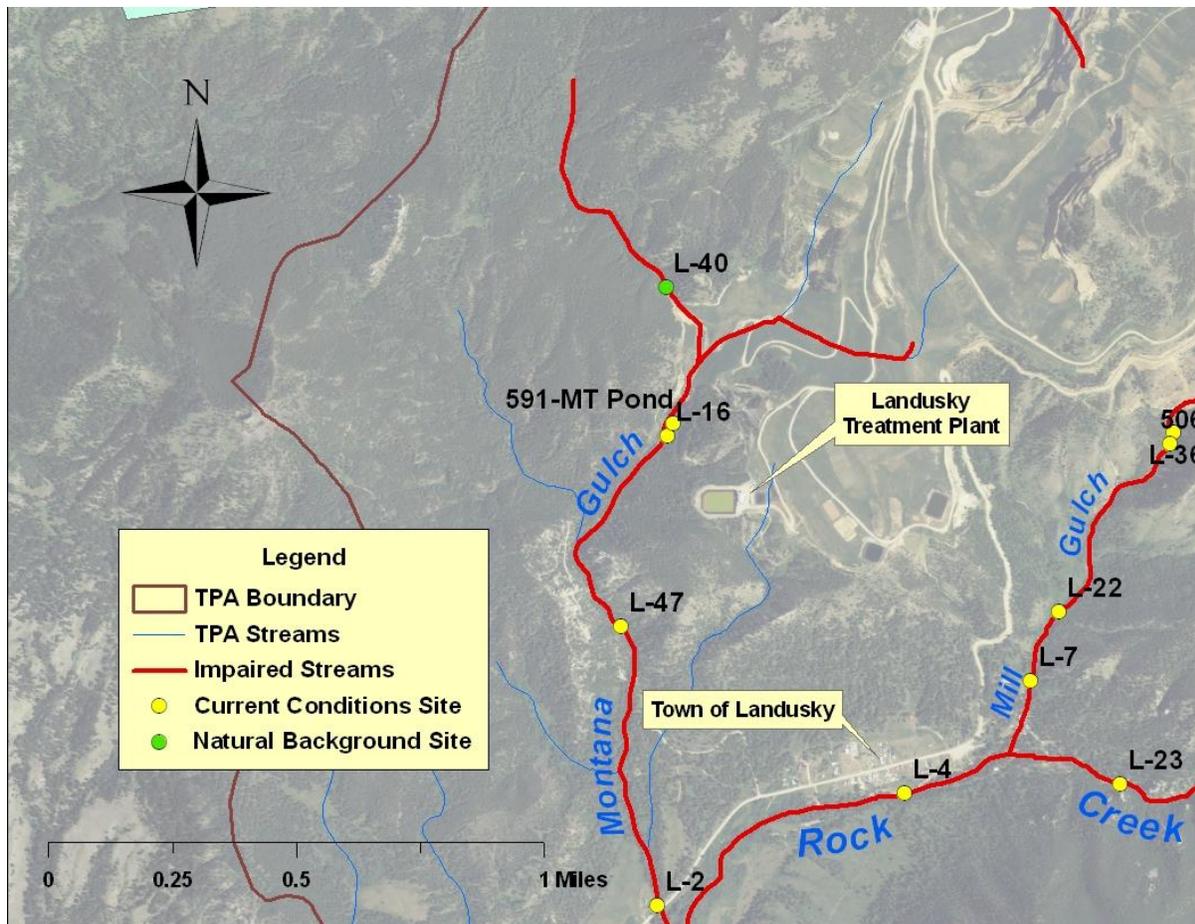
Figure F-12. Montana Gulch, natural background site L-40 and existing condition sites 591, L-16, L-47, and L-2

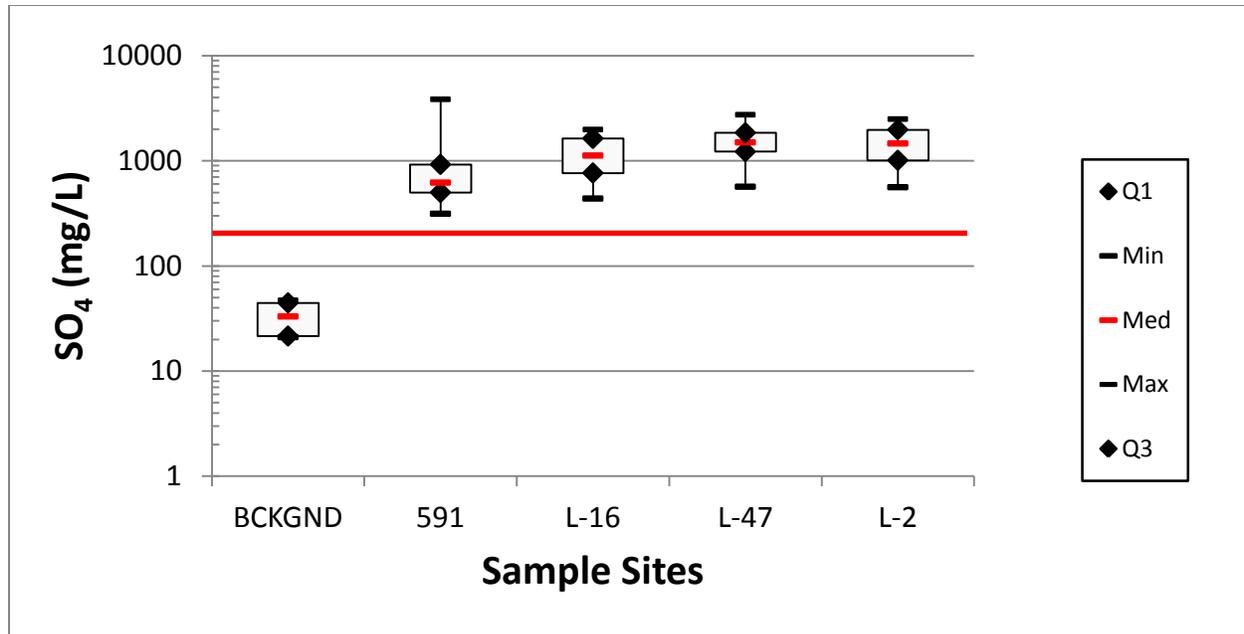
Figure F-13. Boxplot graph of sulfate data distributions at natural background and current condition sites on Montana Gulch compared to the 200 mg/L indicator value.

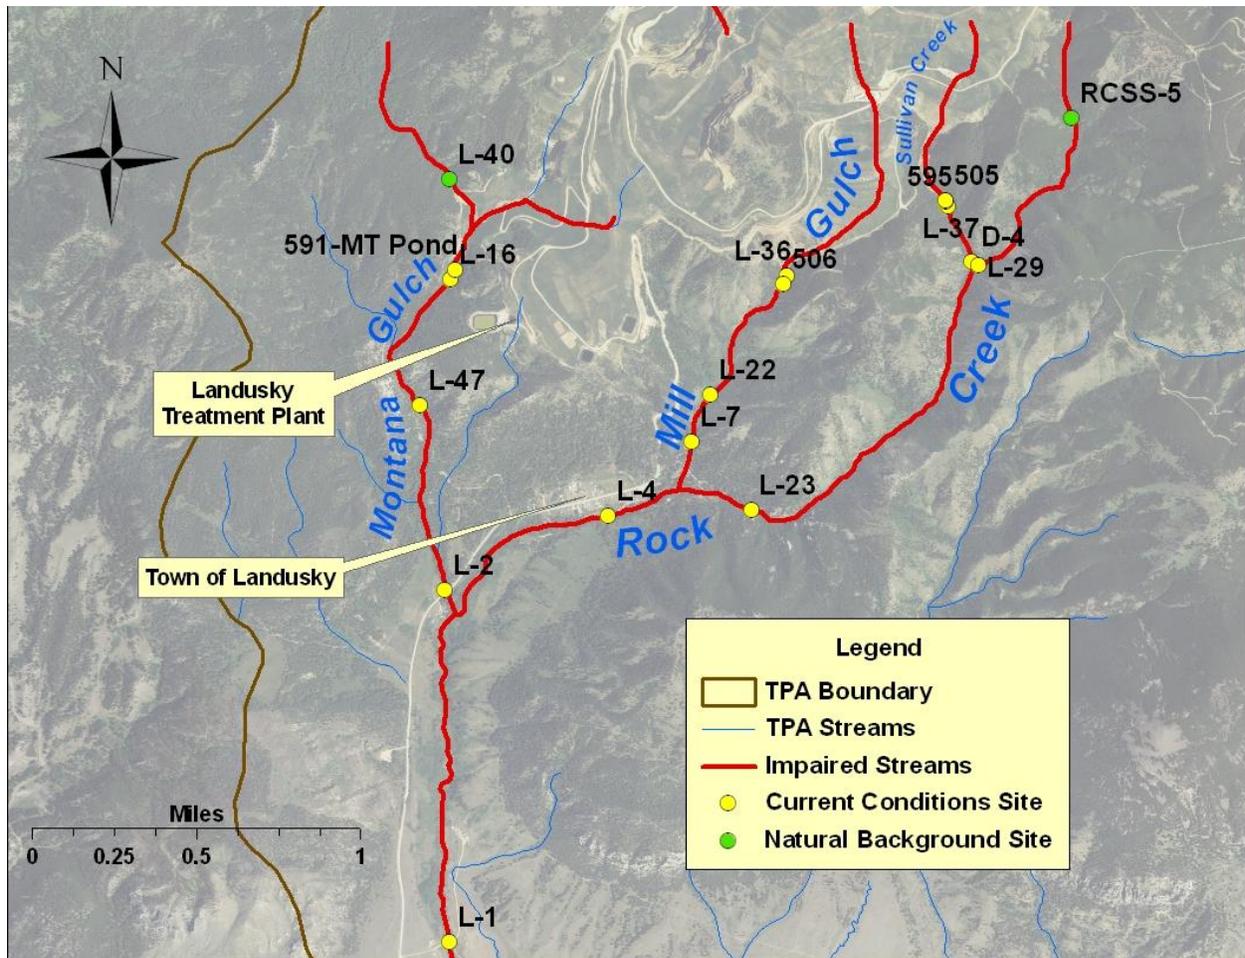
Figure F-14. Extent of Rock Creek, impaired tributaries (left to right) Montana Gulch, Mill Gulch, and Sullivan Creek, and selected water quality monitoring sites

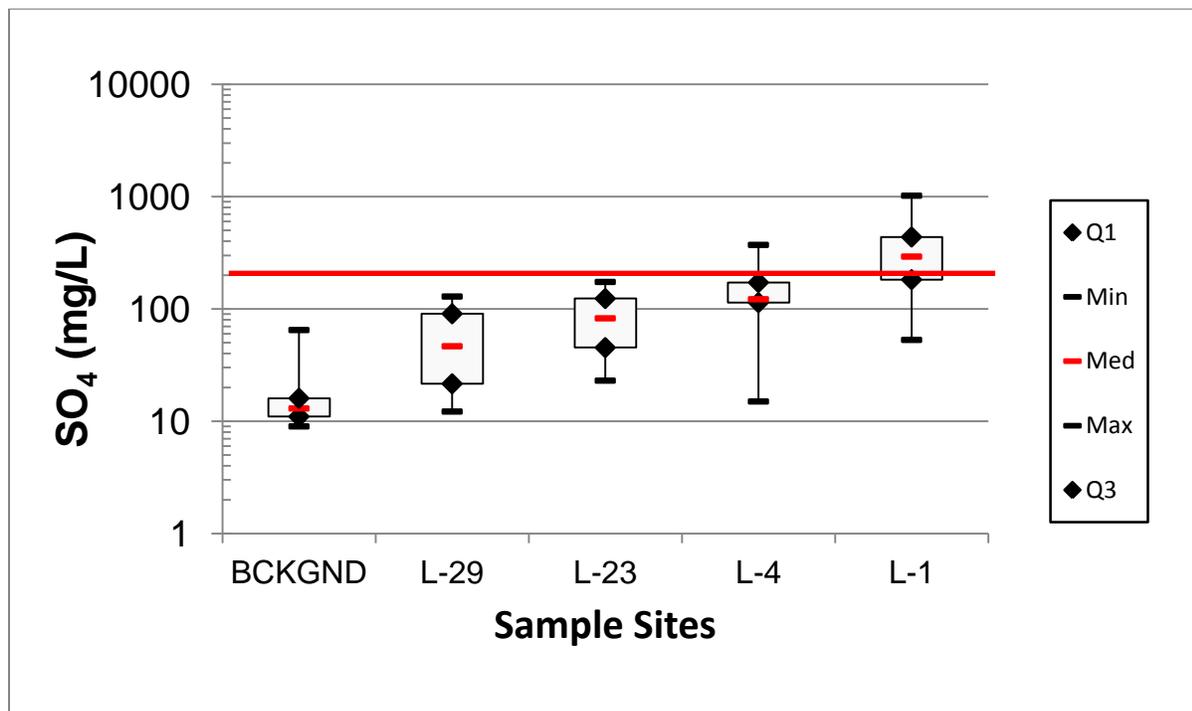
Figure 9-15. Boxplot graph of sulfate data distributions at selected natural background and current condition sites on Rock Creek compared to the 200 mg/L indicator value.

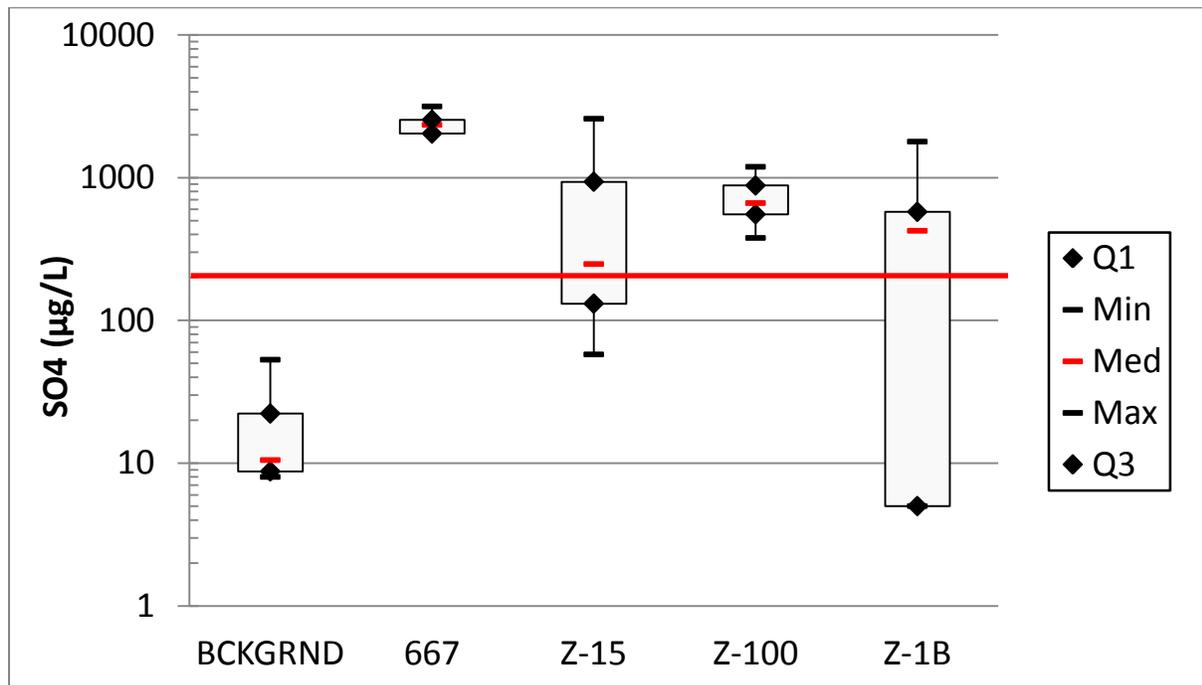
Figure F-16. Boxplot graph of Ruby Gulch sulfate concentration at sites 667, Z-15, Z-100, and Z-1B compared to background levels and the sulfate indicator value of 200 µg/L

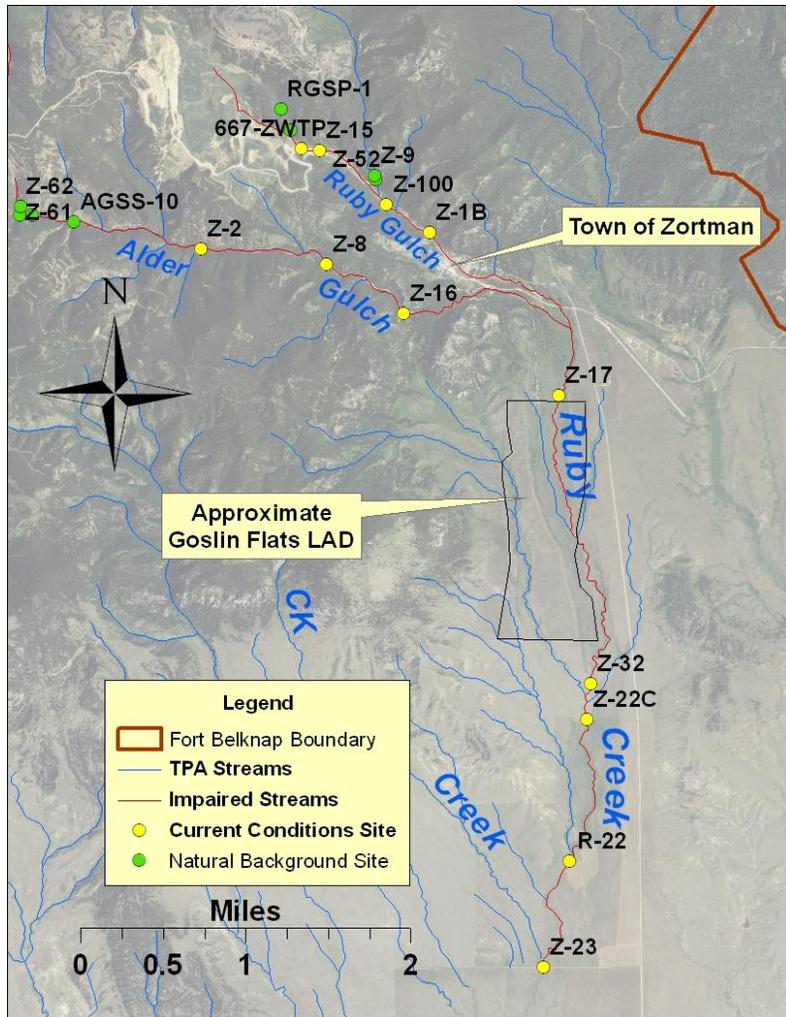
Figure F-17. The Ruby Creek drainage with locations of monitoring sites and Goslin Flats land application disposal (LAD) area.

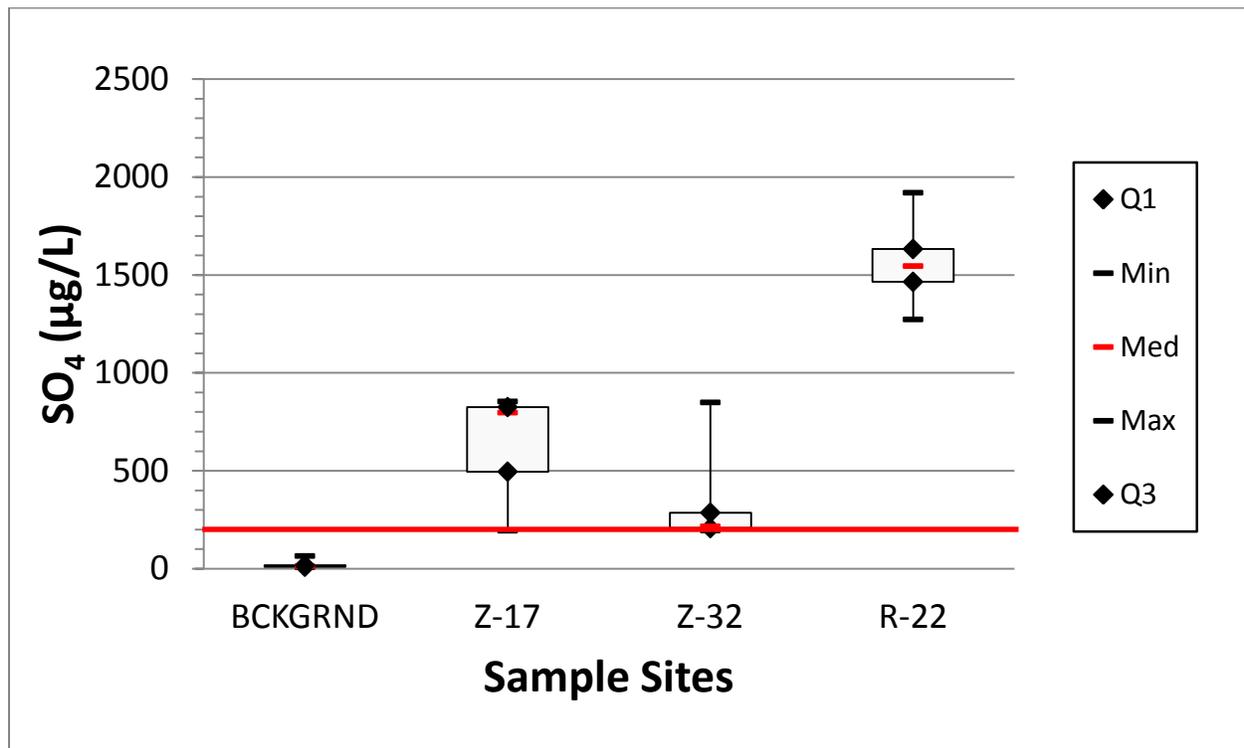
Figure F-18. Boxplot graph of Ruby Creek sulfate concentration at sites Z-17, Z-32, and R-22 compared to background levels and the sulfate indicator value of 200 $\mu\text{g/L}$

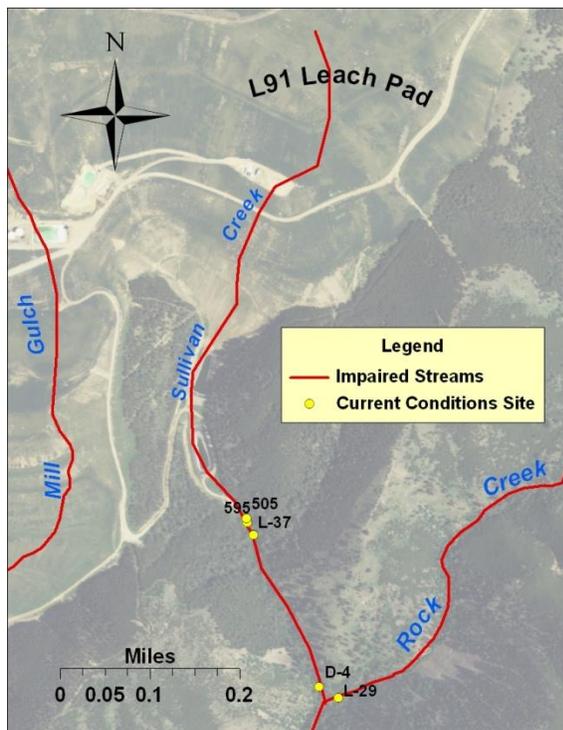
Figure F-19. Sullivan Creek (center), and current condition sites 505, 595, L-37, and D-4

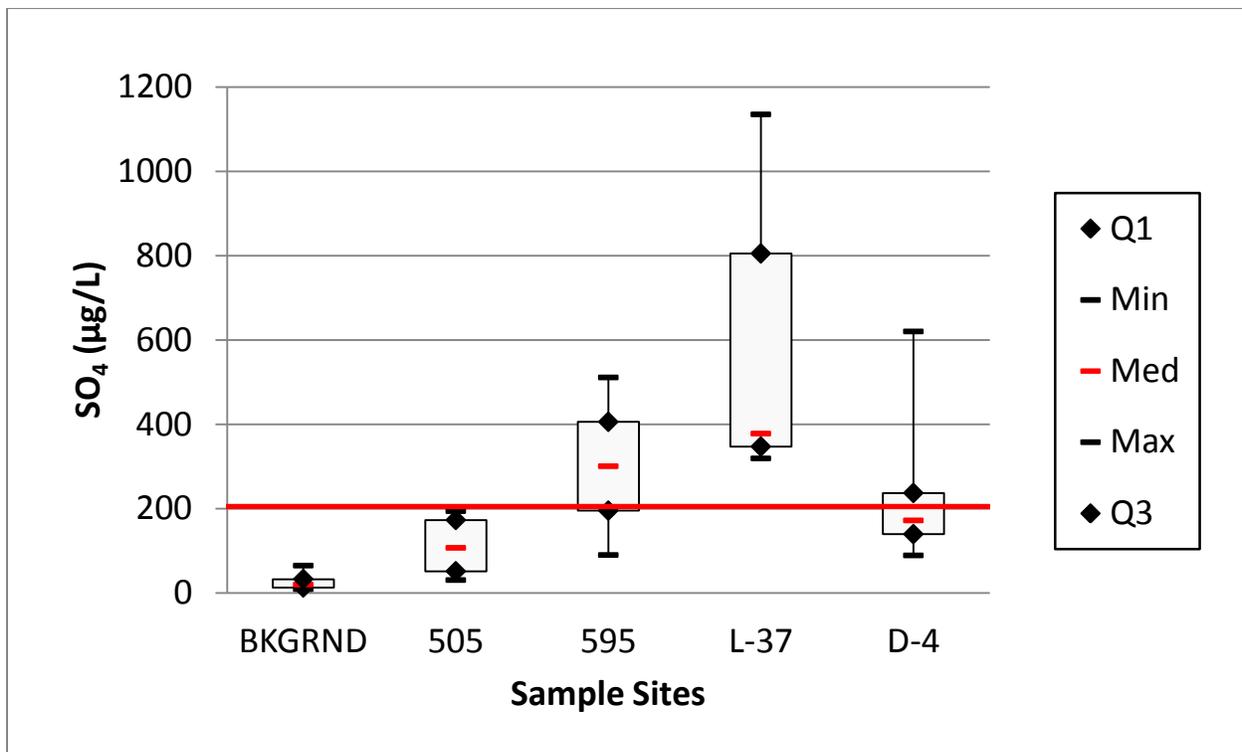
Figure F-20. Boxplots of sulfate data distributions for current condition sites and combined background sites for Sullivan Creek

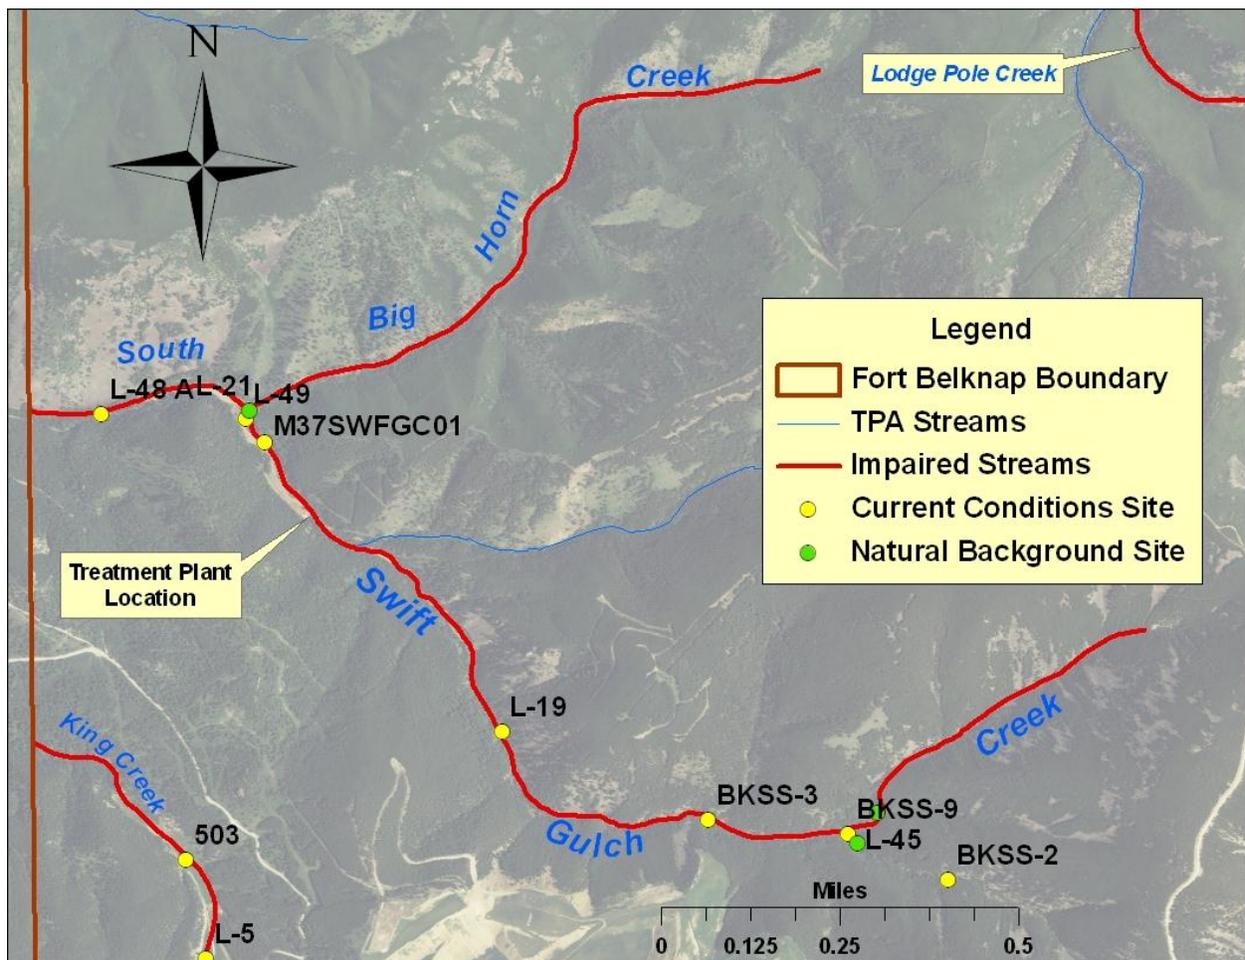
Figure F-21. Swift Gulch Creek and locations of current condition sites BKSS-2, BKSS-3, BKSS-9, L-19, L-49, and M37SWFGC01, and natural background sites L-21, L-41, and L-45.

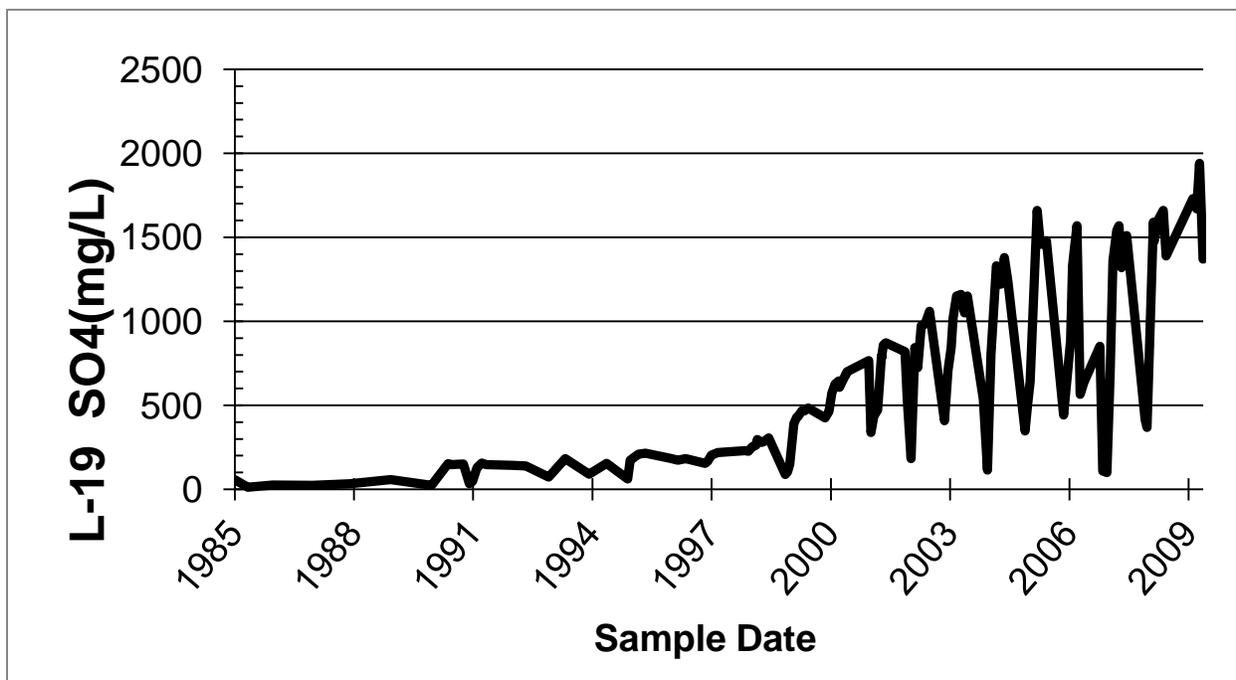
Figure F-22. Sulfate concentration in Swift Gulch Creek surface water at site L-19
