ATTACHMENT B – MEMORANDUM TO FWP FROM APPLIED GEOMORPHOLOGY IN REGARDS TO THE CLARK CANYON CREEK FIELD VISIT, SEPTEMBER 13, 2011

MEMORANDUM

To: Matt Jaeger, Montana Fish, Wildlife and Parks
From: Karin Boyd, Applied Geomorphology, Inc.
Date: September 13, 2011
In Regards To: Clark Canyon Creek Field Visit

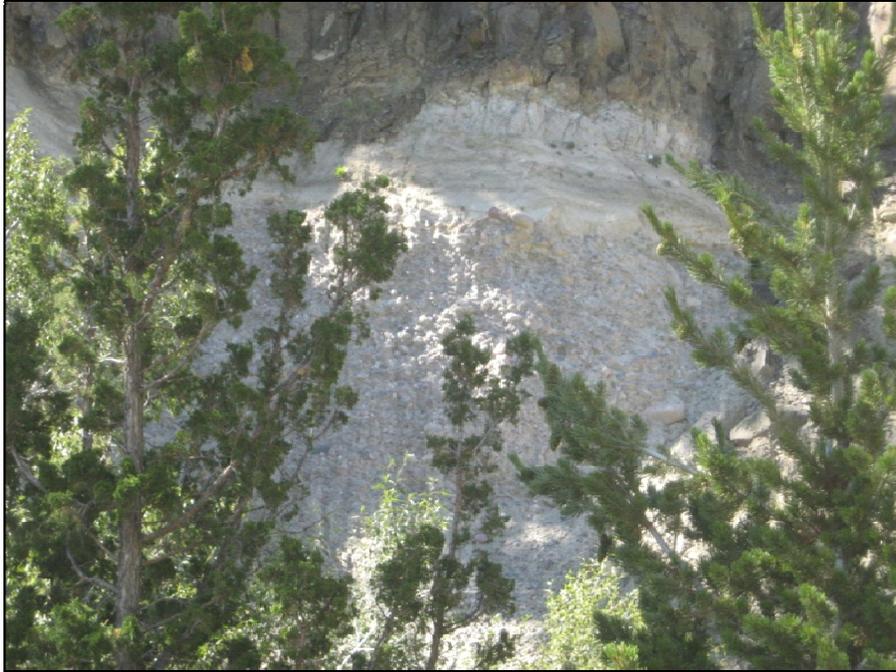
Figure 3. South valley wall of Clark Canyon Creek showing coarse fanglomerate overlain by a basalt cap.

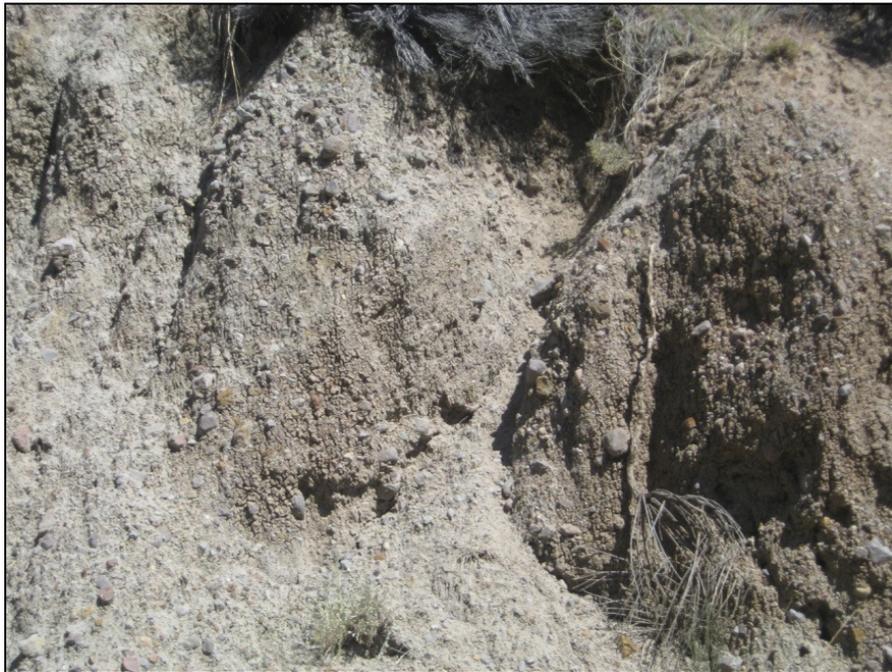
Figure 4. Landslide/debris flow deposits exposed near confluence of North and South Forks of Clark Canyon Creek.

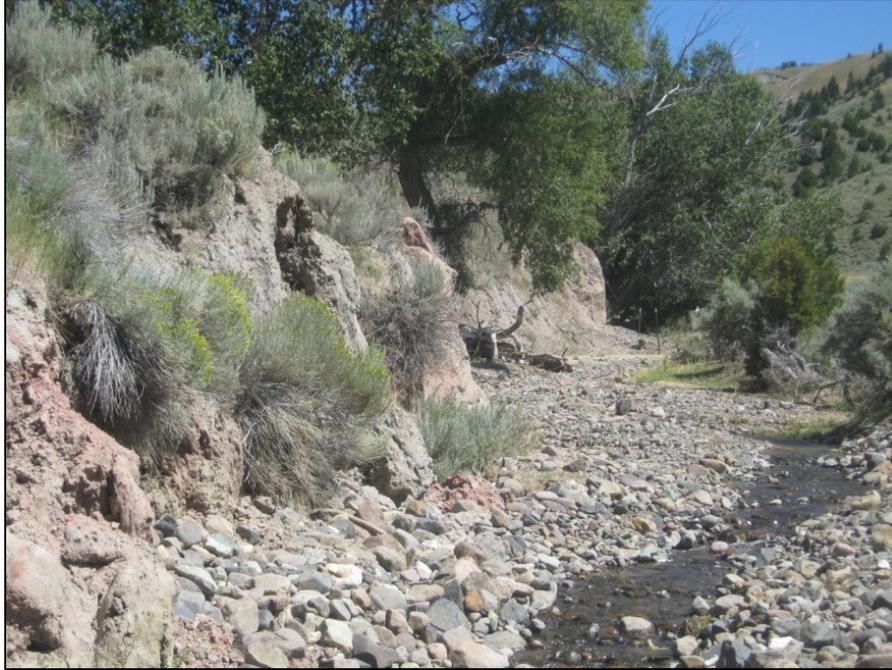
Figure 5. View upstream of North Fork of Clark Canyon Creek showing exposure of massive fine grained volcanic unit in valley wall.

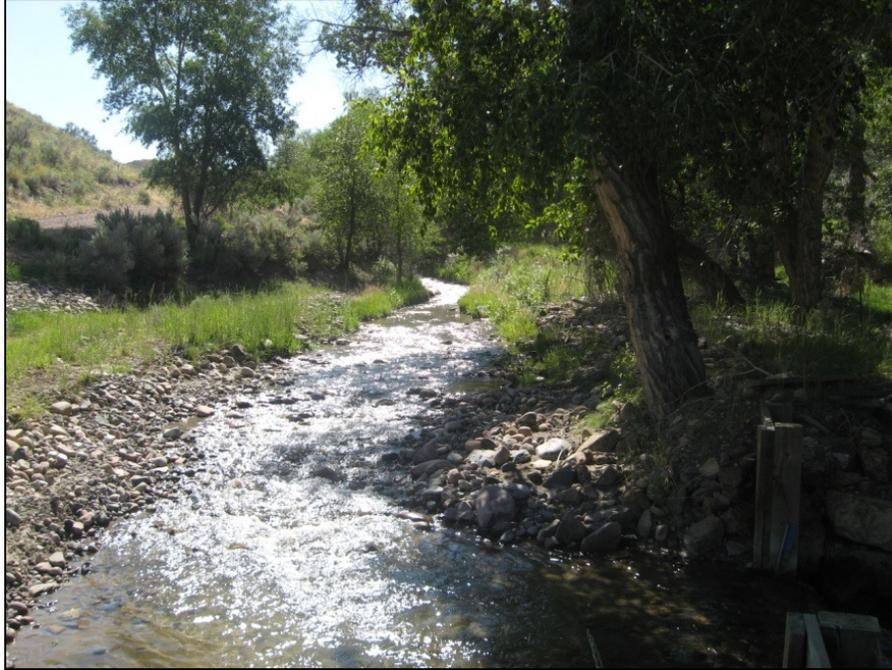
Figure 7. View upstream of the mainstem of Clark Canyon Creek showing coarse substrate, road bed, and woody vegetation corridor. Photo is taken from recently maintained diversion structure.

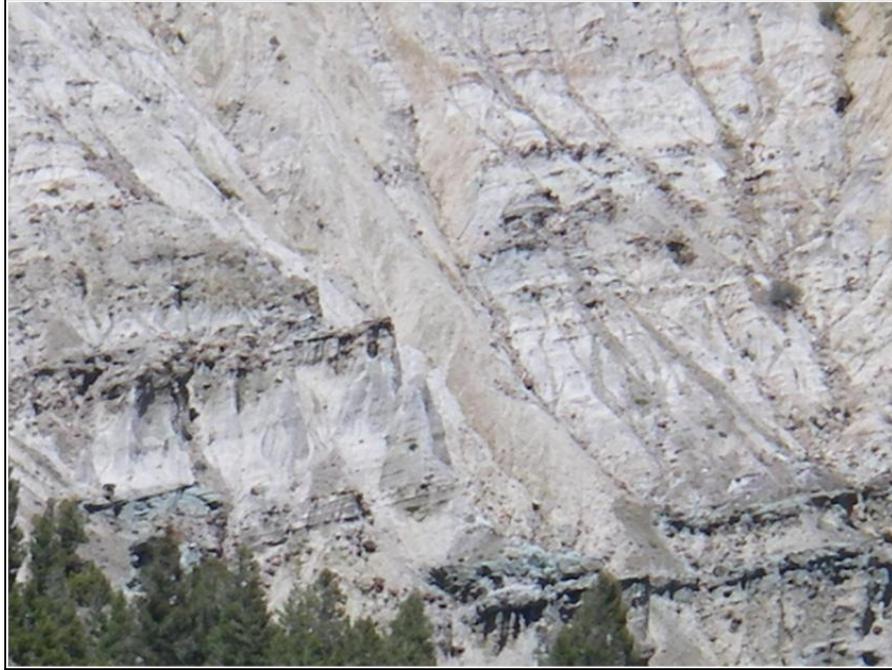
Figure 9. Exposure of Tertiary volcanics in North Fork Clark Canyon Creek (Matt Jaeger).

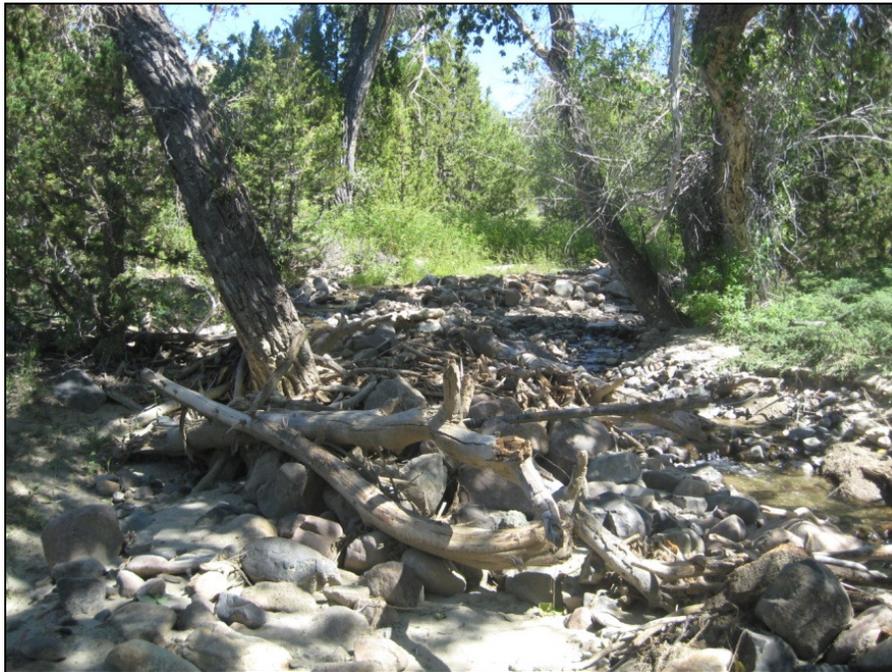
Figure 10. View upstream of North Fork Clark Canyon Creek showing coarse debris flow deposits.

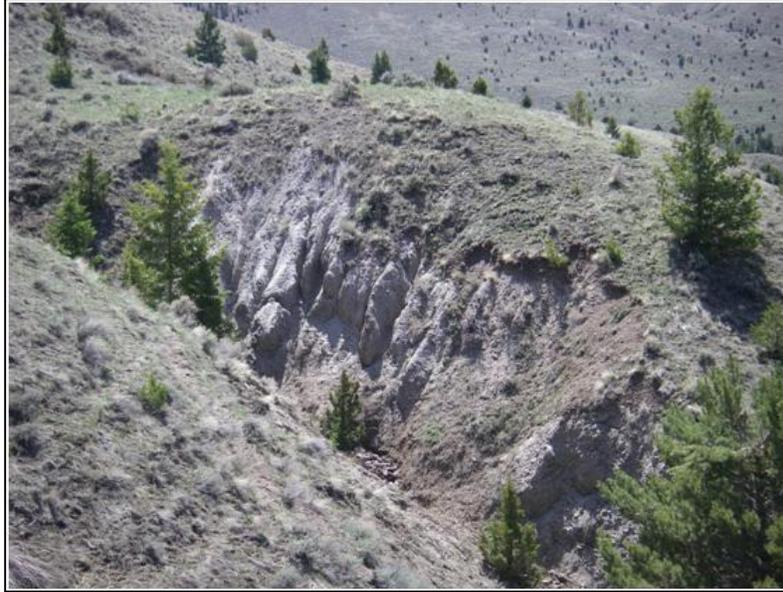
The north side of the Clark Canyon Creek watershed is dissected by numerous ephemeral channels that appear capable of producing large volumes of fine sediment during high runoff events (Figure 11). A potentially appropriate sediment control measure for these areas is grade stabilization structures that form check dams, commonly referred to as “gully plugs”. These structural measures may be built out of woven-wire, brushwood, logs, logs stone, and boulders; they are typically temporary and used to facilitate the growth of permanent vegetative cover (www.fao.org/forestry). If these treatments are further considered, it would be appropriate to map all major point sources of sediment from such drainages, and survey the drainage to assess the size and number of structural features that would be necessary. One challenge with these features is the potential for plug failure and rapid delivery of sediment slugs downstream.

Figure 11. Gully formation in volcanic rock units (Matt Jaeger).

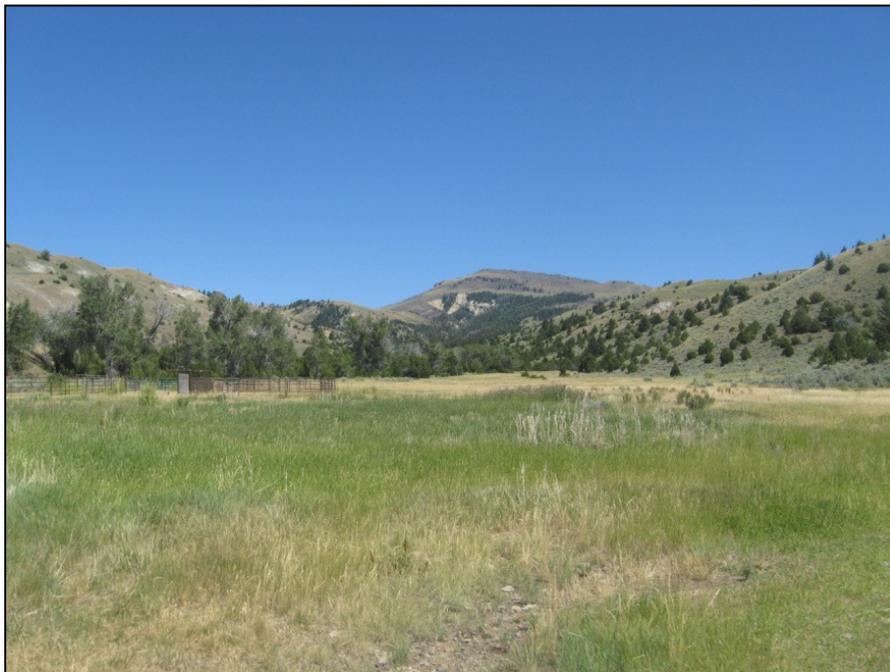
Based on observations made during the field reconnaissance, it appears that the most practical location to consider floodplain sediment storage is in the lowermost section of the North Fork Clark Canyon Creek, just upstream from the gravel road crossing over the North Fork (Figure 13 and Figure 14). This area currently consists of a broad fan-shaped depositional surface that has old spreader dikes, indicating historic irrigation practices. Possible sediment measures on the surface would include managed high flow dispersal into an alluvial fan environment, or potentially dispersal into stepped depressional wetlands. It is not clear as to whether this landform is a deactivated alluvial fan, however the high sediment loads and valley bottom widening in this area suggest that this feature was historically an alluvial fan. No distinct abandoned channel features are visible on

Figure 13. View upstream of lower North Fork Clark Canyon Creek showing potential overflow area.

The activation of alluvial fan depositional processes at the mouth of North Fork Clark Canyon Creek would require engineering design to assess overall trap efficiency of the surface, and to design outflow points and return flow points. Special attention would have to be paid to the road crossing on the downstream end of the fan, as strategically-placed culverts may be necessary to convey flow towards the South Fork Canyon Creek confluence.
