# Bitterroot Temperature and Tributary Sediment Total Maximum Daily Loads and Framework Water Quality Improvement Plan

**August 17, 2011**

Water Quality Planning Bureau  
Watershed Management Section

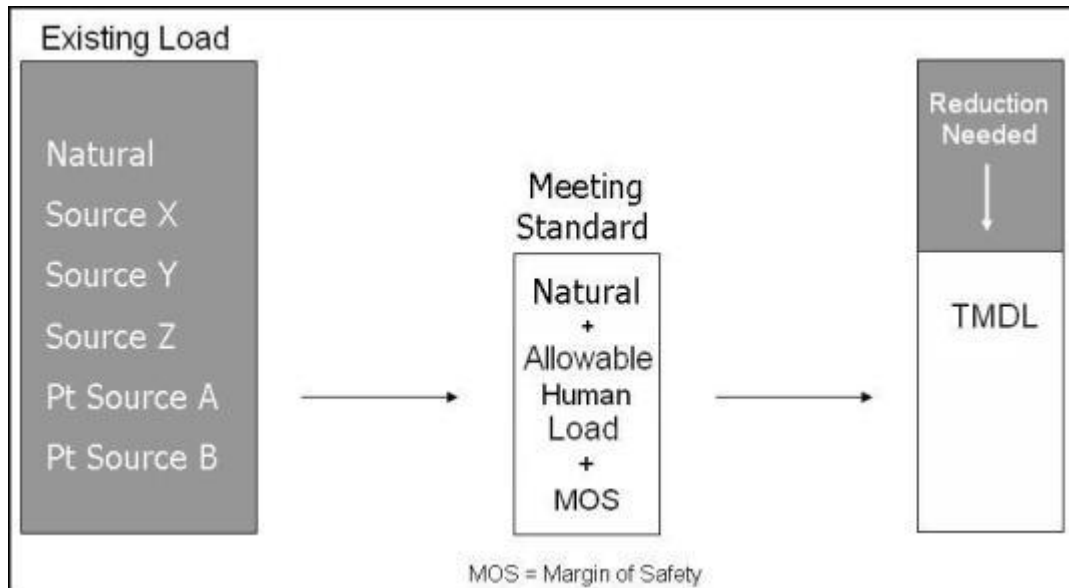
Figure 4-1. Schematic example of TMDL development

The major components that go into TMDL development are target development, source quantification, establishing the total allowable load, and allocating the total allowable load to sources. Although the way a TMDL is expressed may vary by pollutant, these components are common to all TMDLs, regardless of pollutant. Each component is described in further detail below.

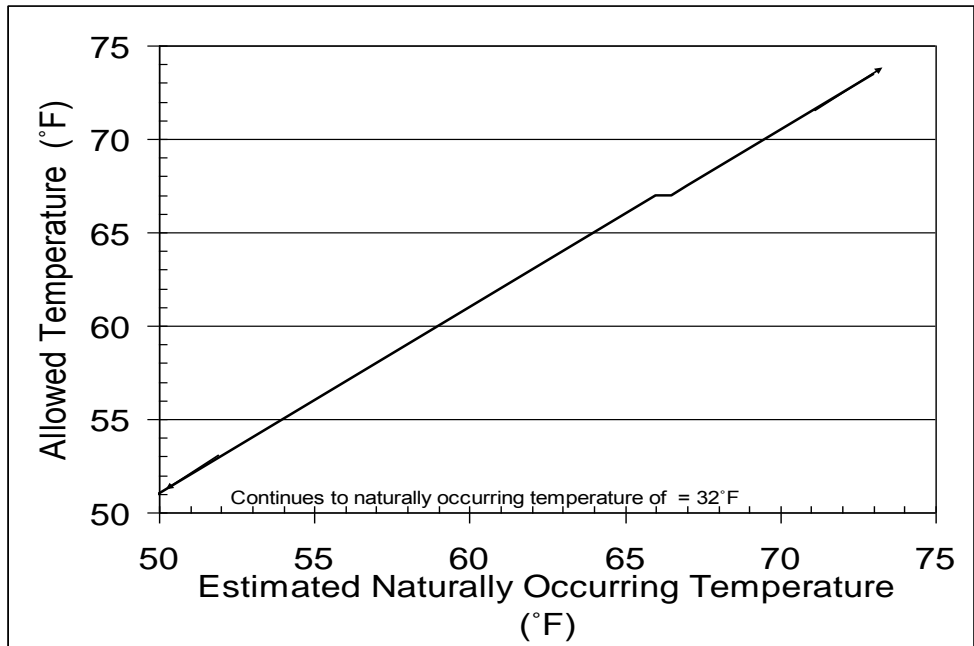
**Figure 6-1. Instream Temperatures Allowed by Montana's B-1 Classification Temperature Standard**

For temperature TMDLs, because of the dynamic temperature conditions throughout the course of a day, the TMDL is the thermal load, at an instantaneous moment, associated with the stream temperature when in compliance with Montana's water quality standards. As stated earlier, the temperature standard for streams in the Bitterroot TPA is defined as follows: For waters classified as B-1, the maximum allowable increase over the naturally occurring temperature is 1°F, if the naturally occurring temperature is less than 66°F. Within the naturally occurring temperature range of 66 to 66.5 °F, the allowable increase cannot exceed 67°F. If the naturally occurring temperature is greater than 66.5°F, the maximum allowable increase is 0.5° F [ARM 17.30.622(e) and ARM 17.30.623(e)]. Montana's temperature standard for B1 classified waters is depicted in **Figure 6-1**.

An instantaneous load is computed by the second and applies at all times. The allowed temperature can be calculated using Montana’s B1 classification temperature standards (**Figure 6-1**) and using a modeled, measured, or estimated naturally occurring instantaneous temperature. The instantaneous total maximum load (per second) at any location in the waterbody is provided by **Equation 6-2**. The allowable loading over a second is expressed as the allowable loading to the liquid form of the water in the stream. This is defined as the kCal increase associated with the warming of the water from 32°F to the temperature that represents compliance with Montana's temperature standard as determined from **Figure 6-1**.

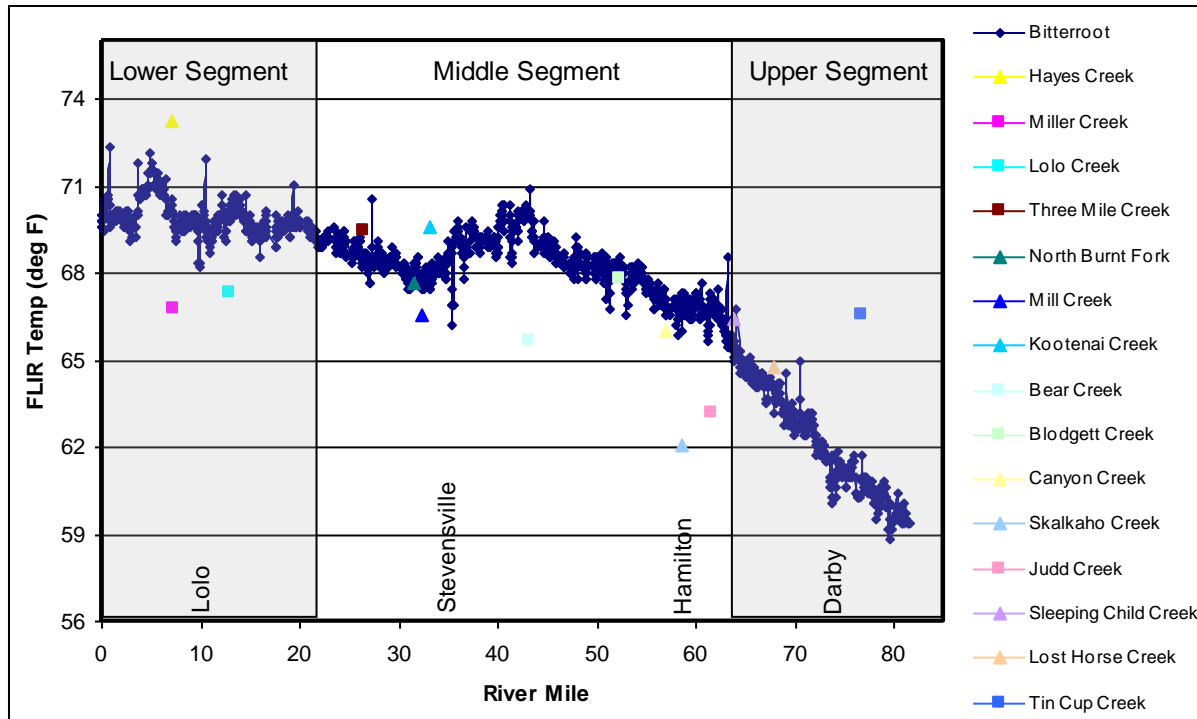
**Figure 6-2. Bitterroot River Thermal Infrared Assessment Results**

During the 2004 data logger deployment, a thermal infrared flight (TIR) was conducted along the Bitterroot River (**Attachment B**). The River heats significantly from the headwaters to near Victor. The TIR results include warm and cold water influences along with temperatures of the main channel (**Figure 6-2**). Identified warm water tributaries include Kootenai and Tin Cup creeks, while most other identified tributaries in this segment had temperatures similar to, or lower than, the Bitterroot River. Many tributaries were not identified in the TIR due to dry conditions or canopy overhang. The TIR report also provides a review of cold water springs entering the river, which cumulatively slightly reduce water temperatures near Stevensville.

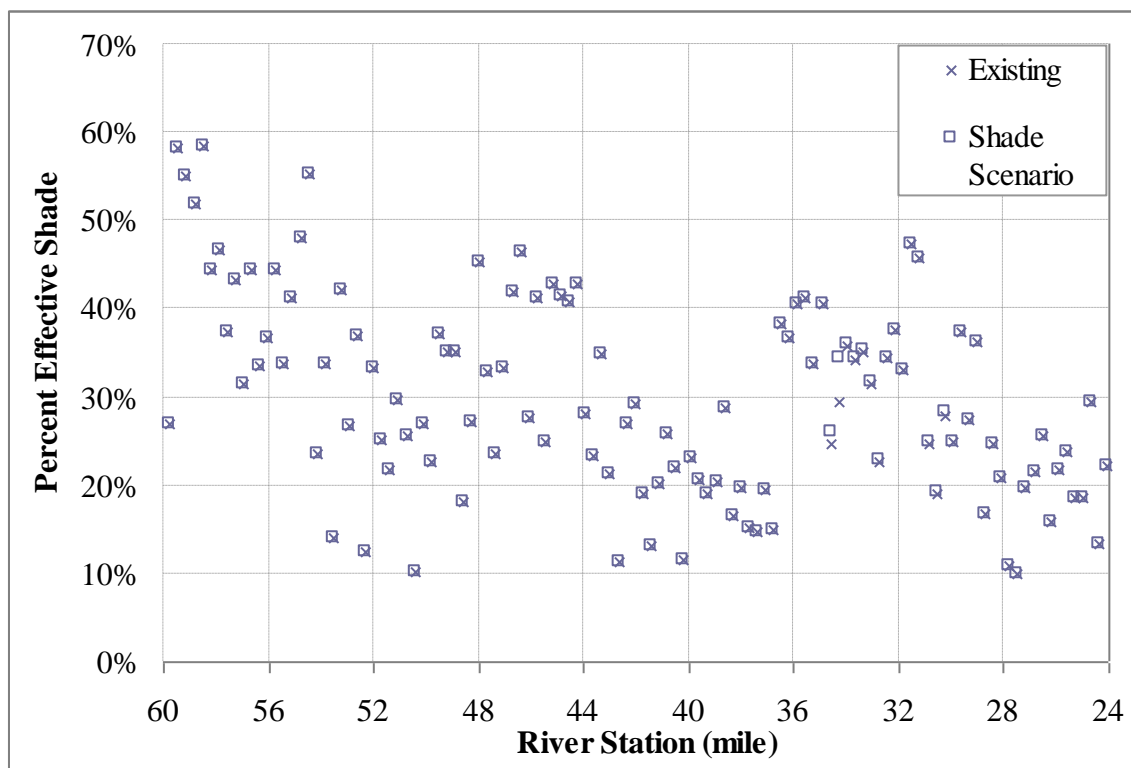
**Figure 6-3. Middle Bitterroot River Effective Shade Assessment Results**

Average daily effective shade ranged from 10% to 58% along the middle segment of the Bitterroot River (**Figure 6-3**). This segment is a relatively large stream with average active channel widths of approximately 220 feet. The channel size is mostly influenced by a large spring runoff from the surrounding mountains, which in turn forms the channel. Channel widths are not considered significantly influenced by human activities.

During 2007 DEQ conducted an assessment of riparian vegetation class, height, density, and offset using a stereoscope and aerial photos (**Attachment A**). Riparian effective shade was estimated along each 500-meter reach (**Figure 6-3**). Field verification was also conducted. The riparian canopy information was used to calibrate the shade components of the QUAL2K water quality temperature model.

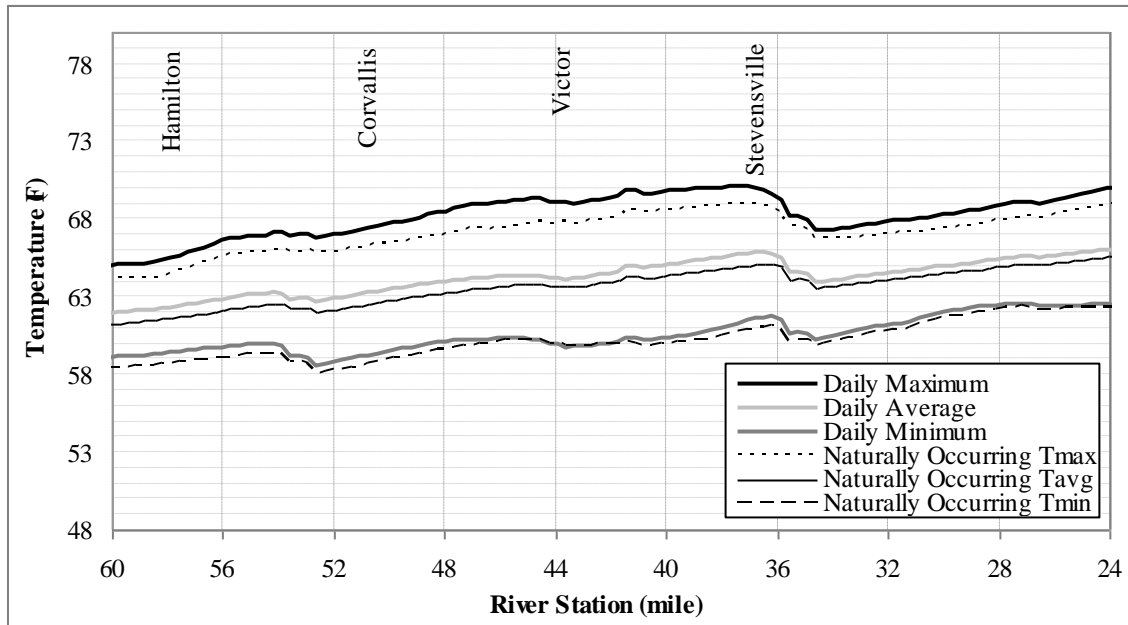
Figure 6-4. Middle segment of the Bitterroot River simulated water temperatures for existing conditions and naturally occurring scenario

A naturally occurring model scenario defines water temperature conditions resulting from the implementation of all reasonable land, soil, and water conservation practices as outlined in ARM 17.30.602. This scenario identifies the naturally occurring temperature in waterbodies of interest and establishes the temperatures to which a 0.5°F temperature increase is allowable in this segment. This, in turn, can be used to identify if standards are exceeded and a TMDL is needed. The naturally occurring scenario for the middle segment of the Bitterroot River (miles 24–60) is a full collection of the restoration scenarios described in the previous sections of this report. In a significant portion of the segment, more than a 0.5°F increase in summertime daily maximum temperature is apparent when compared with a restored scenario, where reasonable land, soil, and water conservation practices are in place (**Figure 6-4**). At river mile 46, the most sensitive location on this segment, maximum daily temperatures can likely be reduced by 1.5°F on an average summer afternoon with reasonable conservation practices.

None of the shade, irrigation water use, irrigation water return flow, or tributary targets are fully met. Both the temperature modeling and target assessments indicate Montana's water temperature standards are not being met. Therefore, the segment is in need of a temperature TMDL.

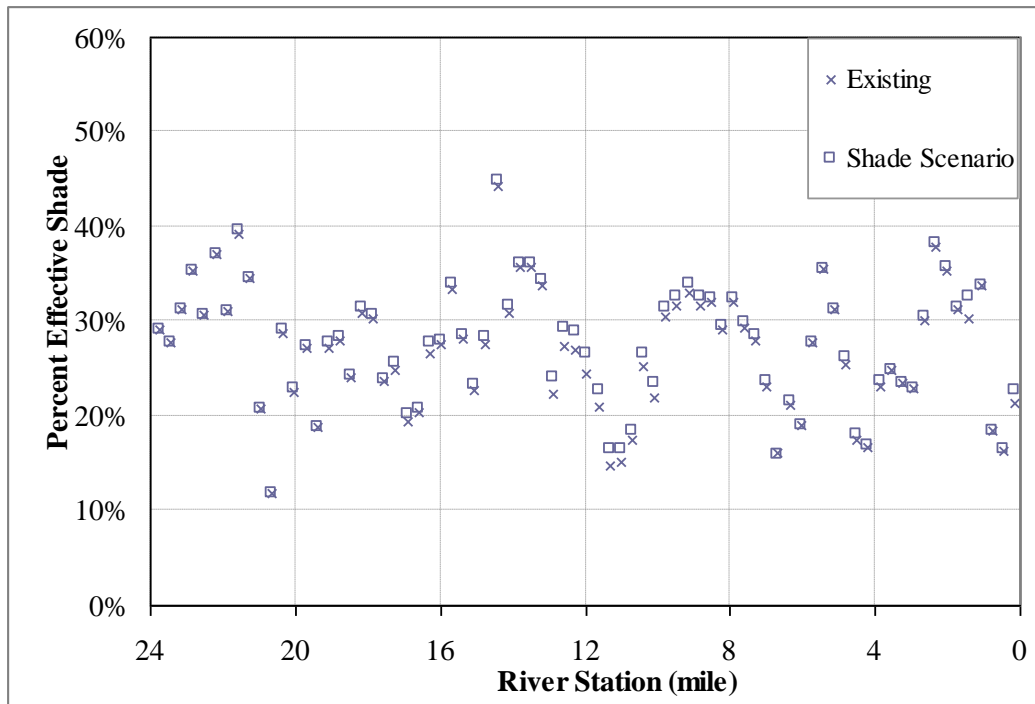
**Figure 6-5. Lower Bitterroot River Effective Shade Assessment Results**

Average daily effective shade ranged from 12% to 45% along the lower segment of the Bitterroot River (**Figure 6-5**). This segment of river is a relatively large stream with average active channel widths of approximately 240 feet. The stream width is mostly driven by natural hydrological process of spring snow melt from the surrounding mountains. Therefore, riparian vegetation is less likely to affect stream temperature than on smaller streams.

During 2007 DEQ conducted an assessment of riparian vegetation class, height, density, and offset using a stereoscope and aerial photos (**Attachment A**). Riparian effective shade was estimated along each 500-meter reach (**Figure 6-5**). Field verification was also conducted. The riparian canopy information was used to calibrate the shade components of the QUAL2K water quality temperature model.

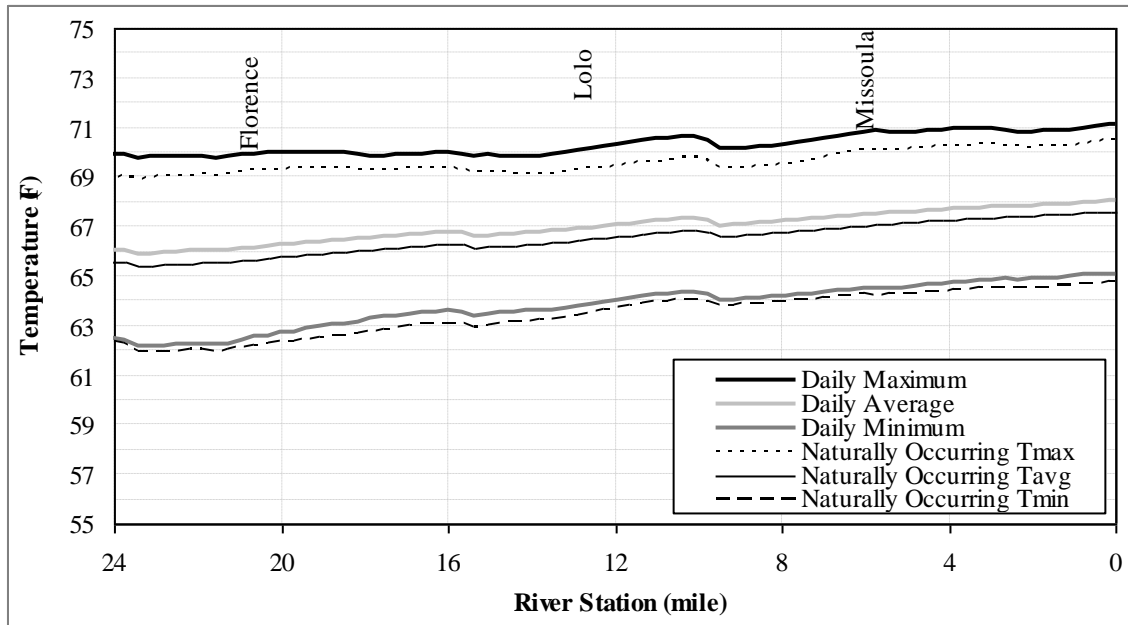
Figure 6-6. Lower segment of Bitterroot River simulated water temperatures for existing conditions and naturally occurring scenario

A naturally occurring model scenario defines water temperature conditions resulting from the implementation of all reasonable land, soil, and water conservation practices as outlined in ARM 17.30.602. This scenario identifies the naturally occurring temperature in waterbodies of interest and establishes the temperatures to which a 0.5°F temperature increase is allowable in this segment. This, in turn, can be used to identify if standards are exceeded and a TMDL is needed. The naturally occurring scenario for the lower segment of the Bitterroot River (miles 0–24) is a full collection of the restoration scenarios described in the previous sections of this report. In a significant portion of the segment, more than a 0.5°F increase in summertime daily maximum temperature is apparent when compared with a restored scenario, where reasonable land, soil, and water conservation practices are in place (**Figure 6-6**). At river mile 11, the most sensitive location on this segment, maximum daily temperatures can likely be reduced by at least 0.8°F with reasonable conservation practices.

None of the shade, irrigation water use, irrigation water return flow, or tributary targets are fully met. Both the temperature modeling and target assessments indicate Montana’s water temperature standards are not being met. Therefore, the segment is in need of a temperature TMDL.

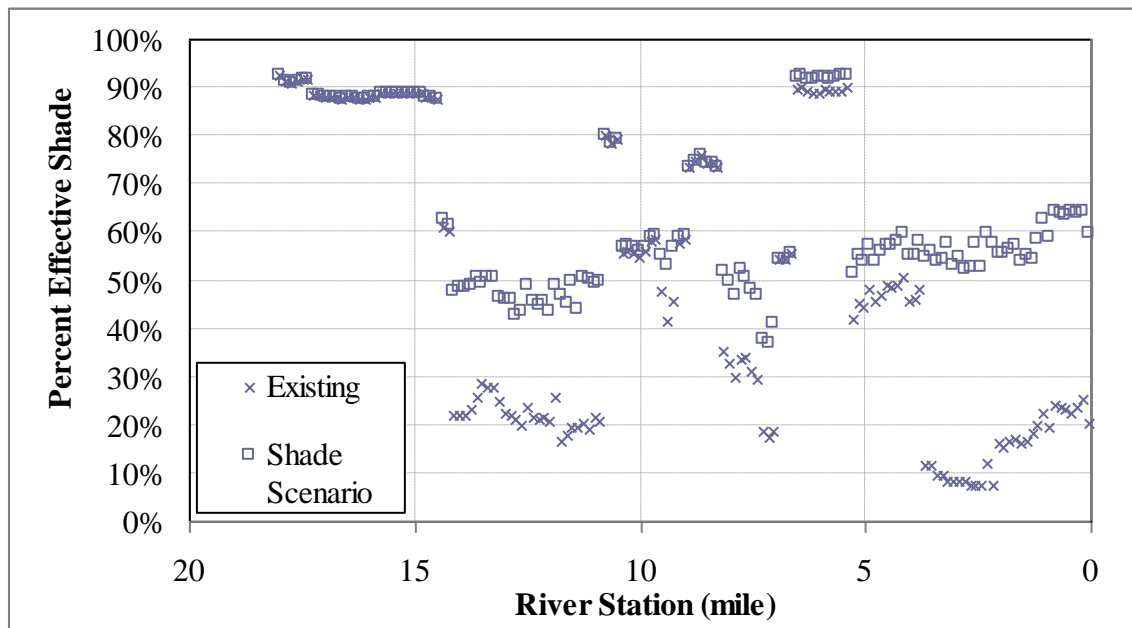
**Figure 6-7. Miller Creek Effective Shade Assessment Results**

Daily effective shade ranged from 92% in the headwaters to 7% near the Bitterroot River (**Figure 6-7**). Miller Creek is a small stream with a very narrow active channel and thus shading from riparian vegetation is likely to affect stream temperatures to a high degree. Riparian vegetation along Miller Creek consists of conifer forest in the headwaters and intermixed shrubs, deciduous trees, forbs and grass in the remainder of the watershed. Predominant human impacts currently influencing streamside vegetation include livestock grazing and hay production between miles 0-4 and 11-15 along with grazing and suburban development along river miles 4-11 (**Figure 6-7, Map A-26**). Also, timber harvest likely impacts shade on tributaries. Average current shade along Miller Creek is estimated at 48% and a restored riparian vegetation condition would increase effective shade to 65% along Miller Creek. This represents a significant potential increase in shade which equates to a 7.5°F reduction in maximum daily

During 2007 DEQ conducted a riparian vegetation class, height, vegetation density and offset assessment using a stereo scope and aerial photos. From this effort, riparian effective shade was estimated along each 500 m reach and a desired condition was also estimated (**Figure 6-7**). A field verification effort was also conducted. This riparian canopy information was used to calibrate the riparian shade components of the QUAL2K water quality temperature model.

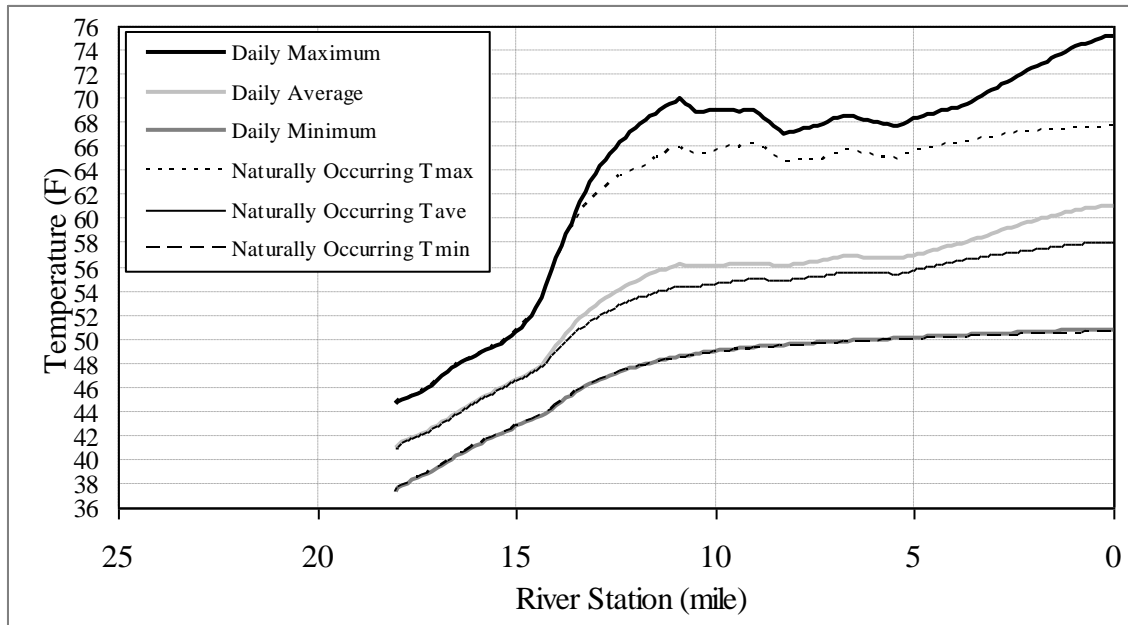
**Figure 6-8. Miller Creek simulated water temperatures for existing conditions and naturally occurring scenario.**

A naturally occurring model scenario for Miller Creek defines water temperature conditions resulting from the implementation of all reasonable land, soil and water conservation practices as outlined in ARM 17.30.602. This scenario identifies the restored temperature condition in waterbodies of interest and establishes the temperatures to which a 0.5°F (0.23°C) temperature increase is allowable. This, in turn, can be used to identify if standards are exceeded and determine if a TMDL is needed. The naturally occurring scenario for Miller Creek assesses sources that impact shade along the segment. In a significant portion of the segment, more than a 0.5°F increase in daily maximum temperature is apparent when compared to a restored scenario where land and water conservation practices are in place (**Figure 6-8**). Maximum daily temperatures can likely be reduced by at least 7.5 to 8°F with reasonable conservation practices that restore shade along the stream.

None of the targets have been attained. Both the modeling and temperature influencing target assessment approaches indicate Montana’s water temperature standards are not being met. Therefore, Miller Creek is in need of a temperature TMDL.

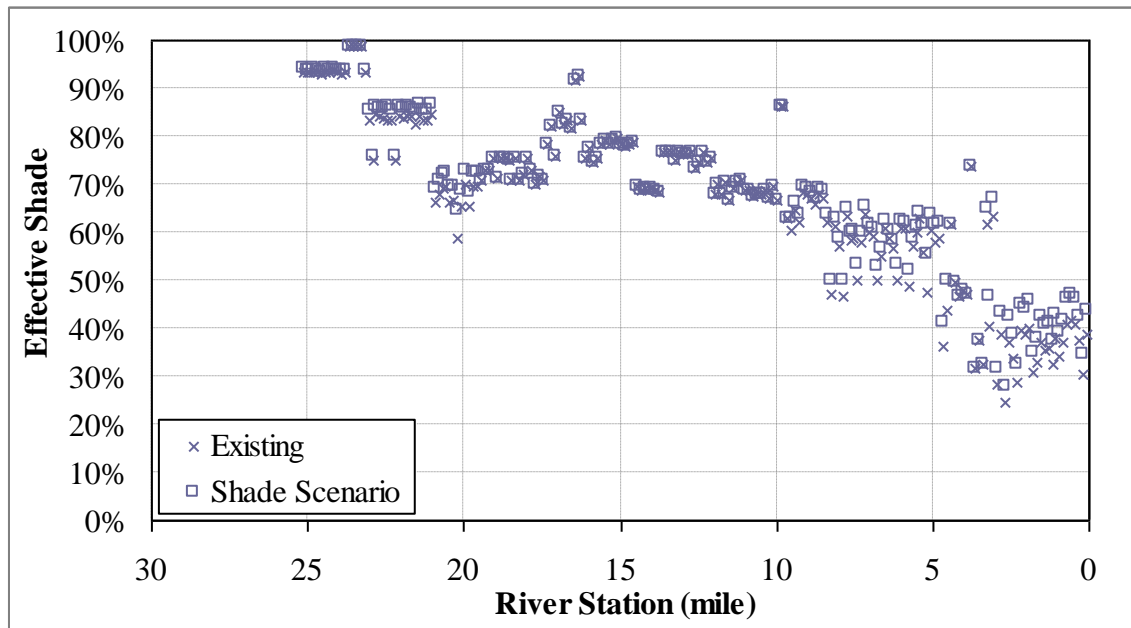
**Figure 6-9. Sleeping Child Creek Effective Shade Assessment Results.**

Daily effective shade ranged from 98% in the headwaters to 25% near the Bitterroot River (**Figure 6-9**). Sleeping Child Creek is a small stream with a narrow active channel and thus streamside shading from vegetation is likely to affect stream temperatures significantly. Riparian vegetation along Sleeping Child Creek consists of conifer forest in the headwaters and intermixed shrubs, deciduous trees, forbs and grass in the remainder of the watershed. Predominant human impacts currently impacting streamside vegetation include livestock grazing and hay production, particularly between miles 0 to 7 (**Figure 6-9**). Also, timber harvest likely impacts shade in the headwaters. Sleeping Child Creek flows through a clearcut section near mile 20. A wildfire burned portions of the riparian area between miles 9 to 19. Riparian vegetation condition aerial photo assessment results are provided in **Map A-27**.

During 2007 DEQ conducted a riparian vegetation class, height, vegetation density and offset assessment using a stereo scope and aerial photos. From this effort, riparian effective shade was estimated along each 500 m reach and a desired condition was also estimated (**Figure 6-9**). A field verification effort was also conducted. This riparian canopy information was used to calibrate the riparian shade components of the QUAL2K water quality temperature model.

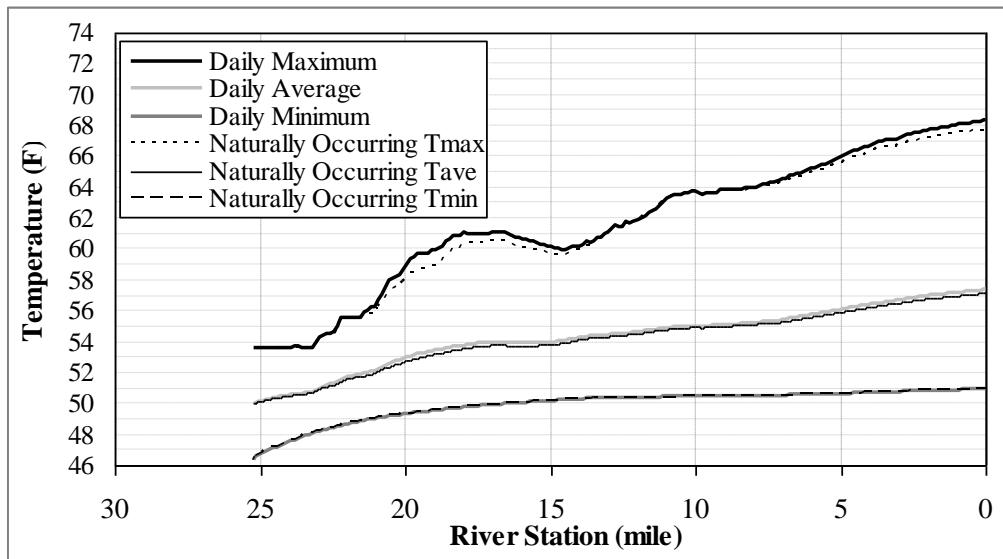
**Figure 6-10. Sleeping Child Creek simulated water temperatures for existing conditions and naturally occurring scenario.**

A naturally occurring model scenario of Sleeping Child Creek defines water temperature conditions resulting from the implementation of all reasonable land, soil and water conservation practices as outlined in ARM 17.30.602. This scenario identifies the “naturally occurring” temperature in waterbodies of interest and establishes the temperatures to which a 0.5°F (0.23°C) temperature increase is allowable. This, in turn, can be used to identify if standards are exceeded and determine if a TMDL is needed. The naturally occurring scenario for Sleeping Child Creek assesses sources that impact shade along the segment. In a small portion of the segment below a clear cut, more than a 1°F increase in daily maximum temperature is apparent when compared to a restored scenario where land conservation practices are in place (**Figure 6-10**). Also, in the lower portion of the stream, water is heated slightly above the 0.5°F threshold from irrigated hay production and riparian grazing that reduce shade from riparian vegetation. The modeling results indicate that temperature standards are slightly exceeded in Sleeping Child Creek.

None of the targets have been attained. Both the modeling and temperature influencing target assessment approaches indicate Montana’s water temperature standards are not being met. Therefore, Sleeping Child Creek is in need of a temperature TMDL.

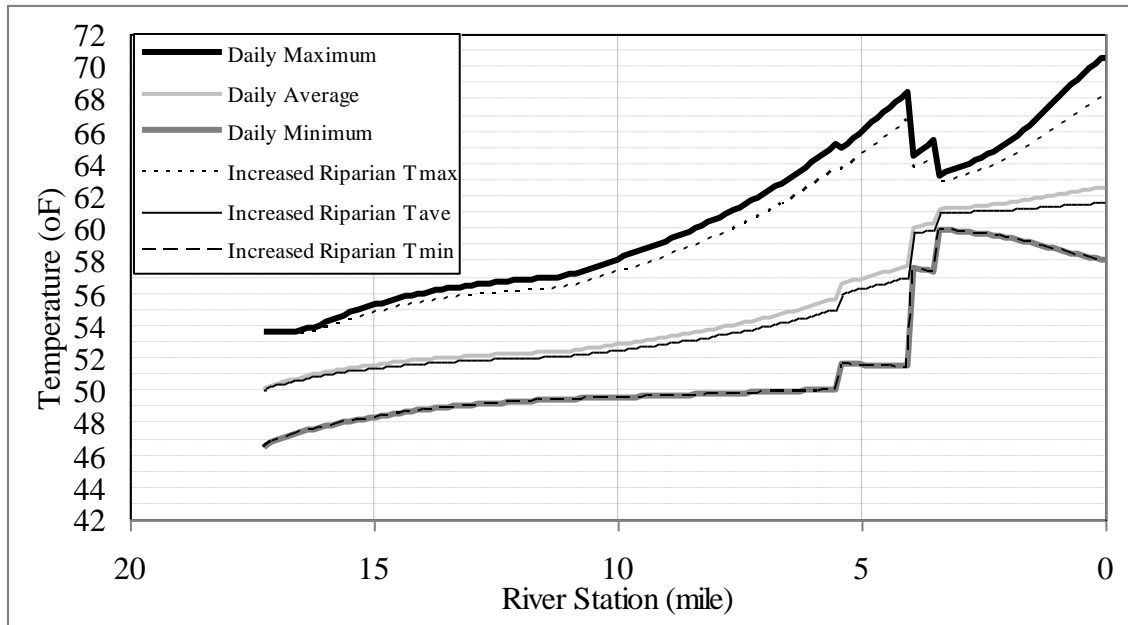
**Figure 6-11. Willow Creek simulated water temperatures for existing conditions and an increased shade scenario.**

A naturally occurring model scenario of Willow Creek defines water temperature conditions resulting from the implementation of all reasonable land, soil and water conservation practices as outlined in ARM 17.30.602. This scenario identifies the “naturally occurring” temperature in waterbodies of interest and establishes the temperatures to which a 0.5°F (0.23°C) temperature increase is allowable. This, in turn, can be used to identify if standards are exceeded and determine if a TMDL is needed. The naturally occurring scenario for Willow Creek assesses sources that impact shade along the segment. In the lowest portion of the stream, water is heated at least 2.5°F from irrigated crop production and riparian grazing that reduce shade by impacting riparian vegetation. The modeling results indicate that temperature standards are exceeded in Willow Creek.

The streamside vegetation shade targets and W/D ratio targets are not met. It’s also likely that the irrigation targets are not met. Both the modeling and temperature influencing target assessment approaches indicate Montana’s water temperature standards are not being met. Therefore, Willow Creek is in need of a temperature TMDL.
