Water Quality Assessment and TMDLs for the Flathead River Headwaters Planning Area, Montana

Prepared by:
U.S. Environmental Protection Agency
Montana Operations Office,
Flathead National Forest,
and Tetra Tech, Inc.

**Prepared for the
Montana Department of Environmental Quality**

December 31, 2004

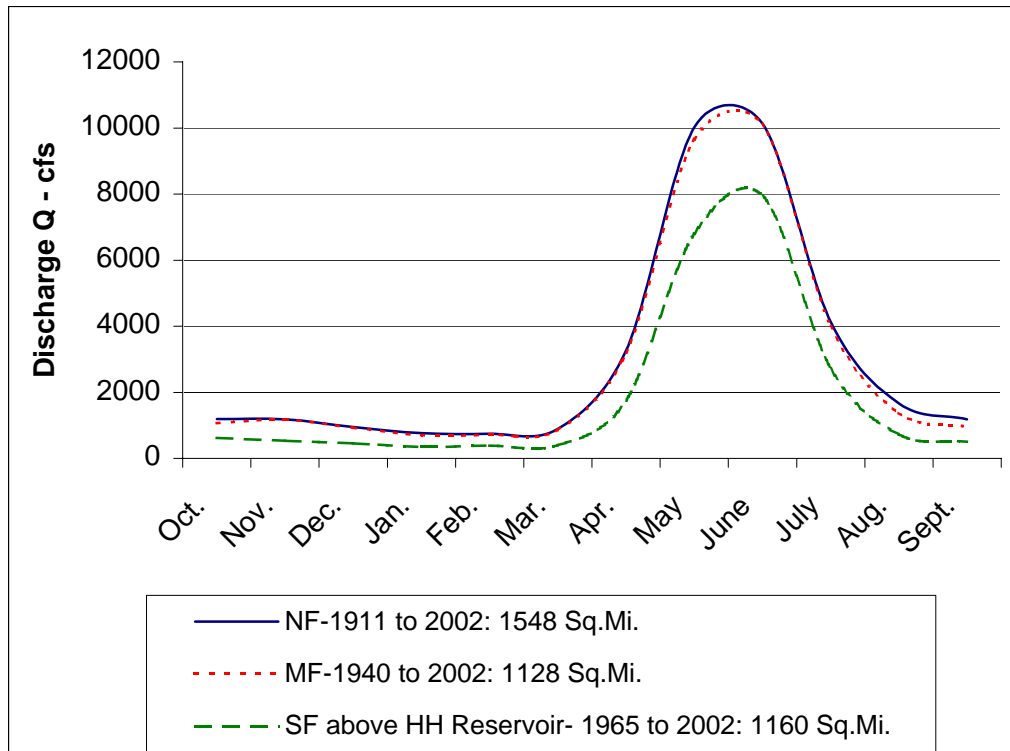
Figure 2-3. Historical average monthly flows at three USGS gaging stations on the Middle Fork, North Fork, and South Fork Flathead rivers.

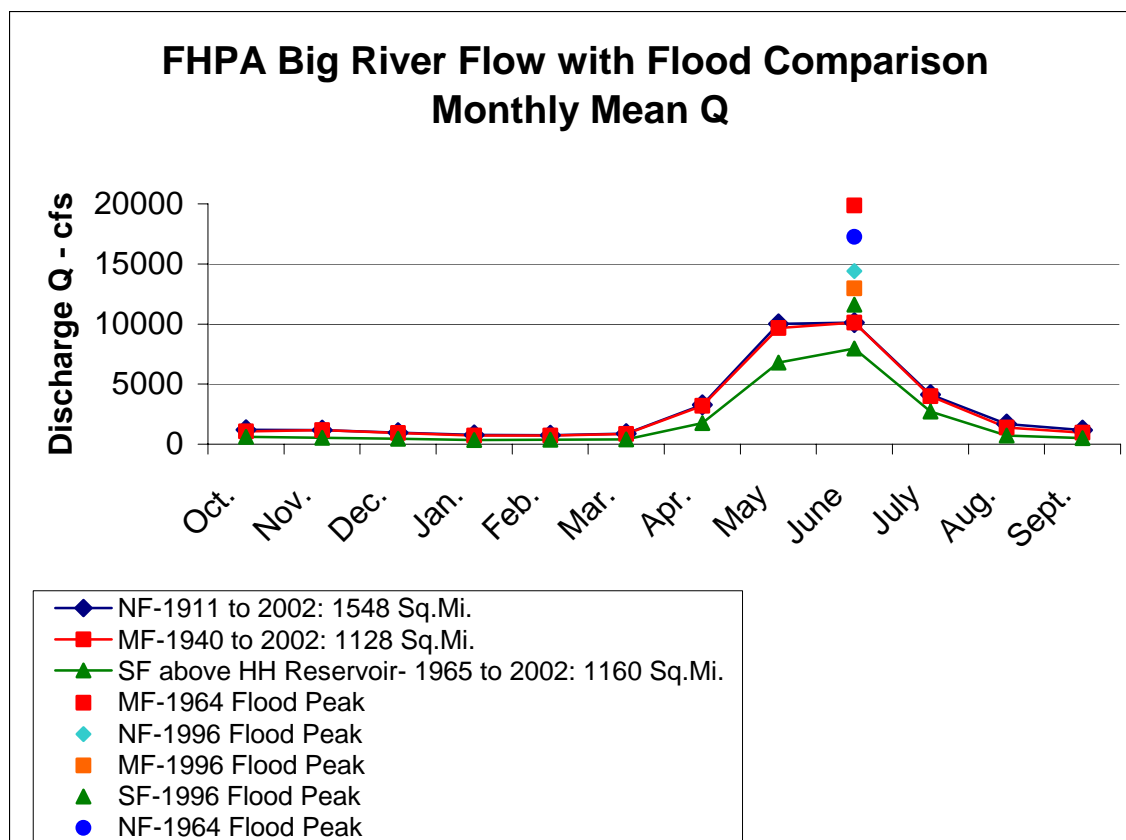
Figure 2-7. Mean monthly discharge in the North Fork, Middle Fork, and South Fork Flathead rivers compared to flood peaks in 1964 and 1996.

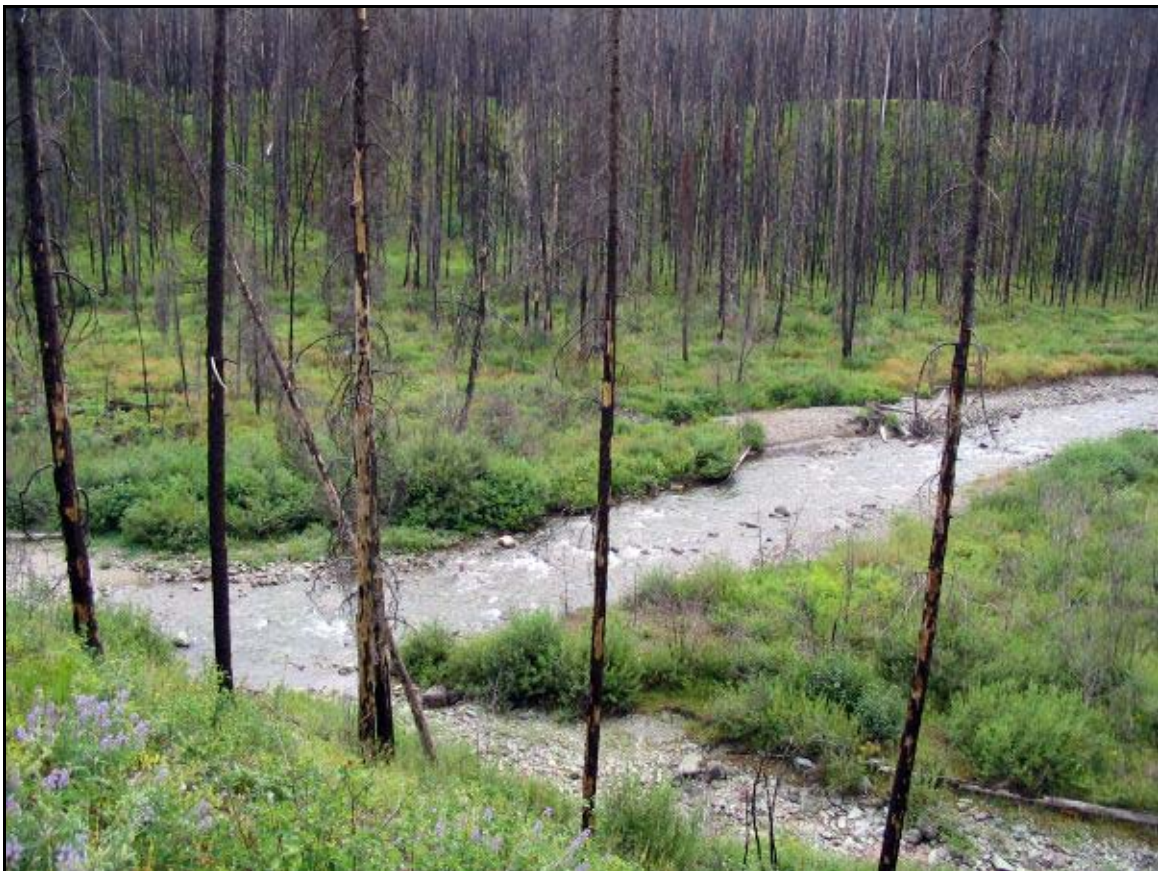
Figure 4-11. Effects of the Moose Fire and vegetative regrowth since 2001 (Note the shrub and herbaceous vegetation that has already resulted in excellent ground cover).

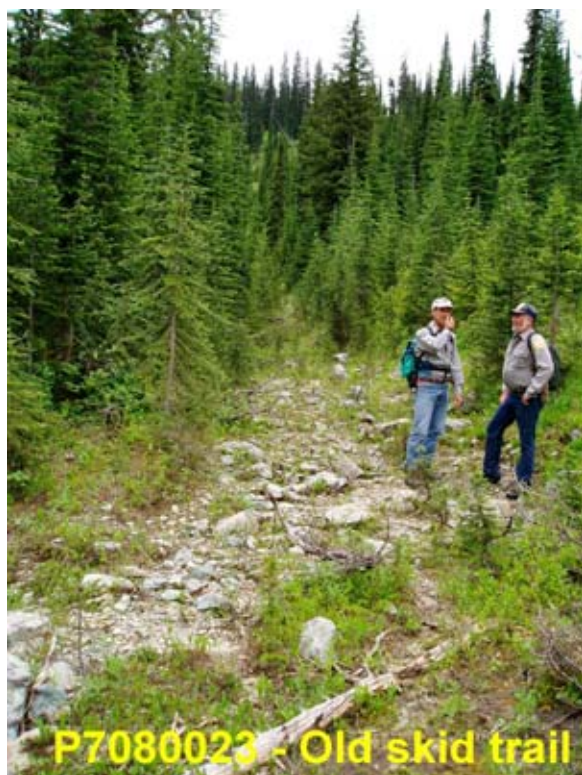
Figure 4-14. Old skid trail with stream formation in the Mathias Creek watershed.

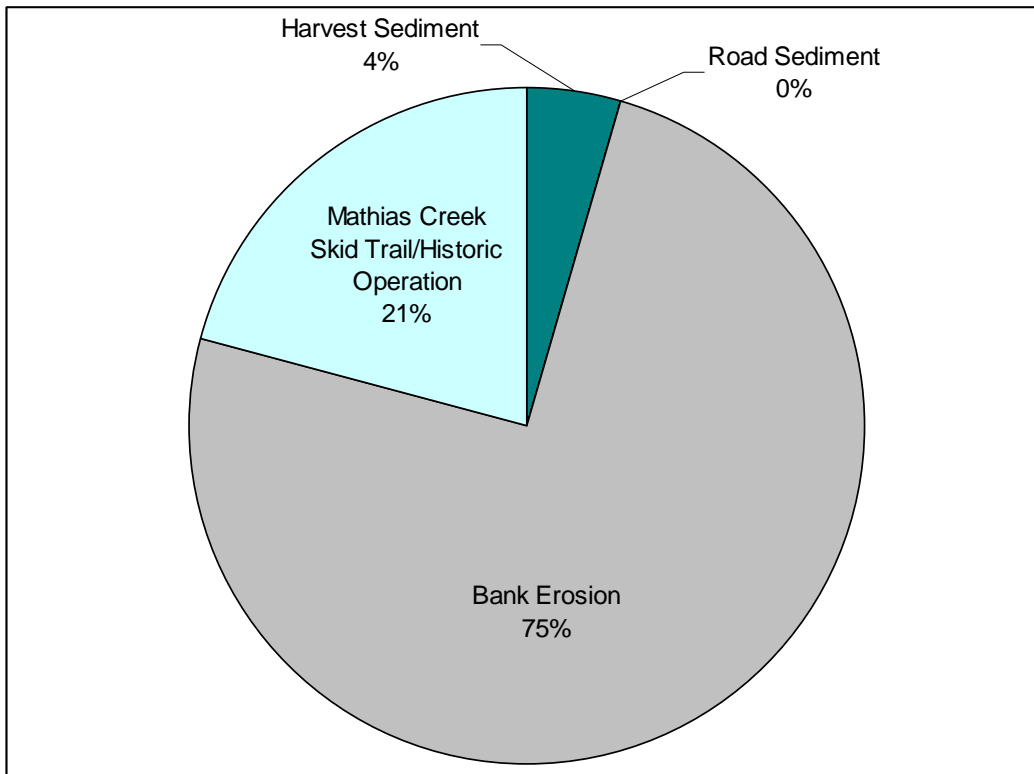
Figure 4-21. Distribution of sediment sources (Without Moose Fire).
