ATTACHMENT A – KOOTENAI-FISHER TMDL PROJECT AREA: SEDIMENT AND HABITAT ASSESSMENT

Kootenai-Fisher TMDL Project Area: Sediment and Habitat Assessment

ATKINS

April 2013

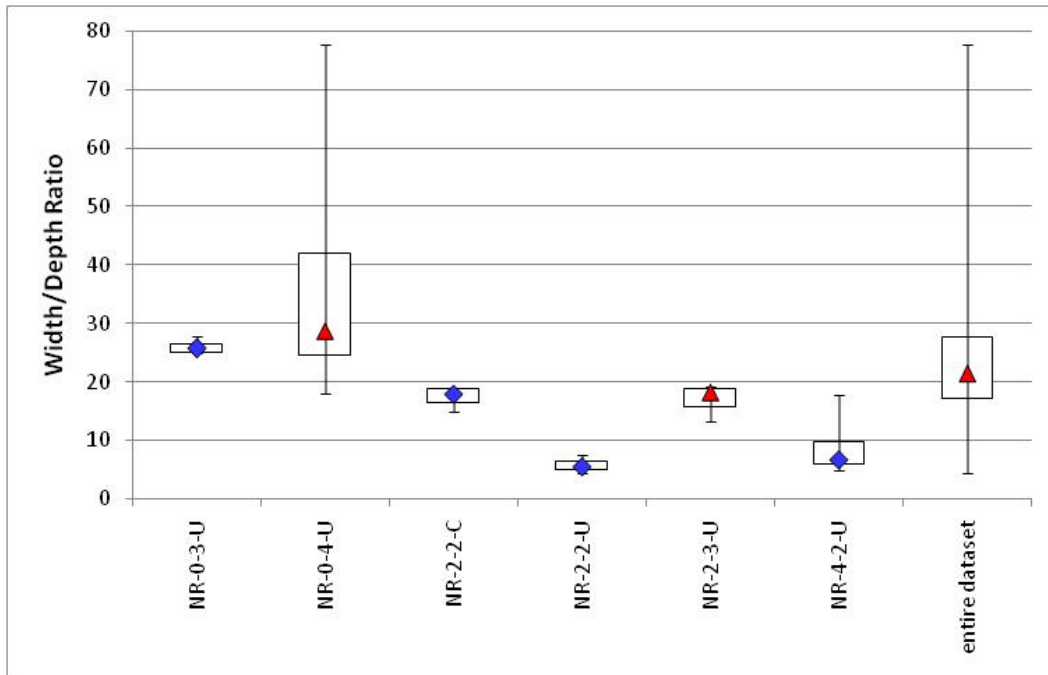
Figure 3-3. Width/Depth Ratio

The channel width/depth ratio is defined as the channel width at bankfull divided by the mean bankfull depth (Rosgen 1996). The channel width/depth ratio is one of several standard measurements used to classify stream channels, making it a useful variable for comparing conditions between reaches with the same stream type (Rosgen 1996). A comparison of observed and expected width/depth ratios is also an indicator of channel over-widening and aggradation, which are often linked to excess streambank erosion and/or sediment inputs from sources upstream of the study reach. Channels that are over-widened are often associated with excess sediment deposition and streambank erosion, contain shallower and warmer water, and provide fewer deepwater refugia for fish. Median width/depth ratios for assessed reach types ranged from 5.5 in NR-2-2-U to 28.6 in NR-0-4-U (Figure 3-3 and Table 3-2).

Blue diamonds denote reach types with one monitoring site; red triangles denote more than one monitoring site.

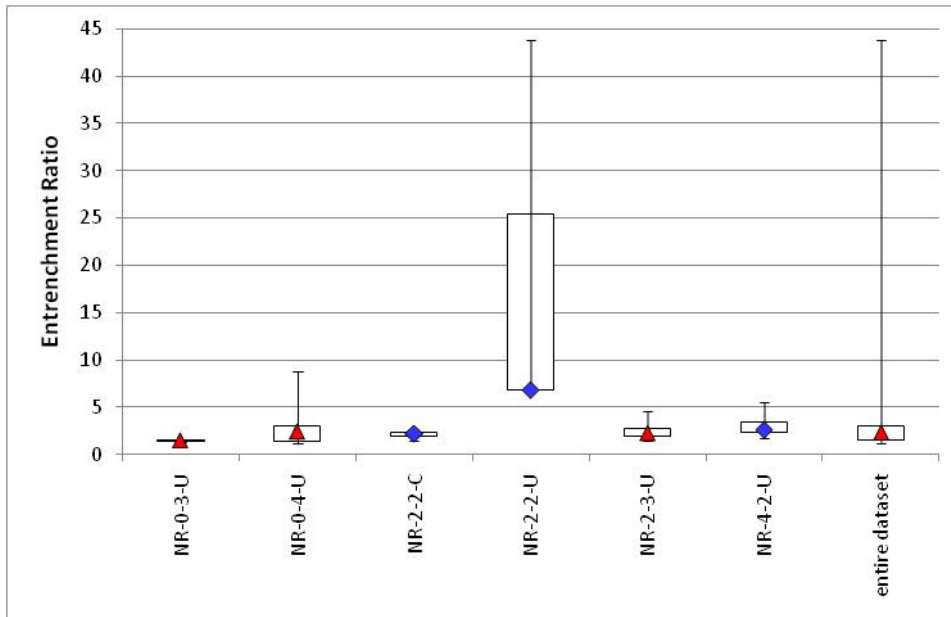
Figure 3-4. Entrenchment Ratio

A stream’s entrenchment ratio is equal to the floodprone width divided by the bankfull width (Rosgen 1996). The entrenchment ratio is used to help determine if a stream shows departure from its natural stream type and is an indicator of stream incision that describes how easily a stream can access its floodplain. Streams can become incised due to detrimental land management activities or may be naturally incised due to landscape characteristics. A stream that is entrenched is more prone to streambank erosion due to greater energy exerted on the streambanks during flood events, which results in higher sediment loads. The entrenchment ratio is an important measure of channel conditions since it relates to sediment loading and habitat condition. Rosgen (1996) defines an entrenched channel as having a ratio less than 1.4, a moderately entrenched channel having a ratio between 1.4 and 2.2, and a slightly entrenched channel as having a ratio greater than 2.2. Therefore, as the entrenchment ratio increases, floodplain access increases. The median entrenchment ratio for assessed reach types ranged from 1.5 in NR-0-3-U to 6.9 in NR-2-2-U (Figure 3-4 and Table 3-3).

Blue diamonds denote reach types with one monitoring site; red triangles denote more than one monitoring site.

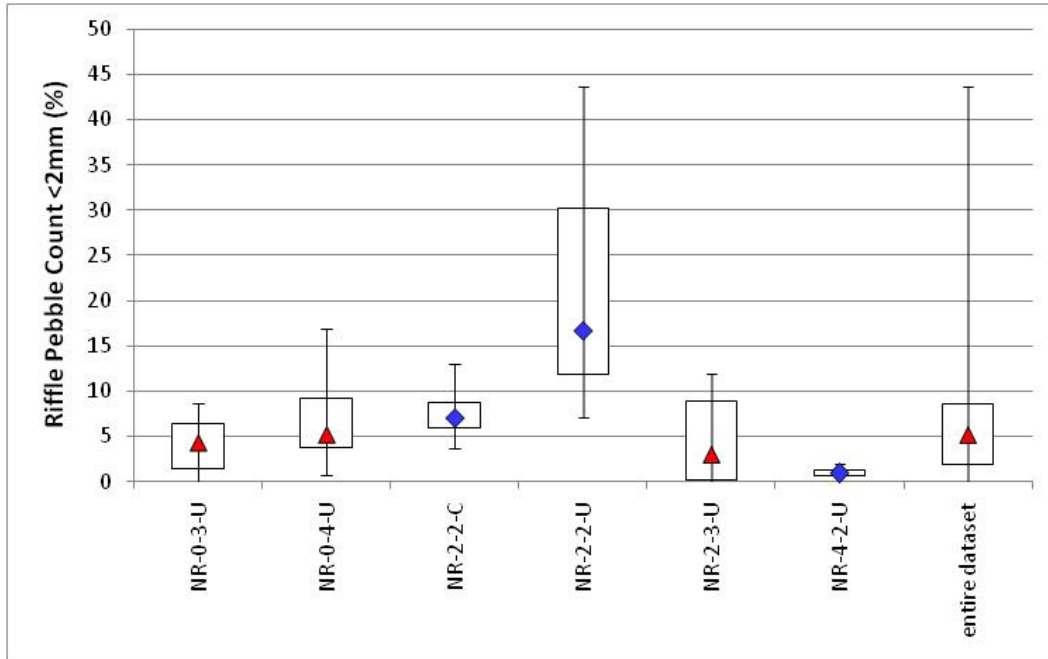
Figure 3-5. Riffle Pebble Count <2mm

Percent surface fine sediment measures the amount of siltation occurring in a river system. Surface fine sediment measured using the Wolman (1954) pebble count method is one indicator of aquatic habitat condition and higher values can signify excessive sediment loading. The Wolman pebble count provides a survey of the particle distribution of the entire channel width, allowing investigators to calculate a percentage of the surface substrate (as frequency of occurrence) composed of fine sediment. Median values for the percent of fine sediment <2mm based on riffle pebble counts ranged from 1% in NR-4-2-U to 17% in NR-2-2-U (Figure 3-5 and Table 3-4).

Blue diamonds denote reach types with one monitoring site; red triangles denote more than one monitoring site.

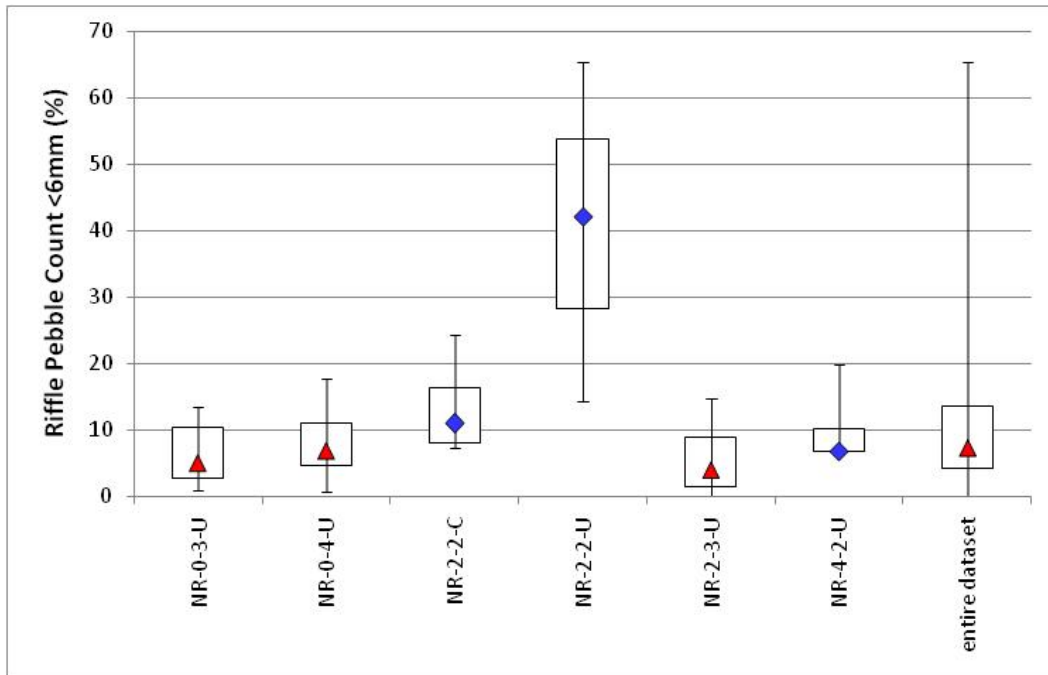
Figure 3-6. Riffle Pebble Count <6mm

As with surface fine sediment <2mm, an accumulation of surface fine sediment <6mm may indicate excess sedimentation. Median values for the percent of fine sediment <6mm based on pebble counts conducted in riffles ranged from 4% in NR-2-3-U to 42% in NR-2-2-U (Figure 3-6 and Table 3-5). The percent of fine sediment <6mm followed the same general trend as the percent of fine sediment <2mm.

Blue diamonds denote reach types with one monitoring site; red triangles denote more than one monitoring site.

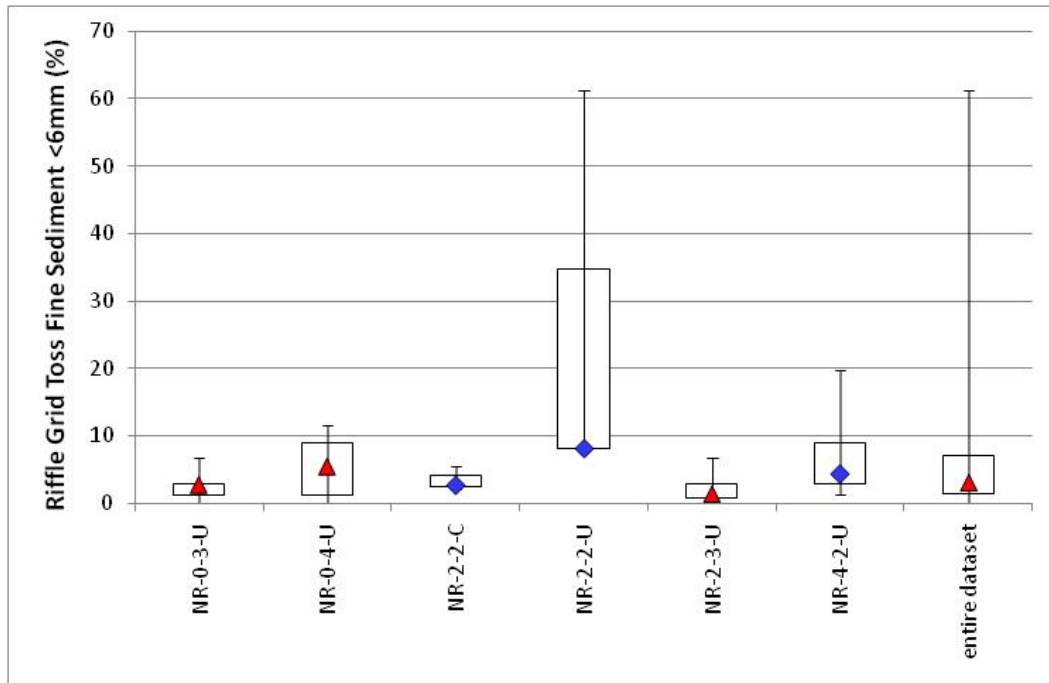
Figure 3-7. Riffle Grid Toss Fine Sediment <6mm

The riffle grid toss is a standard procedure frequently used in aquatic habitat assessments that provides complimentary information to the Wolman pebble count. Median values for riffle grid toss fine sediment <6mm in the Kootenai-Fisher Project Area range from 1% in NR-2-3-U to 8% in NR-2-2-U (Figure 3-7 and Table 3-6).

Blue diamonds denote reach types with one monitoring site; red triangles denote more than one monitoring site.

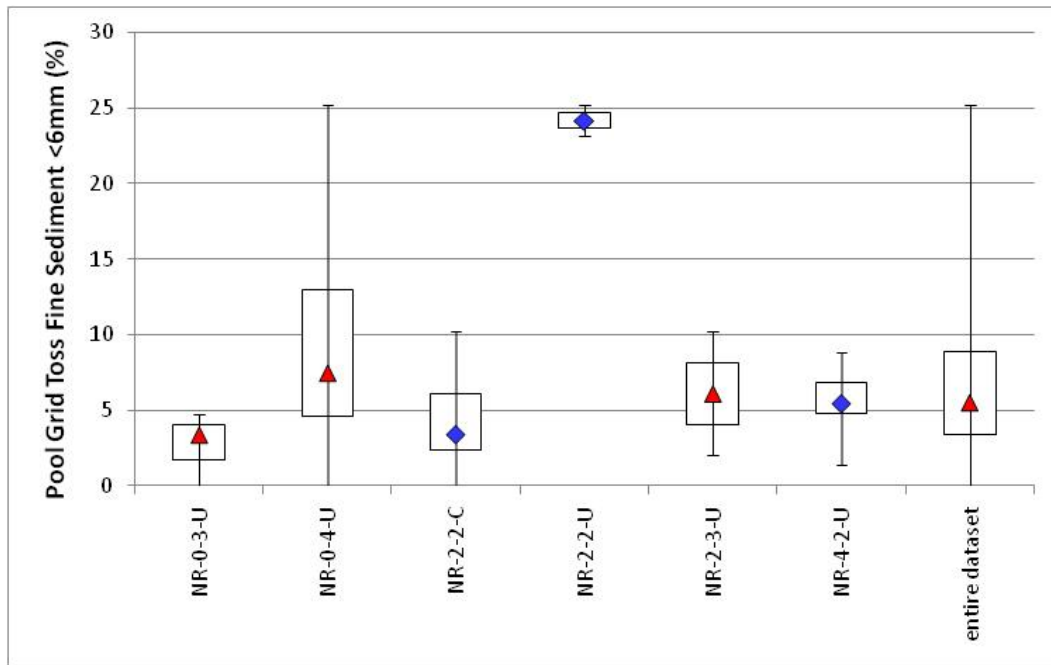
Figure 3-8. Pool Tail-out Grid Toss <6mm

Grid toss measurements in pool tail-outs provide a measure of fine sediment accumulation in potential fish spawning sites, which may have detrimental impacts on aquatic habitat by cementing spawning gravels, preventing flushing of toxins in egg beds, reducing oxygen and nutrient delivery to eggs and embryos, and impairing emergence of fry (Meehan 1991). Weaver and Fraley (1991) observed a significant inverse relationship between the percentage of material less than 6.35mm and the emergence success of westslope cutthroat trout and bull trout, both of which are present in the Kootenai-Fisher Project Area. Median values for pool tail-out grid toss fine sediment <6mm range from 3% in NR-0-3-U and NR-2-2-C to 24% in NR-2-2-U (Figure 3-8 and Table 3-7).

Blue diamonds denote reach types with one monitoring site; red triangles denote more than one monitoring site.

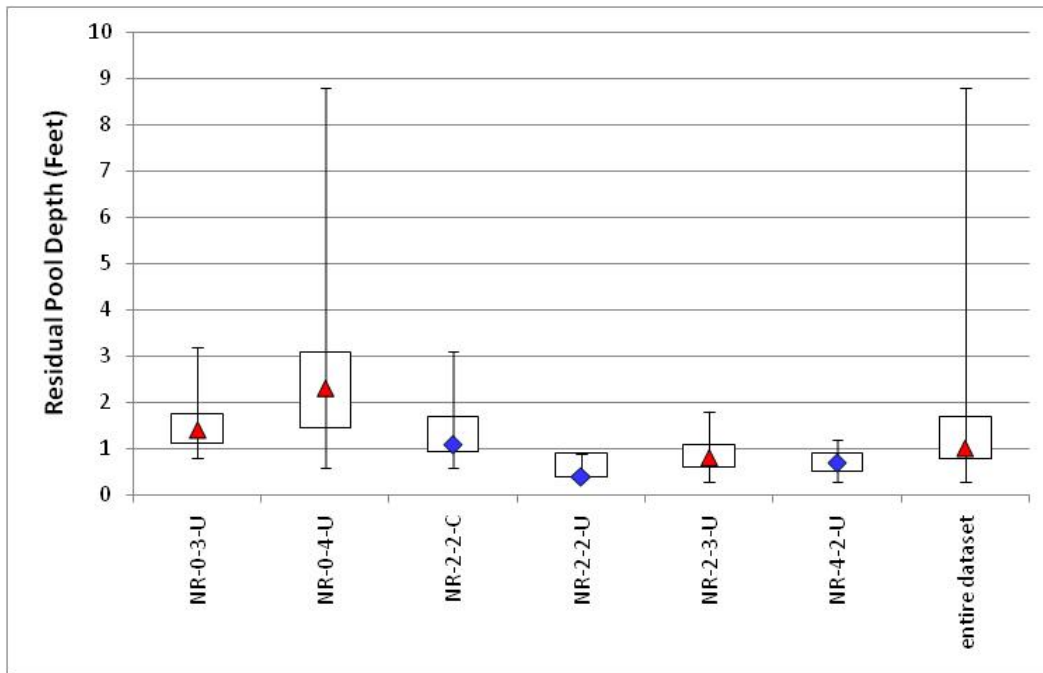
Figure 3-9. Residual Pool Depth

Residual pool depth, defined as the difference between the maximum depth and the tail crest depth, is a discharge-independent measure of pool depth and an indicator of the quality of pool habitat. Deep pools are important resting and hiding habitat for fish, and provide refugia during temperature extremes. Residual pool depth is also an indirect measurement of sediment inputs to streams since an increase in sediment loading can cause pools to fill, thus decreasing residual pool depth over time. Median residual pool depths ranged from 0.4 feet in NR-2-2-U to 2.3 feet in NR-0-4-U (Figure 3-9 and Table 3-8). This analysis indicates that the deepest pools are found in low gradient 4th order streams and that residual pool depth tends to increase as stream order increases in the Kootenai-Fisher Project Area.

Blue diamonds denote reach types with one monitoring site; red triangles denote more than one monitoring site.

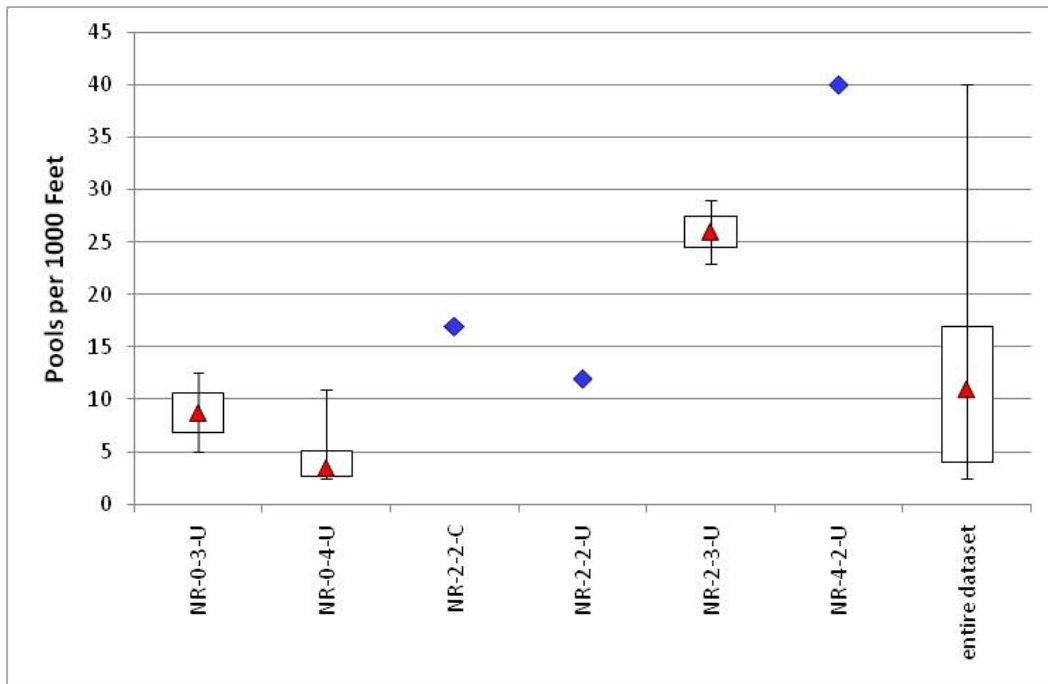
Pool frequency is a measure of the availability of pools to provide rearing habitat, cover, and refugia for salmonids. Pool frequency is related to channel complexity, availability of stable obstacles, and sediment supply. Excessive erosion and sediment deposition can reduce pool frequency by filling in smaller pools. Pool frequency can also be adversely affected by riparian habitat degradation resulting in a reduced supply of large woody debris or scouring from stable root masses in streambanks. Excluding reach types with only one monitoring site, the median value for the number of pools per 1,000 feet ranged from four (NR-0-4-U) to 26 (NR-2-3-U) (Figure 3-10 and Table 3-9). Pool frequency tends to decrease as gradient decreases and stream order increases in the Kootenai-Fisher Project Area.

Blue diamonds denote reach types with one monitoring site; red triangles denote more than one monitoring site.
Figure 3-10. Pools per 1000 Feet

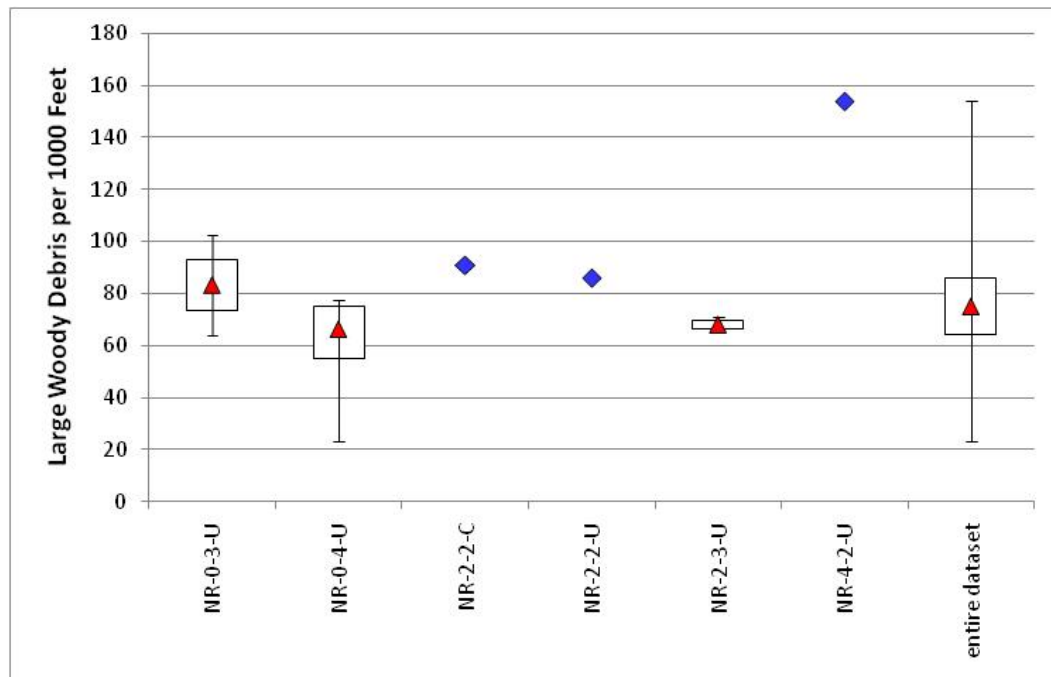
Figure 3-11. Large Woody Debris per 1000 Feet

Large woody debris (LWD) is a critical component of high-quality salmonid habitat, providing habitat complexity, quality pool habitat, cover, and long-term nutrient inputs. LWD also constitutes a primary influence on stream function, including sediment and organic material transport, channel form, bar formation and stabilization, and flow dynamics (Bilby and Ward 1989). LWD frequency can be measured and compared to reference reaches or literature values to determine if more or less LWD is present than would be expected under optimal conditions. Excluding reach types with only one monitoring site, the median value for the amount of large woody debris (LWD) per 1,000 feet ranged from 66 in NR-0-4-U to 83 in NR-0-3-U (**Figure 3-11** and **Table 3-11**). Note that “willow bunches” assigned in the field were tallied as large woody debris. Thus, this analysis makes no distinction as to the size of the woody material.

Blue diamonds denote reach types with one monitoring site; red triangles denote more than one monitoring site.

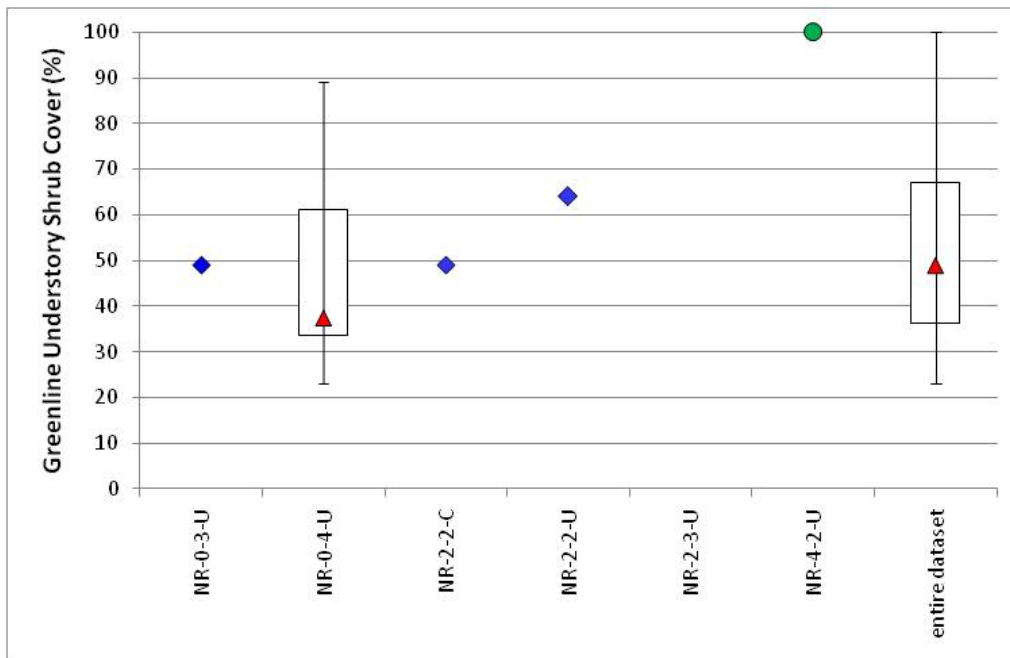
Figure 3-12. Greenline Understory Shrub Cover

Riparian shrub cover is an important influence on streambank stability. Removal of riparian shrub cover can dramatically increase streambank erosion and increase channel width/depth ratios. Shrubs stabilize streambanks by holding soil and armoring lower banks with their roots, and reduce scouring energy of water by slowing flows with their branches. Good riparian shrub cover is also important for fish habitat. Riparian shrubs provide shade, reducing solar inputs and increases in water temperature. The dense network of fibrous roots of riparian shrubs allows streambanks to remain intact while water scours the lowest portion of streambanks, creating important fish habitat in the form of overhanging banks and lateral scour pools. Excluding reach types with only one monitoring site, the median value for greenline understory shrub cover was 38% in NR-0-4-U (Figure 3-12 and Table 3-13).

Blue diamonds denote reach types with one monitoring site; red triangles denote more than one monitoring site; and the green circle indicates the results of a qualitative visual estimate.

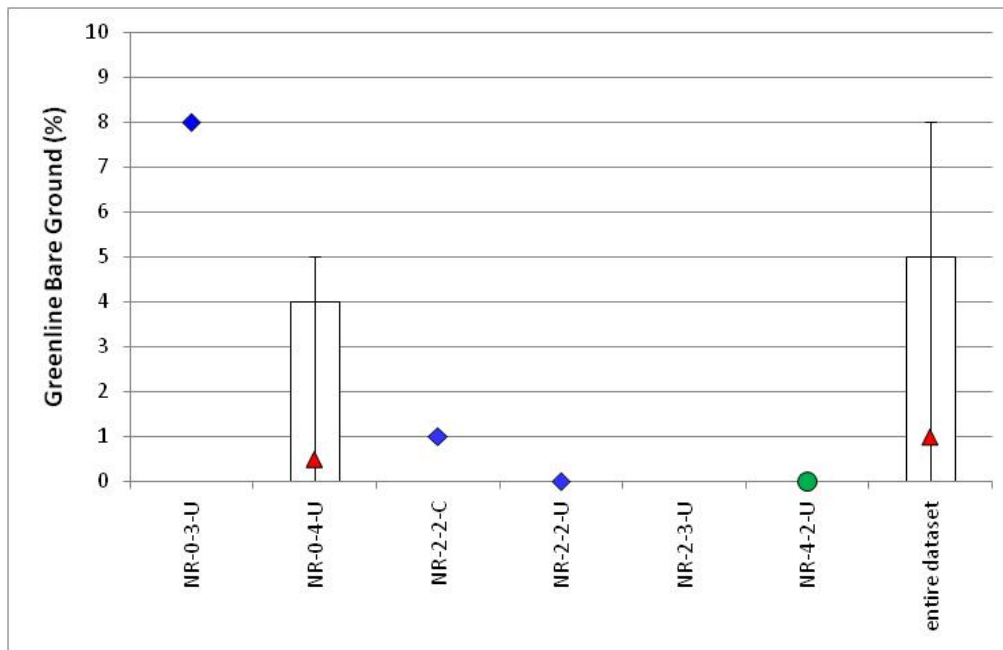
Figure 3-13. Greenline Bare Ground

Percent bare ground is an important indicator of erosion potential, as well as an indicator of land management influences on riparian habitat. Bare ground was noted in the greenline inventory where recent disturbance has resulted in exposed bare soil. Bare ground is often caused by trampling from livestock or wildlife, fallen trees, recent bank failure, new sediment deposits from overland or overbank flow, or severe disturbance in the riparian area, such as from past mining, road-building, or fire. Ground cover on streambanks is important to prevent sediment recruitment to stream channels since sediment can wash in from unprotected areas during snowmelt, storm runoff and flooding. Bare areas are also more susceptible to erosion from hoof shear. Excluding reach types with only one monitoring site, the median value for greenline bare ground was 1% in NR-0-4-U (Figure 3-13 and Table 3-14).

Blue diamonds denote reach types with one monitoring site; red triangles denote more than one monitoring site; and the green circle indicates the results of a qualitative visual estimate.

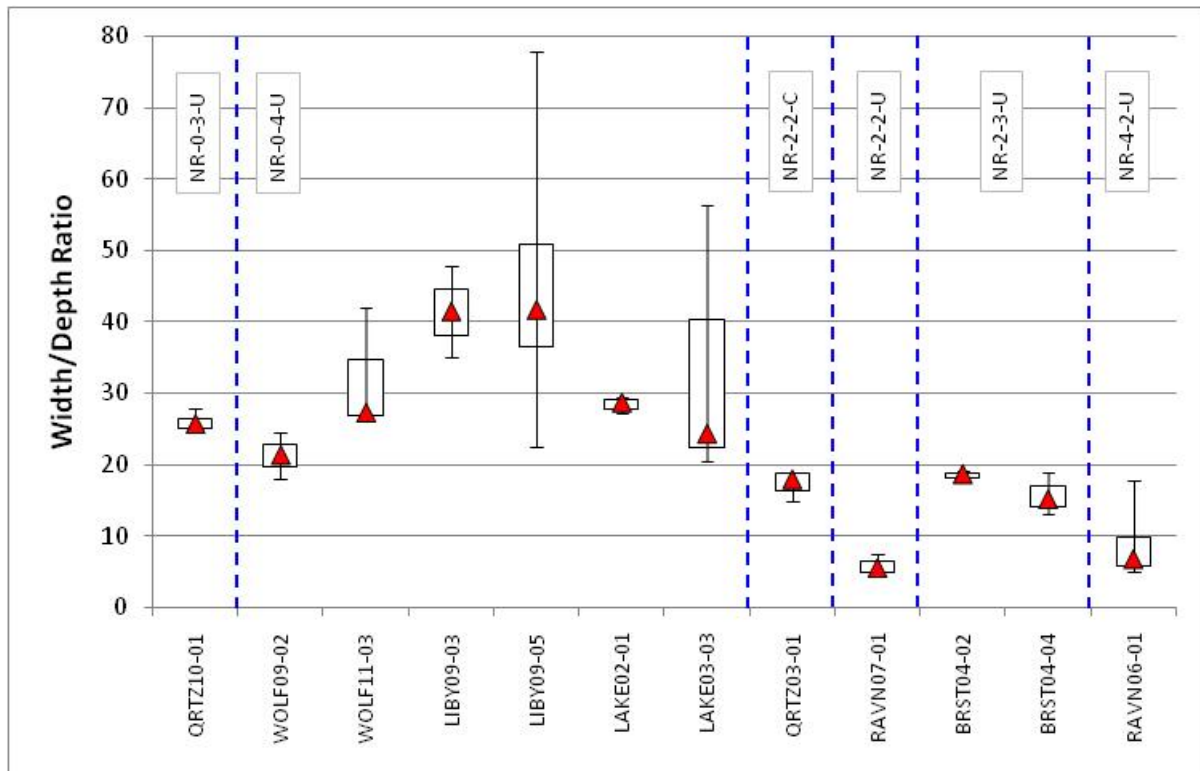
Figure 3-14. Width/Depth Ratio

The highest median width/depth ratio was observed in LIBY09-05 (**Figure 3-14**). Extensive mid-channel gravel bar deposits indicate Libby Creek is aggrading in this reach, while a review of color aerial imagery in GIS indicates this condition extends along the entire lower segment of Libby Creek. It appears that the mobile bedload is the primary source of sediment to Libby Creek, along with additional inputs from streambank erosion as the stream actively meanders across the floodplain.

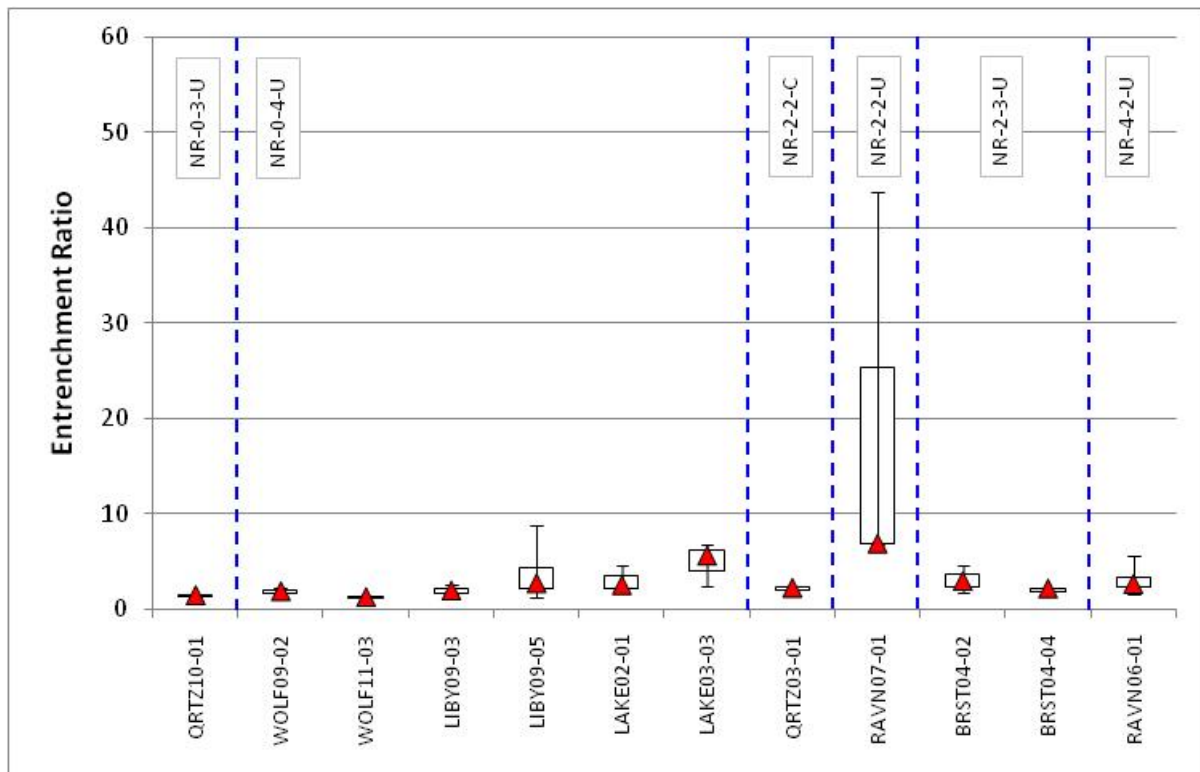
Figure 3-15. Entrenchment Ratio

Entrenchment ratio data collected within the Kootenai-Fisher Project Area indicates the following (Figure 3-15):

1. RAVN07-01 on Raven Creek has the greatest amount of floodplain access out of the sites assessed. This site was located near the confluence of Raven Creek and the Fisher River on the Fisher River floodplain.
2. Entrenched conditions (entrenchment ratio <1.4) were documented in WOLF11-03 as a result of historic channelization due to road and railroad construction.
3. Moderately entrenched conditions (entrenchment ratio 1.4-2.2) were documented in QRTZ10-01 and LIBY09-03 as the result of channelization due to road construction, while moderately entrenched conditions in WOLF09-02 appear to be the result of historic grazing and timber harvest throughout the upper watershed.

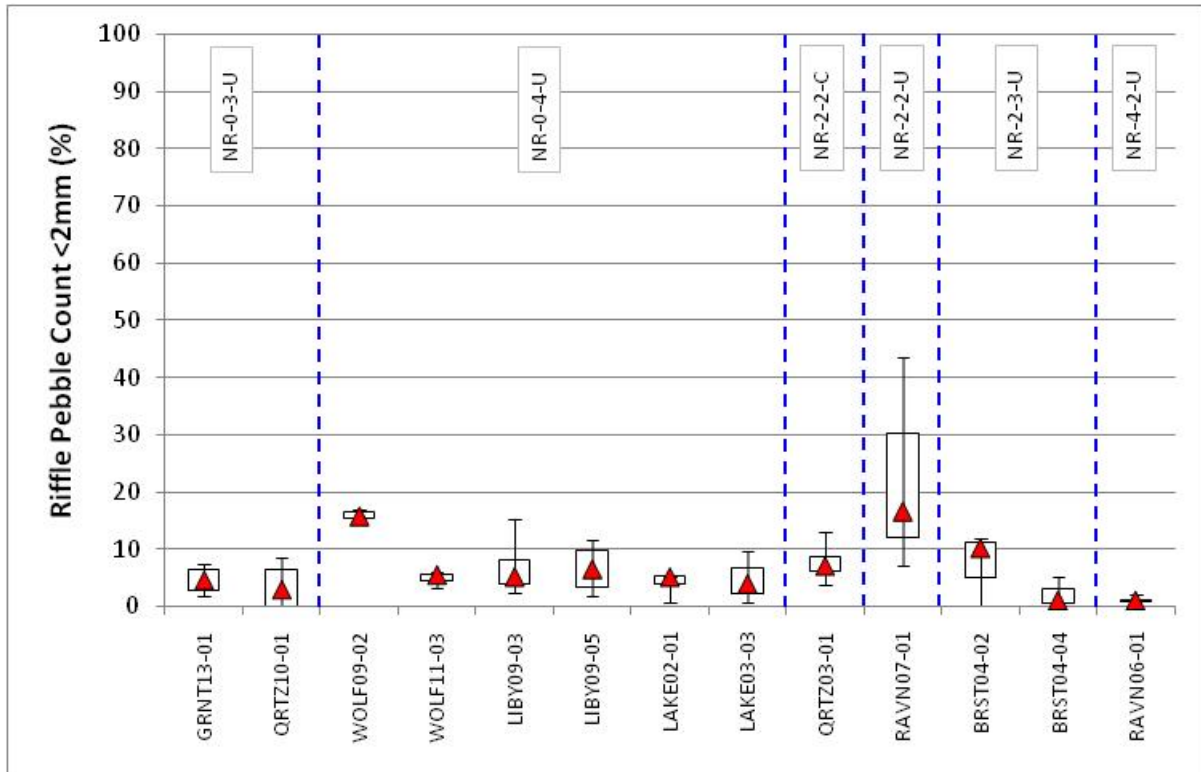
Figure 3-16. Riffle Pebble Count <2mm

The median percent of fine sediment in riffles <2mm as measured by a pebble count was highest in RAVN07-01, followed by WOLF09-02 (Figure 3-16).

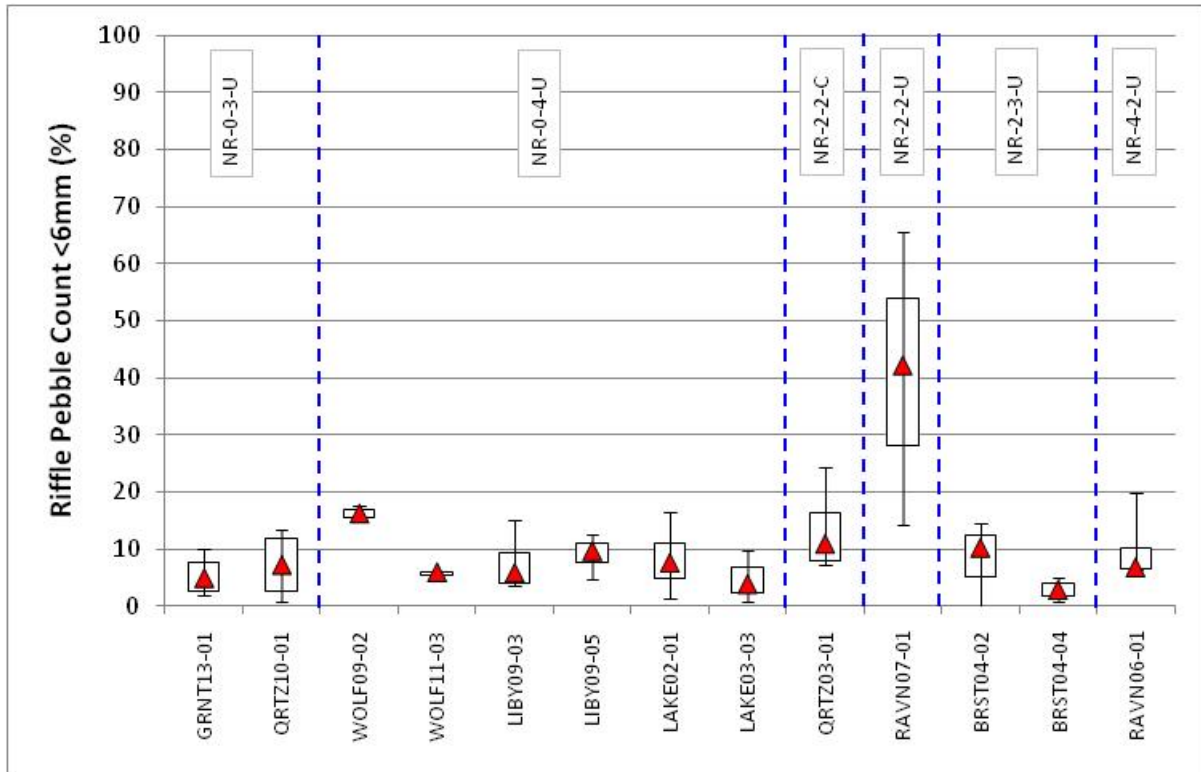
Figure 3-17. Riffle Pebble Count <6mm

The percent of fine sediment in riffles <6mm as measured by a pebble count followed a similar trend as the percent of fine sediment <2mm, with the highest median values in RAVN07-01, followed by WOLF09-02 (Figure 3-17).

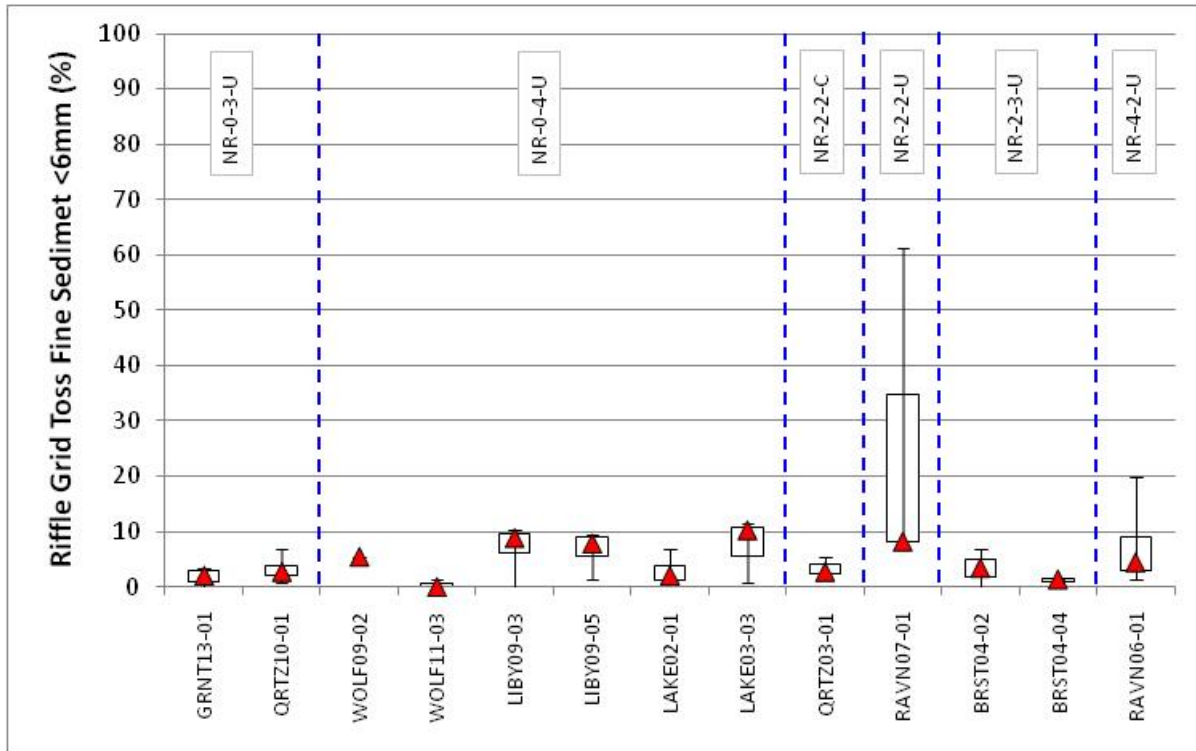
Figure 3-18. Riffle Grid Toss <6mm

The median percent of fine sediment in riffles <6mm as measured by a grid toss was highest in LAKE03-03, followed by LIBY09-03 and RAVN07-01 (Figure 3-18).

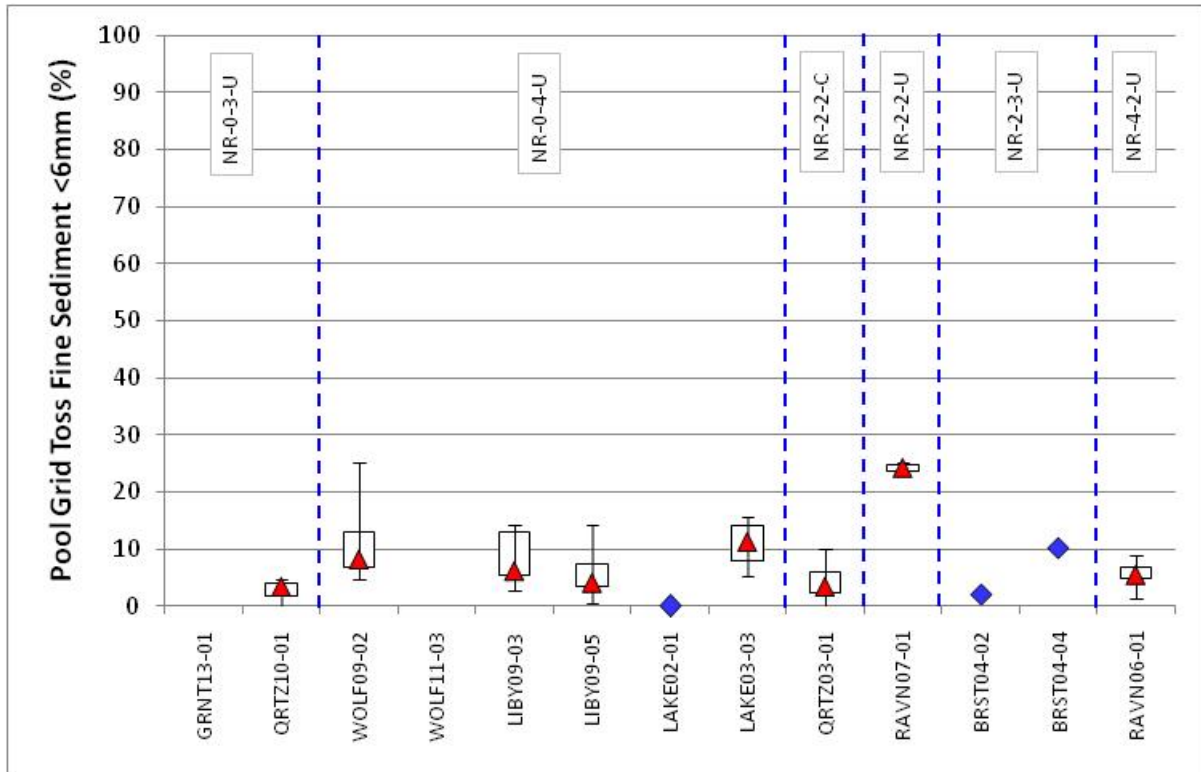
Figure 3-19. Pool Tail-out Grid Toss <6mm

Fine sediment in pool tail-outs as measured by the grid toss followed a similar pattern as the riffle grid toss. The median percent of fine sediment in pool tail-outs as measured with the grid toss was highest in LAKE03-03, followed by RAVN07-01 (Figure 3-19).

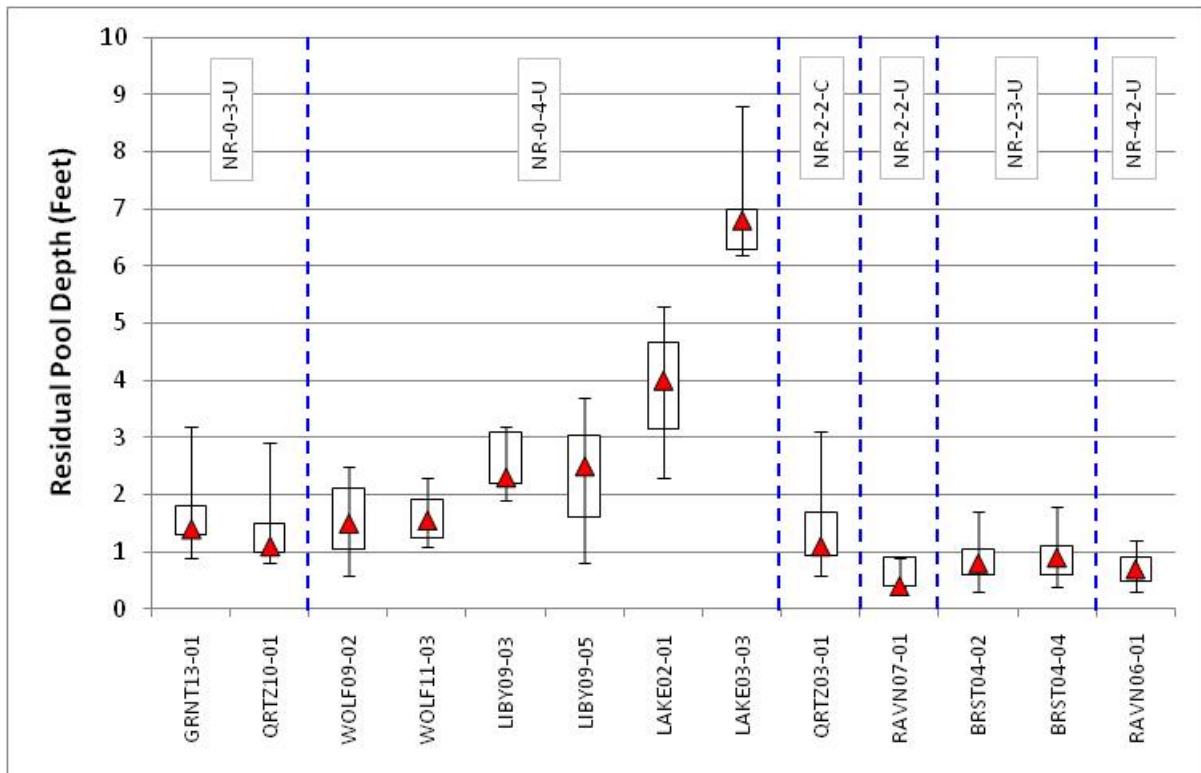
Figure 3-20. Residual Pool Depth

The greatest median residual pool depth was measured in LAKE03-03, followed by LAKE02-01, both of which contained very deep pools in which the maximum depth was estimated (**Figure 3-20**). Maximum depths were also estimated in a portion of the pools in both Libby Creek monitoring sites. The lowest residual pool depth was found in RAVN07-01, which is a small stream flowing across the Fisher River floodplain. In general, residual pool depths increase in the downstream direction within the assessed streams.

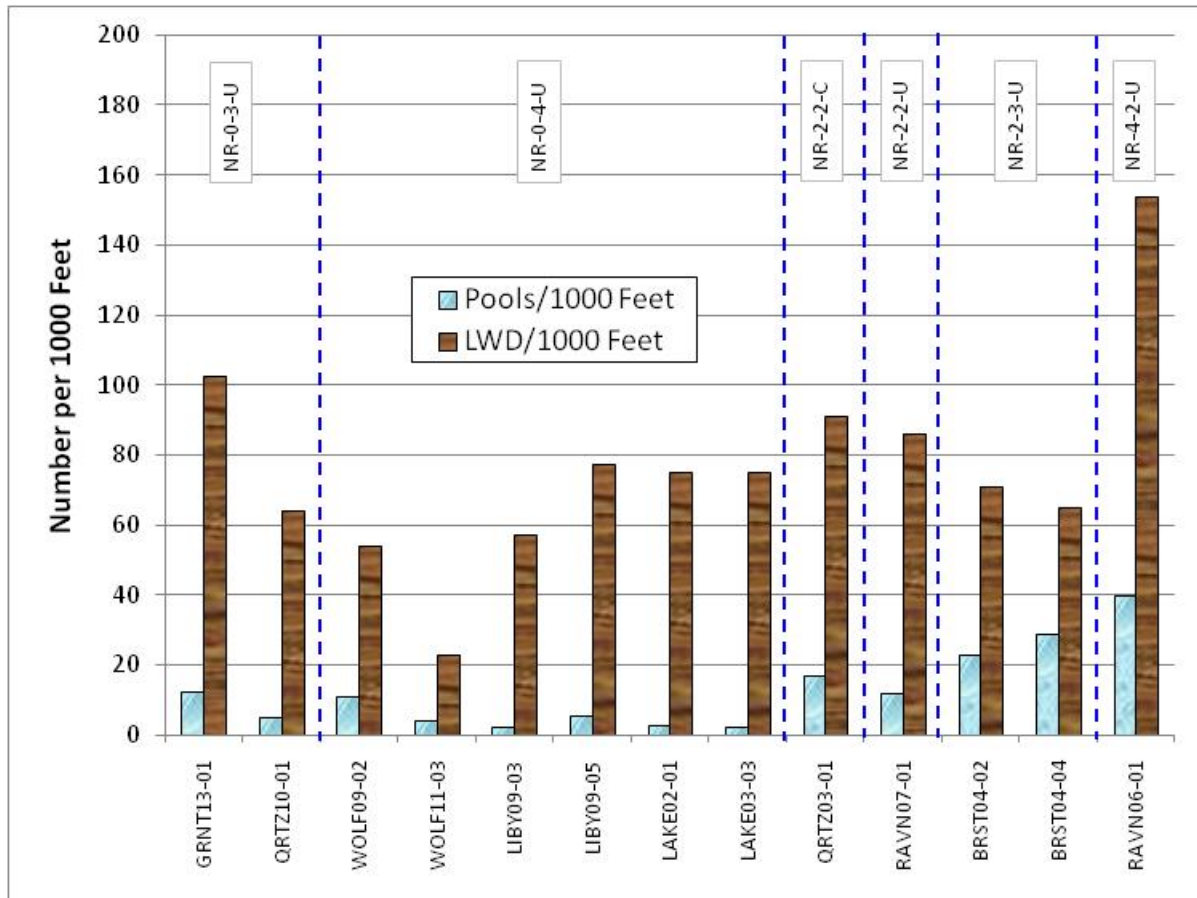
Figure 3-21. Pool and Large Woody Debris Frequency

RAVN06-01 had the greatest number of pools per 1000 feet, followed by BRST04-04 (**Figure 3-21**). Numerous small pools in RAVN06-01 on Raven Creek were formed by interactions with coarse woody debris inputs along this narrow alder-lined stream channel. Pools in BRST04-04 were typical of a cobble and boulder dominated step-pool mountain stream with frequent small pools and large substrate.

RAVN06-01 had the greatest amount of large woody debris per 1000 feet, followed by GRNT13-01, which was assessed for potential reference conditions (**Figure 3-21**). Small woody debris inputs from the alder-lined streambanks along Raven Creek comprised the majority of the large woody debris total at RAVN06-01. In GRNT13-01, the channel was lined by large cedar trees with pools formed primarily by large woody debris, which occurred both individually and in several large woody debris aggregates.

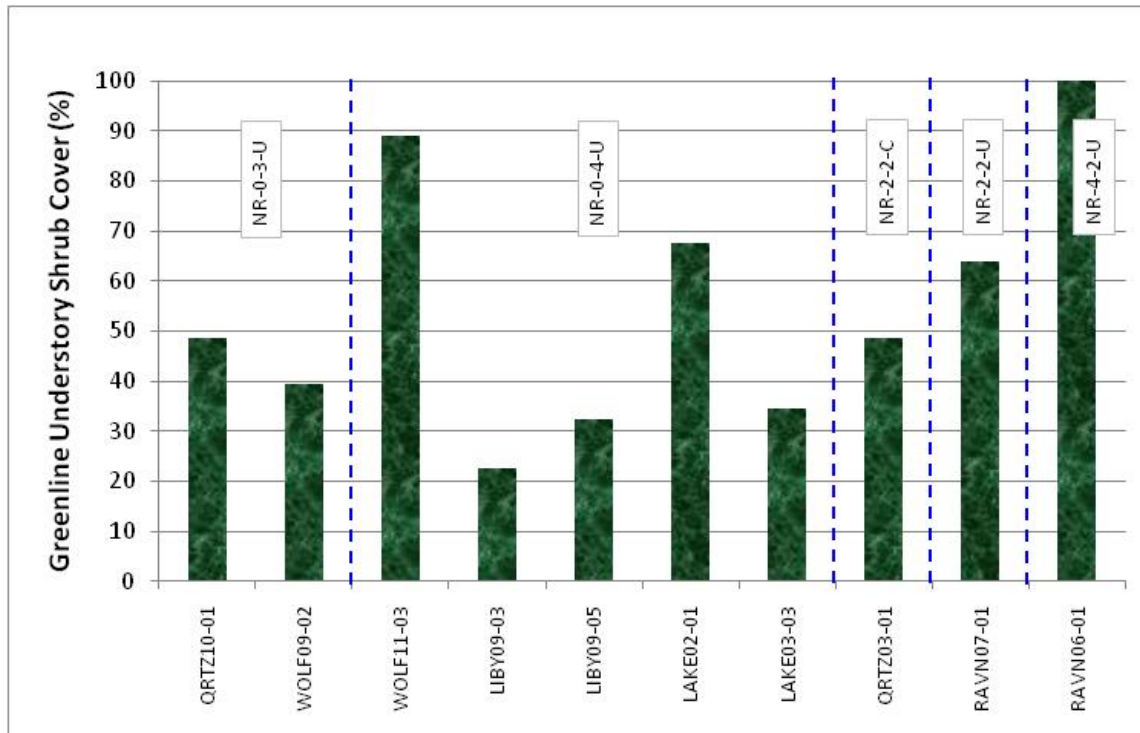
Figure 3-22. Greenline Understory Shrub Cover

Mean understory shrub cover exceeded 50% in WOLF11-03, LAKE02-01, and RAVN07-01, while mean shrub density was less than 50% in QRTZ10-01, WOLF09-01, LIBY09-03, LIBY09-05, and LAKE03-03, and QRTZ03-01 (Figure 3-22). No greenline measurements were performed in GRNT13-01, BRST04-02, or BRST04-04 since these monitoring sites were located in dense coniferous forests in which dense understory shrub cover was not an expected component of the riparian ecosystem. The greenline understory shrub cover was visually estimated as 100% along RAVN06-01 since the entire reach was lined with dense alders.

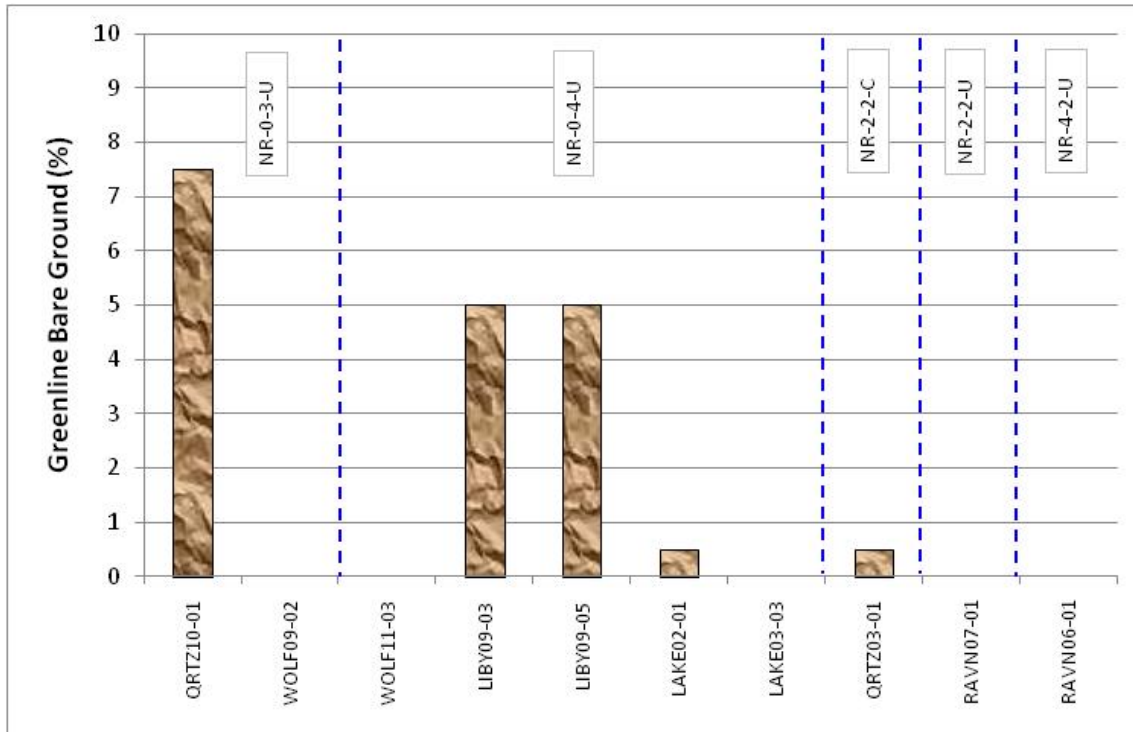
Figure 3-23. Greenline Bare Ground

Mean bare ground values equaled or exceeded 5% in QRTZ10-01, LIBY09-03, and LIBY09-05, with all other monitoring sites remaining below 5%, including RAVN06-01 in which bare ground was visually estimated (Figure 3-23).

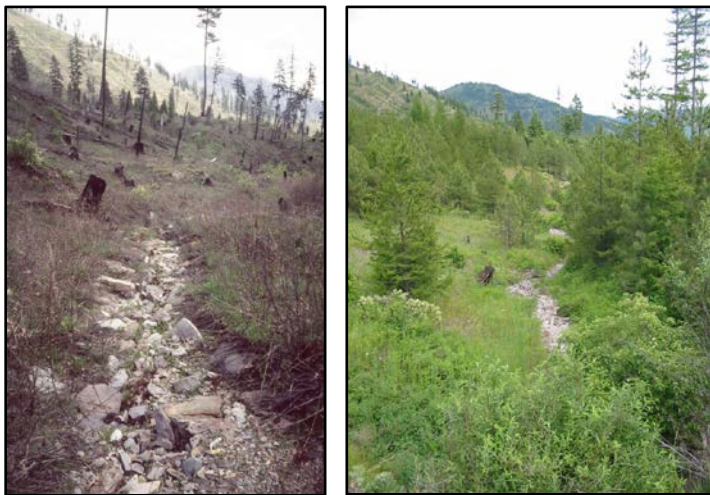
A streambank erosion assessment was performed at RAVN04-01, which was located on a dry ephemeral reach of Raven Creek upstream of a road crossing. Logging and fire appear to be the primary landscape scale disturbances along this site. The low streambanks were generally comprised of cobble and streambank erosion was likely limited by the relatively straight cascading stream channel. Grass, small shrubs, and knapweed lined the channel margin of this ephemeral reach. **Figure 3-24** shows Raven Creek in May 1994 following the fire compared to July 2011 looking downstream from the road crossing that the monitoring site was located upstream of.

Figure 3-24. Raven Creek in May 1994 (left) and July 2011 (right), photos courtesy of Plum Creek
