Lone Tree Creek TMDL Implementation Evaluation

May 2017

Water Protection Bureau
Watershed Protection Section
Mark Ockey, Water Quality Specialist

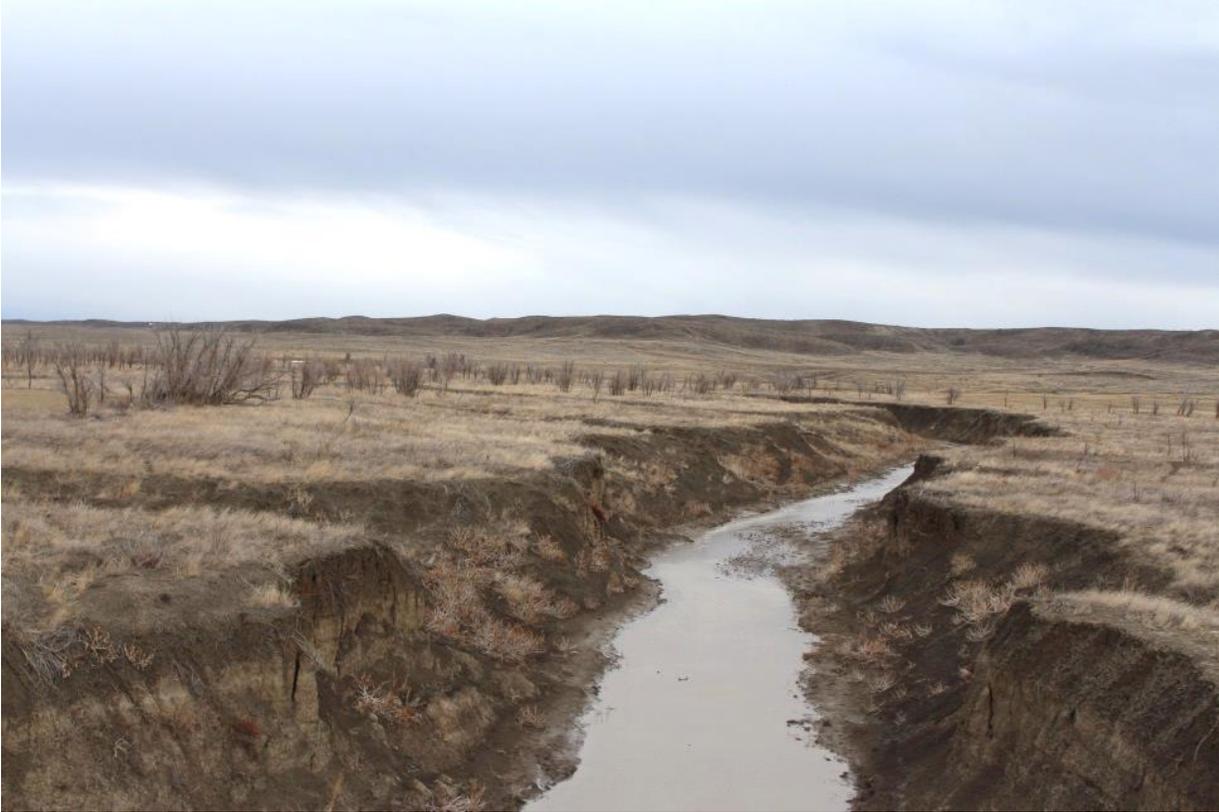
Figure 4 Headcut Through Gutshot Detention Reservoir Bottom

The Gutshot Detention Reservoir dam failed in 2009, causing a swift-moving headcut to migrate up through the soft reservoir bottom sediments, creating a canyon roughly 40 feet wide, 8 feet deep, and 2,000 feet long (Figure 4). Construction costs and lack of suitable, on-site dam building material have prevented repair. Over time, the Creek is likely to reestablish an inset floodplain within the downcut reach, resulting in the return of a more natural habitat condition.

- Figure 4 demonstrates the quantity of reservoir bottom deposits that can be eroded into the creek as a result of dam failure.
- Reservoirs can become nitrogen sinks, capable of collecting and concentrating nitrogen in plant debris, domestic and wild animal waste, and decaying aquatic organisms. Over time, nitrogen-containing organic matter can accumulate in reservoir bottom sediments. There currently is no data on nitrogen enrichment of the reservoir sediments in the Lone Tree Creek watershed.

Discussions regarding potential repair of the Gutshot Reservoir dam should consider the benefits to the Creek of not repairing it. Based on BLM's analysis, existing, on-site construction materials are not adequate for reconstruction, and bringing suitable materials into the area would likely make reconstruction cost-prohibitive. The dam used to serve as an access point for ranchers and recreationalists to get across the creek. Moving the access point to a narrower, more stable section of the valley would likely be more cost-effective than attempting to restore the dam or construct a bridge at the existing, highly unstable dam site. When the Gutshot Detention Reservoir dam failed, a headcut carved a deep, narrow channel up through the old reservoir bottom (Figure 4). Over time, processes of channel migration and streambank erosion should widen out the channel and return it to a more natural state.
