# Madison Sediment and Temperature TMDLs and Water Quality Improvement Plan - Draft

**July 2020**

Water Quality Planning Bureau  
Watershed Protection Section

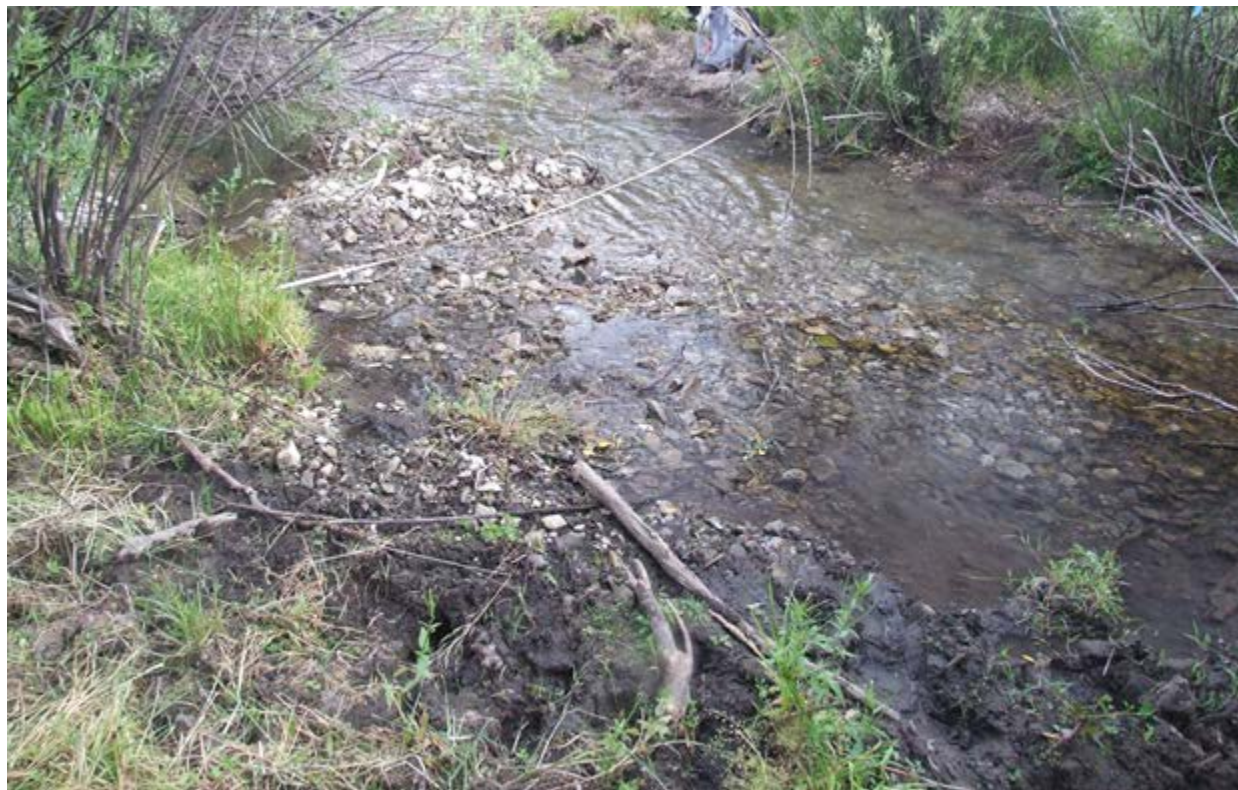
**Figure 5-2. Evidence of cattle use including pugging, hoof shear, and eroding banks at ALTP 04-02**

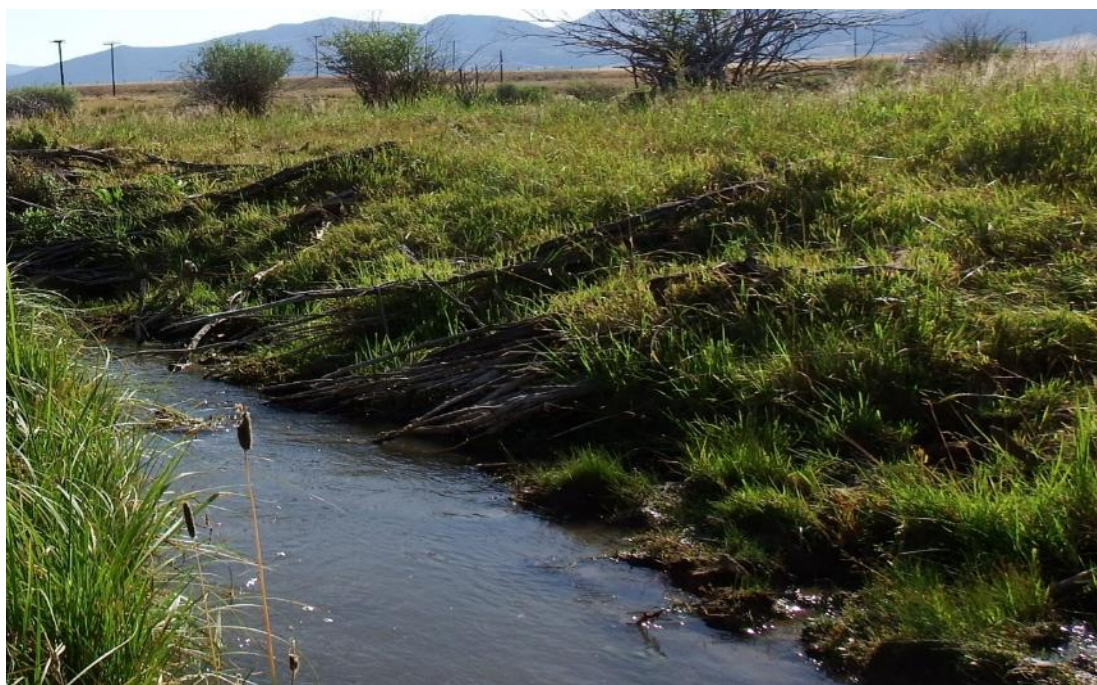
**Figure 5-3. An example of hummocking on Bear Creek**

hummocking. (**Figure 5-3**). Most of the land use impacts at this site appeared to be either historical (i.e., lack of woody vegetation, eroding banks, hummocking) or from upstream grazing (i.e., high fine sediment). Streambanks were generally stable at the site and were composed primarily of fine gravel (0-20%) and sand/clay (75-100%) with only a small amount (0-15%) being coarse gravel or larger sediment (DEQ 2015). About 18% of the site length had eroding banks with about half (52%) being attributed to natural processes and the remainder being from riparian grazing. Many fish were observed at this site. Sample diatom counts were evaluated to determine the probability of impairment for sediment using the sediment increaser taxa list for the Middle Rockies. Based on this data, a 45.8% probability existed that the sample collected at BEAR 10-01 represented a site impaired by sediment. One diatom sample collected at the site yielded a probability of 45.8% that the assemblage represented a stream impaired by sediment.

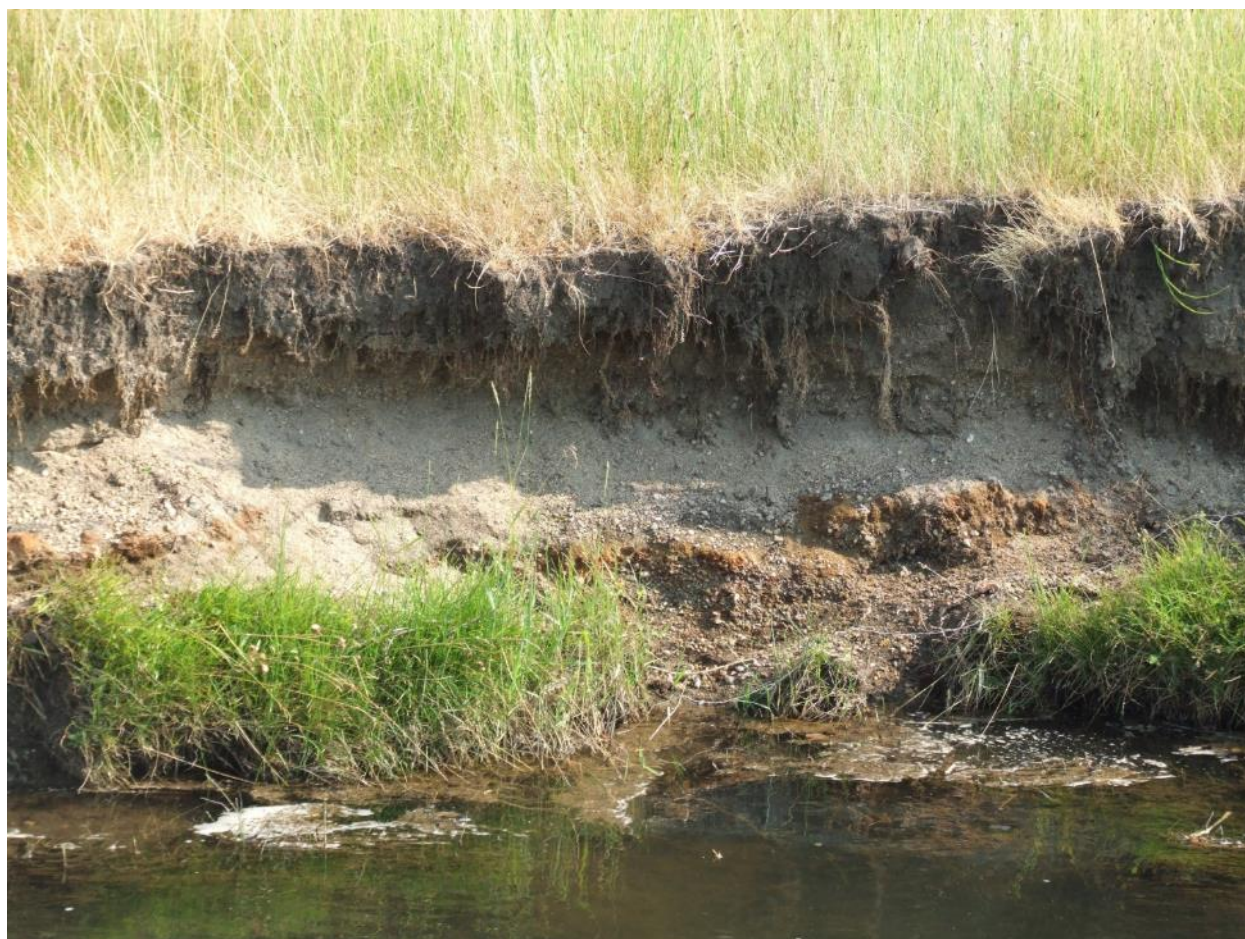
**Figure 5-5. Eroding bank displaying a layer of easily eroded sand**

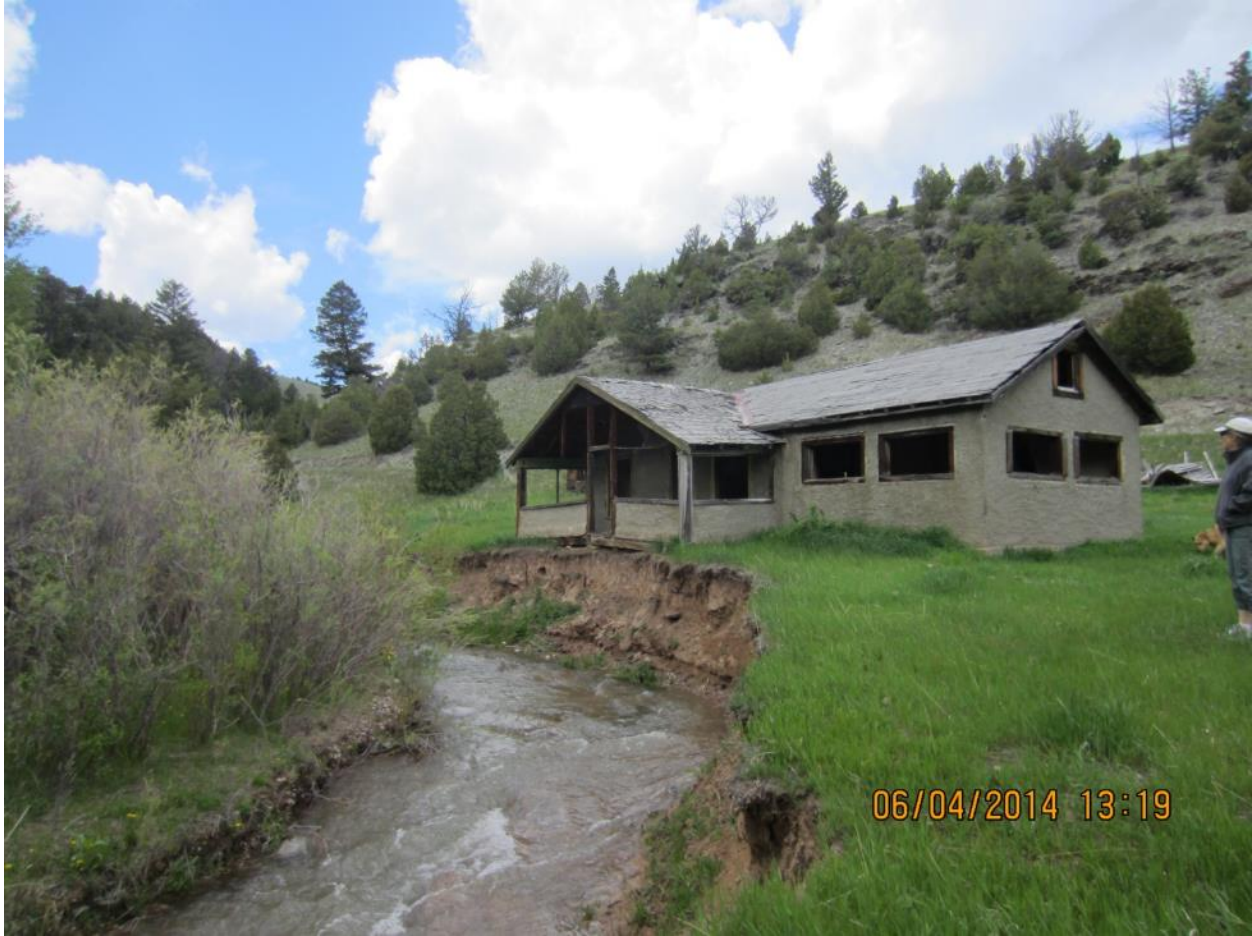
**Figure 5-6. Ruby Creek at the McAtee Homestead cabin prior to restoration in October 2015 (FWP photo by Pat Clancey)**

In October 2015, about 75 feet of channel was relocated and restored on Ruby Creek (see FWP 2014 for plan details) to address a seven-foot-tall eroding bank and prevent an historical building from falling into the creek. Before and after photos of the project site are shown in **Figures 5-6** and **5-7**, respectively.

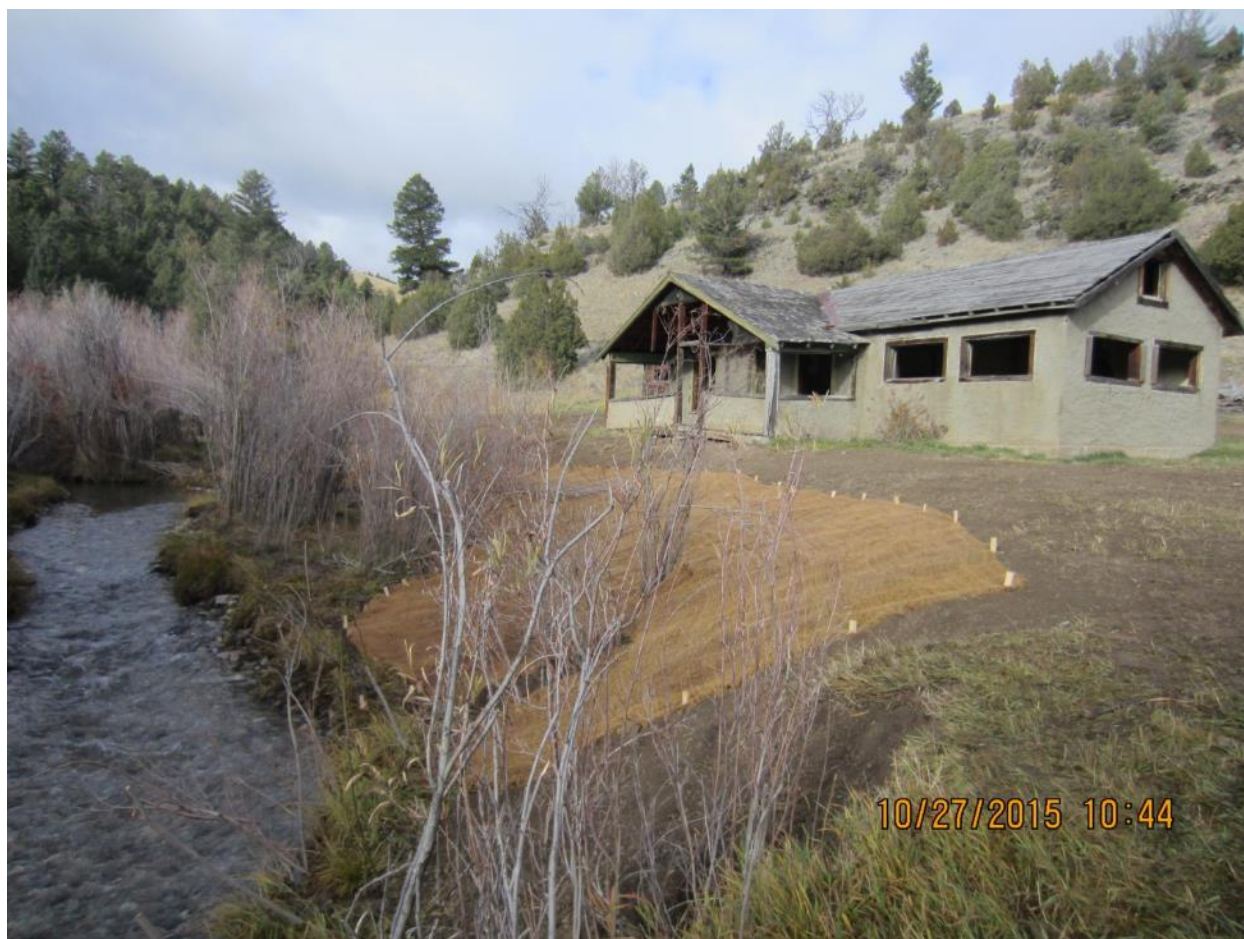
**Figure 5-7. Ruby Creek at the McAtee Homestead cabin after restoration in October 2015 (FWP photo by Pat Clancey)**

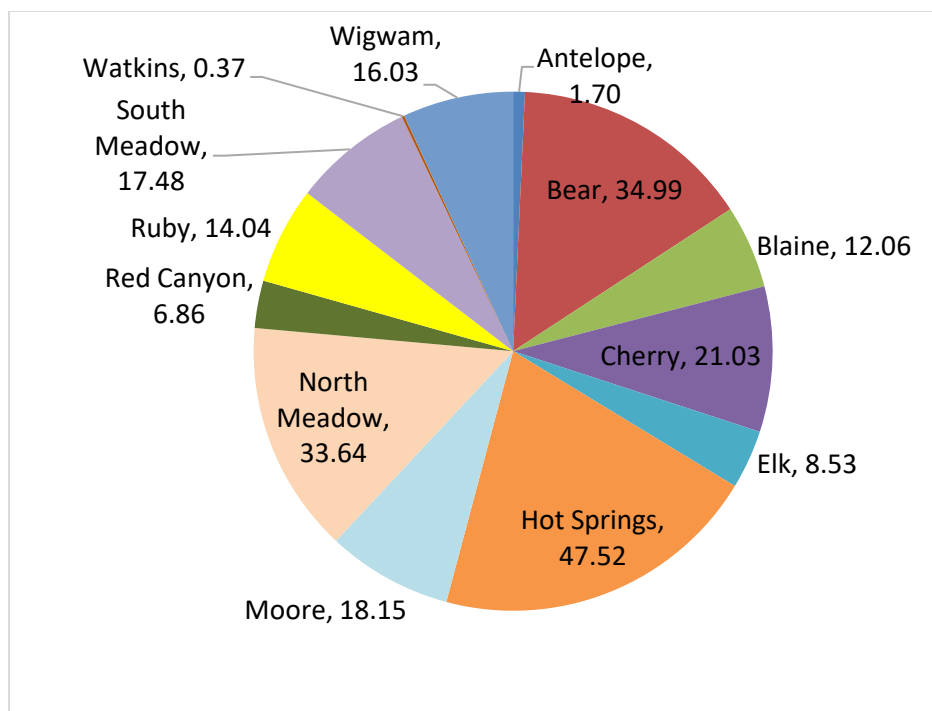
Figure 5-8. Estimated percent sediment contribution by subwatershed from unpaved road crossings and parallel road segments

Loading per stream mile may be used to more accurately assess the potential impact of roads on aquatic biota because it indicates a higher intensity of roads and more potential deposition to the stream bed. The two subwatersheds with notably higher loading per stream mile are South Meadow and Red Canyon. Antelope and Watkins have the lowest estimated sediment contributions per stream mile (**Table 5-27**).

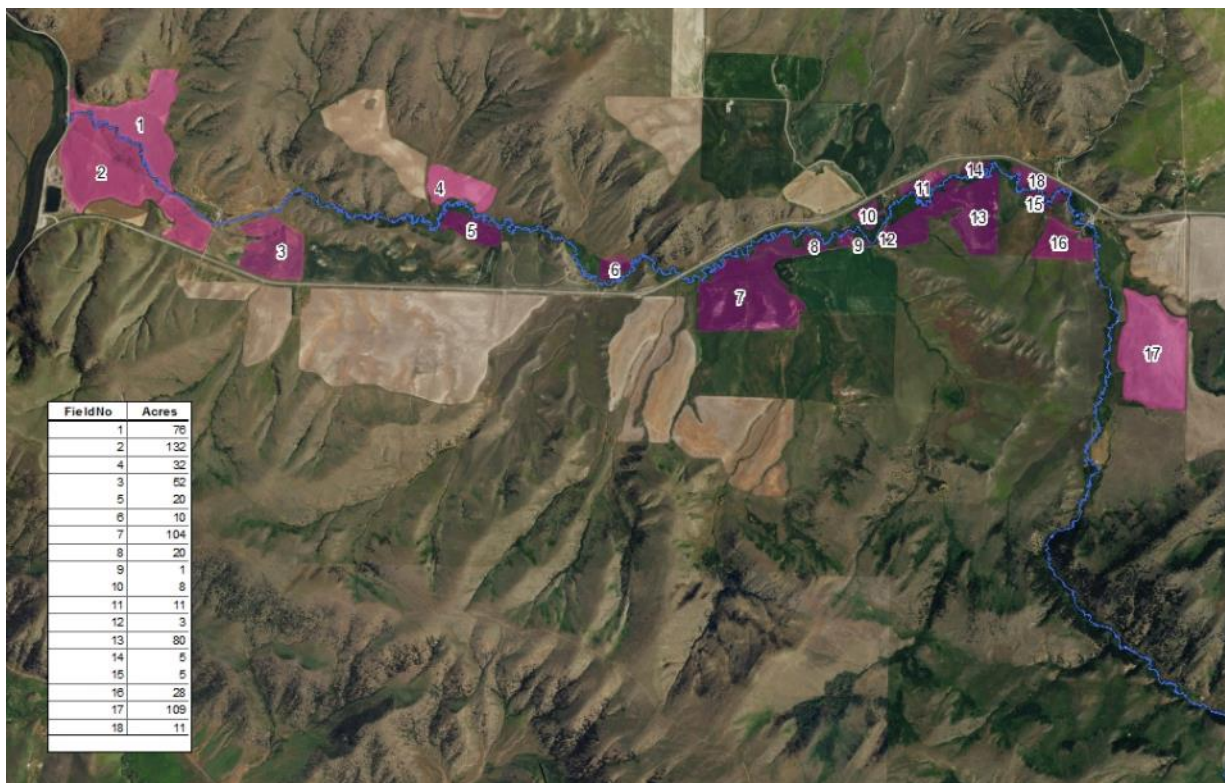
**Figure 5-9. Fields along Elk Creek identified as having an elevated sediment contribution to the stream**

DEQ conducted an analysis of upland sediment for Elk Creek, identifying numerous near stream agricultural fields may have a significant sediment contribution to the stream (**Figure 5-9**). Many of the agricultural fields have areas within 50-100 feet of the stream that have poor cover and little to no riparian buffer or buffer strips to filter sediment contribution to the stream. Collectively, these areas of ground disturbance have the potential to be significant sediment sources if proper BMPs are not implemented and maintained.

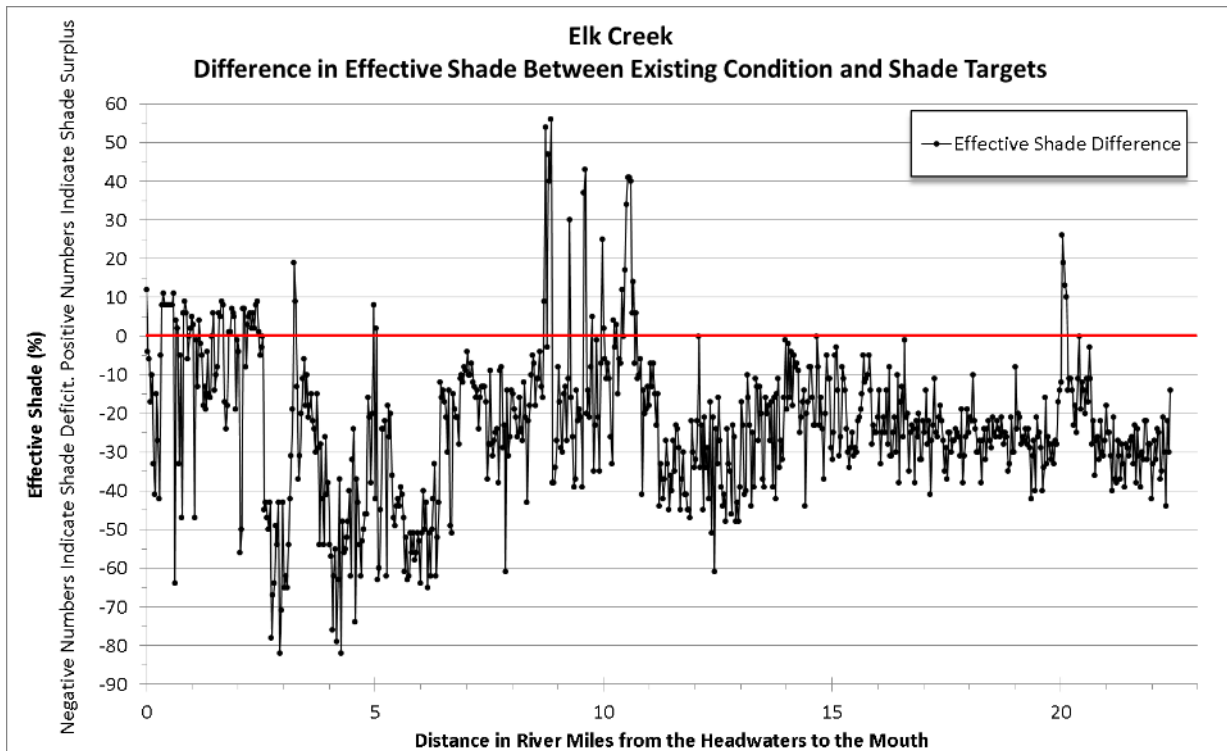
Figure 6-10. Difference in Effective Shade between Existing Condition and Shade Targets for Elk Creek

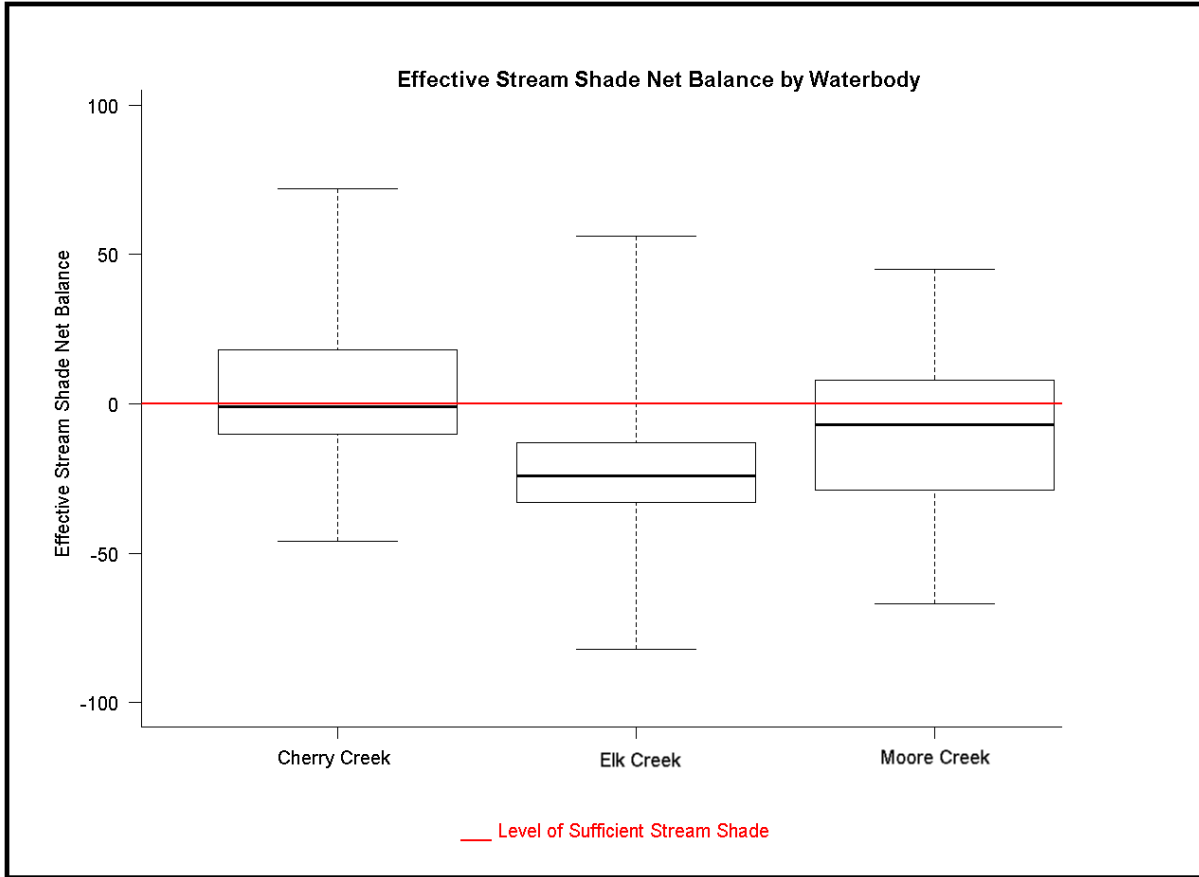
Figure 6-15. Box plot showing the effective stream shade net balance for Cherry Creek, Elk Creek, and Moore Creek

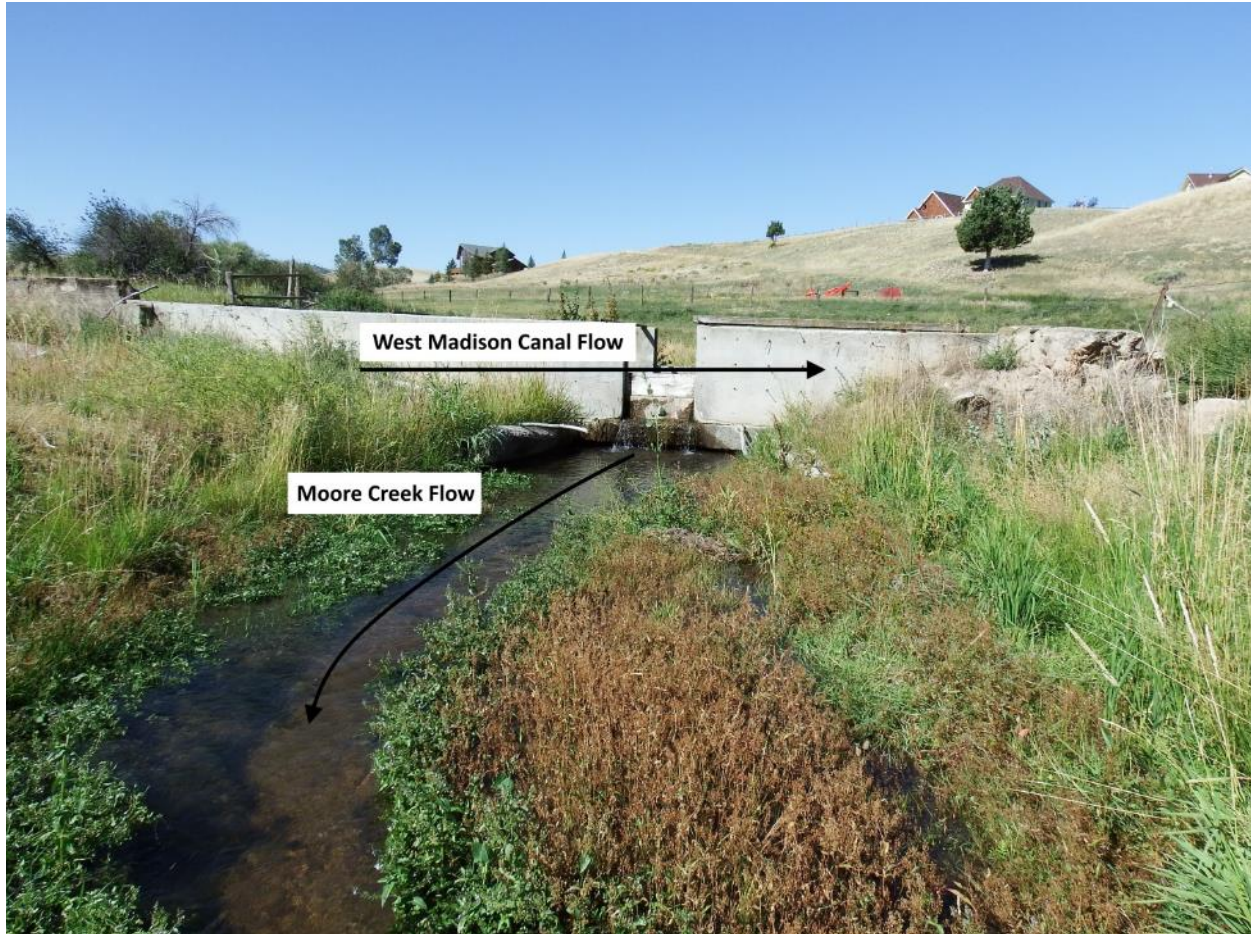
**Figure 6-22. Photo showing West Madison Canal crossing Moore Creek and mixing through leaky check-boards in the center of the photo. Headgate releases water into Moore Creek to the left of photo (off photo).**
