APPENDIX C - ANALYSIS OF BASE PARAMETER DATA AND EROSION INVENTORY DATA FOR SEDIMENT TMDL DEVELOPMENT WITHIN THE ROCK TPA

Appendix C is based on a report prepared for the DEQ by Water & Environmental Technologies, PC, June 2012, which is on file in the DEQ WQPB Library.

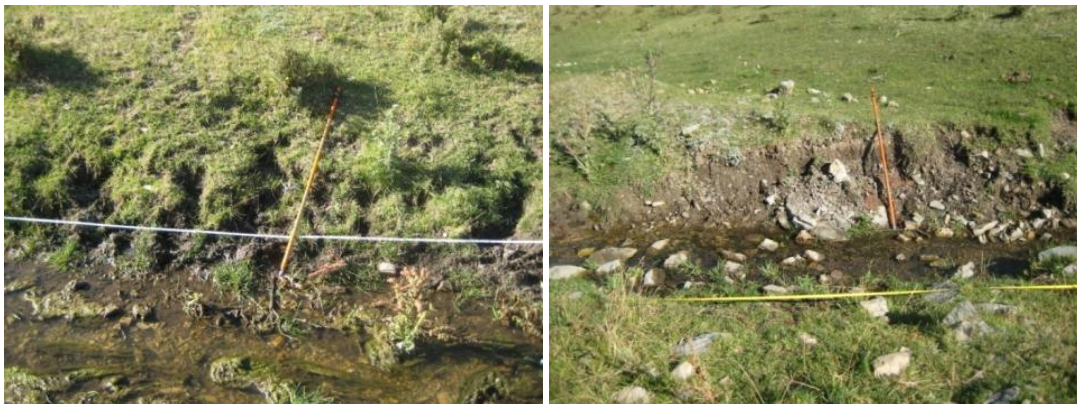
Five eroding banks were identified in this reach, including one actively eroding bank and four slowly eroding banks. Banks are typically low, grass-covered and hummocky from cattle, although the actively eroding bank is taller. Typical eroding streambank conditions are depicted for this reach in **Figure C4-1** and sediment loading results are provided in **Table C4-5**.

Figure C4-1. Typical eroding streambank conditions in Antelope Creek Reach 07-01.

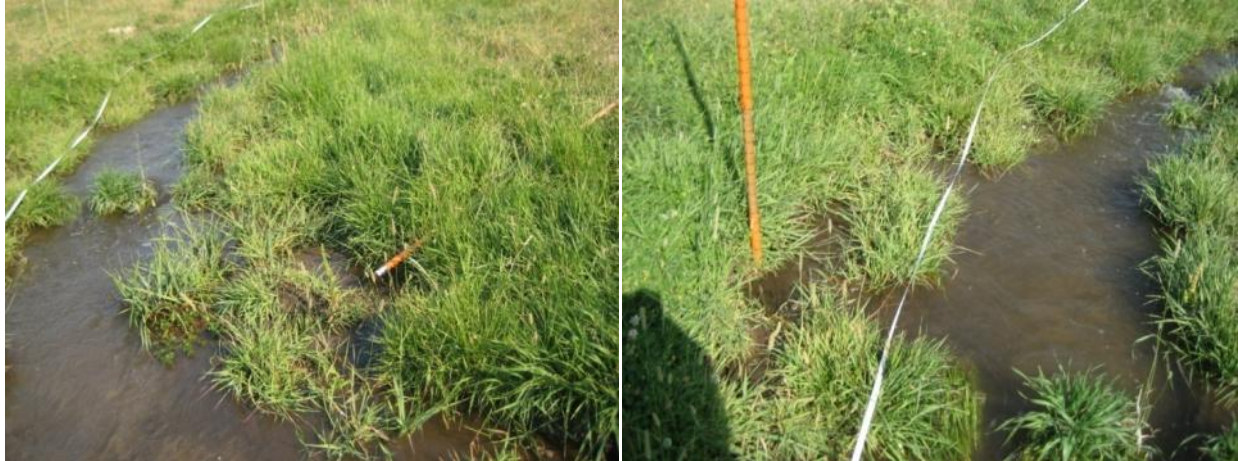
This reach had two slowly eroding banks. Eroding banks were low grass-covered banks which were heavily grazed this year, likely in spring. Hummocking occurs along the entire length of the reach. Typical eroding streambank conditions are depicted in **Figure C4-2** and sediment loading results are provided in **Table C4-5**.

Figure C4-2. Typical eroding streambank conditions in Antelope Creek Reach 21-01.

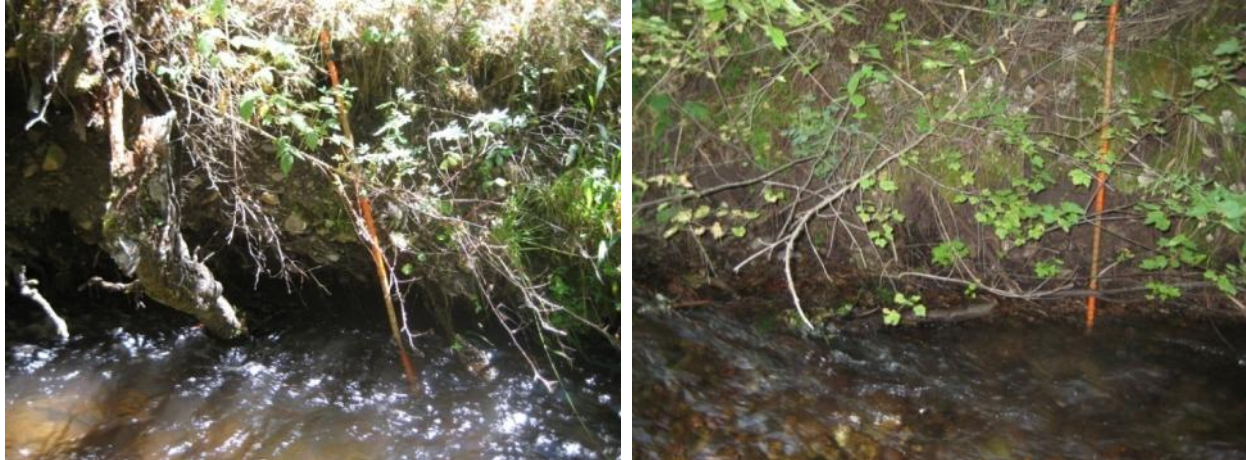
This reach has eleven slowly eroding banks. Eroding banks were typically well vegetated overhanging banks with cobble. Typical eroding streambank conditions are depicted for this reach in **Figure C4-3** and sediment loading results are provided in **Table C4-6**.

Figure C4-3. Typical eroding streambank conditions in Brewster Creek Reach 05-01.

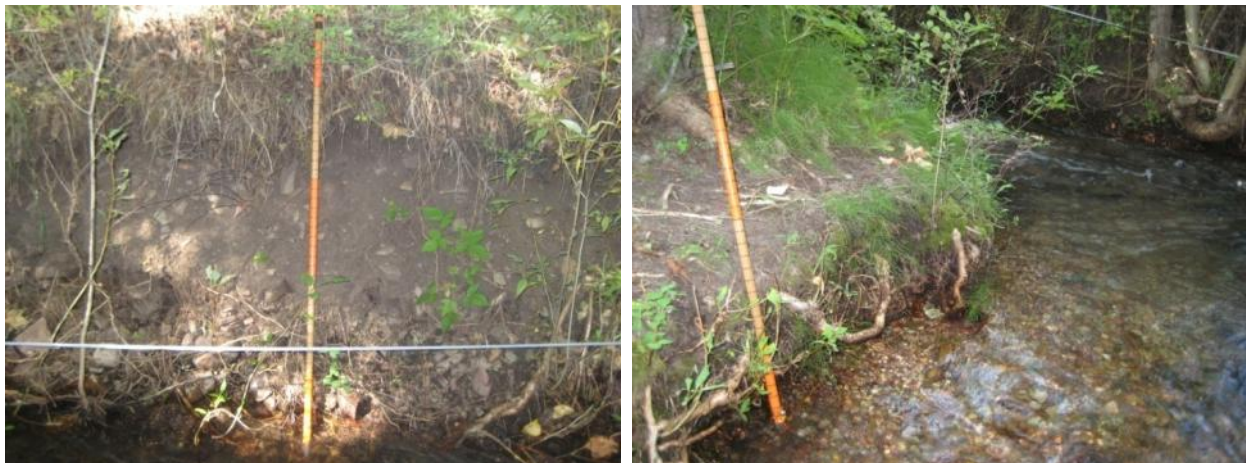
This reach had eleven slowly eroding banks with two bank types. Eroding banks are typically well vegetated with a high root density. Some banks are associated with the small bridges that cross the stream within the surveyed reach. Typical eroding streambank conditions are depicted for this reach in **Figure C4-4** and sediment loading results are provided in **Table C4-6**.

Figure C4-4. Typical eroding streambank conditions in Brewster Creek Reach 06-01.

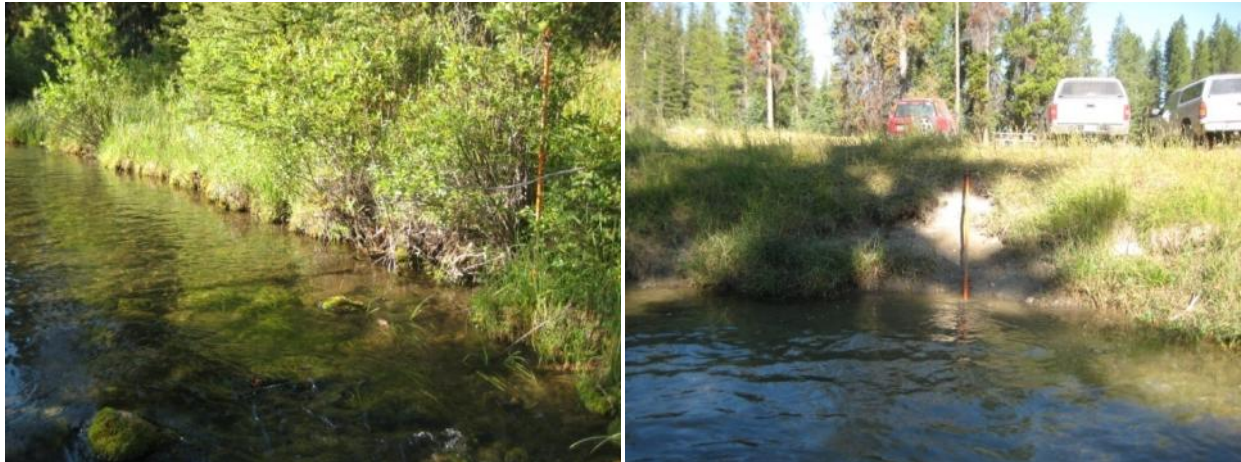
This reach has ten slowly eroding banks. Banks are generally slowly eroding, well-vegetated, undercut banks located on outside meander bends. Recreational trails have contributed to streambank erosion in some places. Typical eroding streambank conditions are depicted for this reach in **Figure C4-5** and sediment loading results are provided in **Table C4-7**.

Figure C4-5. Typical eroding streambank conditions in East Fork Rock Creek Reach 01-02.

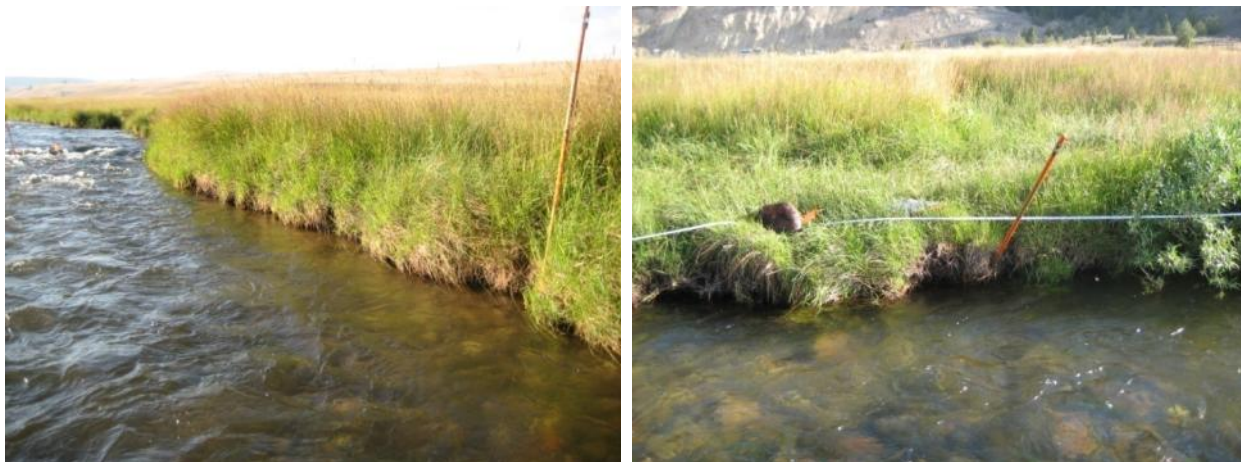
This reach has six slowly eroding banks. Eroding banks are generally well-vegetated undercut banks located on outside meander bends. Typical eroding streambank conditions are depicted for this reach in **Figure C4-6** and sediment loading results are provided in **Table C4-7**.

Figure C4-6. Typical eroding streambank conditions in East Fork Rock Creek Reach 03-03.

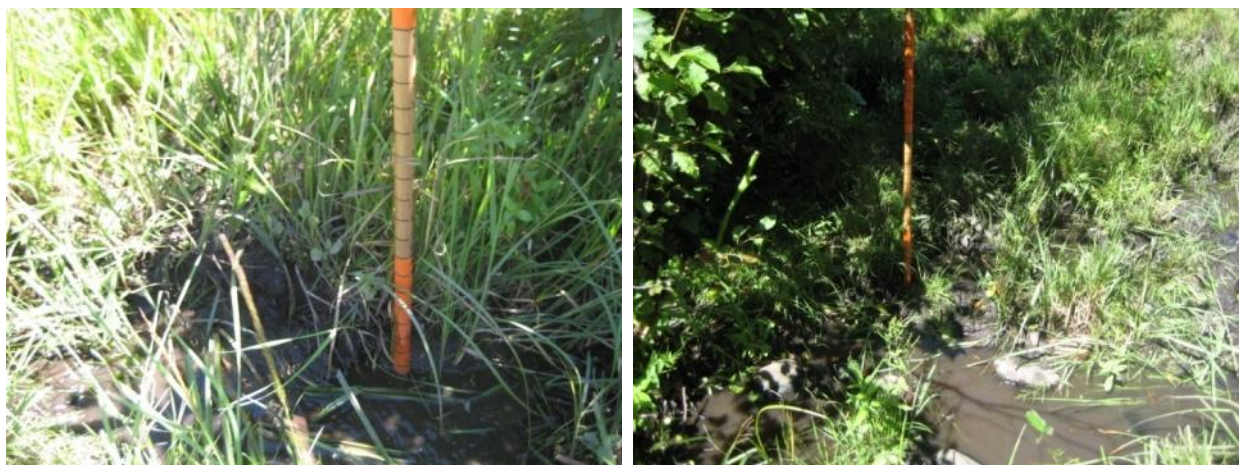
Only two eroding streambanks were identified in this reach, but they extended throughout 87% of the reach length. Eroding banks were slowly eroding vegetated banks which were severely trampled by cattle. Typical eroding streambank conditions are depicted in **Figure C4-7** and sediment loading results are provided in **Table C4-8**.

Figure C4-7. Typical eroding streambank conditions in Flat Gulch Reach 12-01.

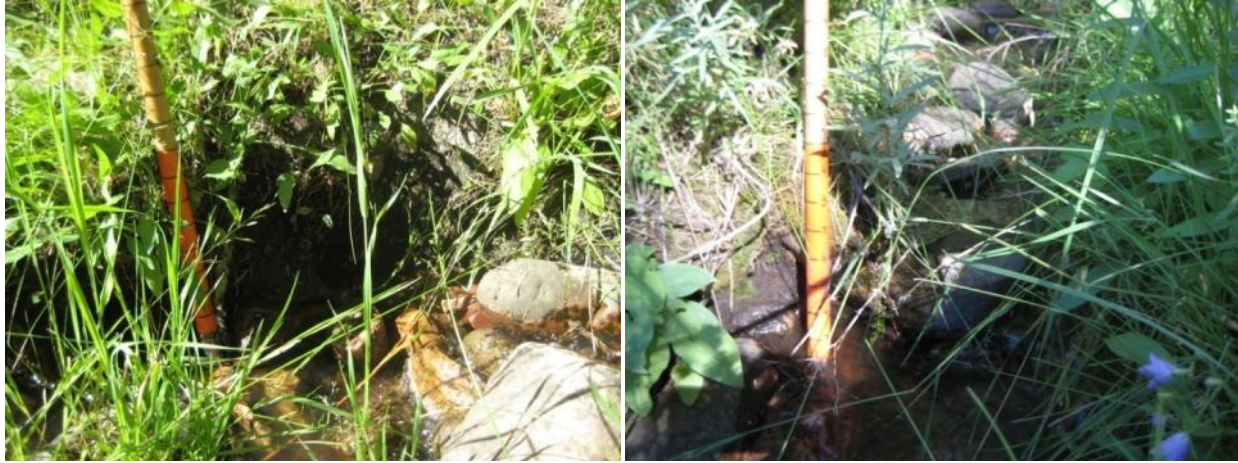
Six eroding streambanks were identified in this reach with one primary bank type. Eroding banks are low and well vegetated but show evidence of trampling. Typical eroding streambank conditions are depicted in **Figure C4-8** and sediment loading results are provided in **Table C4-8**.

Figure C4-8. Typical eroding streambank conditions in Flat Gulch Reach 13-01.

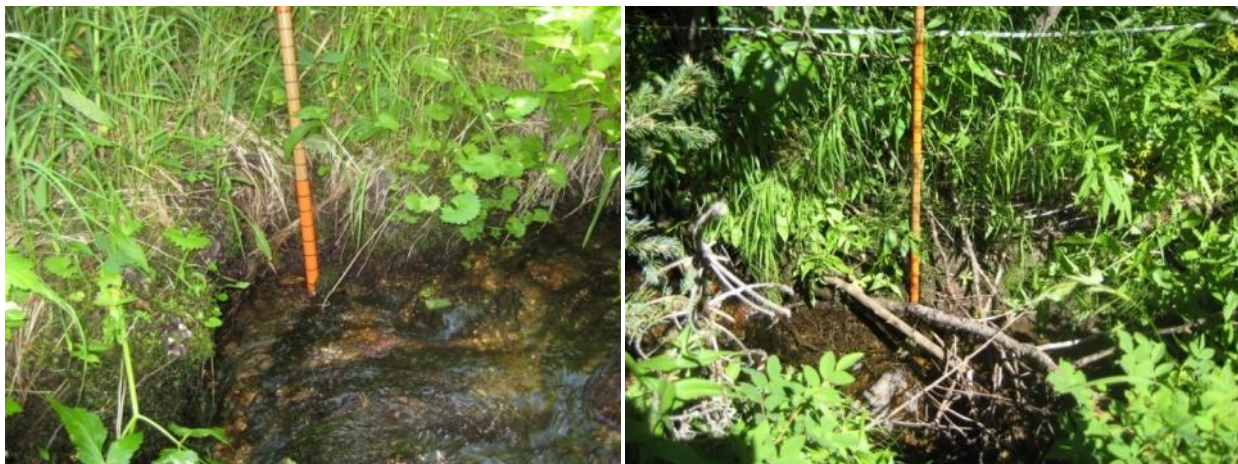
Four slowly eroding banks were identified in this reach. Eroding banks were typically slowly eroding well-vegetated banks with high root density. Typical eroding streambank conditions are depicted in **Figure C4-9** and sediment loading results are provided in **Table C4-9**.

Figure C4-9. Typical eroding streambank conditions in Miners Gulch Reach 10-02.

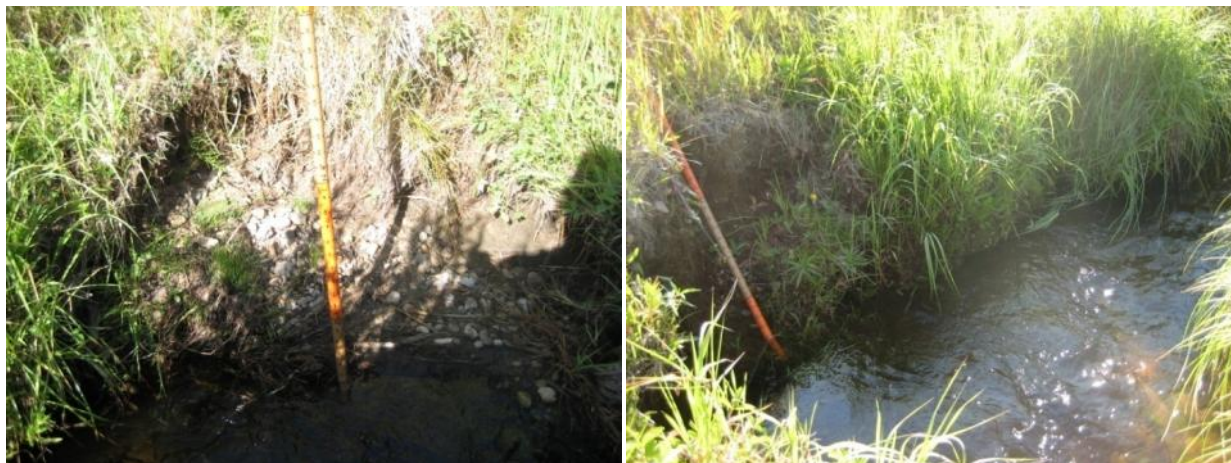
This reach had two actively eroding banks and ten slowly eroding banks. Slowly eroding banks were typically low and well vegetated. Actively eroding banks were taller and occur where banks have sloughed into the stream channel. Typical eroding streambank conditions are depicted in **Figure C4-10** and sediment loading results are provided in **Table C4-9**.

Figure C4-10. Typical eroding streambank conditions in Miners Gulch Reach 14-02.

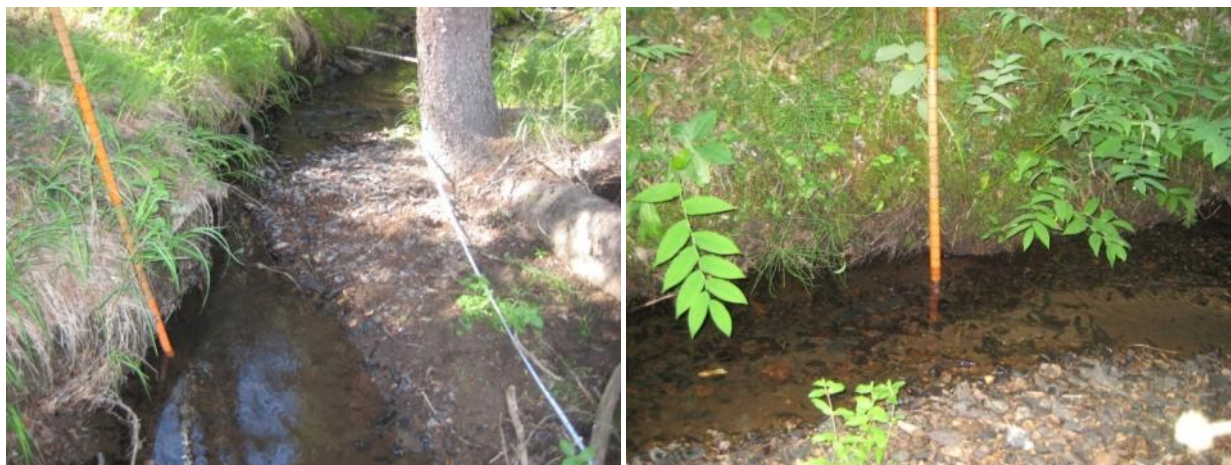
This reach has five slowly eroding streambanks. Eroding banks are well vegetated and located on outside meander bends. Typical eroding streambank conditions are shown in **Figure C4-11** and sediment loading results are provided in **Table C4-10**.

Figure C4-11. Typical eroding streambank conditions in Quartz Creek Reach 09-01.

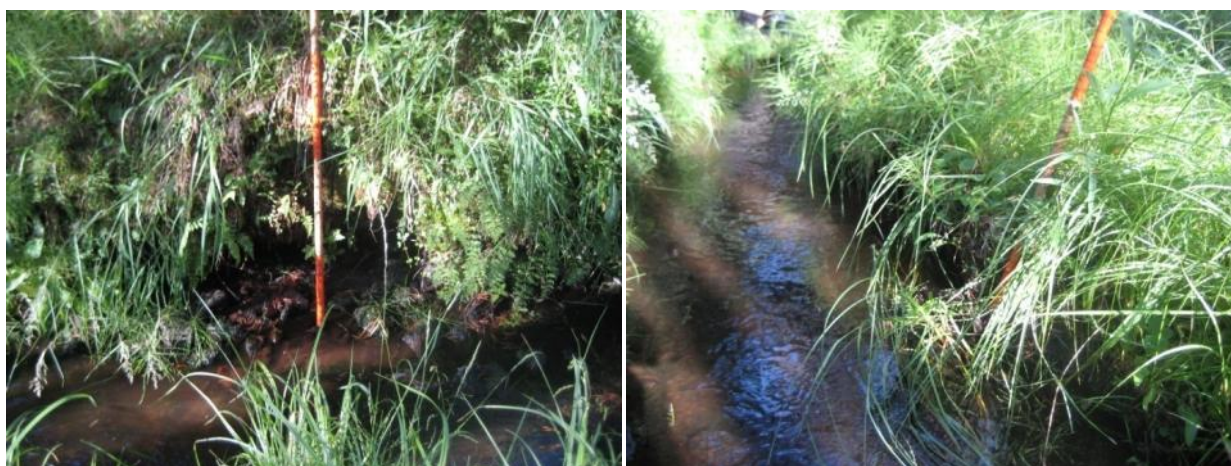
This site has eleven slowly eroding banks that are recovering from heavy grazing. Many banks are overhanging and sloughing into the stream channel. Typical eroding streambank conditions are depicted in **Figure C4-12** and sediment loading results are provided in **Table C4-11**.

Figure C4-12. Typical eroding streambank conditions in Scotchman Gulch Reach 08-01.

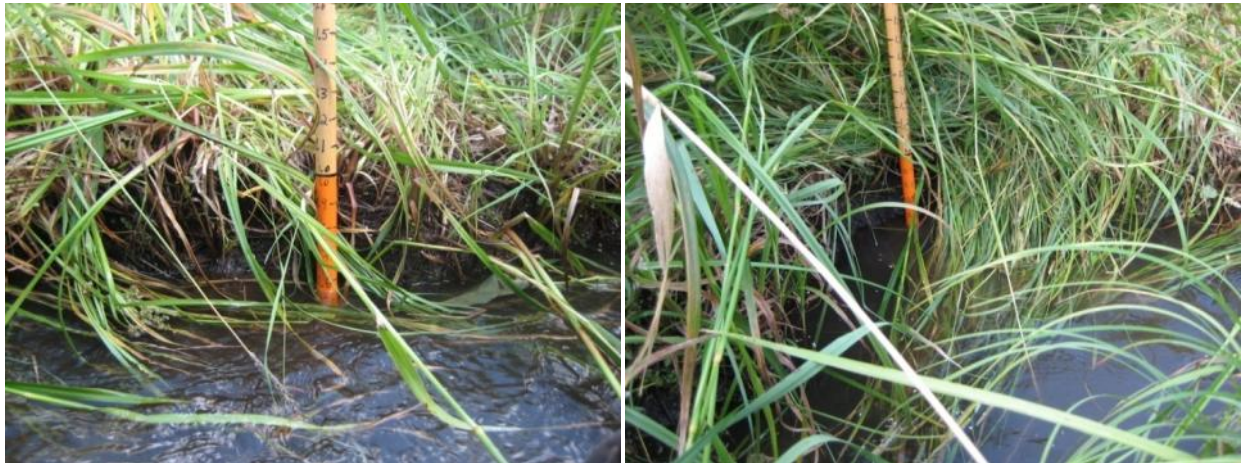
This reach has five slowly eroding streambanks which are well-vegetated, low, and occur on outside meander bends. Typical eroding streambank conditions are depicted in **Figure C4-13** and sediment loading results are provided in **Table C4-11**.

Figure C4-13. Typical eroding streambank conditions in Scotchman Gulch Reach 16-01.

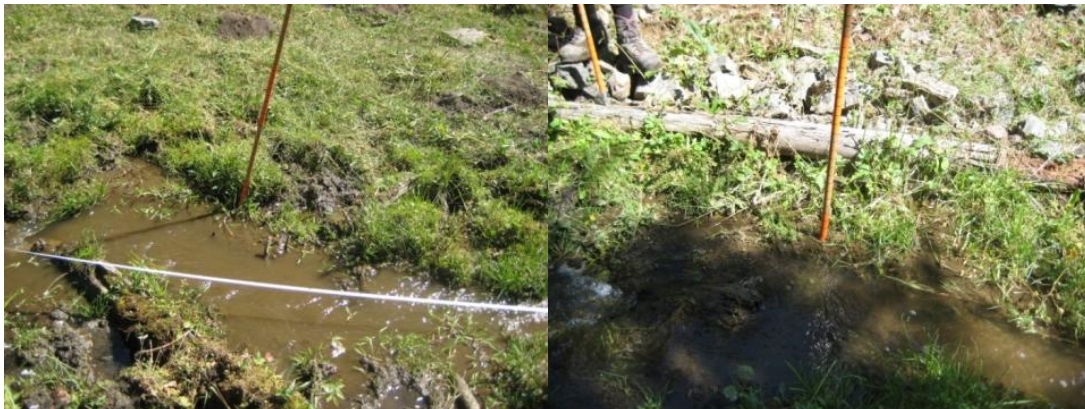
Three slowly eroding streambanks were identified in this reach, but they make up more than 73% of the entire reach. Banks are well vegetated but have been extensively trampled by cattle throughout the reach. Typical eroding streambank conditions are depicted in **Figure C4-14** and sediment loading results are provided in **Table C4-12**.

Figure C4-14. Typical eroding streambank conditions in South Fork Antelope Creek 06-01.

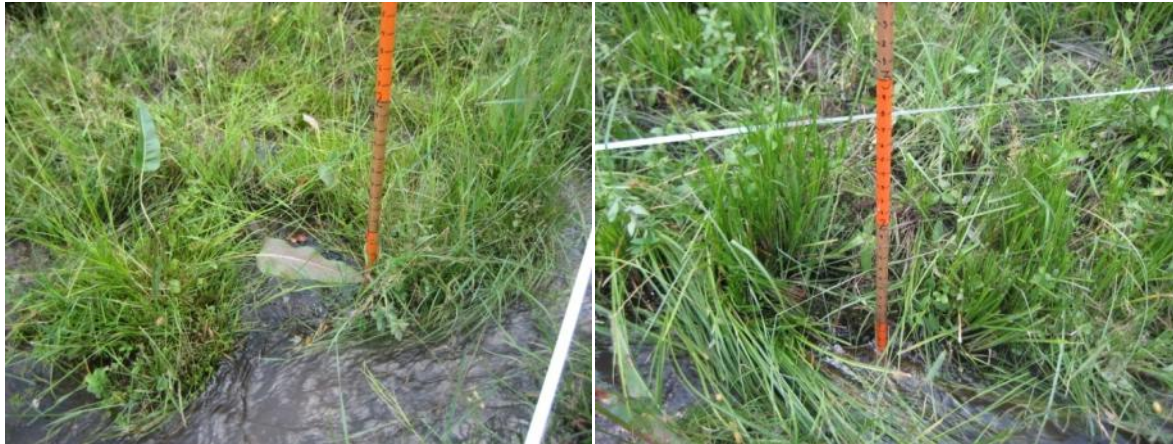
Just two slowly eroding streambanks were identified in this reach, but they comprise nearly 95% of the entire reach. Banks are slowly eroding and well vegetated with a dense root mass, but suffer from extensive cattle grazing. Typical eroding streambank conditions are depicted in **Figure C4-15** and sediment loading results are provided in **Table C4-12**.

Figure C4-15. Typical eroding streambank conditions in South Fork Antelope Creek 13-01.

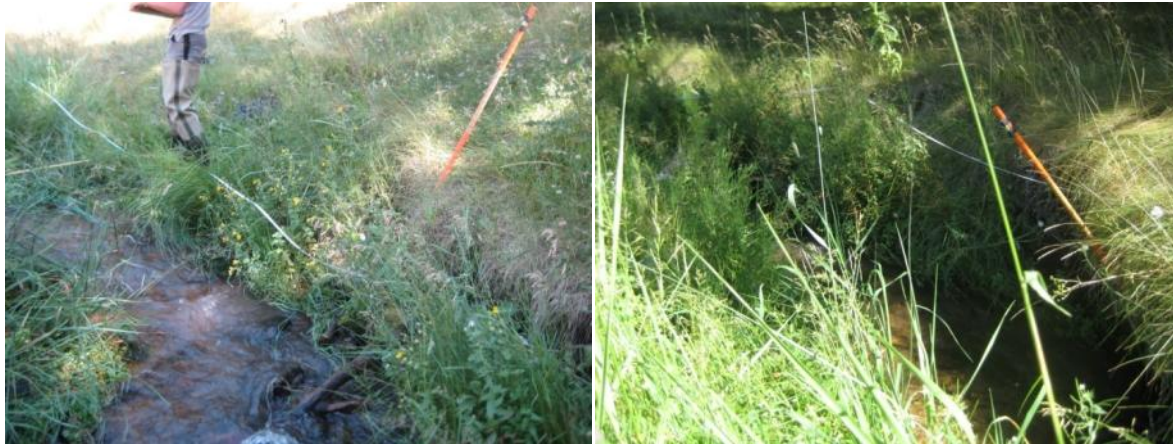
This reach has seven slowly eroding banks, which are recovering from historic grazing and are well vegetated with grasses and weeds with high surface protection. Typical eroding streambank conditions are depicted in **Figure C4-16** and sediment loading results are provided in **Table C4-13**.

Figure C4-16. Typical eroding streambank conditions in Sluice Gulch Reach 14-01.

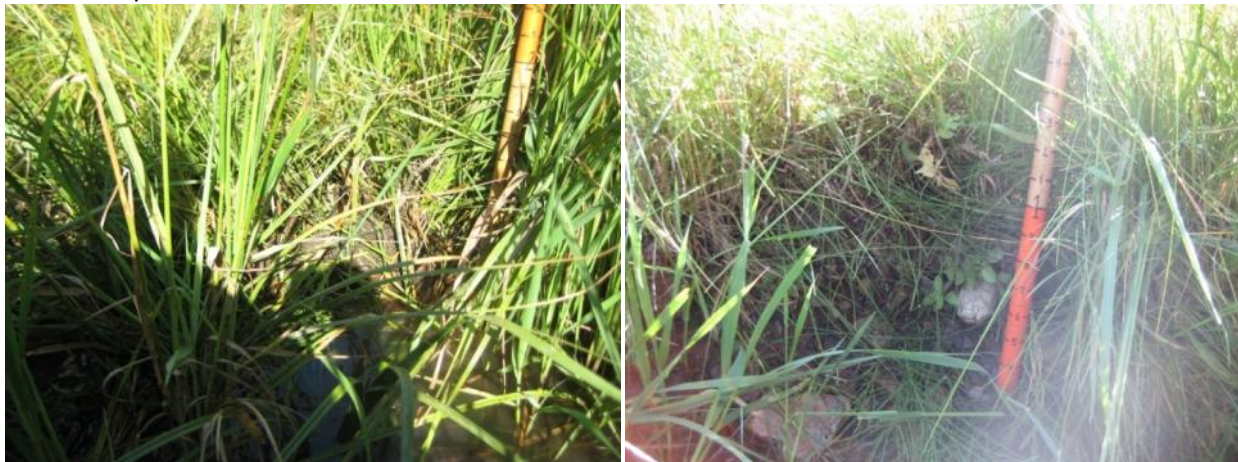
This reach has two slowly eroding banks that extend throughout the entire reach length. Banks are stable and well vegetated with tall grasses. Signs of recent grazing exist which causes pugging along the entire reach. Typical eroding streambank conditions are depicted in **Figure C4-17** and sediment loading results are provided in **Table C4-13**.

Figure C4-17. Typical eroding streambank conditions in Sluice Gulch Reach 18-02.

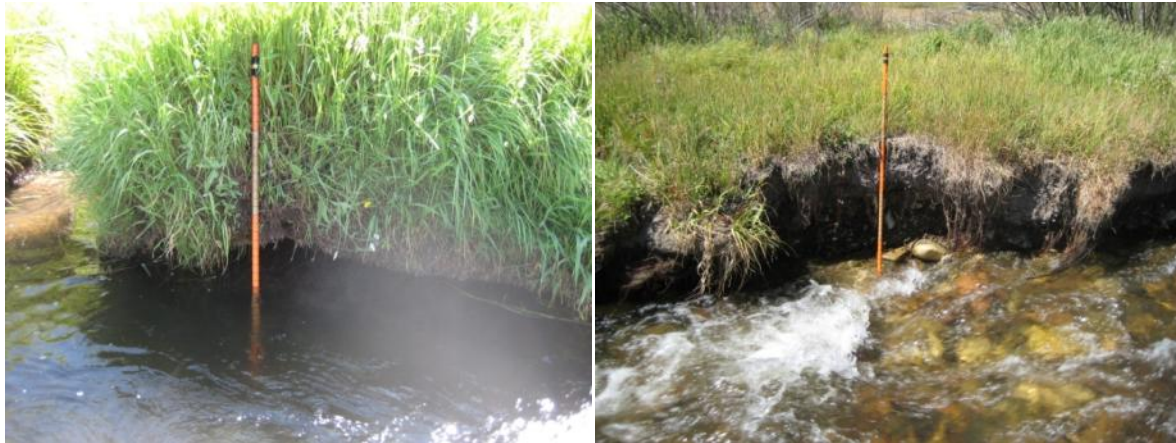
This reach has one actively eroding bank and eleven slowly eroding banks. Slowly eroding banks are typically near vertical and well vegetated, typically occurring on outside meander bends. The actively eroding bank has a cobble bottom that is eroding away. Typical eroding streambank conditions are depicted in **Figure C4-18** and sediment loading results are provided in **Table C4-14**. A slowly eroding bank is shown on the left, and the actively eroding bank is shown on the right.

Figure C4-18. Typical eroding streambank conditions in Upper Willow Creek Reach 11-05.

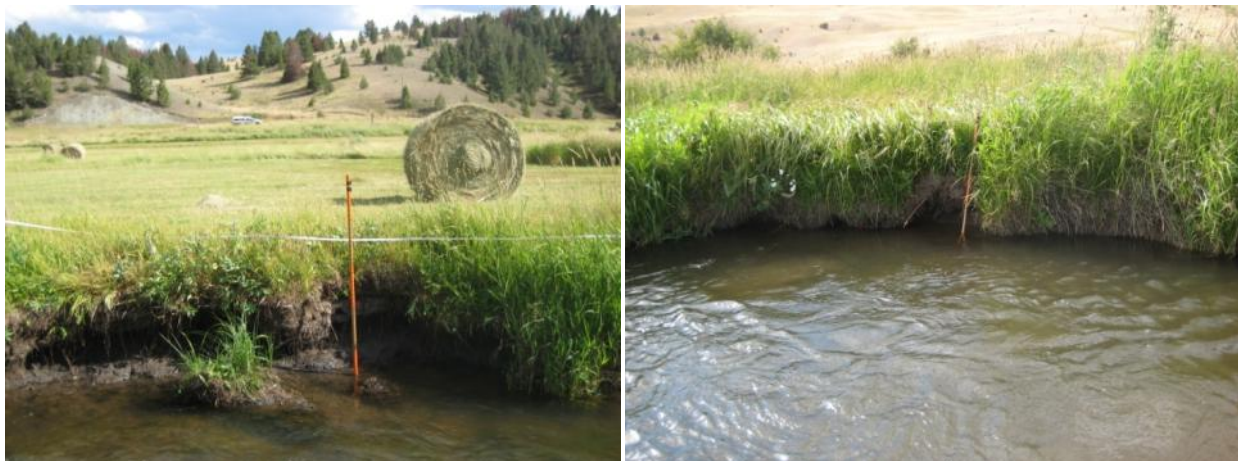
This site has two distinct bank types, including actively eroding banks with large portions of bank sloughing into the stream, and slowly eroding well-vegetated banks with undercuts. Both occur on outside meander bends. Typical eroding streambank conditions are depicted in **Figure C4-19** and sediment loading results are provided in **Table C4-14**. An actively eroding bank is shown on the left, and a slowly eroding bank is shown on the right.

Figure C4-19. Typical eroding streambank conditions in Upper Willow Creek Reach 15-01.

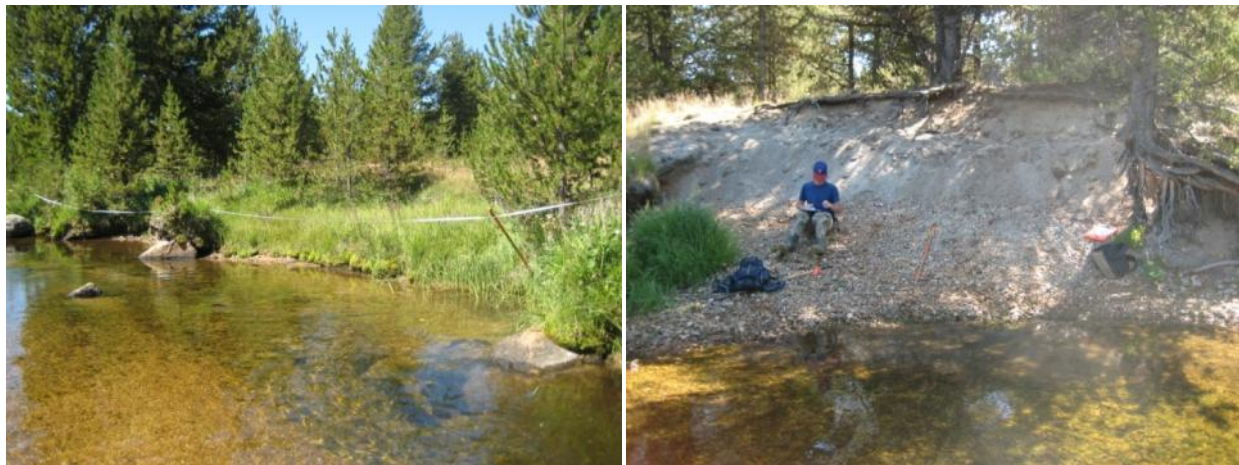
This reach has twelve slowly eroding streambanks that are generally well-vegetated and undercut. One large exposed bank appears to be created from an excavation area and has no vegetation or surface protection. Typical eroding streambank conditions are depicted in **Figure C4-20** and sediment loading results are provided in **Table C4-15**. Typical bank conditions are shown on the left, while the excavated bank is shown on the right.

Figure C4-20. Typical eroding streambank conditions in West Fork Rock Creek 14-03.

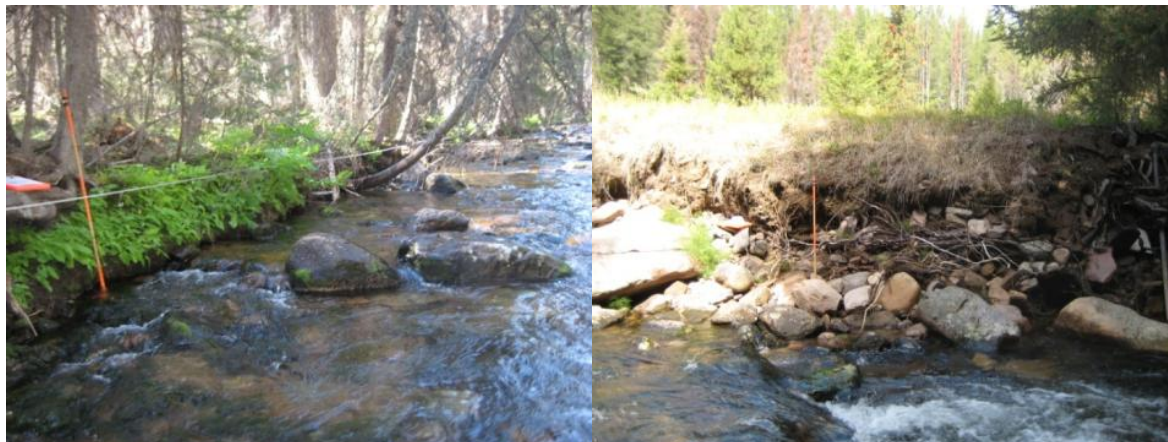
This reach has six slowly eroding banks and one actively eroding bank. Slowly eroding banks are typically well vegetated and undercut with dense tree roots. The one actively eroding bank is tall and has sloughed into the channel, but is well armored with large cobble and boulders. Typical eroding streambank conditions are depicted in **Figure C4-21** and sediment loading results are provided in **Table C4-15**. A slowly eroding bank is shown on the left and an actively eroding bank is shown on the right.

Figure C4-21. Typical eroding streambank conditions in West Fork Rock Creek 27-02.

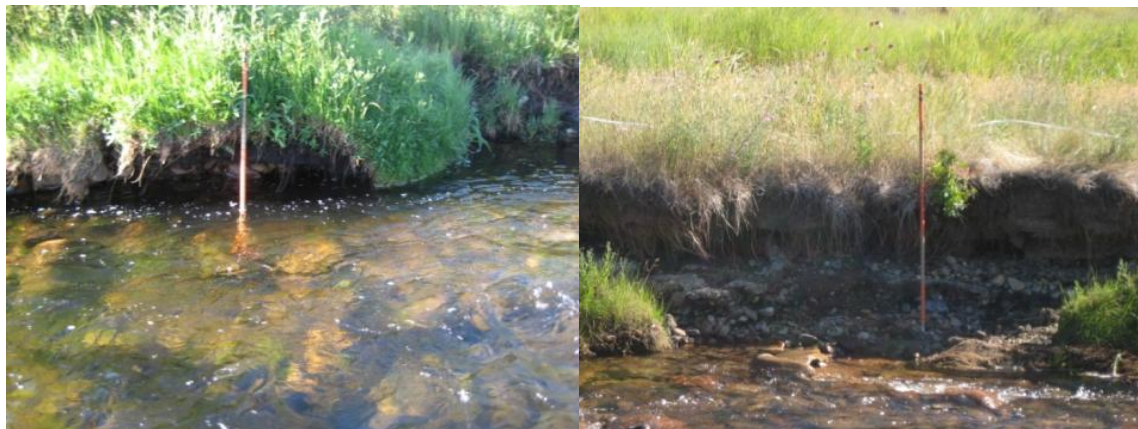
This reach has five slowly eroding banks and one actively eroding bank. Most slowly eroding banks are well-vegetated and undercut with a stratified cobble layer that leads to sloughing of banks. The actively eroding bank is taller with a steeper angle. Typical eroding streambank conditions are depicted in **Figure C4-22** and sediment loading results are provided in **Table C4-15**. A slowly eroding bank is shown on the left and an actively eroding bank is shown on the right.

Figure C4-22. Typical eroding streambank conditions in West Fork Rock Creek 30-02.
