**WATER QUALITY MANAGEMENT PLAN &  
TMDLS  
FOR THE  
TETON RIVER WATERSHED**

**FINAL  
September 2003**

# EXECUTIVE SUMMARY: WATER QUALITY MANAGEMENT PLAN & TMDLS FOR THE TETON RIVER WATERSHED

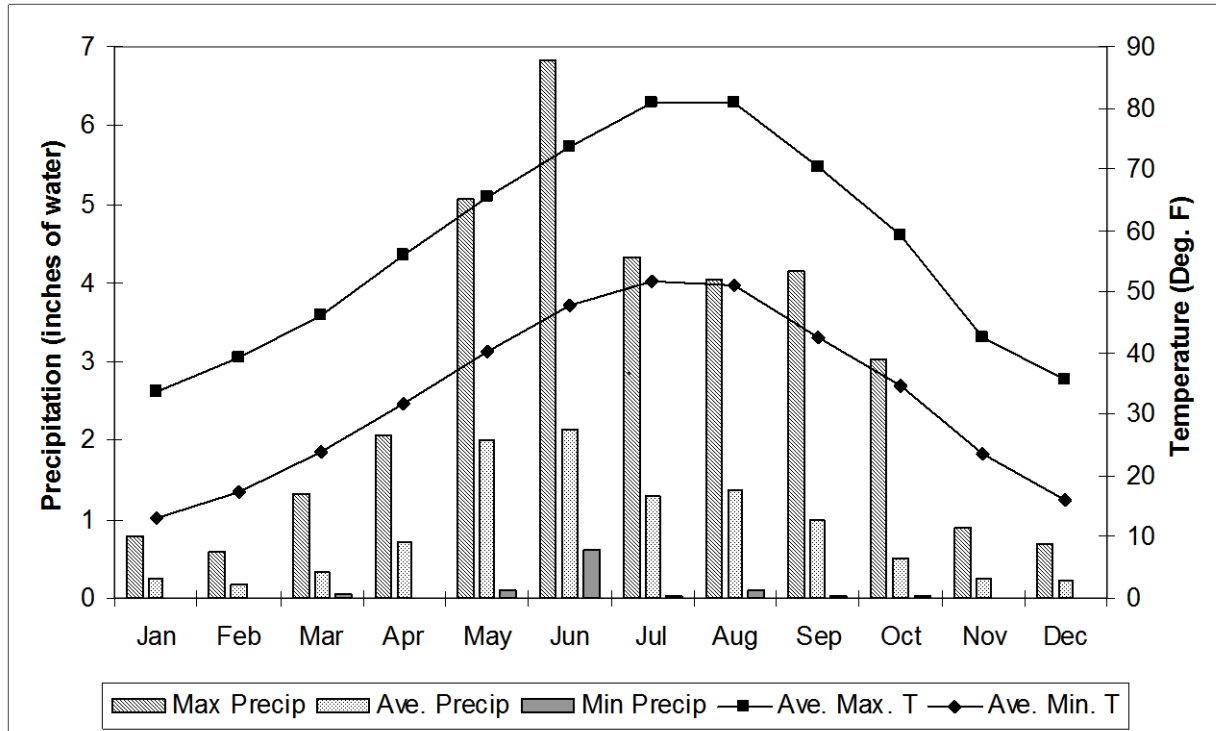
**Figure 2-1.** Average monthly precipitation and temperature data for Choteau Airport during the period 1971 to 2000 (data from the Western Regional Climate Center).

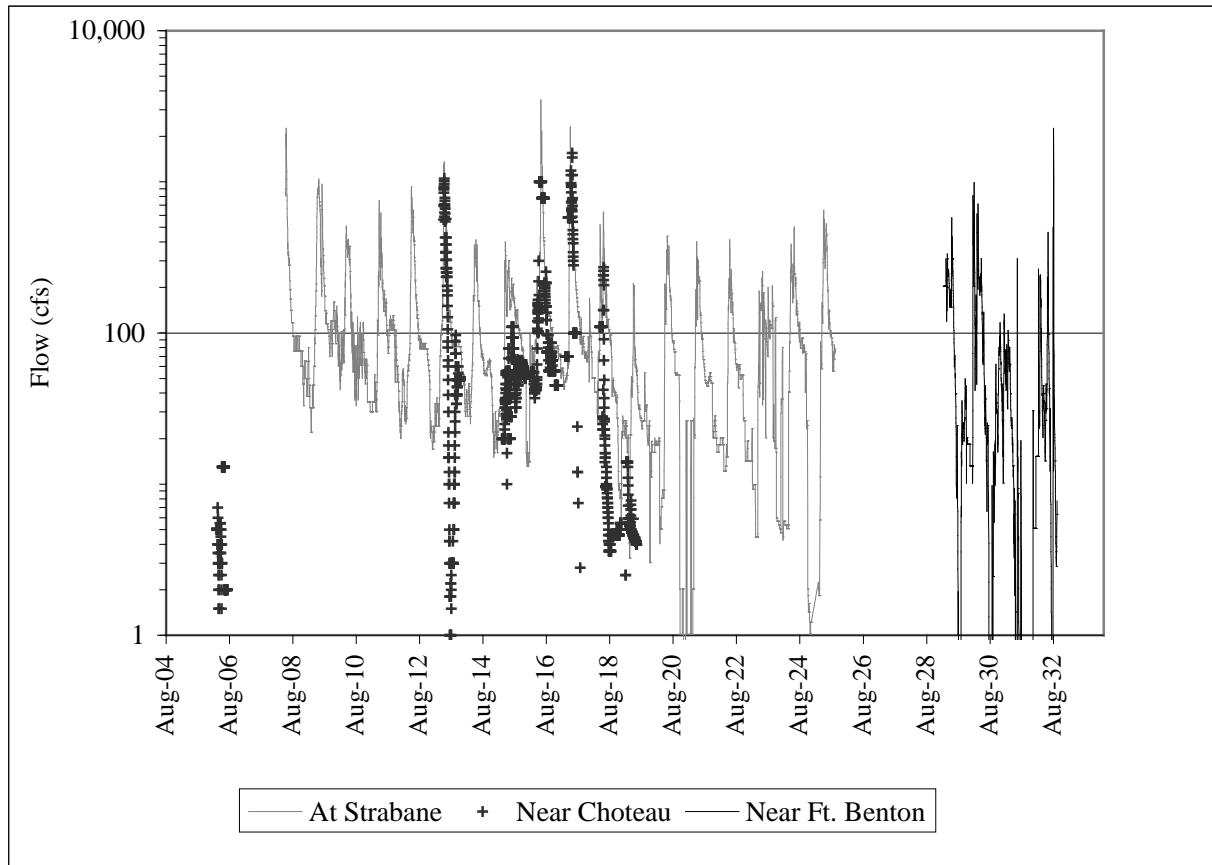
**Figure 2-3.** Historical mean daily stream flows on the Teton River recorded at USGS gaging stations. Flows of less than one cfs represent zero-flow conditions.

through mid-January 1921 were consistently low (i.e. less than 2 cubic feet per second (cfs)) and there is a good likelihood that the zero-flow recorded is due to cold temperatures and freeze-up.

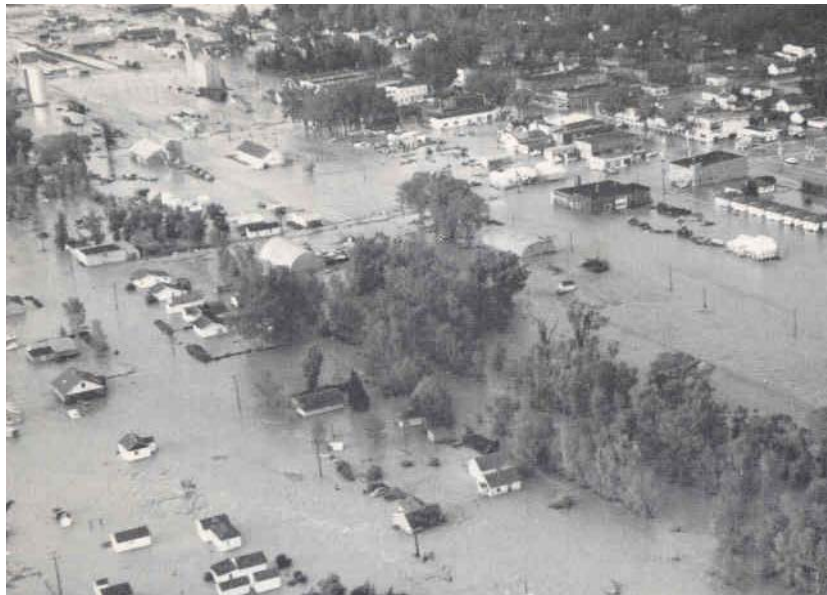
**Figure 2-9.** City of Choteau on June 8, 1964. From Boner and Stermitz (1967)

The impact of this flood event on the Teton River was significant. The city of Choteau was evacuated when floodwaters up to six feet deep inundated the town of 2,000 residents damaging 640 homes and businesses (Figures 2-8 and 2-9). Boner and Stermitz (1967) report that the damage across the Teton watershed included five of eight bridges were destroyed while the remaining three requiring repairs to their approaches. Additionally, the flood destroyed many

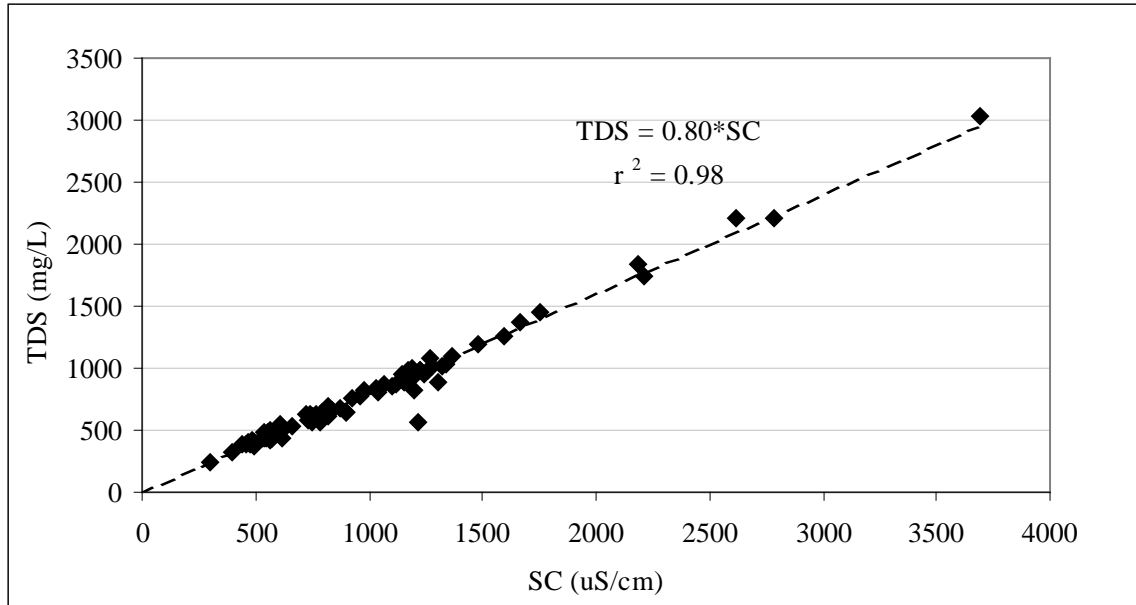
**Figure 3-1.** Relationship of total dissolved solids (TDS) and specific conductance (SC) in the Teton River, Montana. Samples were collected in the Teton and N. Fork Teton Rivers from 1974 to 1998 (n=86).

The relationship of TDS and SC in the Teton River is highly correlated, with a coefficient of determination ( $r^2$ ) of 0.98 and was calculated by graphing related samples and fitting a trend line with the y-intercept forced through zero (Figure 3-1). The closer an  $r^2$  is to 1.0 the stronger the correlation. The equation that describes the correlation between TDS and SC is  $\text{TDS} = 0.80(\text{SC})$ , which can be used to estimate TDS based on SC measurements.

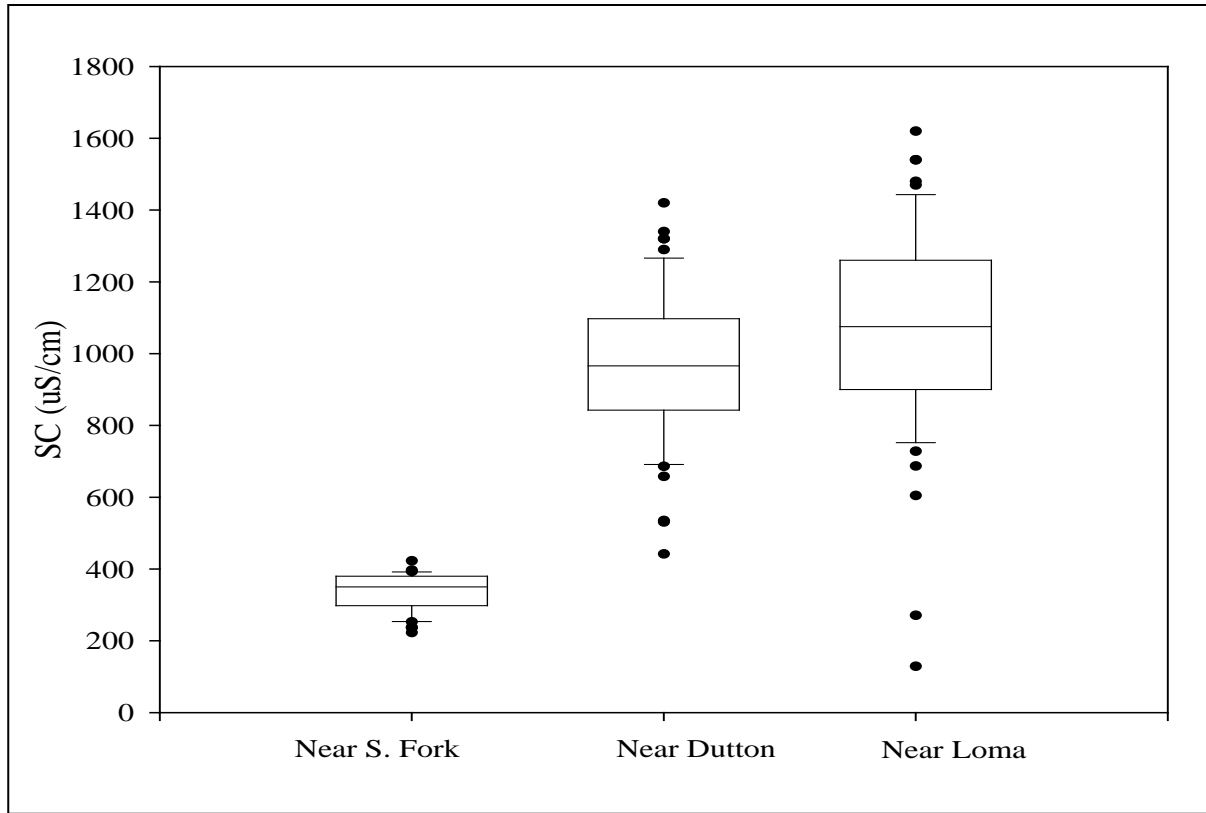
**Figure 3-2.** Specific conductance data collected at USGS gaging stations along the Teton River. The South Fork station is the most upstream station and Loma is the most downstream. Data presented are from 1998 to 2001 (Table 3-4).

Measured median SC levels and overall SC variability in the Teton River increased from the upper to lower reaches of the river during 1998 to 2001 (Figure 3-2). Between the “South Fork” and “Dutton” stations, median SC values increased by 276% and the minimum and maximum recorded values increased by 198% and 336%, respectively. Between the “South Fork” and “Loma” stations median and maximum values increased 307% and 383%, respectively while the minimum recorded SC value decreased by 58%. The reason for the decrease in this minimal value is unclear. However, the majority of the SC samples, or those defined as between the 5<sup>th</sup> and 95<sup>th</sup> percentiles, are greater than the equivalent percentile values at the Dutton station.

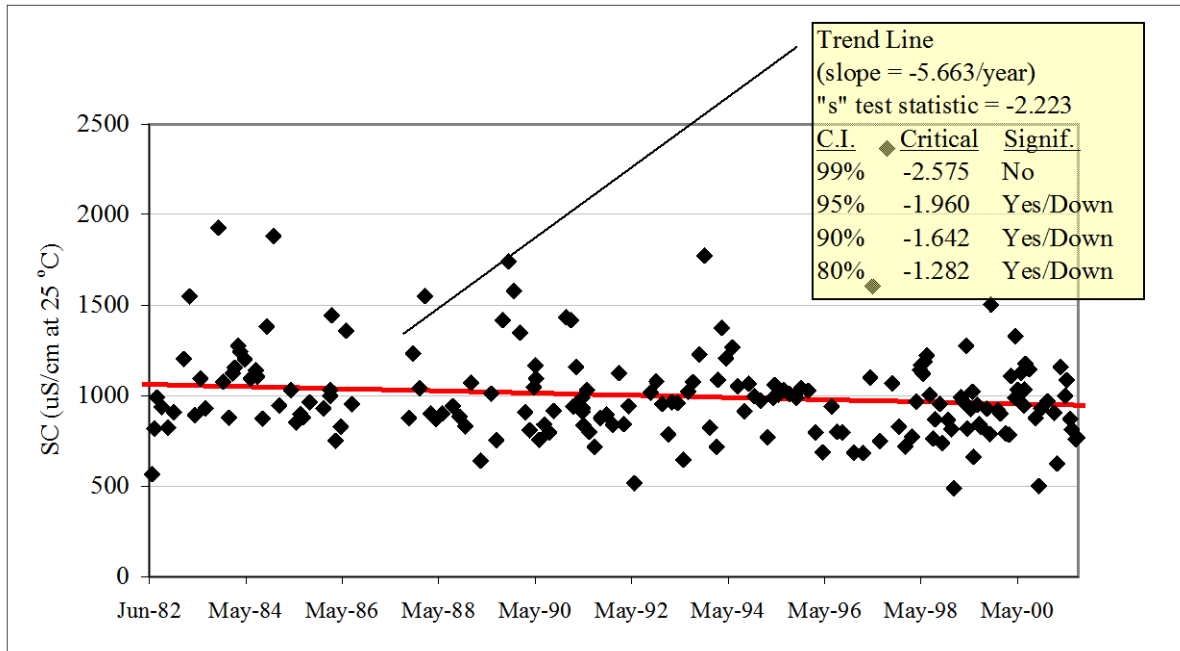
**Figure 3-4.** Time series of flow-adjusted SC data at the Dutton gage and associated Mann Kendall trend test results.

A Mann Kendall trend test indicates that SC in the Teton River at Dutton decreased between 1982 and 2001 with a 95% confidence level (Figure 3.4). The Mann Kendall trend test assumes the lack of serial correlation and a constant data spread or distribution within the data set. Rank Von Neumann test results indicate some serial correlation within the data set. Although a Seasonal Kendall trend test could be applied if seasonality were the cause of the correlation, seasonality test results indicate some other cause. Since visual inspection of the time series graph suggests that the level of serial correlation is moderate, the significance level of the trend test is relatively high, the number of data points used is relatively large, and the period of record is reasonably long, it is probable that a decreasing SC trend is present. Data sets from the gage near the South Fork (e.g., upper watershed) and gage near Loma lacked sufficient periods to record to support meaningful statistical analyses.

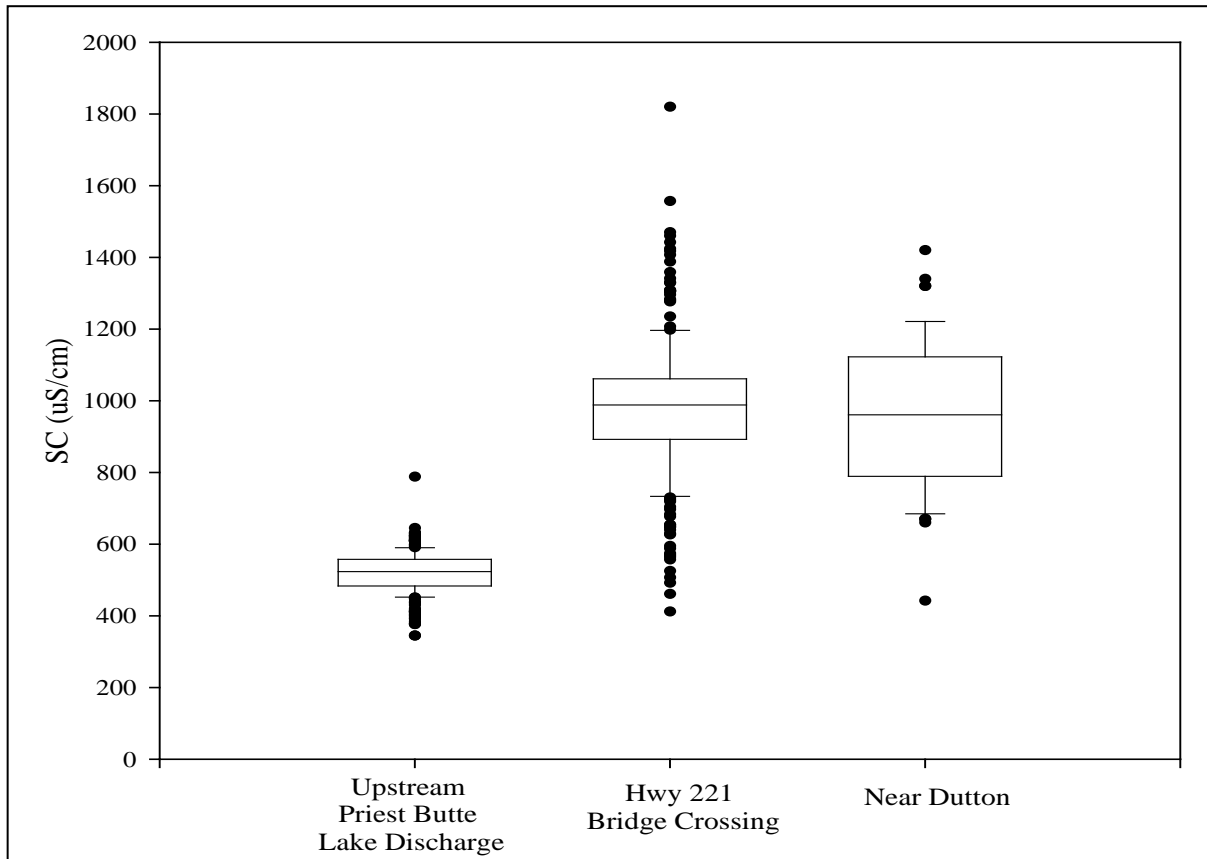
**Figure 3-5.** SC data near the Priest Butte Lakes discharge. Hwy 221 Bridge crossing is below the mixing zone of Priest Butte Lakes’ outfall in the Teton River.

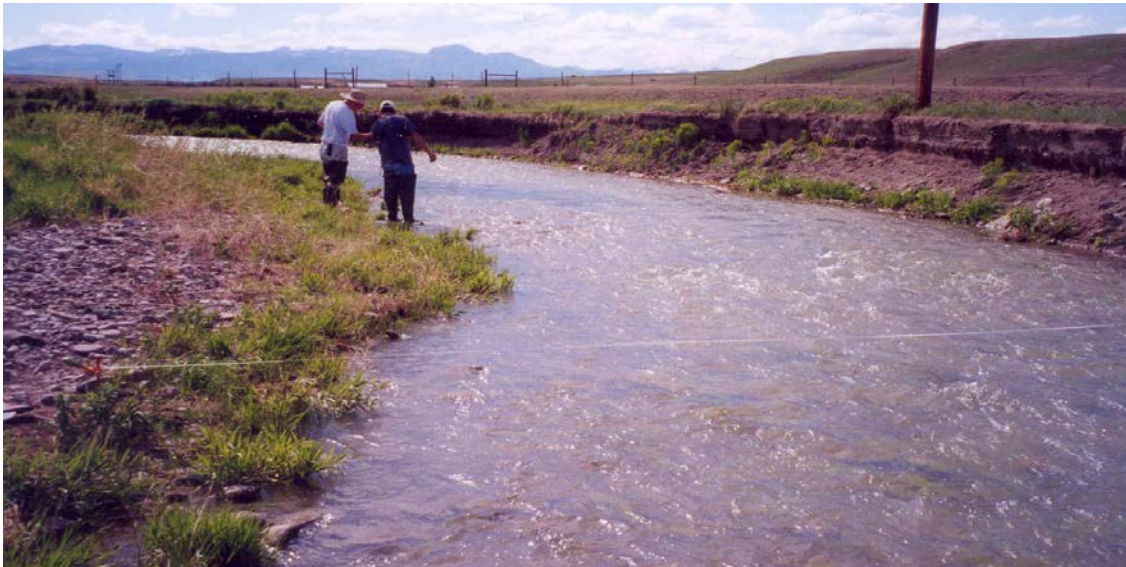
**Figure 3-6.** Riparian zone devoid of stabilizing or shading vegetation on Deep Creek (outside bank).

Photos from Deep Creek show a channel that has potentially downcut and has minimal to no riparian vegetation (Figure 3-6). Willow Creek shows similar characteristics, along with vertical, actively eroding banks (Figure 3-9). MDEQ notes from 2002 field visits on Teton Spring Creek state that some reaches of the stream are over-widened and lack proper riparian communities (i.e. a suite of plants with good root binding characteristics that can slow high stream flows and trap sediment), while other reaches show evidence of channelization. As a result, many locations were noted to have “excessive sediment deposition” or high embeddedness of gravels. Channelization of Spring Creek and the conversion of woody riparian species to turf grasses (Figure 3-10) are common through the town of Choteau (Decker-Hess, 1986). A site located downstream of Choteau was found to have sufficient riparian species and no active widening or downcutting was noted (Figure 3-11).

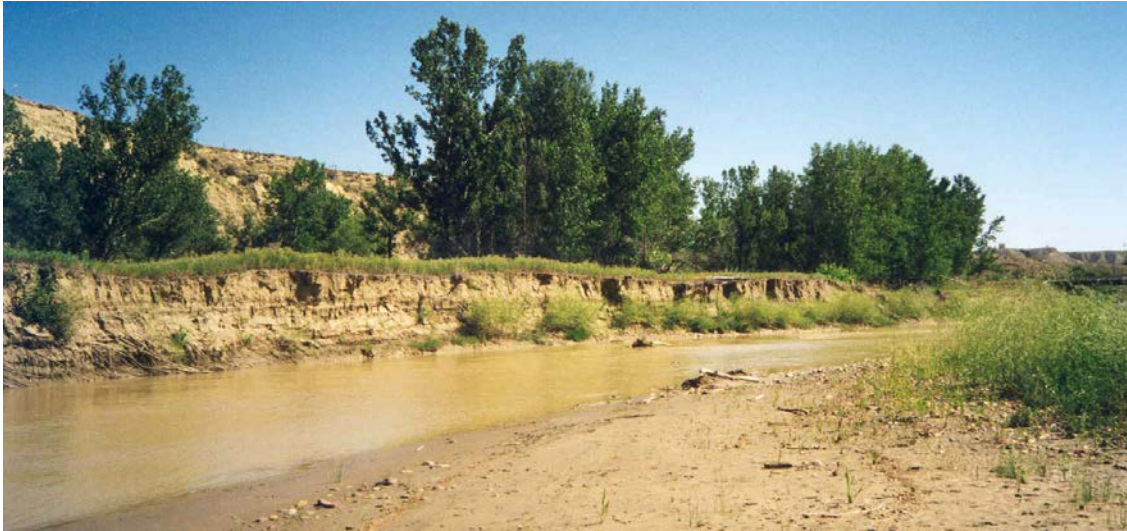
**Figure 3-7.** High banks along the Teton River are indicative of downcutting and restricted access to the flood plain (far bank in photo).

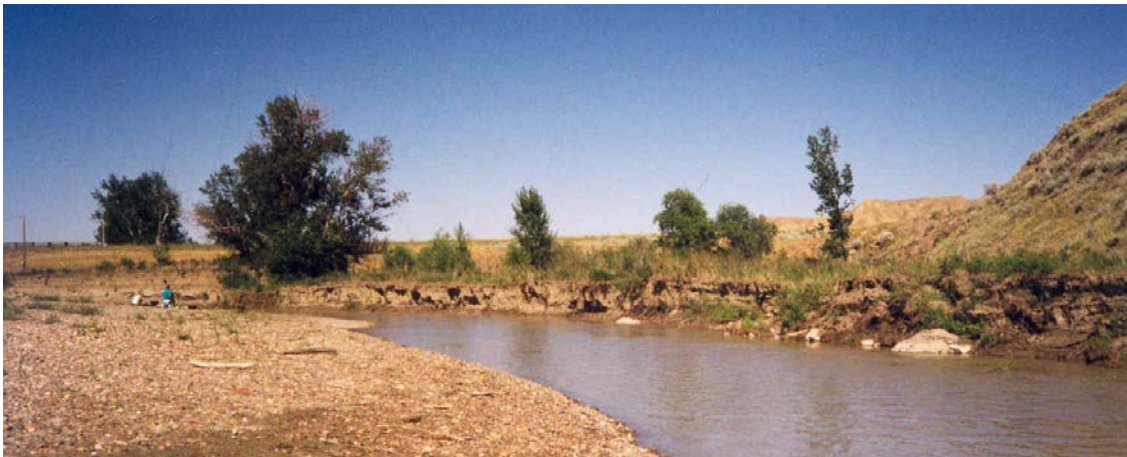
**Figure 3-8.** Farmland and vegetation removal along the Teton River has restricted flood plain and riparian function.

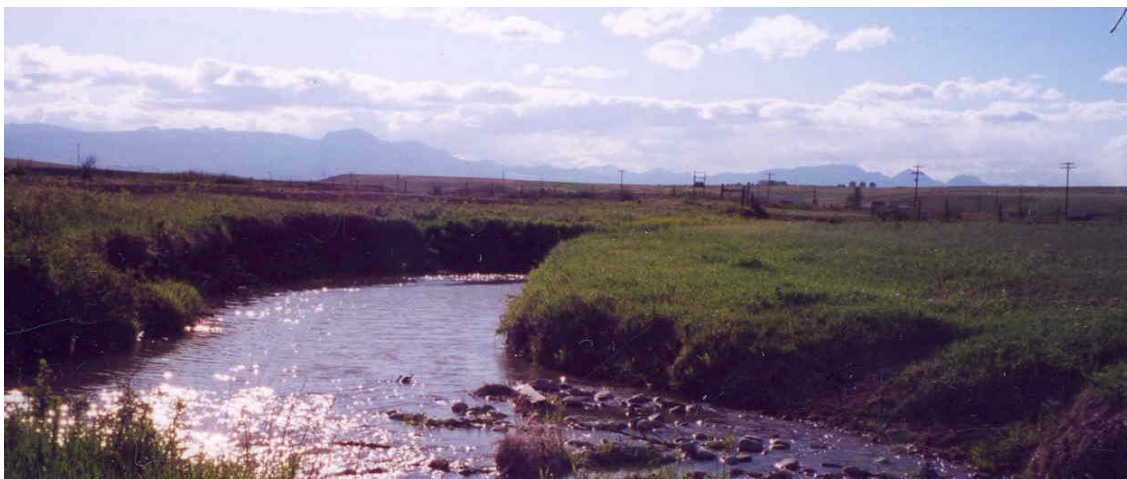
**Figure 3-9.** Riparian removal and apparent downcutting on Willow Creek.

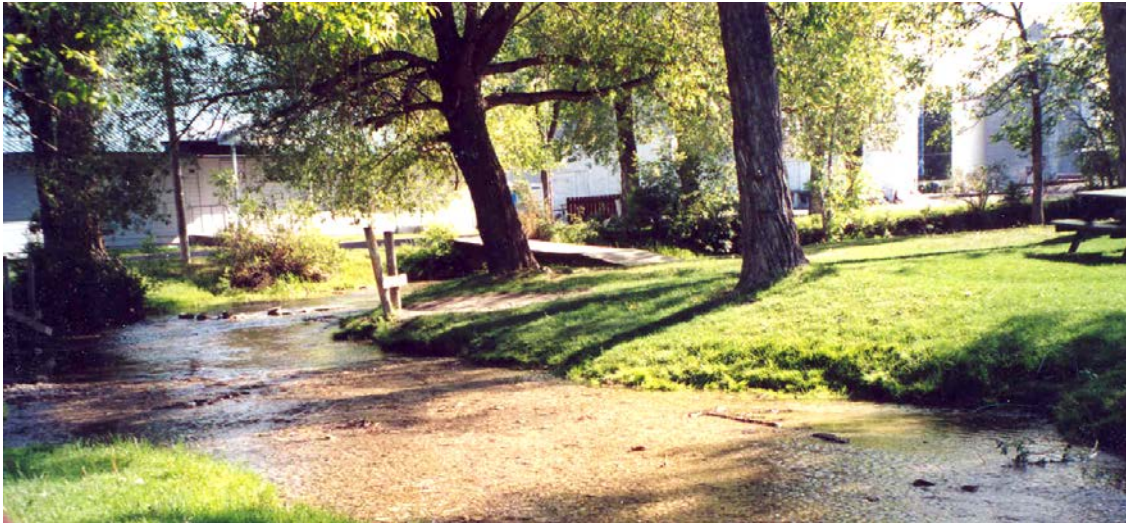
**Figure 3-10.** Teton Spring Creek shows a tendency to be over-widened through Choteau.

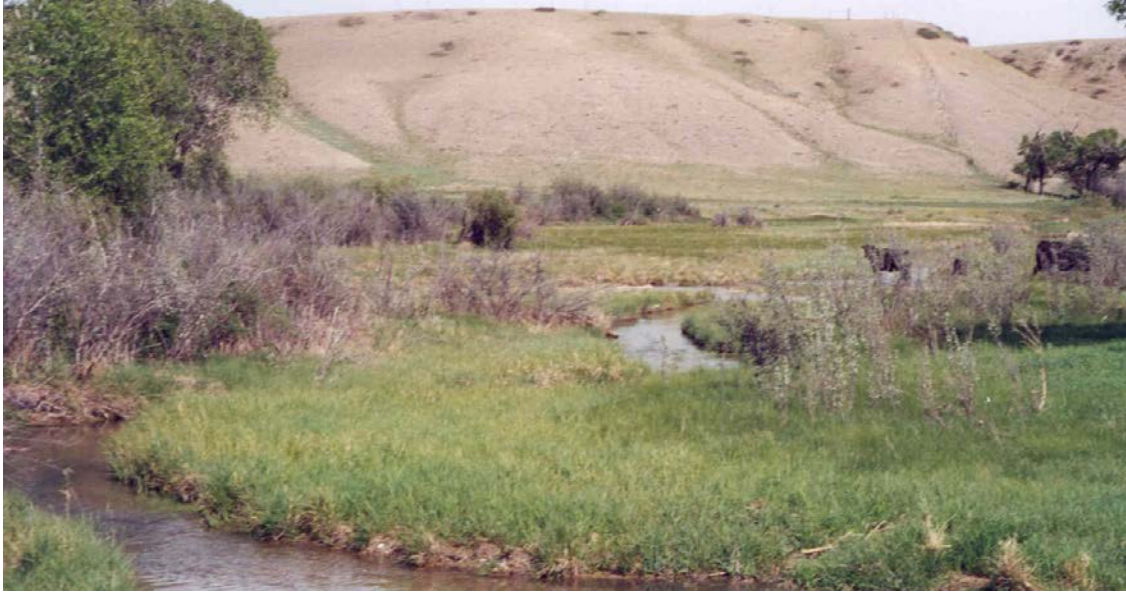
**Figure 3-11.** Teton Spring Creek downstream of Choteau; channel has narrowed.

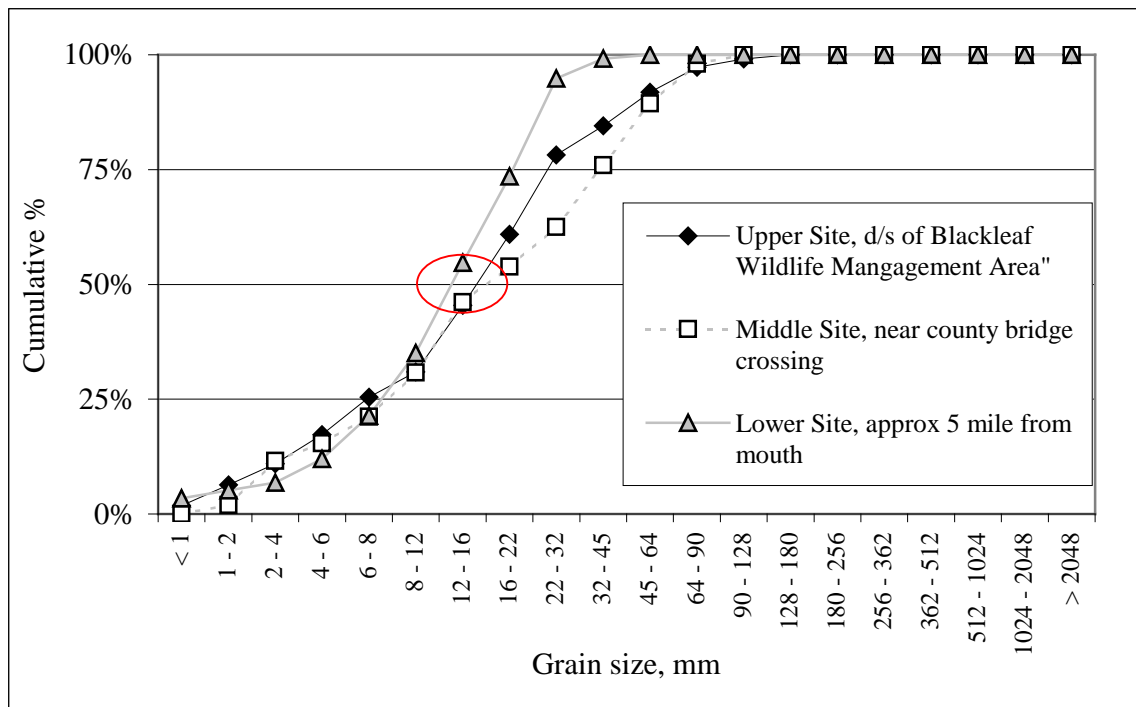
**Figure 3-12.** Wolman pebble count data collected along Blackleaf Creek by MDEQ, July 2002. The red circle indicates the D<sub>50</sub> value, or the median particle size.

Blackleaf Creek (also referred to as North Fork Muddy Creek) was listed on the 1996 list as being impaired for aquatic life, cold-water fishery, and drinking water caused by siltation. Fieldwork completed in 2002 show that sediment is not impairing Blackleaf Creek at this time. Cobbles and gravel-sized particles were the dominant substrate and did not show evidence of excessive deposition or embeddedness. Wolman pebble count data from the three sites show close resemblance in size distribution (Figure 3-12). A shift to the left, or to smaller particles, is expected as a stream moves down gradient, as shown by Lower Site data. Energy decreases as a stream moves into gentler gradients and will deposit its sediment load. Cumulative percentages of fine particles <6 mm are low for all three sites. Approximately three percent of the particles measured at the lowest site were <1 mm, or diameters representative of clay and fine sediment. Some increase in the range of sand is shown at all three sites (1-2 mm); however total cumulative percent for particle sizes less than two mm is 6.4 %. The red circle is around the “D<sub>50</sub>”, or the diameter of the 50% percentile or median grain size. Basically, this shows that 50% of the sampled particles are 12-16 mm (medium gravel) or smaller.

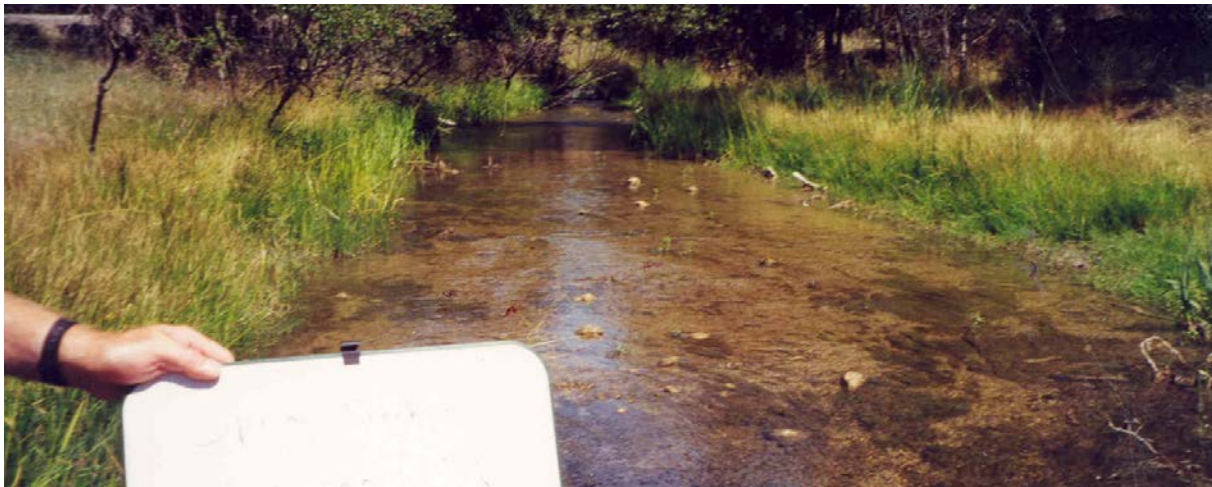
**Figure 3-13.** Teton Spring Creek upstream of Choteau. Channel is wide and shallow.

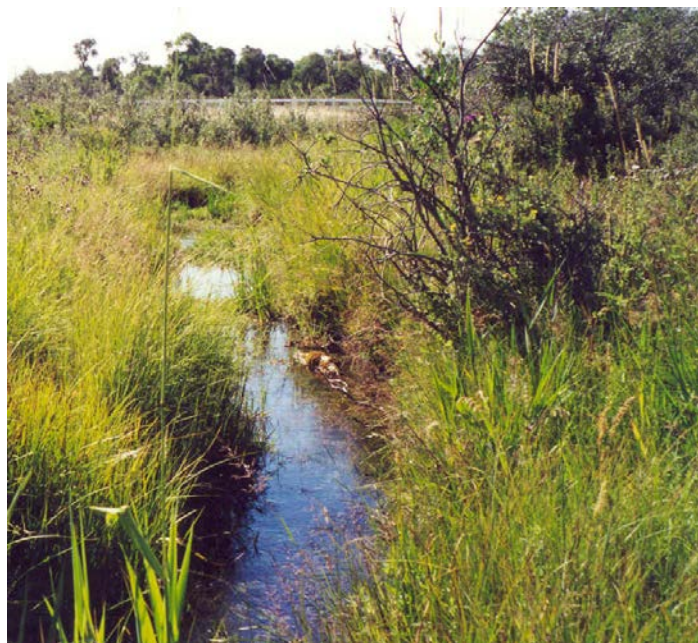
**Figure 3-14.** Teton Spring Creek, upstream of Choteau. E-Type channel: narrow and deep, with well-vegetated banks.

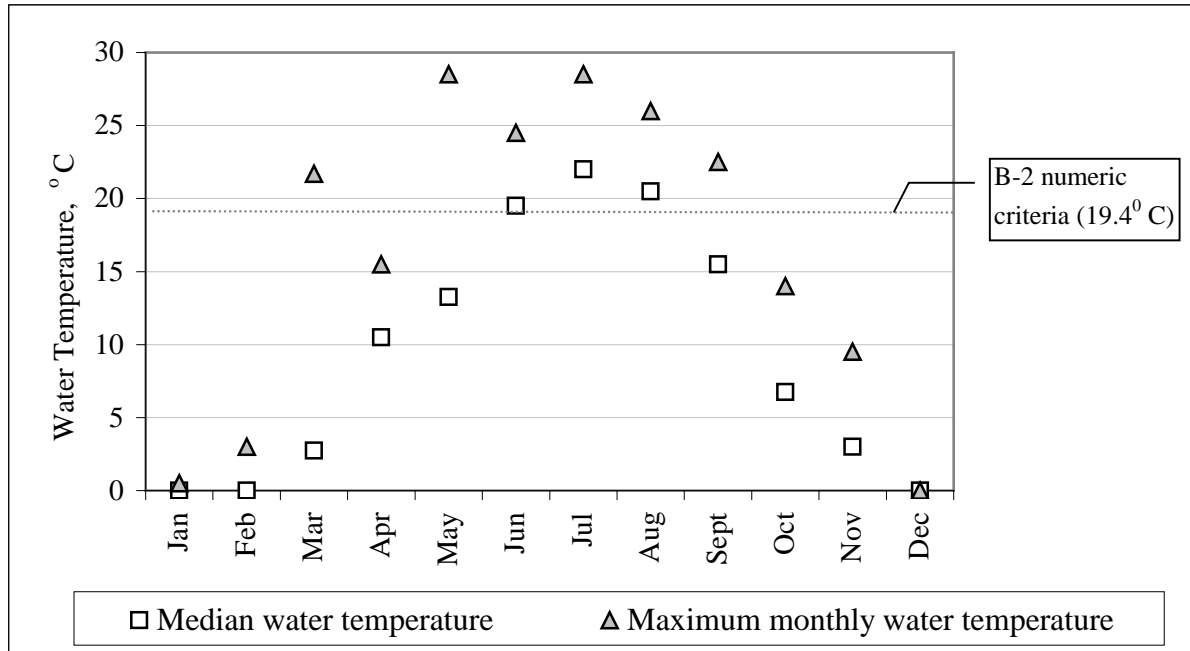
**Figure 3-15.** Monthly maximum and median water temperature data for the Teton River near Dutton (USGS).

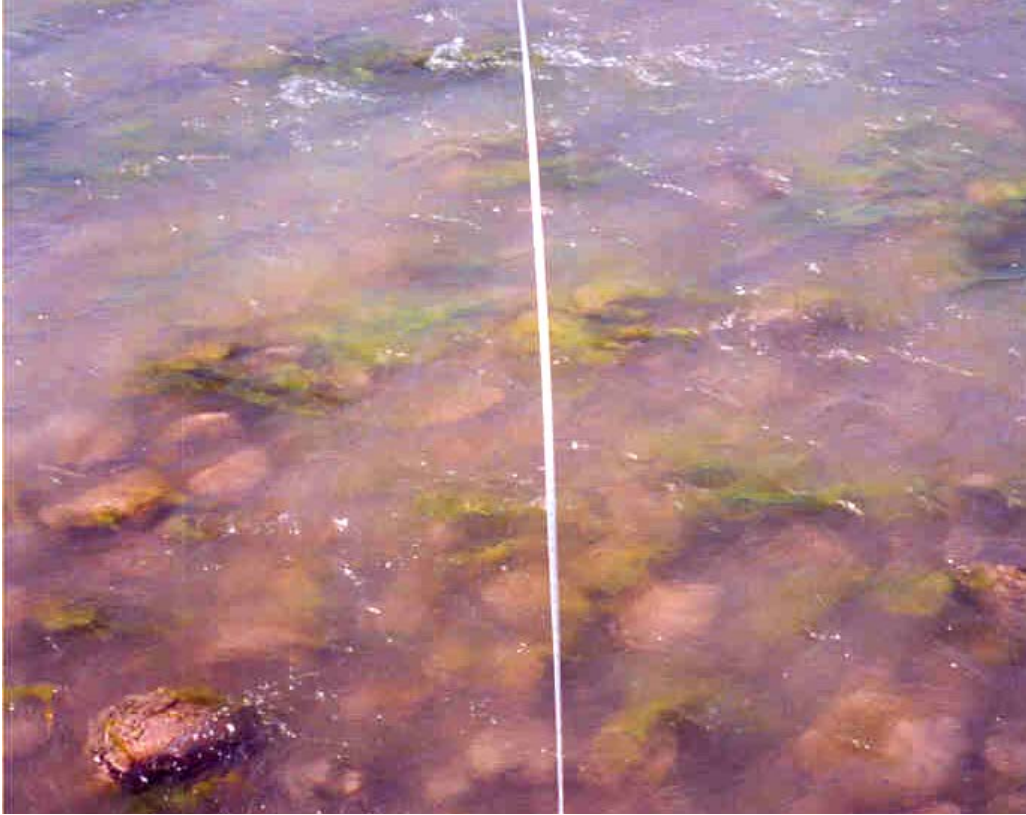
**Figure 3-16.** Filamentous algae in Deep Creek, May 2001.

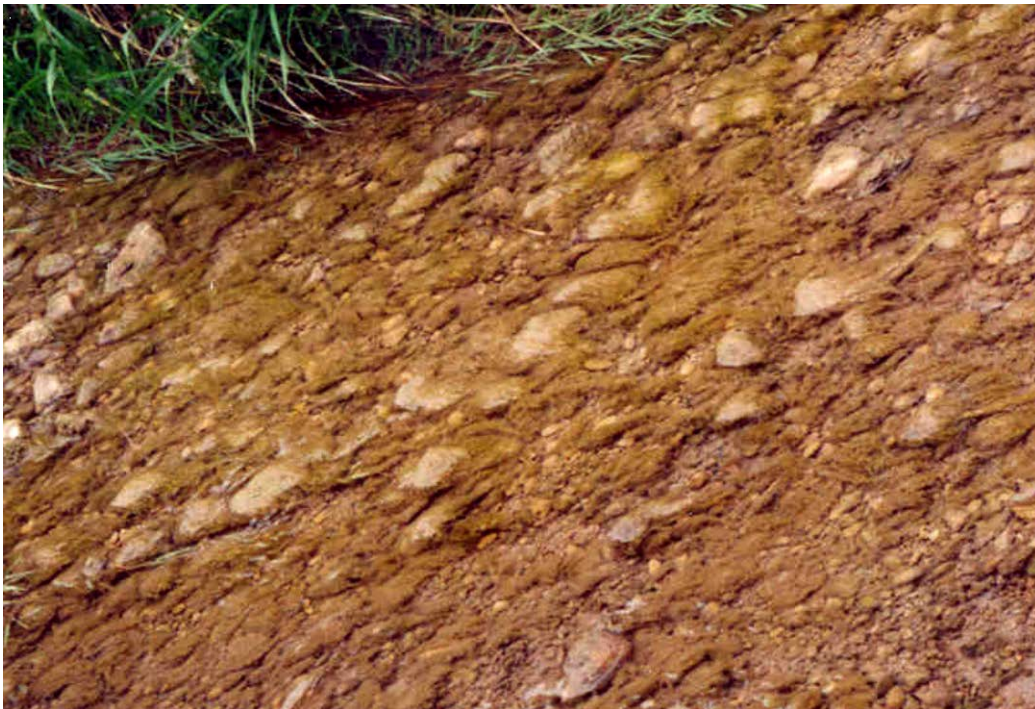
**Figure 3-17.** Algae in Teton Spring Creek, downstream of Choteau, May 2001.

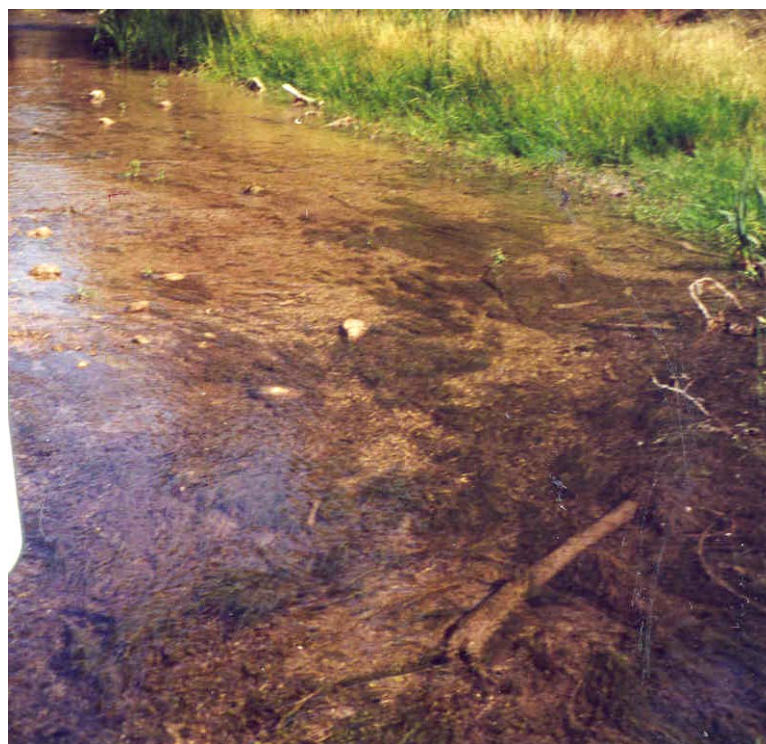
**Figure 3-18.** Aquatic vegetation in Teton Spring Creek, upstream of Choteau, August 2000.

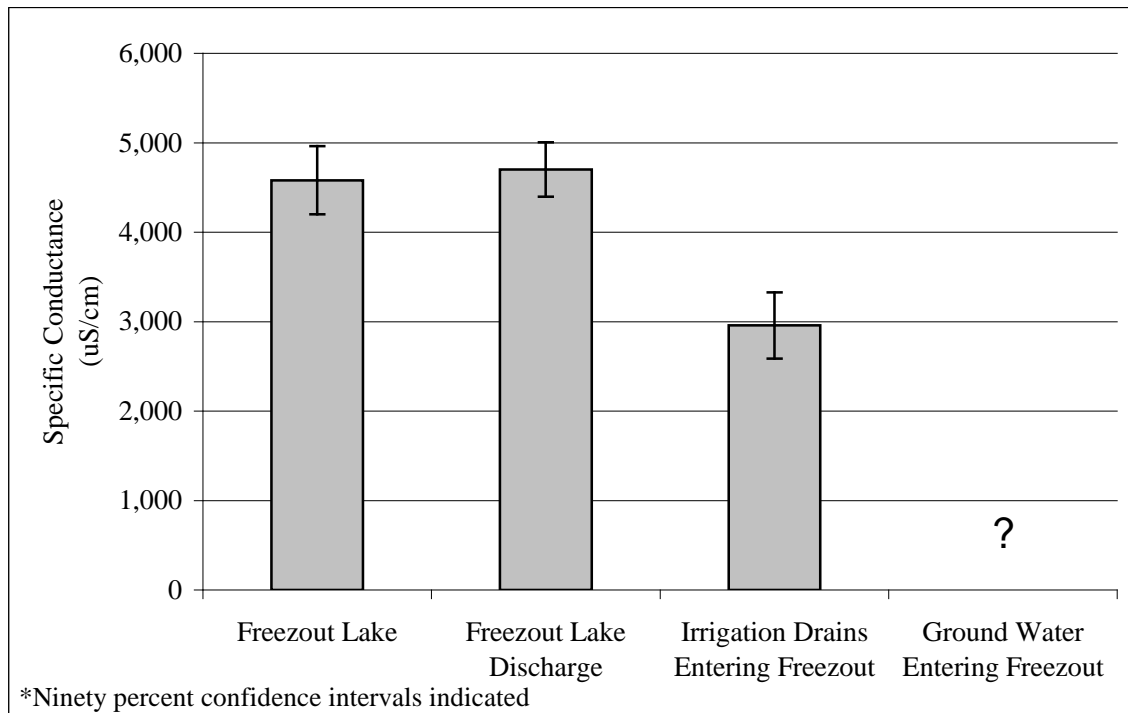
**Figure 4-1.** Specific conductance levels in Freezout Lake, Freezout Lake Discharge, and irrigation drains entering Freezout Lake. (Data collected from 1980 – 1995.)

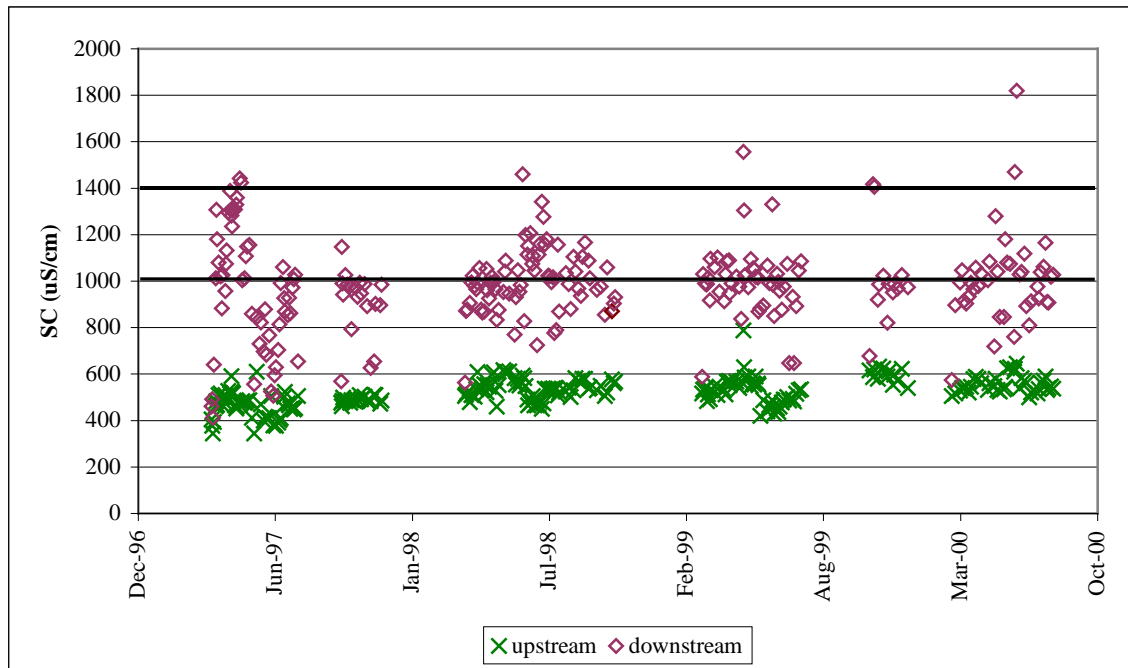
**Figure 4-2.** Specific Conductance (SC) measurements from 1997 to 2000 in the Teton River near the Priest Butte Lakes discharge. Darkened lines are placed at 1,000  $\mu\text{S}/\text{cm}$  and 1,400  $\mu\text{S}/\text{cm}$  levels and represent SC target values for the Teton River.

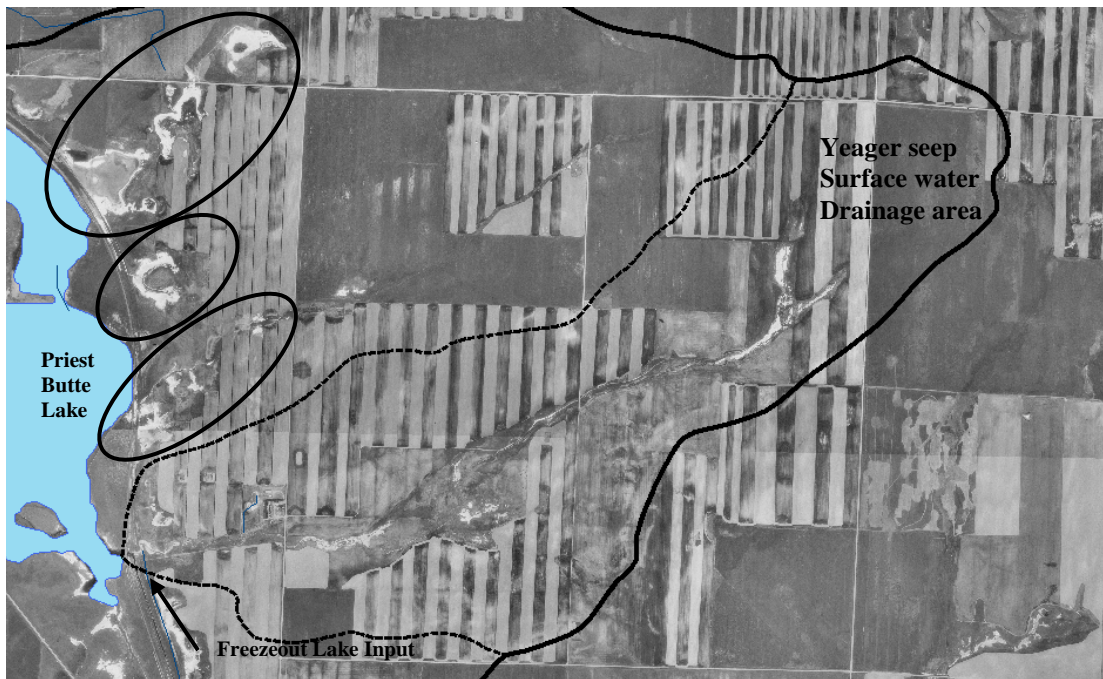
**Figure 4-4.** Yeager seep surface water drainage area (dashed line) and other Priest Butte Lakes east-side saline seep areas (solid ovals). The light blue lines are man-made ditches or canals. (Photo source is USGS; north is to the top of the photo; scale is approximately 1:25,000.)

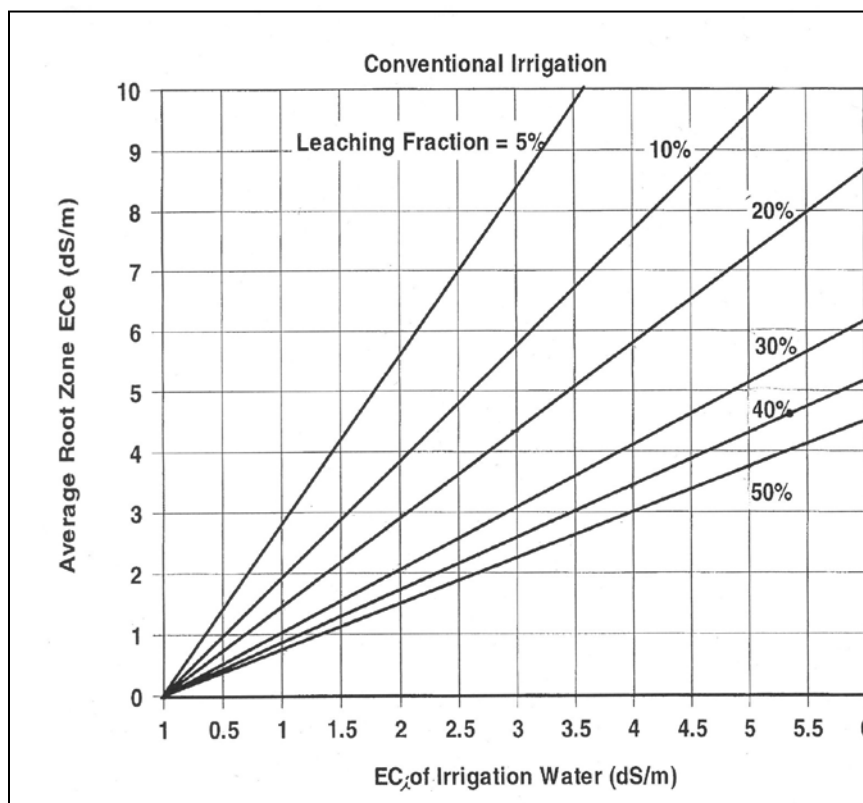
**Figure 4-9.** Relationship between leaching fractions, irrigation water, and soil water SC (adopted from Hansen et al., 1999).

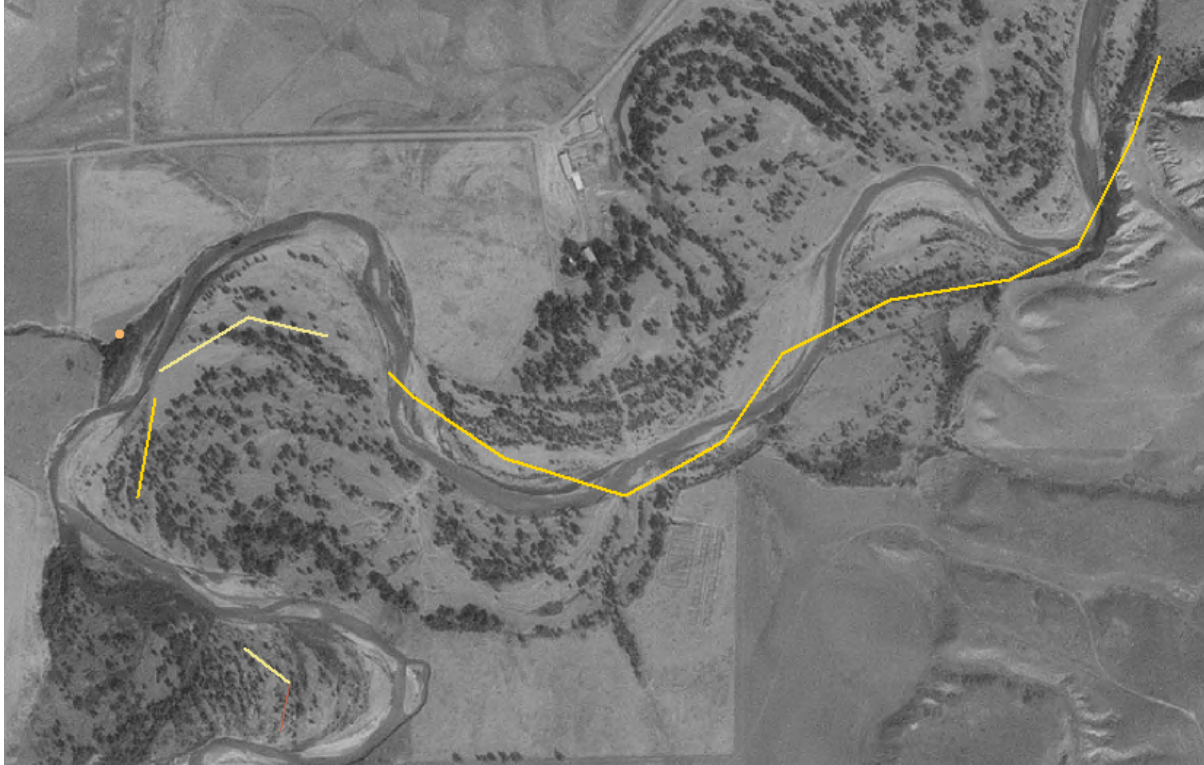
**Figure 4-11.** An example of linear feature mapping from the rapid aerial assessment and characterization (Hawn et al., 1998). Refer to text for greater explanation. Photo scale is approximately 1:7,000.

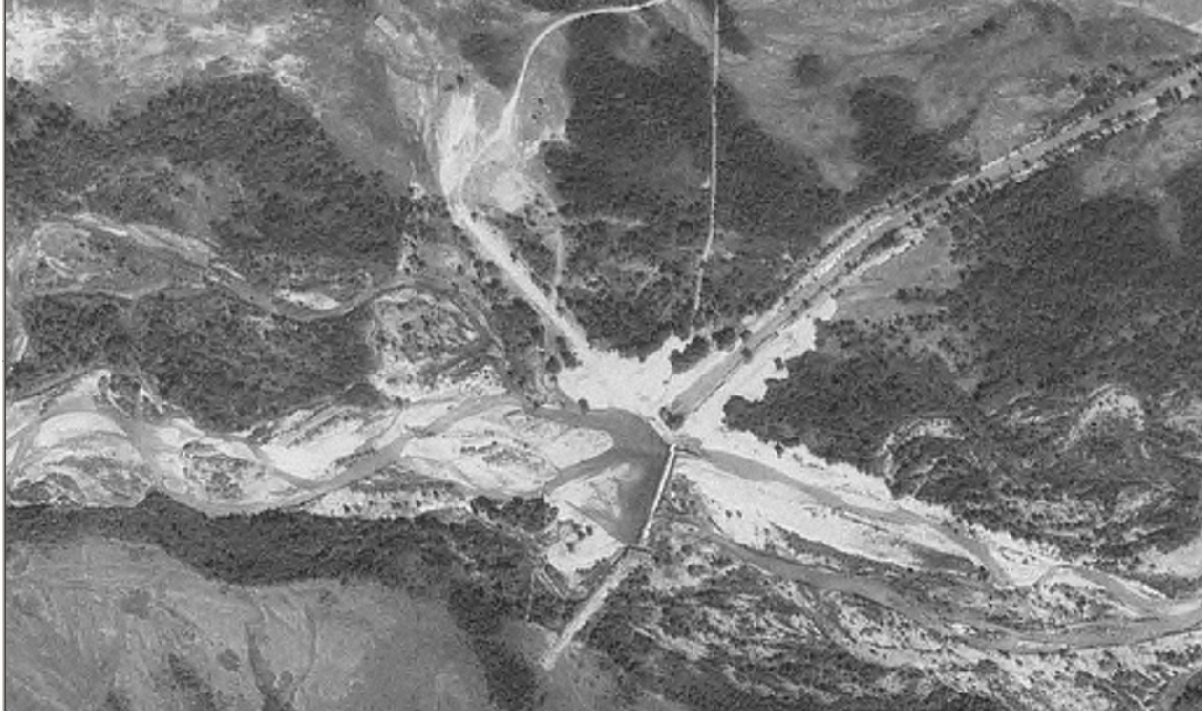
**Figure 4-12.** Example of an instream diversion structure on the upper Teton River (photo scale is 1:4,000).

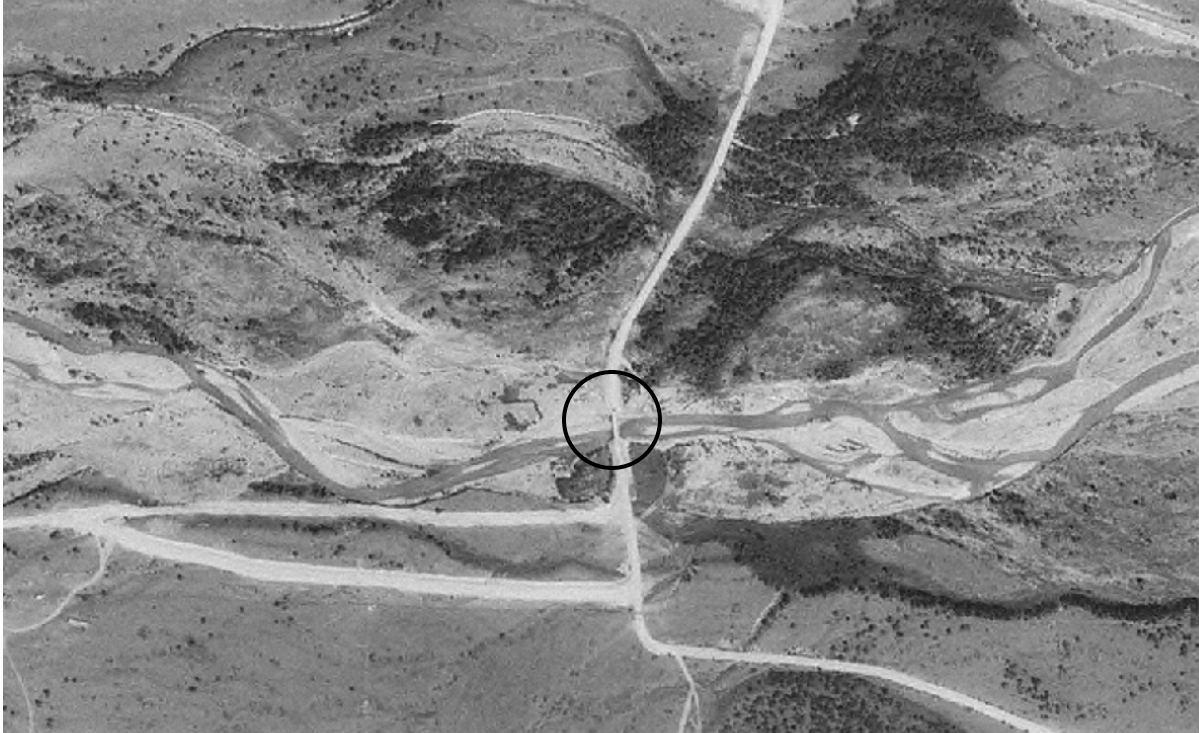
**Figure 4-13.** An undersized highway structure (bridge in circle) on the upper Teton River that limits floodway access and creates a constricted stream channel (photo scale is 1:5,000).

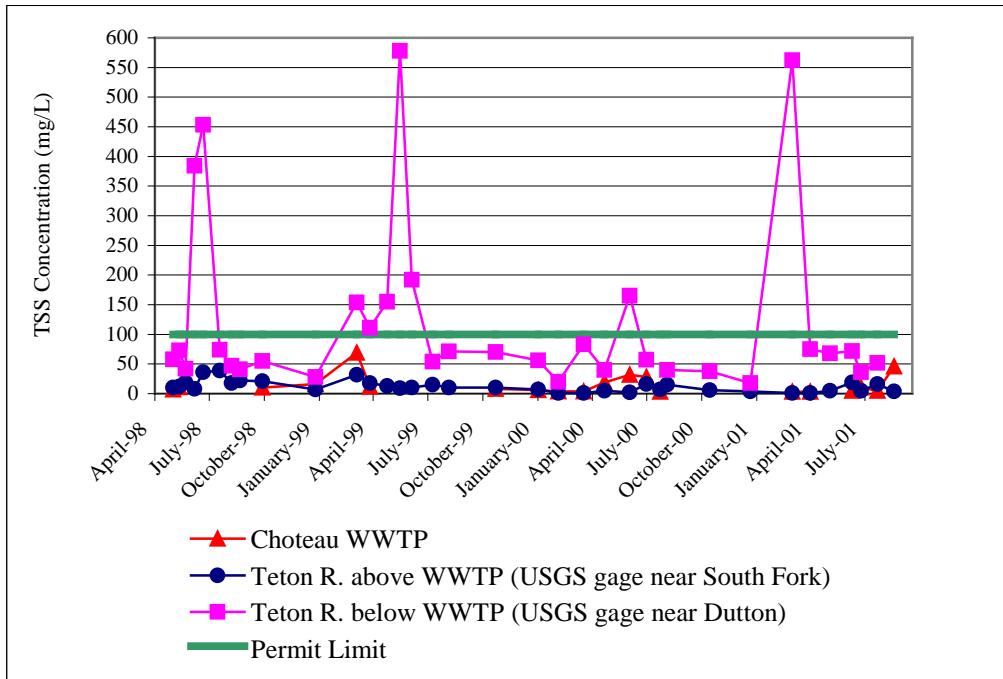
**Figure 4-15.** TSS concentrations from the City of Choteau’s WWTP discharge and the Teton River upstream and downstream of the discharge in relation to the TSS concentration limit set in the Choteau’s MPDES permit.
