**WATER QUALITY MANAGEMENT PLAN &  
TMDLS  
FOR THE  
TETON RIVER WATERSHED**

**FINAL  
September 2003**

# EXECUTIVE SUMMARY: WATER QUALITY MANAGEMENT PLAN & TMDLS FOR THE TETON RIVER WATERSHED

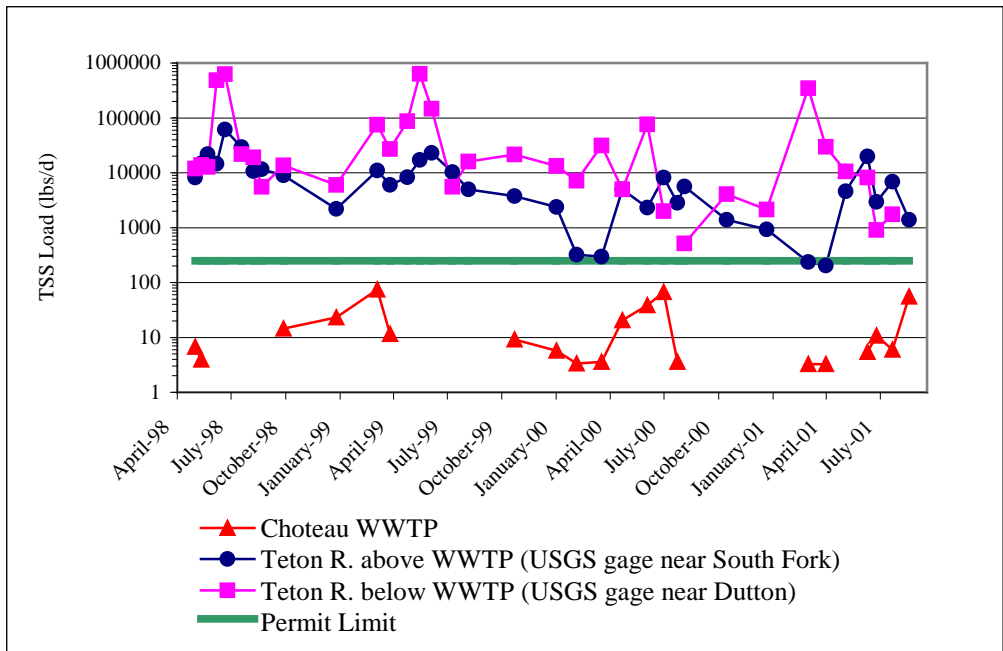
**Figure 4-16.** Average annual TSS loads from the City of Choteau’s WWTP discharge and the Teton River upstream and downstream of the discharge in relation to the TSS load limit set in the Choteau’s MPDES permit. Note: the y-scale is logarithmic and is used to accommodate the full range of measured load values.
