APPENDIX D - SEDIMENT AND HABITAT ASSESSMENT

This appendix is derived from a sediment and habitat assessment report prepared by Water and Environmental Technologies (2008) for presentation to the Kootenai River Network and the Montana Department of Environmental Quality (DEQ). In 2008, DEQ initiated an effort to collect data to support the development of sediment TMDLs for streams within the Tobacco River TPA. The data collection effort involved assessing sediment and habitat conditions within the Tobacco River watershed, as these conditions influence aquatic life beneficial uses. The data collection effort included stream stratification, sampling design, ground surveys, and sediment and habitat analyses, and is intended to assist DEQ in evaluating the impairment status of tributary streams in the Tobacco River TPA and for developing TMDLs where necessary.

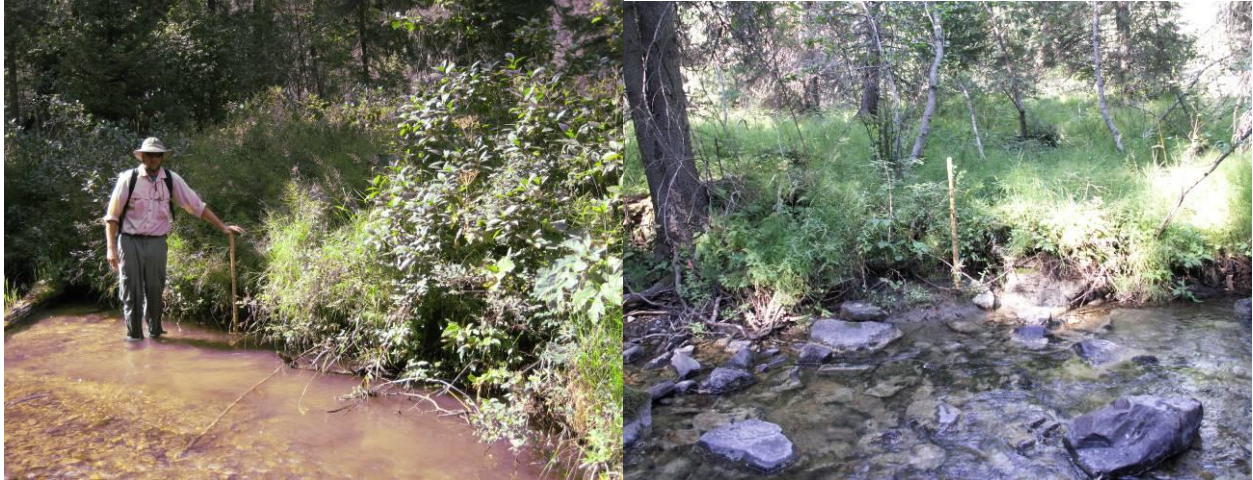
Figure D-1. Low BEHI Rating: Sites ENA 11-1 (bank 1) and FTN 7-2 (bank 1)

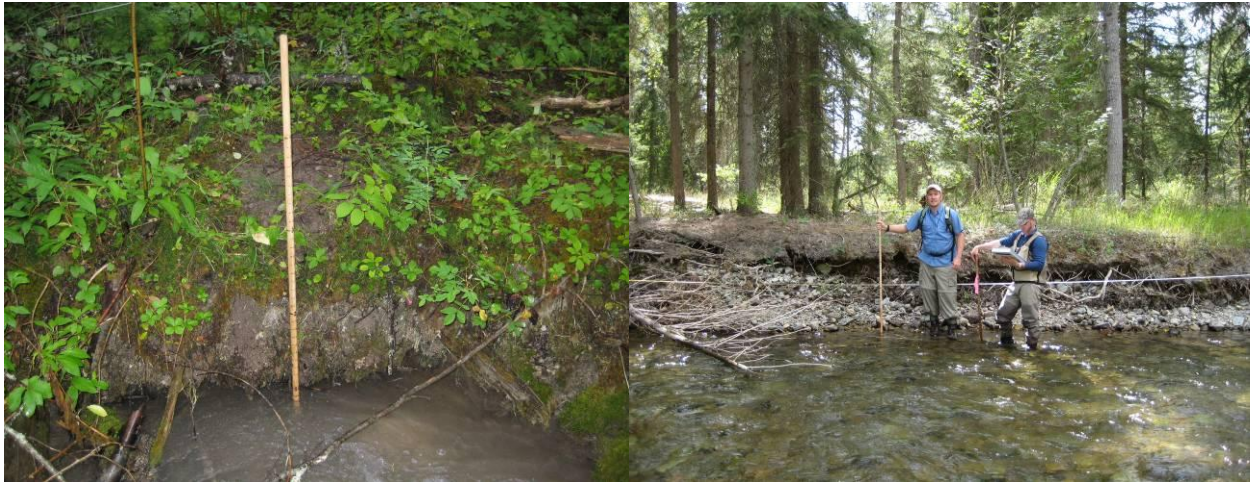
Figure D-2. Moderate BEHI Rating: Sites LME 6-1 (bank 1) and TOB 1-1 (bank 2)

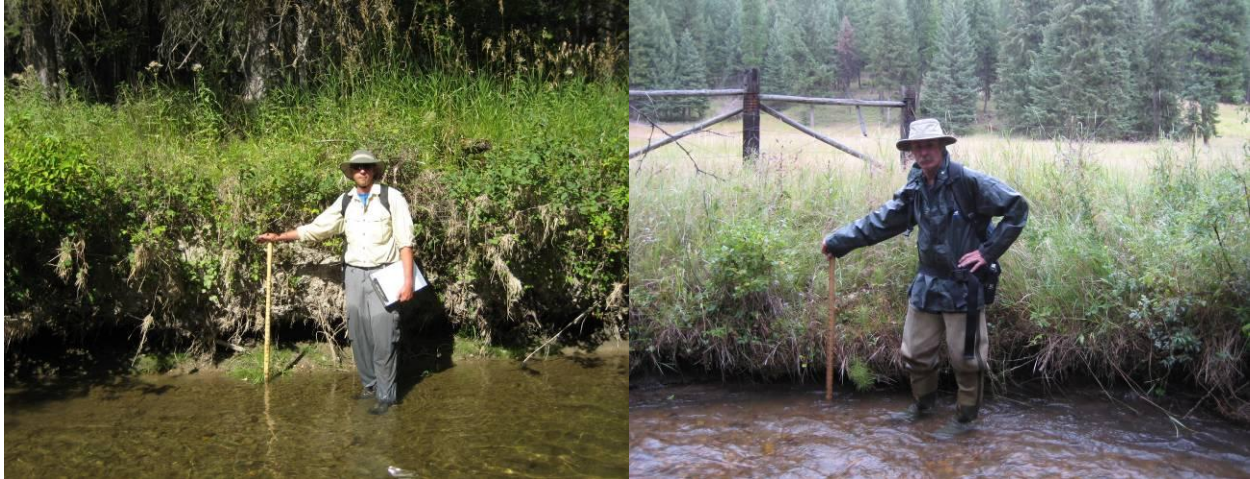
Figure D-3. High BEHI Rating: Sites FTN 13-1 (bank 1) and THR 14-1 (bank 1)

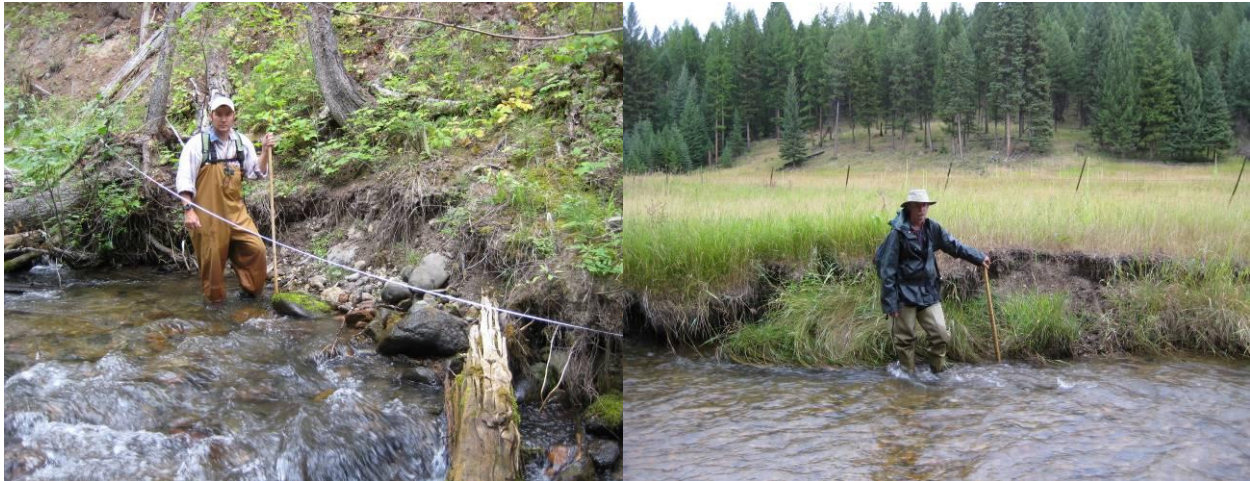
Figure D-4. Very High BEHI Rating: Sites THR 9-5 (bank 5) and THR 14-1 (bank 2)

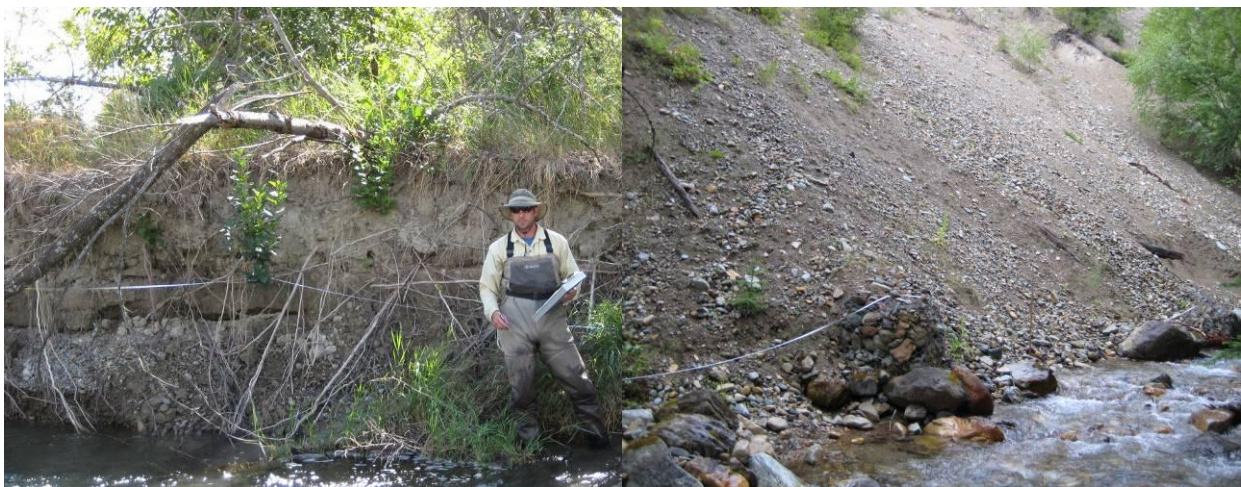
Figure D-5. Extreme BEHI Rating: Sites TOB 2-6 (bank 3) and DEP 9-2 (bank 1)
