Addendum to Upper Clark Fork River Tributaries Sediment, Metals, and Temperature TMDLs and Framework for Water Quality Restoration

April 2014

Water Quality Planning Bureau
Watershed Management Section

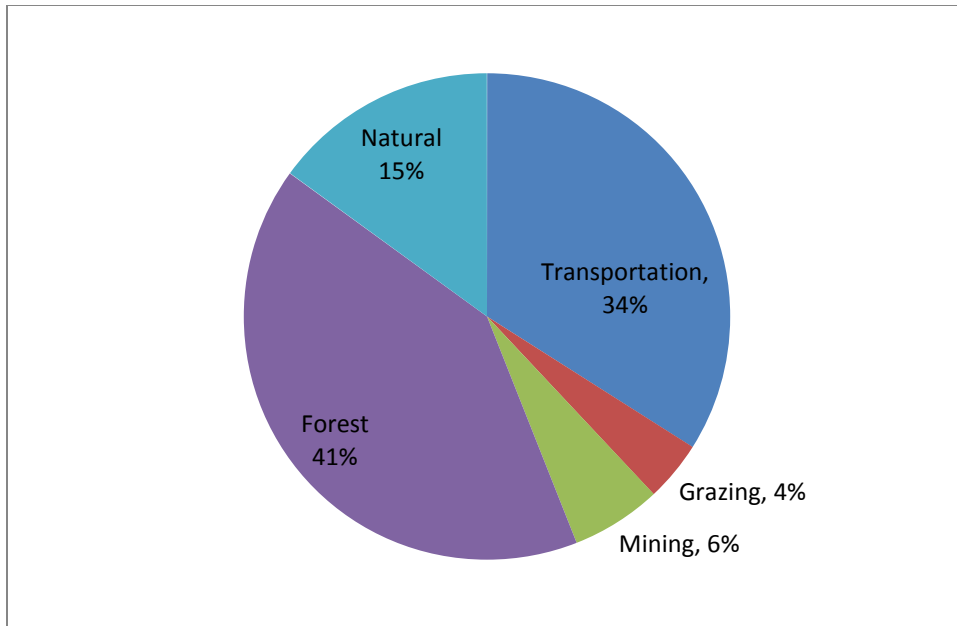
Figure 5-2. Distribution of Influencing Factors on Bank Erosion for Upper Warm Springs Creek near Phosphate

Table 5-13. Upper Warm Springs Creek Distribution Influence on Bank Erosion

Upper Warm Springs Creek is dominated by forest and transportation influences while Browns Gulch has myriad sources but grazing is likely the most significant.

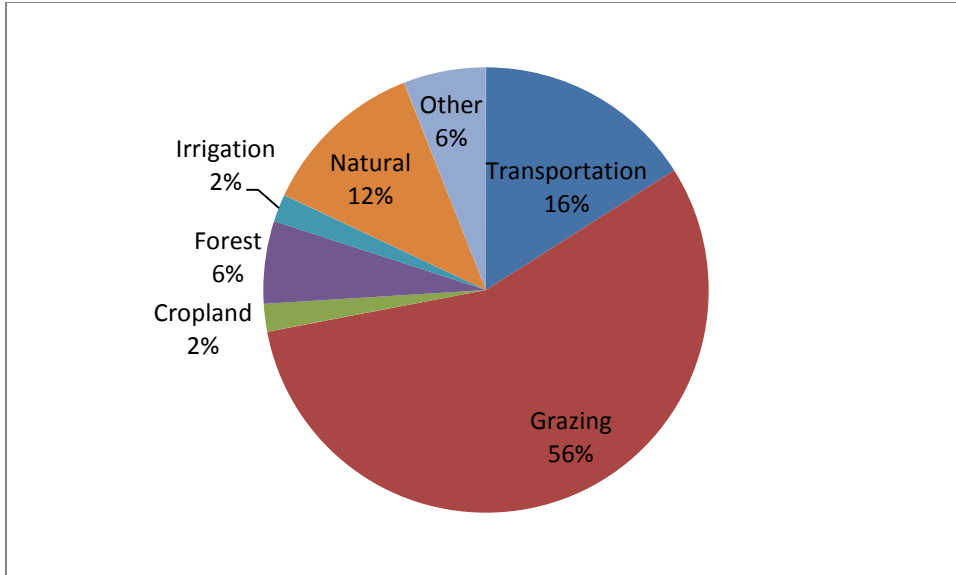
Figure 5-3. Distribution of Influencing Factors on Bank Erosion for Browns Gulch

Table 5-14. Browns Gulch Distribution Influence on Bank Erosion
