Upper Clark Fork River Tributaries Sediment, Metals, and Temperature TMDLs and Framework for Water Quality Restoration

March 4, 2010

Montana Department of Environmental Quality
P.O. Box 200901
Helena, MT 59620-0901

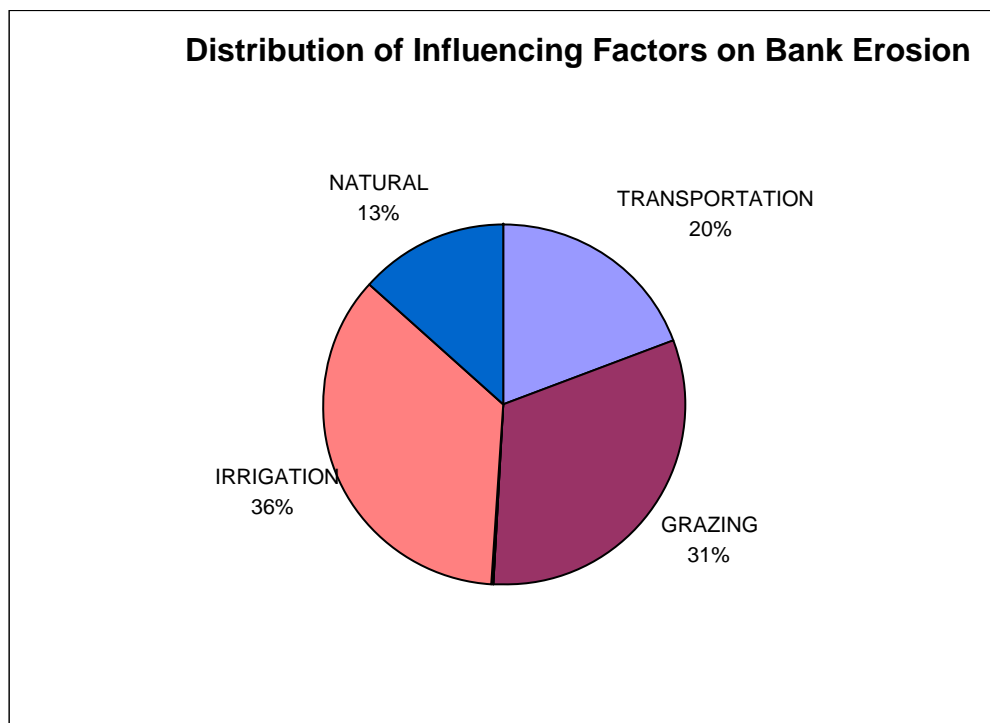
Figure 5-1. Example of Distribution of Bank Erosion Influencing Factors

Table 5-30. Peterson Creek Distribution Influence on Bank Erosion

Reach ID	Reach Length	Natural		Transportation		Grazing		Irrigation	
		%	Length	%	Length	%	Length	%	Length
PTR-01	2558	50	1279	10	256	40	1023	0	0
PTR-02	3306	30	992	40	1322	30	992	0	0
PTR-03	2060	30	618	40	824	30	618	0	0
PTR-04	3226	20	645	60	1936	20	645	0	0
PTR-05	2772	30	832	40	1109	30	832	0	0
PTR-06	1331	30	399	50	666	20	266	0	0
PTR-07	5029	0	0	60	3017	20	1006	20	1006
PTR-08	1793	40	717	0	0	60	1076	0	0
PTR-09	8630	20	1726	0	0	80	6904	0	0
PTR-10	3834	40	1534	0	0	60	2300	0	0
PTR-11	1661	40	664	0	0	60	996	0	0
PTR-12	4708	20	942	10	471	70	3295	0	0
PTR-13	14628	0	0	10	1463	0	0	90	13165
PTR-14	934	0	0	0	0	0	0	100	934
PTR-15	10532	0	0	0	0	40	4213	60	6319
PTR-16	9999	0	0	40	4000	0	0	60	6000
Total Length			10348		15063		24167		27424
% of Total Length			13%		20%		31%		36%

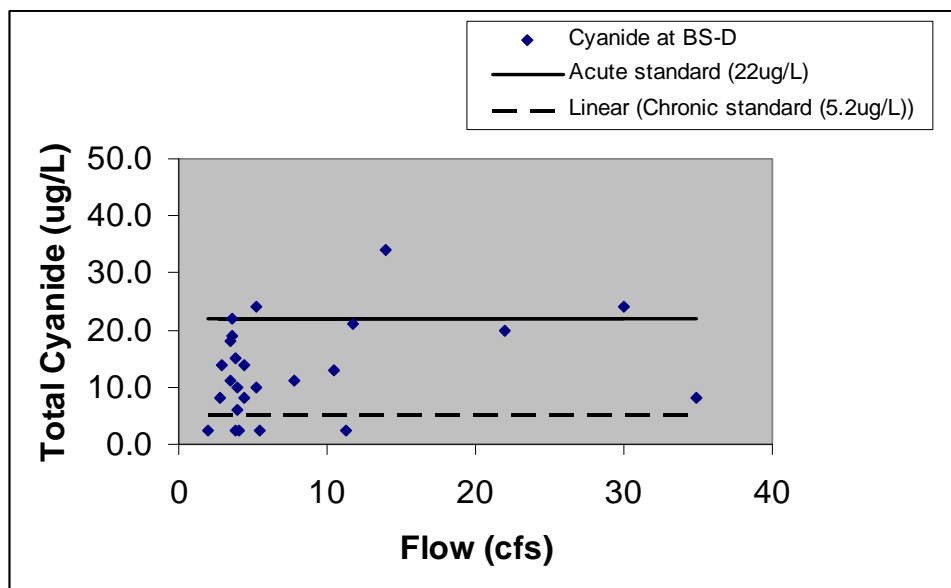
Figure 7-1. Cyanide data for Beefstraight Creek relative to the aquatic life standard.

Of the recent samples collected by the USFS, 73 percent of the samples exceeded the chronic aquatic life standard for cyanide and 18 percent exceeded the acute aquatic life standard for cyanide (**Table 7-5**). Because intensive post mine closure sampling was conducted in 2003, close to half of the samples were collected in 2003. Sample data with corresponding flow measurements were plotted to help assess if target exceedances exhibit a flow-related trend (**Figure 7-1**). Although more samples were collected at low flow compared to high flow (**Table 7-5**), there does not appear to be a flow-related trend to the target exceedances. Heap leach waste has been treated and land applied sporadically since 2001, and cyanide concentrations in the heap leach pad have declined during that time period (Maxim Technologies, Inc., 2005). This decline is mirrored in the sample data; all of the exceedances of the acute aquatic life standard occurred in 2003. Samples below the detection limit (i.e. 5µg/L) are plotted at half of the detection limit in **Figure 7-1**, and four of the seven non-detects occurred in 2006 and 2008. However, despite a decline in target exceedances and no recent exceedances of the acute standard, target exceedances continue to occur and a cyanide TMDL will be developed for Beefstraight Creek.

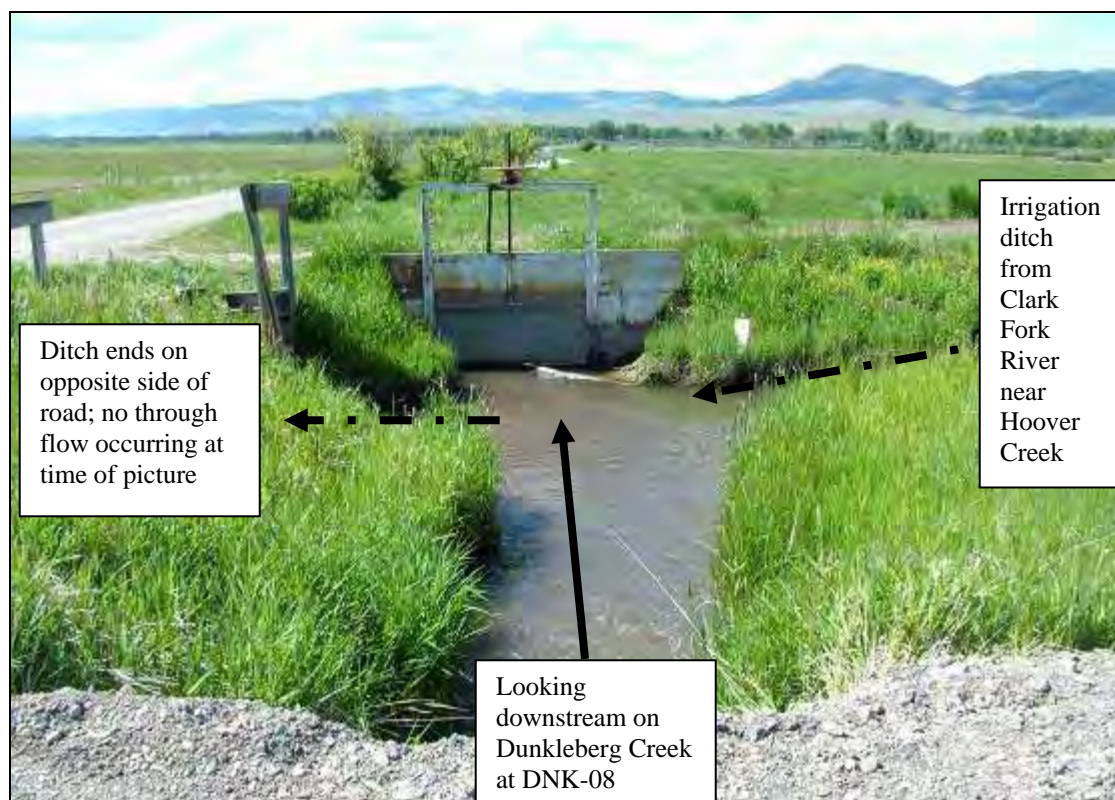
Figure 7-2. Looking downstream on Dunkleberg Creek at DNK-08 showing mixing with irrigation ditch from the Clark Fork River. Arrows indicate flow direction.

The lower segment of Dunkleberg Creek may receive some metals loading from the Forest Rose and Jackson Park mines, priority mines in the upper watershed, but the abandoned mines databases do not indicate mining sources along the lower segment of Dunkleberg Creek. Dunkleberg Creek is a tributary to the Clark Fork River, which has been documented as having elevated metals in the floodplain as a result of historical mining sources upstream (Lipton, 1993). The highest floodplain tailings concentrations along the Clark Fork River occur upstream of Deer Lodge (which is upstream of Dunkleberg Creek). An additional potential source of metals to the lower segment of Dunkleberg Creek is an irrigation channel that withdraws from the Clark Fork River near Hoover Creek and mixes with Dunkleberg Creek near its mouth (**Figure 7-2** and

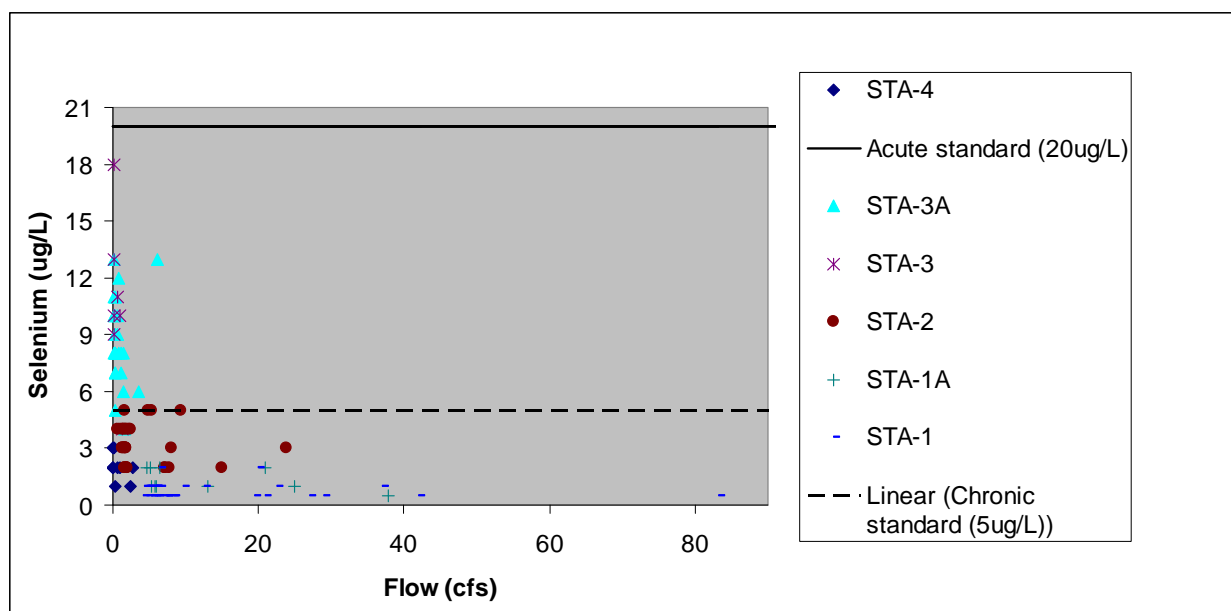
Figure 7-3. Selenium sample data at various USFS sites relative to the aquatic life standard.

The USFS has conducted extensive sampling in German Gulch related to the reclamation and closure of the Beal Mountain Mine. One hundred and thirty samples were collected at six sites from the headwaters to downstream of Beefstraight Creek monthly between 2003 and 2005 and also in 2006 and 2008 during high flow and base flow (**Table 7-10** and **Figure 7-3**). Other recent data includes sediment samples and high and low flow water samples collected by DEQ in 2007/2008 at five sites from downstream of Beal Mountain Mine to the mouth (**Tables 7-10** and **7-11**; **Figure 7-3**). Note, although an entire suite of metals was sampled, only listed metals or those with target/supplemental indicator exceedances are presented in **Tables 7-10** and **7-11**.

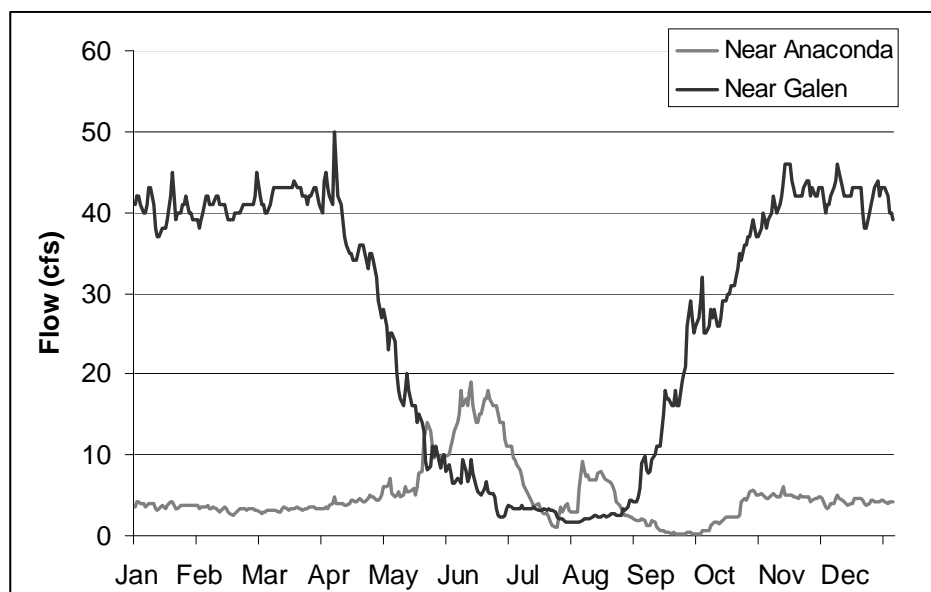
Figure 7-8. Average daily discharge at the gaging stations on Lost Creek.

Lower Lost Creek is heavily used for irrigation withdrawals, which is indicated by the downward summertime shift in average daily flow between the Anaconda and Galen gages (**Figure 7-8**). During the irrigation season, lower Lost Creek receives return flows from Gardiner Ditch (30-50cfs), which originates at Warm Springs Creek, and it also receives major ground water inputs, which can exceed 40cfs over the 8 miles downstream of LC-2/Anaconda gage (**Figure A-26**) (Pioneer Technical Services, Inc., 2002). Storm event sampling indicates that significant loading for all metals occurs in the vicinity of LC-2/Anaconda gage and from a tributary that drains the north slope of Stuckey Ridge and flows into Gardiner Ditch. Loading from other tributaries that contributes to target exceedances is limited to high flow and storm events. During low flow, arsenic inputs downstream of LC-2 are likely associated with the large influx of ground water. Return flows from Gardiner Ditch also likely constitute some low flow loading of arsenic, and possibly other metals, but sampling in 1993 showed a doubling in flow in the vicinity of the ditch but a decrease in load, indicating that Gardiner Ditch may actually dilute arsenic concentrations within Lost Creek. This is consistent with a 1995 RI report for the Anaconda Superfund site that concluded that Gardiner Ditch has a minimal impact on metals concentrations in Lost Creek (Environmental Science and Engineering, Inc., 1995). Overall, these trends in loading
