# Water Quality Assessment and TMDLs for the Dearborn River Planning Area

Prepared for:  
Montana Department of Environmental Quality

Prepared by:  
U.S. Environmental Protection Agency  
Montana Operations Office  
and Tetra Tech, Inc.

February 17, 2005

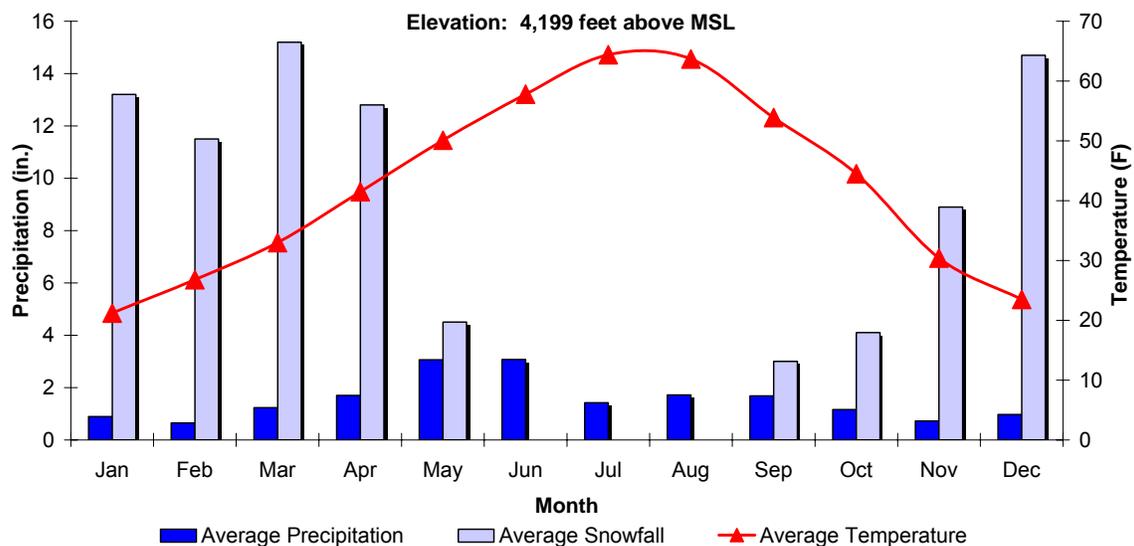
**Figure 2-1. Climagraph for Rogers Pass 9NNE MT, Station 247159-4. Data cover the period 1971 to 2000.**

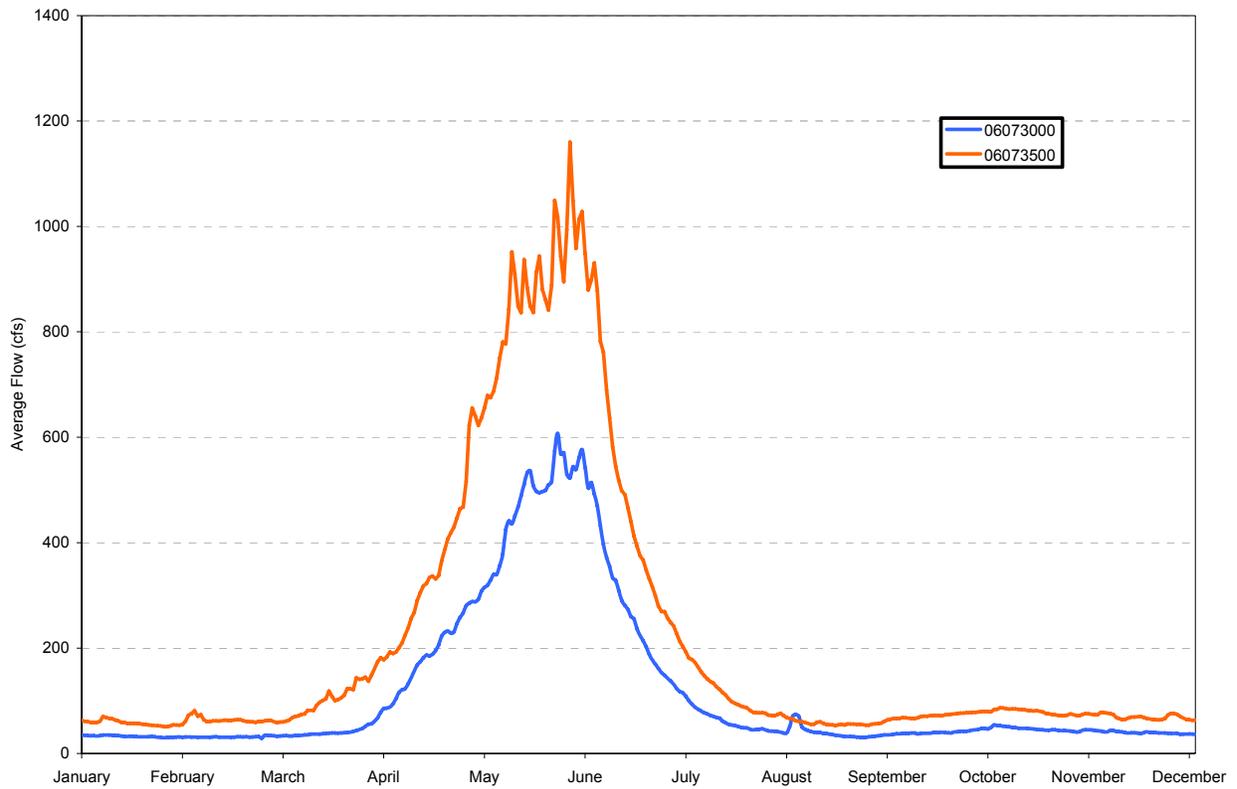
**Figure 2-3. Average daily flows at two USGS gages on the Dearborn River main stem. Data show the entire period of record for both gages.**

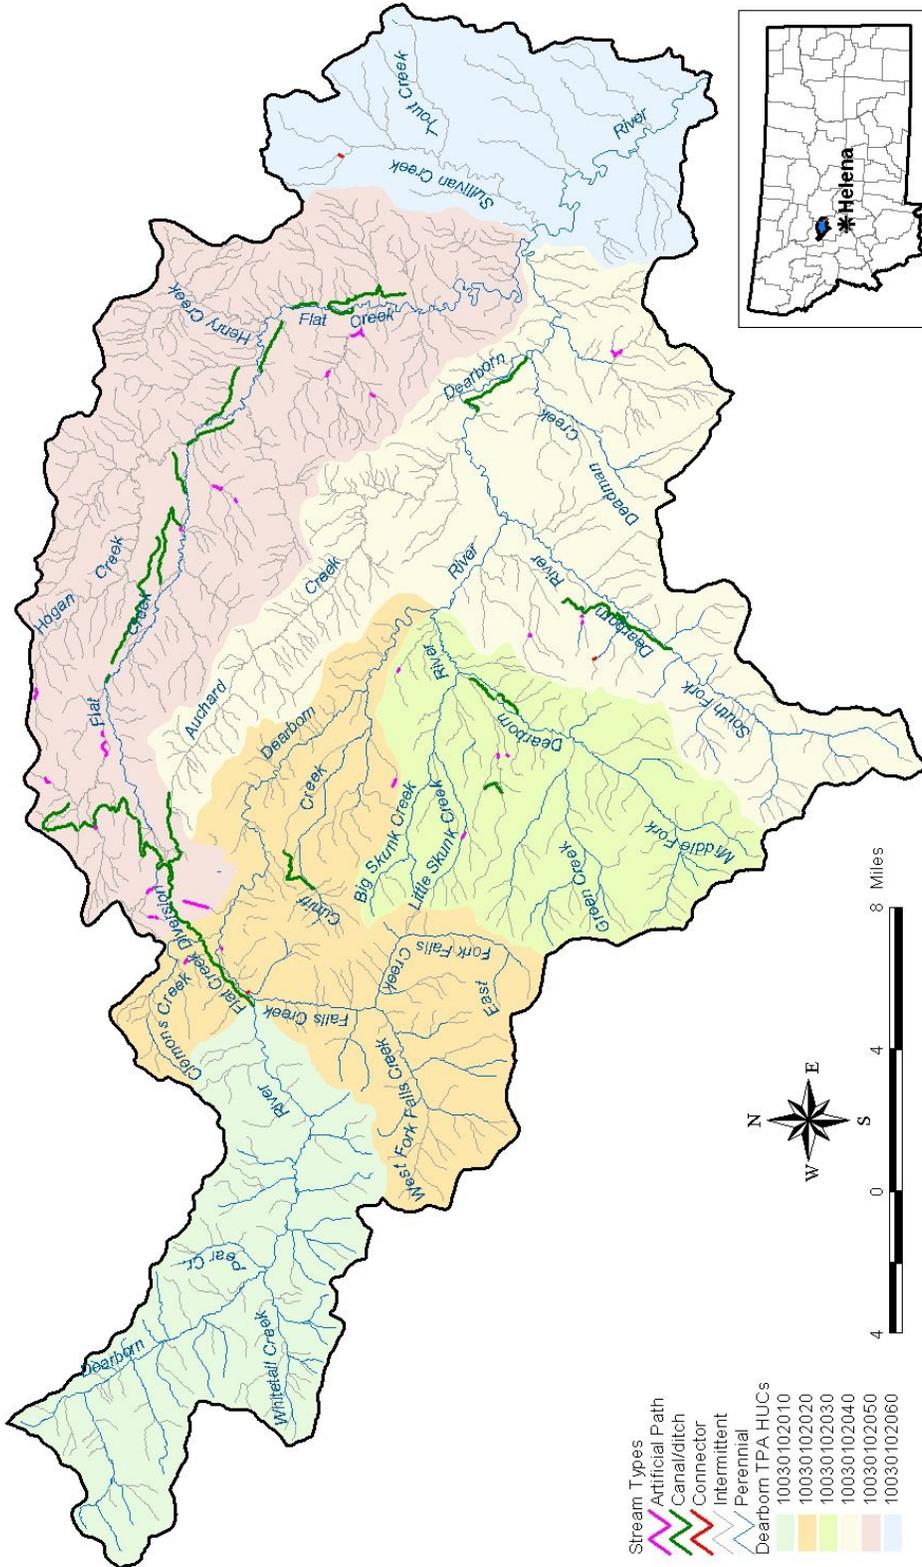
Figure 2-4. Stream types in the Dearborn River watershed.

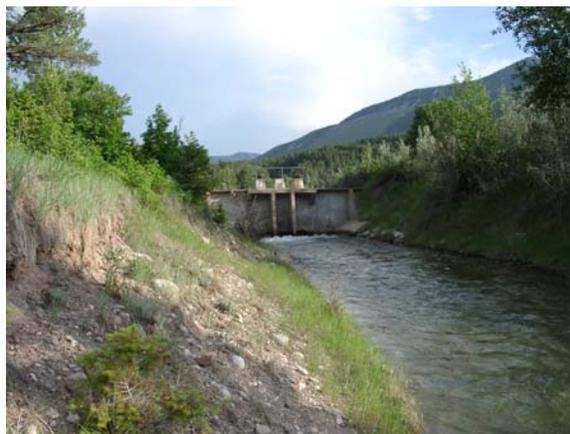
**Figure 2-6. Flat Creek diversion canal.**

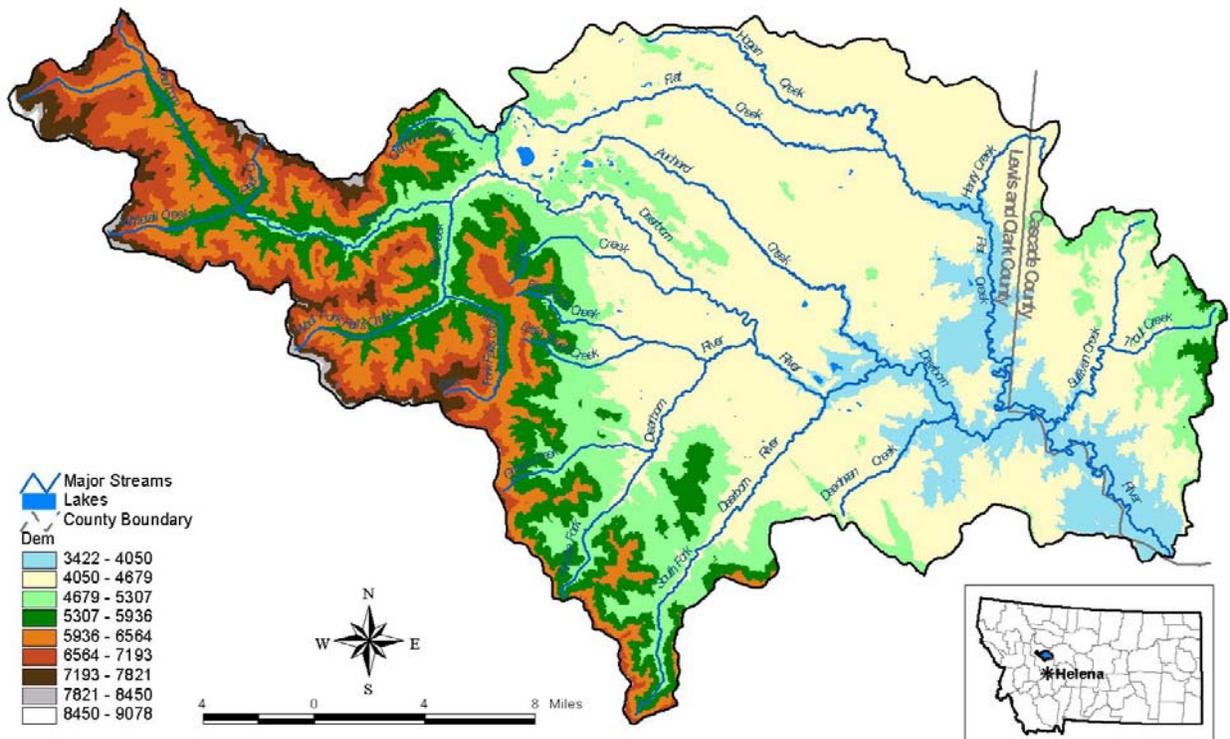
Figure 2-7. Elevation in the Dearborn River watershed.

Figure 2-7 displays the general topography within the Dearborn River TPA, and a shaded relief map of the watershed is presented in Figure 2-8. Elevations range from around 3,422 feet above mean sea level at the confluence with the Missouri River to 9,078 feet at the highest point in the watershed.

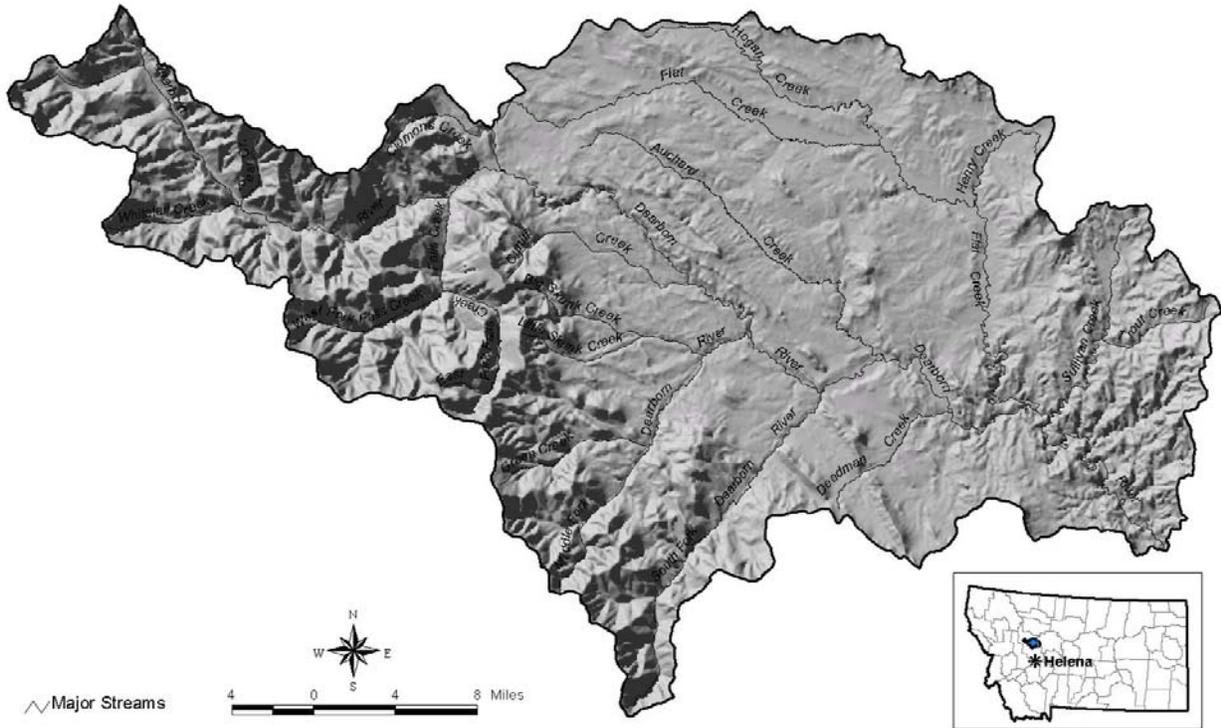
Figure 2-8. Topographic relief in the Dearborn River watershed.

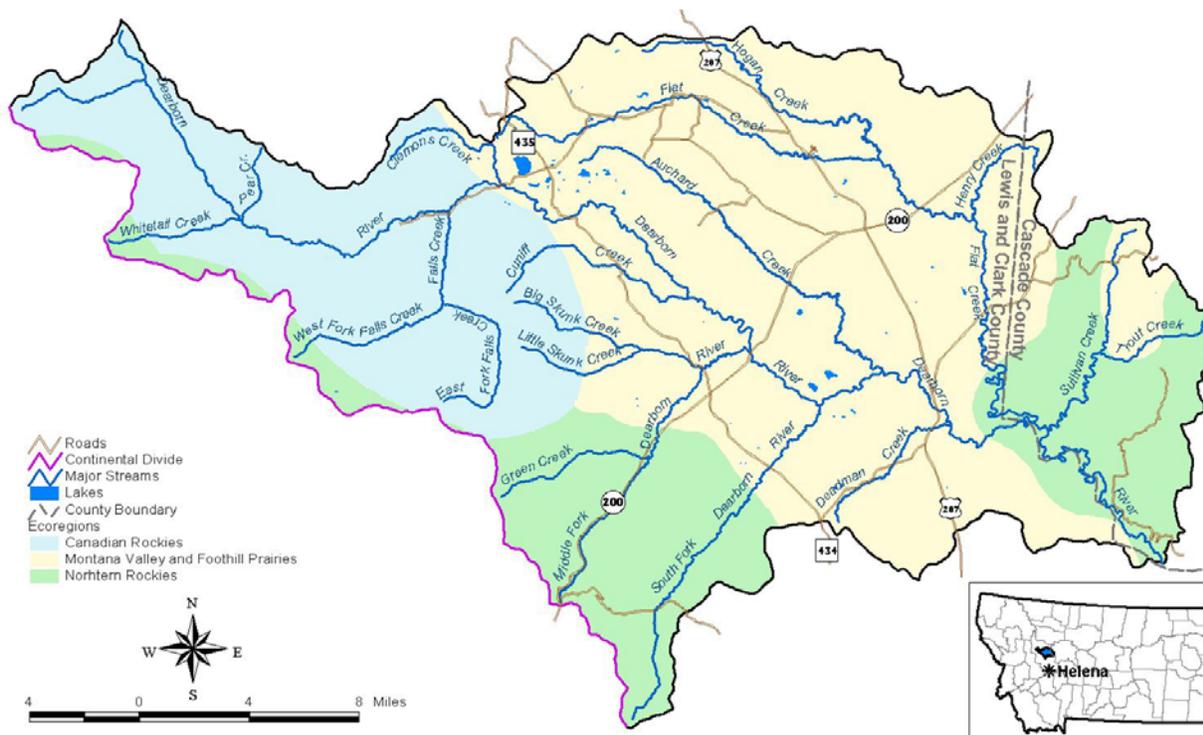
**Figure 2-9. Ecoregions in the Dearborn TPA.**

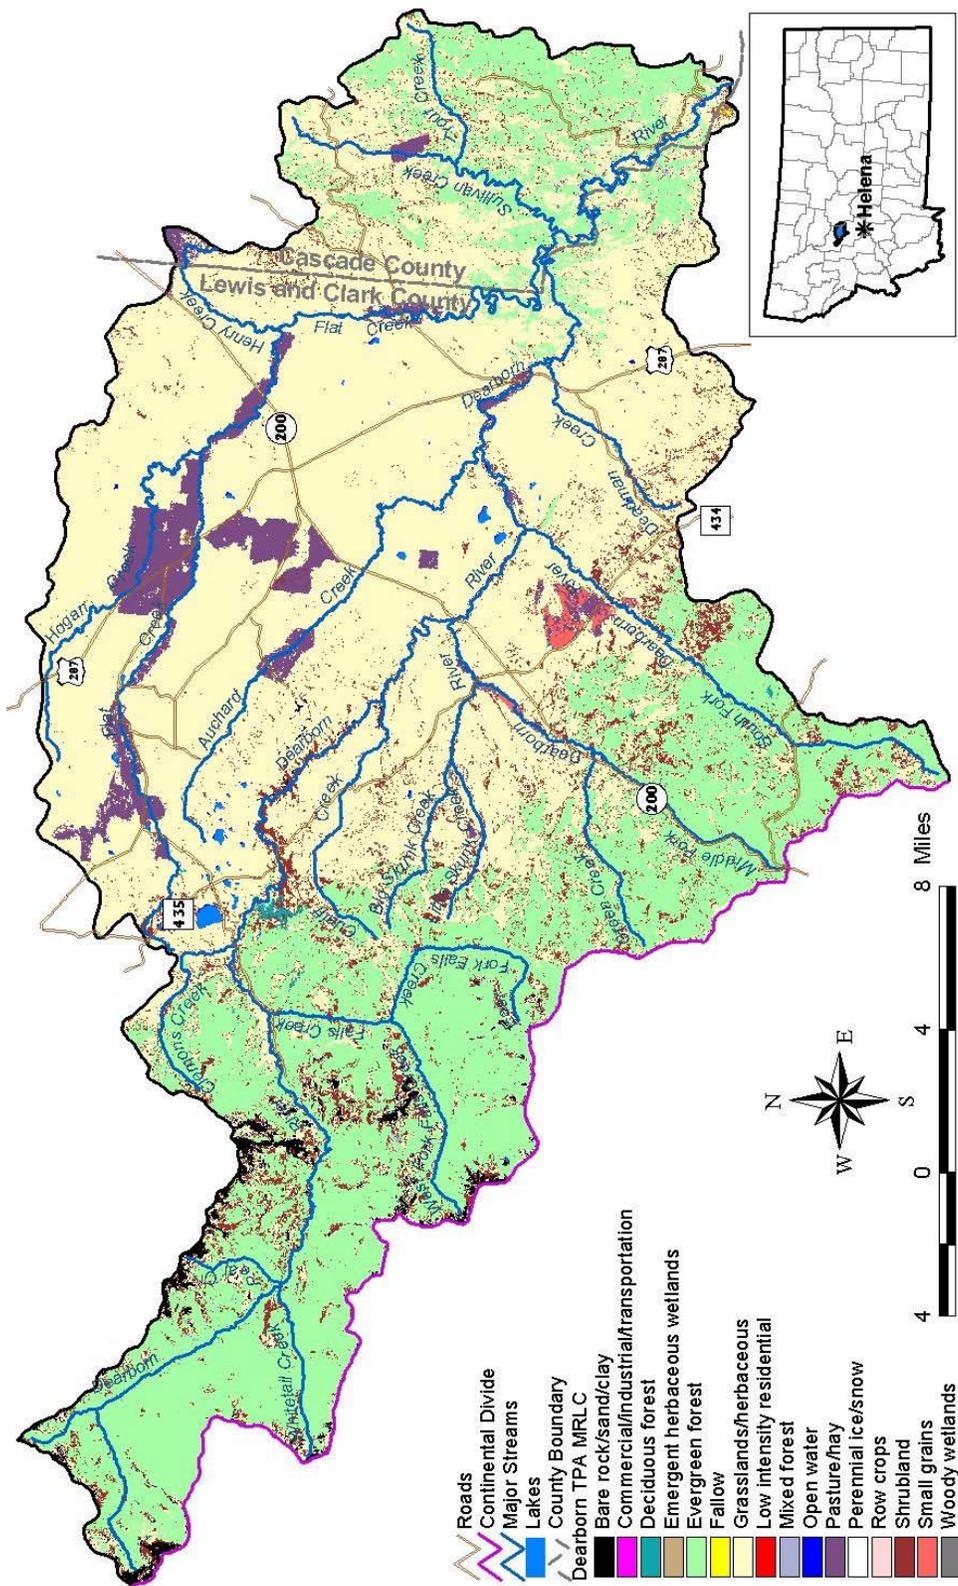
Figure 2-10. MRLC land use/land cover in the Dearborn River watershed.

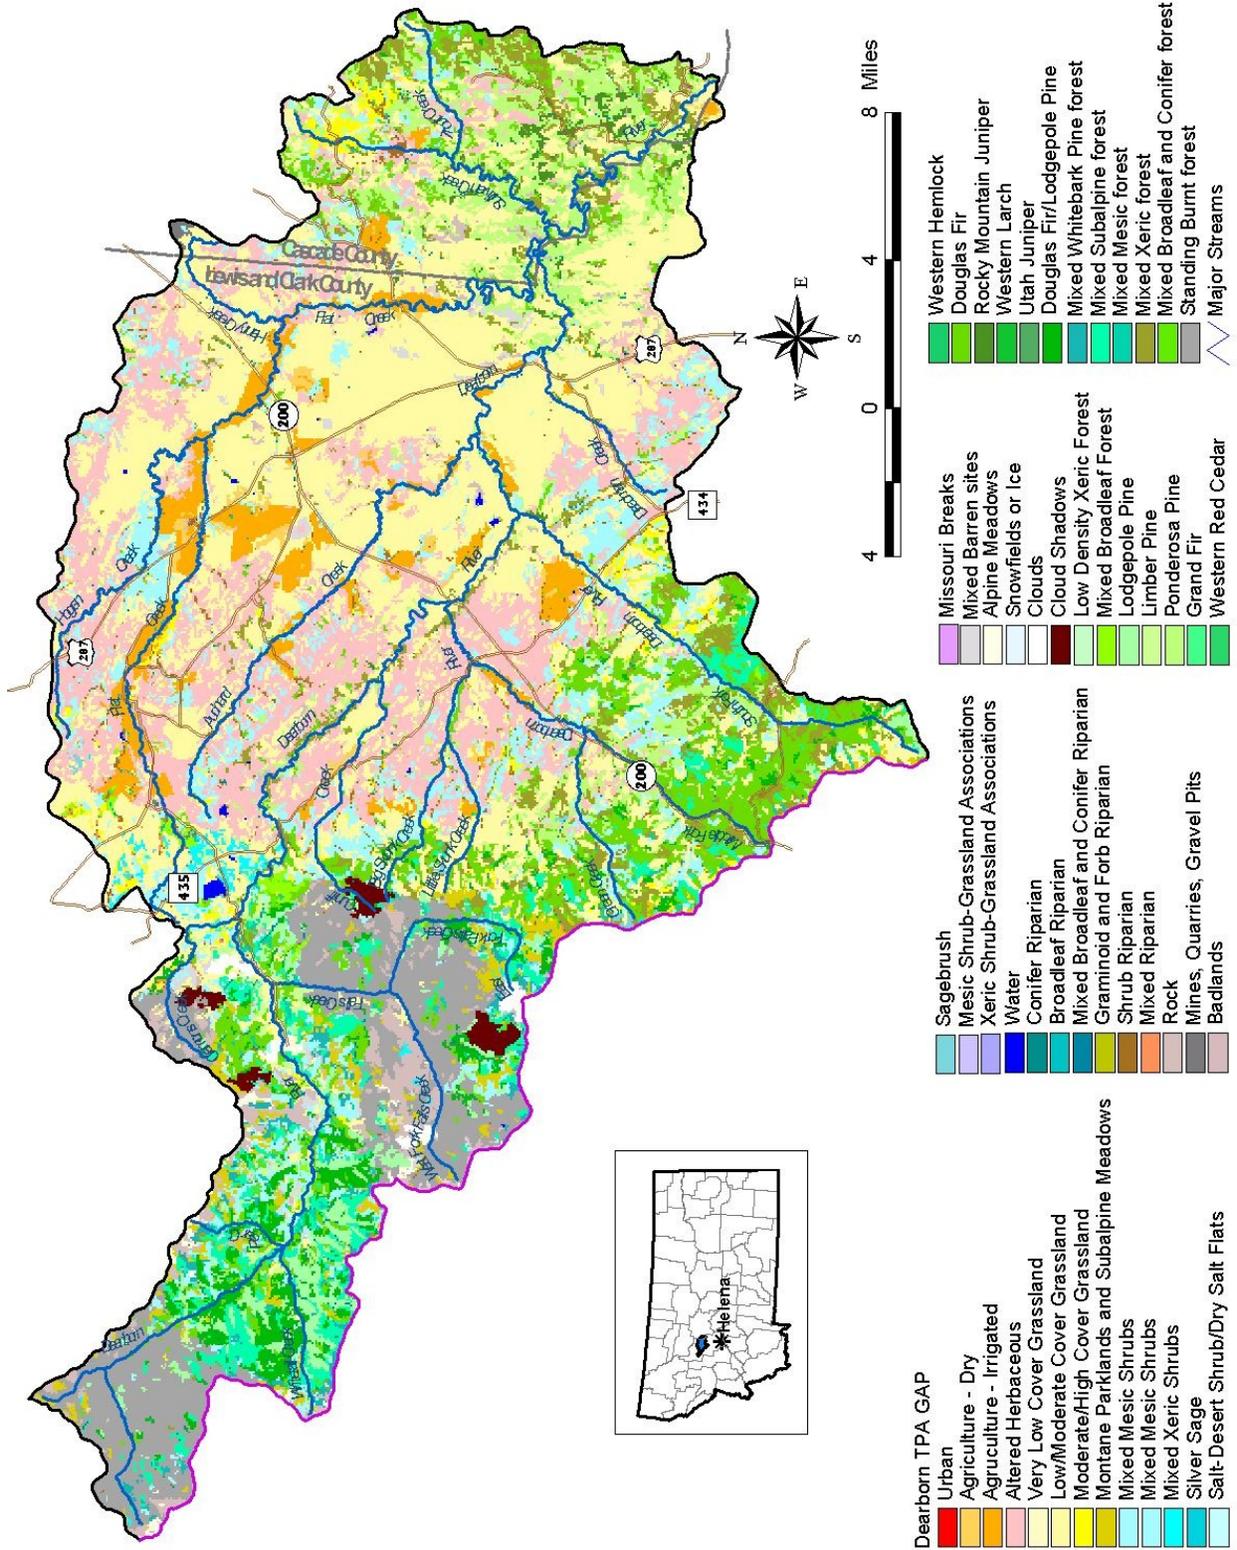
Figure 2-11. GAP vegetative cover in the Dearborn River Watershed.

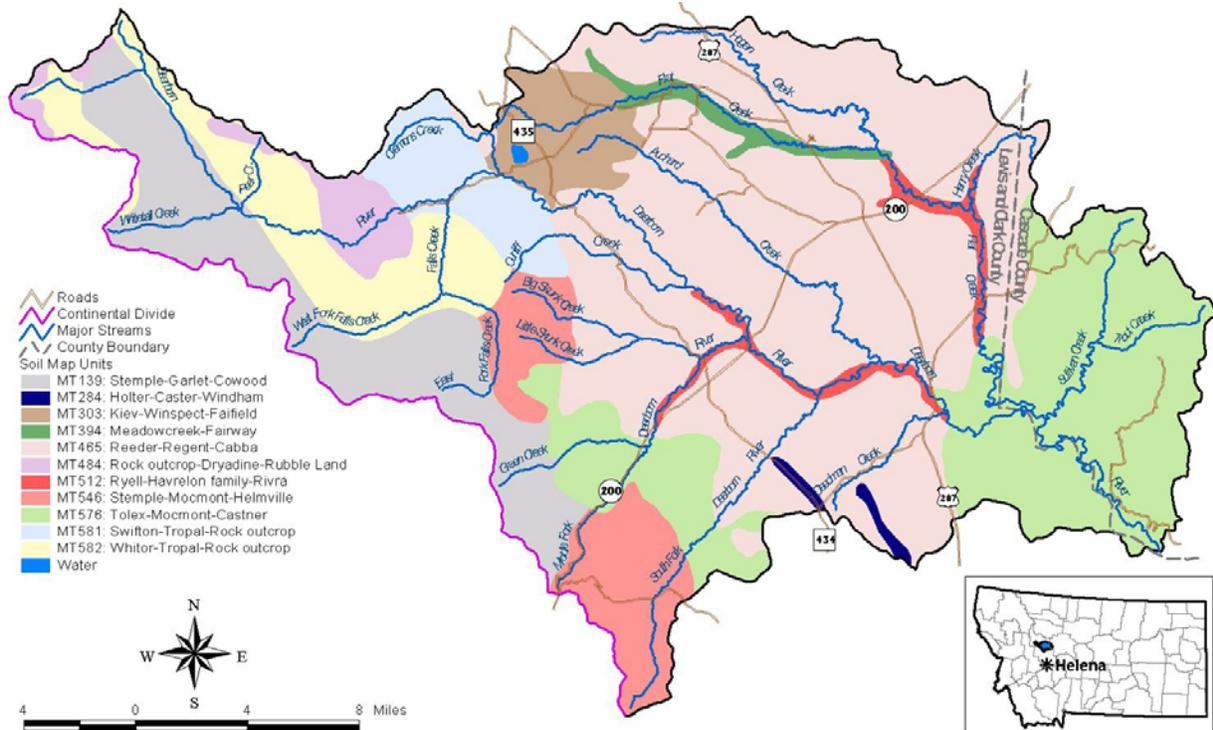
Figure 2-12. General soil units in the Dearborn River TPA.

The majority of soils in the middle portion of the Dearborn River Basin are moderately deep, fine-textured C soils, characterized by moderately slow infiltration rates. A large portion of soils in the upper Dearborn TPA have moderate infiltration rates typical of moderately well drained alluvial B soils. The remainder of the basin contains poorly drained D soils. These areas have very slow infiltration rates and high amounts of runoff resulting from high soil clay content.

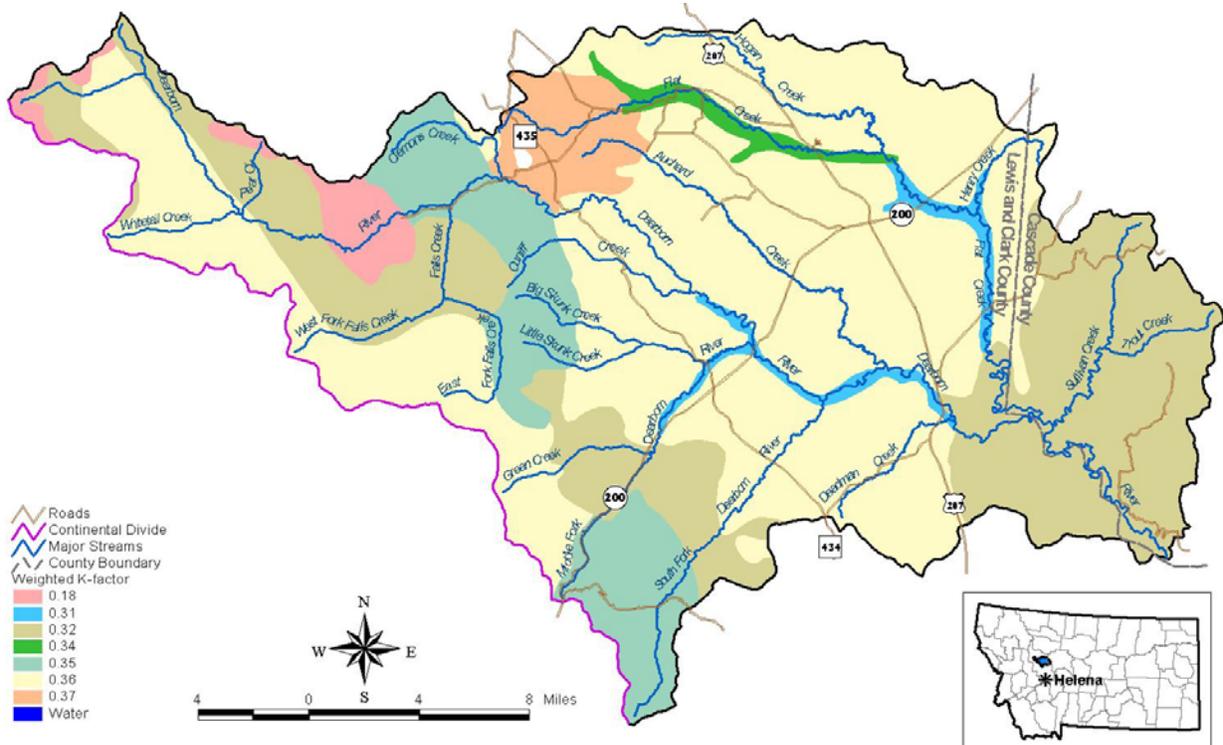
Figure 2-13. Distribution of USLE K-factor.

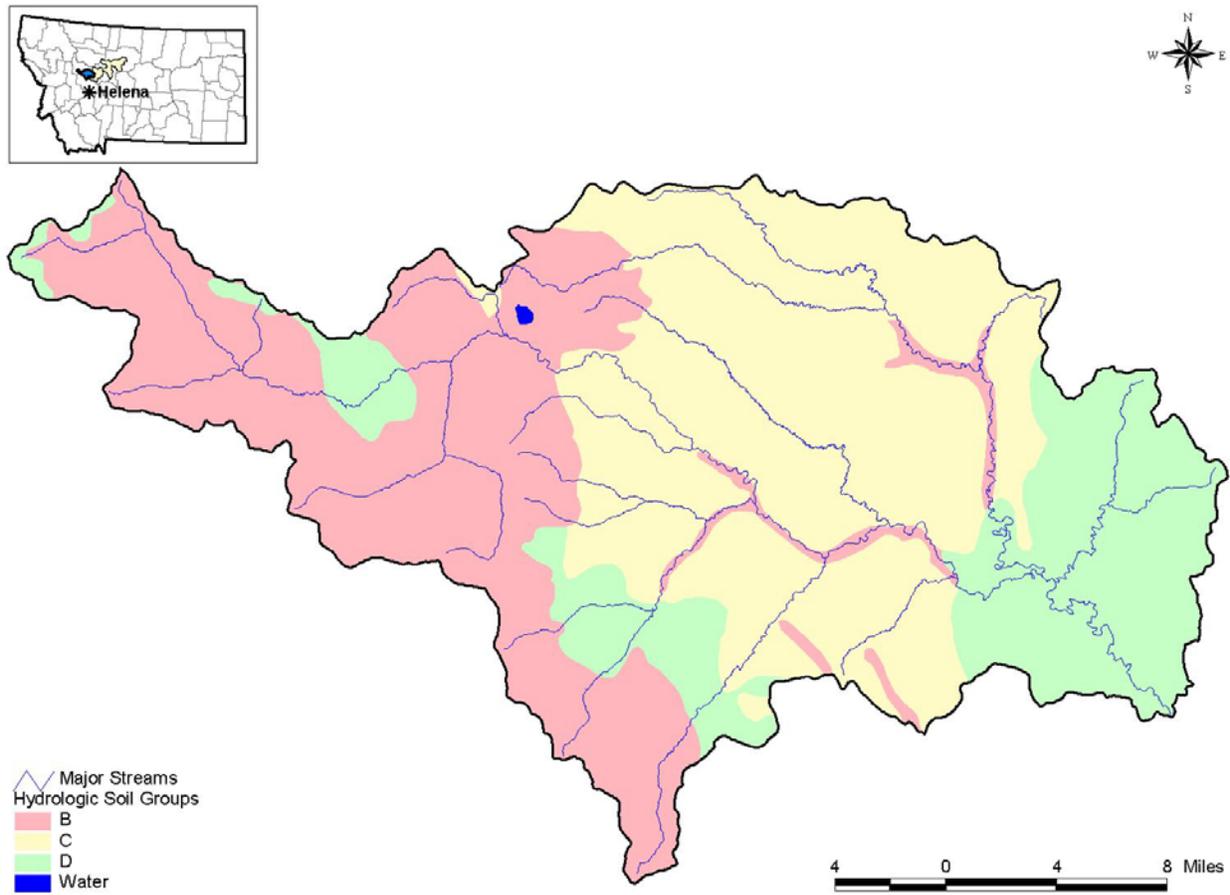
Figure 2-14. Distribution of hydrologic soil groups.

The hydrologic soil group classification is a means for grouping soils by similar infiltration and runoff characteristics during periods of prolonged wetting. Typically, clay soils that are poorly drained have the slowest infiltration rates, while sandy soils that are well drained have the fastest infiltration rates. NRCS has defined four hydrologic groups for soils. Data for the Dearborn River TPA were obtained from STATSGO and summarized based on the major hydrologic group in the surface layers of the map unit (Table 2-7) (NRCS, 2001). The resulting hydrologic soil information is displayed in Figure 2-14.

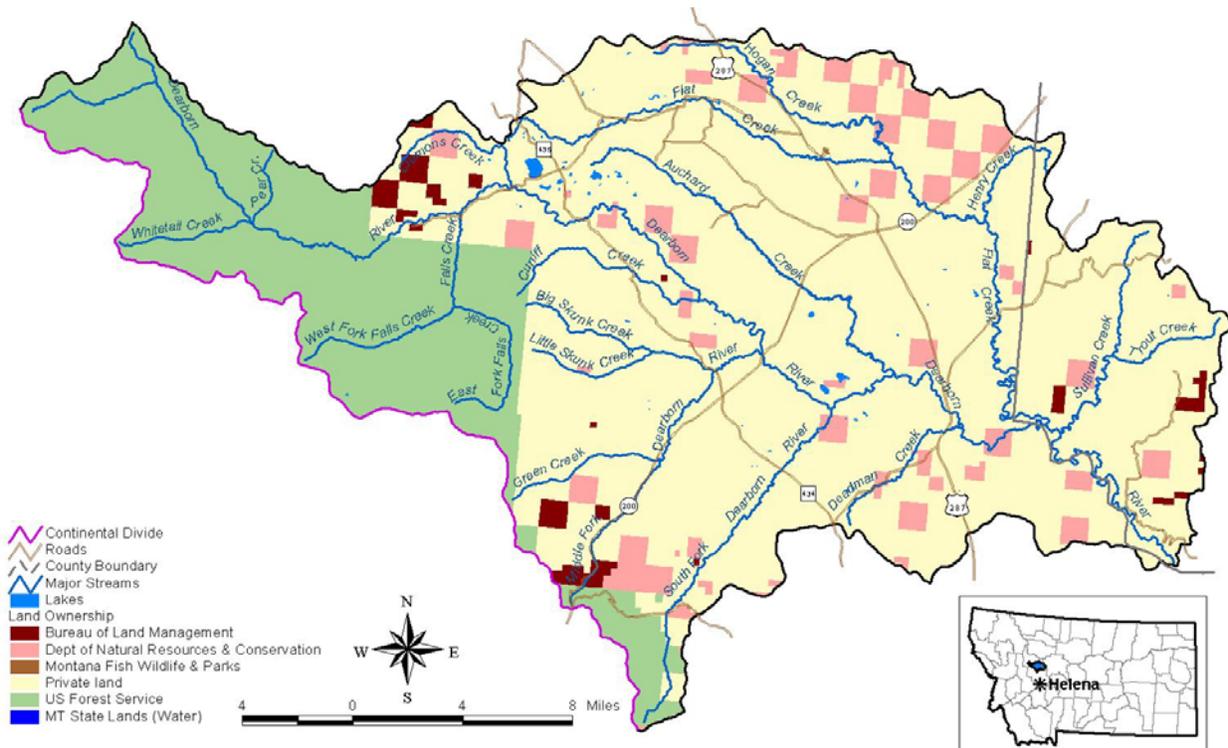
Figure 2-15. Land ownership in the Dearborn TPA.

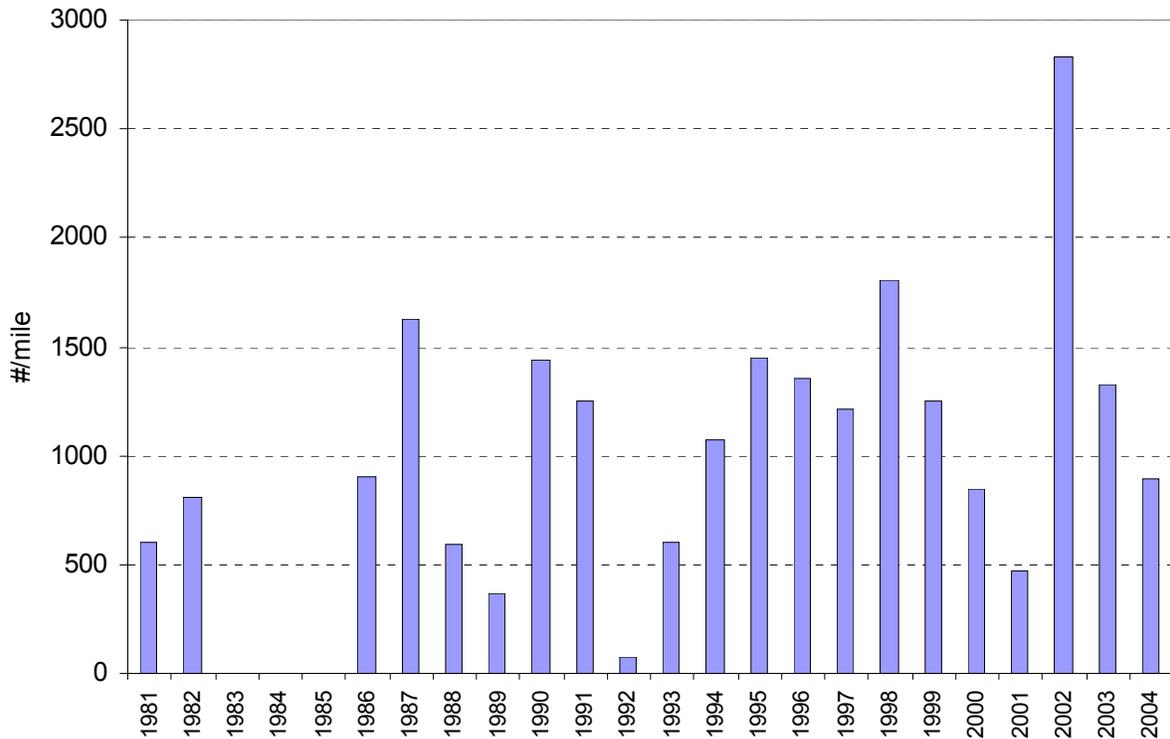
**Figure 2-16. Fall estimates of age-1 rainbow trout in the Missouri River at Pelican Point.**

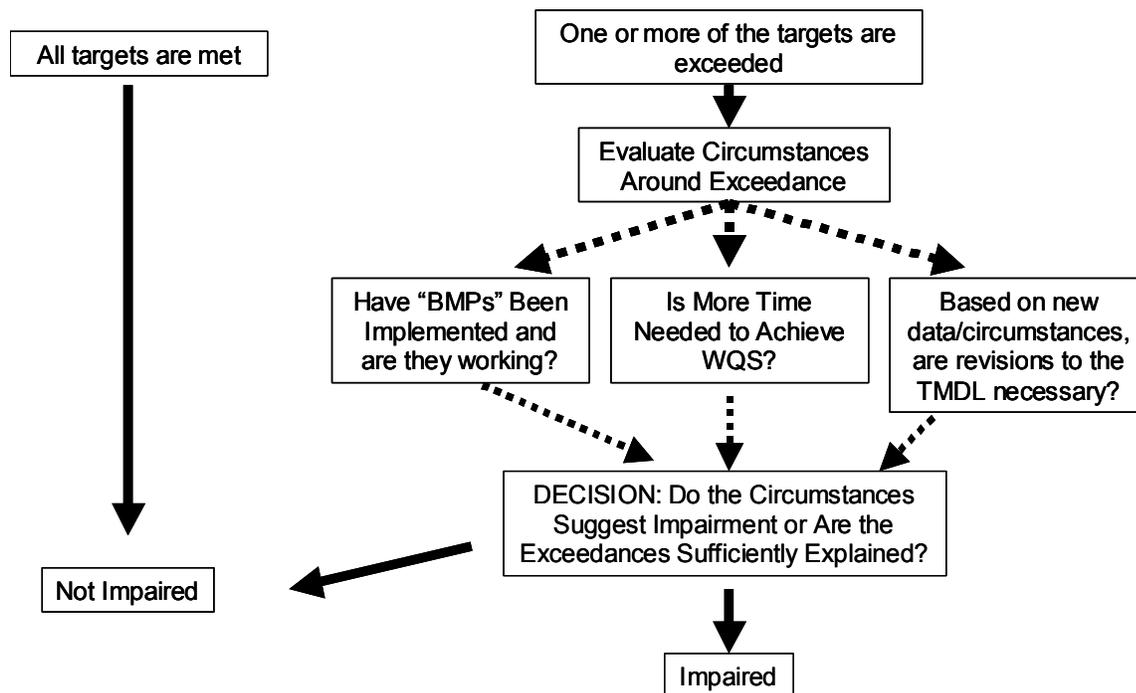
Figure 3-3. Methodology for determining compliance with water quality standards.

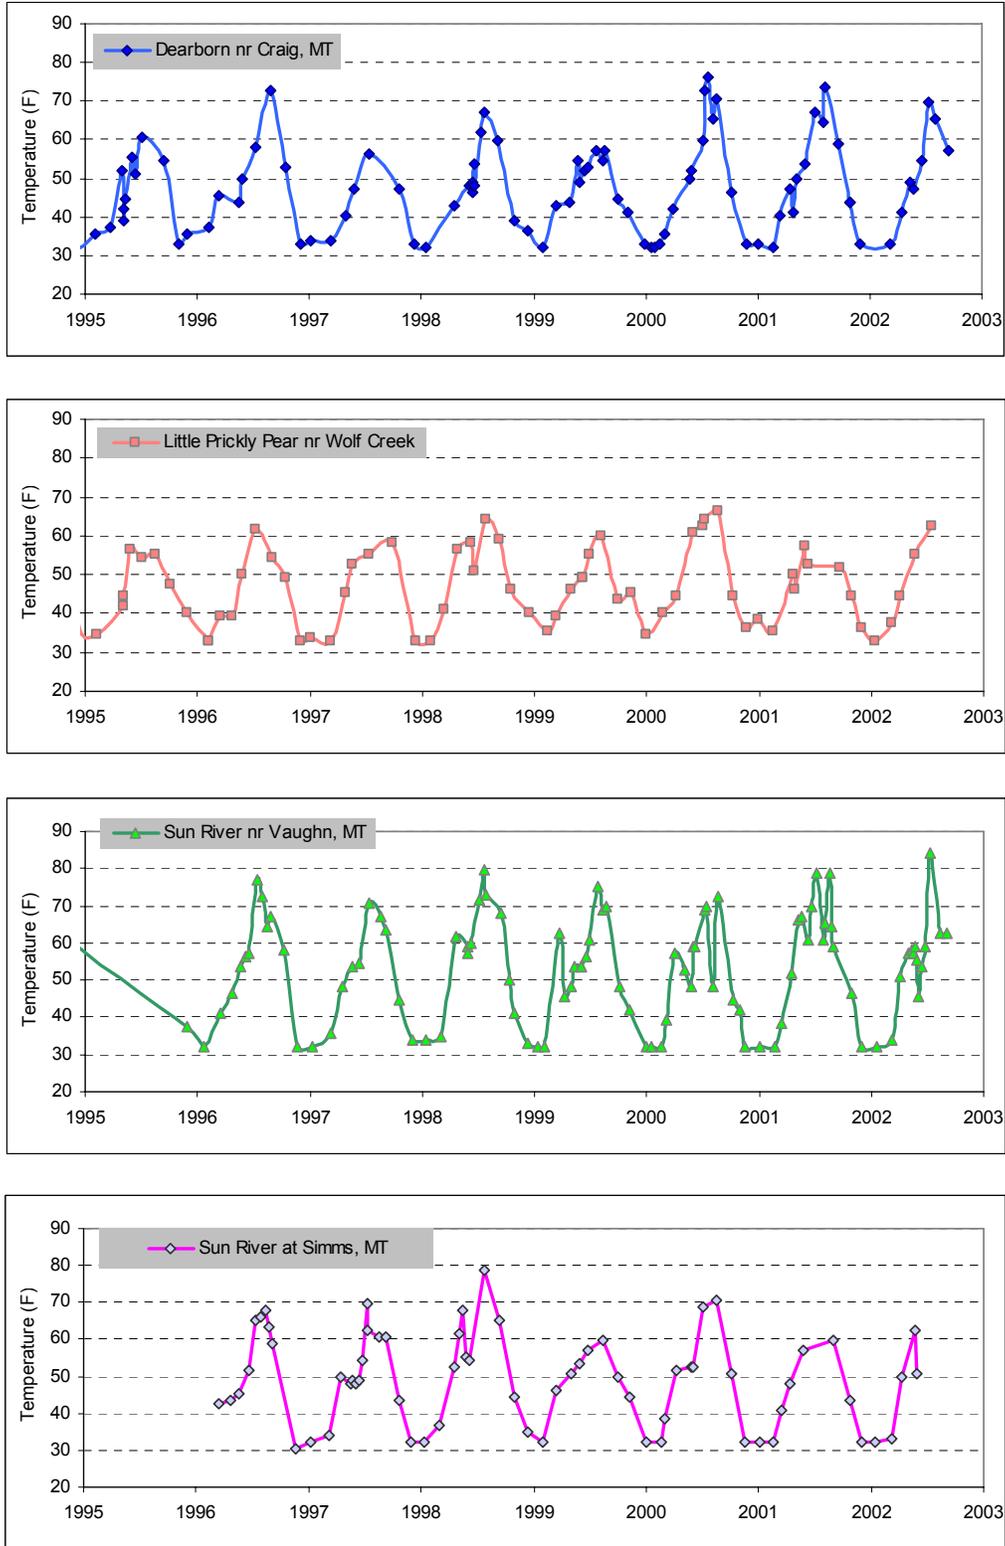
Figure 3-4. Comparison of Dearborn River temperature data to the Sun River and Little Prickly Pear Creek.

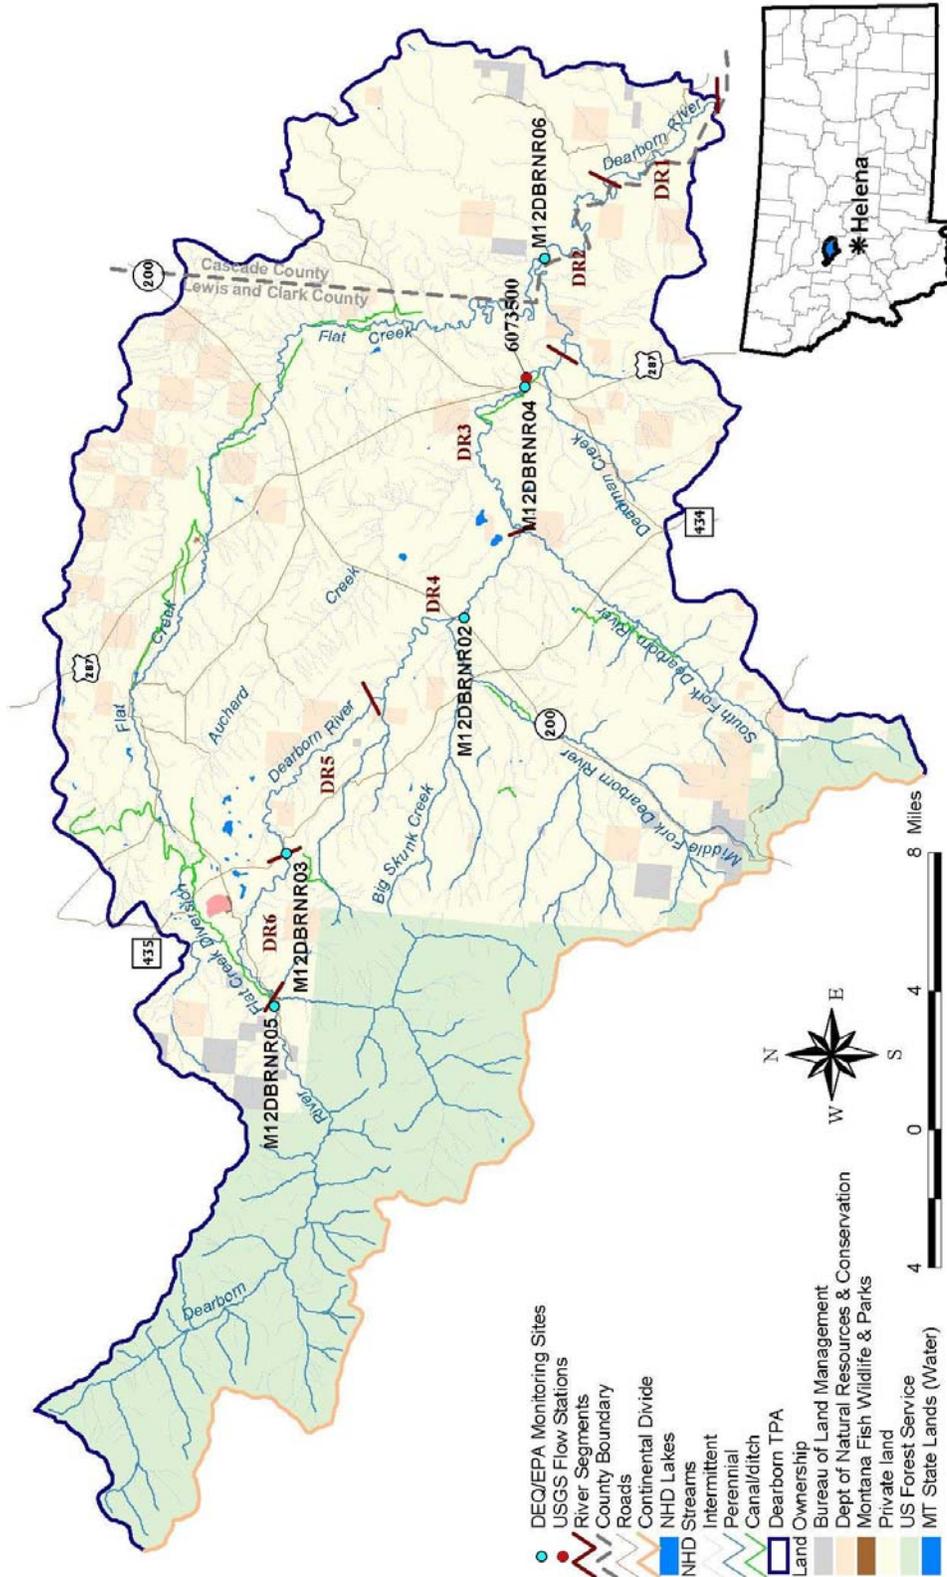
Figure 3-7. Sampling locations in the mainstem Dearborn River.

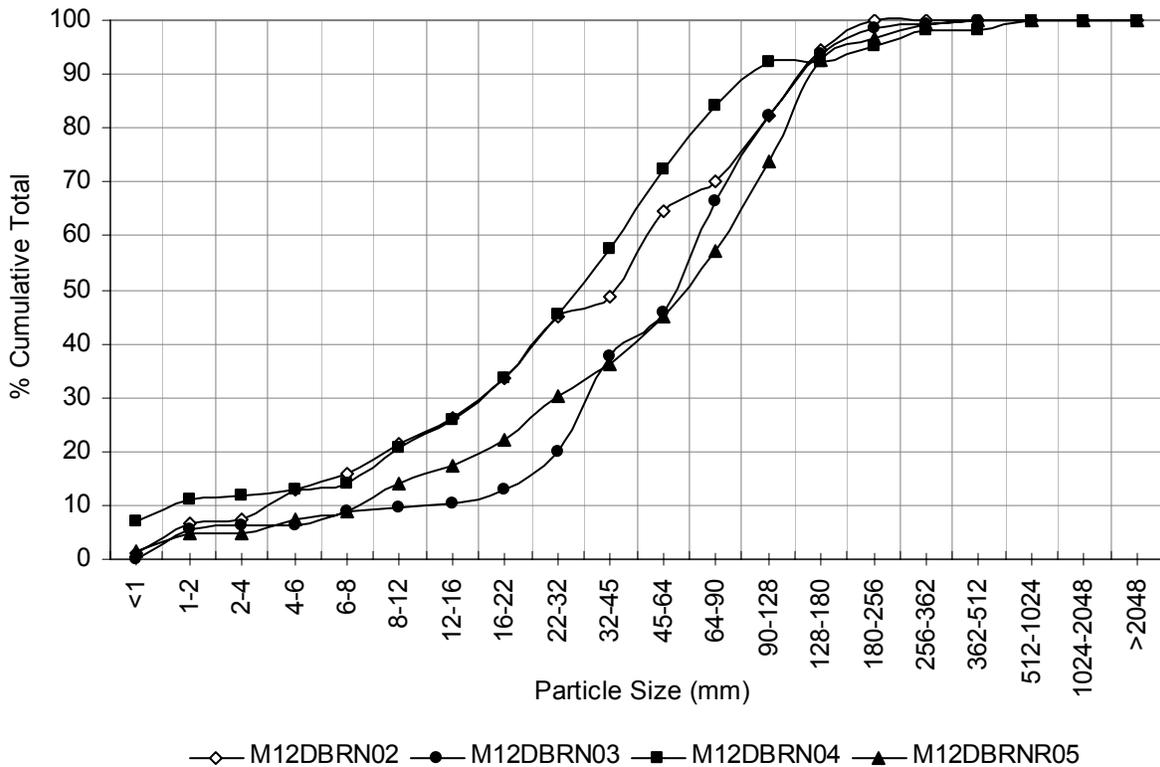
**Figure 3-8. Cumulative stream bottom particle distribution for the Dearborn River.**

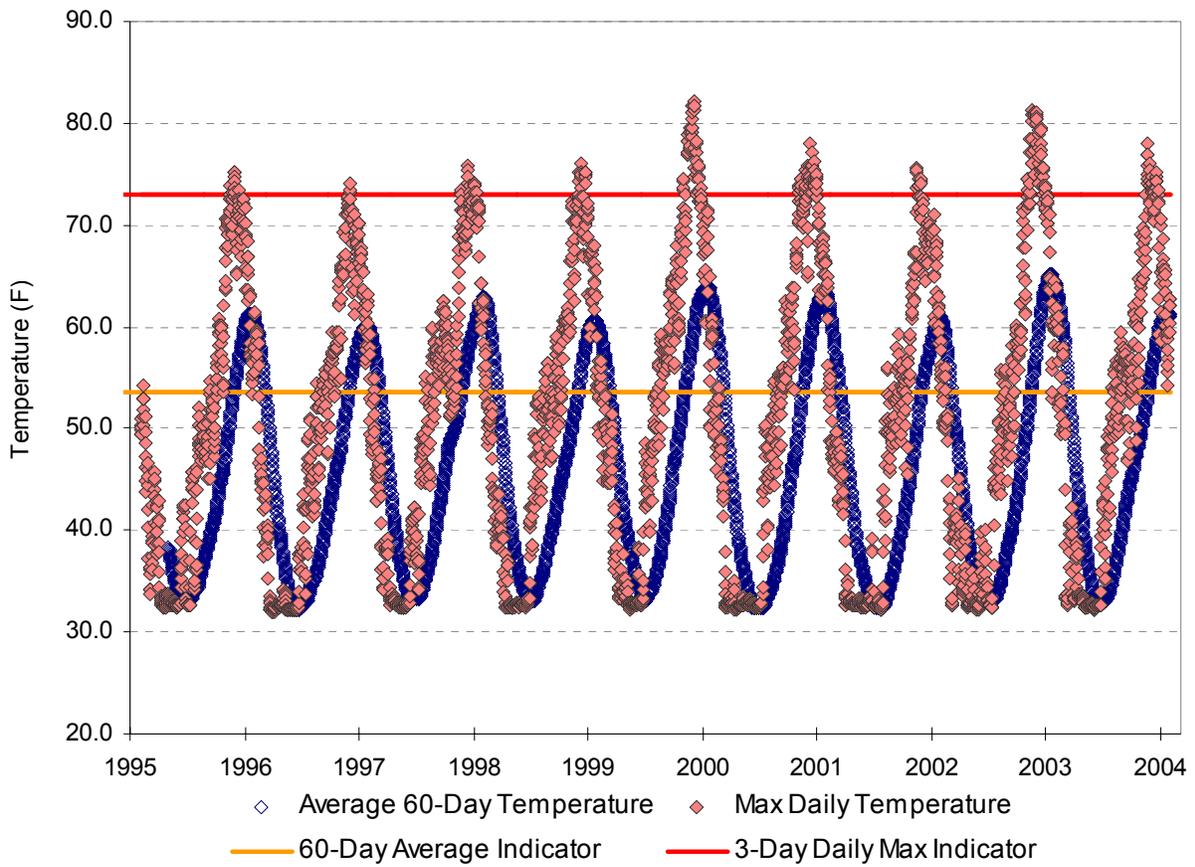
Figure 3-9. Evaluation of continuous temperature data for the Dearborn River at Highway 287 (USGS gage 06073500).

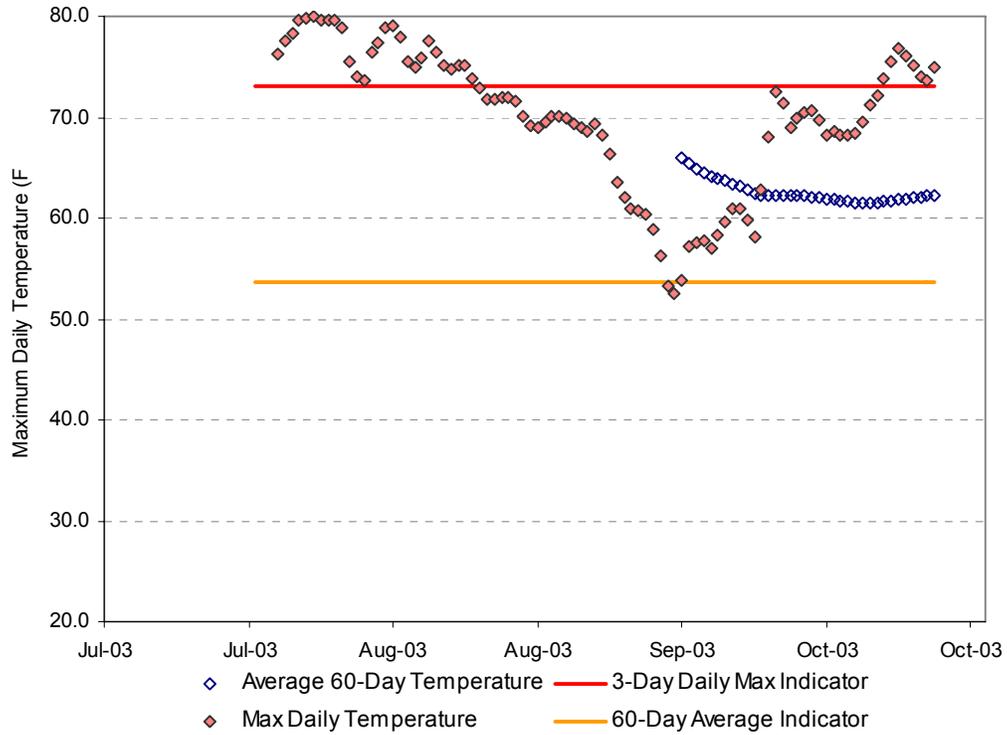
Figure 3-10. Continuous temperature evaluation for the Dearborn River downstream of Flat Creek.

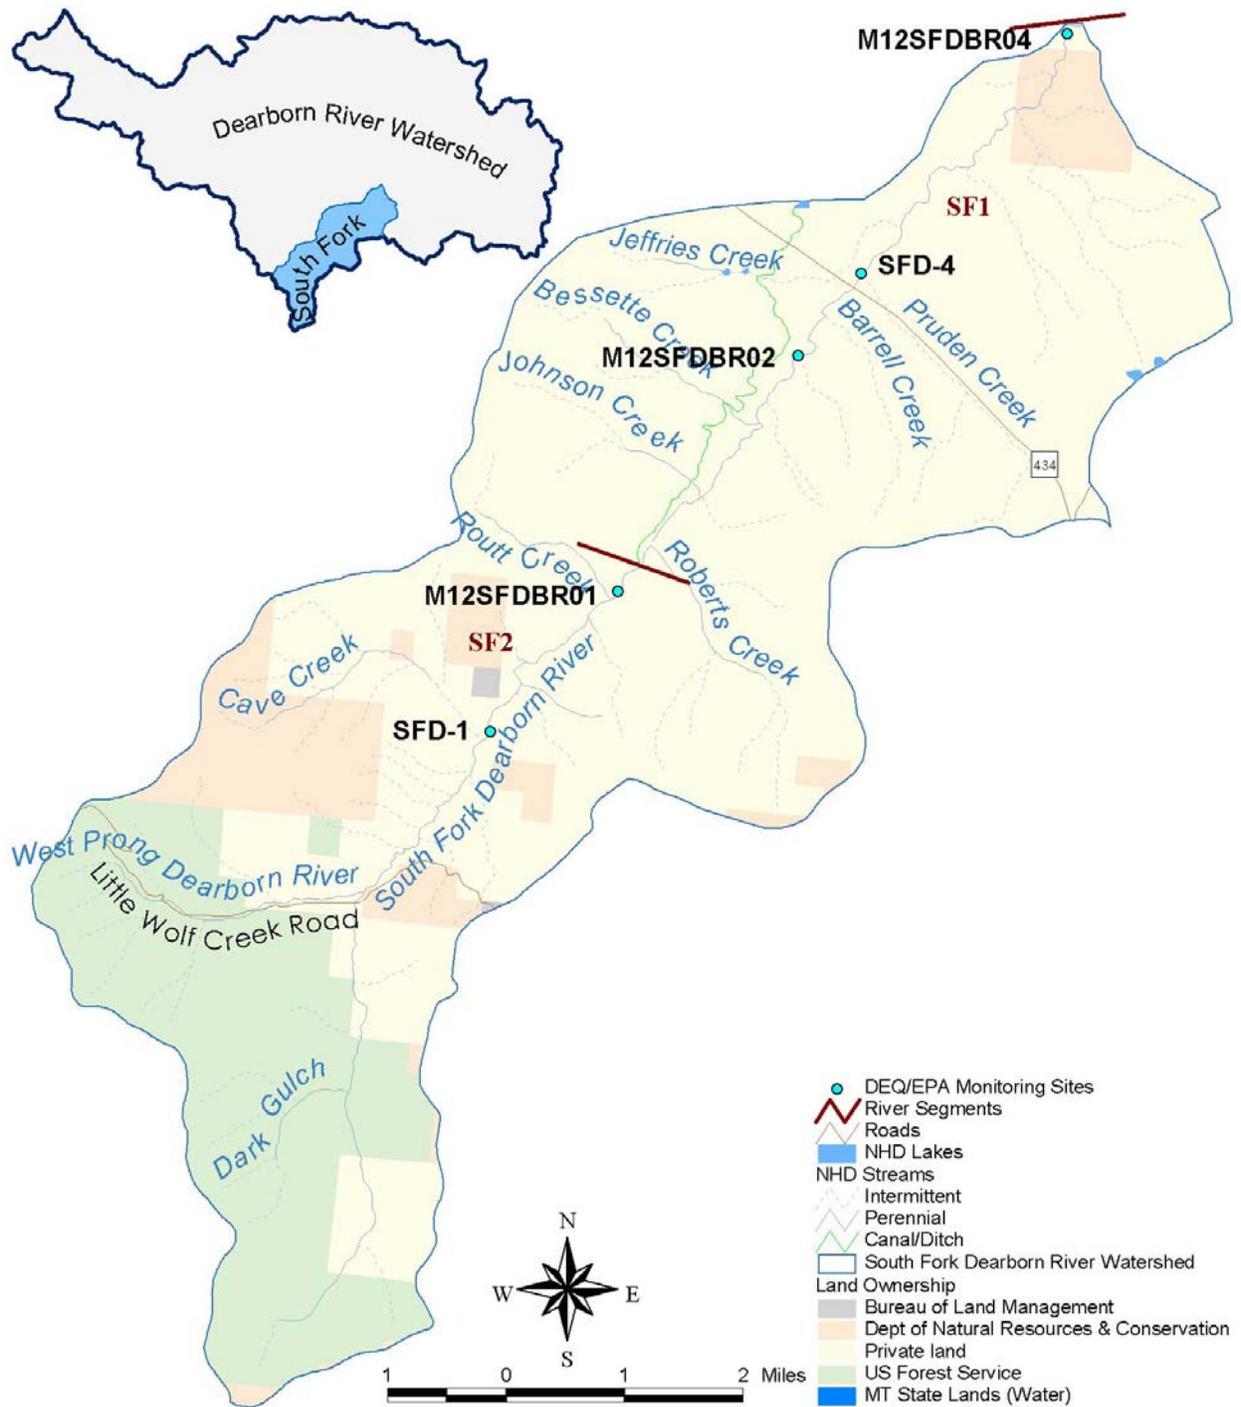
Figure 3-14. Sampling locations in the South Fork Dearborn River watershed.
