# Water Quality Assessment and TMDLs for the Dearborn River Planning Area

Prepared for:  
Montana Department of Environmental Quality

Prepared by:  
U.S. Environmental Protection Agency  
Montana Operations Office  
and Tetra Tech, Inc.

February 17, 2005

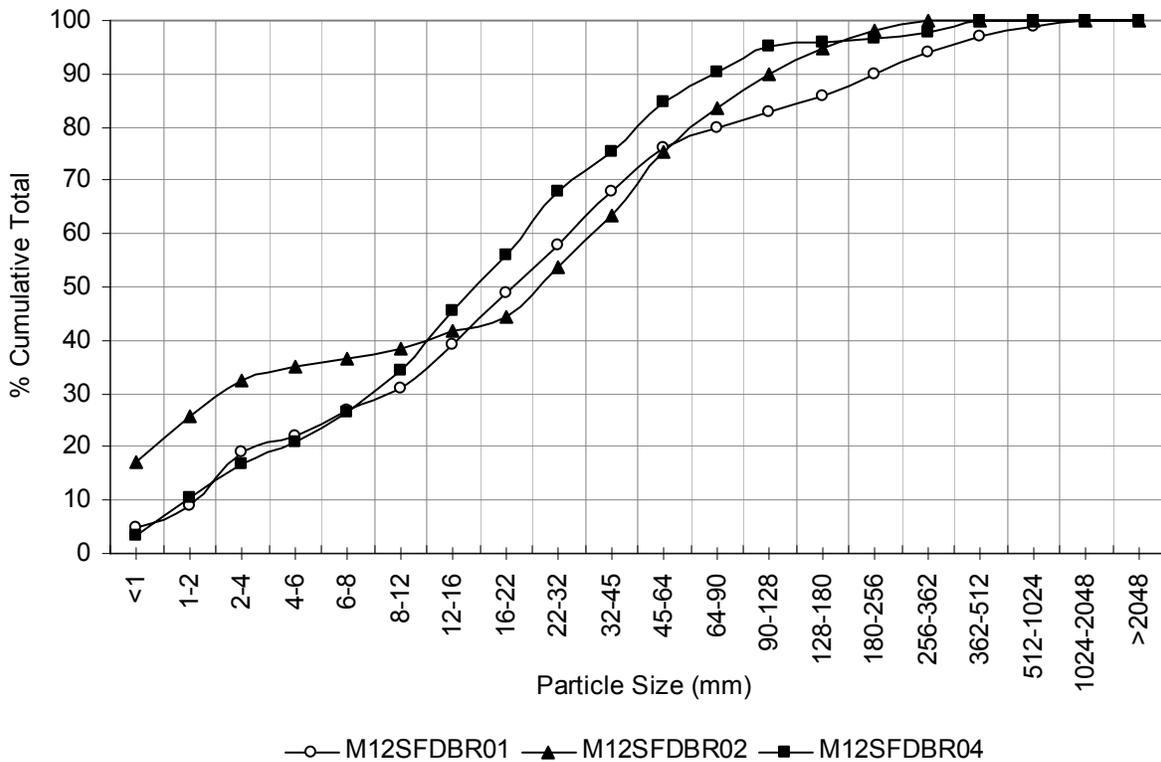
**Figure 3-15. Cumulative stream bottom particle distribution for the South Fork of the Dearborn River.**

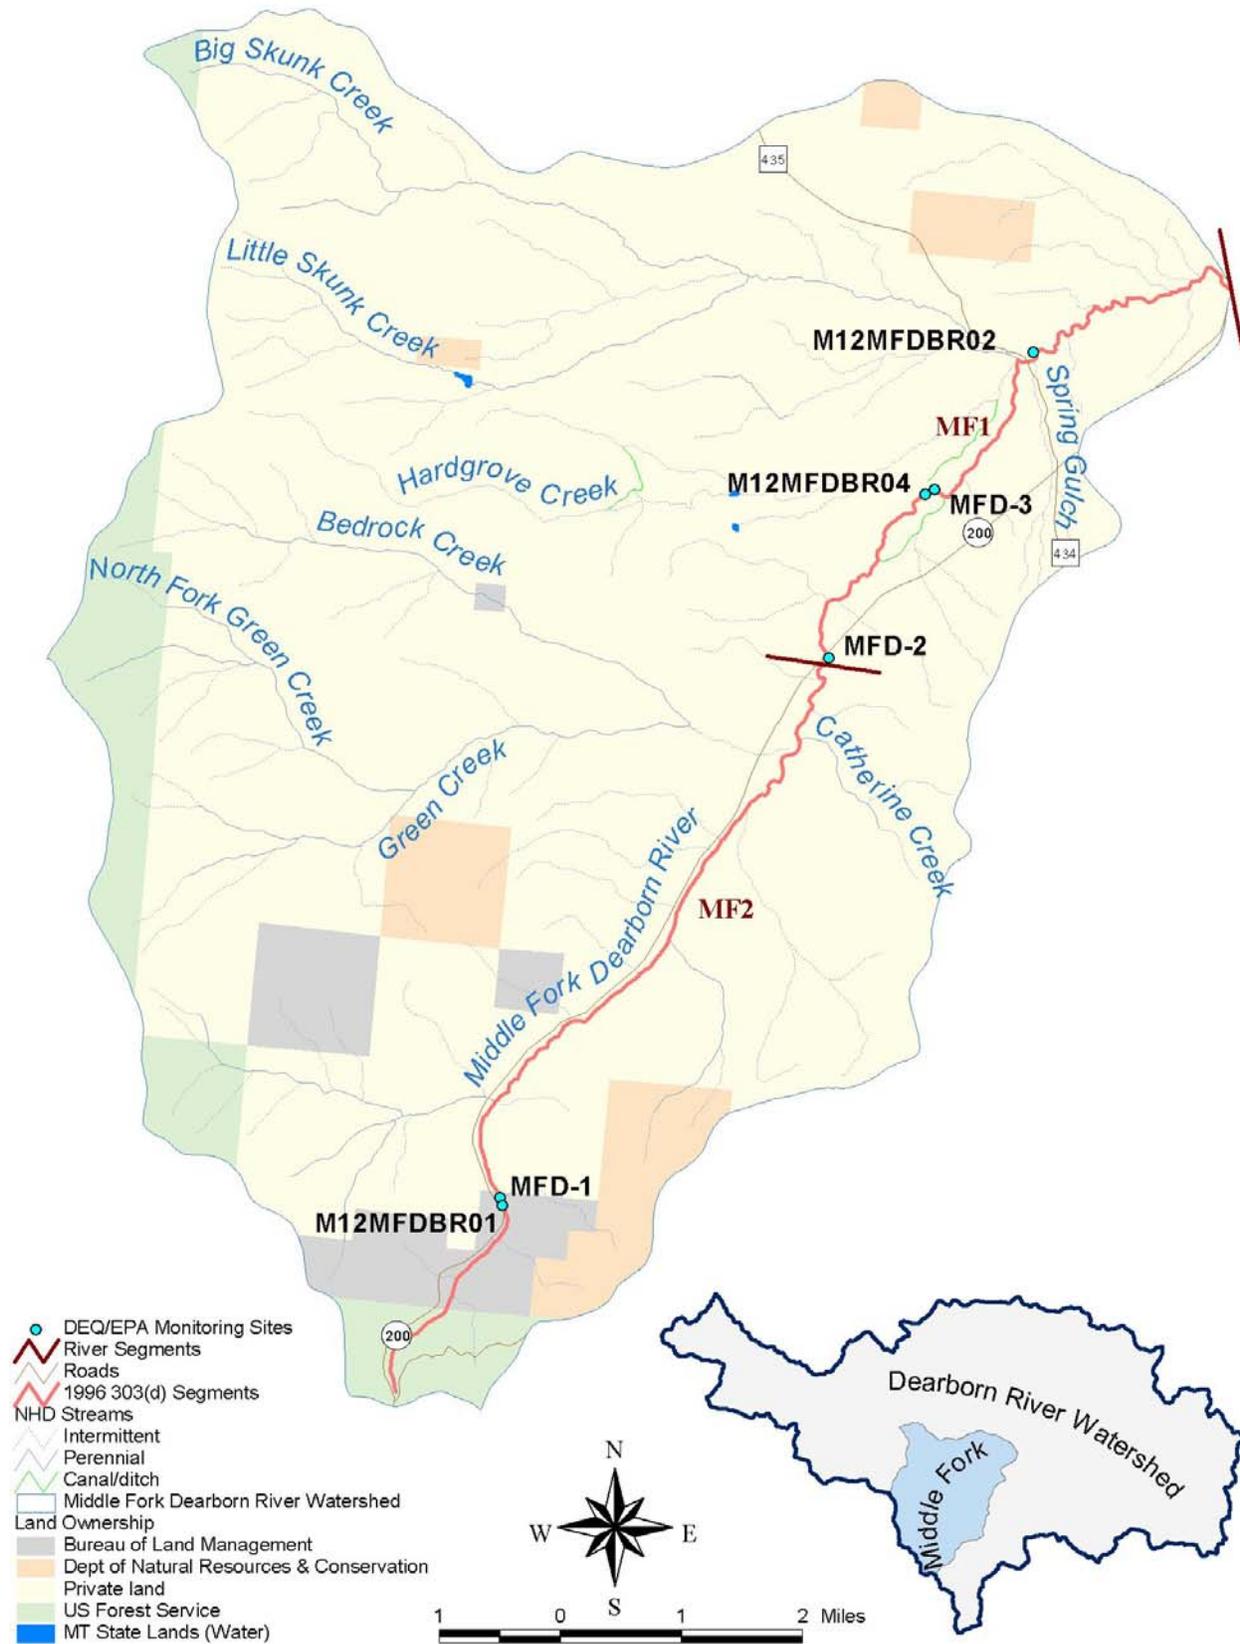
Figure 3-18. Sampling locations in the Middle Fork Dearborn River watershed.

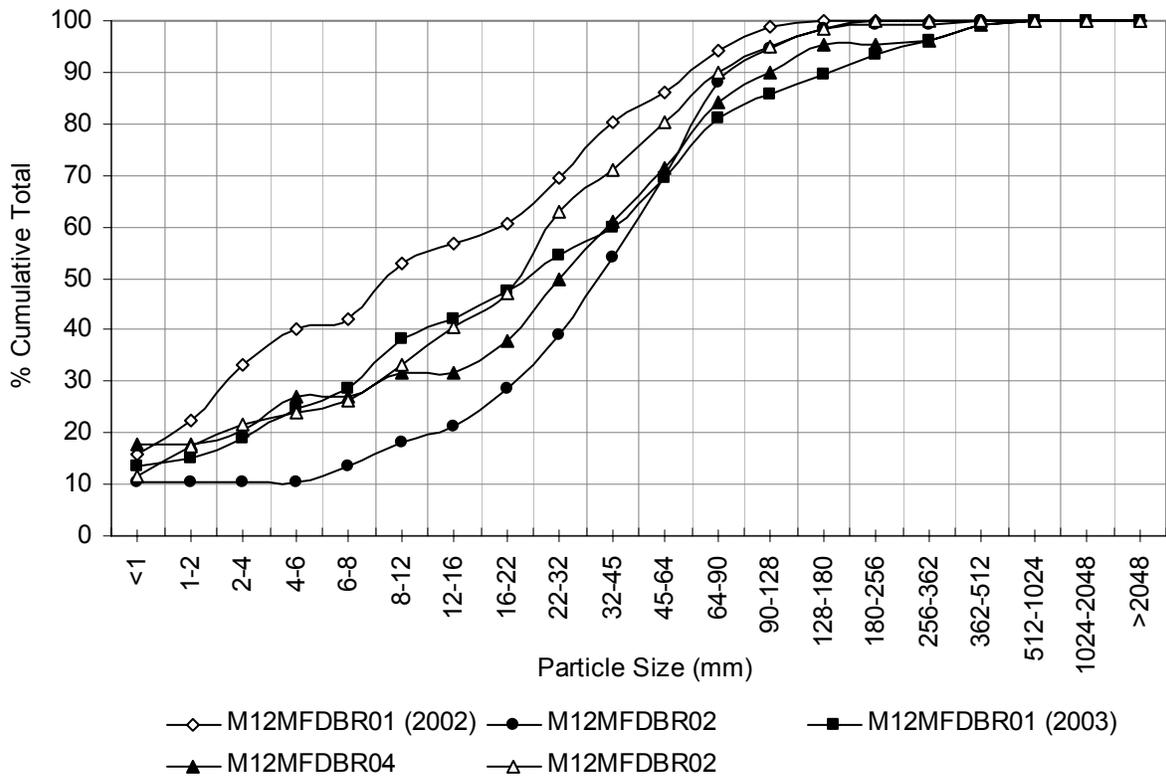
**Figure 3-19. Cumulative stream bottom particle distribution for the Middle Fork of the Dearborn River.**

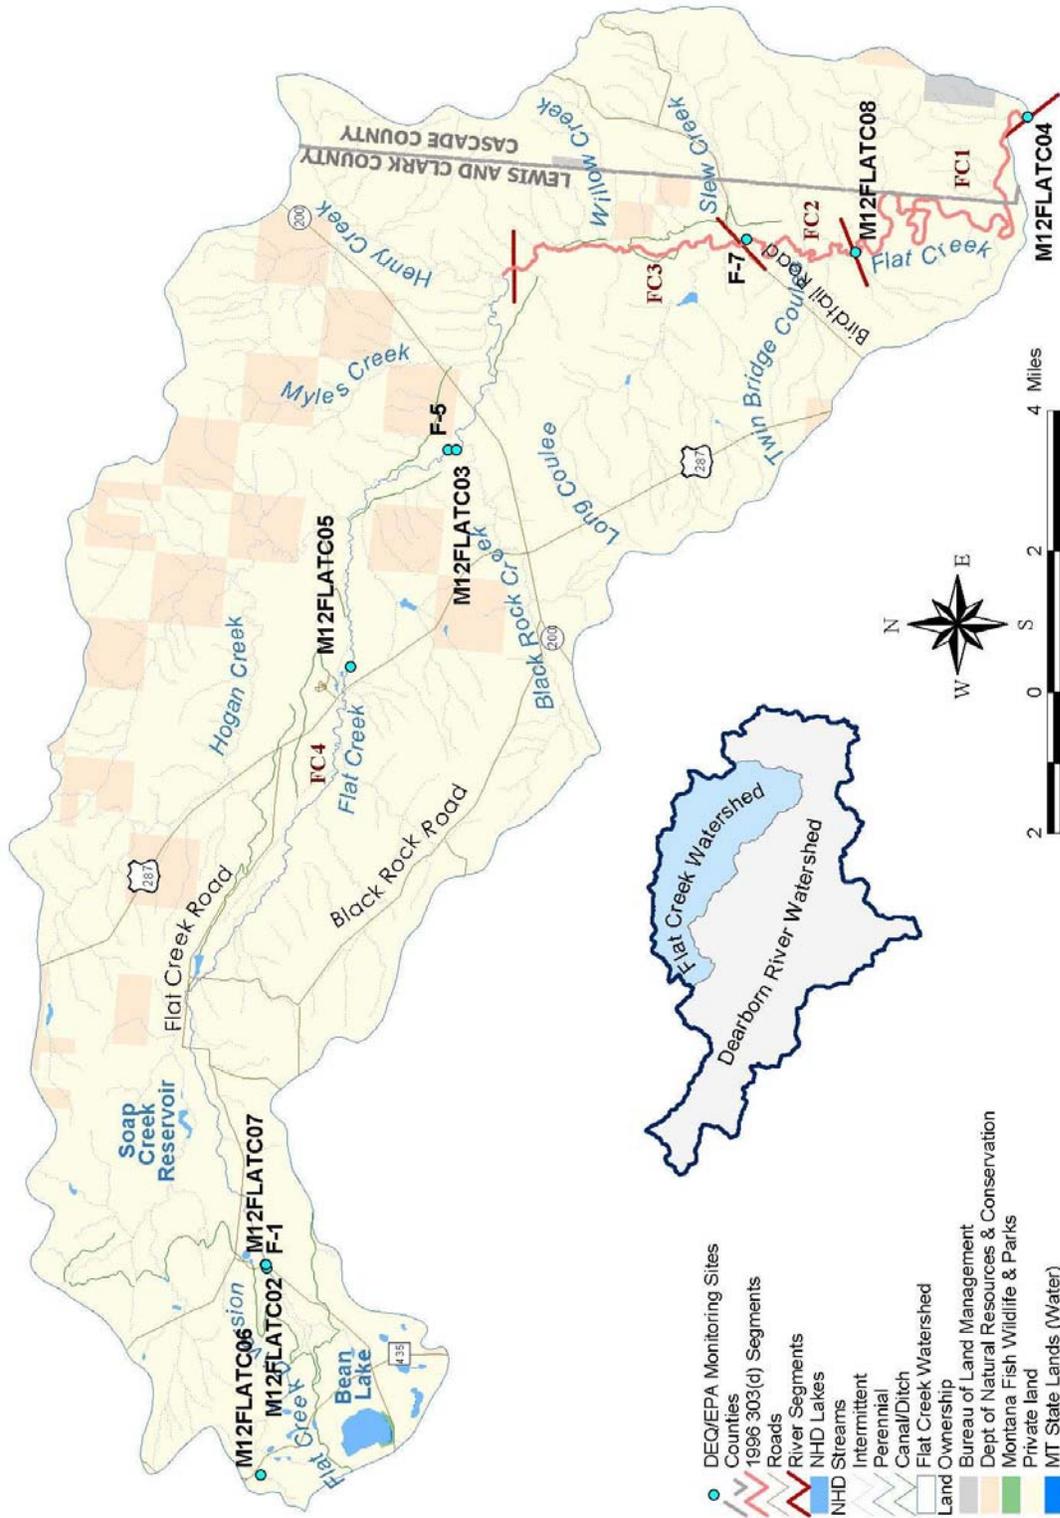
Figure 3-22. Sampling locations in the Flat Creek watershed.

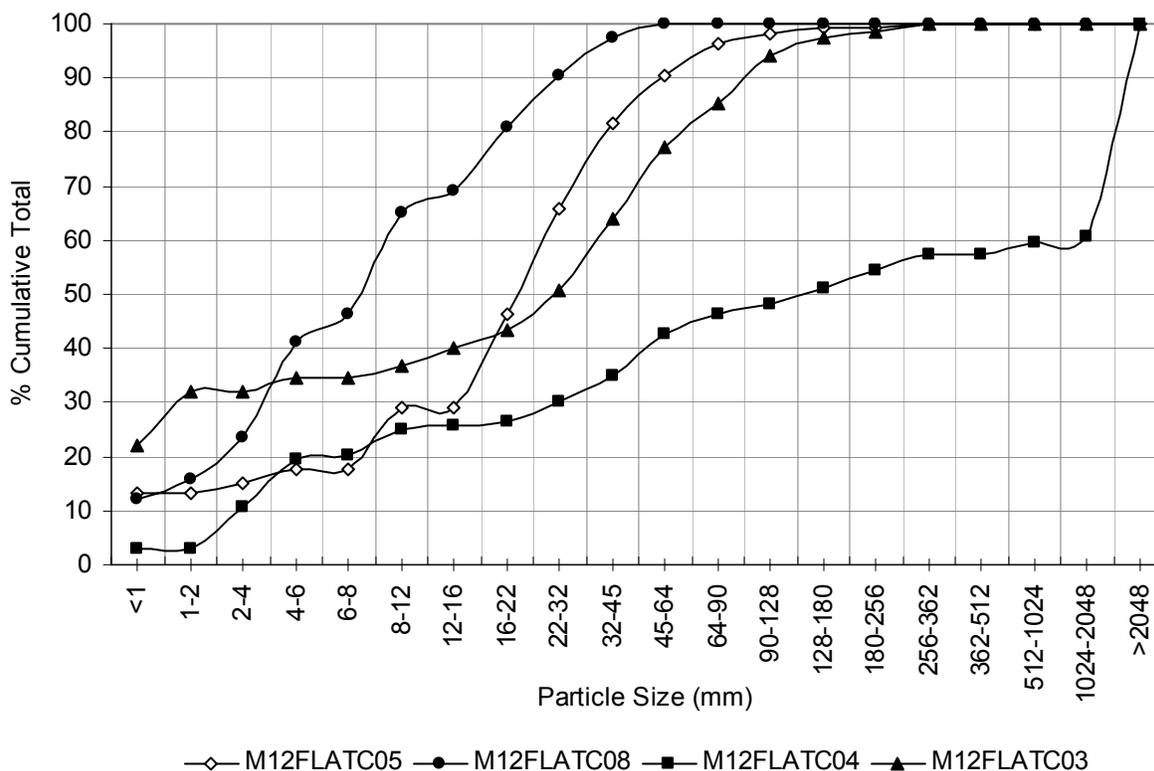
**Figure 3-23. Cumulative stream bottom particle distribution for Flat Creek.**

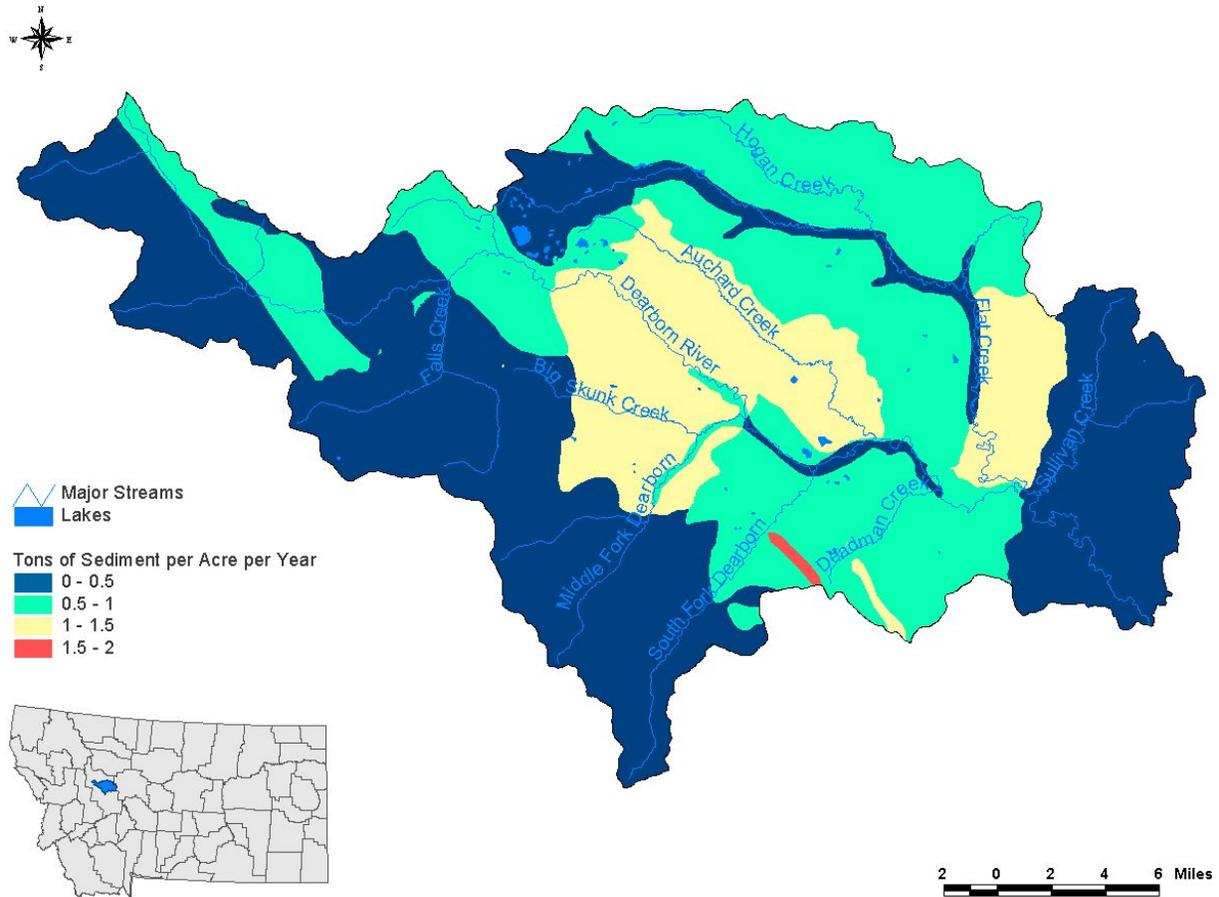
Figure 4-1. USLE soil loss in the Dearborn River watershed.

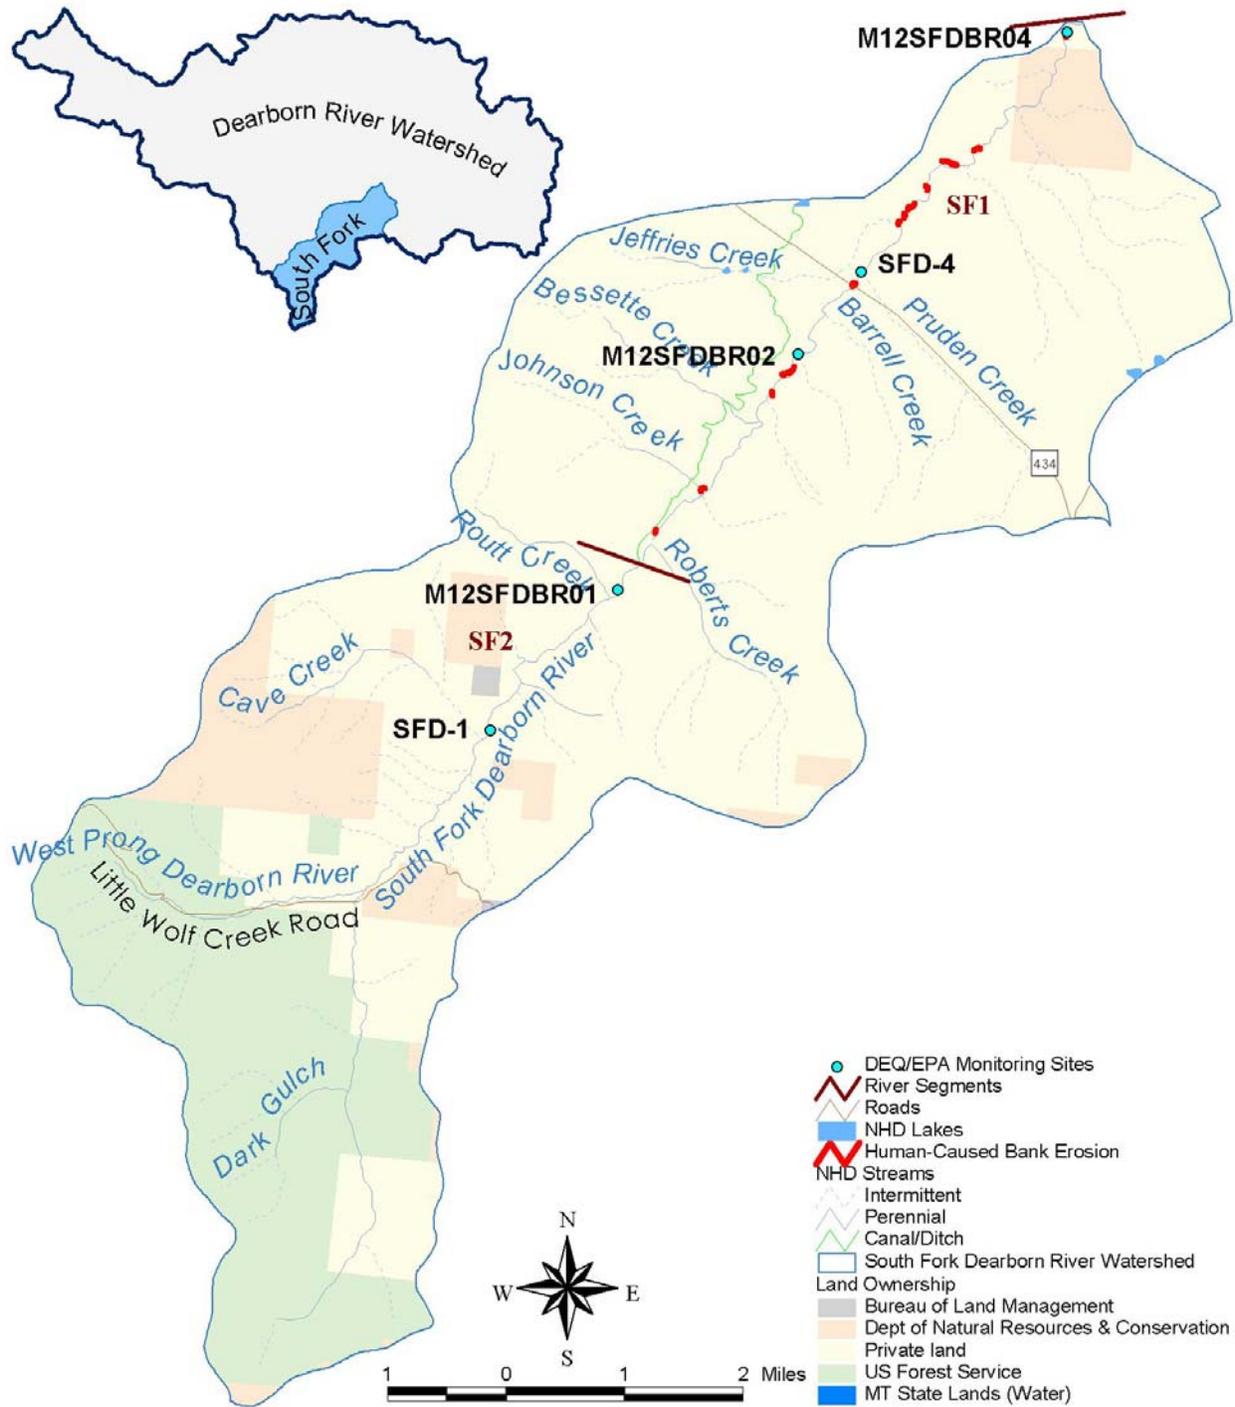
Figure 5-1. Human-caused sources of bank erosion along the South Fork Dearborn River.

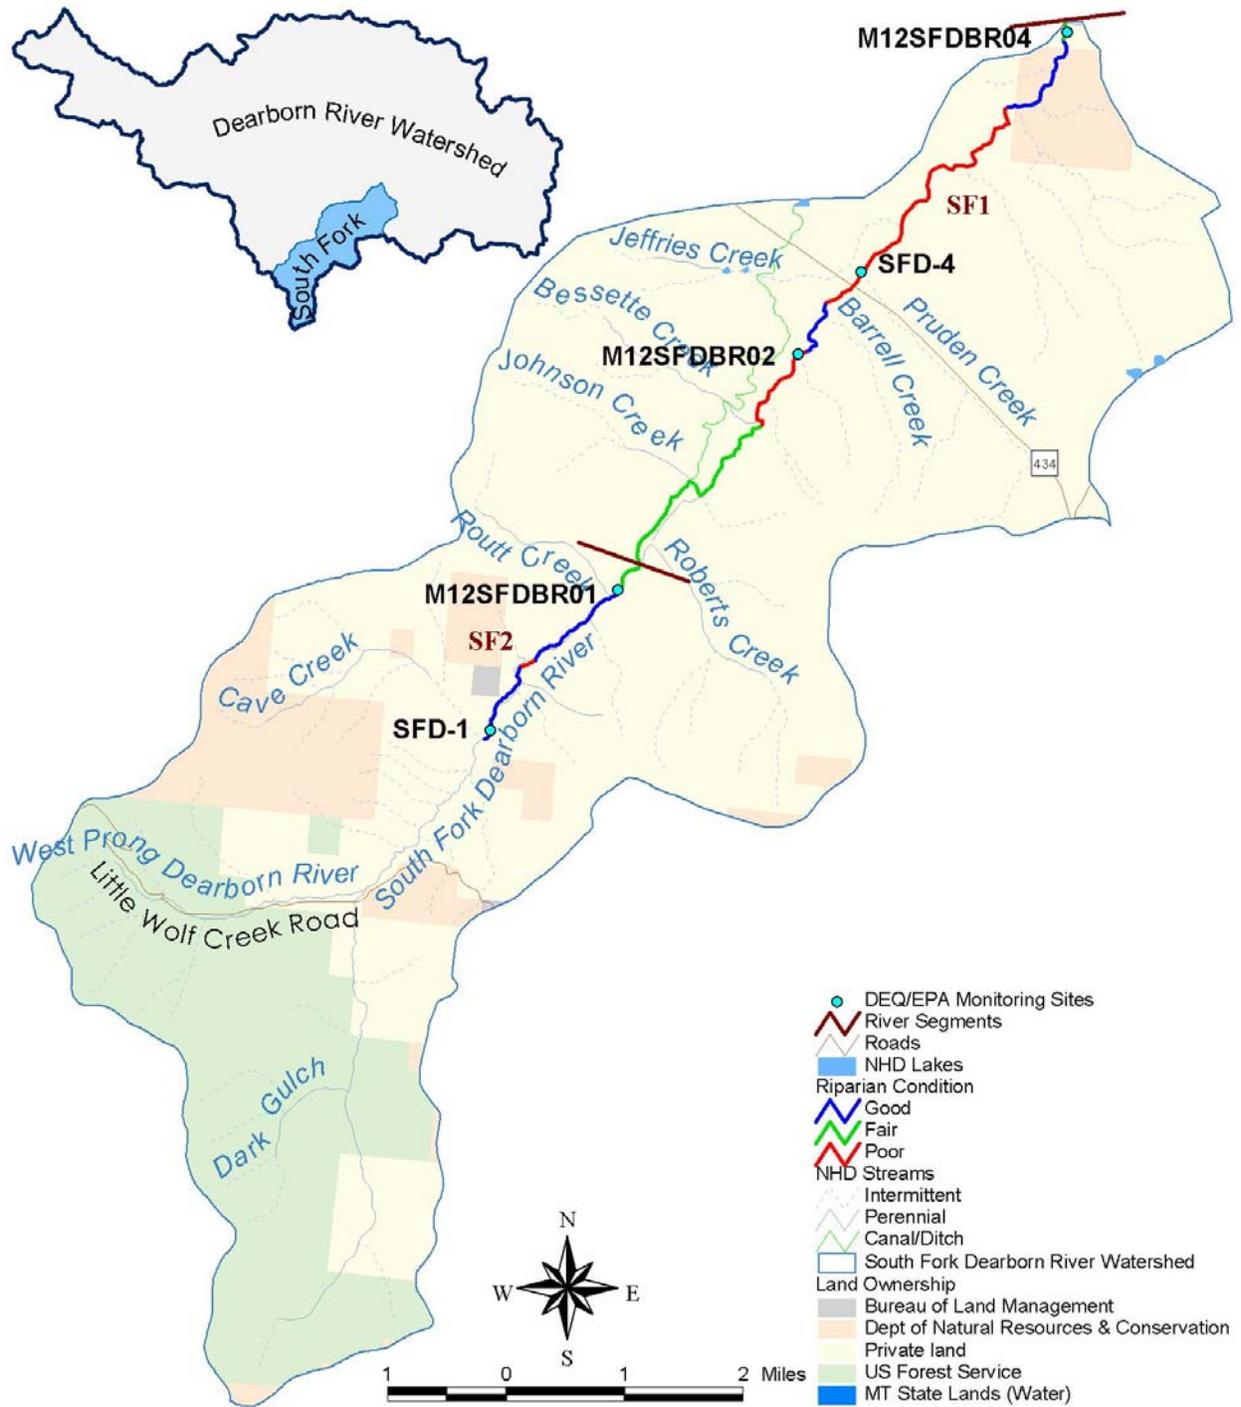
Figure 5-2. Riparian condition along the South Fork Dearborn River.

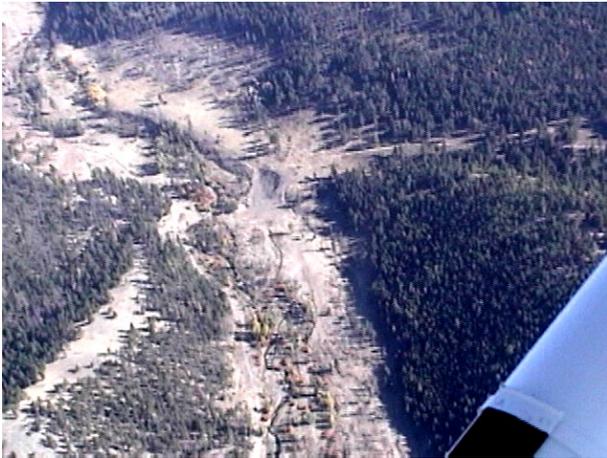
**Figure 5-3. Extensive riparian clearing in the upstream section of the South Fork.**

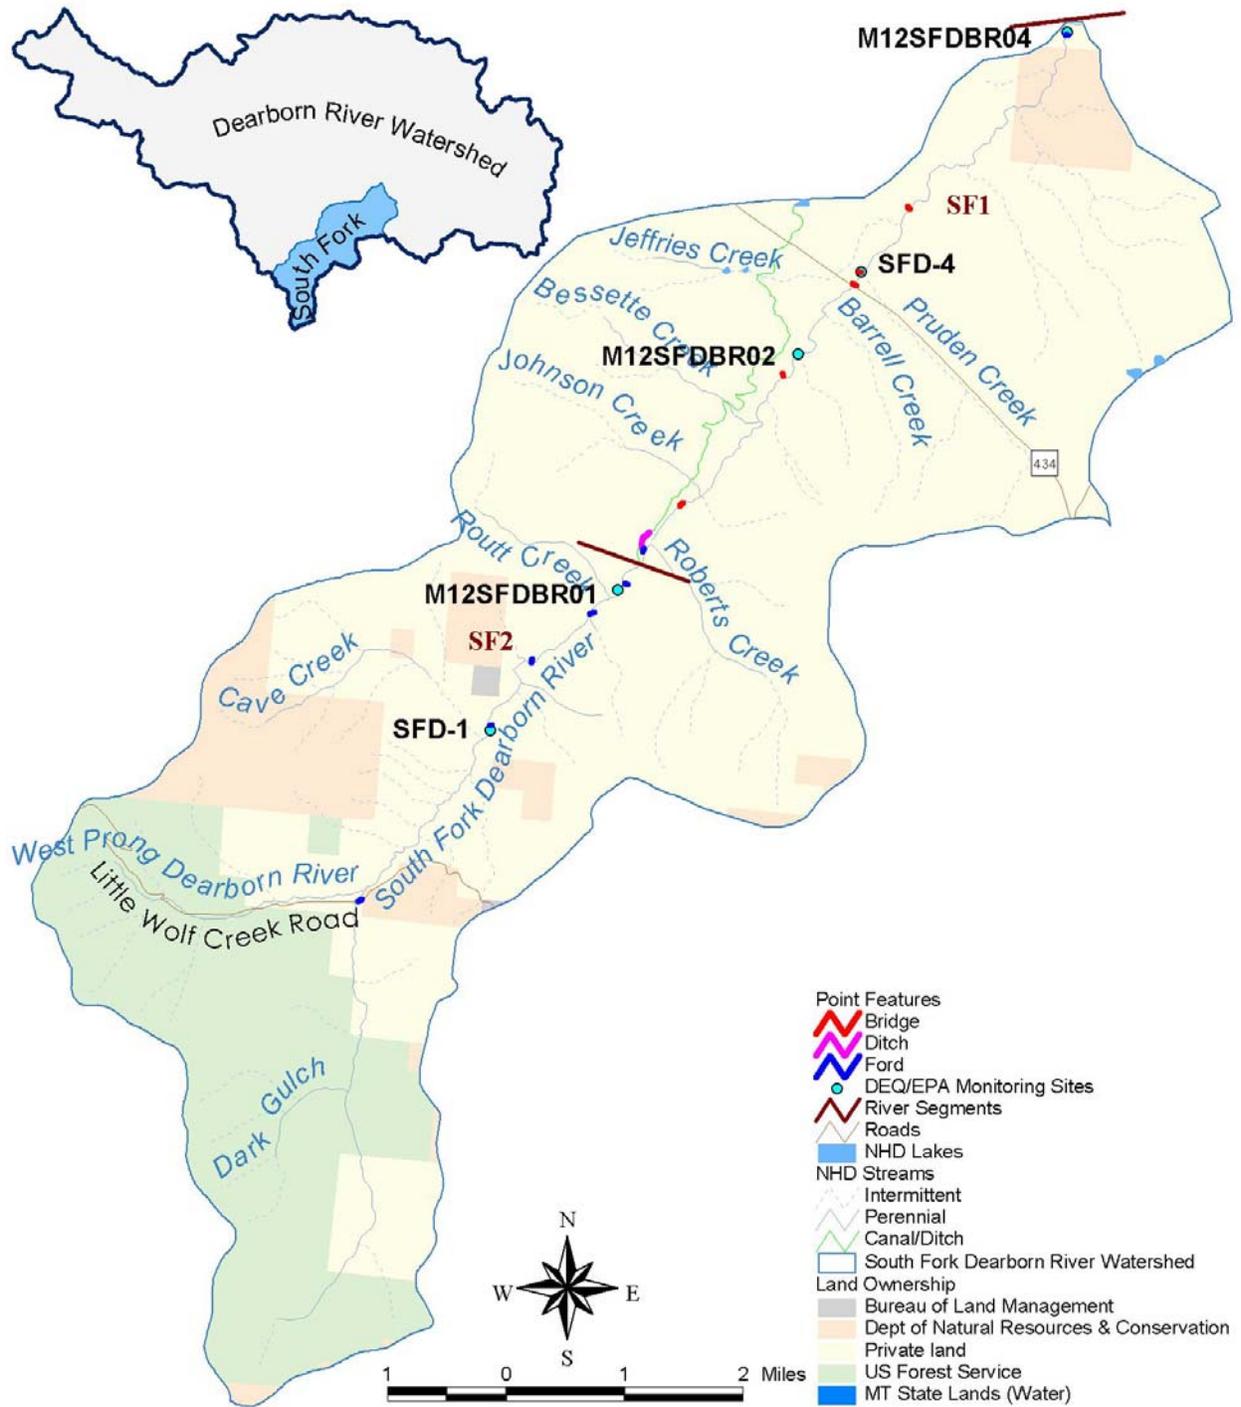
Figure 5-6. Point features along the South Fork Dearborn River.

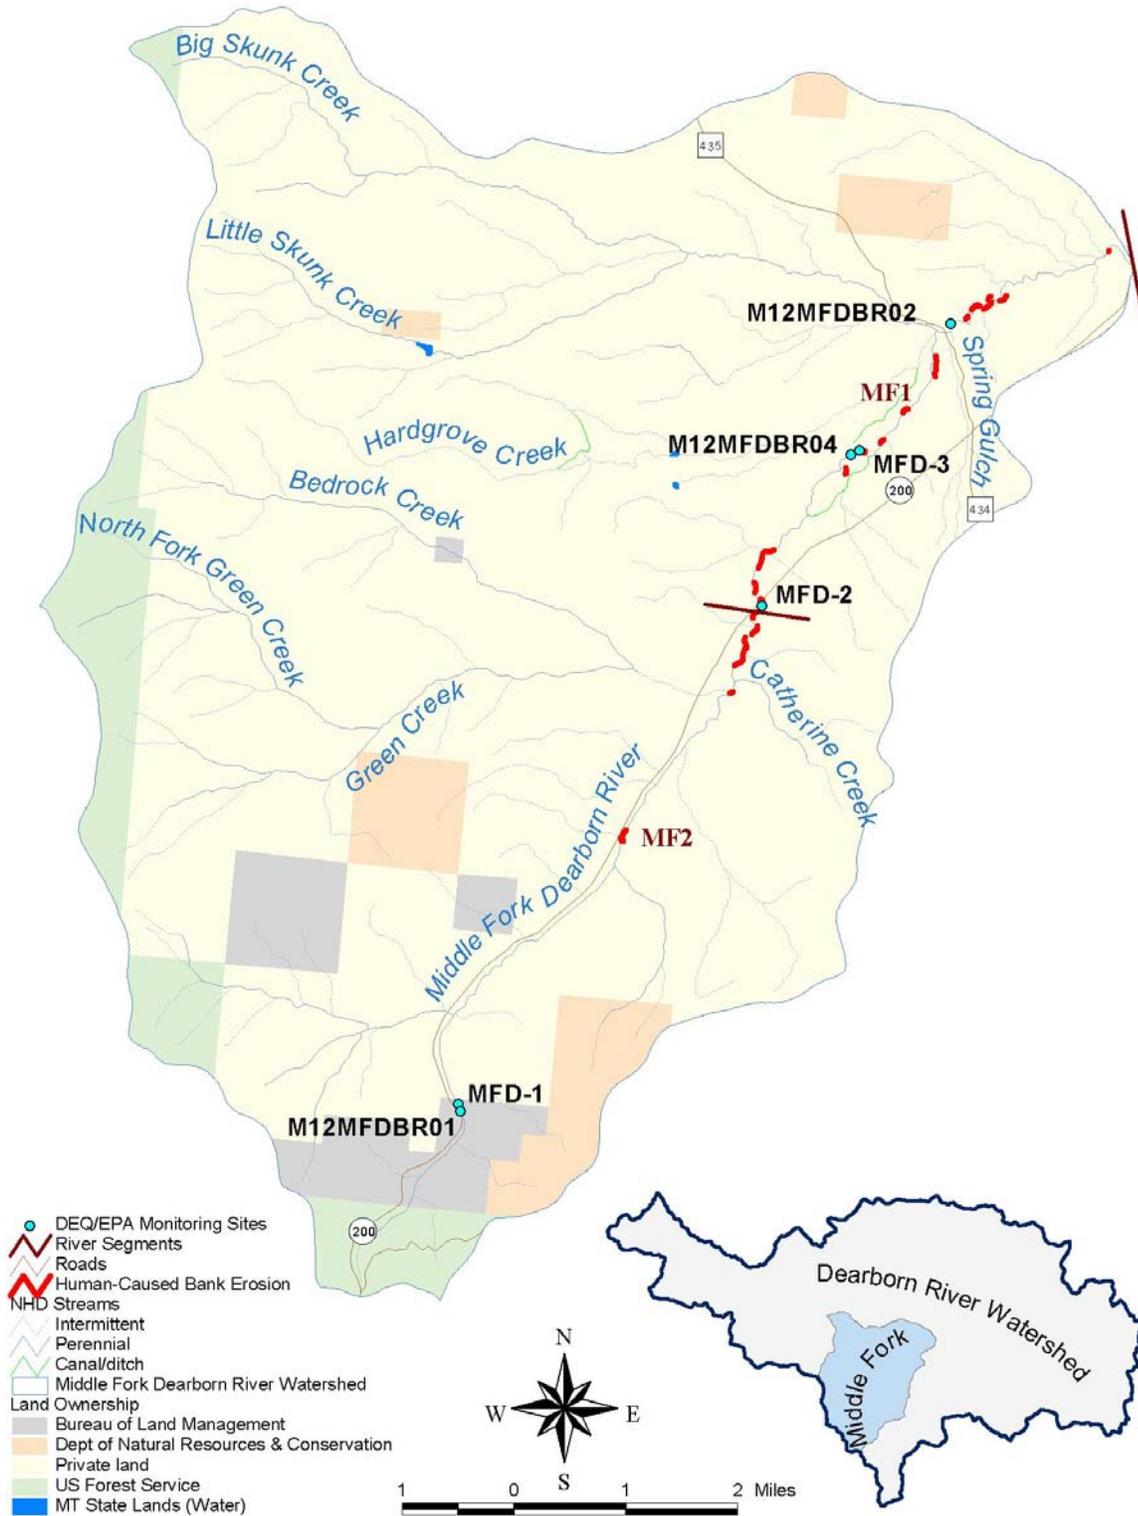
Figure 5-7. Human-caused sources of bank erosion along the Middle Fork Dearborn River.

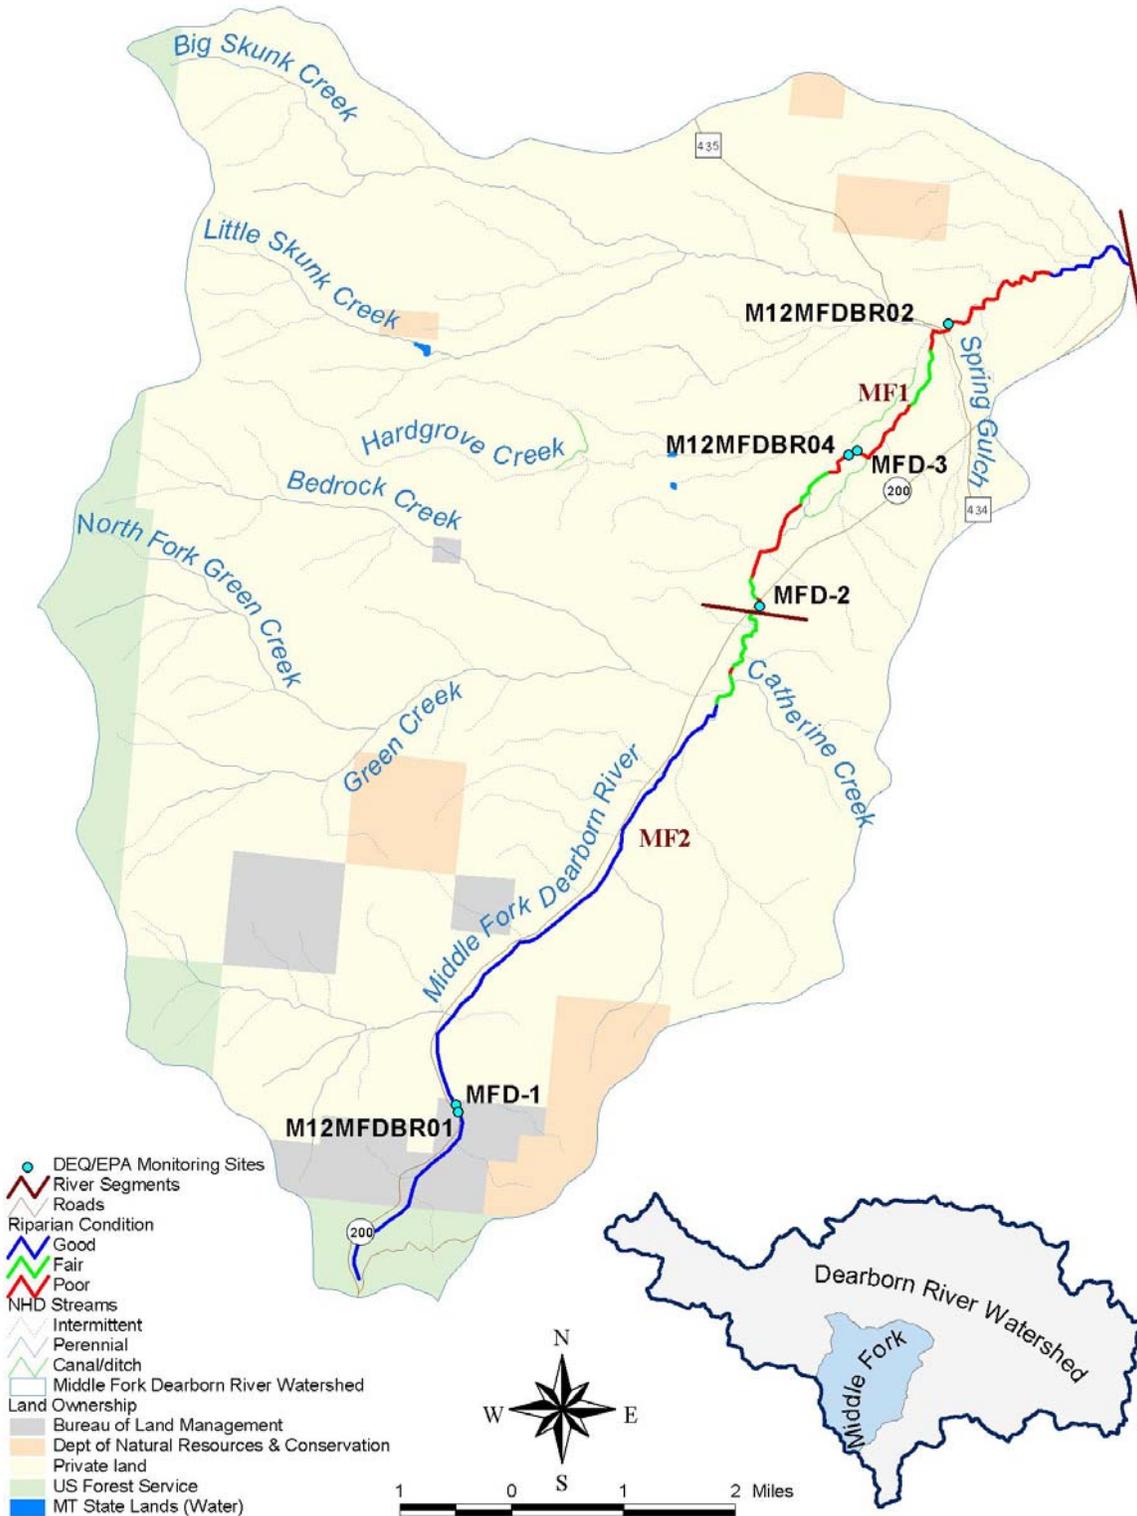
Figure 5-8. Riparian condition along the Middle Fork Dearborn River.

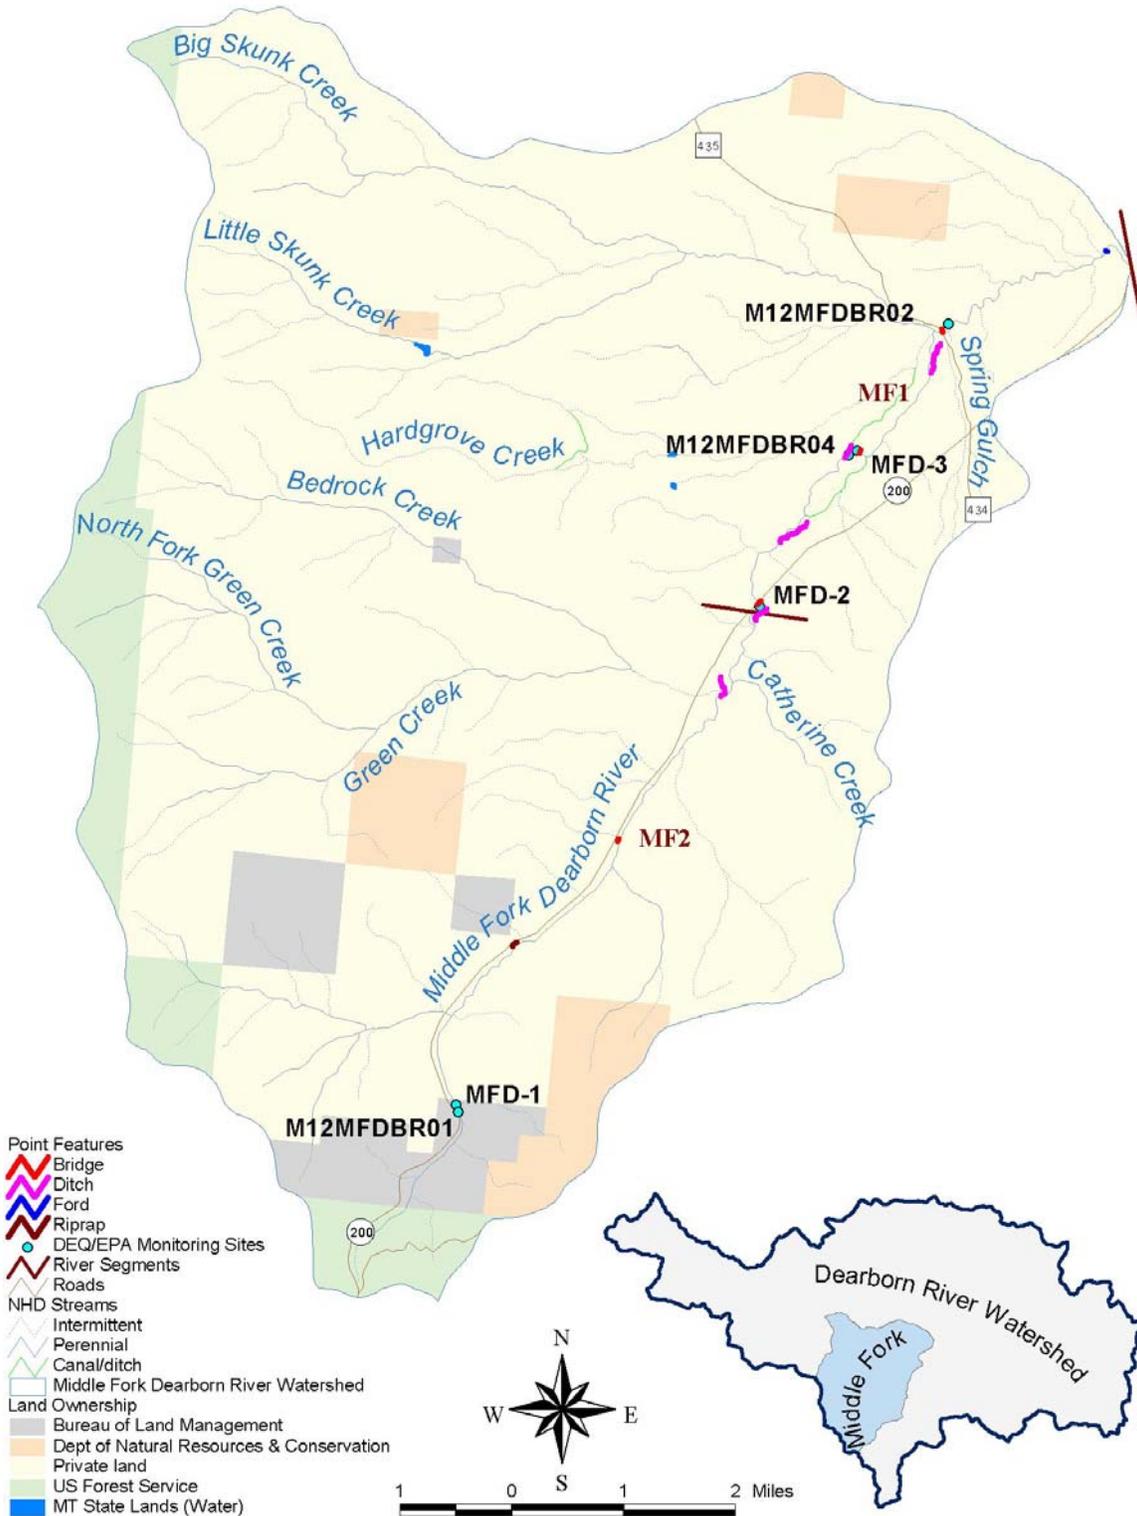
Figure 5-9. Point features along the Middle Fork Dearborn River.

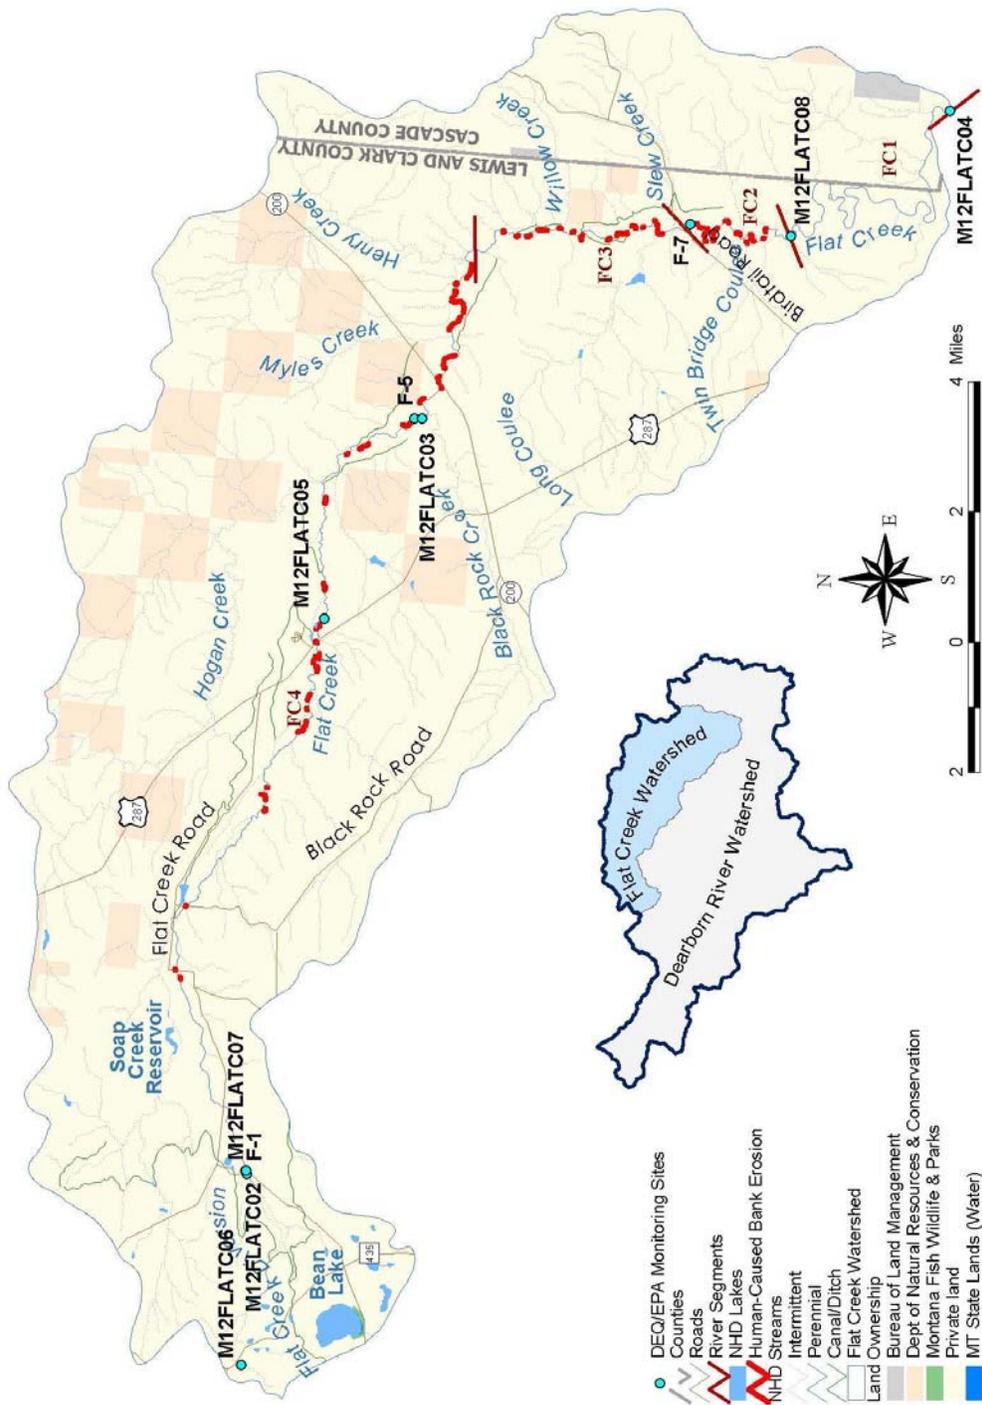
Figure 5-14. Human-caused sources of bank erosion along Flat Creek.

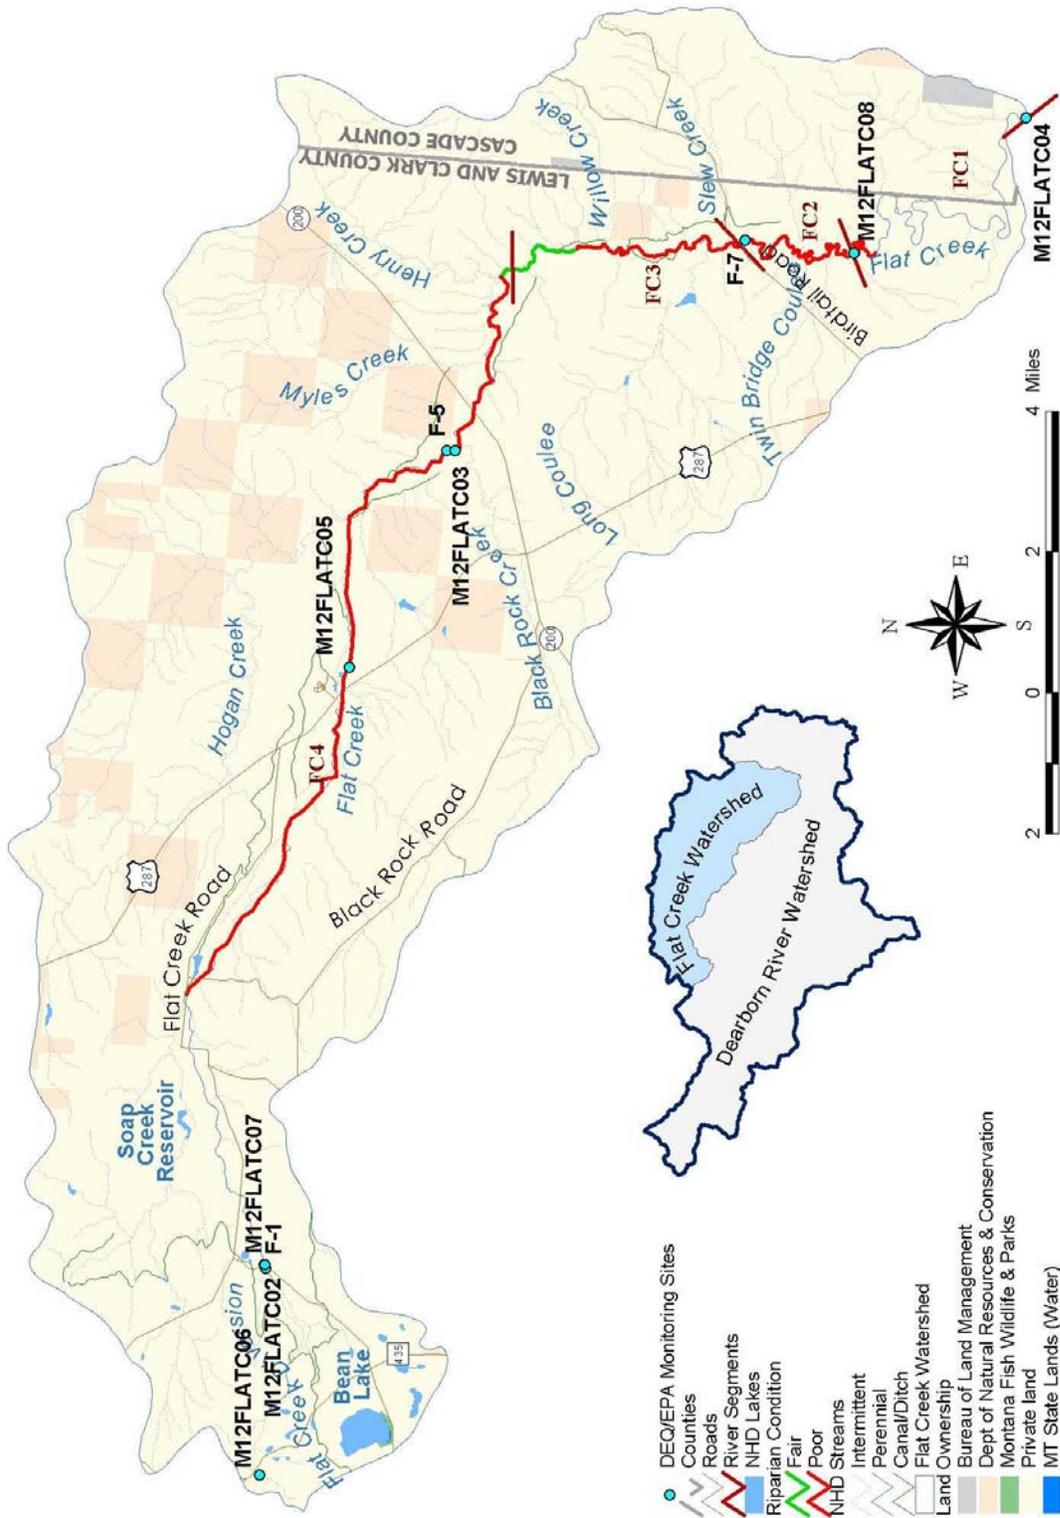
Figure 5-15. Riparian condition along Flat Creek.

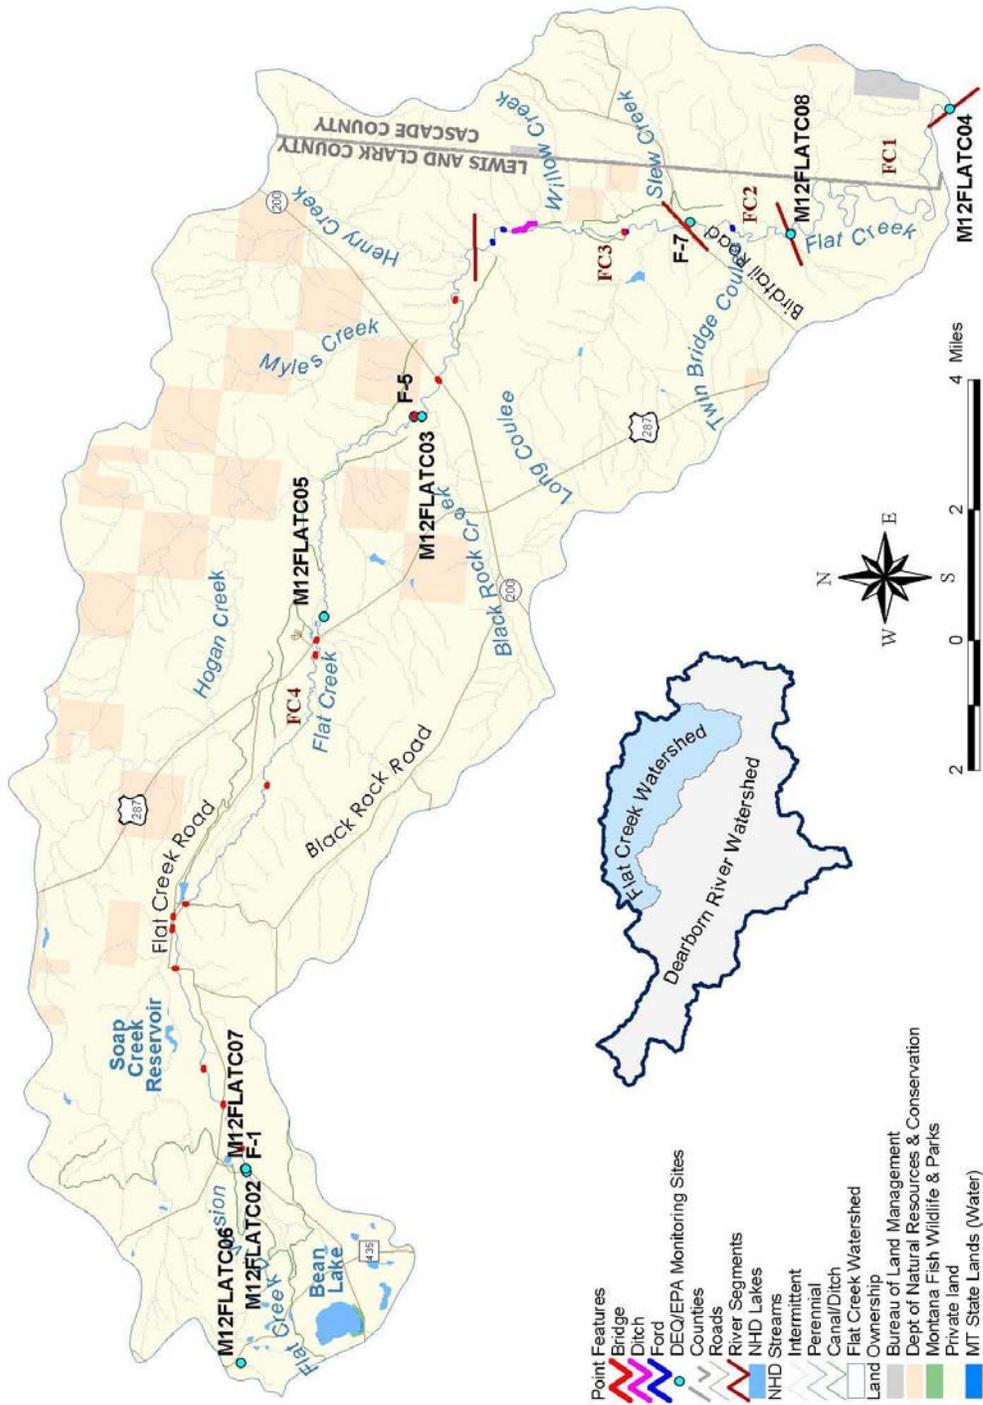
Figure 5-20. Point features along Flat Creek.
