**ADDENDUM 2 to  
FINAL COOLING POND  
REMOVAL WORK PLAN**

**FINAL - Work Plan for Compressor Building Area Soil  
Removal**

**Bonner Mill Cooling Pond and Vicinity  
Bonner, Montana**

**December 23, 2015**

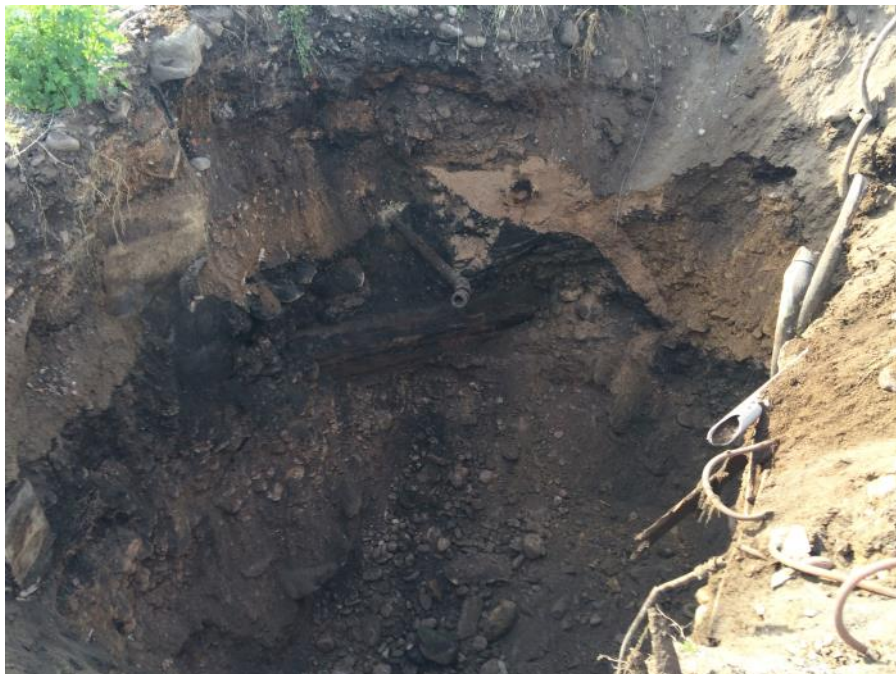
**Photo 2.** TP-1, view of south wall

CB-TP-1 (TP-1) was excavated to a depth of 15 ft bgs adjacent the northwestern corner of the former Compressor Building, nearest the sample collected by WMD in May 2014. Material encountered within the test pit appeared to be all fill material, consisting of gravel fill, pipes, and large blocks of concrete. PHC staining was observed from approximately 7 to 12 ft bgs along the southern edge of the pit (**Appendix A**, photographs #1 & #2).

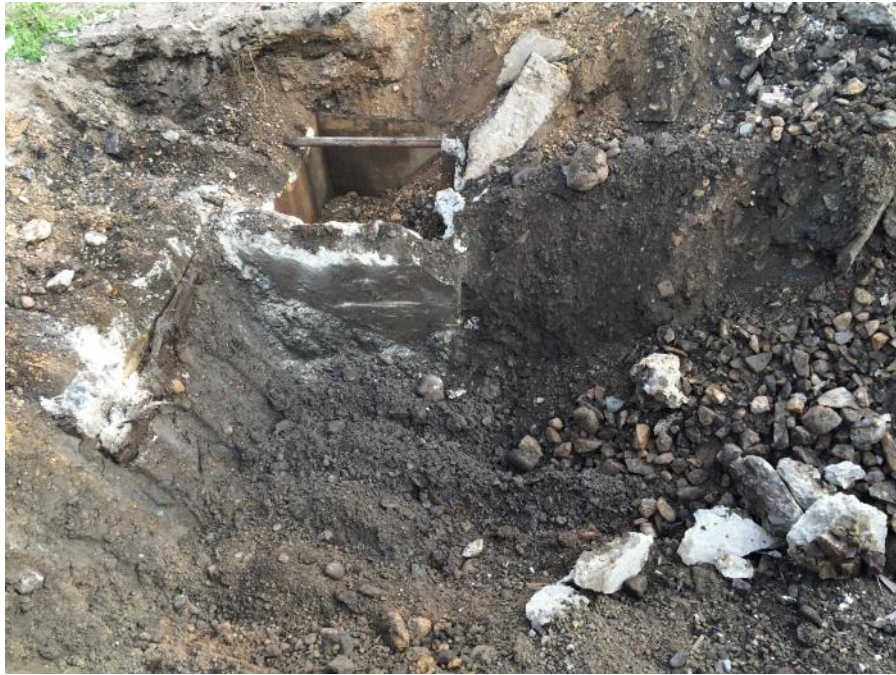
**Photo 3.** TP-3, ground surface to 3 ft bgs

TP-3 was excavated to a depth of 15 ft bgs south of the southwest portion of the former Compressor Building. Material encountered within this test pit appeared to be entirely fill material, consisting of gravel fill, wood beams and wood waste material, pipes, electrical conduit, and numerous large blocks of concrete. A concrete chamber was encountered from approximately 2 to 12 ft bgs, and the test pit was advanced adjacent to the north side of this structure. Staining was observed from approximately 2 to 10 ft bgs within the pit, with no staining or odor in the gravel fill material from 10 to 15 ft bgs (**Appendix A**, photographs #3 & #4).

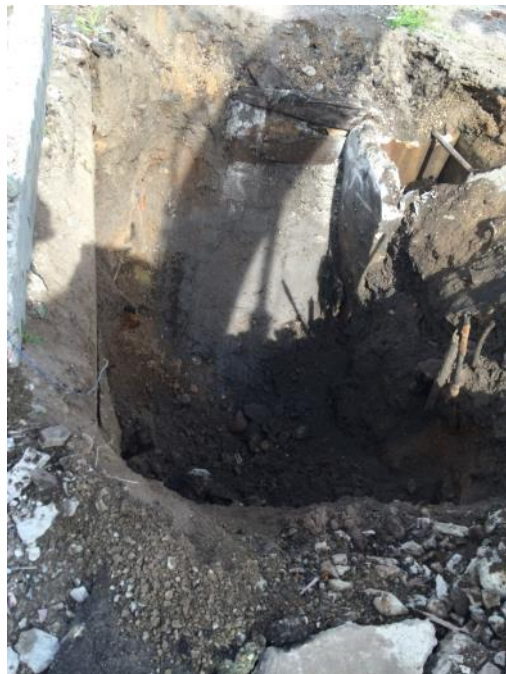
**Photo 4.** TP-3, ground surface to 8 ft bgs

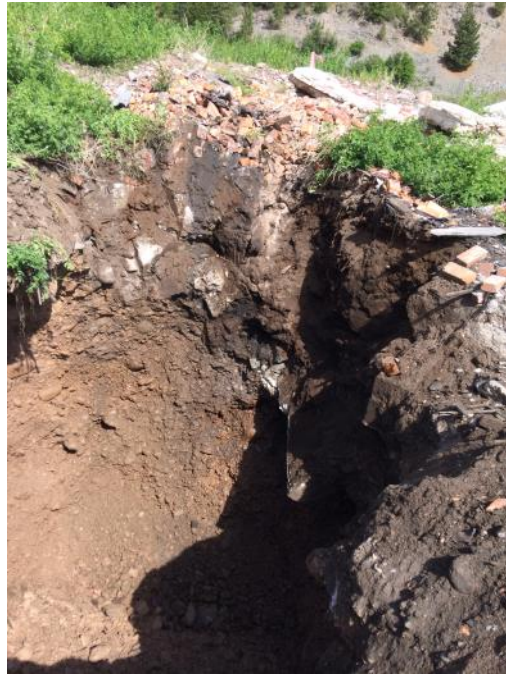
**Photo 5.** TP-6, ground surface to 12 ft bgs

TP-6 was excavated to a depth of 15 ft bgs adjacent the southeastern corner of the former Compressor Building. Loamy, dark colored soil containing broken brick, concrete, and other building demolition debris was observed within the test pit from ground surface to 5 ft bgs. Cobbles, boulders, and concrete with gravel fill material were primarily encountered below 5 ft bgs.

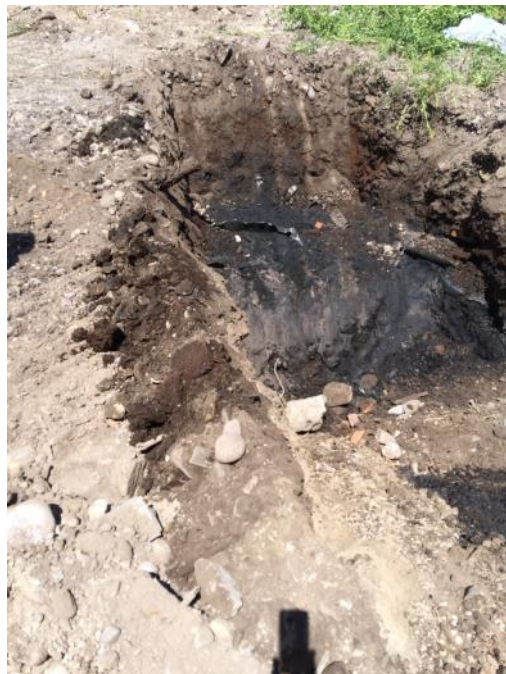
**Photo 6.** TP-4, first indication of buried tank

12:45	TP5-3 PID = 214 ppm
12:50	TP4 Excavation Begins
	<del>TP4 Excavation Begins</del> 0-7 ft: 0-2 ft: light brown soil w/ cobbles & pebbles & some root system 2-7 ft: large (~8-10 ft diameter) tank with extensive petroleum staining -- Soil inside tank is black from petroleum; tank walls show evidence of rusting. Tank had no lid => open tank that was filled in?

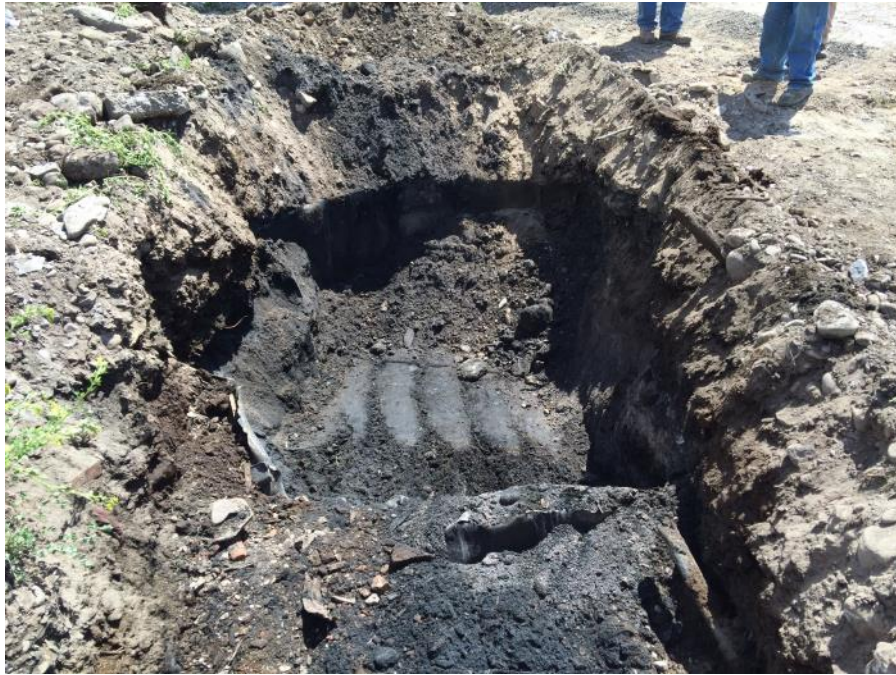
**Photo 7.** TP-4, inside of tank at 7 ft bgs

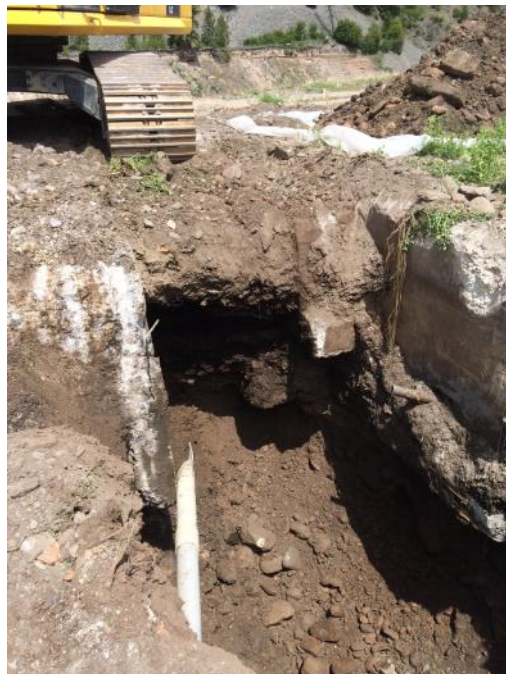
**Photo 8.** TP-2, ground surface to 8 ft bgs

TP-2 was excavated to a depth of 15 ft bgs near the west-central side of the former Compressor Building. This test pit was excavated between two concrete foundations. The concrete on the west wall extended from near ground surface to 6 ft bgs, while the concrete on the east wall extended to approximately 12 ft bgs. Material encountered between these concrete structures consisted of gravel fill material with numerous pipes and remnants from the building demolition, including wood debris and dark organics.

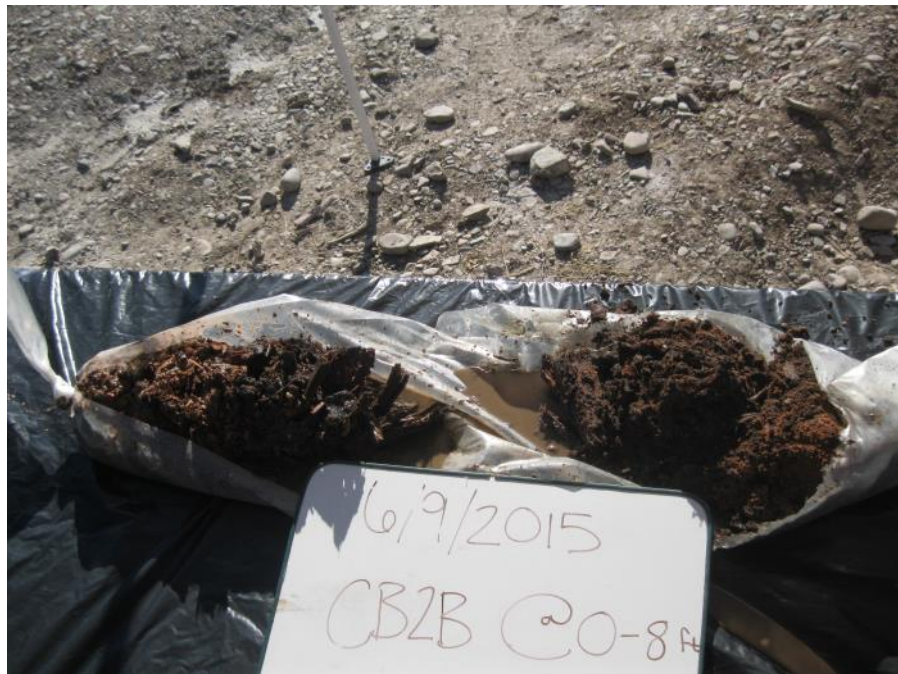
**Photo 10.** CB-2B, 0 to 8 ft bgs

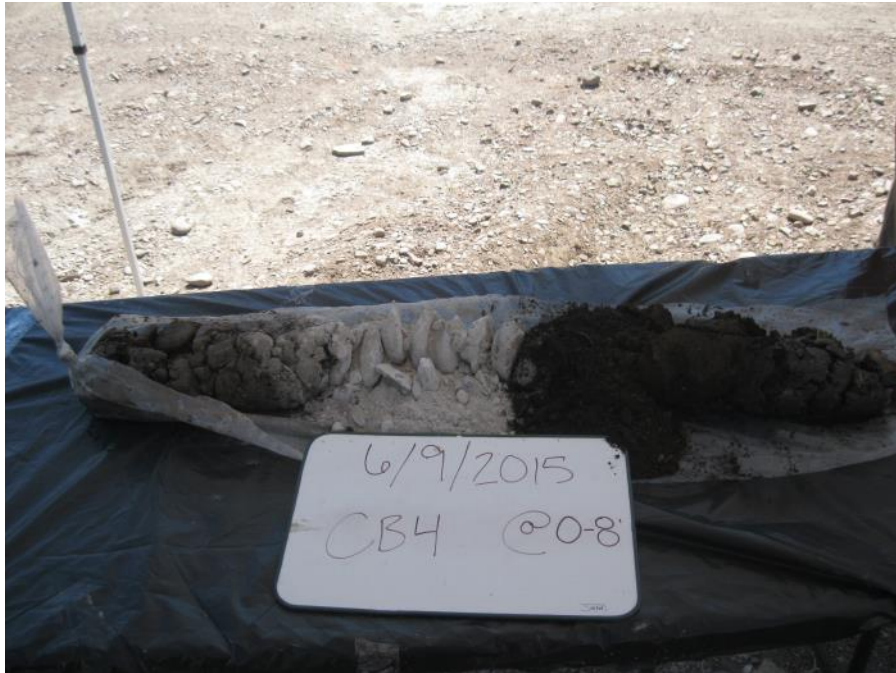
**Photo 11.** CB-4, 0 to 8 ft bgs

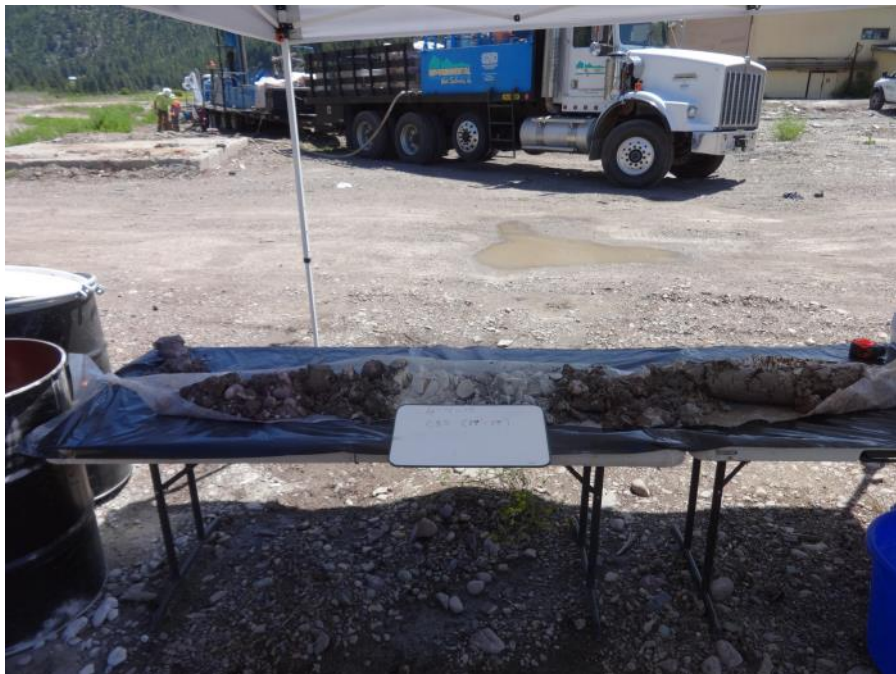
**Photo 12.** CB-5, 19 to 29 ft bgs

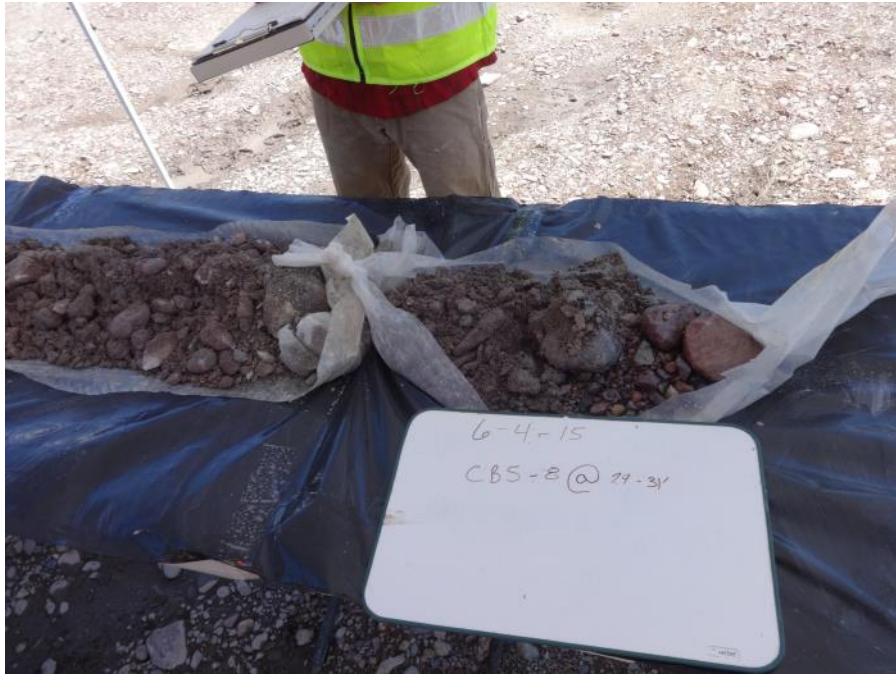
**Photo 13.** CB5-8, 29 to 31 ft bgs

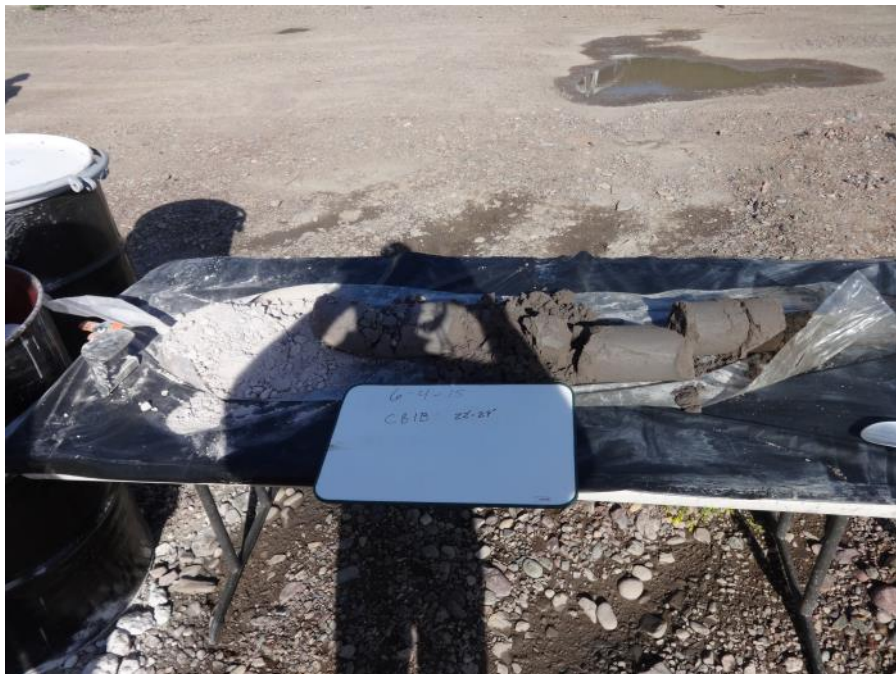
**Photo 14.** CB-1B, 22 to 29 ft bgs

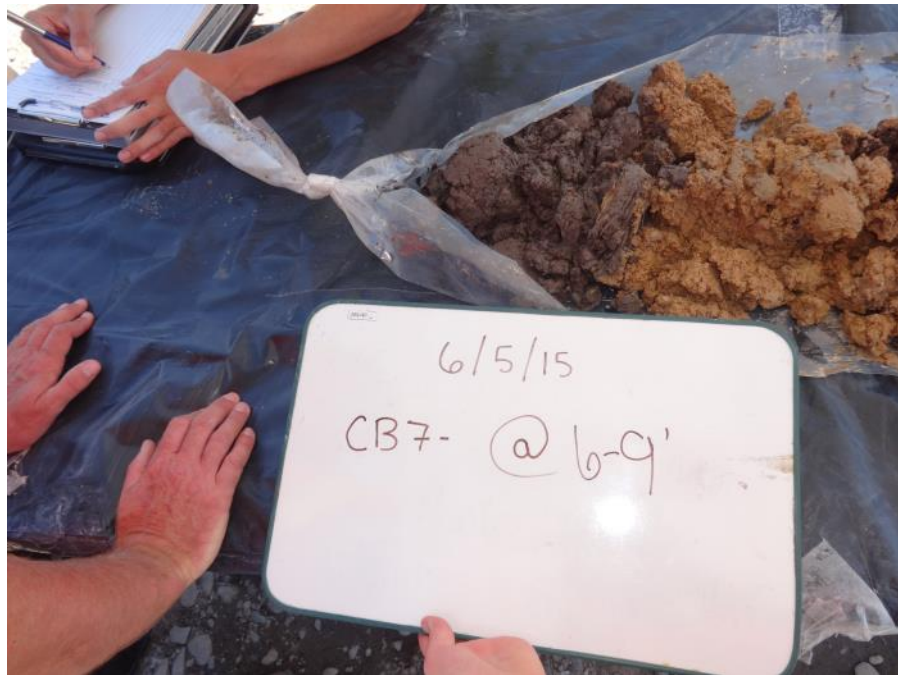
**Photo 15.** CB7-1, 6 to 9 ft bgs
