Re: Groundwater Monitoring Work Plan IDs 35209 and 35210
Former Good2Go #8
1600 N Crawford Ave
Hardin, Big Horn County, Montana 59034 (Site)

GROUNDWATER MONITORING WORK PLAN

Good2Go #8
1600 N Crawford Ave
Hardin, Montana 59034

Facility ID 02-00538
Facility Code 17731
Release IDs# 5050 and 5157
Work Plan IDs# 35209 and 35210

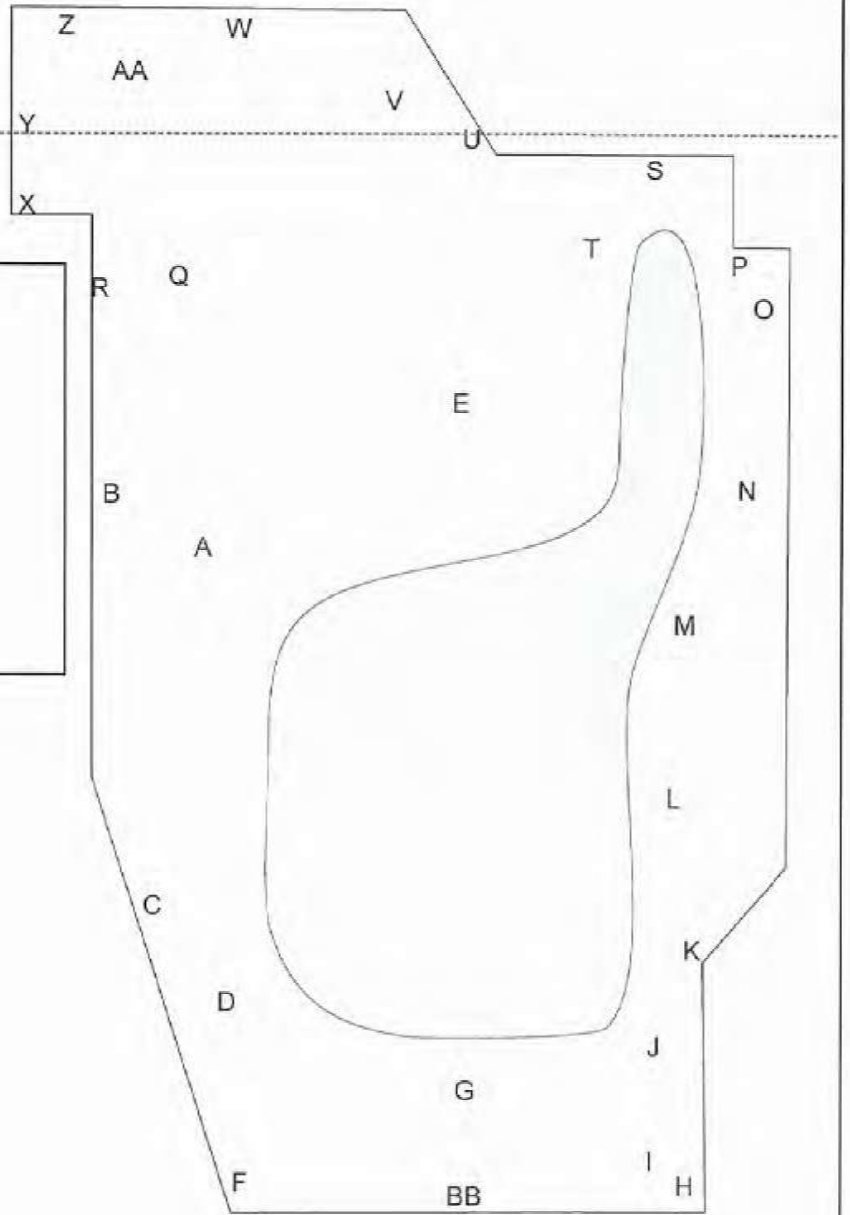
Figure 3
 Confirmation Soil Sample Locations
 Hardin Shell
 1600 North Crawford Ave
 Hardin, Montana

Confirmation Sample Designations

- A - WC Floor-9
- B - WWC-6
- C - SWW-6
- D - SW-Floor-8
- E - DISP-Floor-11
- F - S-Wall-6
- G - S-Floor-11
- H - SE-Cor-Wall-10
- I - SE-Cor-Floor-13
- J - SE (N-10)-Floor-12
- K - SE (N-20)-Wall-8
- L - SE-Floor-10
- M - EC-Floor-10
- N - EWC-8
- O - NE-Floor-10
- P - NE Corner Wall-7
- Q - NW-Floor-14
- R - WWN-7
- S - NWE-7
- T - NNE-Floor-12
- U - N Wall Ctr-8
- V - N Floor Ctr-12
- W - NWW-7
- X - NW-SWC-7
- Y - NW-WW-7
- Z - NW-NW-7
- AA - NW Cor Floor-15
- BB - SW-7

A total of 28 confirmation soil samples were collected from the sidewalls and floor of the excavation. Three of the samples were representative of contaminated material left in place. Samples WWC-6 (west wall center 6) and WWN-7 (west wall north 7) were representative of contaminated material remaining in place under the station building. Sample NW-Floor-14 was representative of contaminated material in the floor of the excavation at depths greater than 14 feet near the northeast corner of the building. These samples contained detectable concentrations of toluene, ethylbenzene, xylenes, total purgeable hydrocarbons (TPH) and VPH range aliphatic and aromatic compounds. Only sample WWC-6 contained gasoline range compounds at concentrations exceeding applicable Tier 1 risk based screening levels (RBSLs). Toluene and ethylbenzene were detected in the sample at 45 milligrams per kilogram (mg/kg) and 27 mg/kg respectively. Samples WWN-7 and NW-Floor-14 contained TPH at concentrations of 210 mg/kg and 310 mg/kg respectively.

Hydrocarbon compounds were detected at concentrations below RBSLs in samples WC-Floor-9 (west center floor 9), SWW-6 (southwest wall 6), SW-Floor-8 (southwest floor 8), Disp-Floor-11 (dispenser floor 11), S-Wall-6 (south wall 6), SE-Cor-Floor-13 (southeast corner floor 13), NWW-7 (north wall west 7), NW-SWC-7 (northwest

excavation, southwest corner), NW-WW-7 (northwest excavation, west wall 7), and NW-NW-7 (northwest excavation, north wall 7).

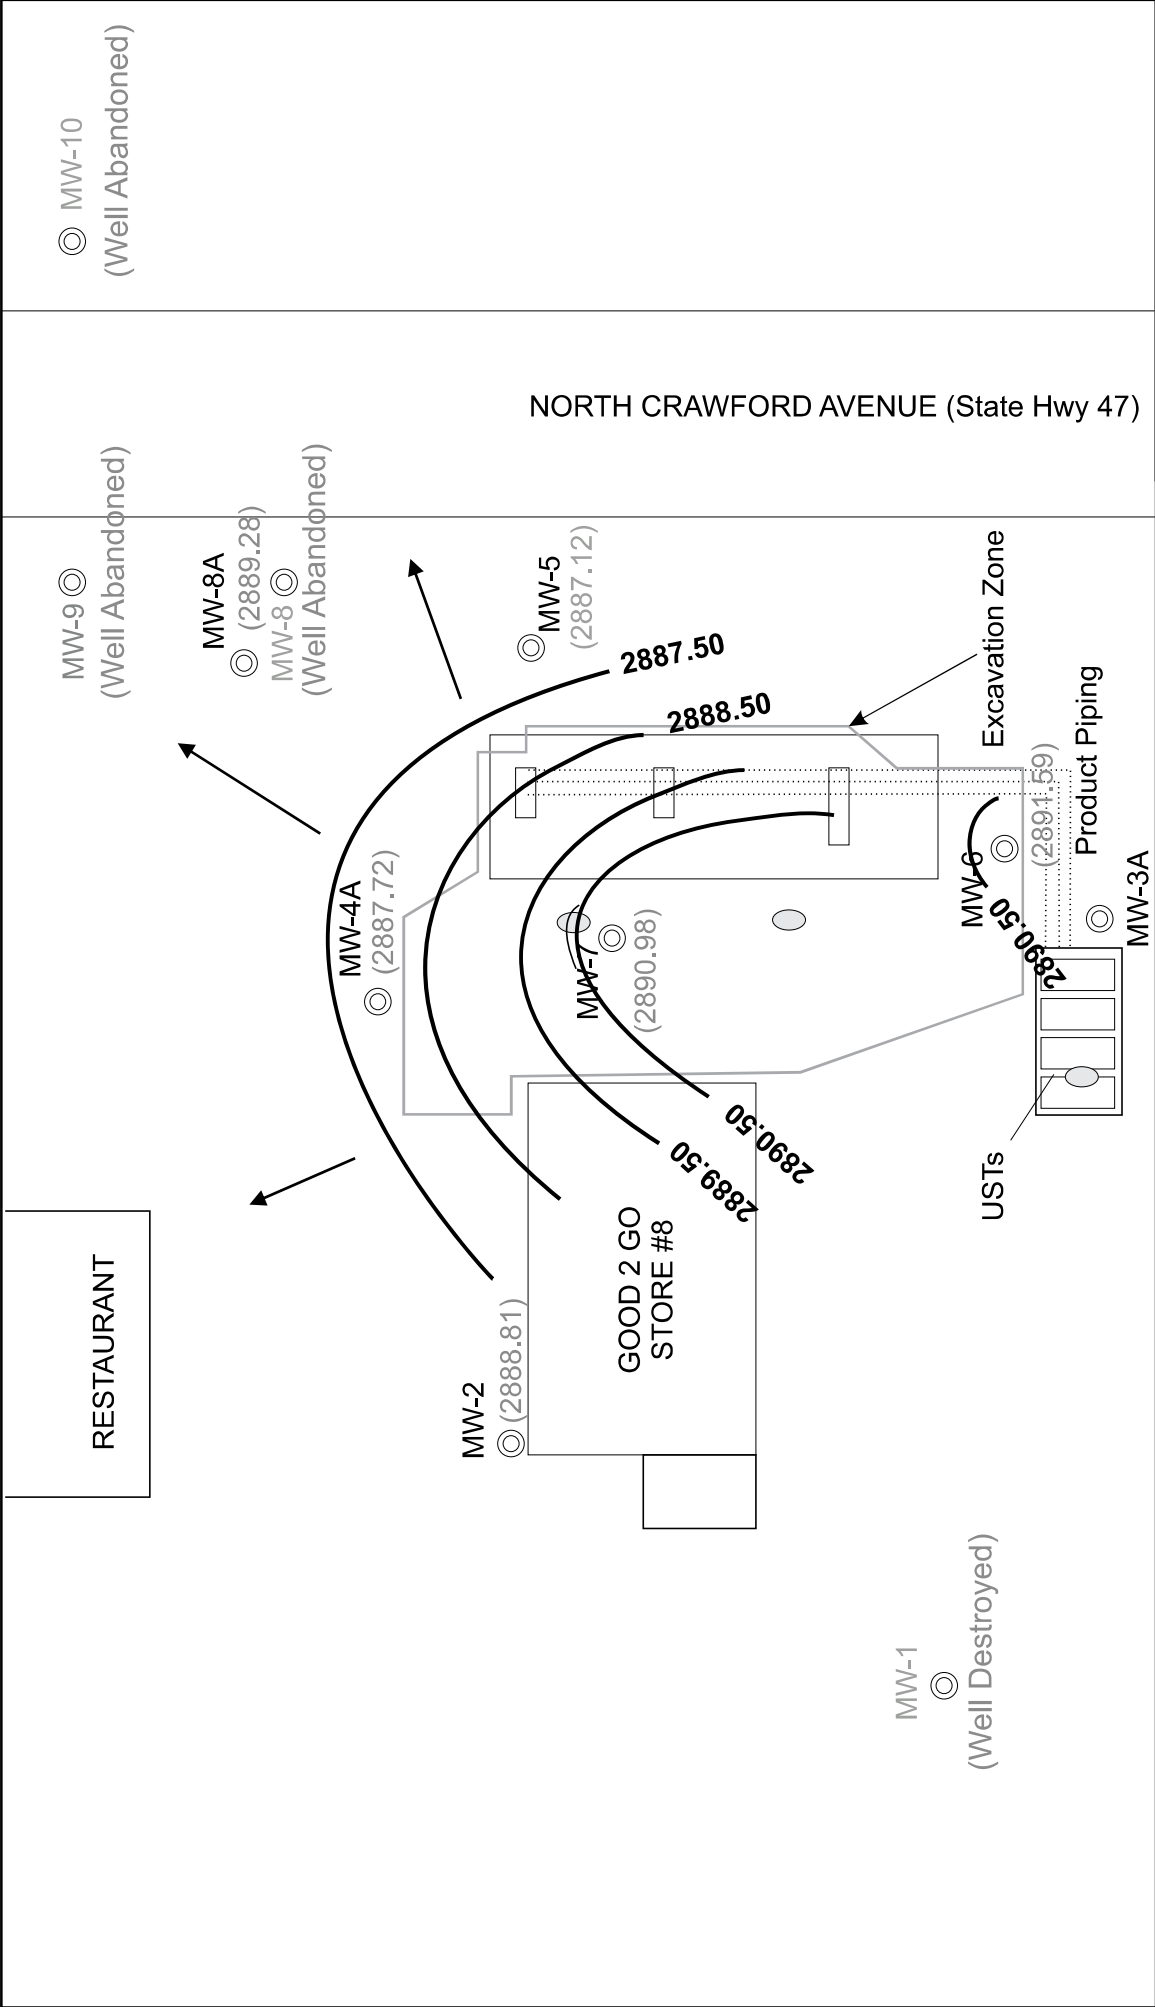
Figure 4

Potentiometric Surface Map
January 8, 2018
Good 2 Go Store #8
1600 North Crawford Ave
Hardin, Montana

Groundwater Flow Direction
