Subject: Emergency Response Work Plan
Cromwell Petroleum, Scobey, Montana
DEQ Facility ID No. 10-01223
DEQ Release No. (pending)

Environmental Resources, LLC is pleased to submit this Emergency Response Work Plan to outline activities associated with Initial Response actions following a dyed diesel fuel release at the above referenced petroleum release site. Submittal of this work plan was requested by the Montana Department of Environmental Quality (DEQ).

CROMWELL PETROLEUM
 SCOBEE, MONTANA
SITE INVESTIGATION
 FIGURE 1, REGIONAL SITE LOCATION MAP

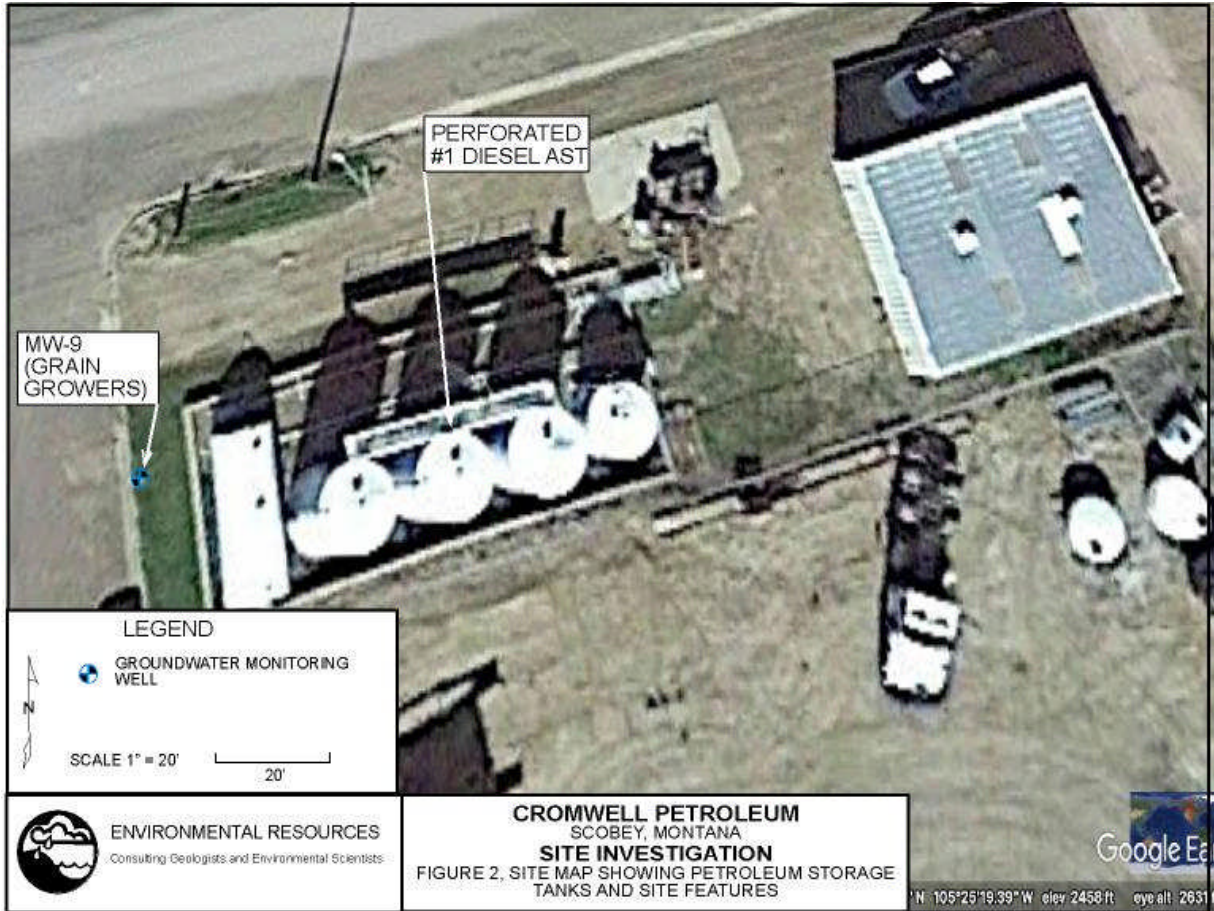
CROMWELL PETROLEUM
SCOBEEY, MONTANA
SITE INVESTIGATION
FIGURE 2, SITE MAP SHOWING PETROLEUM STORAGE
TANKS AND SITE FEATURES

The AST containment area was constructed in the 1970's and consists of five ASTs used for storage of gasoline and diesel fuel as shown on Figure 2. The ASTs serve a bulk fuel fill rack and a dispenser island for retail fuel sales. The containment area consists of an unlined gravel surface surrounded by a concrete containment wall.

MW-9
(GRAIN
GROWERS)

PERFORATED
#1 DIESEL AST

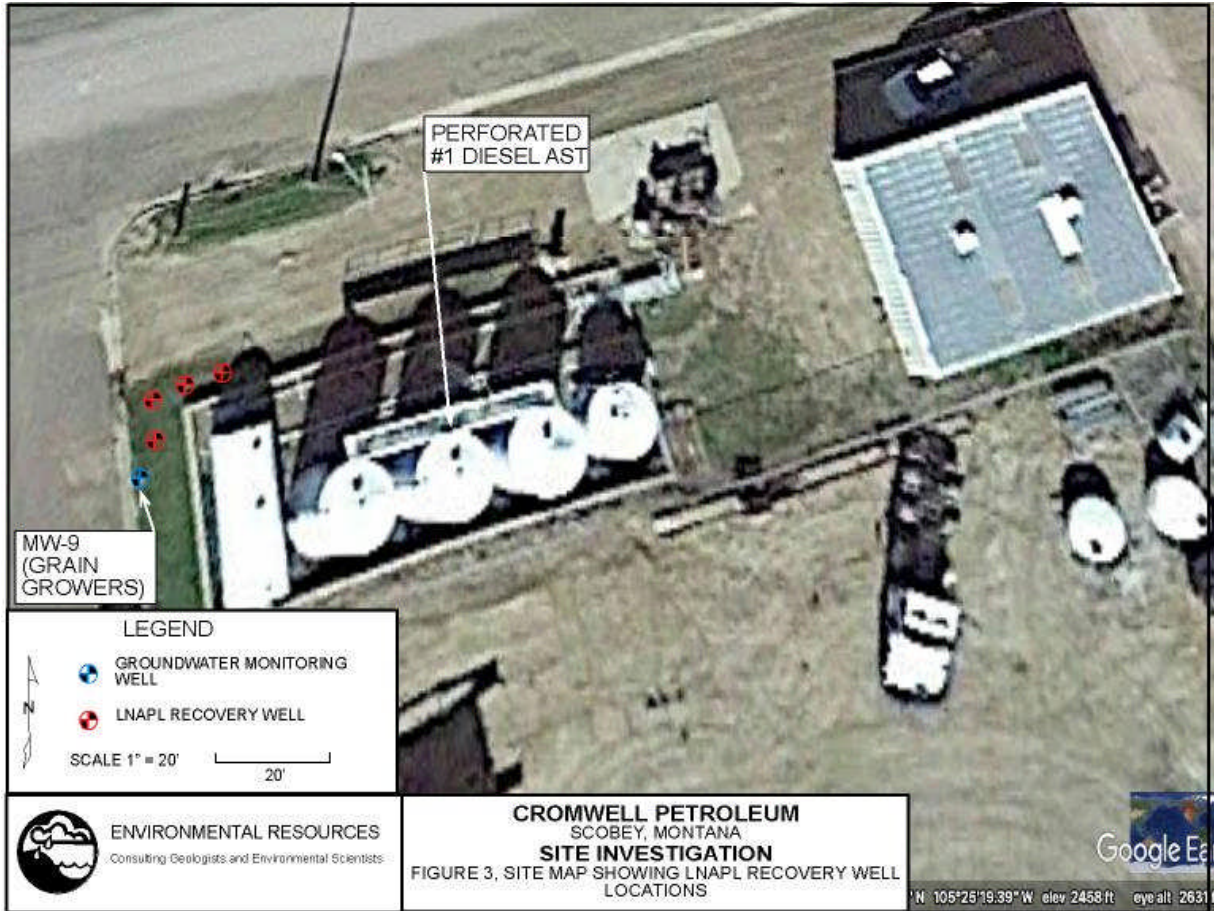
CROMWELL PETROLEUM
SCOBEEY, MONTANA
SITE INVESTIGATION
FIGURE 3. SITE MAP SHOWING LNAPL RECOVERY WELL
LOCATIONS

Additional work conducted on Thursday May 30, 2024 consisted of investigating the extent of LNAPL near the AST containment. Four four-inch diameter recovery wells were installed using a ten-inch diameter post hole auger. The borings were installed to a depth of approximately 6-7 feet below ground surface. The borings were cased with an eight foot section of four inch PVC pipe perforated vertically. The annulus around each recovery pipe was filled with ½ inch washed gravel. LNAPL recovery was facilitated using a surface mounted transfer pump discharging into a 250-gallon plastic tank. Approximately 100 gallons of diesel fuel were recovered as of Friday May 31, 2024. LNAPL recovery was also conducted in the well bore of monitoring well MW-9 associated with a neighboring petroleum release site (Figure 3).

MW-9
(GRAIN
GROWERS)

PERFORATED
#1 DIESEL AST

LNAPL RECOVERY WELL

Groundwater monitoring well MW-9 (installed for Grain Growers petroleum release site situated west of Cromwell facility) is situated a few feet west of the AST containment. Inspection of the monitoring well on Wednesday May 30, 2024 indicated the presence of 4.2 feet of floating diesel fuel product. Recovery of the product was implemented using a bailer initially and later using a surface mounted transfer pump.

Following discovery of LNAPL in monitoring well MW-9, four four-inch diameter PVC recovery wells were installed around the northwest corner of the AST containment. The recovery wells were installed using a post hole auger to approximately 6-7 feet below ground surface. The borings were cased with an eight foot section of vertically perforated four inch diameter PVC pipe. The annulus around each recovery pipe was filled with ½ inch washed gravel to above the LNAPL level at approximately three feet below ground surface. Drilling was halted to the east due to lack of product in the easternmost recovery well but that well later developed approximately 0.7 feet of LNAPL. LNAPL recovery was facilitated using a surface mounted transfer pump discharging into a 250-gallon plastic tank. Approximately 100 gallons of diesel fuel were recovered as of Friday May 31, 2024. Additional temporary recovery wells will be installed to roughly define the lateral extent of LNAPL and to facilitate placement of permanent recovery wells. Proposed additional temporary recovery wells will be installed at the locations shown on Figure 5.

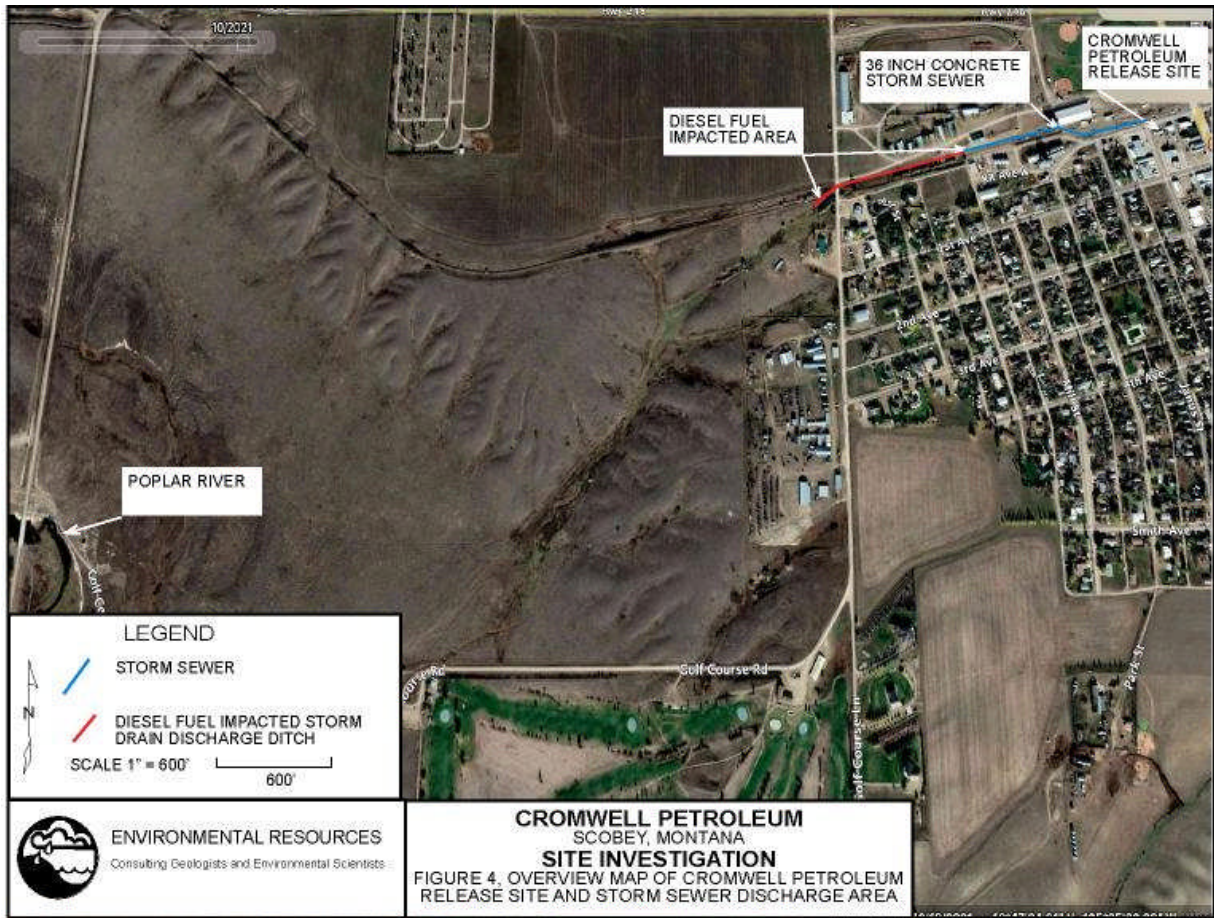
approximately 1500 gallons of water discharged from a nearby fire hydrant. All of the flush water was removed with the vacuum truck. No appreciable amounts of LNAPL were observed during the flushing operation. It is not known if impacted sediments are present within the storm sewer that could contribute to further discharge of contaminants. Layout of the impacted storm sewer and discharge ditch is shown on Figure 4.

Diesel fuel introduction into the storm sewer situated at the northeast corner of the intersection of Daniels Street and Railroad Avenue in Scobey, Montana was discovered on Tuesday May 28, 2024. The pathway for entry into the storm sewer was determined to be a French drain, most likely installed for dewatering purposes during construction of the bulk fuel storage facility in the 1970s. An estimated 150-200 gallons of dyed diesel fuel entered the storm drain sometime between Thursday May 23, 2024 and Tuesday May 28, 2024. The French drain was capped and no additional diesel fuel entry into the storm sewer has been noted. It is not known if LNAPL is migrating along
