2017 Beaverhead River Flushing Flow Synopsis

Prepared by:

Matt Jaeger
Fisheries Management Biologist
Montana Fish, Wildlife & Parks
730 1/2 N. Montana
Dillon, MT 59725
(406) 683-9310

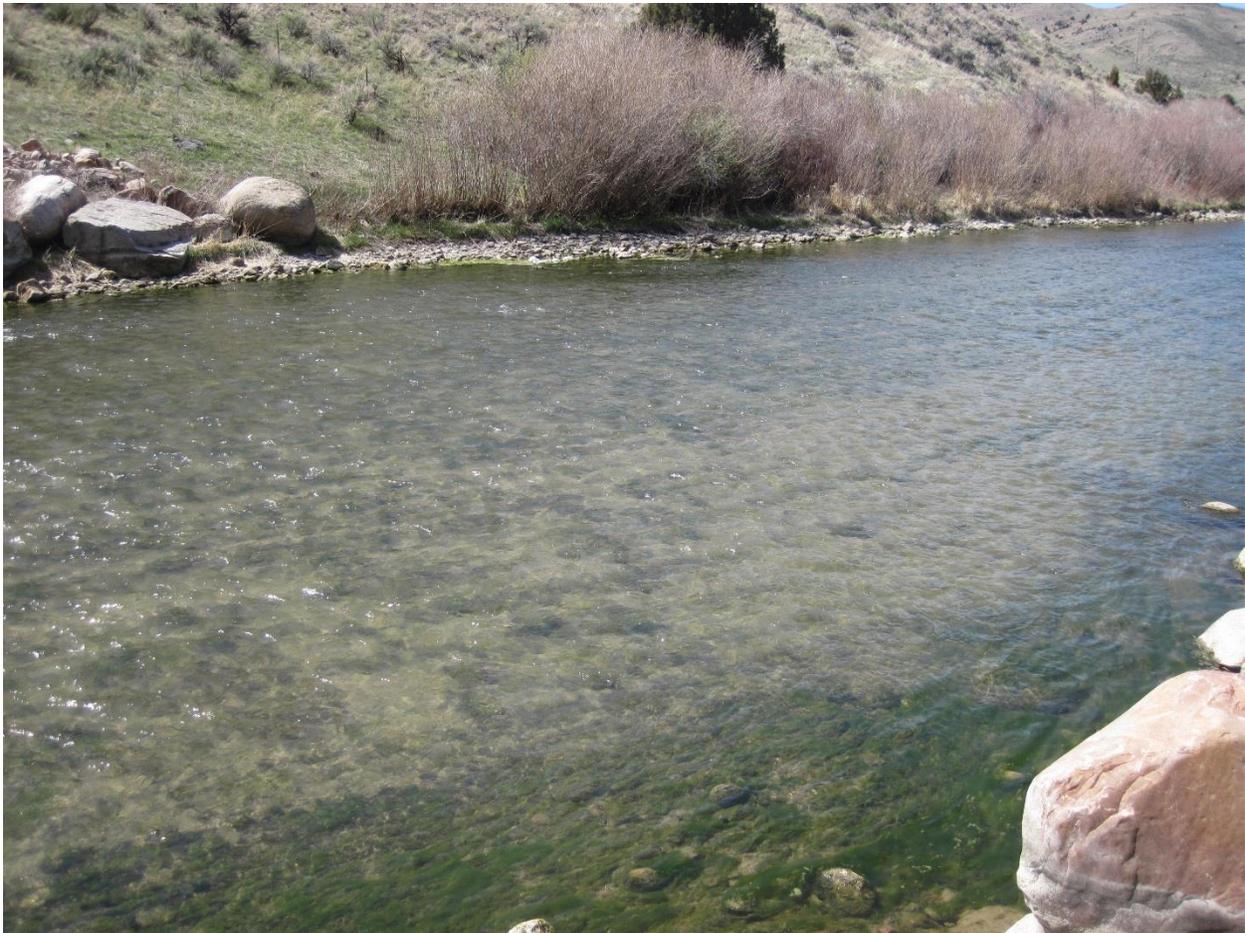
Figure 2. Sediment covering the Beaverhead River channel at High Bridge on May 3rd, 2017.

A Clark Canyon Creek sediment event occurred between April 28th and May 1st, 2017. This event deposited fine sediment throughout the Beaverhead River from the mouth of Clark Canyon Creek to several hundred yards below High Bridge (Figure 2). On May 3rd representatives of the East Bench Unit and FWP met on-site and confirmed that a sediment event had occurred and that, although the event was smaller than those in previous years, a flushing flow was warranted. Reclamation concurred with the recommendation and a flushing flow was scheduled to commence on May 5th. The flushing flow was intended to follow the hydrograph described by AGI (2014) and transition directly into irrigation releases based on water orders the East Bench unit had received. On May 4th FWP posted signs at Beaverhead River fishing access sites and notified guides and outfitters of the impending flushing flow via email.

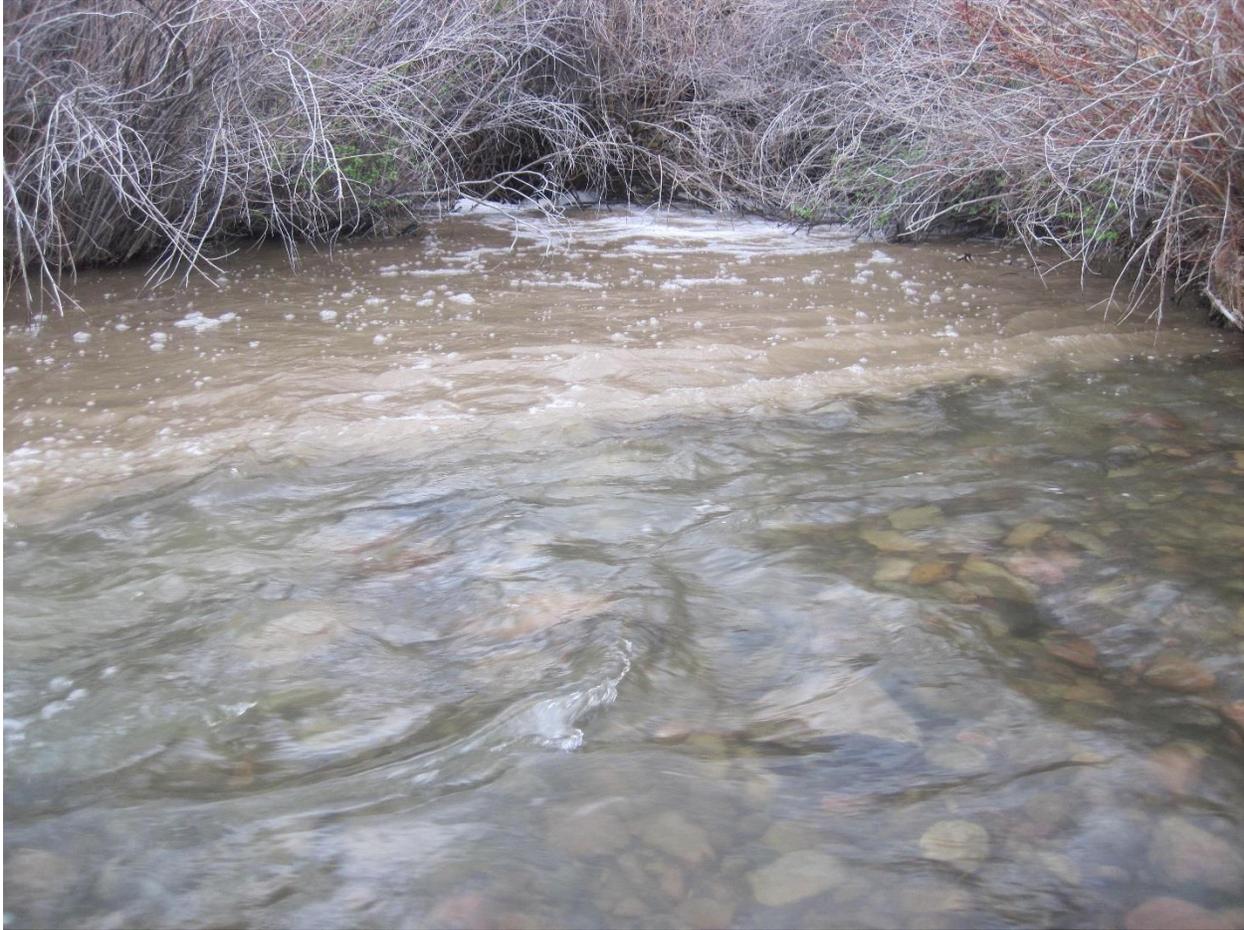
Figure 4. Confluence of Clark Canyon Creek and the Beaverhead River during sediment delivery on May 6th.

cfs) over the following 56 hours. About 12 hours after the flushing flow begin a second likely sediment event from Clark Canyon Creek occurred; high flows and sediment were transported into the Beaverhead River for about 24 to 48 hours coinciding with the rising limb of the hydrograph and peak of the flushing flow (Figure 4).
