2021 319 Application Form

Project Name Upper Ruby River Restoration	
Sponsor Name Ruby Valley Conservation District	
Registered with the Secretary of State?	Registered with SAM? Y
Duns #	Does your organization have liability insurance? Y
Primary Contact	Signatory Gary Giem
Stewardship Director	Title Board Chairman - Ruby Valley Conservation District
Address 402 S. Main Street	Address 402 S. Main Street
City Sheridan State MT Zip Code 59749	City Sheridan State MT Zip Code 59749
Phone Number	Phone Number (406) 596-0920
Email Address	Email Address giem@3rivers.net
Signature Dominique Shore Digitally signed by Dominique Shore Date: 2020.11.13 08:19:06 -07'00'	Signature GARY GIEM Digitally signed by GARY GIEM Date: 2020.11.13 10:01:10 -07'00'
Technical and Administrative Qualifications

Ruby River at RVHA Geomorphic Evolution Stream and Riparian Restoration Alternatives

PROJECT DESCRIPTION

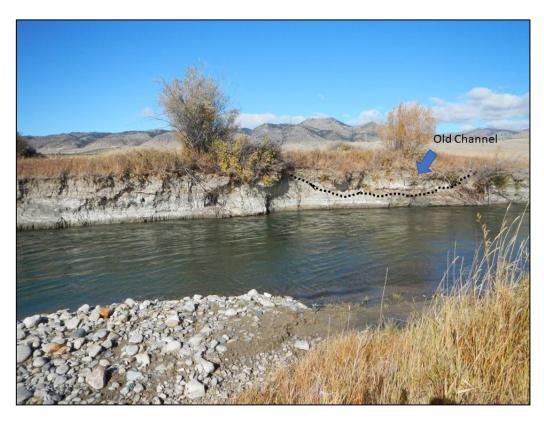
Figure 4. Typical fine-grained eroding bank with a perched side channel on the RVHA. This suggests that the Ruby River was historically connected to valley floor but is now downcut and disconnected.

Beaver are considered a keystone species that greatly affect ecosystem structure and dynamics. The removal of beaver from our riverscapes has resulted in dramatic changes to thousands of miles of streams in Montana, with persistent downcutting and resulting loss of connectivity between streams and their floodplains. Beaver dam complexes promote fine sediment deposition, flow spreading, wetland development and vigorous growth of riparian vegetation. These conditions translated into a mosaic of diverse aquatic and wildlife habitats. As the beaver were trapped out, the dams failed and streams cut through those wetland areas, leaving deeper, higher energy channels flowing through fine materials. The very fine bank sediments through RVHA support the notion that this system was historically a broad wetland complex, which was very likely sustained by beaver. It is also not uncommon to see old channels in the banklines that are smaller than the river today, indicating historic multi-thread channel networks typical of beaver dominated valley bottoms (Figure 4).

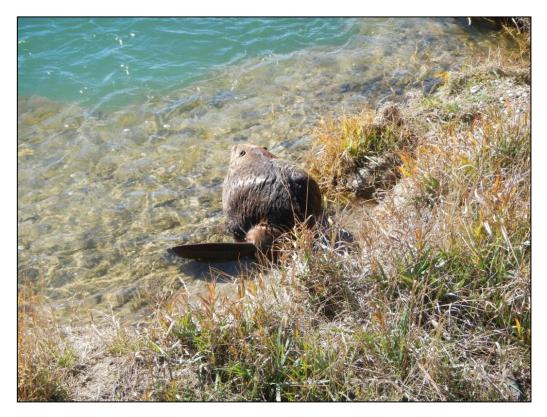
Figure 5. Ailing Beaver spotted on RVHA reach, October 2017.

While on the RVHA parcel, we saw one beaver and overall very little beaver sign. Unfortunately, the beaver could hardly move, and as it tried to escape us by diving, it couldn't go underwater due to what appeared to be bloating. These symptoms are typical of Tularemia, which is a disease caused by the bacteria *Francisella tularensis*. Tularemia, which is also called rabbit fever, occurs naturally world-wide. The manager of Red Rock Lakes Wildlife Refuge in the Centennial Valley has recently had positive test results for the disease in beaver. A graduate student at Montana State who is tracking tagged beaver in the region suggested that increasingly widespread reports indicate a potential outbreak in other upper Missouri systems such as the Madison and Gallatin Rivers (Torrey Ritter, pers, comm, 2018). So far, we don't really know how to anticipate population rebound as this disease runs its course.

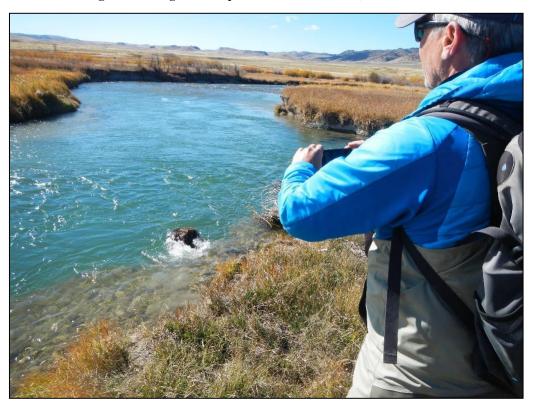
Figure 6. Beaver unsuccessfully trying to dive, RVHA.

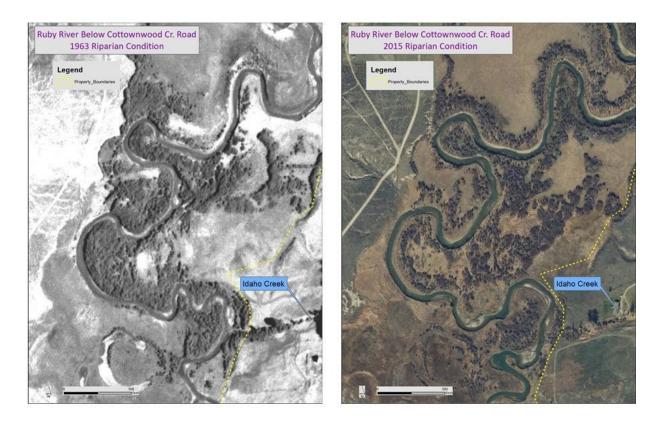
Figure 7. Ruby River just below Idaho Creek in 1963 (left) and 2015 (right) showing loss of woody riparian density. The RVHA has excellent potential to recover and expand its riparian and wetland communities.

Another major trend in the region is the reduction of woody riparian cover on the Ruby and Beaverhead Rivers during the early 20th Century. Figure 7 shows air photos from 1963 and 2015 at the mouth of Idaho Creek, where there has been a loss of woody riparian density through time. On the RVHA parcel, most of the floodplain had been converted to hayfields by 1955, however there has been some additional loss of woody riparian vegetation since then. These more recent losses in woody cover are probably not due to active clearing, but due to some historic stream downcutting (post-beaver) that has perched the floodplain above the river and water table and created high eroding banks. Figure 8 shows the current riparian vigor in the upper portion of RVHA which is well below potential. A series of air photos showing the progression of stream and floodplain conditions from 1953 to 2015 are compiled in Appendix 1.

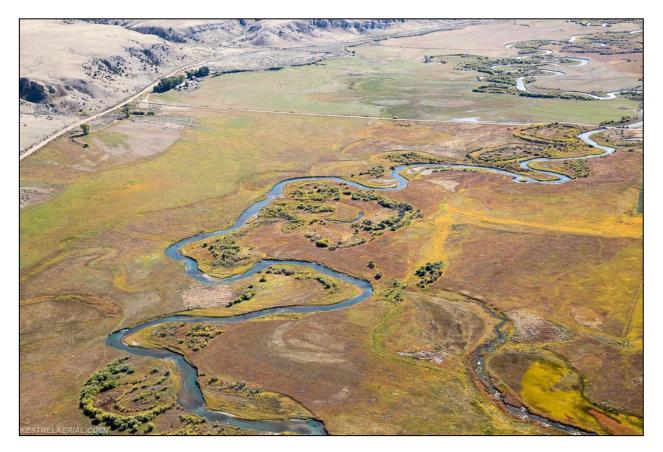
Figure 8. View upstream of RVHA showing current density of woody riparian vegetation; note increased densities upstream of bridge (Kestrel Aerial Services).

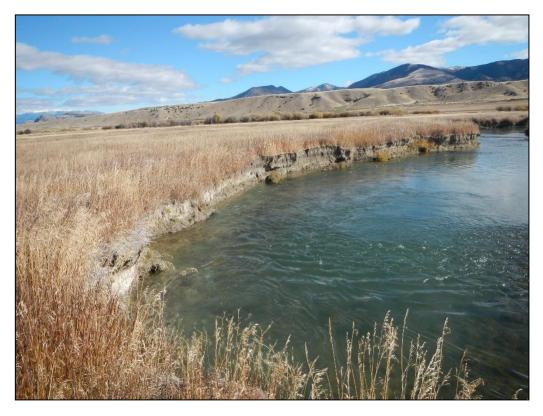
Figure 11. View downstream of high, fine-grained eroding streambank typical of RVHA.

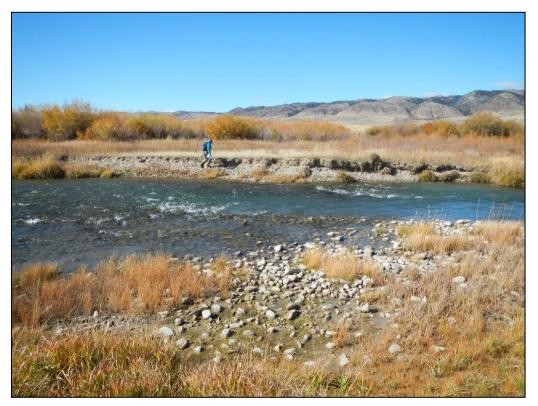
Figure 12. View across river of gravel bankline where a meander cut off during the 1984 flood.

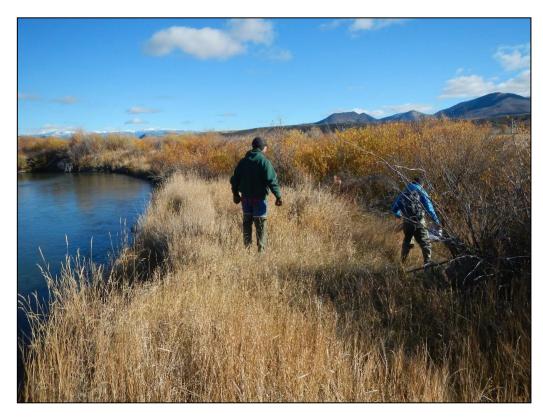
Figure 15. View downstream of berm blocking the entrance to the first meander below the bridge; P. Trischman is on the berm and S. Gillilan is down in the old channel to the right.

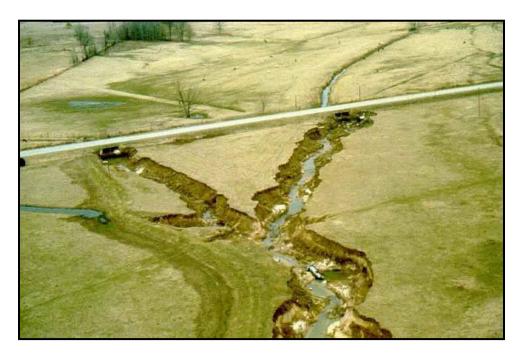
Figure 17. Stream downcutting caused by channelization downstream; the headcuts migrated upstream until intercepted by a road culvert.

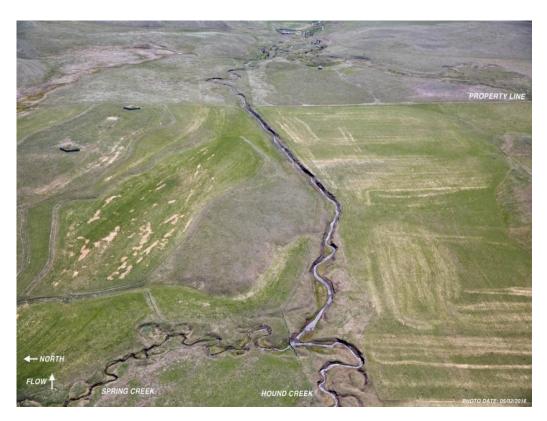
Figure 18. View downstream of channelized creek near Cascade MT (kestrel aerial services).

The flurry of channelization projects was quickly followed by the discovery of the unintended consequences of that work. In the southeastern US for example, the steepening caused by channelization created headcuts (essentially waterfalls in the stream bed) to form that rapidly migrated upstream. This work was not unheard of in Montana; we recently worked on a restoration plan for a rancher near Cascade whose grandfather had channelized much of their creek, driving major instability and riparian degradation upstream (Figure 18).

A tremendous amount of restoration work has been carried out on streams that were historically shortened. In many cases, such as on Hound Creek shown in Figure 18, the downcutting is so severe that restoring the stream to some semblance of its historic condition isn't financially feasible. On the RVHA parcel, however, the shortening has not been too severe, so the instability is manageable and cost-effective restoration appears highly feasible.

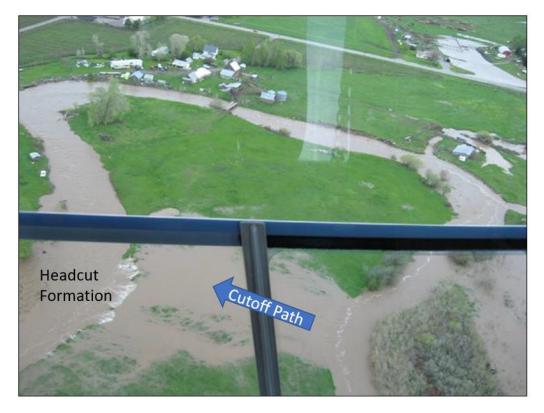
Figure 20. Example meander cutoff during a May 2008 flood on the East Gallatin River in Bozeman (DNRC).

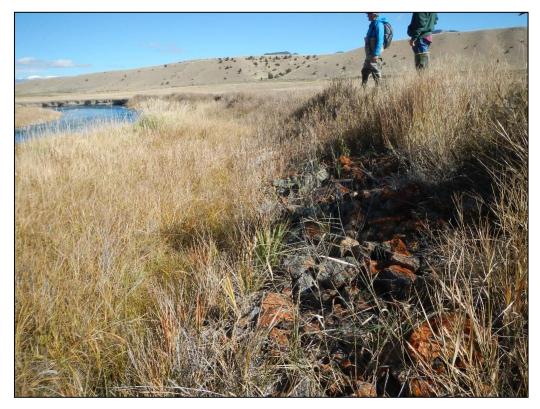
Figure 26. View downstream at RVHA showing old perched riprap.

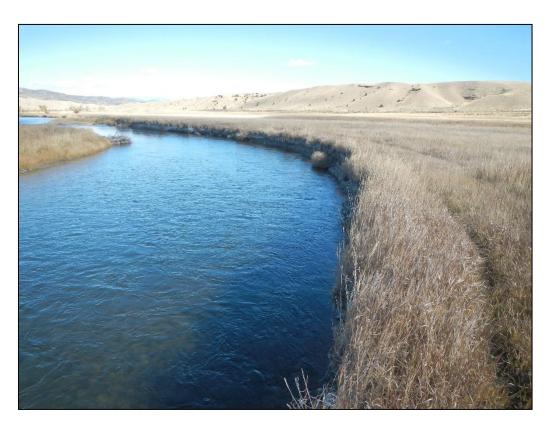
Figure 32. View downstream of typical grassed eroding bankline, RVHA.

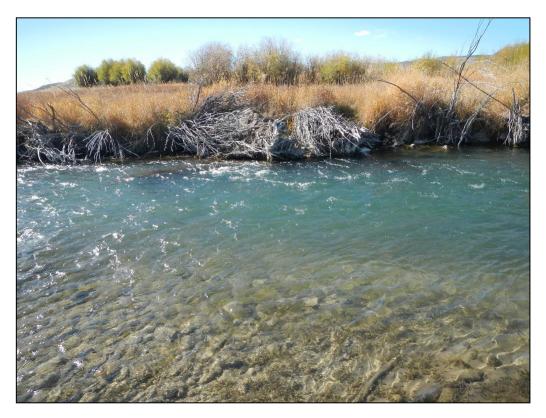
Figure 33. View across river of rock/wood erosion control structures.

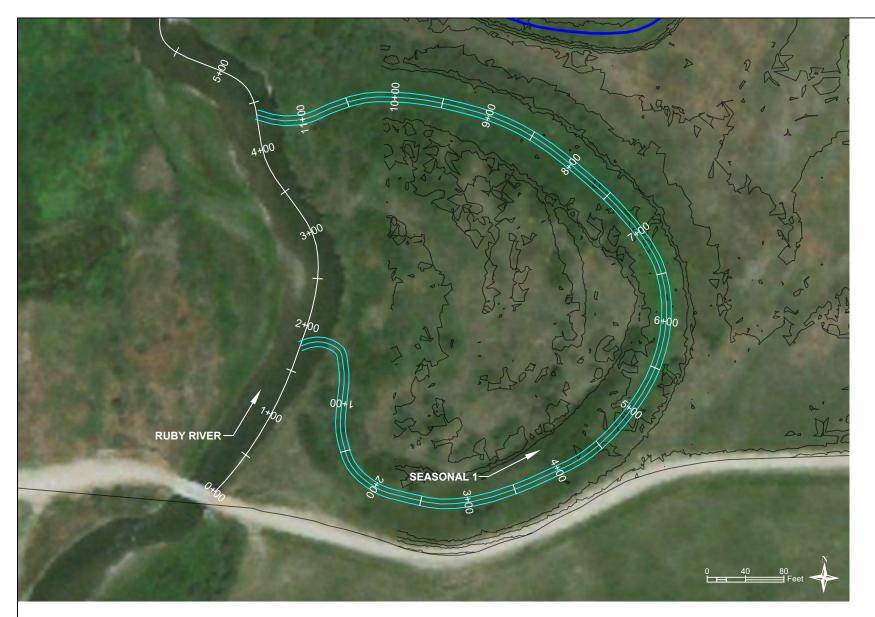
SEASONAL 1 TYPICAL CROSS SECTION

ACTIVATION CHANNEL	
ACTIVATION CHANNEL	DETAILS
MAIN CHANNEL START STATION	1+78
MAIN CHANNEL END STATION	4+37
ACTIVATED CHANNEL LENGTH (FT)	N/A
CONSTRUCTED CHANNEL LENGTH (FT)	1075
TARGET INLET ELEVATION (FT)	5436.5
TARGET OUTLET ELEVATION (FT)	5435.0
ACTIVATION STAGE ABOVE BED (FT)	2.3
ACTIVATION Q (CFS)	480
DAYS PER YEAR ACTIVATED	26
SLOPE	0.14%

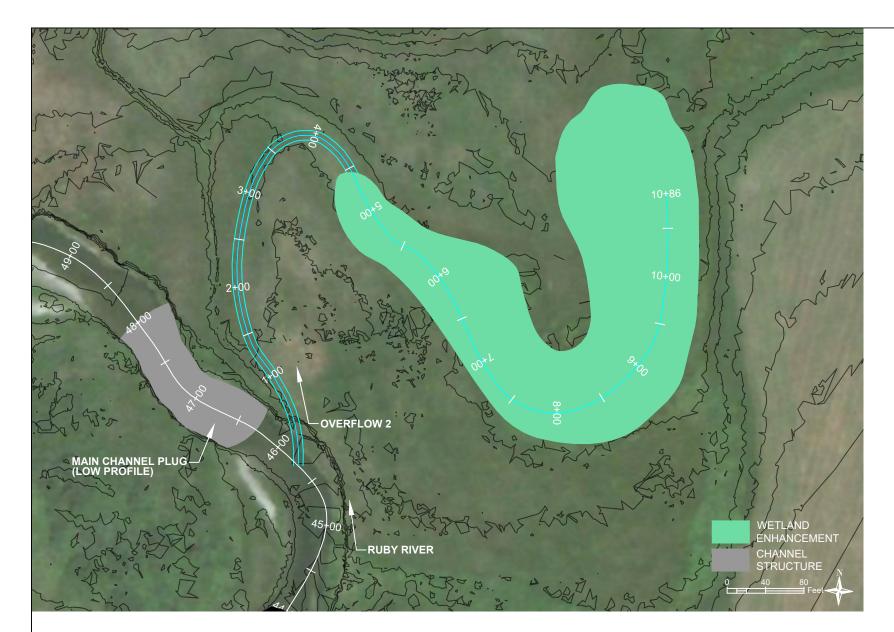
OVERFLOW 2 TYPICAL CROSS SECTION

ACTIVATION CHANNE MAIN CHANNEL START STATION MAIN CHANNEL END STATION ACTIVATED CHANNEL LENGTH (FT) CONSTRUCTED CHANNEL WITH WETLAN ENHANCEMENT LENGTH (FT) TARGET INLET ELEVATION (FT) TARGET OUTLET ELEVATION (FT) ACTIVATION STAGE ABOVE BED (FT) ACTIVATION Q (CFS) DAYS PER YEAR ACTIVATED SLOPE MAIN CHANNEL PLUG LOW PROFILE ELEVAT

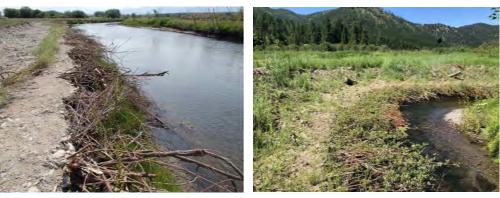
EXAMPLES OF WOODY DEBRIS MATRIX STREAMBANK TREATMENTS

- 1. EXCAVATE STREAMBANK TO SUBGRADE ELEVATIONS.
- AND ACCORDING TO SPECIFIED DIMENSIONS.
- 3 ANGLE TO THE STREAMBANK. CLUMPS CAN OVERLAP AND CAN BE BELOW THE BANKFULL ELEVATION.
- IF OUTSIDE OF DORMANCY PLACE WILLOW CUTTINGS INTO THE MATRIX AS 4. SHOWN IN THE DRAWING WITH THE STEMS IN CONTACT WITH THE BASEFLOW WATER TABLE AND TOPS AT OR ABOVE THE BANKFULL ELEVATION.
- BACKFILL STREAMBANK WITH FLOODPLAIN BACKFILL TO DESIGN 5 EXTEND BEYOND THE WOODY DEBRIS MATRIX. THE WIDTH OF INSET FLOODPLAINS VARIES AND WILL BE DEFINED FOR EACH FEATURE.
- 6. AND INSET FLOODPLAIN WITH THE ADJACENT EXISTING GROUND.
- 7. INSTALLED.

2. FOR TYPE 2 INSTALL BRUSH TOE FASCINE AND ANCHOR TO BACK OF EXCAVATION. FOR TYPE 3 CONSTRUCT STREAMBANK TOE WHERE NEEDED INSTALL WHOLE WILLOW CLUMPS IN THE STREAMBANK AT A DOWNWARD

ORIENTED FACING UPSTREAM OR DOWNSTREAM, BUT SHOULD BE PLACED

ELEVATIONS. WASH FINES INTO THE FLOODPLAIN BACKFILL TO SEAL VOIDS. IN LOCATIONS WITH AN INSET FLOODPLAIN, FLOODPLAIN BACKFILL WILL WHERE THE EXISTING BANKLINE ABUTS THE FLOODPLAIN BACKFILL, LAY BACK THE GROUND BY EXCAVATING MATERIAL TO FORM A SLOPE AT A MINIMUM OF 4H:1V TO BLEND THE WOODY DEBRIS MATRIX STREAMBANK THE FLOODPLAIN BENCH SHOULD BE ROUGHENED AND RIPARIAN PLANTS
