Project Name Teton Spring Creek Restoration Project

Sponsor Name Montana Freshwater Partners

TETON SPRING CREEK RESTORATION CONCEPT

Teton Spring Creek Photo Log

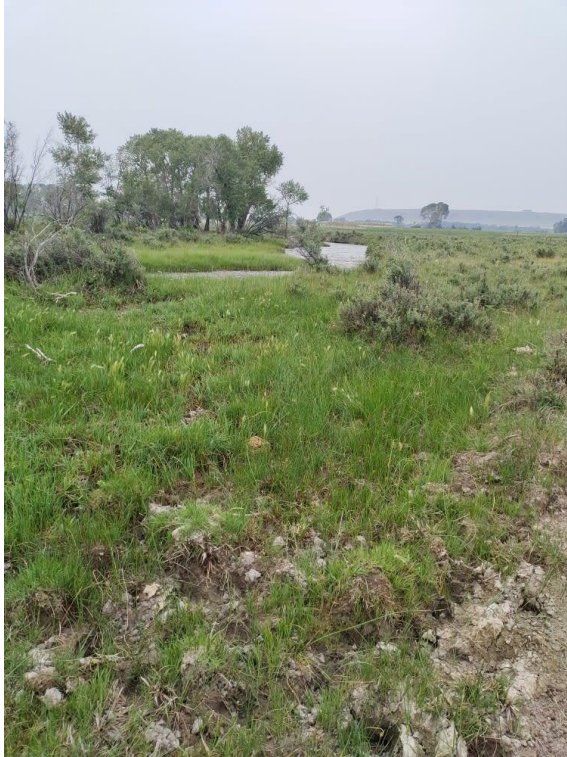
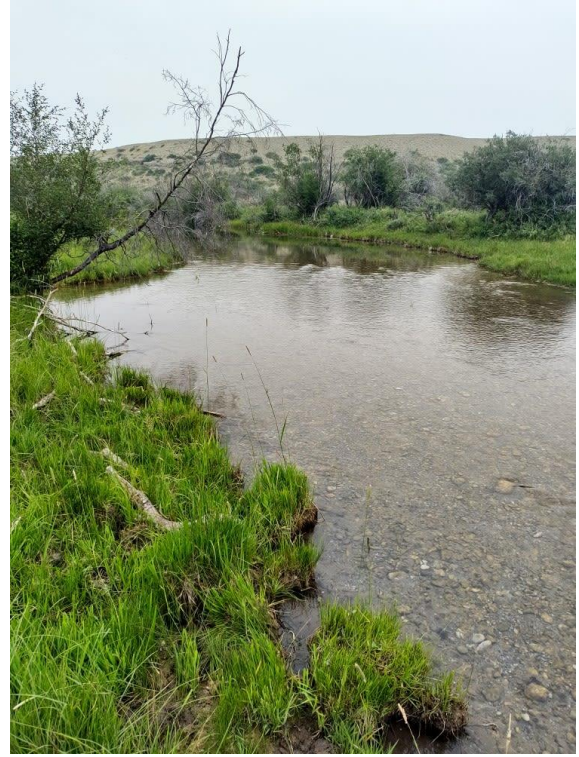
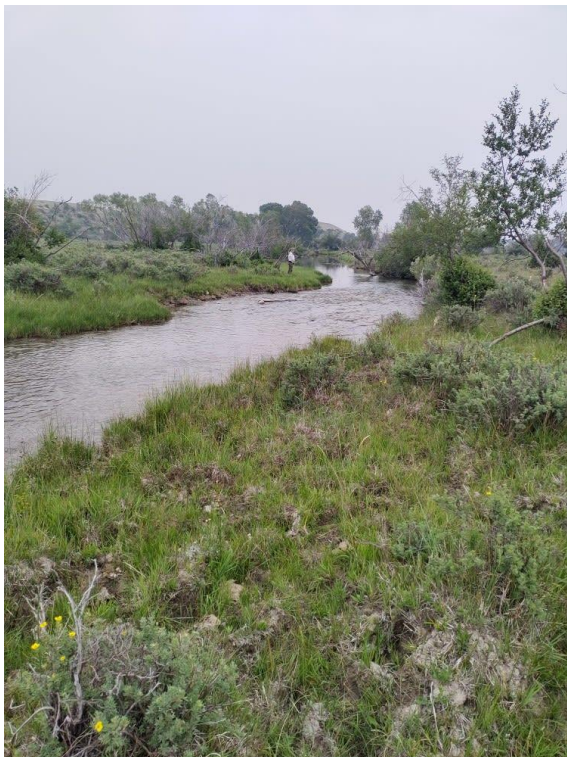
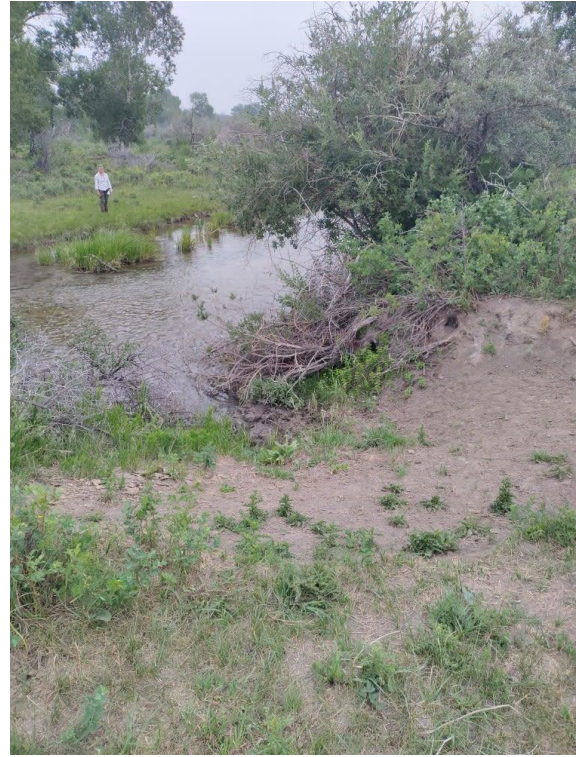
TETON SPRING CREEK PHOTO LOG – JULY 2021 and JUNE 2022

The following photos showcase the effect of cattle in over-widening the creek, trampling the banks and overgrazing the riparian area within the proposed project area. Shrubby cinquefoil was the only woody shrub that remained in areas, which is very unpalatable to livestock. There was also knapweed, hounds' tongue, Canada thistle and leafy spurge infestations along the riparian corridor.

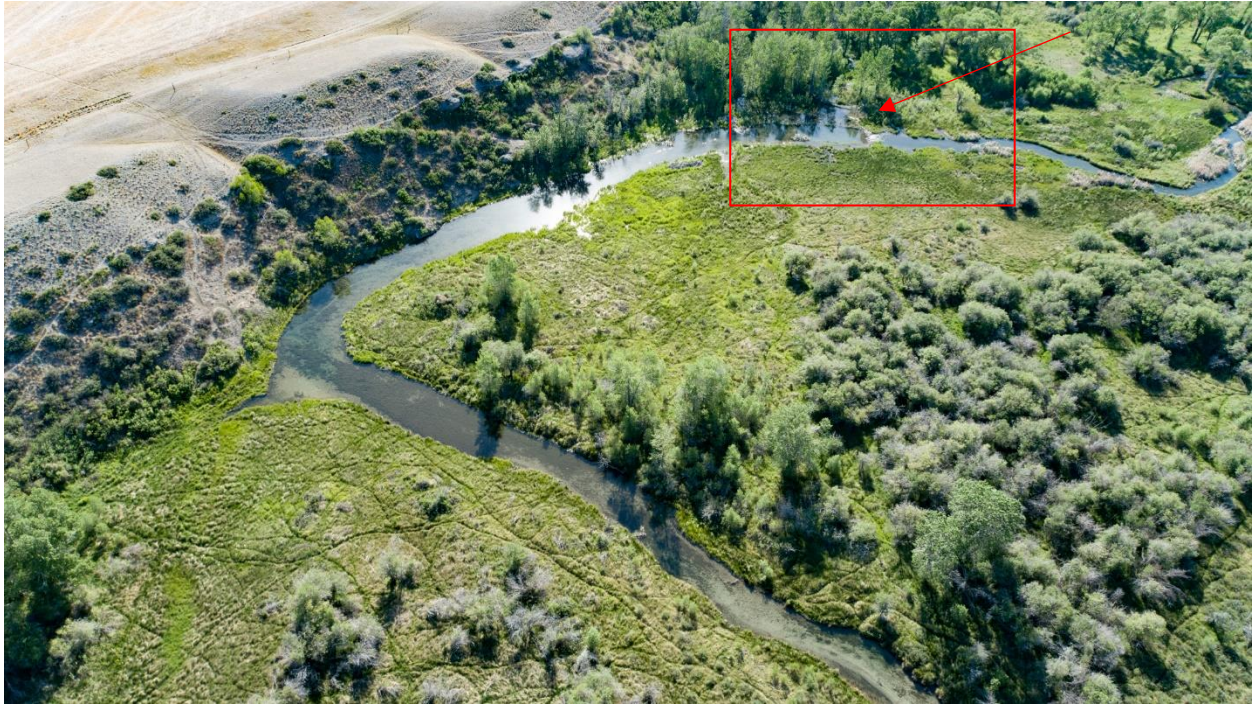
Drone image showing one of multiple beaver dams in the reference site. The floodplain upstream of the beaver dam was extremely wet and as a result, vegetation was thriving as can be seen in the below photos.

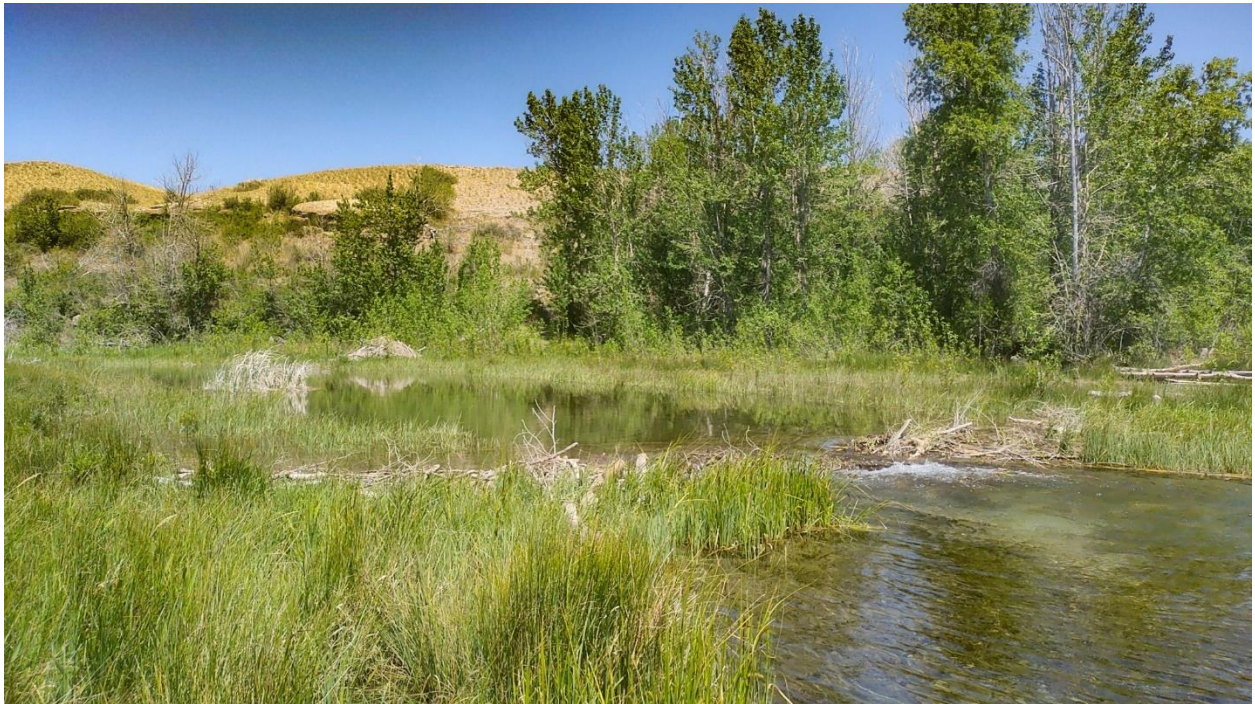
Close-up of a beaver dam within the reference site.

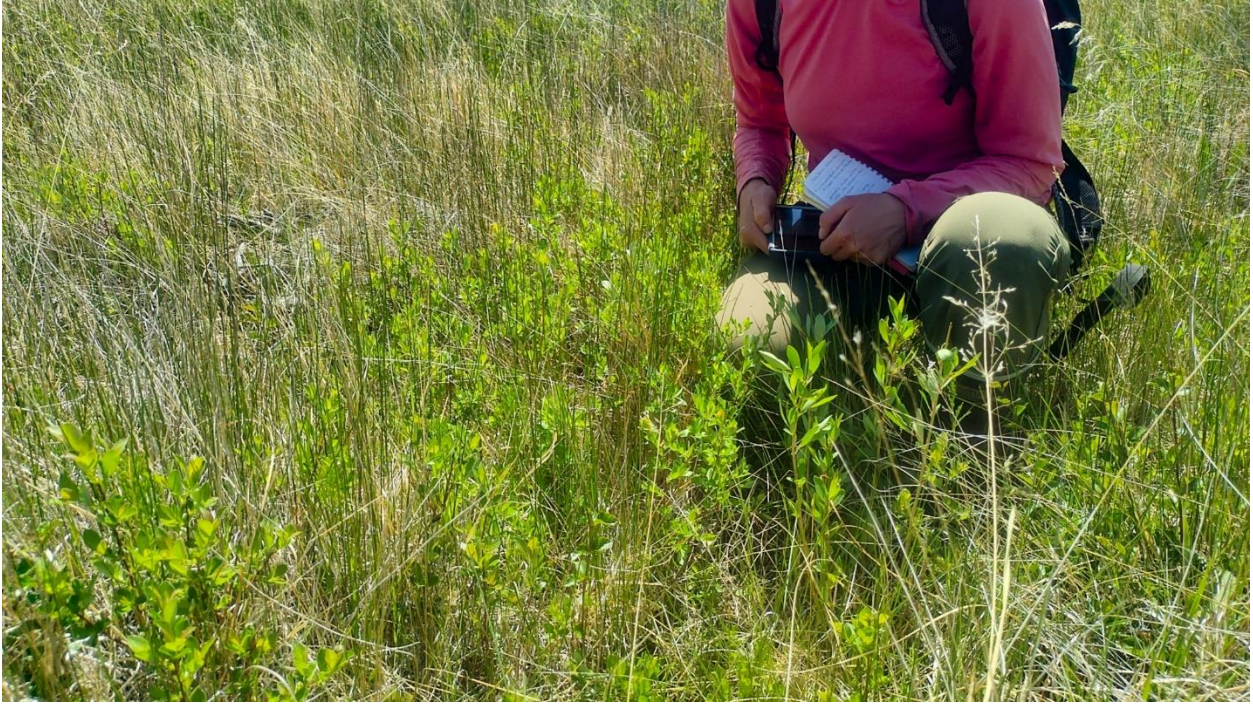
Cottonwood and willow seedlings were abundant throughout the areas with moist soils due to beaver dams.

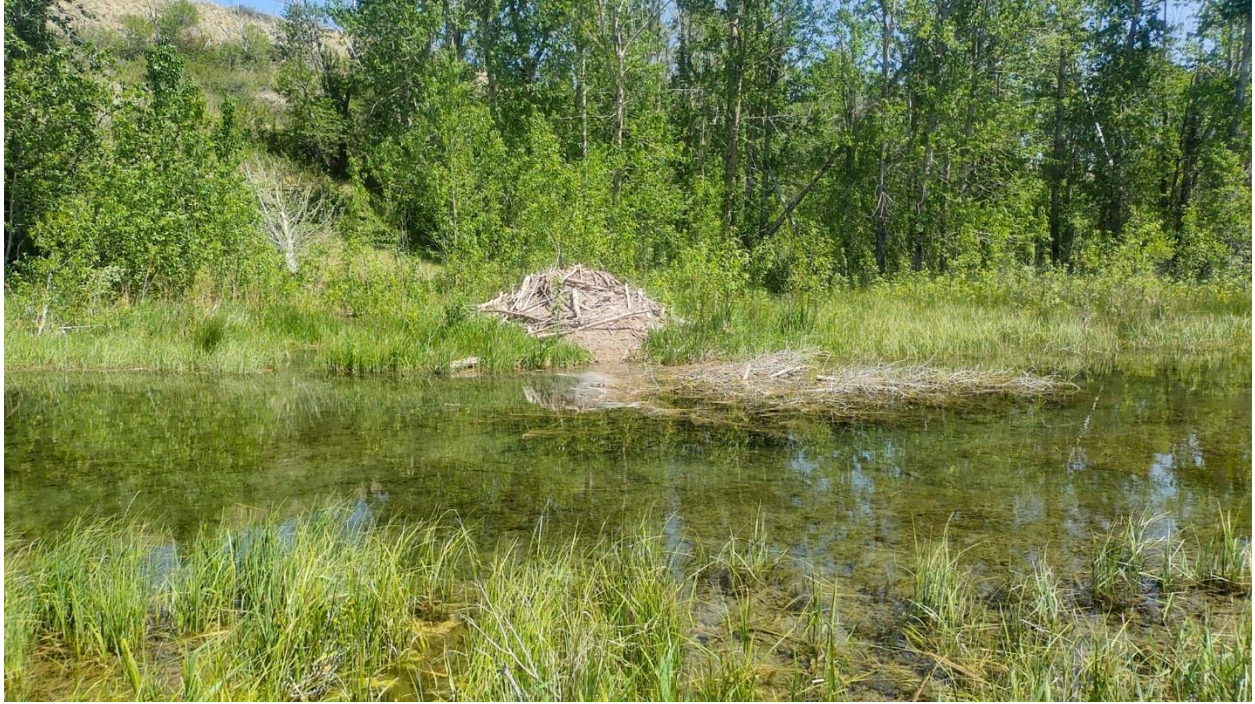
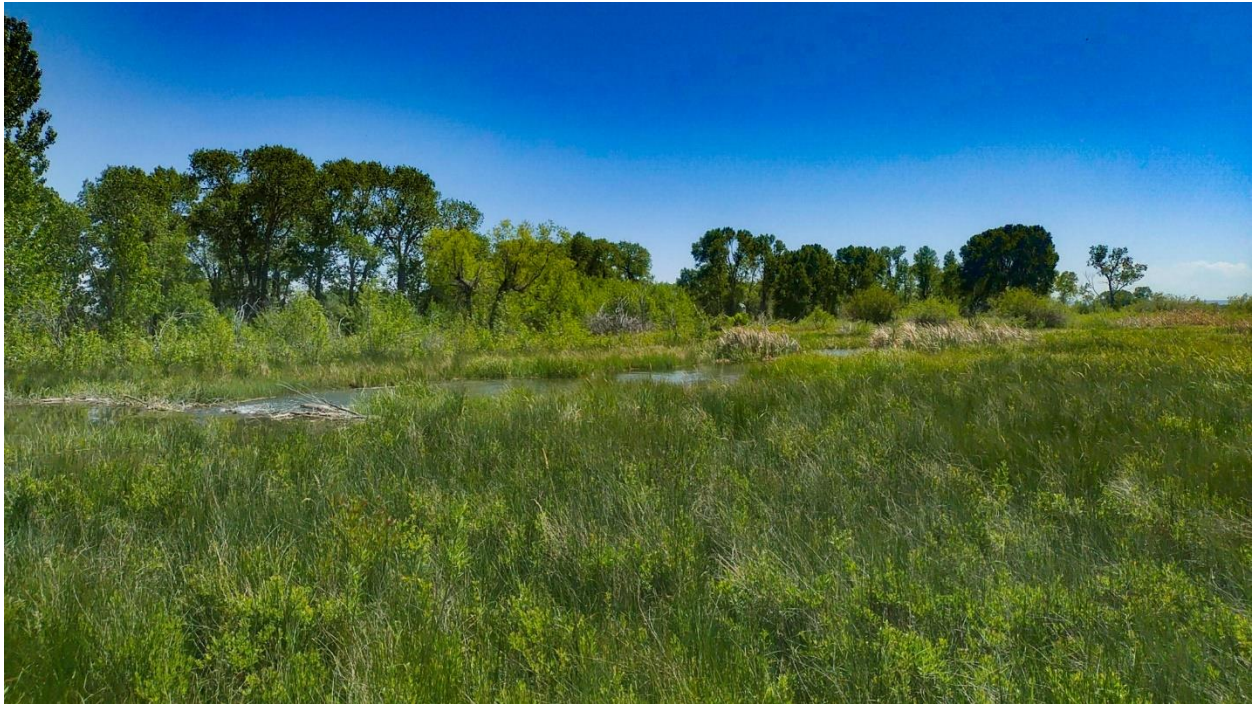
View (looking downstream) at uppermost beaver dam. Teton Spring Creek was impounded upstream of this beaver dam, with multiple inundated overflow channels out on the floodplain.

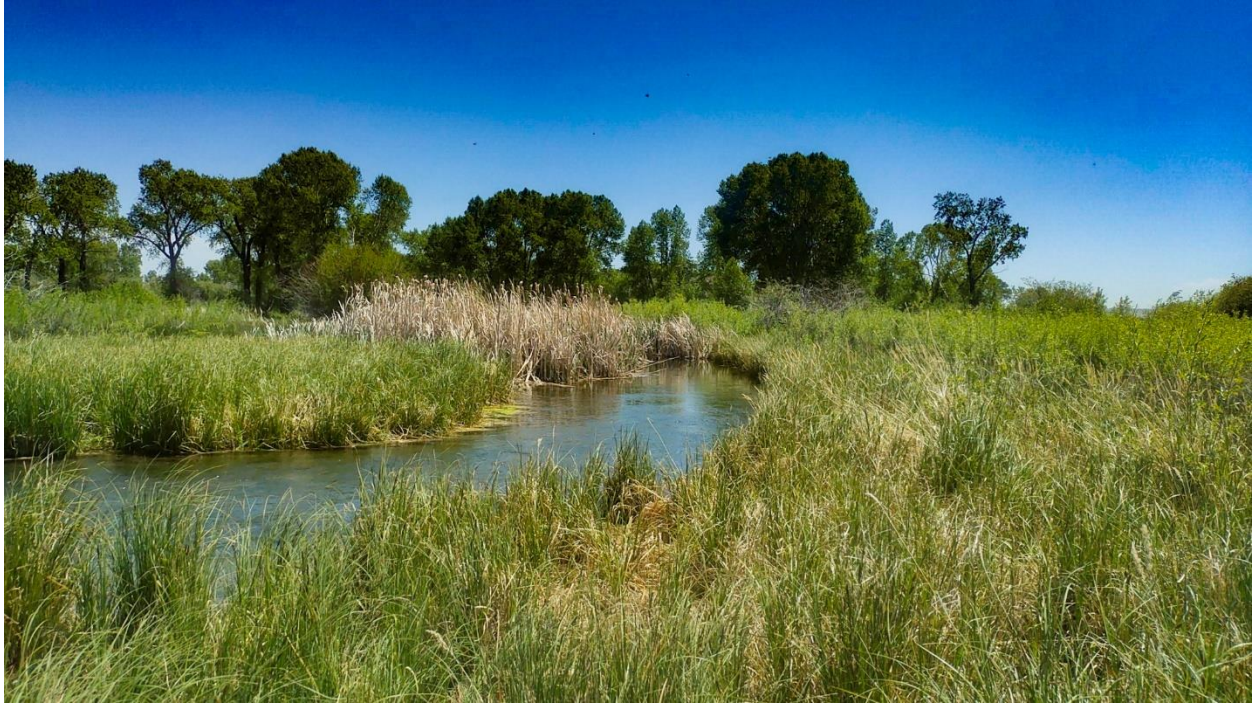
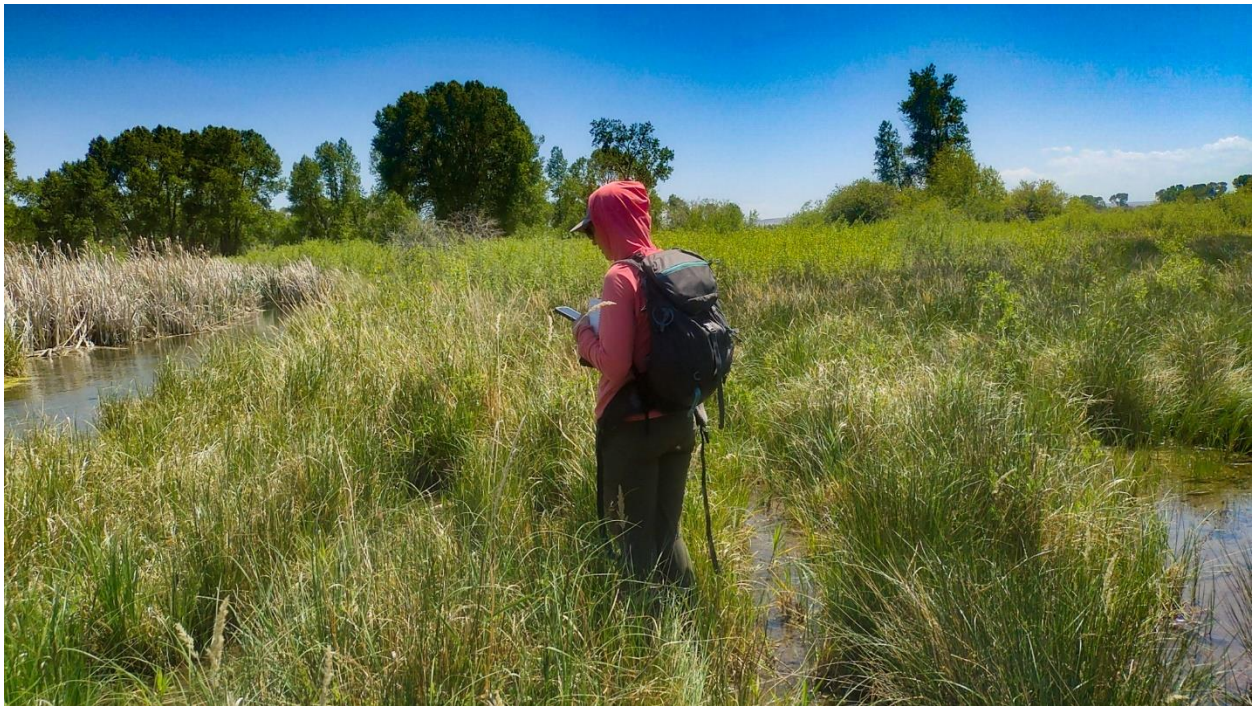
Floodplain within the reference site. The main channel of Spring Creek is on the left side of the photo and multiple overflow channels can be seen through the grass and sedge communities due to the high water table on the right side of the photo. Numerous young cottonwood trees can be seen in the background.

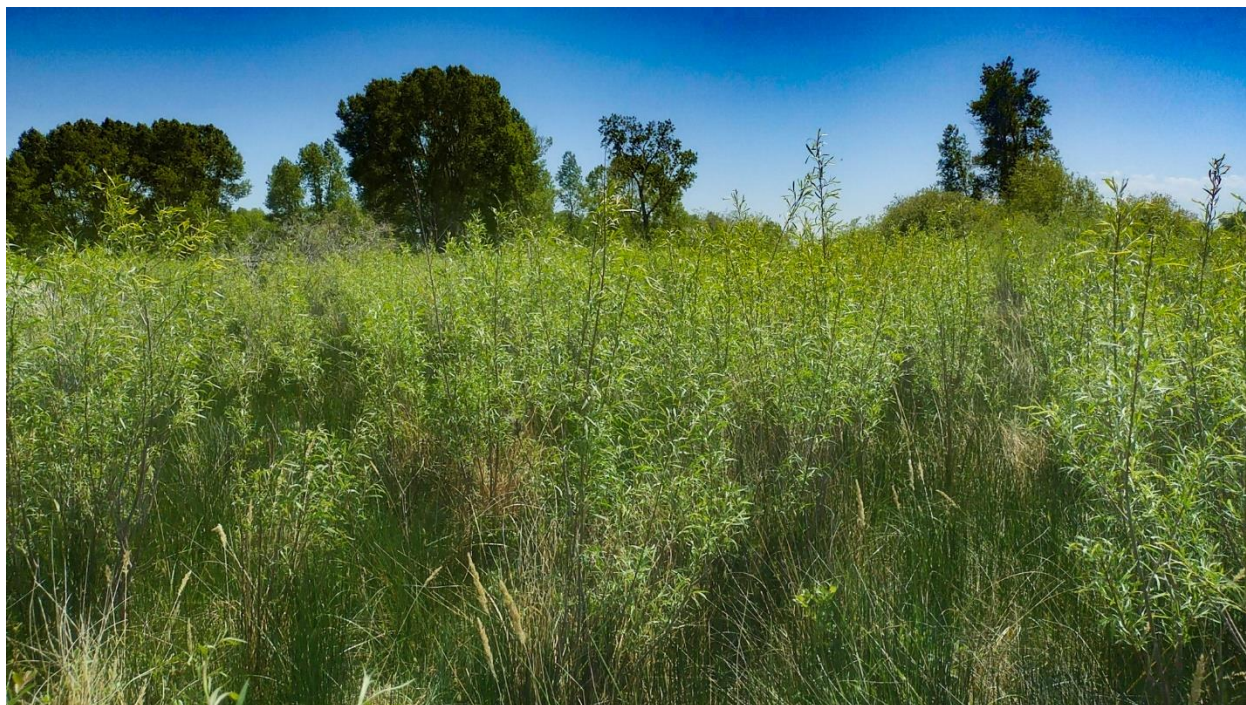
Juvenile willows.

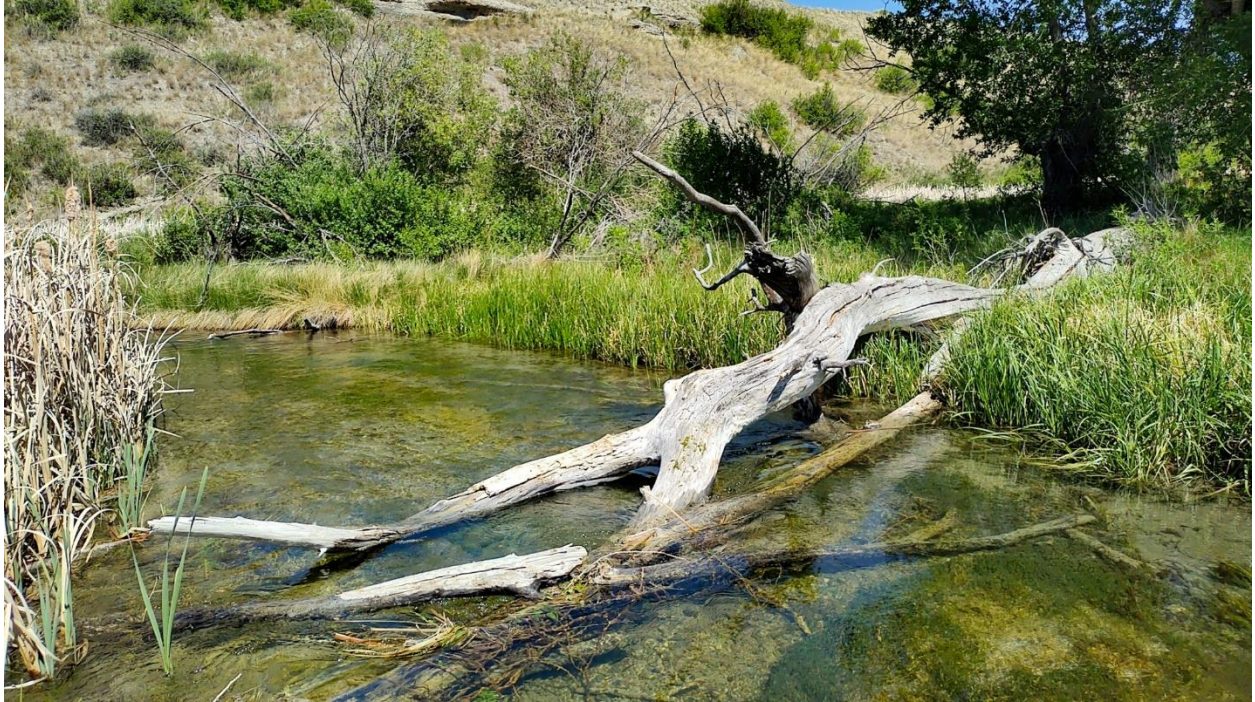
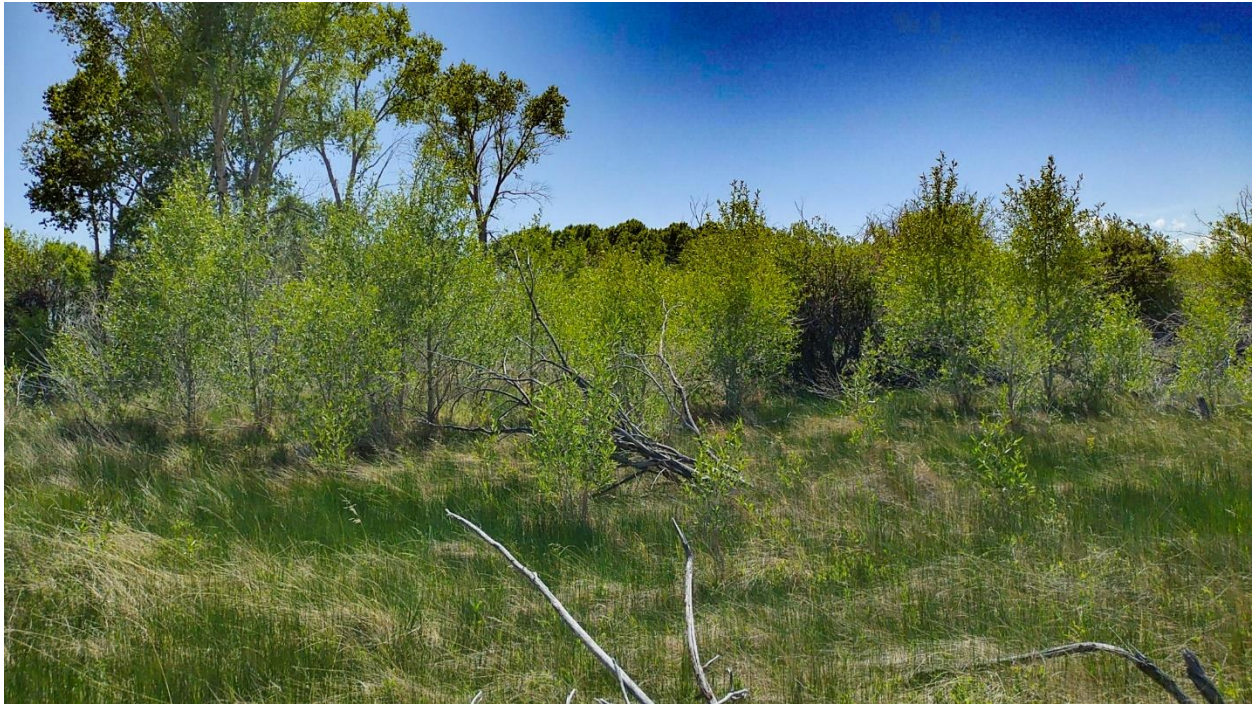
Young cottonwood trees and seedlings were abundant in areas where beaver dams were checking up water.

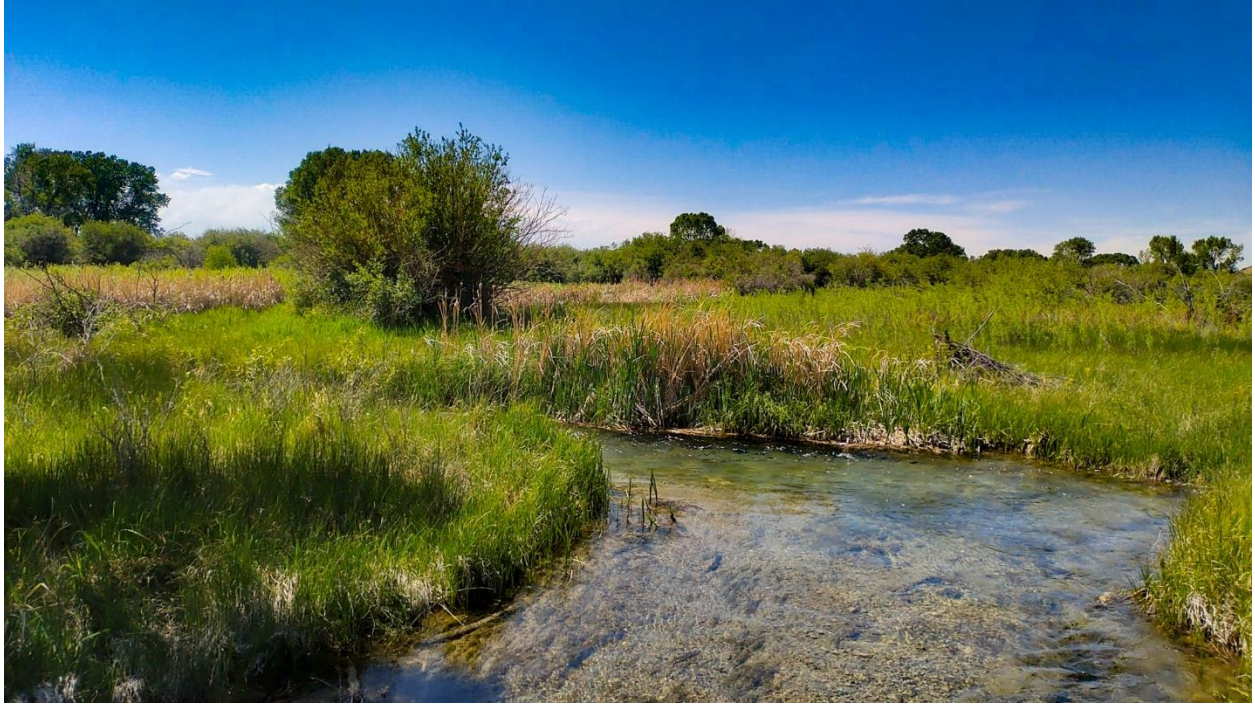
The stream channel had much higher sinuosity and increased complexity in the reference site as compared to the project reach and bankfull widths were narrower overall. There were also discrete patches of cattails interspersed along the stream.
