Lolo Creek

Watershed Restoration Plan

2013

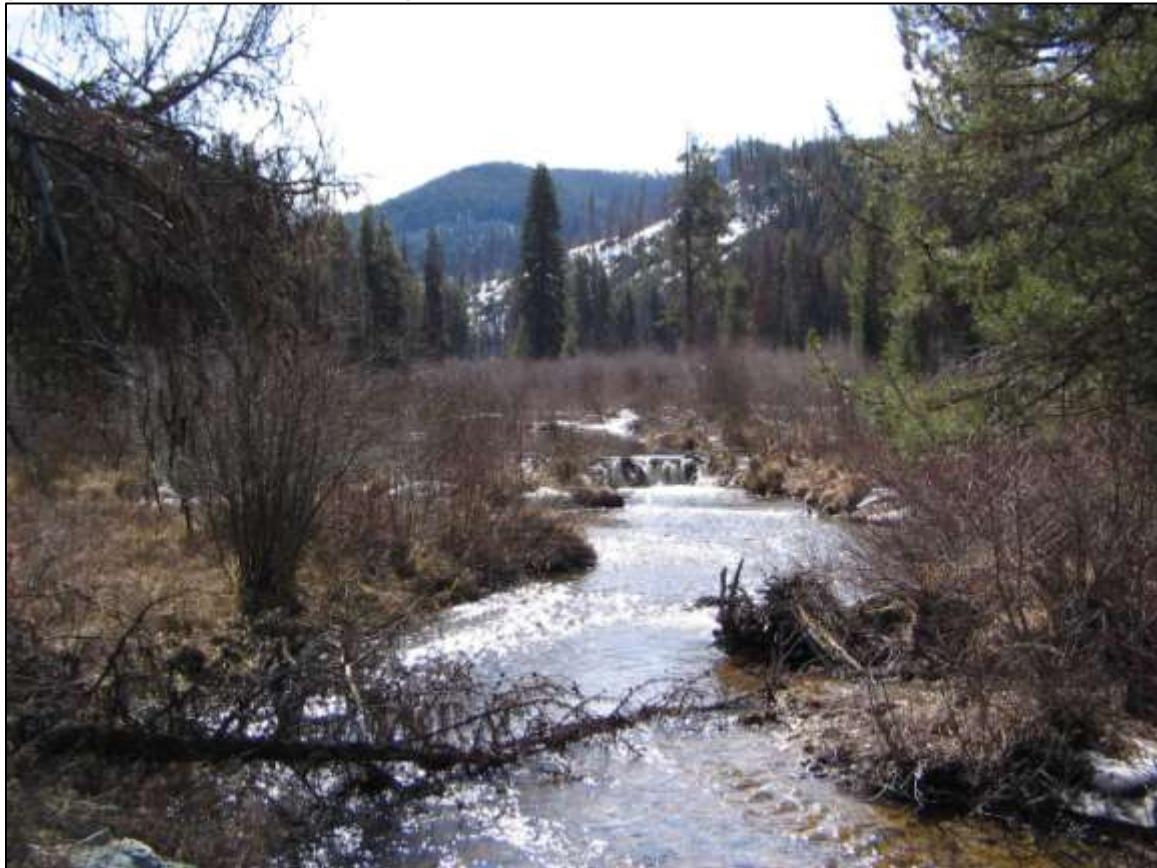
**Figure 1.2. East Fork of Lolo Creek at the Confluence with the West Fork.
(04/12/2011.Roberta Bartlette)**

Note the cutting units in the background.

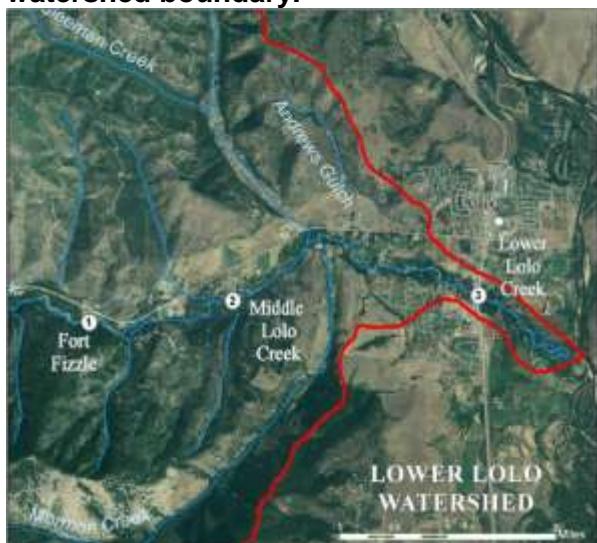
Figure 2.2. Mapped locations of sample sites: Fort Fizzle or Upper site, Landquist property or Middle site, and Larson property or Lower site. Red line identifies Lolo Creek watershed boundary.

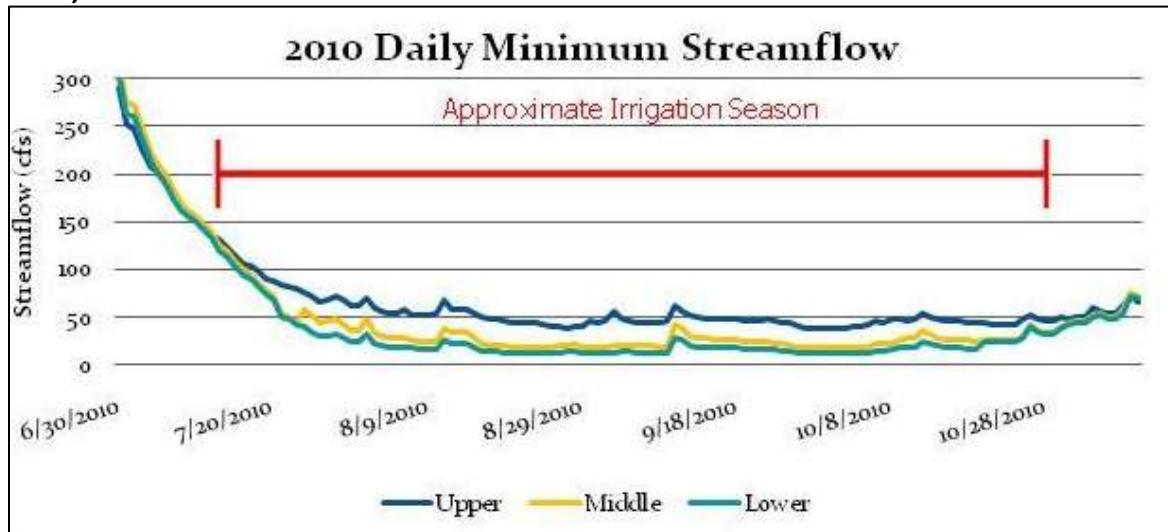
The effects of the diversion ditches are evident when one looks at stream flows from spring through fall. (Gaut 2010). The following graph illustrates little difference in streamflow, measured in cubic feet per second (cfs), in the spring and fall outside of irrigation season. The flow decreases at each measured point downstream of Fort Fizzle during irrigation season showing the effects of water drawn out of the stream channel.

Figure 2.3. 2010 daily maximum streamflow from June 30 through October 31. (Gaut 2010).

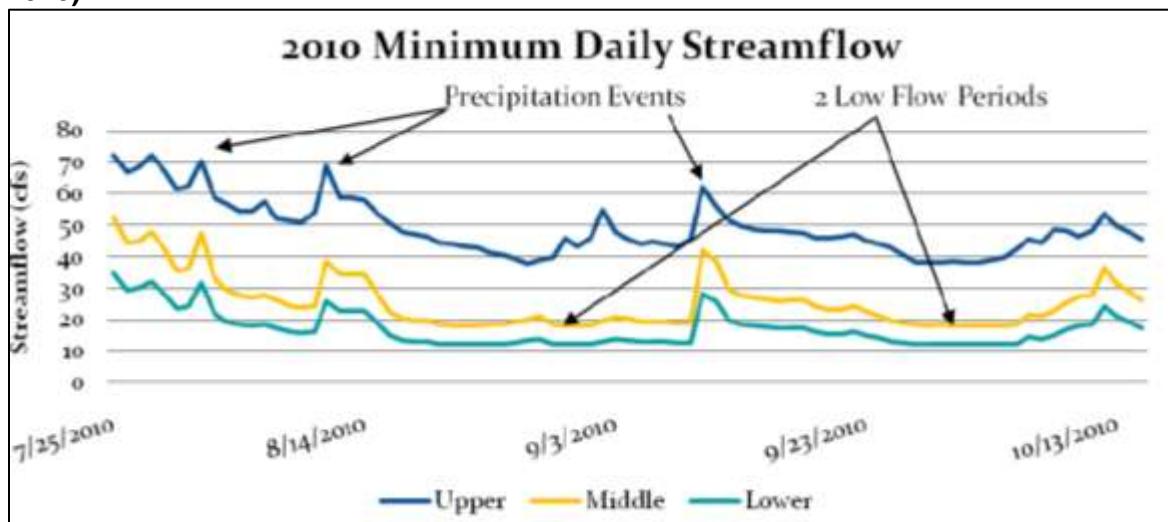
Streamflow at all three sites is very similar in spring, before irrigation season, and in late autumn. The loss between the upper and middle sites averaged about 20 cfs through the irrigation season. The loss between the middle and lower site averaged 10 cfs.

Figure 2.4. 2010 late summer and fall streamflow data at the three monitoring sites. (Gaut 2010)

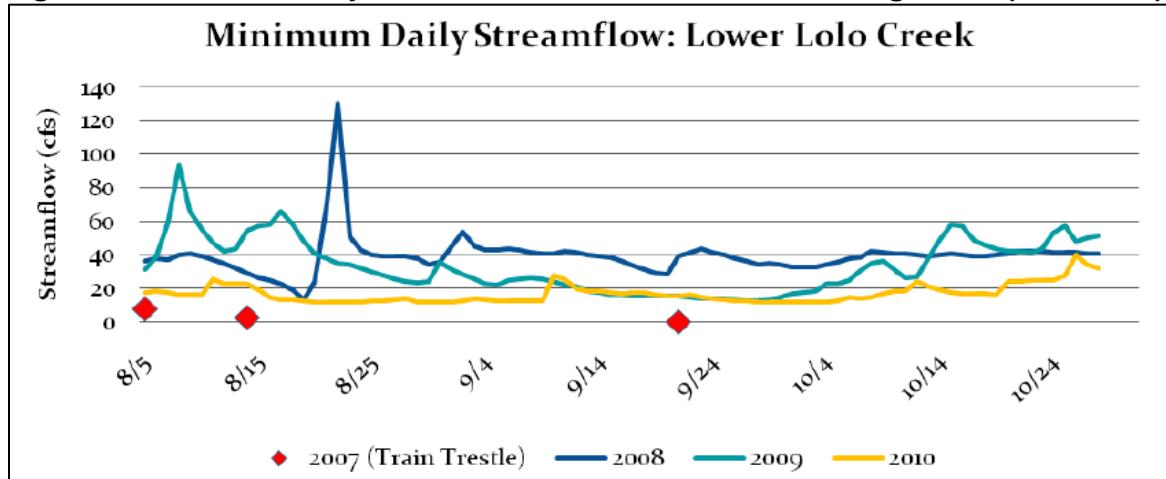
The lowest flow periods occurred in late August - early September, and again in late September - early October, measuring 12 cfs at the lower site. The streamflow data also show rapid response to rainfall events in the nearly vertical rising peak in flow following rain.

Figure 2.5. Minimum daily streamflow on Lolo Creek 2007 through 2010 (Gaut 2010).

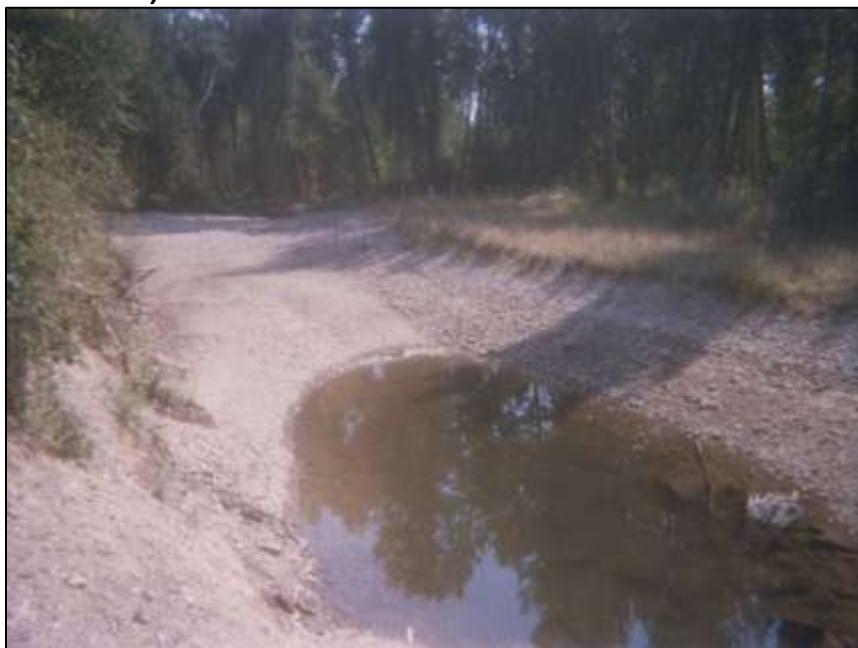
This comparison of stream flow at the Fort Fizzle site is for the years 2008-2010. The red dots show the flow in 2007 at the train trestle below Highway 93 on the severely dewatered lower creek that became totally dewatered at this site.

Figure 2.6. Dewatered Lolo Creek ¼ mile downstream of Highway 93 bridge. (08/16/2010 Katie Gaut)

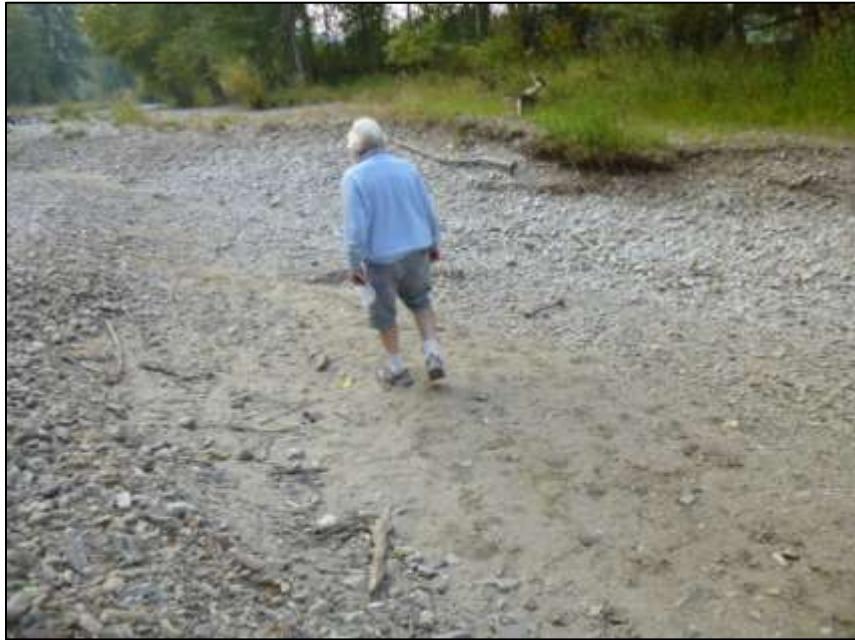
Lolo Creek became dewatered again in September 2012 about ½ mile downstream of the Larson sampling site during extended warm, dry summer. The effects of groundwater use and

Figure 2.7. Dewatered Lolo Creek ¼ mile downstream of railroad bridge east of Hwy 93 bridge. (September 19, 2012 Roberta Bartlette)

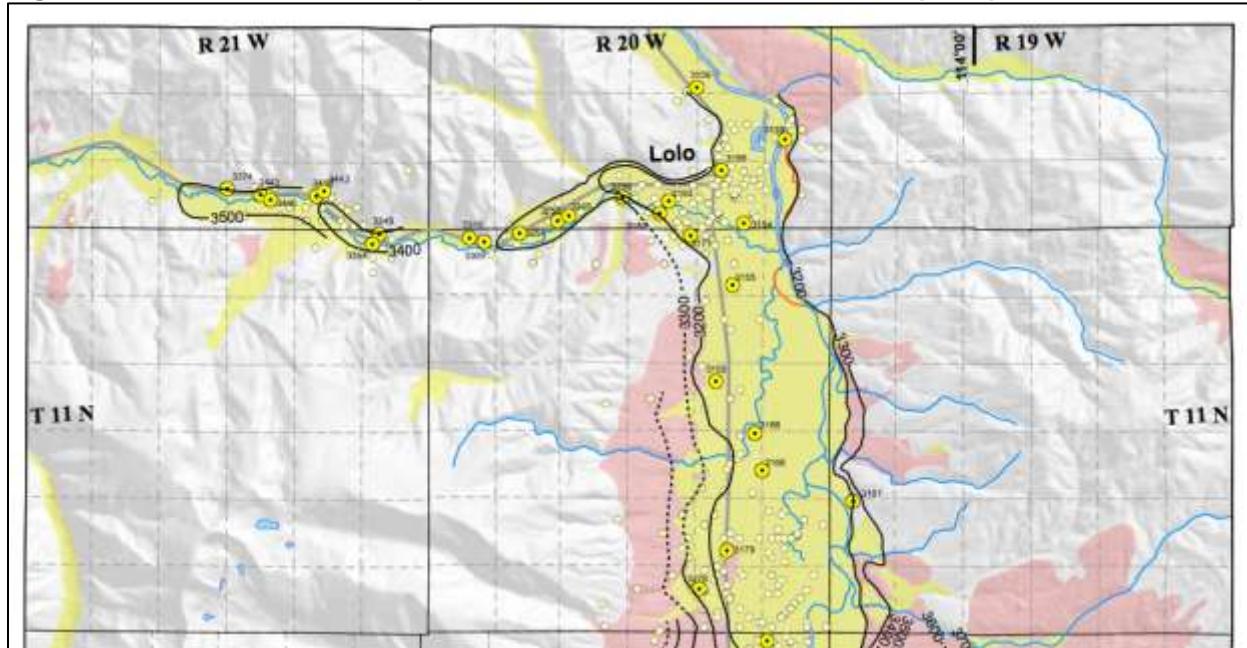
Figure 2.8. Shallow basin-fill potentiometric surface from Lafave (2006)

Yellow areas indicate Quaternary sediments of alluvium, outwash and alluvial fill. Red shading indicates Tertiary sediments of alluvium and alluvial fill. Contours were drawn between measured water level altitudes (shown as yellow dots). The map can be used to estimate the general direction of water flow.

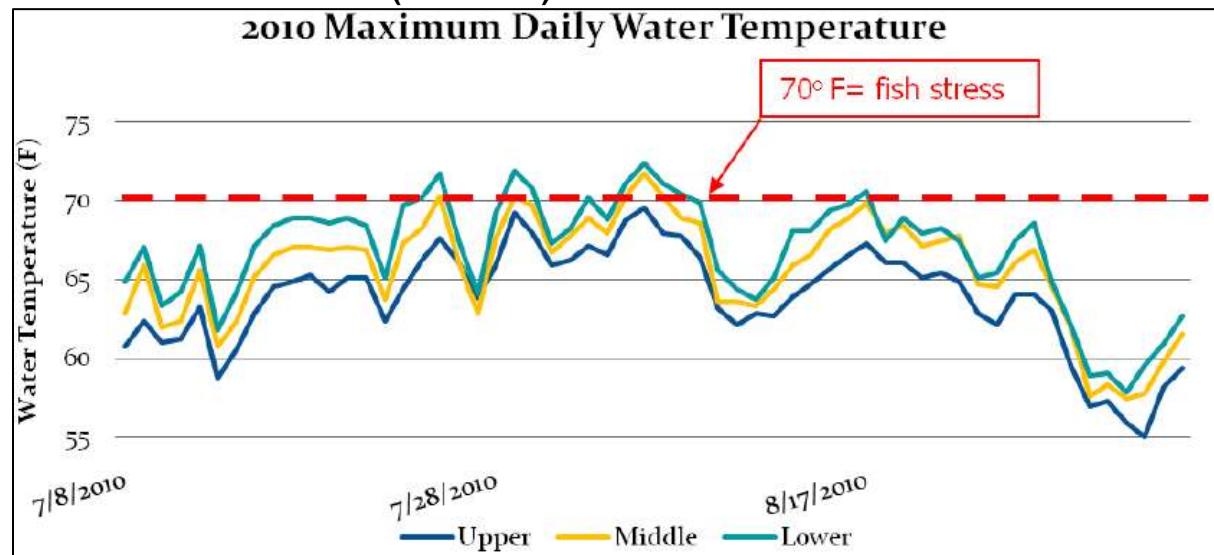
The effects of dewatering also can be observed in the water temperature as compared between three monitoring sites on Lower Lolo Creek between Fort Fizzle (the upper site), Landquist site (middle) and Larson site just east of the Highway 93 bridge crossing). Both the middle and the lower sites reach or exceed the 70 degree F marker for fish stress. The figure below gives an example of temperatures at the sample sites. Additional temperature data is shown in Appendix E.

Figure 2.9. The maximum daily water temperature recorded in 2010 at three monitoring sites on Lower Lolo Creek. (Gaut 2010).

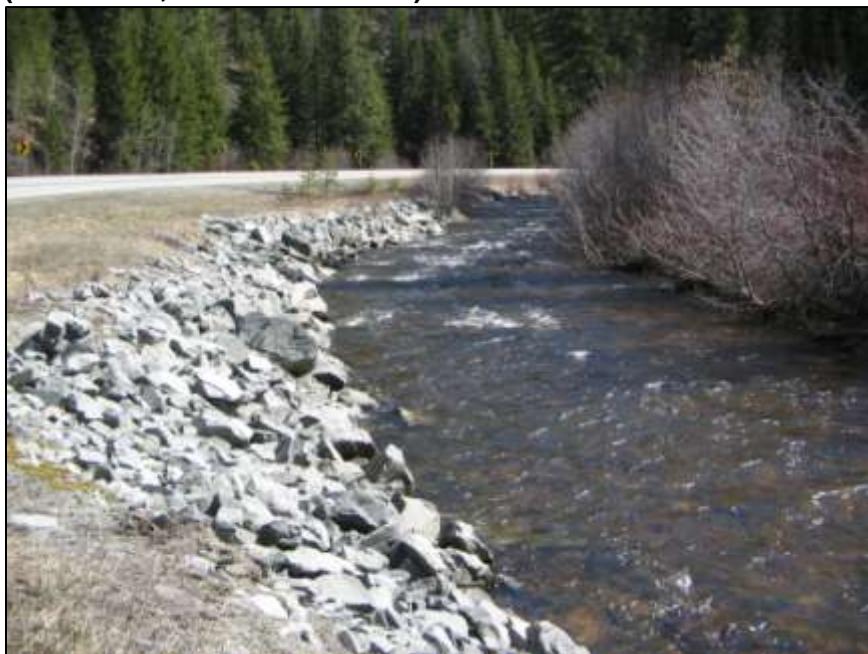
Figure 2.10. Lolo Creek channelized and armored. Native vegetation on the south bank provides some shading. The north bank is impacted by highway maintenance materials. (04/12/2011, Roberta Bartlette)

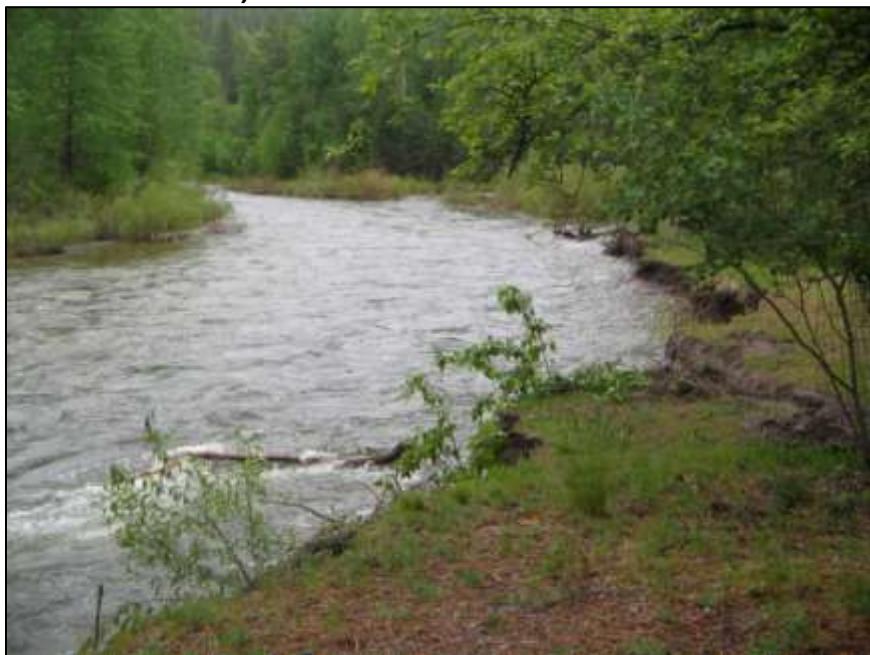
Figure 2.11. Riparian vegetation was stripped by the spring flows of Lolo Creek leaving the bank vulnerable to undercutting and erosion. 2.5 miles west of Lolo. (06/04/2008, Roberta Bartlette)

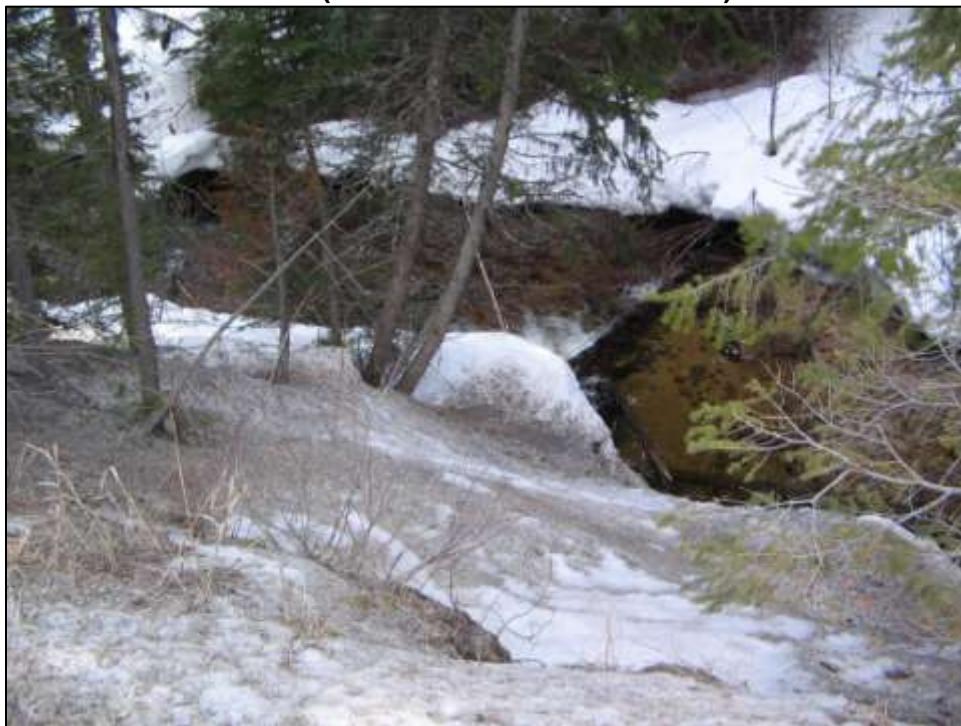
Figure 2.12. Photo of Highway 12 traction sand distributed down the embankment to the West Fork Lolo Creek. (04/12/2011 Roberta Bartlette)

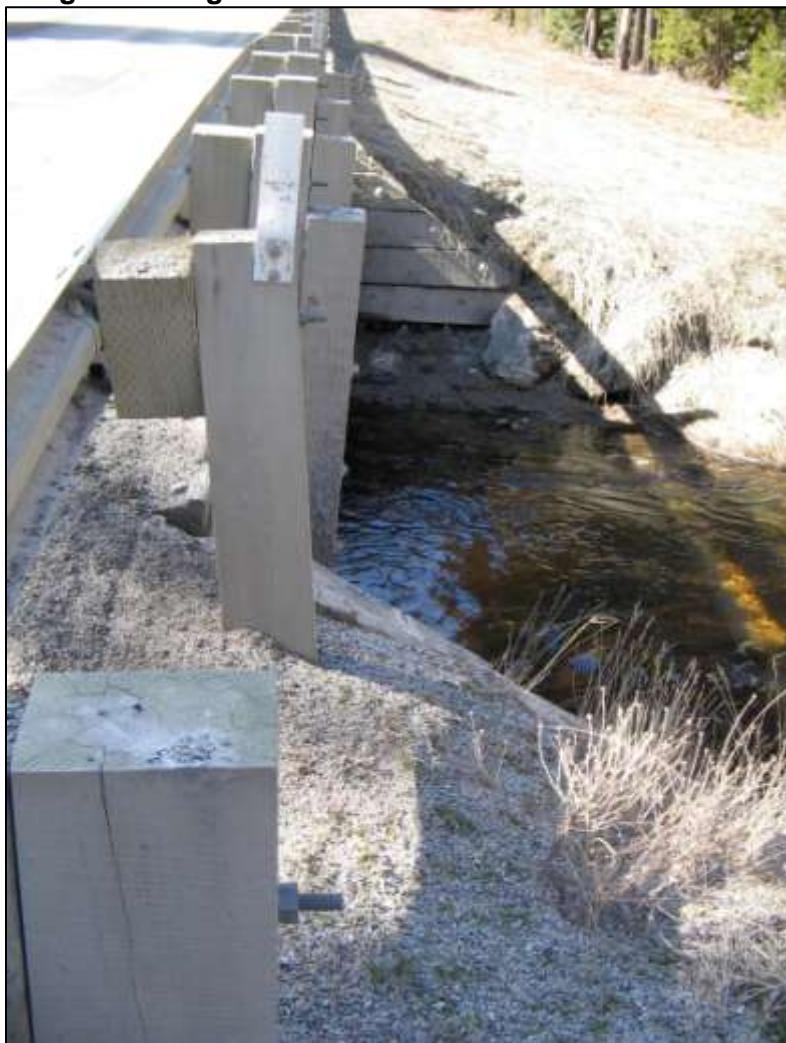
Figure 3.1. Deicing salts and traction sand/gravel have direct pathways to Lolo Creek at bridge crossings. Photo 04/12/2011 Roberta Bartlette.

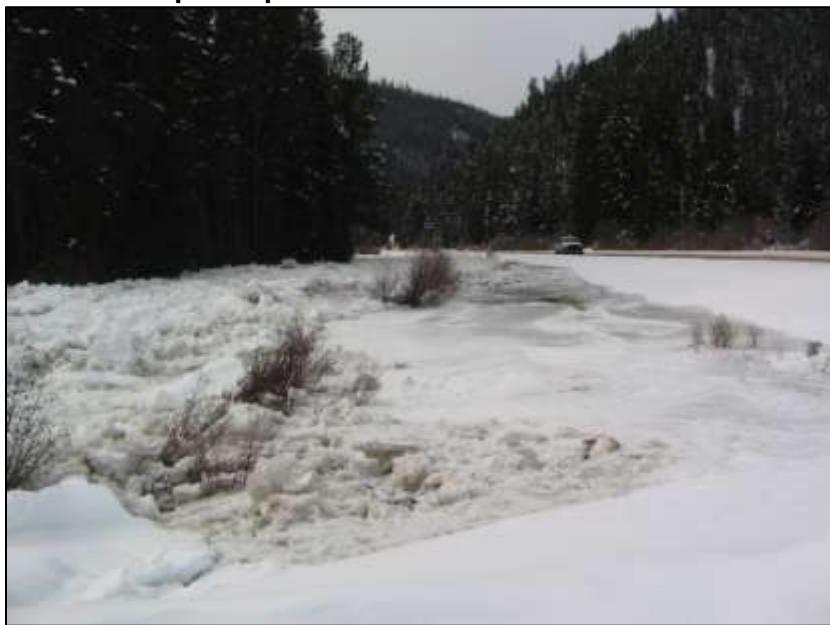
Figure 3.2 Ice jam on Lolo Creek at the Earl Tennant recreation site. Ice and water are elevated to near the height of the highway and the bridge crossing the creek at the photo point. Photo 2/27/2011. Roberta Bartlette.

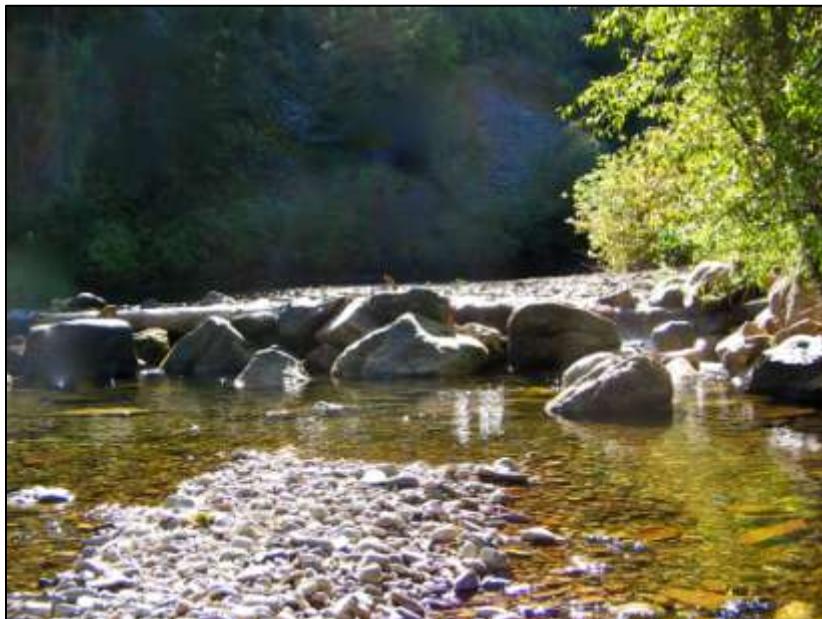
Figure 3.3 Diversion dam on Lolo Creek in autumn effectively blocks fish passage. Photo 09/20/2011. Roberta Bartlette.

A fish ladder and pools to encourage passage was recently installed on this diversion dam although the ditch itself remains without a fish screen to prevent entrainment into the ditch.

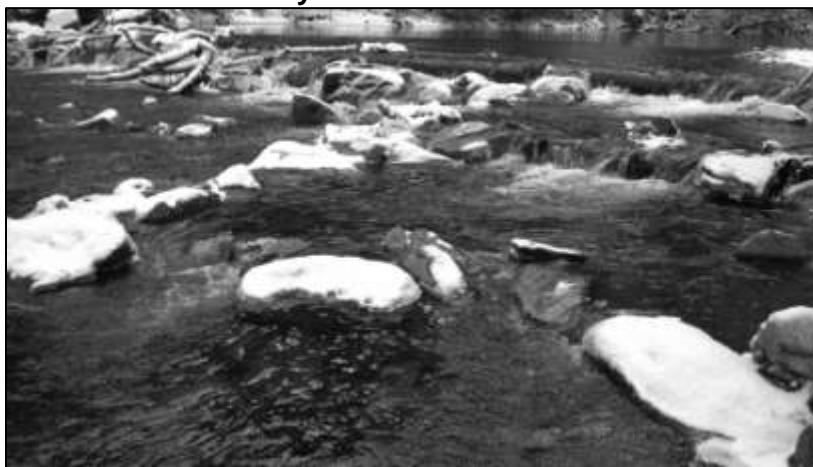
Figure 3.4 Fish ladder and pools installed to replace the diversion dam's fish barrier. Photo 11/11/2012. Gayland Enockson.

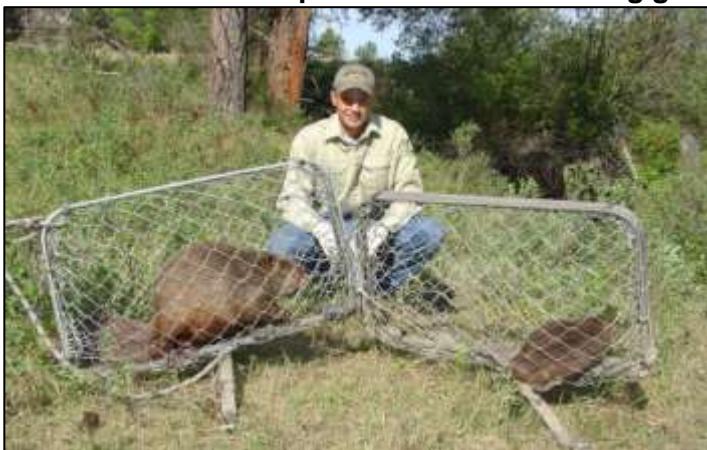
Figure 4.1. Beaver reintroduction efforts on the Custer National Forest are turning intermittent streams perennial and facilitating greater water for cattle.

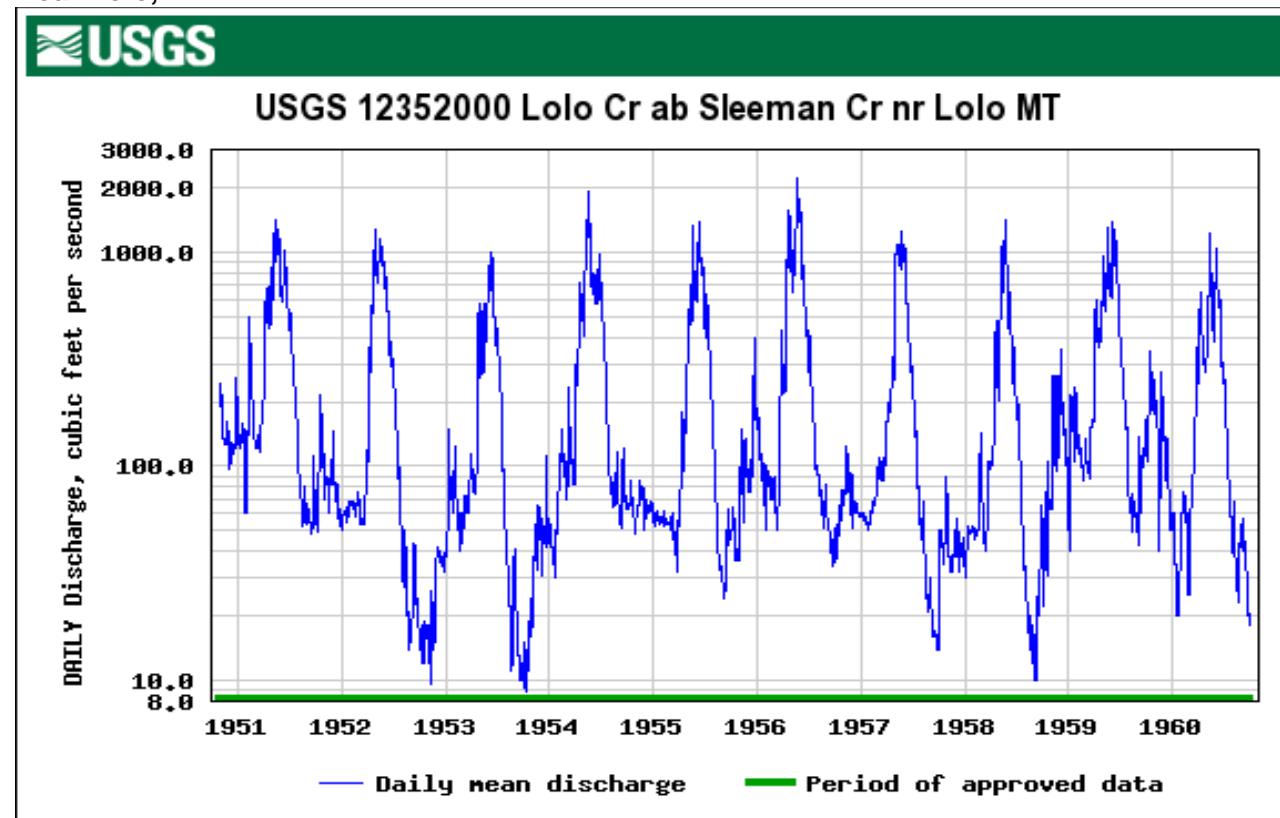
Figure D.1. Streamflow recorded for Lolo Creek from 1950 through 1960 at USGS Station 1235200 above Sleeman Creek, Near Lolo, MT.

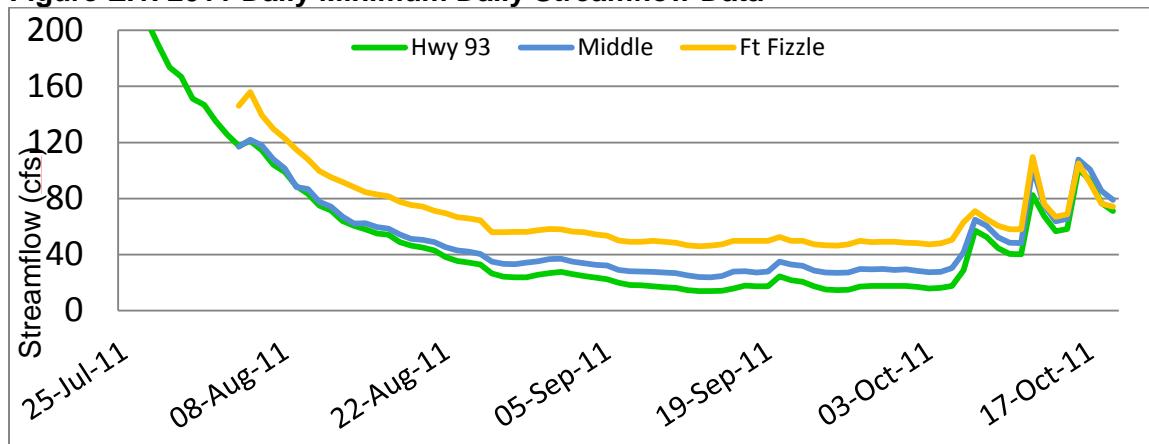
Figure E.1. 2011 Daily Minimum Daily Streamflow Data

This graph illustrates dual seasonal minimums in the third week of September and the first week of October and precipitation events (peaks) in October. By mid October effects of irrigation use on streamflow have diminished as headgates are closed for the season.

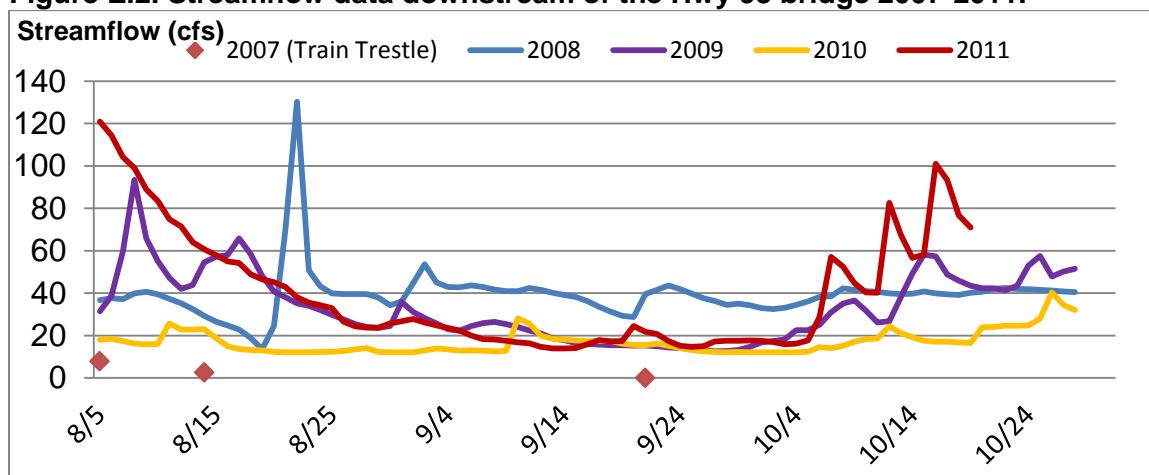
Figure E.2. Streamflow data downstream of the Hwy 93 bridge 2007-2011.

In 2007 point measurements were taken downstream of the railroad trestle (about $\frac{1}{2}$ mile downstream of the HWY 93 bridge). Summer season flow minimums were no flow in 2007, 13.6 cfs in 2008, 12.7 cfs in 2009, 12.2 cfs in 2010, 13.9 cfs. In 2011.

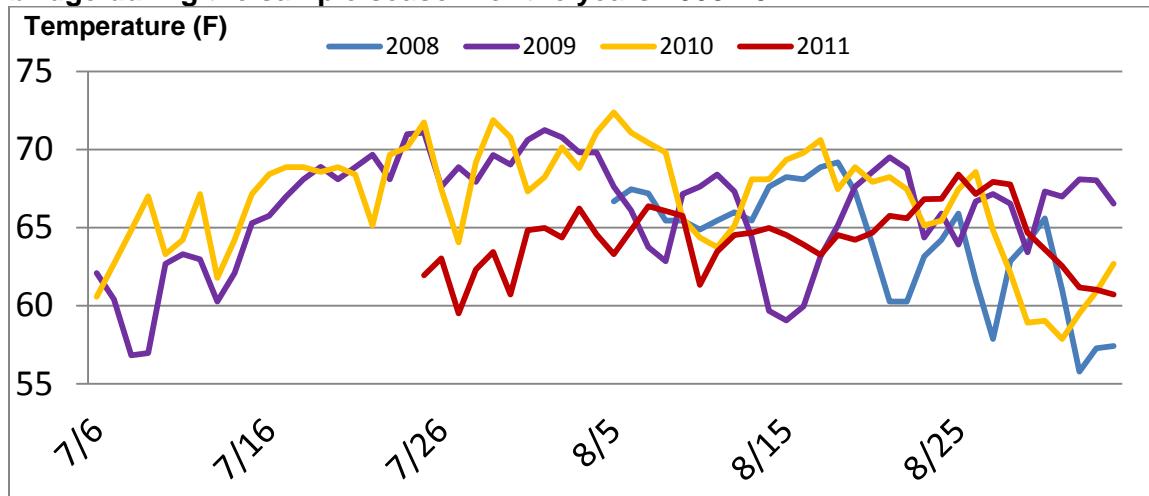
Figure E.3. Maximum water temperature at the Larson site downstream of Hwy 93 bridge during the sample season for the years 2008-2011.

The higher water flows during summer of 2011 resulted in cooler daily maximum temperatures than had been measured during periods without rain in other years. The seasonal maximums were as follows 69°F in 2008 (with limited data), 71°F in 2009, 72°F in 2010, 68°F in 2011.

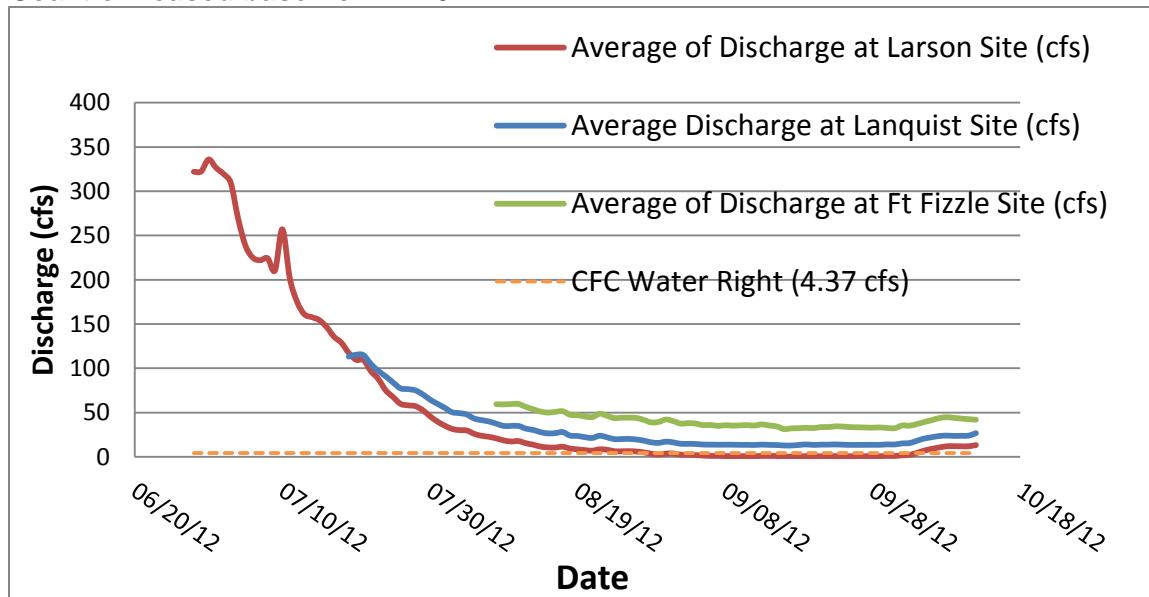
Figure E.4. Streamflow (discharge rate) at three sample sites and Clark Fork Coalition leased base flow in 2012.

The Clark Fork Coalition water right of 4.37 cfs as measured at the Larson site below the Hwy 93 bridge is not adequate to assure Lolo Creek will remain connected to the Bitterroot River as shown in September 2012 when the creek became totally dewatered below the railroad trestle.

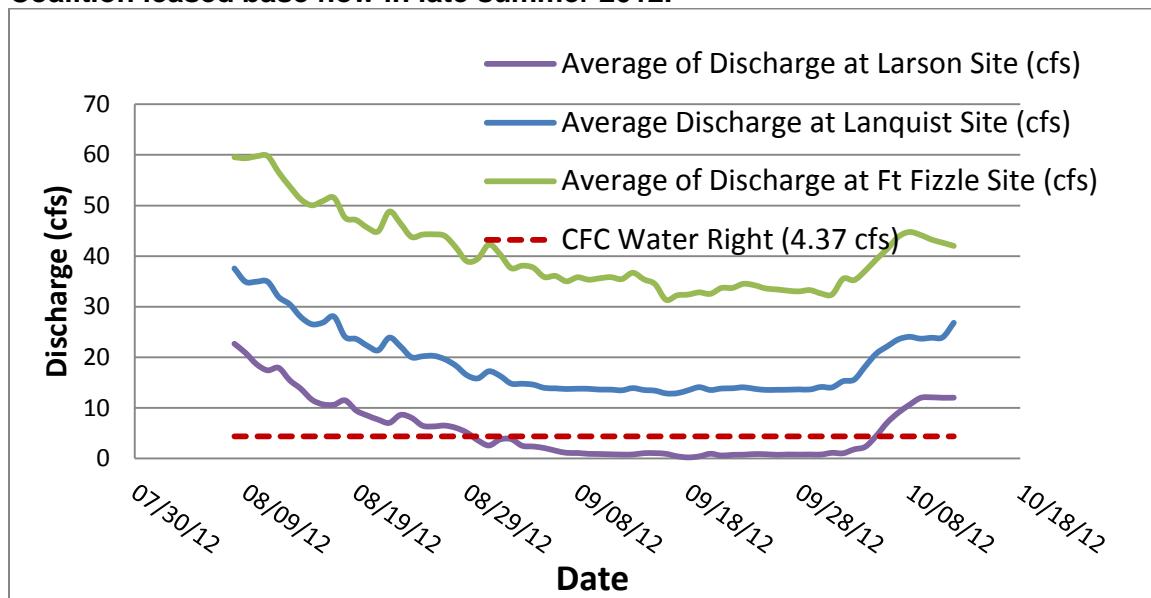
Figure E.5. Streamflow (Discharge rate in cfs) at three sample sites and Clark Fork Coalition leased base flow in late summer 2012.

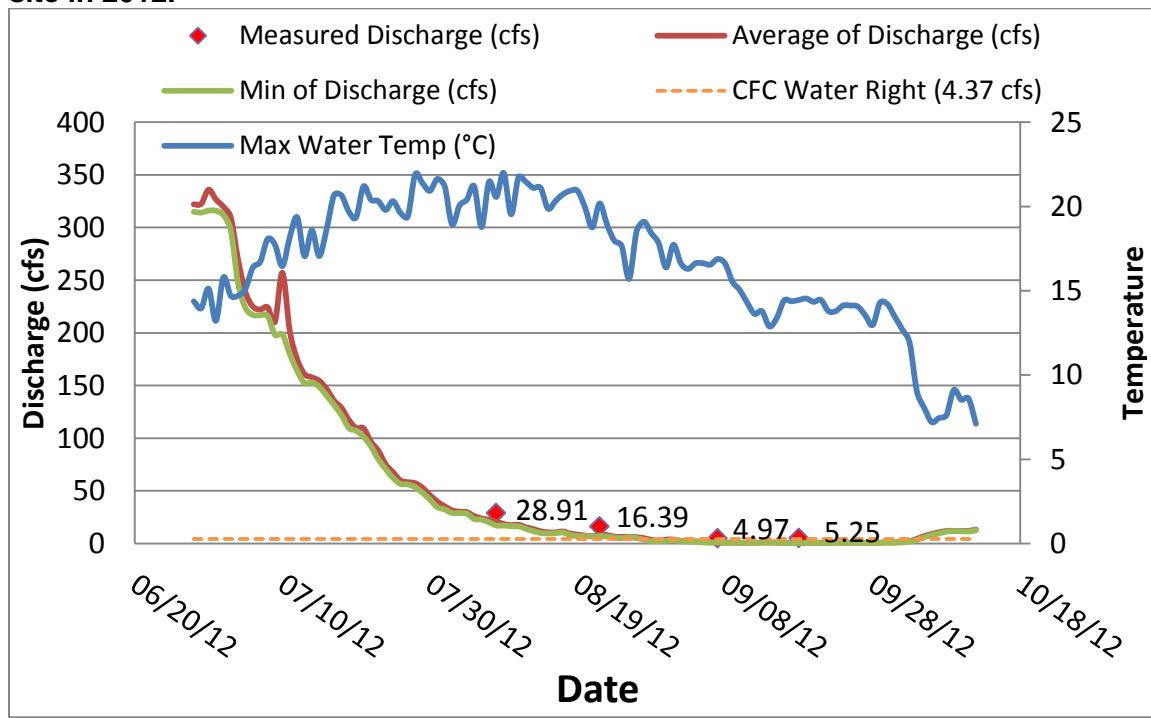
Figure E.6. Streamflow (Discharge rate in cfs) and maximum temperature at Larson site in 2012.

The maximum temperature reached at the Larson sample site downstream of the Hwy 93 bridge in 2012 was 71.6°F. The minimum discharge was .15 cfs on 9/16 and 9/17.

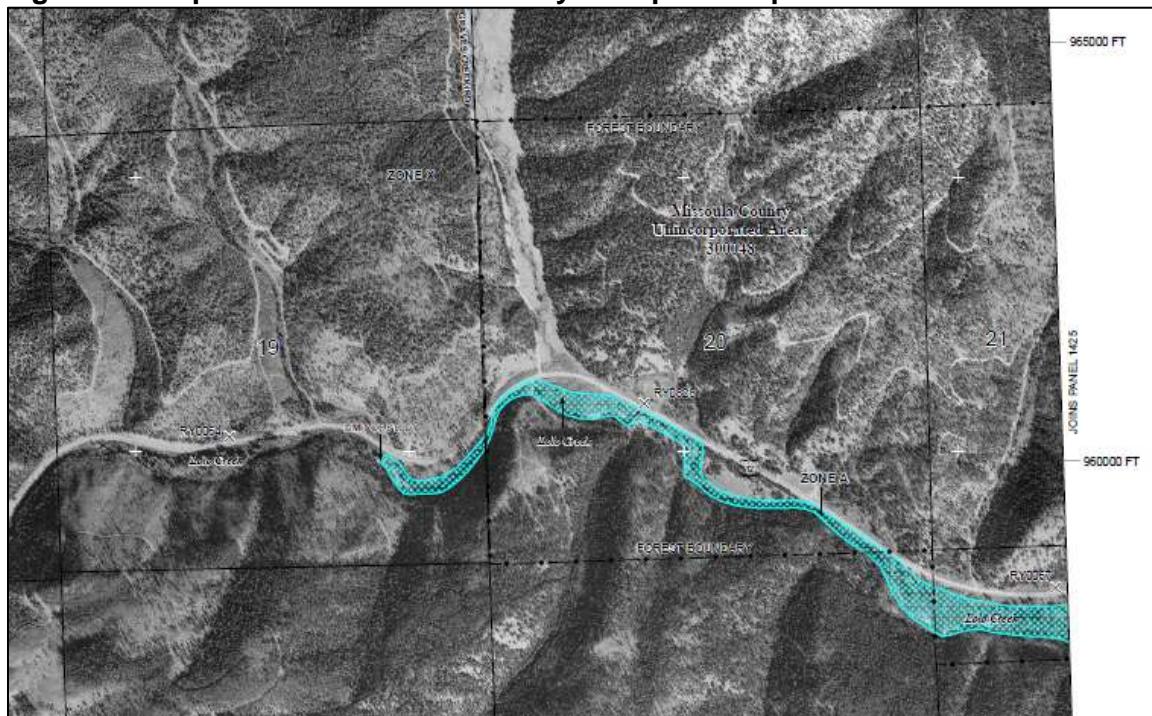
Figure E.1. A portion of Missoula County floodplain map 30063C1395E.

For reference, Grave Creek is the tributary running roughly north/south on the western edge of section 20 in the image above. Sections 19 and 20 are the only sections captured in this image. Highway 12 runs in an east to west direction across the image. Note the floodplain designation adjacent to the highway in some locations.

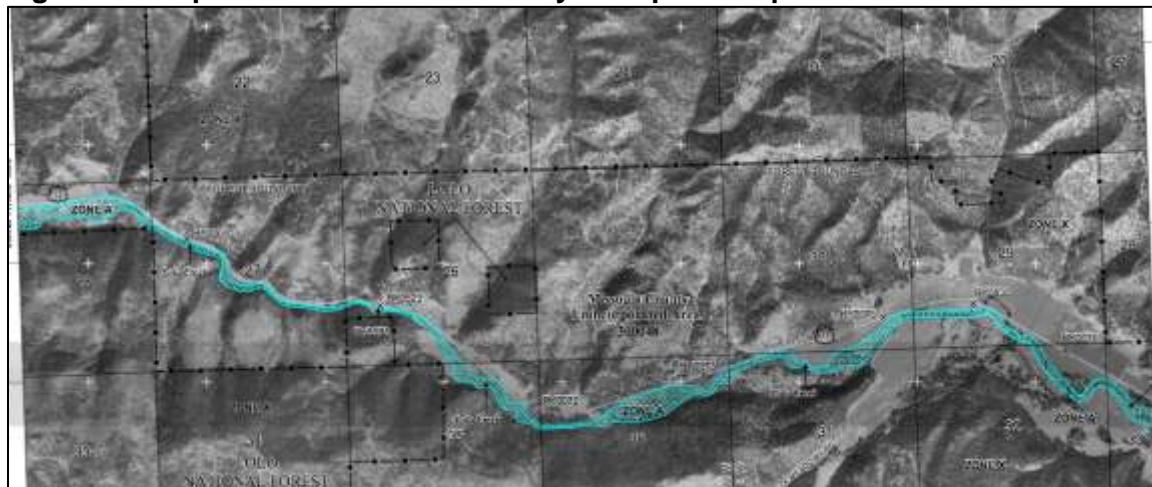
Figure E.2. A portion of Missoula County floodplain map 30063C1425E.

The Elk Meadow Road enters from the southwest through section 31 in the lower right quadrant of the image above.

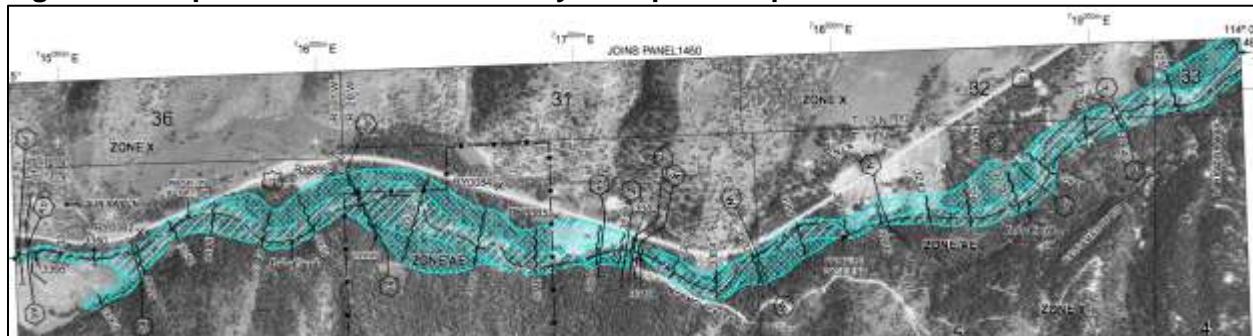
Figure E.3. A portion of Missoula County floodplain map 30063C1735E.

For reference, the bridge across Lolo Creek for the Mormon Ridge Rd is roughly in the center of this image.

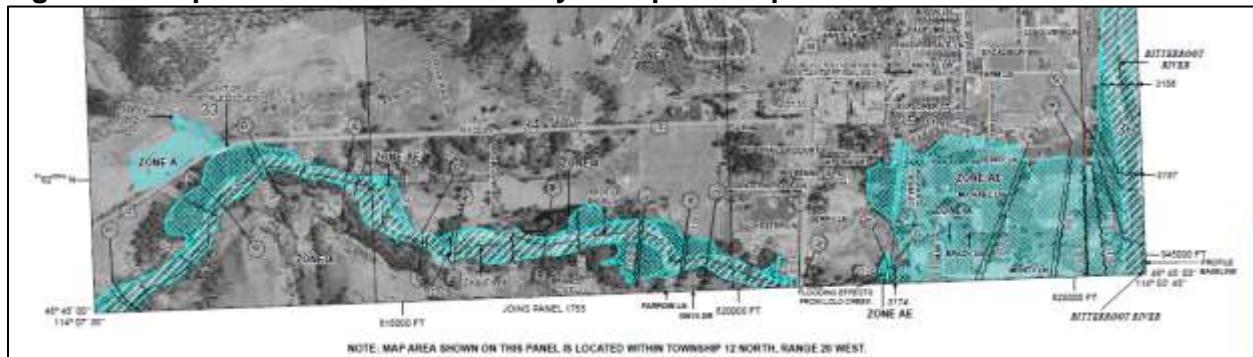
Figure E.4. A portion of Missoula County floodplain map 30063C1465E.

This map illustrates lower Lolo Creek from Sleeman Creek's confluence to the point Lolo Creek passes under Highway 93. This segment of Lolo Creek passes through residential properties including properties that have taken bank stabilization actions.

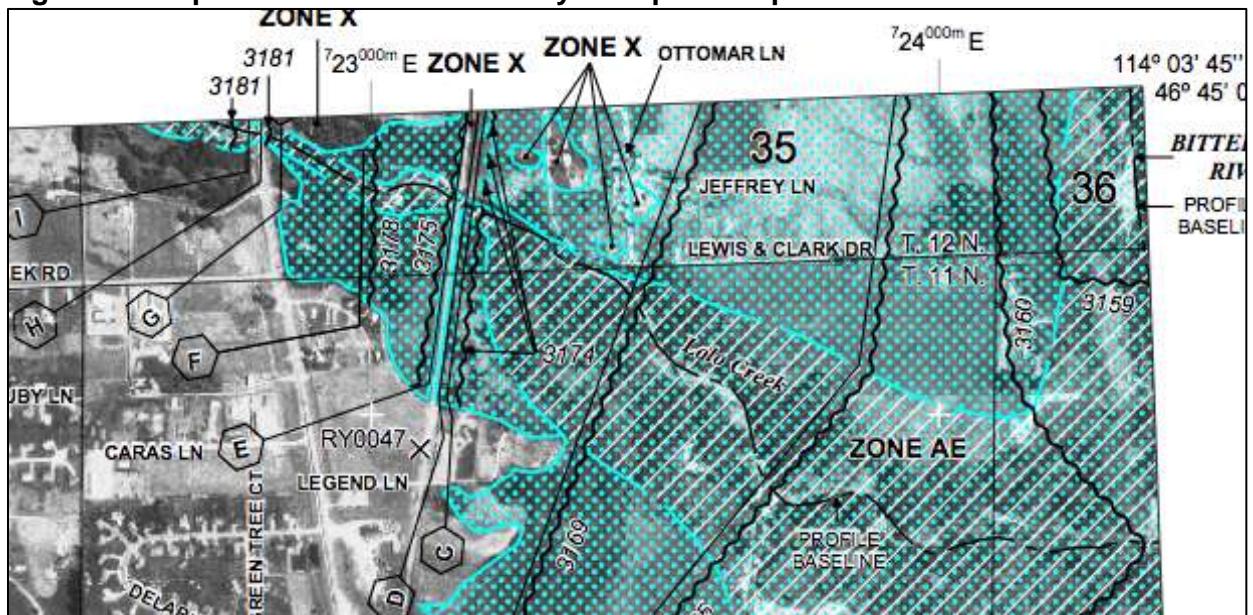
Figure E.5. A portion of Missoula County floodplain map 30063C1755E.

For reference, Hwy 93 runs north/south in the western third of this image. There is a broad area of floodplain from Lolo Creek and the Bitterroot River on the east side of Hwy 93.
