Miller Creek
Watershed Restoration Plan
2018

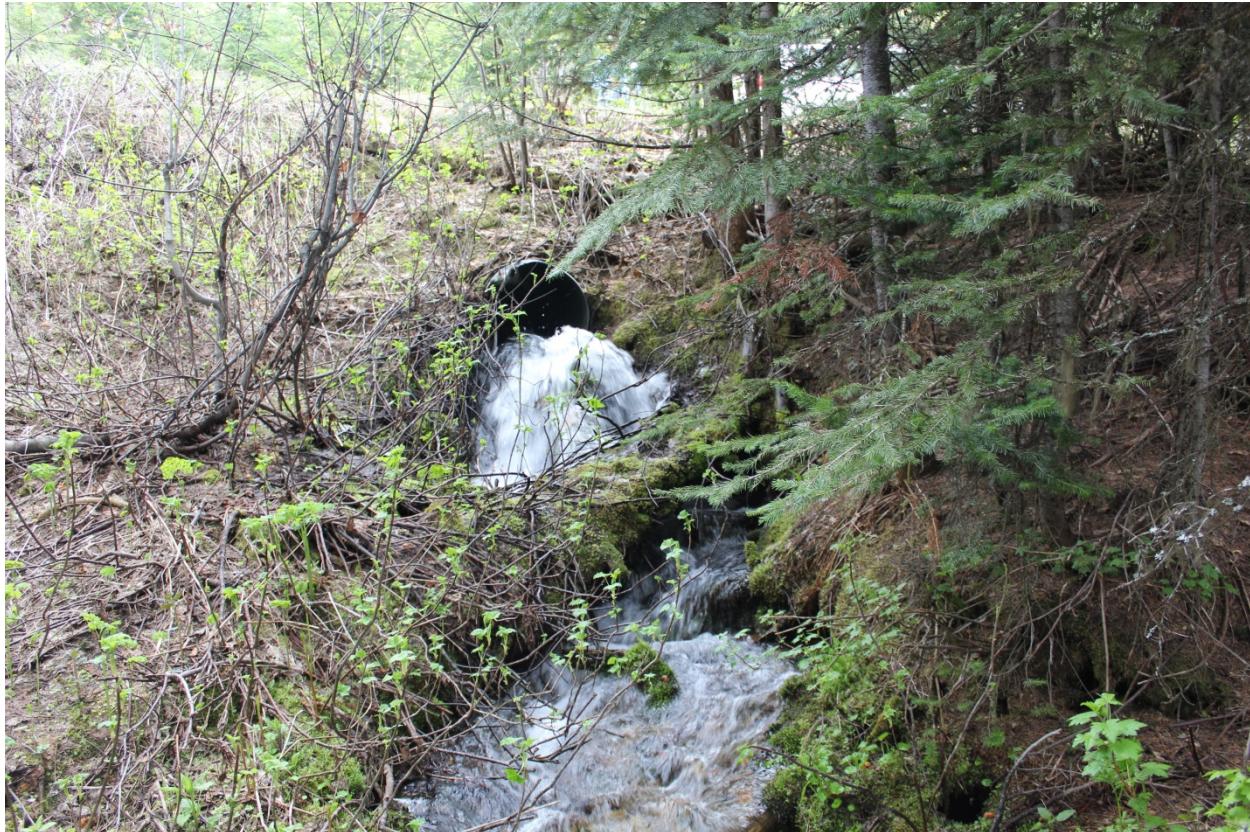
Figure 4 Miller Creek Headwaters: Though the headwaters are relatively healthy, undersized culverts carry high velocity flows that serve as a barrier to fish migration

this watershed (undersized, malfunctioning culverts and contribution of sediment from roads) (Figure 4). Fish passage obstructions in the watershed need to be assessed and a plan for mitigation developed and implemented (Knotek, 2017).

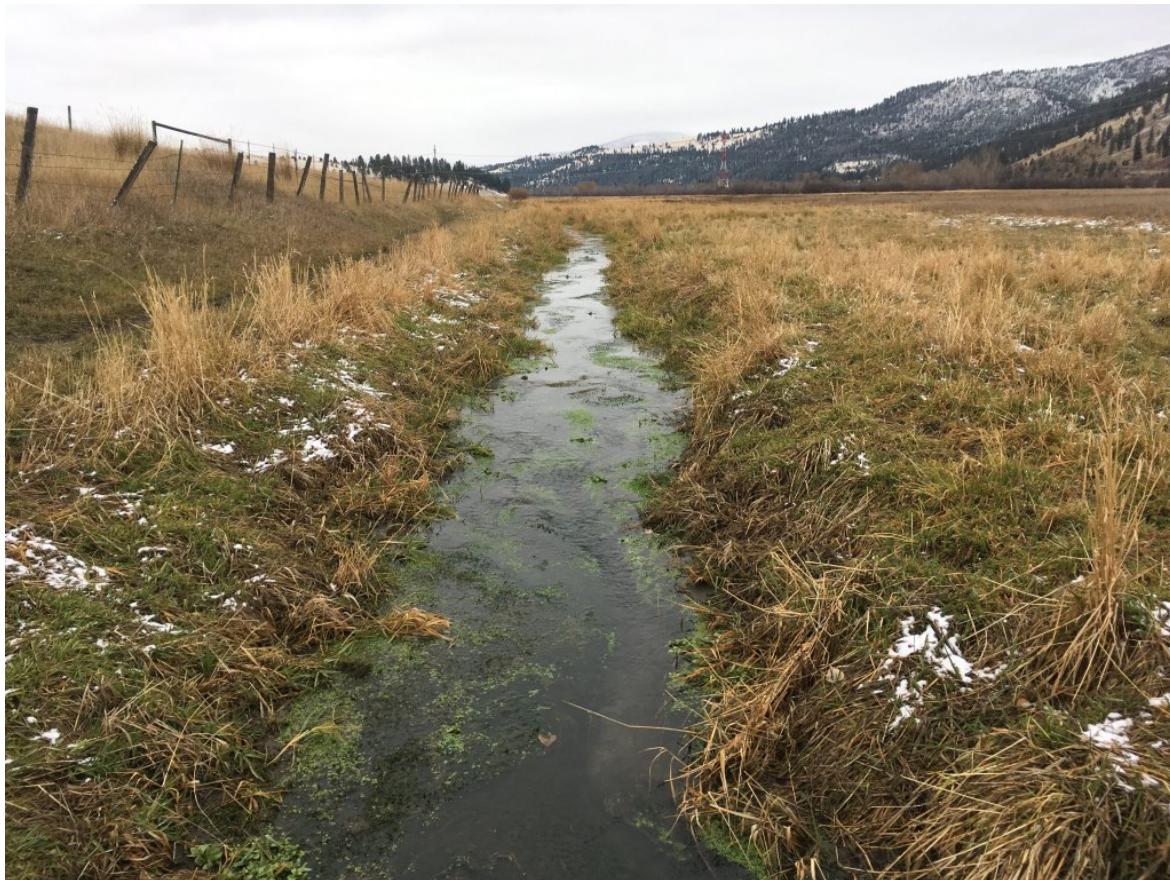
Figure 11: Lower section of Miller Creek was straightened by previous owners and large trees removed.

Physical assessment of the stream shows the lower reach to be partially channelized and separated from its floodplain by low berms in places (Figure 11). The lower reach is starved of large woody debris and is comprised of one continuous riffle. To restore this section of Miller Creek, a combination of fencing, revegetation, addition of large woody debris, passive restoration by elevating the stream bank through use of beaver analogs, and capturing and dispersing sediment will improve both sediment and temperature conditions. Relocation of the stream in order to reconnect it to its floodplains may be necessary in certain reaches. Increasing effective shade to 65% should result in a reduction of stream temperatures by 7.5-8 degrees Fahrenheit, according to the TMDL (DEQ, 2011). Consequently, a major goal of this WRP is to make progress toward achieving 65% effective shade per mile of stream. This will be focused in the lower and middle stream sections, where degradation of riparian vegetation and elevated temperatures are most severe. Physical assessments in the middle section of the stream noted that the stream was overly-wide due to grazing. Some important ways to improve temperature and sediment in these areas are through streamside protection efforts such as providing a buffer between tilled or grazed land and the stream using fences or management practices, and actively replanting some areas where natural regeneration is not likely to be successful in a reasonable timeframe. Some stretches of Miller Creek have conservation easements in place, and finding additional areas for protection could help achieve restoration goals. Planting projects carried out over the larger scale of agricultural lands can be challenging due to the need for watering, weeding and other maintenance for several years. Fencing and other management practice changes that allow natural regeneration may be more feasible and cost effective in many of these areas.

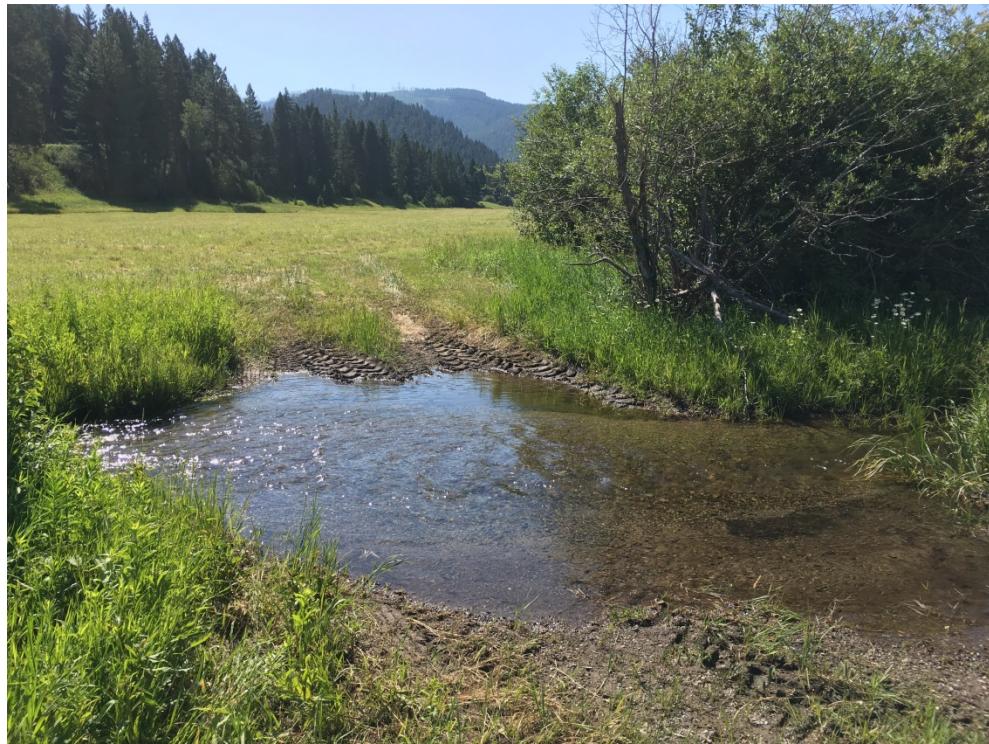
Figure 13: Agricultural creek crossing introduces sediment into Miller Creek

The major sources of sediment to Miller Creek (Table 5) – eroding banks, roads (including sanding and agricultural access (Figure 13)) and stormwater runoff– can be addressed by a number of restoration measures (Table 6). Many of the measures implemented to address temperature impairment, discussed above, would also be effective in reducing sediment loads to the stream. The primary measures that will be used to address sediment in Miller Creek are:
