Lower Clark Fork Tributary Watershed Restoration Plan

October 2019

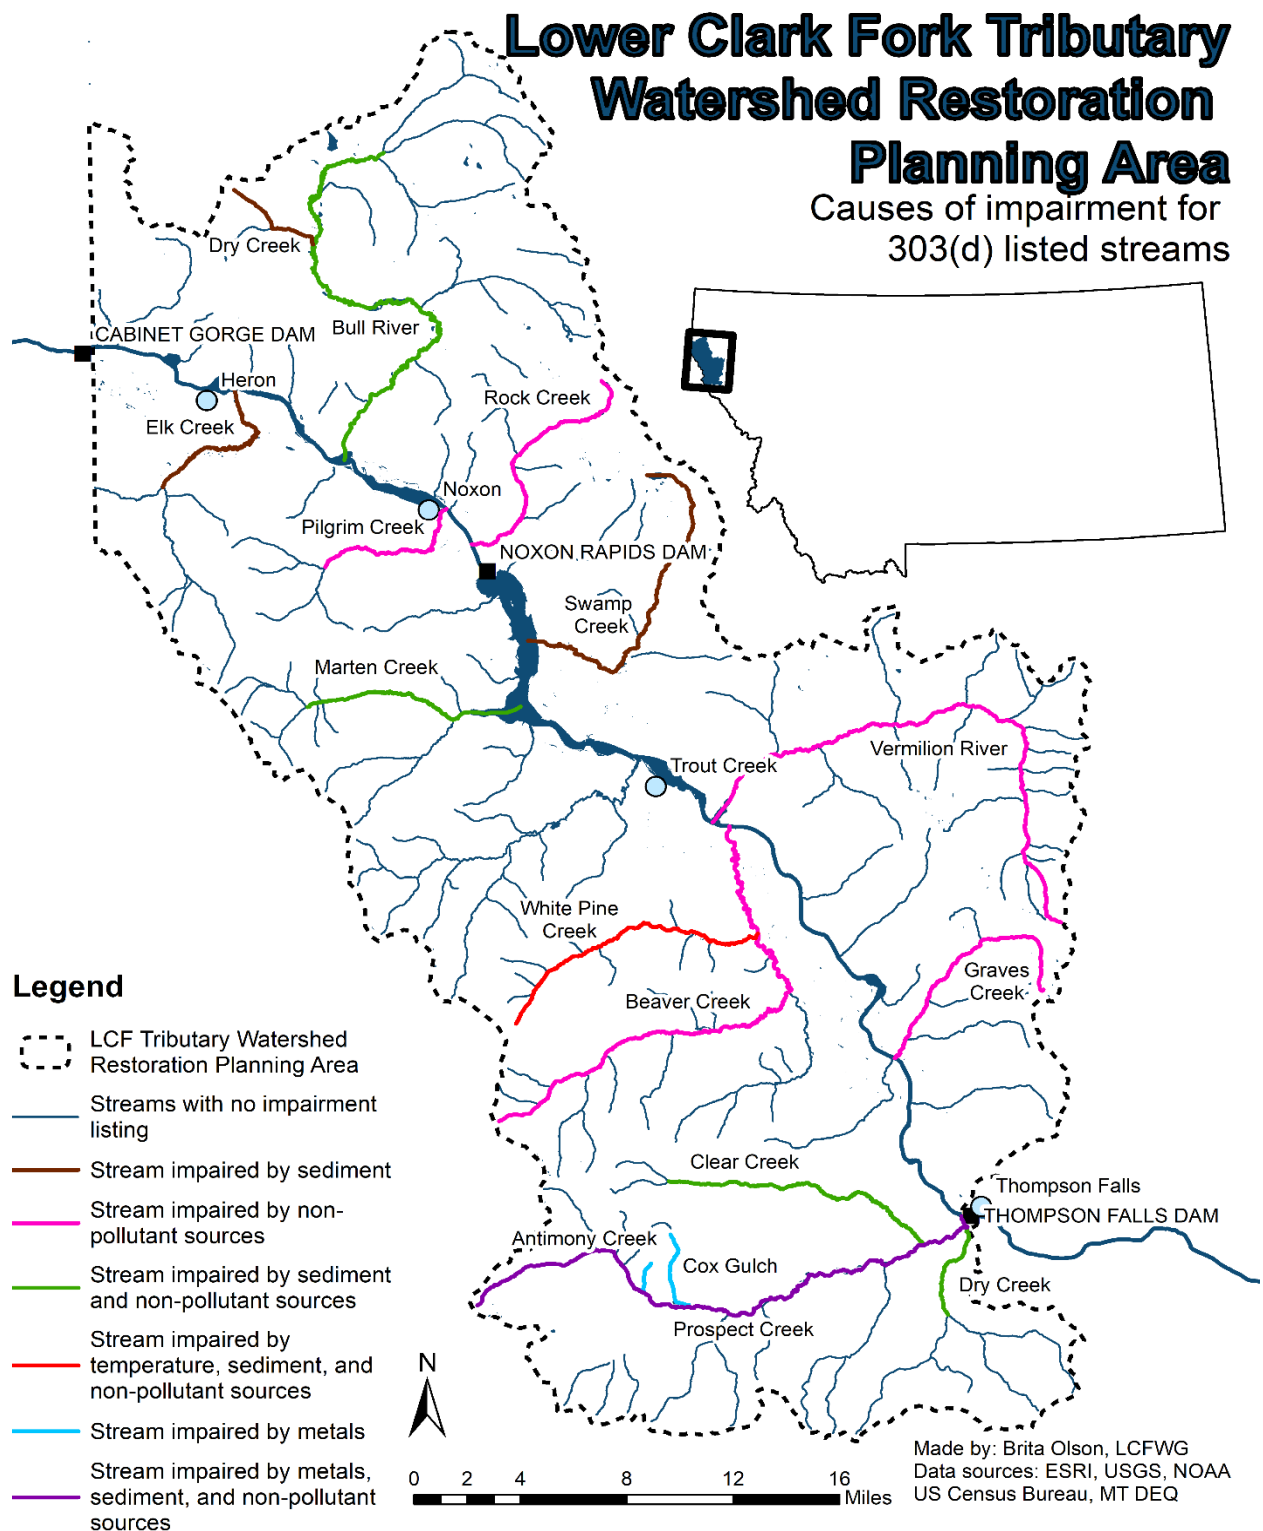
Figure 2F. DEQ-listed impaired streams and impairments identified within the LCF Tributary Watershed Restoration Planning Area.

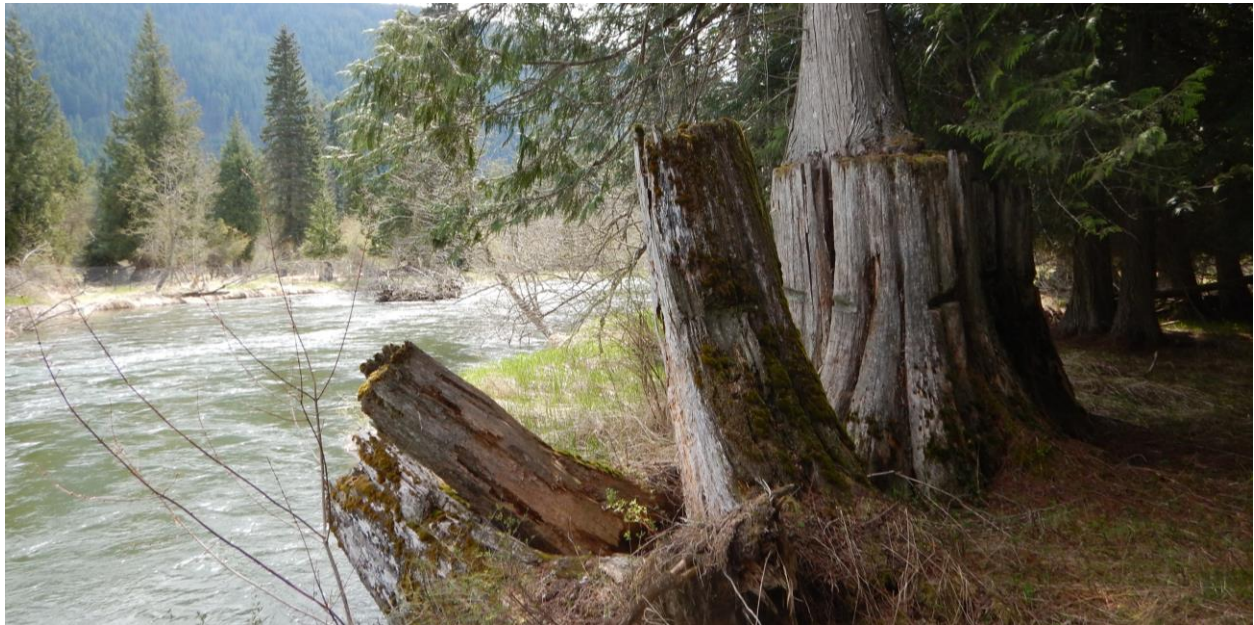
Figure 4.3B. Large stumps with springboard cuts located along the riparian area of the Bull River.

The Bull River watershed has been influenced by a number of anthropogenic disturbances, including agriculture, commercial logging, road construction, and the introduction of non-native vegetation. Combined, these influences have resulted in less favorable habitat and channel conditions in the Bull River watershed (Land and Water Consulting 2001a). Historic land clearing via timber harvesting (including riparian areas) for development, agriculture, and grazing has caused the native vegetation along much of the mainstem Bull River to convert to non-native Reed Canarygrass. Historical timber harvesting of large cedars in the riparian area of the Bull River and East Fork Bull River occurred in the late 1800s and as late as the 1980s (GEI 2005). Evidence of historic logging activity (large stumps with springboard cuts) are easily spotted along the riparian area (GEI 2005; Figure 4.3B).

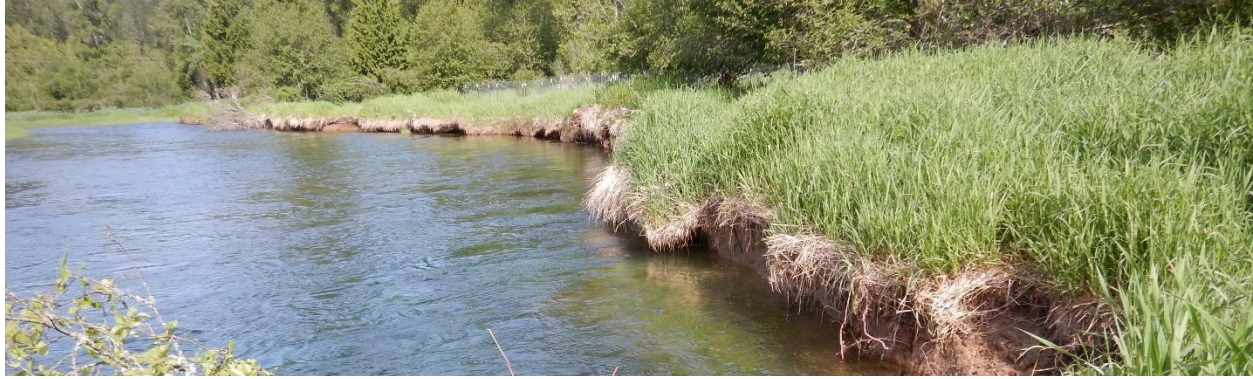
Figure 4.3C. Typical Reed Canarygrass dominated riparian vegetation along the Bull River; note bank instability and areas of sloughing in the foreground.

Reed Canarygrass was originally introduced as an additional food source for cattle in the mid-1900s and it quickly replaced native shrubs and vegetation, creating large monocultures of the grass. Reed Canarygrass out-competes native plants for light, water, space, and nutrients and reduces overall biological and structural diversity of riparian zones, including wetlands, along the Bull River. More problematic from a restoration perspective is that dense rhizomatous mat of established Reed Canarygrass that prohibits the regeneration of native woody riparian shrubs (Land and Water Consulting 2001a; Vander Meer 2006; RDG 2013). Though they may be dense, the rhizomatous mat of roots is shallow and provides very little bank stability and shade compared to native woody riparian vegetation with more diverse root structure. The primary impact of loss of the riparian tree and shrubs and their replacement with Reed Canarygrass is excessive streambank erosion and elevated sediment levels (Figure 4.3C; GEI 2005; Vander Meer 2006; RDG 2013). Reed Canarygrass encroachment in the Bull River valley has been further exacerbated by fire suppression (which limits disturbance to the grass and available seeding sites for other species), reductions in the amount of regenerating shrubs and trees, and intense browsing pressure on regenerating shrubs and trees by ungulates and beaver (Land and Water Consulting 2001a).

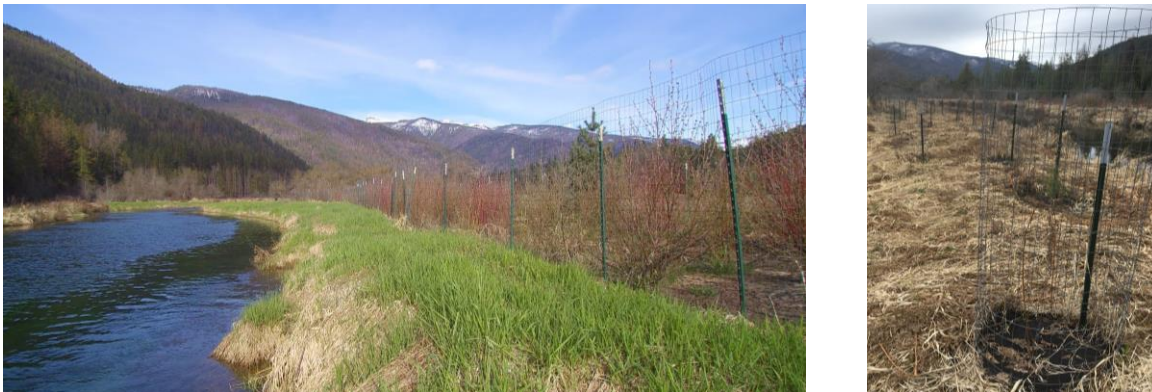
Figure 4.3D. Examples of two exclosure techniques used. Pictured left: Large fencing exclosures installed at the Wood Duck revegetation project (May 2017). Pictured right: Small fencing exclosures encircling individual plantings at another Bull River revegetation site (April 2018).

The Bull River watershed has a rich history of watershed restoration management due to the desire of local stakeholders to protect this habitat for native Bull Trout and Westslope Cutthroat Trout populations (Table 4.3B). Many private landowners and stakeholders within the watershed have participated in large-scale revegetation projects and have helped preserve beneficial riparian habitat through conservation easements along the mainstem Bull and East Fork Bull Rivers (S. Moran, Avista, personal communication). Nearly 2,000 acres of conservation easements have been put in place to protect private lands and watershed restoration work from development and will be an important aspect to future restoration work as well (Figure 4.3A; B. Olson, LCFWG, personal communication). Some of the most recent revegetation efforts have been made between 2014 and 2018 by the LCFWG, Green Mountain Conservation District (GMCD), USFS-KNF, local landowners, and other stakeholders to implement revegetation projects on both public and private land along the mainstem Bull River. Most of these efforts laid heavy fabric for two growing seasons to suppress Reed Canarygrass growth from the treatment area. Following the two seasons of matting, native riparian trees and shrubs were planted, which over time will provide long-term bank stability and improved fish habitat (cover and shade). Large fencing exclosures were built around these plantings to reduce wildlife browse and allow new plantings to become established (Olson *In prep*; Figure 4.3D). Alternative techniques, aimed at reducing maintenance burdens for sponsoring organizations and private landowners, have included individual plantings after mechanical removal of Reed Canarygrass (Olson *In prep*; Figure 4.3D).

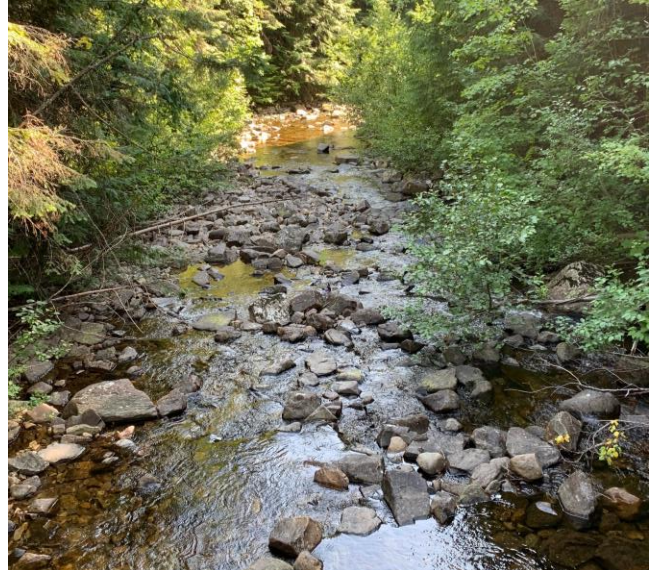
Figure 4.9B. Typical large, boulder-sized substrate of Rock Creek.

This watershed can be broken into three main subwatersheds: Lower Rock Creek, Upper Rock Creek (also known as East Fork Rock Creek), and West Fork Rock Creek. The Lower and Upper mainstem watersheds are delineated by the confluence of West Fork Rock Creek (GEI 2005) and additionally by extensive intermittent stream conditions within the middle reaches of mainstem Rock Creek (Figure 4.9A; Moran and Storaasli 2016b). West Fork Rock Creek also exhibits intermittency in its lower reaches (Moran and Storaasli 2016b) and a natural high gradient barrier to upstream movement of fish at RM 2 (RKM 3.2) (KNF 2017). The stream channel of Rock Creek is primarily comprised of large, boulder-sized substrate, particularly in Upper Rock Creek above the confluence with West Fork Rock Creek (Figure 4.9B). The substrate of Lower Rock Creek is still primarily made up of large cobbles, few boulders, and limited fine sediment, with boulder presence increasing upstream (GEI 2005; Moran and Storaasli 2016b).

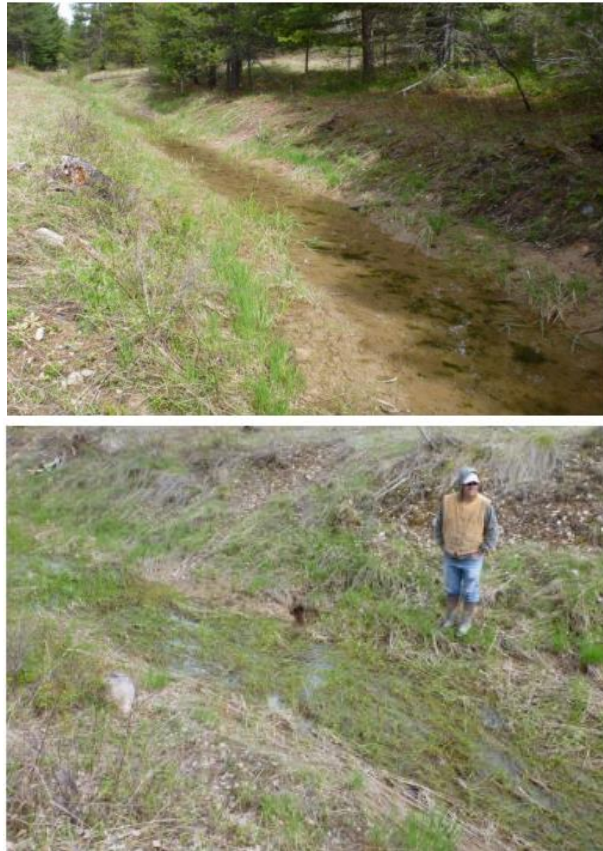
Figure 4.10C. Varying vegetation conditions of the main Swamp creek Ditch (Neesvig 2014).

Within the private lands of mainstem Swamp Creek, there is an extensive ditch system supplying irrigation water in the form of canals, ditches, and ponds. The ditch is roughly 13 mi (21 km) long with approximately 15 connected ponds and three arterials stemming from one main canal. The ditch was built around the turn of the 20th century and the main canal originates from a headgate located at approximately RM 5.1 (RKM 8.2). During low water, this ditch potentially draws as much as 49% of Swamp Creek's flow and likely contributes to an increase in water temperatures in lower Swamp Creek (Kreiner and Tholl 2014). The largest water right held on Swamp Creek supported by this ditch system is 50 CFS by the Green Mountain Water Users Association, which, if fully utilized, would capture the entire flow of Swamp Creek (R. Kreiner, Montana Fish, Wildlife and Parks, personal communication). Adjacent landowners and users of the ditch have previously raised concerns about the age and condition of the ditch, which may require restoration and maintenance in the future. The primary water losses result from leaks and overbank spillage in the ditch canals, evaporation of impounded water during the summer, and transpiration from vegetation. Some problems identified in a cursory survey in 2012 included vegetation growth within the canal which causes fine sediment deposition and adds to transpiration loss. Some areas along the ditch also show signs of overgrazing, active headcutting, bank collapse, and lack of routine maintenance (Figure 4.10C; DEQ 2010; Neesvig 2014).

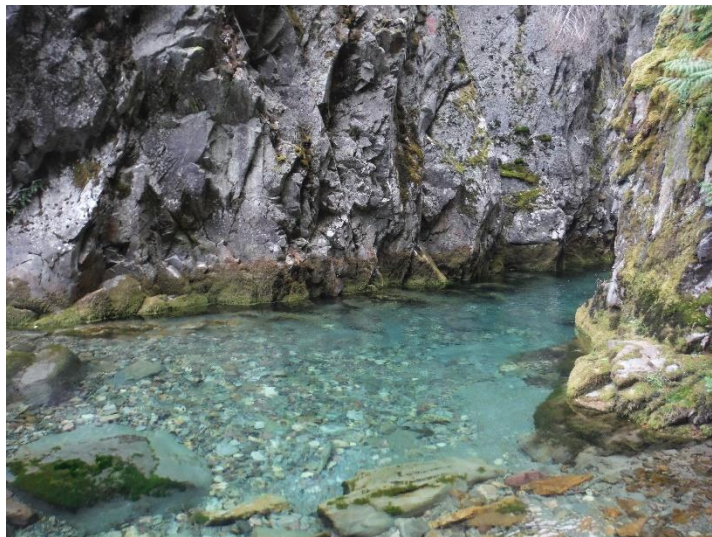
Figure 4.12B. China Gorge, lower Vermilion River October 2018; note large migratory Bull Trout and redd in middle foreground. Photo Credit: J. Storaasli.

Introduced species that have established populations are Brown Trout, Brook Trout, and Rainbow Trout. Brook and Brown Trout are well established while Rainbow Trout are present in low numbers (Moran 2002, Kreiner and Tholl 2014). Brown and Rainbow Trout are restricted to the lower river below China Gorge (Figure 4.12B), a seasonal fish barrier located approximately halfway between the mouth and Vermilion Falls (Moran 2002; Kreiner and Tholl 2014). Brook Trout are present throughout the entire drainage and reach the highest densities recorded
