2022 319 Application Form - General and Focus Watershed

| Project Name | Miller and O'Brien Creeks Sediment Reduction and Restoration | | |
| Sponsor Name | Clark Fork Coalition | | |

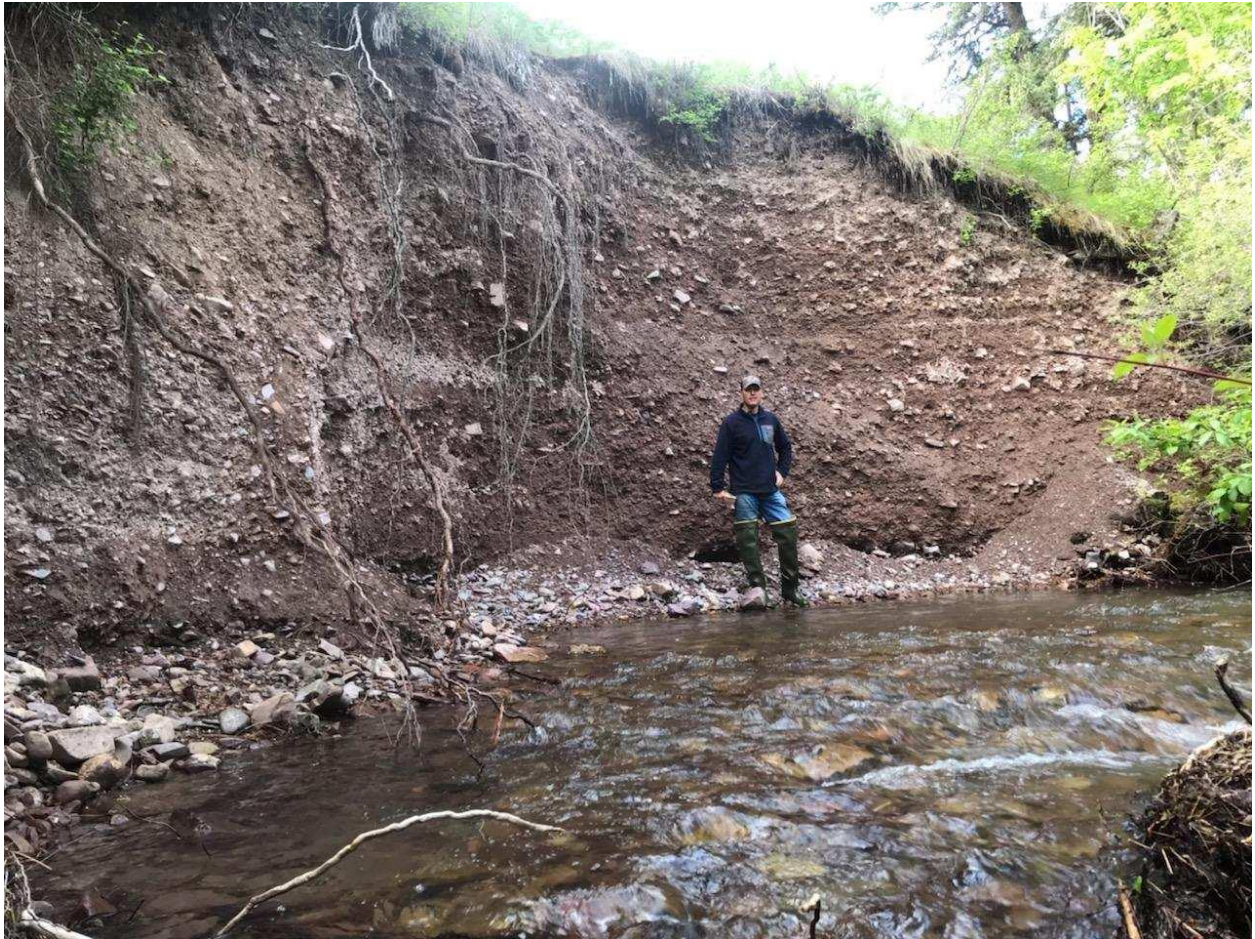
Large cut bank at the top of Reach 3

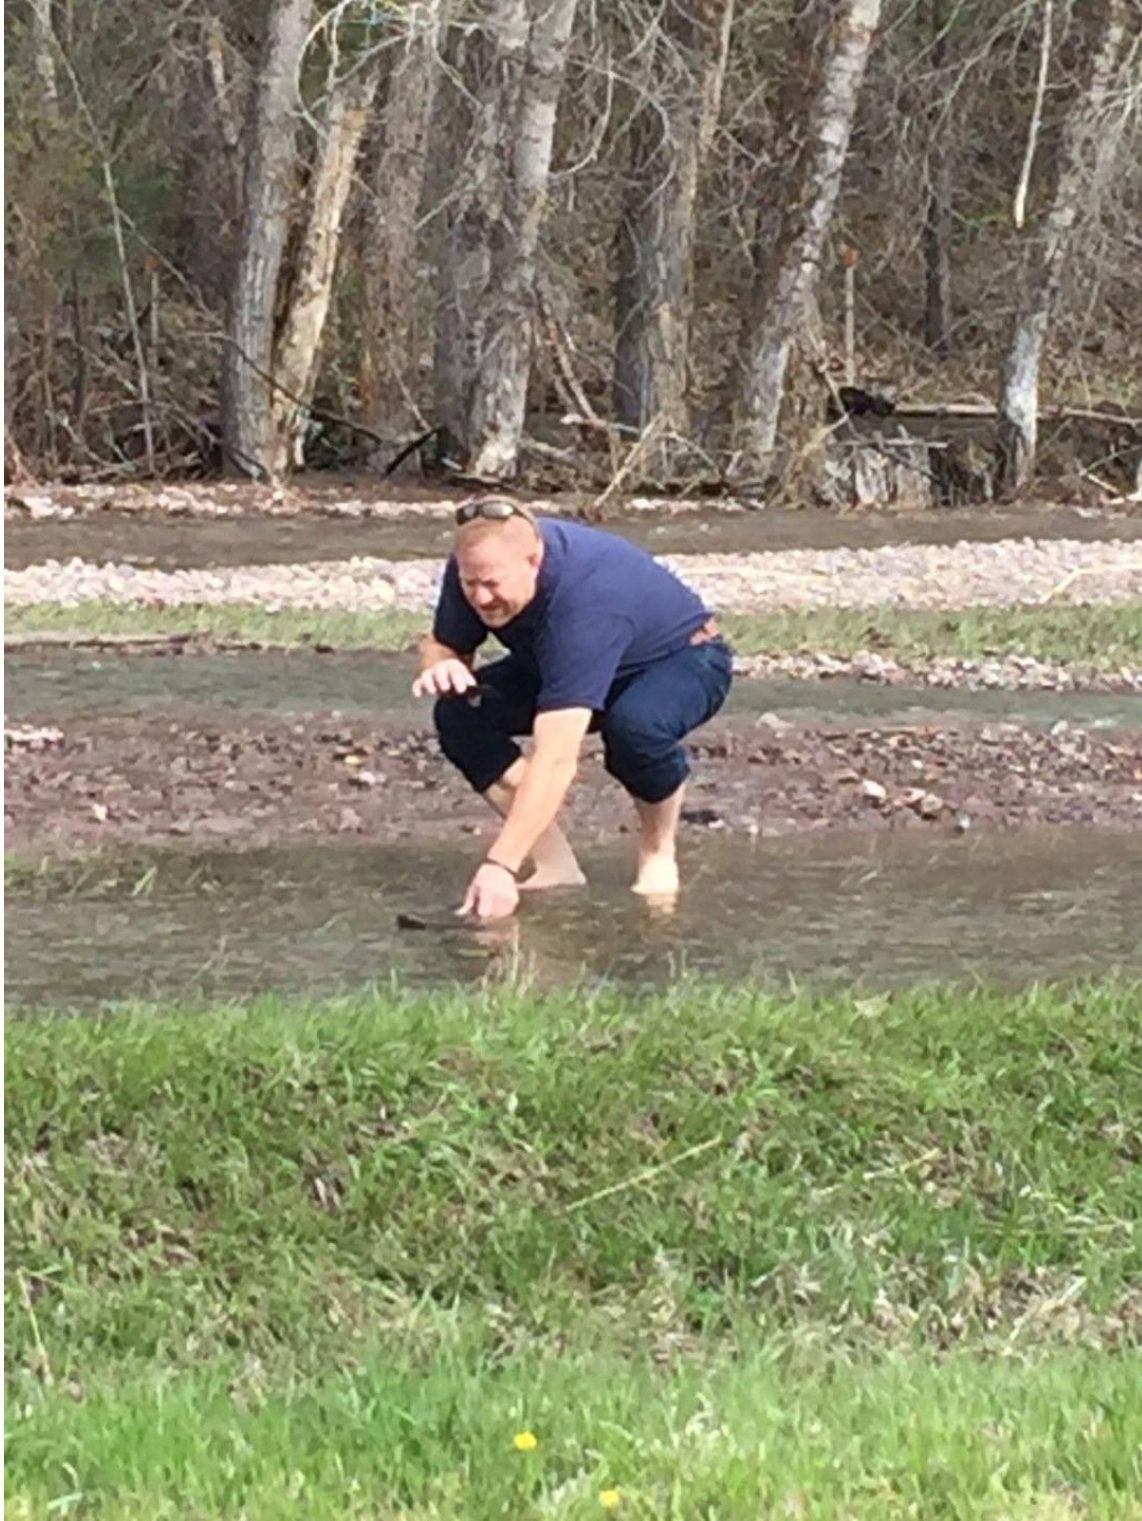
O'Brien Creek left its banks spring of 2019 and flooded large areas due to massive sediment aggradation

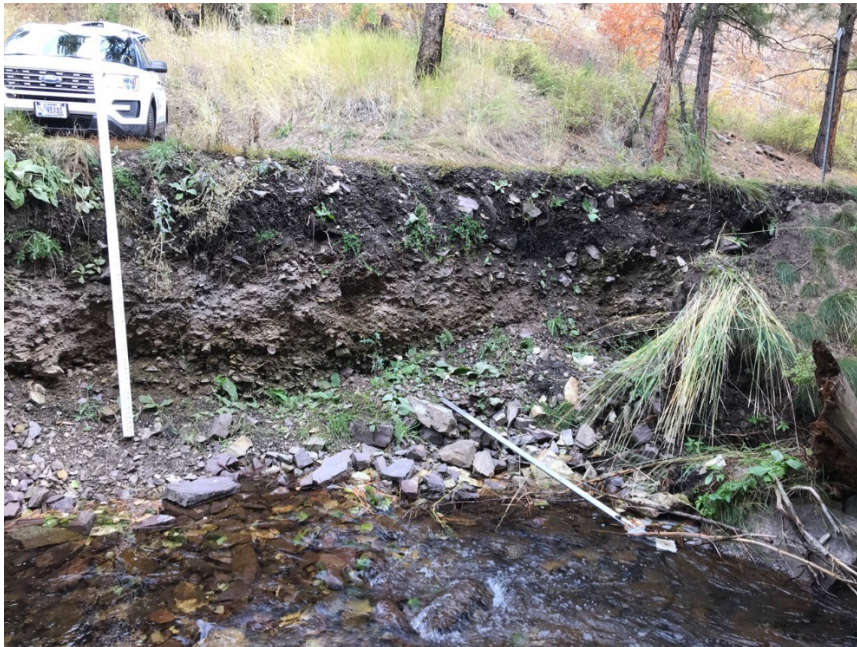
A major road washout next to a Forest Service gate. This is the beginning of the reach to be restored.

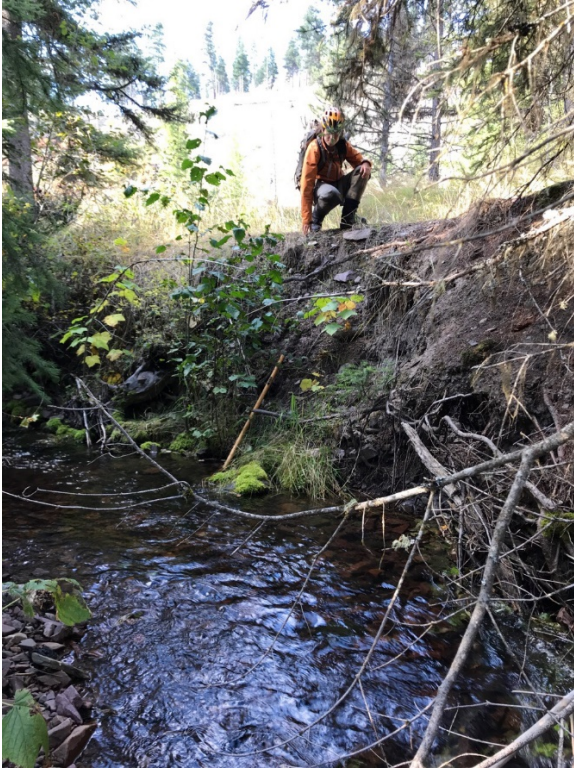
The road failure is 6 feet in height and 54 feet long.

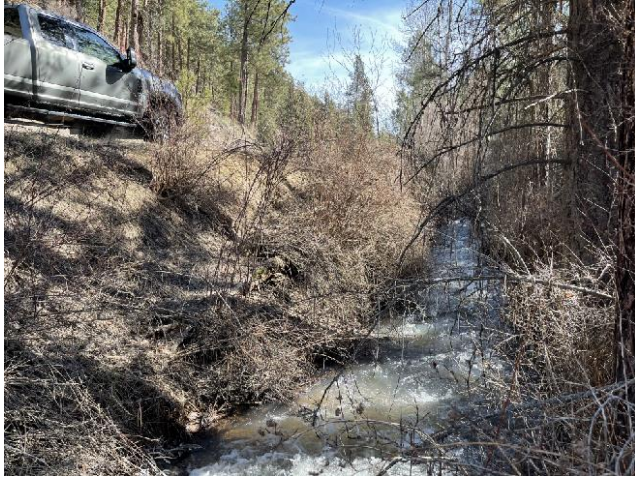
Example of O'Brien Creek road delivering sediment into O'Brien Creek

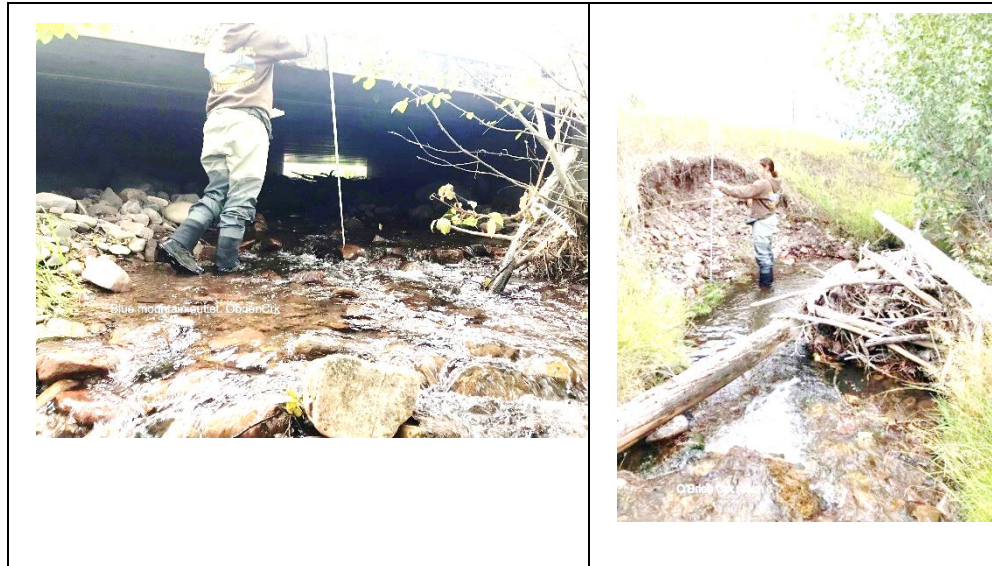
Figure A.9. Road crossing of O'Brien Creek at Blue Mountain Road and bank failure immediately upstream.

Reach 2 consists of the segment between Blue Mountain Road and the road crossing accessing O'Brien Meadow Subdivision. The crossing at the lower end of the reach at Blue Mountain Road is a 20' wide concrete structure (Figure A.9). Stream substrates exist continuously throughout the structure, indicating that fish passage is likely possible at most flows. Additional morphologic assessment is necessary to determine an appropriate bankfull width; however, a reasonable estimate is 12-14 ft. As such, the road crossing span is likely meeting typical stream-simulation design criteria to accommodate at least the bankfull width. Flooding freeboard to accommodate large debris and bedload during large floods may be compromised. (Figure A.10).

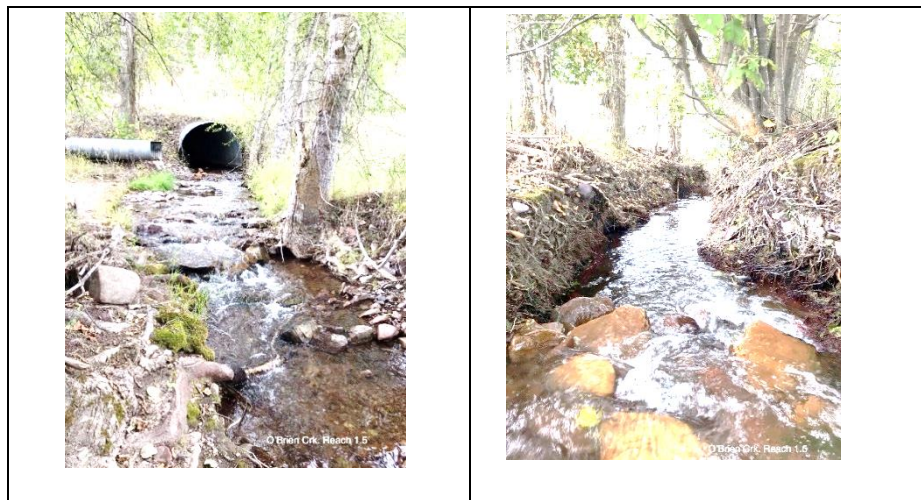
Figure A.10. Road crossing to O'Brien Creek Meadow Subdivision and critically undersized and actively downcutting segment downstream of the subdivision crossing and upstream of Blue Mtn. Rd.

Reach 2 is actively incising upstream of the Blue Mountain Road with significantly undersized channel capacity. Because of the low stream widths, stream depths are deeper and holding some fish.

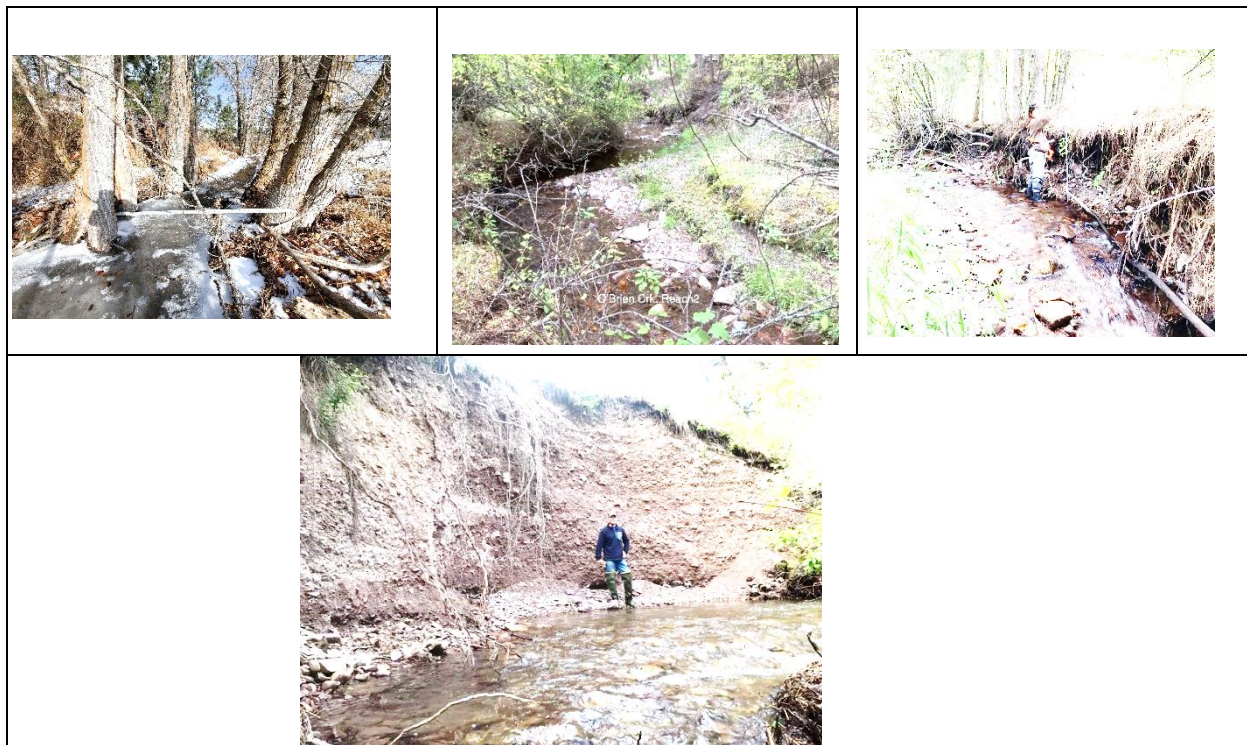
Figure A.13. Reach 3 - undersized segment, incision, bank erosion/land loss, and massive bank failure.

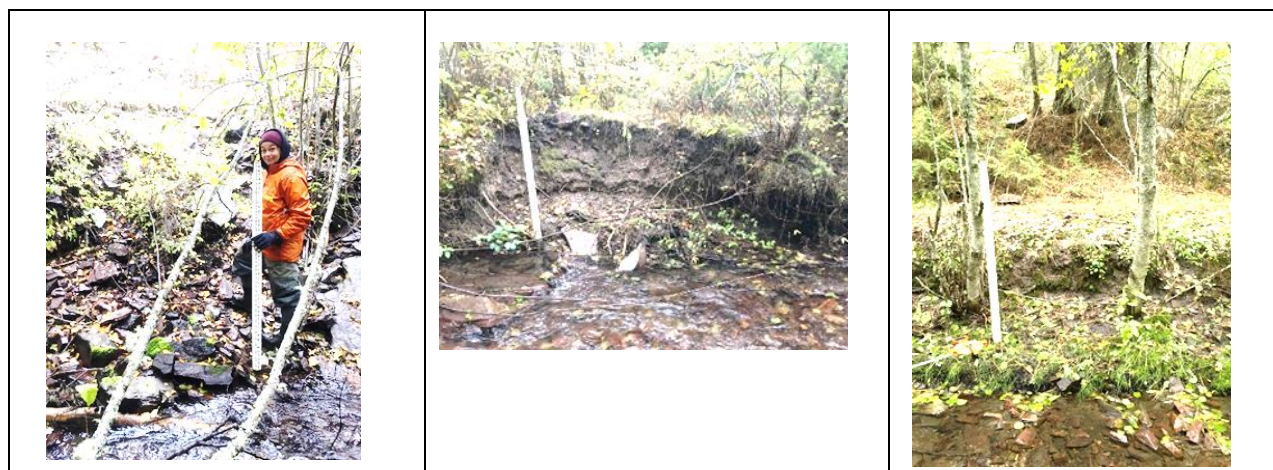
Figure A.16. Reach 6 – High bank erosion with some segments with low banks and floodplain connectivity.

two road fill failures are causing substantive sediment delivery. This segment appears near an old road bed or historic railroad prism. Average stream gradient is 1.7%.

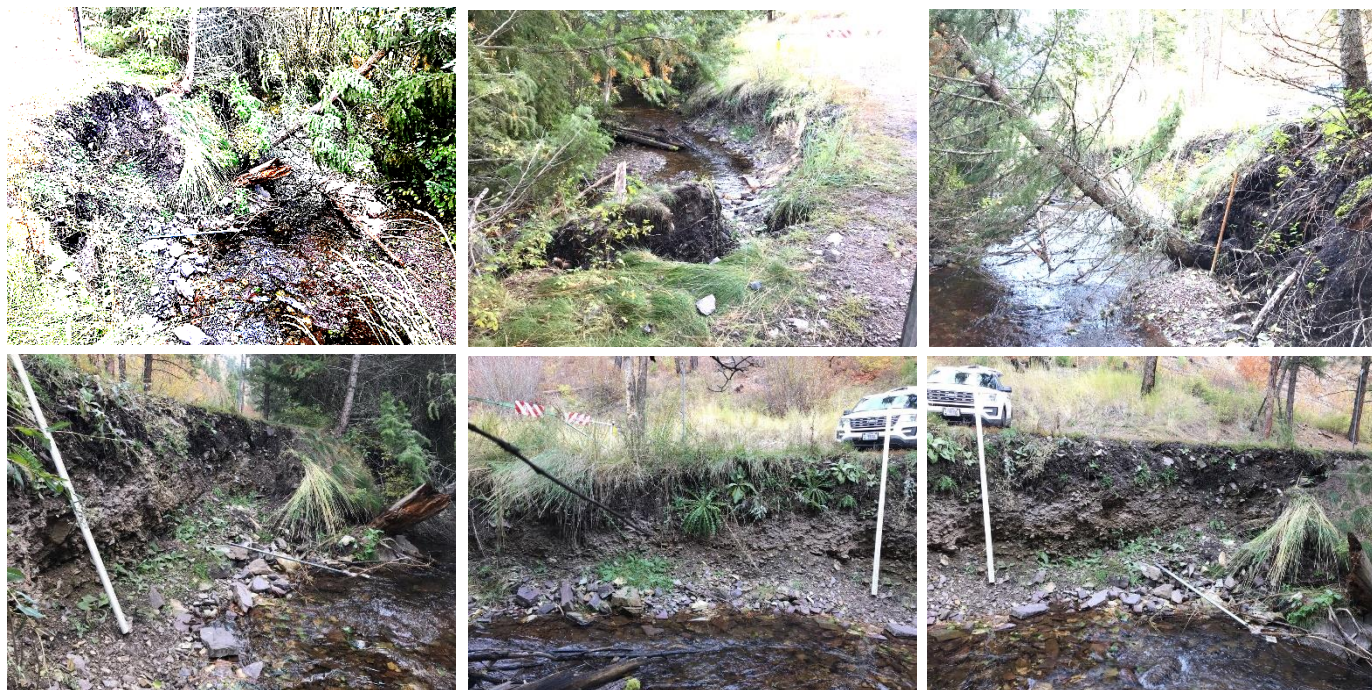
Figure A.18: Reach 8 – significant bank erosion section along streamside Forest Road. No. 123.

Road No. 123, a large road failure is actively slumping into O'Brien Creek. As of early October 2019, the dimensions of the sediment contribution from the slump were measured to be 54 x 6 x 6.2 ft (approximately 2,678 ft³). A newly fallen tree and road sign was in the stream. Parking is limited to one car, with 12 ft. road width and user-created turnaround off.

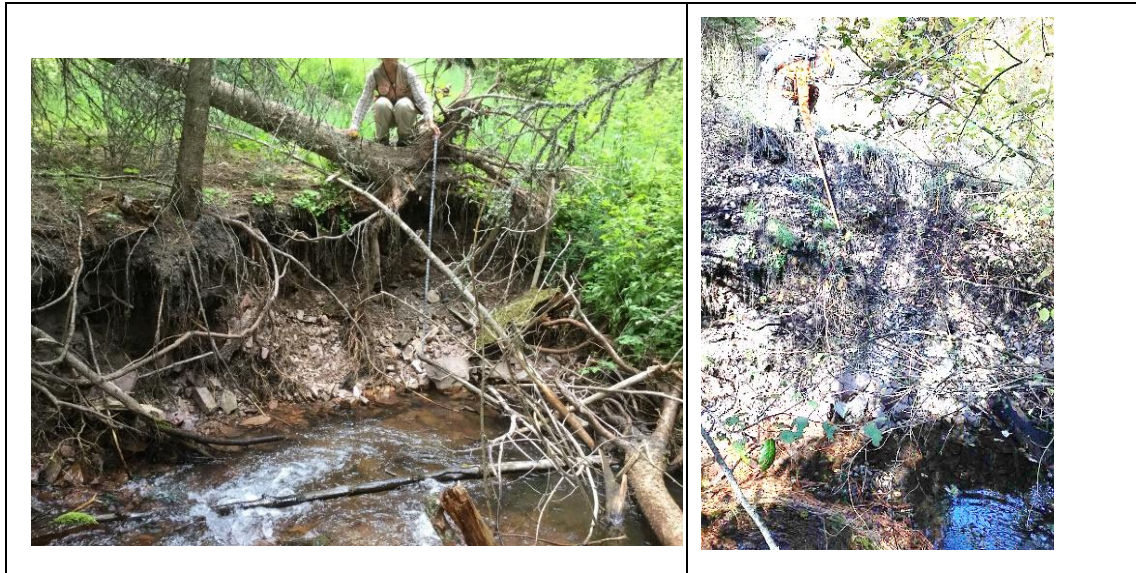
Figure A.19: Road 123 (non-motorized trail) – Reach 8 – High erosive banks caused from likely historic channel manipulation and recovering stream adjustments.

Above the upper Forest Service gate, Road No. 123, an old bridge crosses O'Brien Creek to decommissioned Road No. 19244. The bankfull width here is 10.2 feet. The bridge appears unsound with over widening at the inlet. Negative road and stream interactions continue upstream for several hundred feet with many road fill failures, bank erosion, and high sediment deliveries.

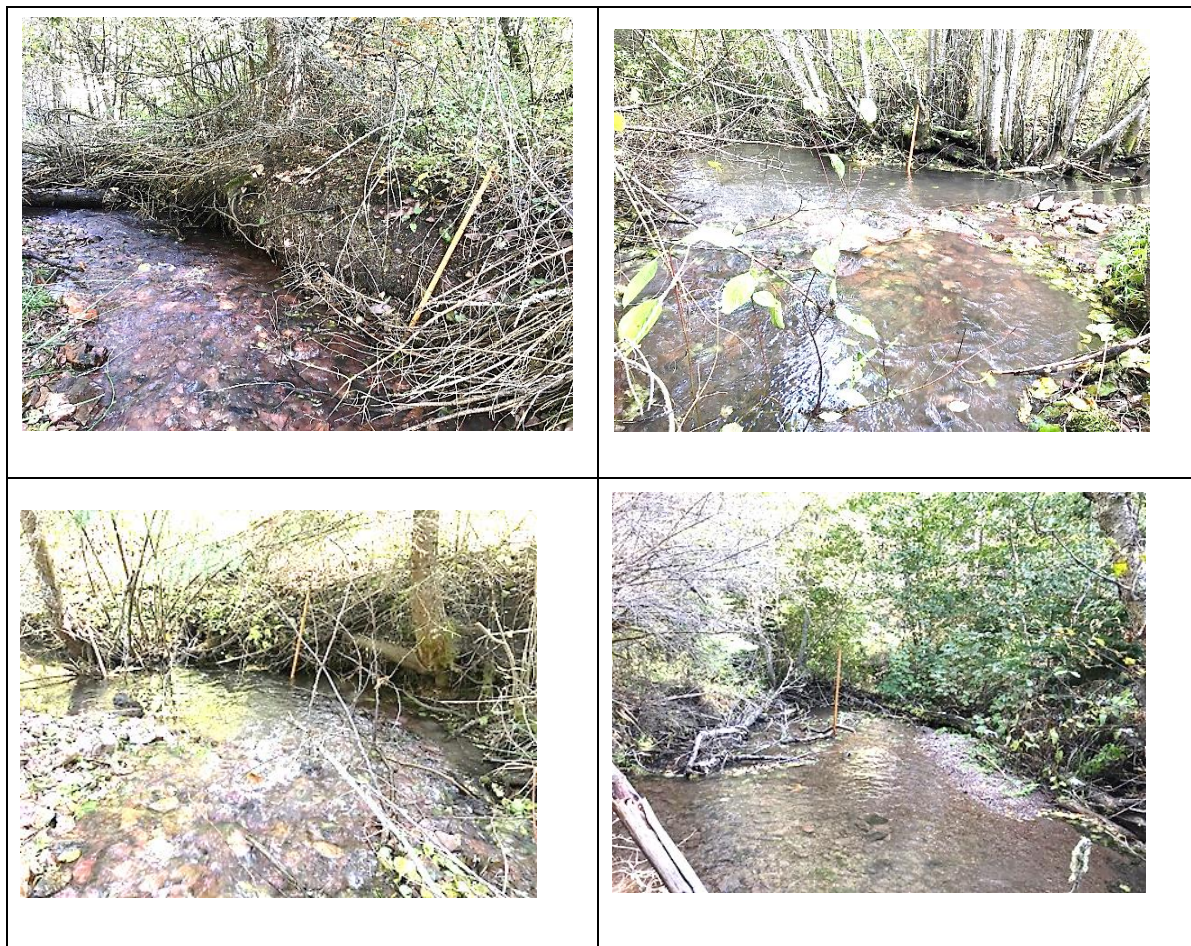
Figure A.21: Reach 9 – Bank erosion and aggradation present. Pool habitat and stream dimensions are more representative of stable channel conditions.

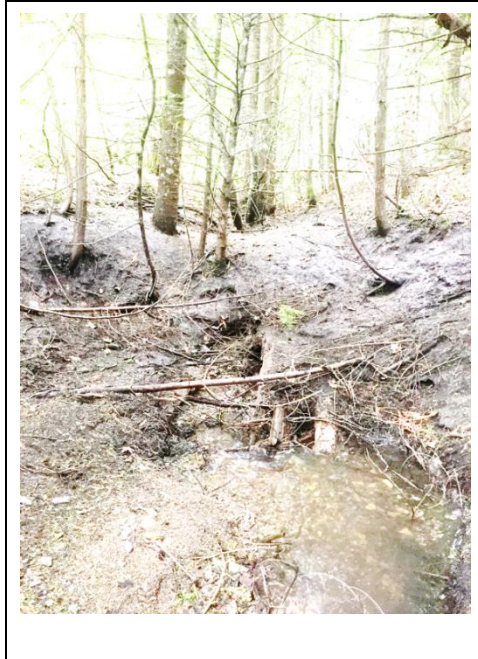
Figure A.22: Failed log culvert on jammer road in Upper O'Brien Creek jammer road system.

Figure A.6 in first section displays contributing sediment sources located during WAM road surveys (USFS, 2019). Figure A.22 below displays erosion at stream crossing on old jammer roads. Most jammer roads are reforested, but some may need remediation to address sediment deliveries. Open roads are in need of maintenance and improvements to adhere to federal and state standards for best management practices.

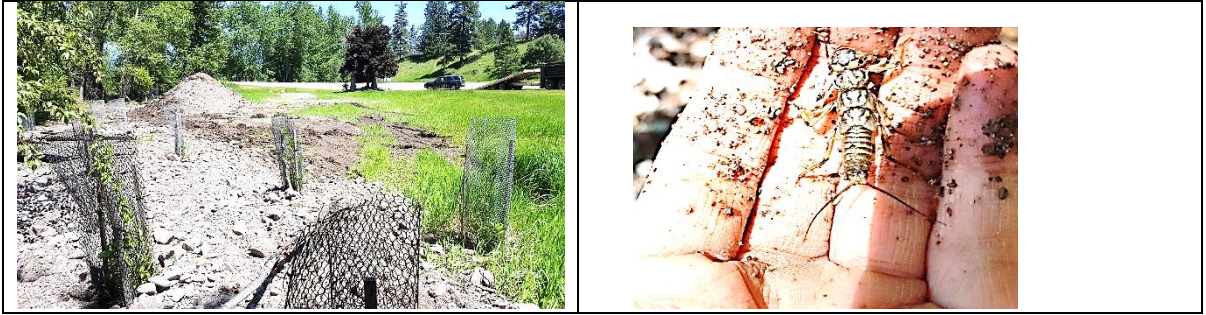
Figure A.23. Reach 3 - 2019 Emergency Channel Remediation conducted by O'Brien Creek HOA with tree donation from Hillsdale Estates. Mass failure and temporary remediation with large tree toe protection; salvage of large rainbow trout and macroinvertebrates.

2019 Post-flood remediation at O'Brien Creek Road crossing included removal of substrate deposition, returning stream to existing channel, re-grading channel, and placing large trees at the base of the mass failure side to temporarily reduce undercutting and risk of more failure until appropriate channel design and rehabilitation can occur. There was fish salvage of a large rainbow trout trapped in the meadow grass during the avulsion. The O'Brien Creek HOA hired a specialized articulating excavator with clam-shell to carefully extract stream bed deposition with minimal channel disturbance per 310 permit requirements.

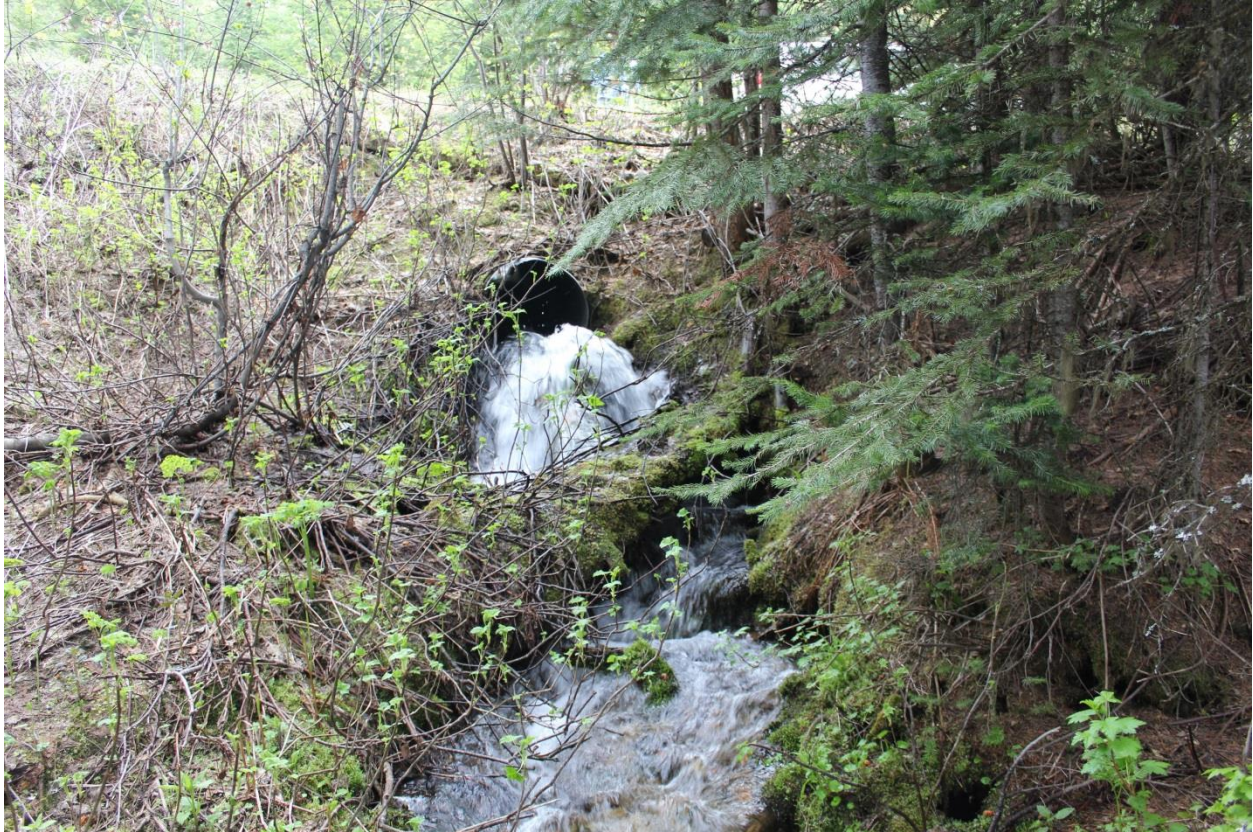
Figure 4 Miller Creek Headwaters: Though the headwaters are relatively healthy, undersized culverts carry high velocity flows that serve as a barrier to fish migration

this watershed (undersized, malfunctioning culverts and contribution of sediment from roads) (Figure 4). Fish passage obstructions in the watershed need to be assessed and a plan for mitigation developed and implemented (Knotek, 2017).

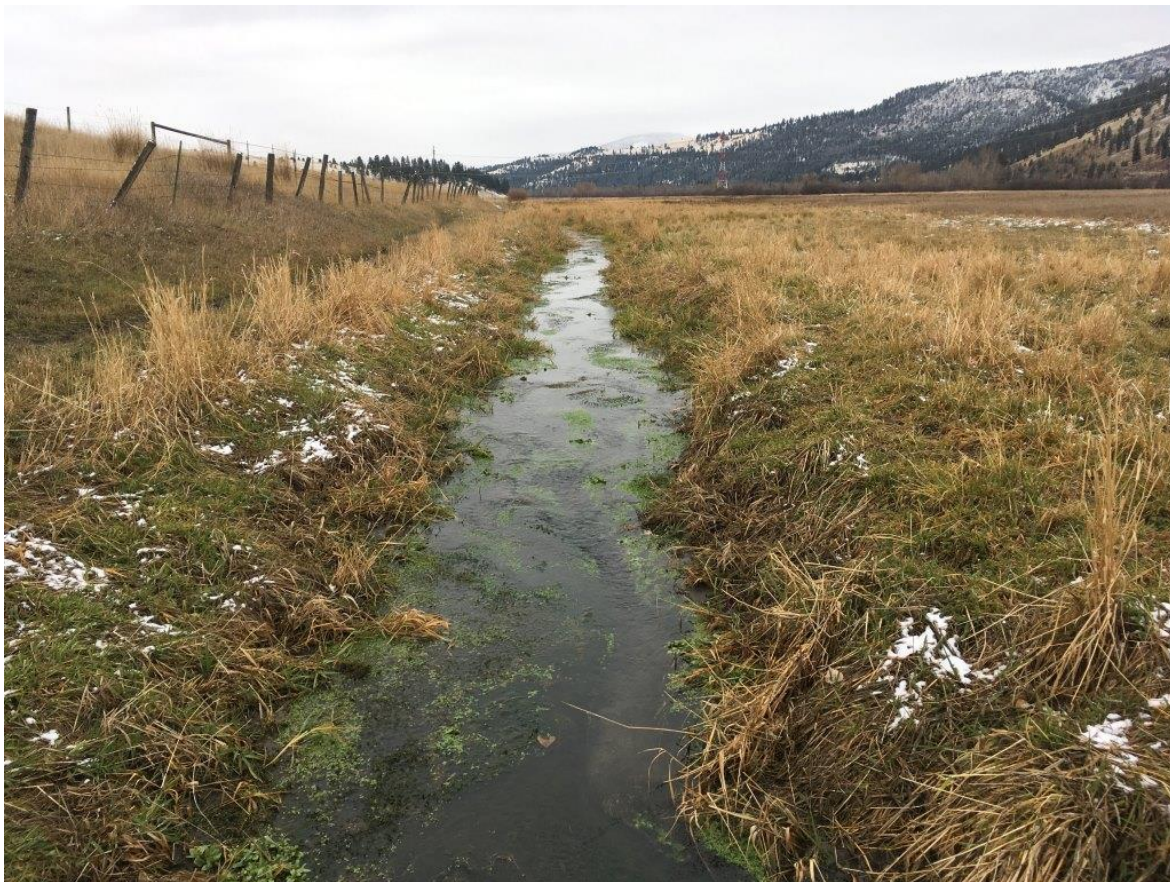
Figure 11: Lower section of Miller Creek was straightened by previous owners and large trees removed.
