# 2022 319 Application Form - General and Focus Watershed

# Flint Creek Riparian Restoration Project – Phase 2 Project Map

## 1. Introduction and Background

# Riparian Habitat Assessment for Flint Creek and Boulder Creek Granite County, Montana

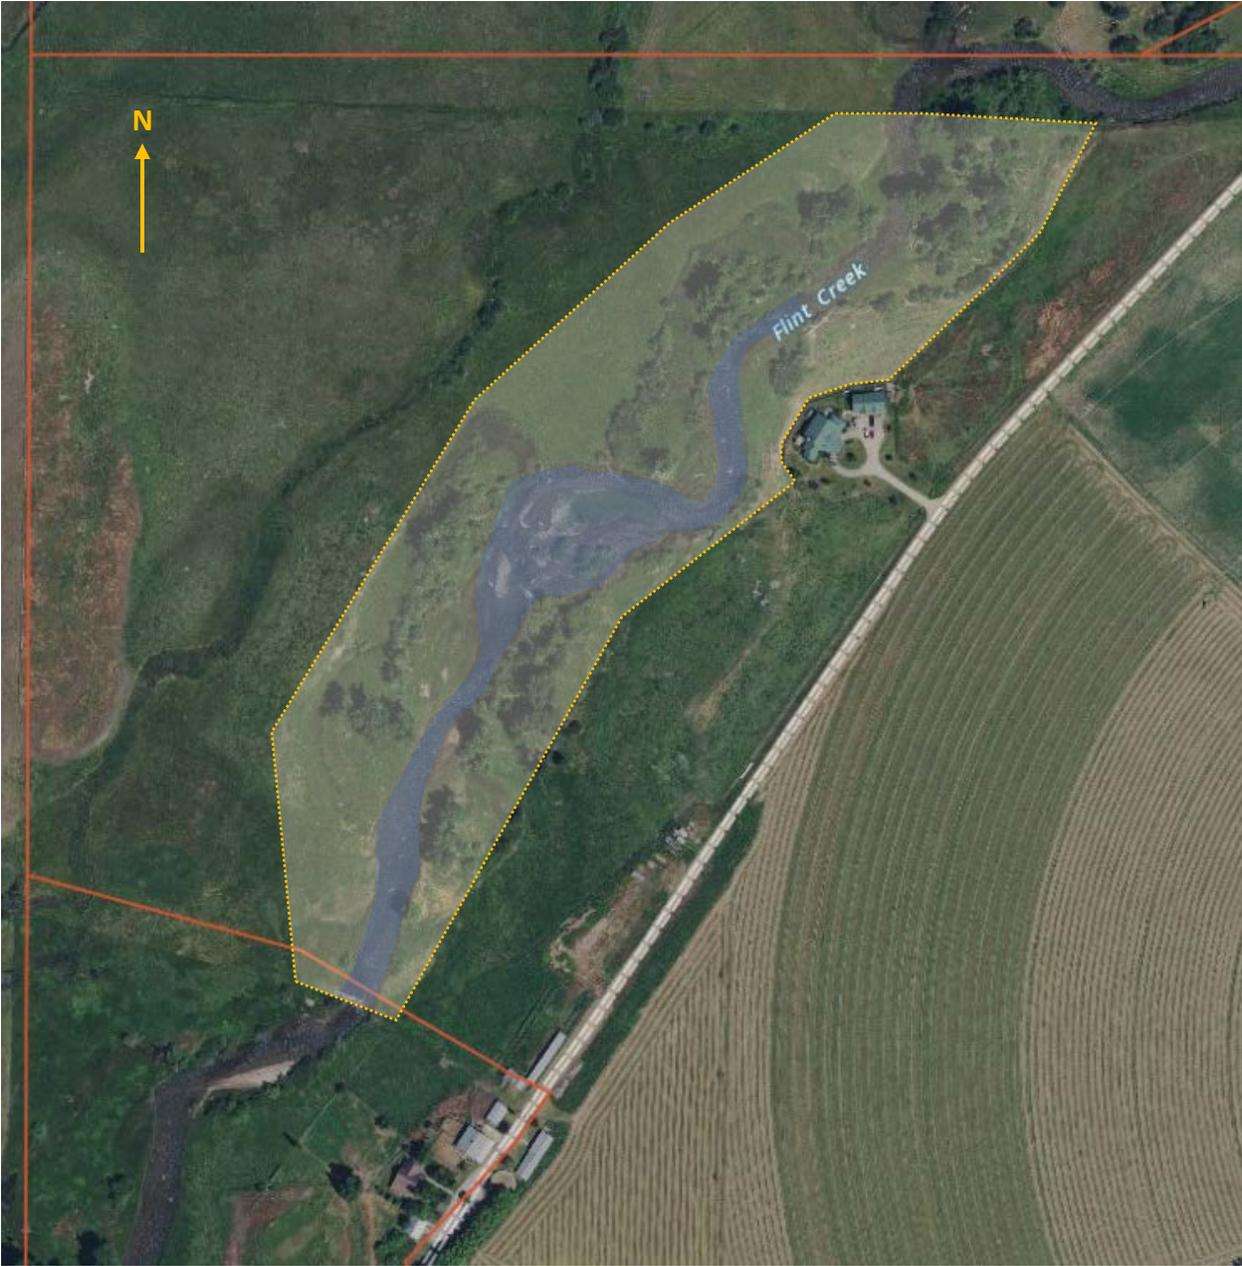
Flint Creek Riparian Restoration Project – Phase 2  
Project Map

Riparian Habitat Enclosure and Active Revegetation

Bank and Channel Treatment Reach

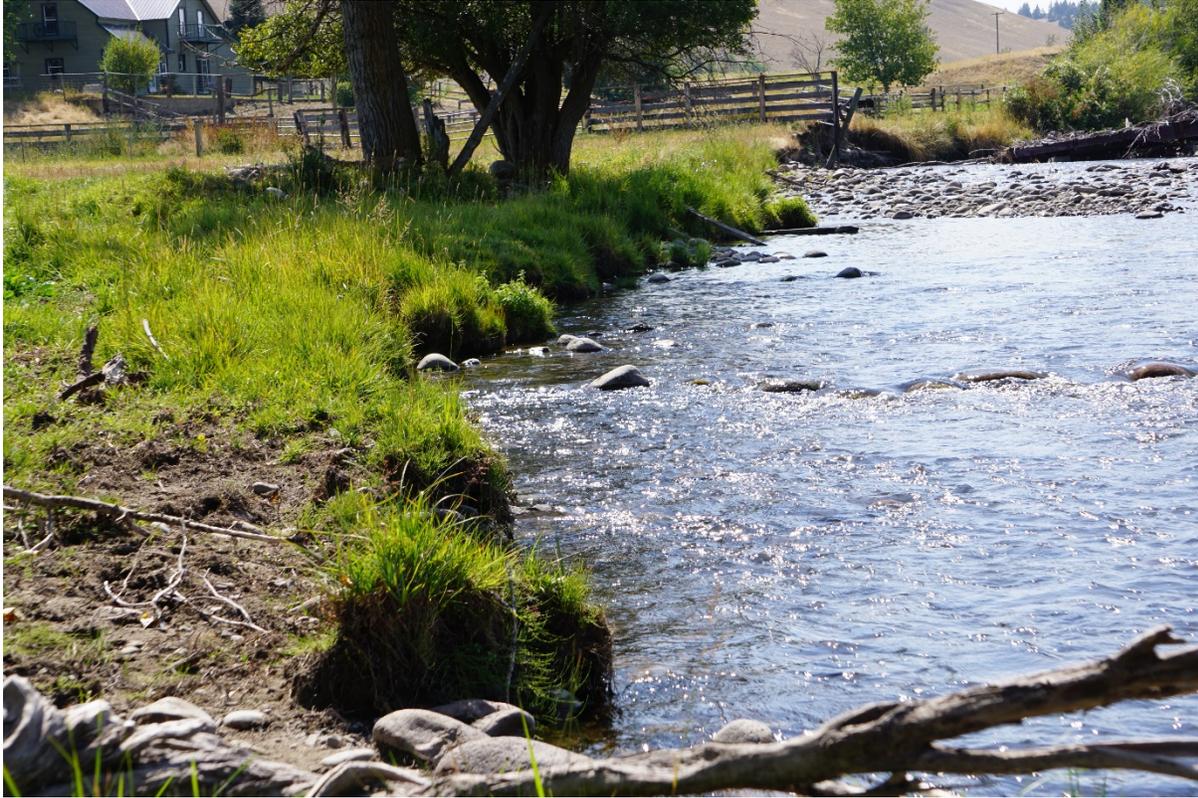
Right bank looking upstream at upper end of site.

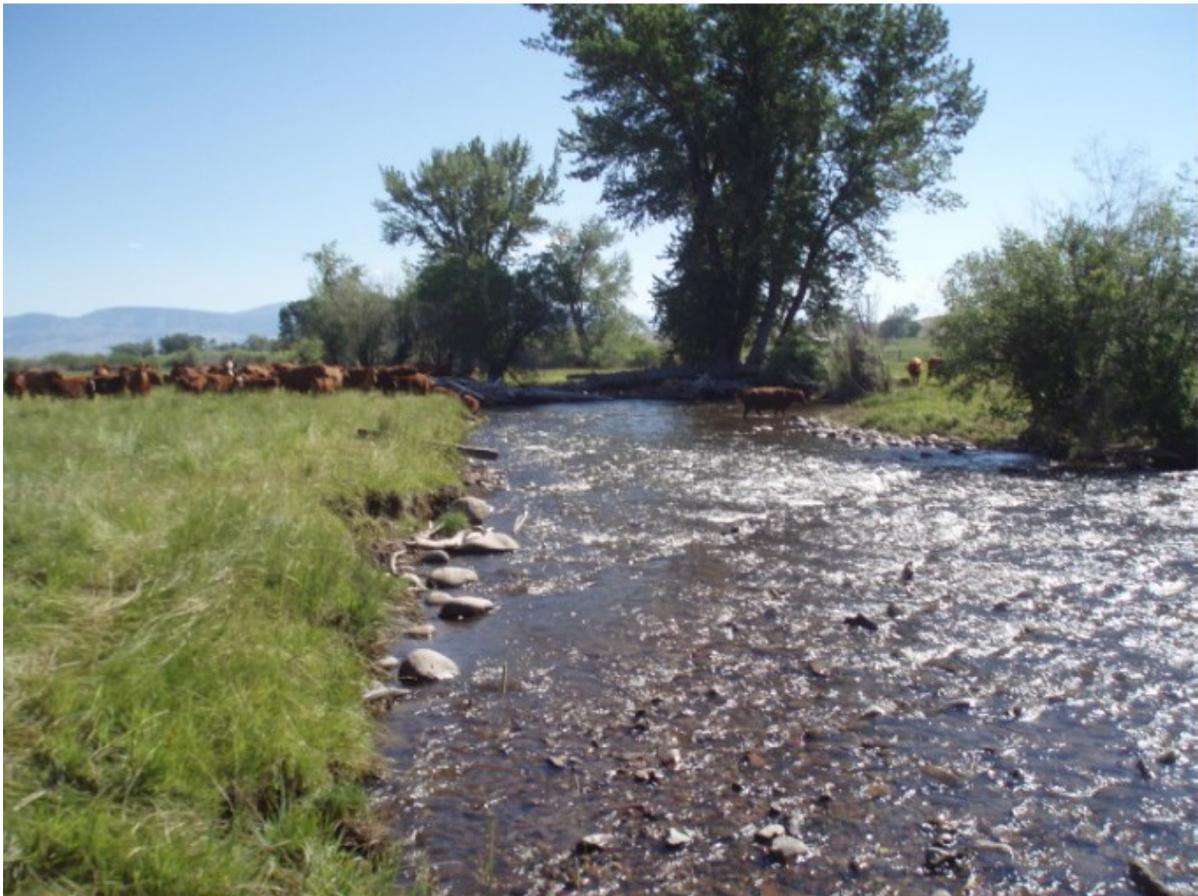
Left bank looking downstream at upper end of site.

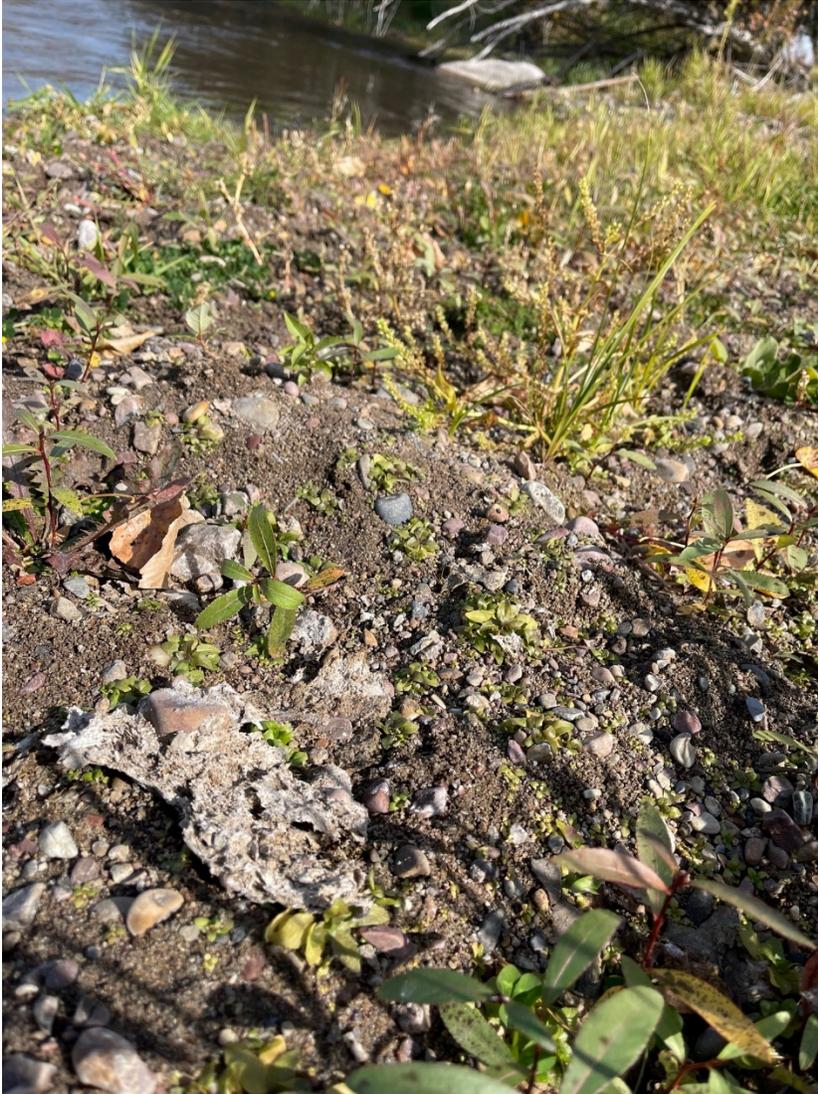
Point bar showing natural willow and cottonwood recruitment potential

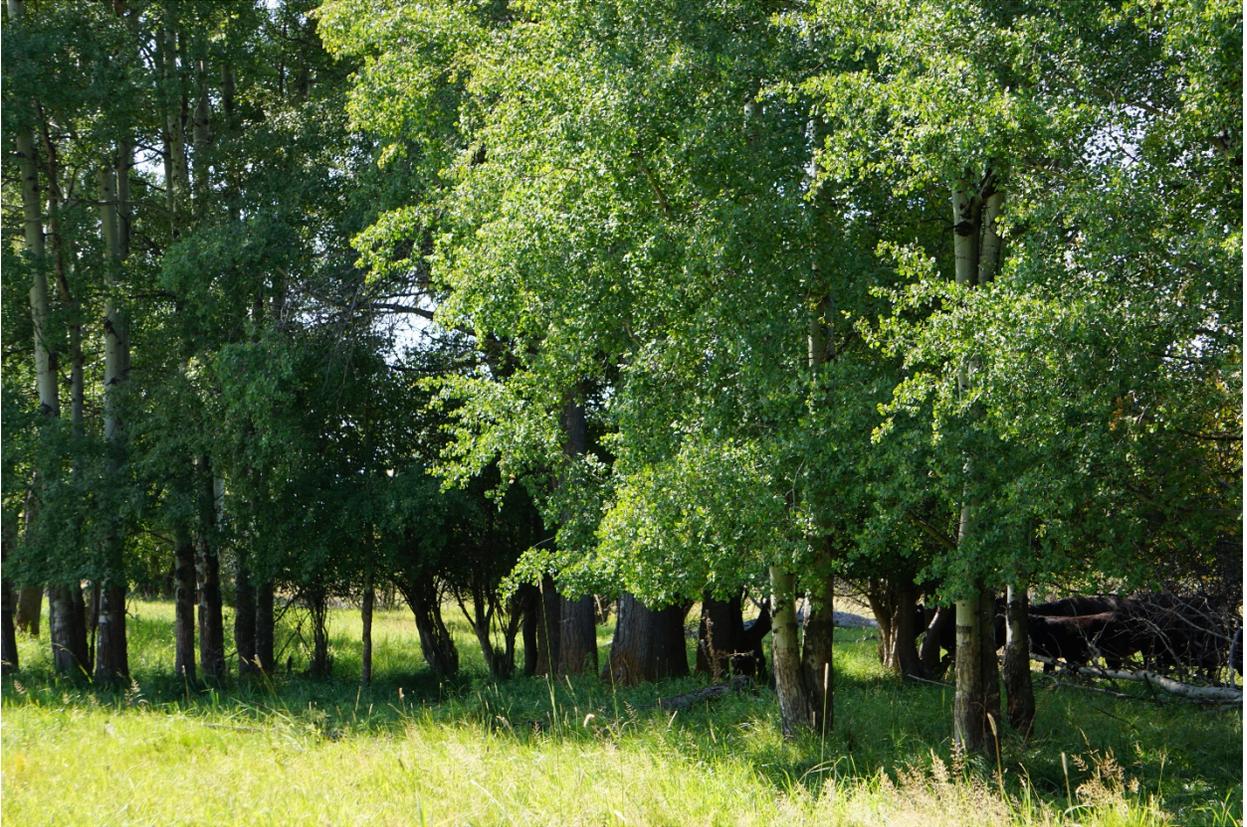
Aspen stand with high regeneration potential within proposed riparian fencing.

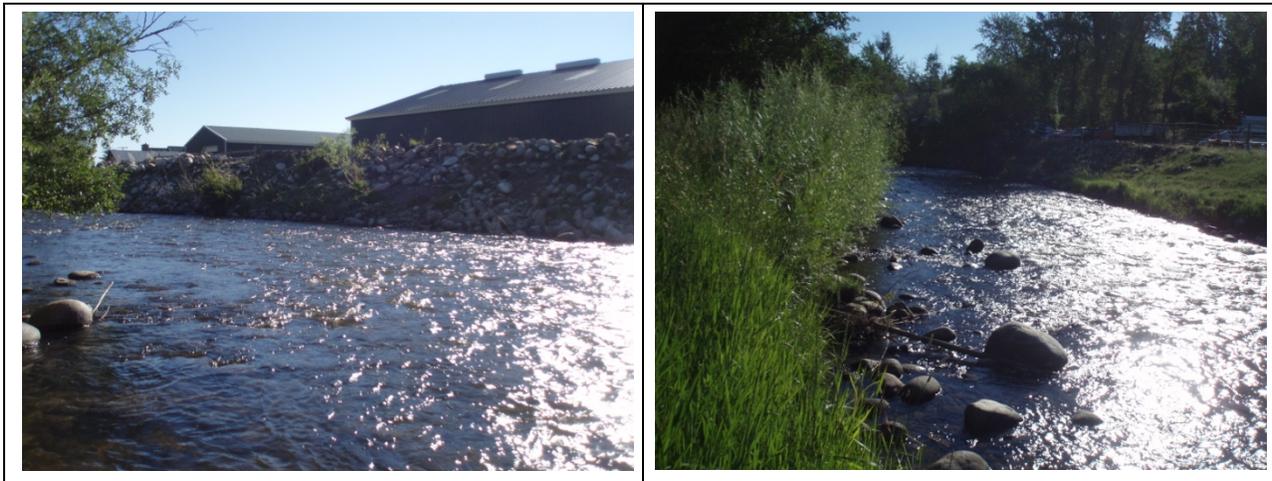
Armored bank on river right to protect property at F30.

Typical bank conditions in F30

One irrigation diversion was noted on site, which was determined to likely be a high entrainment concern. Armored banks, decreased understory cover and a lack of woody debris in the channel were noted as limiting factors for fish habitat.

- Conservation of streamside fencing
- Stabilization of high and bare banks on river right with bioengineering techniques, willow staking

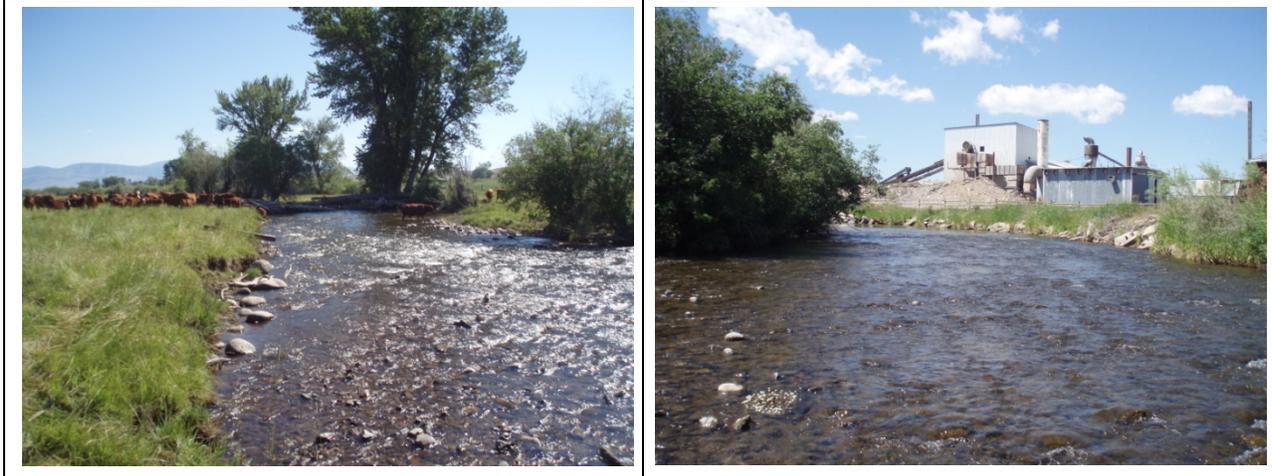
Heavy cattle use area in F31

View upstream near lumber operation and rip-rapped banks in F31

In the downstream-most ownership by the lumber operation, streambanks are heavily rip-rapped to protect structures and the stream may have been straightened in the past. Banks in this southernmost ownership do not exhibit the active erosion observed upstream and are stable. The stream has ready access to its floodplain on the river right.

- Riparian fencing or fencing of cottonwood and willow stands to promote regeneration
- Grazing management including off-site water, decreased intensity on riparian areas
- Fish screens or removal of diversions
