**Final -
Blackfoot Headwaters Planning Area
Water Quality and Habitat Restoration
Plan and TMDL Addendum for Sediment –
Sandbar Creek**

November 2014

Water Quality Planning Bureau
Watershed Management Section

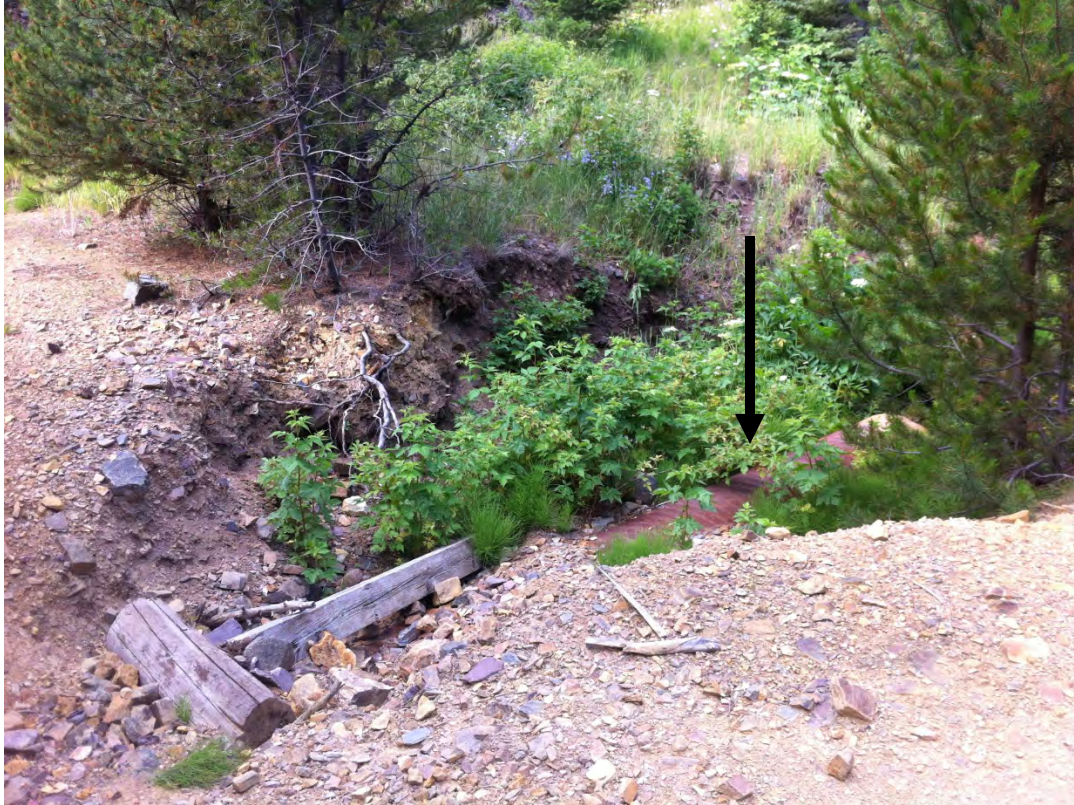
Figure 3-1. Failing culvert (pipe indicated by the black arrow) in the Sandbar Creek watershed

Road sediment delivery is the result of current and historical impacts to the Sandbar Creek stream channel. Unpaved road sediment delivery to Sandbar Creek was estimated using the methods described in Appendix J of DEQ (2004). **Table 3-1** provides summary road data for Sandbar Creek and the estimated annual unpaved road delivery to the creek of 1.8 tons. This estimate does not account for failing culverts such as the one shown in **Figure 3-1**.

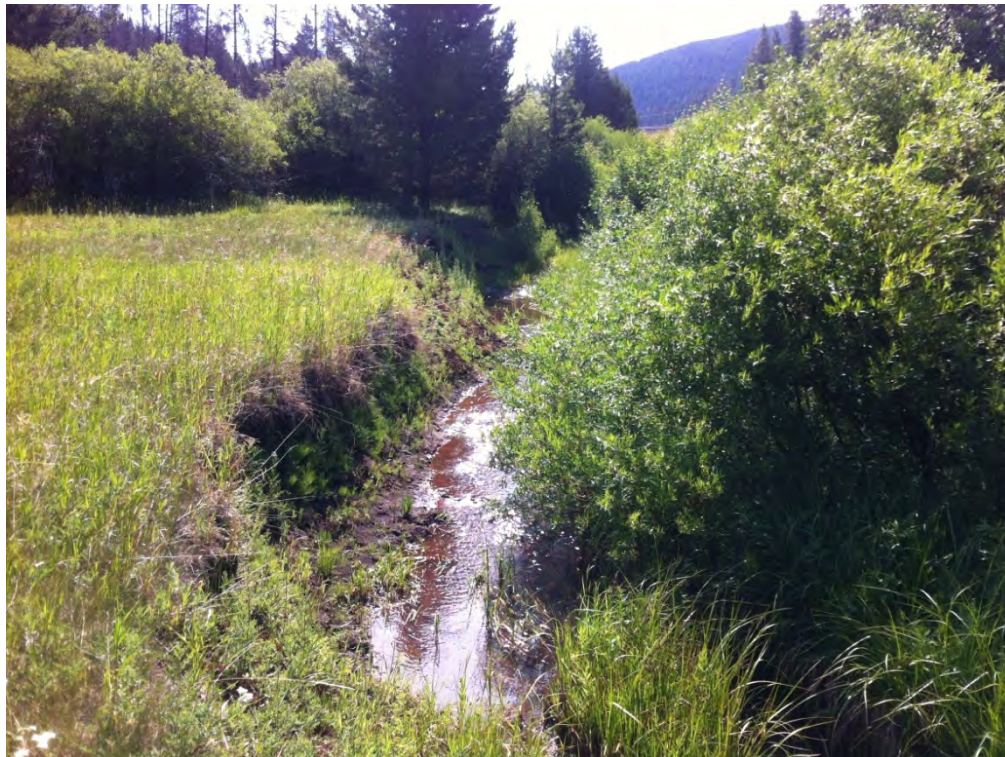
Figure 3-2. Streambank erosion near the mouth

To estimate sediment delivery from bank erosion in Sandbar Creek, the total loading rate and the percentage of load that is human-induced for the upper segment of the Blackfoot River (MT76F001_010; headwaters to Landers Fork) were used (Appendix F of DEQ, 2004). Sandbar Creek and this segment of the Blackfoot River are in the same watershed within close proximity and have experienced similar historical land use (i.e., road construction, mining, and timber harvest). Bankfull width data was used to account for the difference in size between Sandbar Creek and the upper segment of the Blackfoot River when estimating the loading rate. Sandbar Creek has an average bankfull width of 5.8 feet at the PIBO sampling site. The upper segment of the Blackfoot River has a bankfull width of approximately 45 feet (Appendix E of Montana Department of Environmental Quality et al., 2004). Because the bankfull width of Sandbar Creek is 13% of the bankfull width measured in the upper segment of the Blackfoot River, the loading rate used to estimate streambank erosion to Sandbar Creek is 13% of the rate for the upper segment of the Blackfoot River (**Table 3-2**). Using this information, the estimated annual streambank load to Sandbar Creek is 18.5 tons (**Table 3-2**). Applying the same percentage of the load that is from human-caused bank erosion in the upper Blackfoot River (21%), about 3.9 tons of the streambank load to Sandbar Creek is from human-induced erosion. **Figure 3-2** shows an example of human-induced bank erosion on Sandbar Creek where the channel has been straightened.

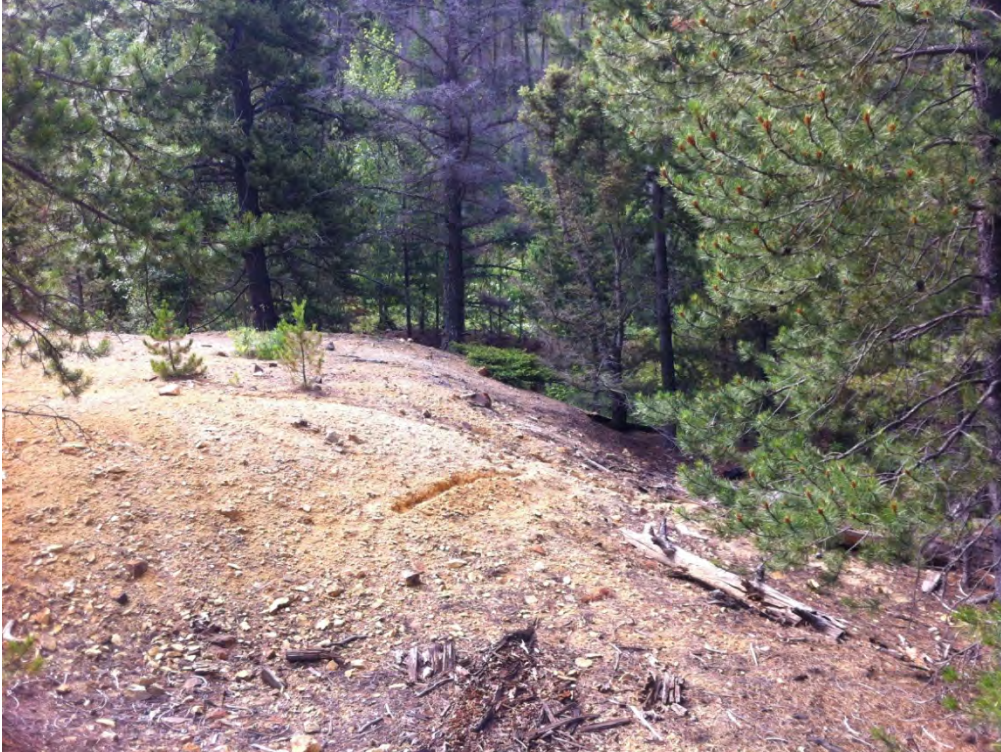
Figure 3-5. Mining waste rock pile adjacent to Sandbar Creek

Mining waste rock piles are a historical impact and are found at various locations along Sandbar Creek (Montana Department of Environmental Quality, 2003). Some of these piles are adjacent to Sandbar Creek (**Figure 3-5**) while others define the stream channel and were used in road construction (**Figure 3-6**). It is likely that these piles erode in a manner that would classify them as road, streambank, and/or hillslope sediment sources. As such, the allocation for mining waste rock piles in the Sandbar Creek watershed is addressed by the allocations for unpaved road, streambank, and hillslope erosion.

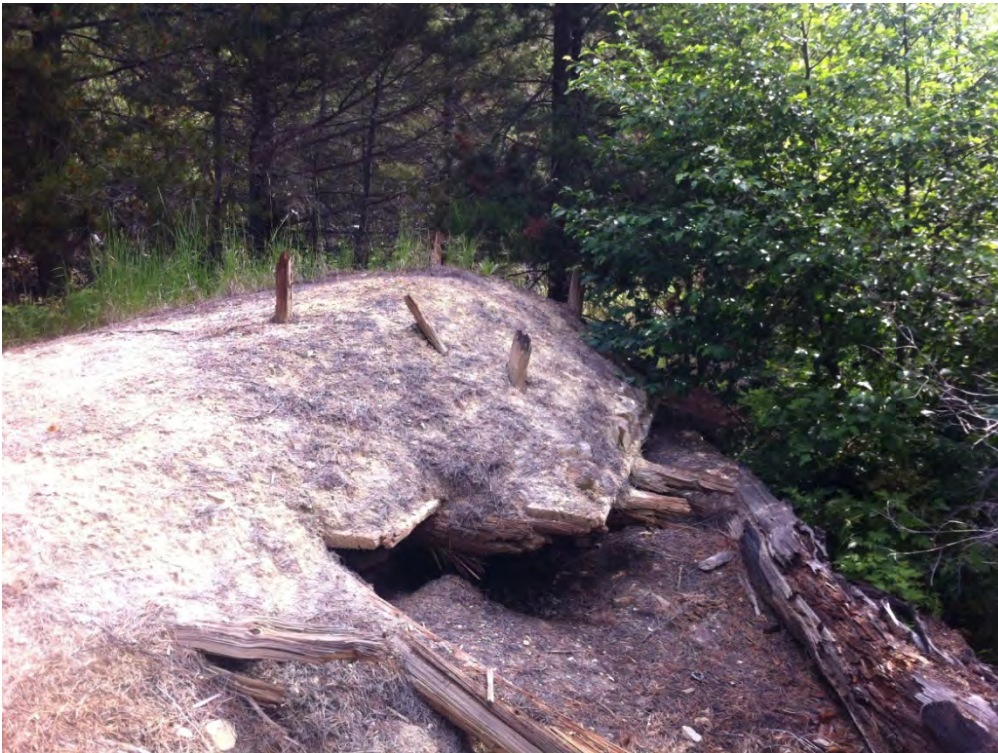
Figure 3-6. Mining waste rock pile and collapsed bridge on Sandbar Creek

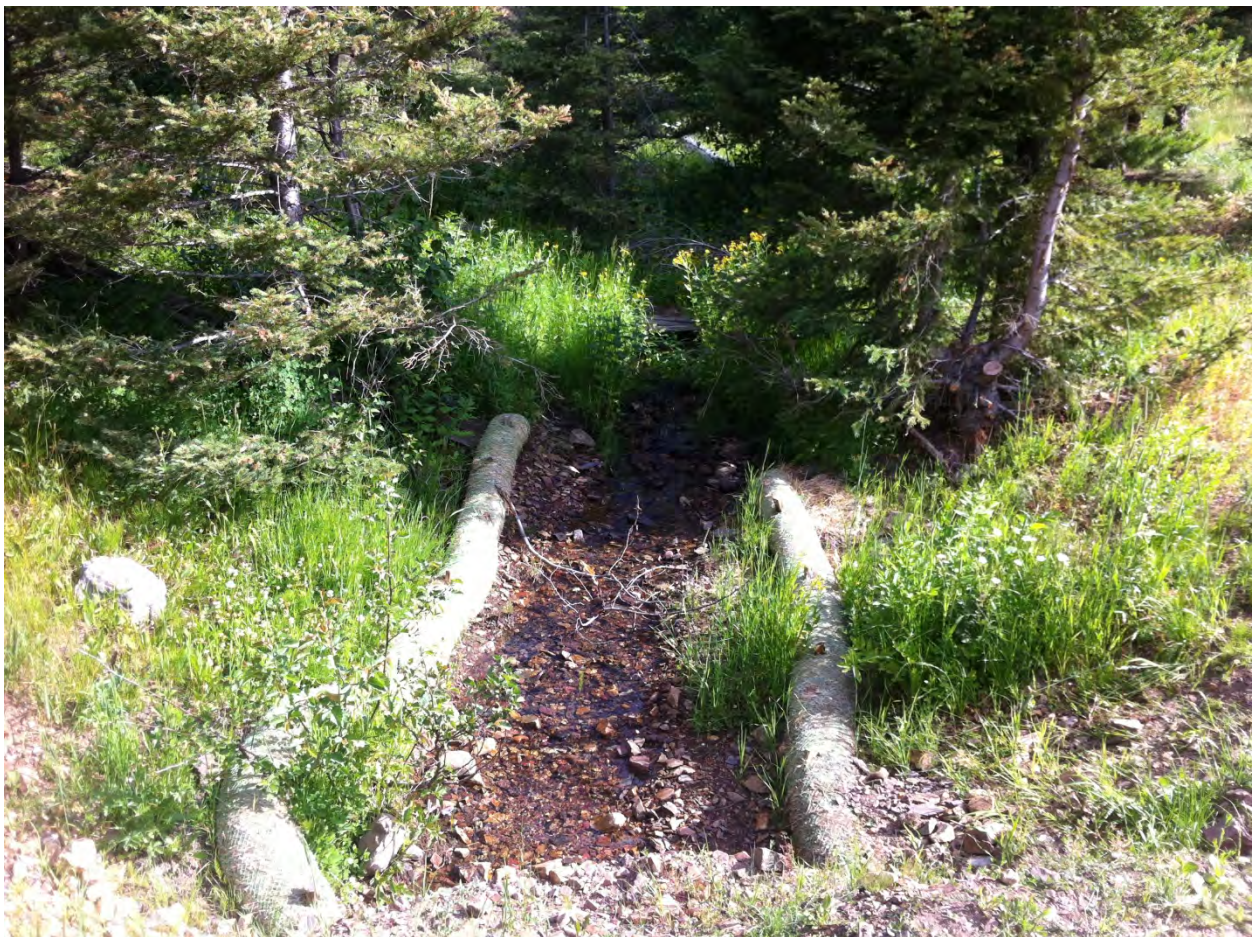
Figure 5-1. Culvert replaced by the US Forest Service in 2012

Implementation and monitoring recommendations presented in Section 6.4 of DEQ (2003) and Sections 6.3.4 and 6.3.5 of DEQ (2004) provide a basic framework for achieving the Sandbar Creek sediment TMDL in this addendum. Implementation should focus on the application of BMPs that improve channel and streambank stability and reduce sediment input from unpaved roads and mining waste rock piles. In 2012, the US Forest Service replaced an undersized (and failed) culvert with a bottomless arch in the Sandbar Creek watershed (**Figure 5-1**). The proposed action for the Sandbar Creek watershed in the U.S. Forest Service Blackfoot Travel Plan includes putting 2.0 miles of roads into storage (i.e., pulling stream culverts and restoring bank/valley contours, stabilizing surfaces) and obliterating 2.7 miles of roads (i.e., restoring to original landform/conditions, including any crossings) (Callery, Dave, personal communication 2014¹).
