# Final - Central Clark Fork Basin Tributaries TMDLs and Water Quality Improvement Plan

**September 2014**

Water Quality Planning Bureau  
Watershed Management Section

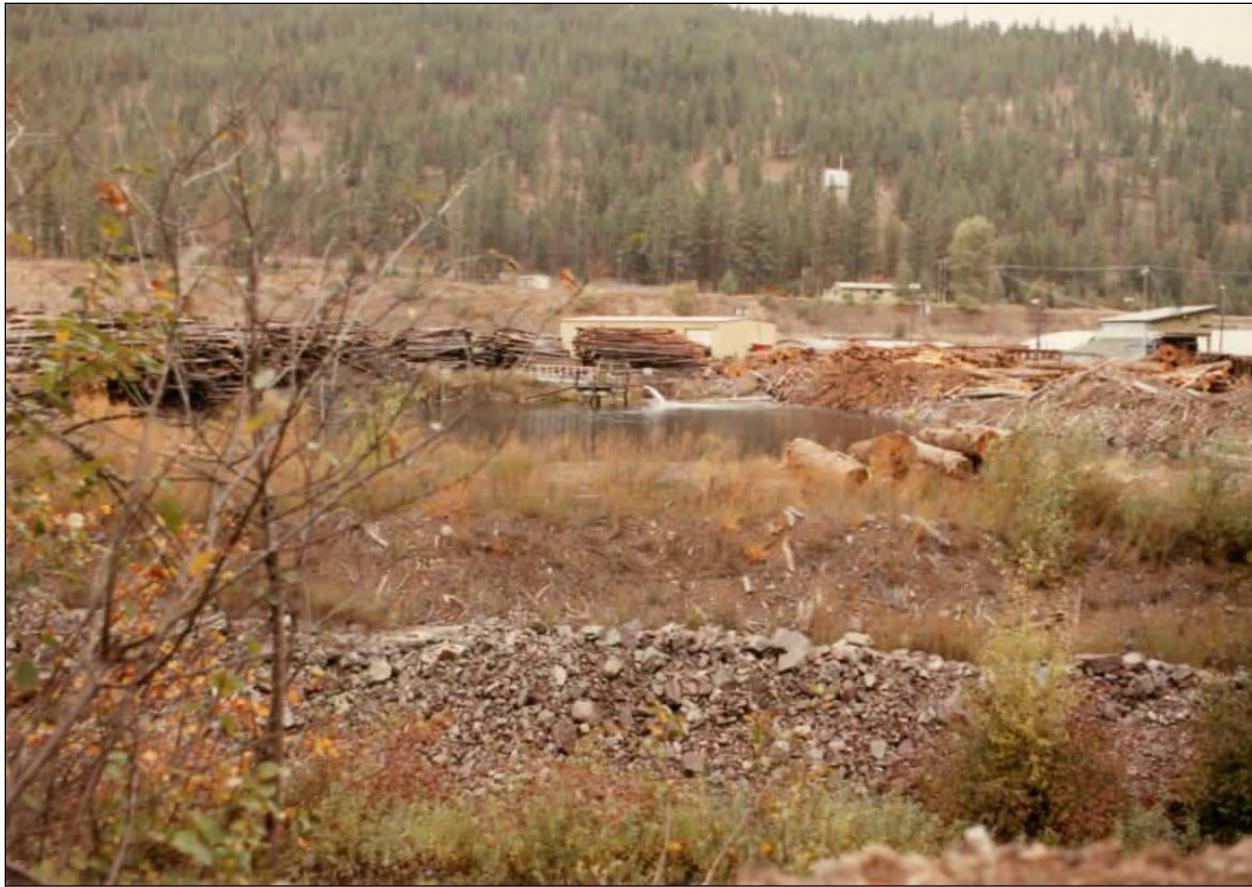
**Figure 8-3. Photo T-1 of discharge pond at sawmill operation on Trout Creek, 10/3/1990**

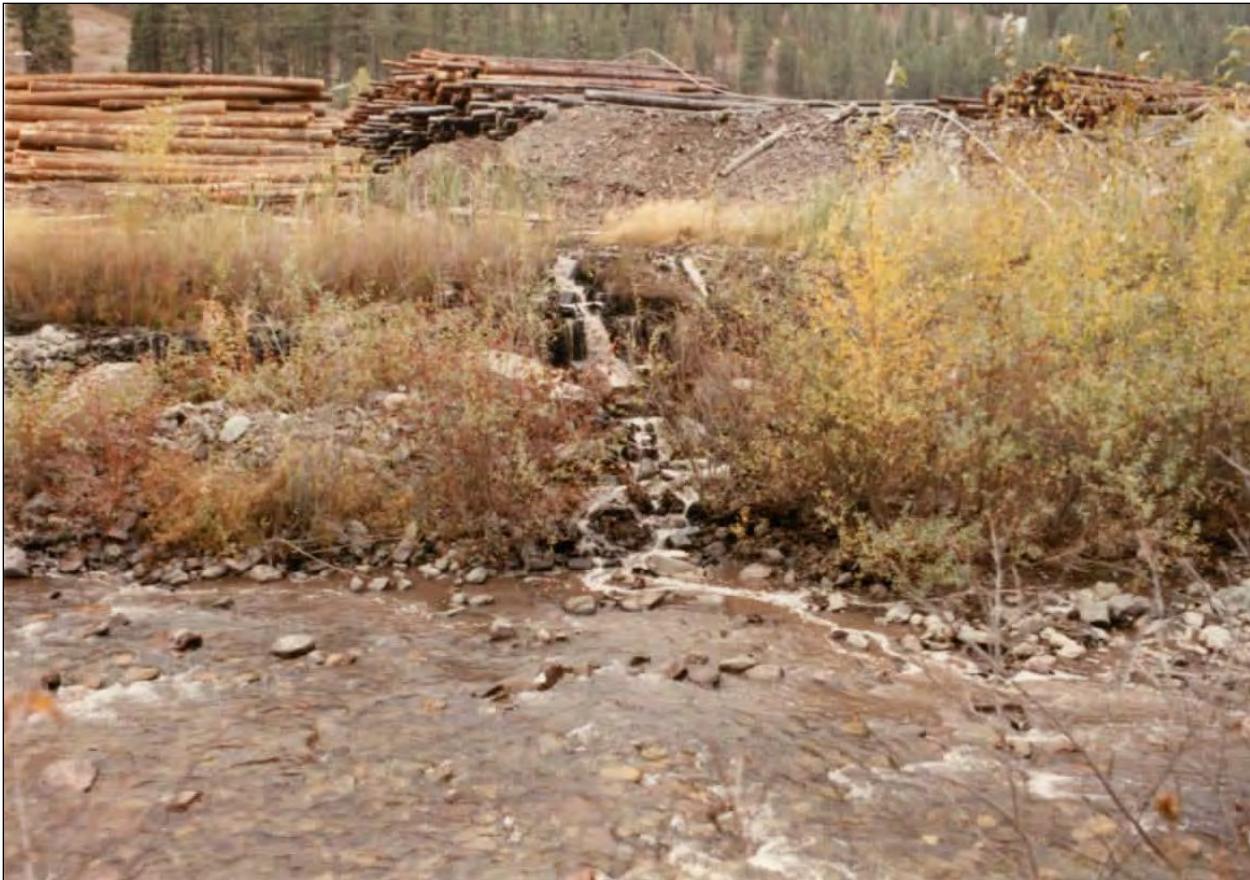
Figure 8-4. Photo T-2 of surface water discharge from log pond to Trout Creek, 10/3/1990
