Water Quality Assessment and TMDLs for the Dearborn River Planning Area

FINAL

Prepared for:
Montana Department of Environmental Quality

Prepared by:
U.S. Environmental Protection Agency
Montana Operations Office
and Tetra Tech, Inc.

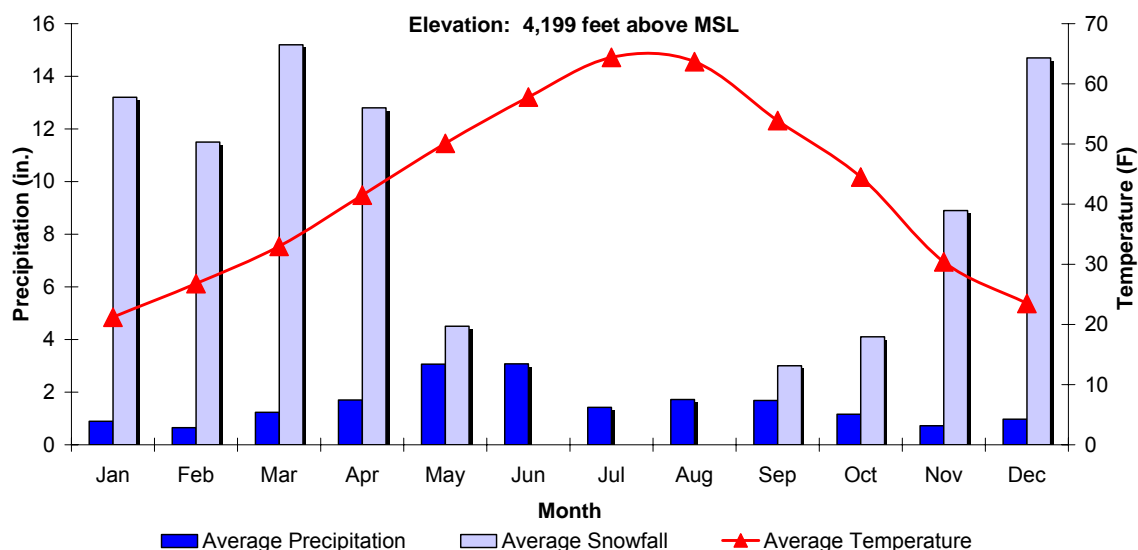
Figure 2-1. Climagraph for Rogers Pass 9NNE MT, Station 247159-4. Data cover the period 1971 to 2000.

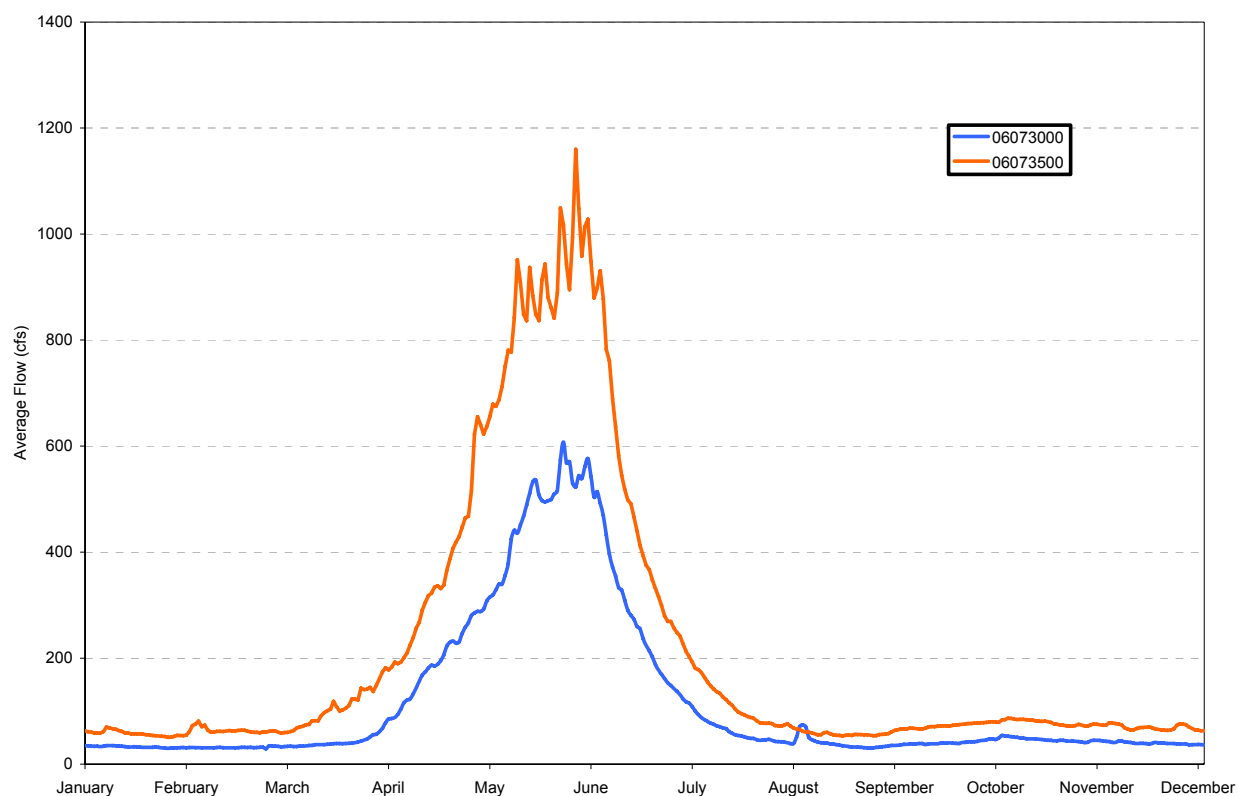
Figure 2-3. Average daily flows at two USGS gages on the Dearborn River main stem. Data show the entire period of record for both gages.

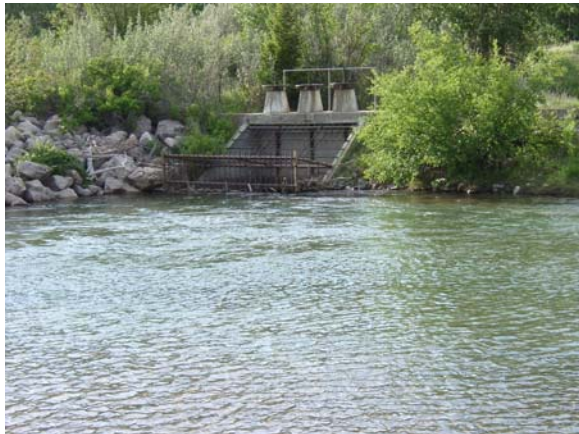
Figure 2-5. Flat Creek diversion gate structure (view from Dearborn River)

Flow measurements at various points in the Dearborn River watershed were taken on July 24, 2003, to assess the significance of the Flat Creek diversion. The results of these measurements are presented in Table 2-3 and several observations can be made. First, approximately 55 percent of the flow in the Dearborn River was diverted to Flat Creek at the time of the field visit. The Middle and South Forks returned an additional 7.2 cubic feet per (cfs) second (combined) flow to the Dearborn River downstream of the Flat Creek diversion, but flows at the Highway 287 bridge were still only 38 cfs. An additional 15.2 cfs were therefore lost from the Dearborn River as a result of other irrigation diversions, groundwater percolation, and evaporation. These water losses, combined with the loss due to the Flat Creek diversion, affect water quality in the Dearborn River by concentrating pollutants and elevating temperatures. Another observation that can be made is that the volume of water added to Flat Creek is several times greater than would naturally occur in the stream channel. The impact of this is discussed in Sections 3 and 4.

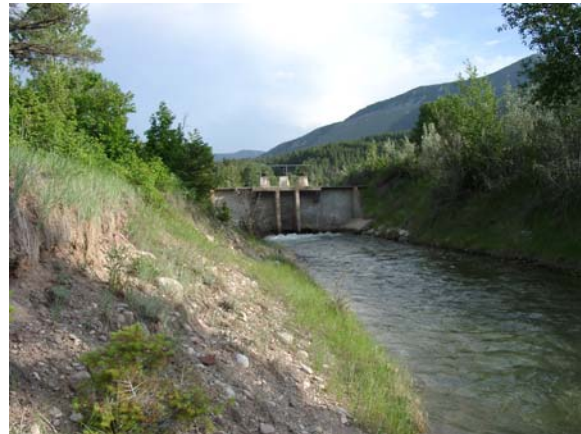
Figure 2-6. Flat Creek diversion canal.

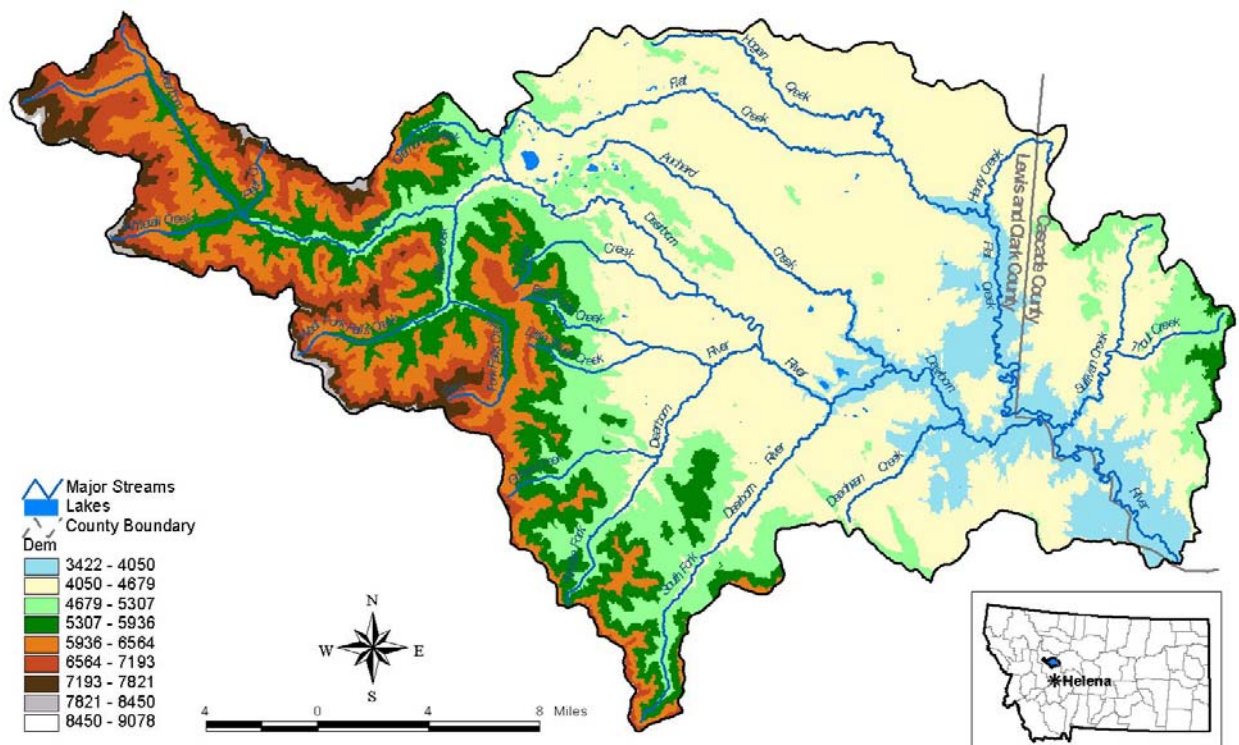
Figure 2-7. Elevation in the Dearborn River watershed.

Figure 2-7 displays the general topography within the Dearborn River TPA, and a shaded relief map of the watershed is presented in Figure 2-8. Elevations range from around 3,422 feet above mean sea level at the confluence with the Missouri River to 9,078 feet at the highest point in the watershed.

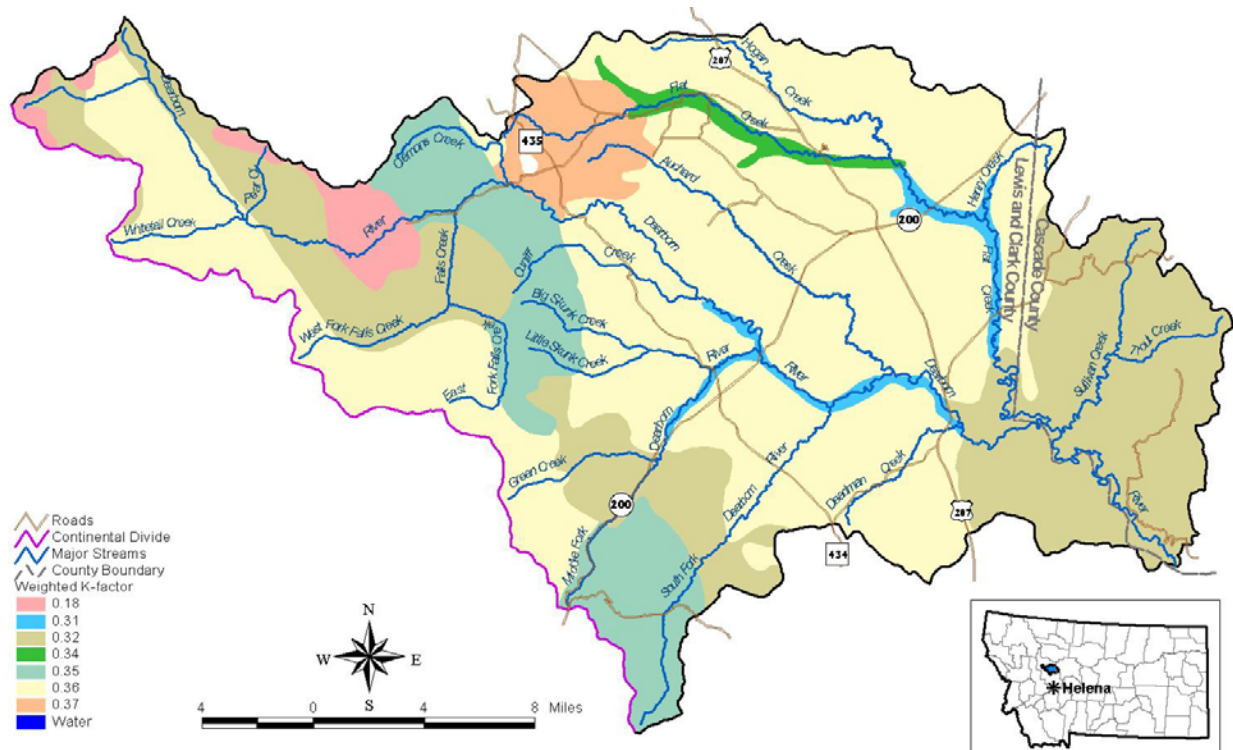
Figure 2-13. Distribution of USLE K-factor.

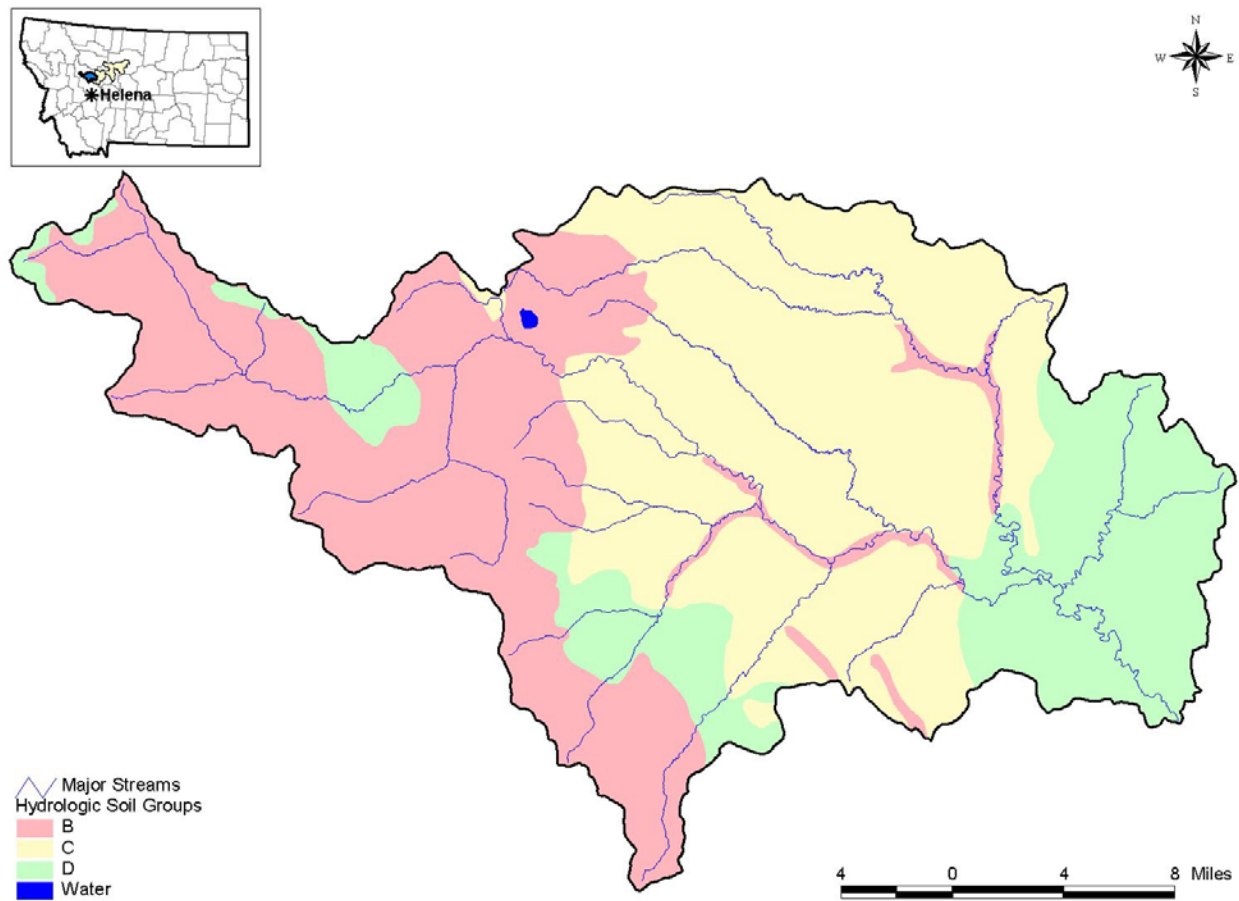
Figure 2-14. Distribution of hydrologic soil groups.

The hydrologic soil group classification is a means for grouping soils by similar infiltration and runoff characteristics during periods of prolonged wetting. Typically, clay soils that are poorly drained have the slowest infiltration rates, while sandy soils that are well drained have the fastest infiltration rates. NRCS has defined four hydrologic groups for soils. Data for the Dearborn River TPA were obtained from STATSGO and summarized based on the major hydrologic group in the surface layers of the map unit (Table 2-7) (NRCS, 2001). The resulting hydrologic soil information is displayed in Figure 2-14.

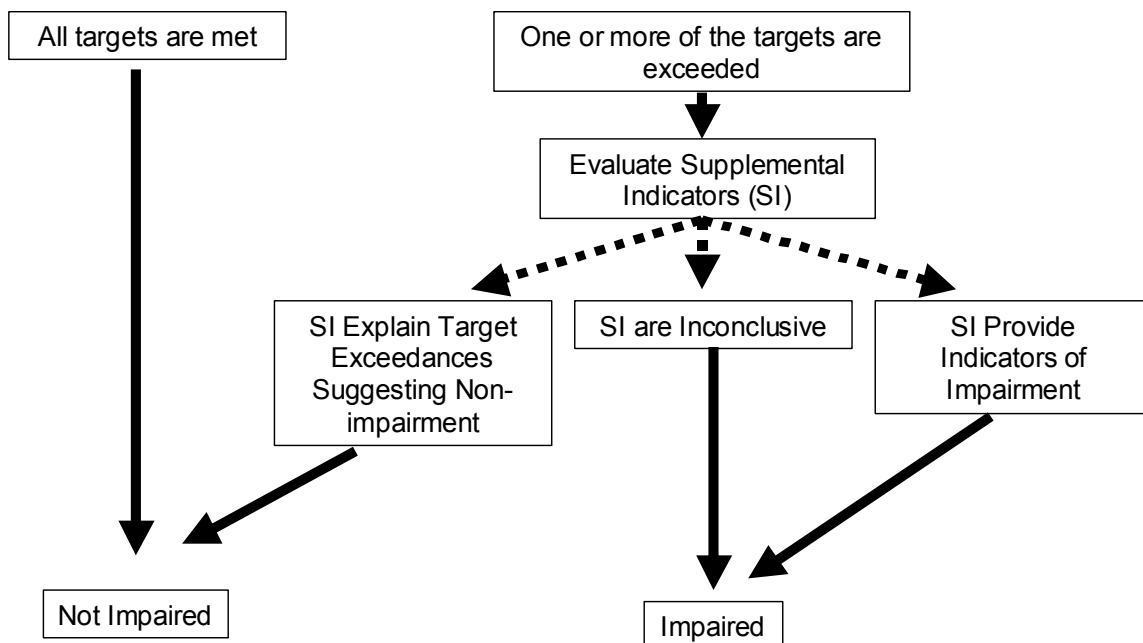
Figure 3-2. Weight-of-evidence approach for determining beneficial use impairments.

The beneficial use impairment determinations presented in Section 3.4 are based on a weight-of-evidence approach in combination with the application of best professional judgment. The weight-of-evidence approach outlined in Figure 3-2, is applied as follows. If none of the target values are exceeded, the water is considered to be fully supporting its beneficial uses and a TMDL is not required. This is true even if one or more of the supplemental indicator values are exceeded. On the other hand, if one or more of the target values are exceeded, the circumstances around the exceedance are investigated and the supplemental indicators are used to provide additional information to support a determination of impairment/non-impairment. In this case, the circumstances around the exceedance of a target value are investigated and it is not automatically assumed that the exceedance represents anthropogenic impairment (e.g., Are the data reliable and representative of the entire reach? Might the exceedance be a result of natural causes such as floods, drought, fire, or the physical character of the watershed?). This is also the case where the supplemental indicators assist by providing collaborative and supplemental information, and the weight-of-evidence of the complete suite of targets and supplemental indicators is used to make the impairment determination. A conservative approach is used if the supplemental indicators are inconclusive. When the supplemental indicators support neither impairment nor non-impairment, it is assumed that the water is impaired.

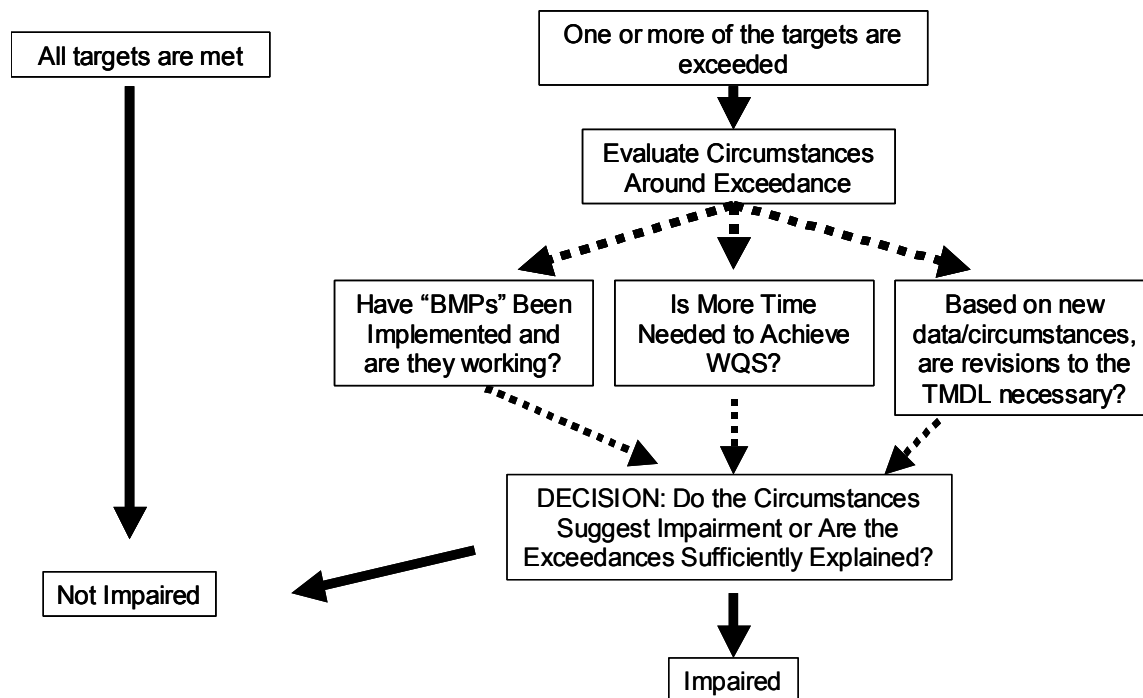
Figure 3-3. Methodology for determining compliance with water quality standards.

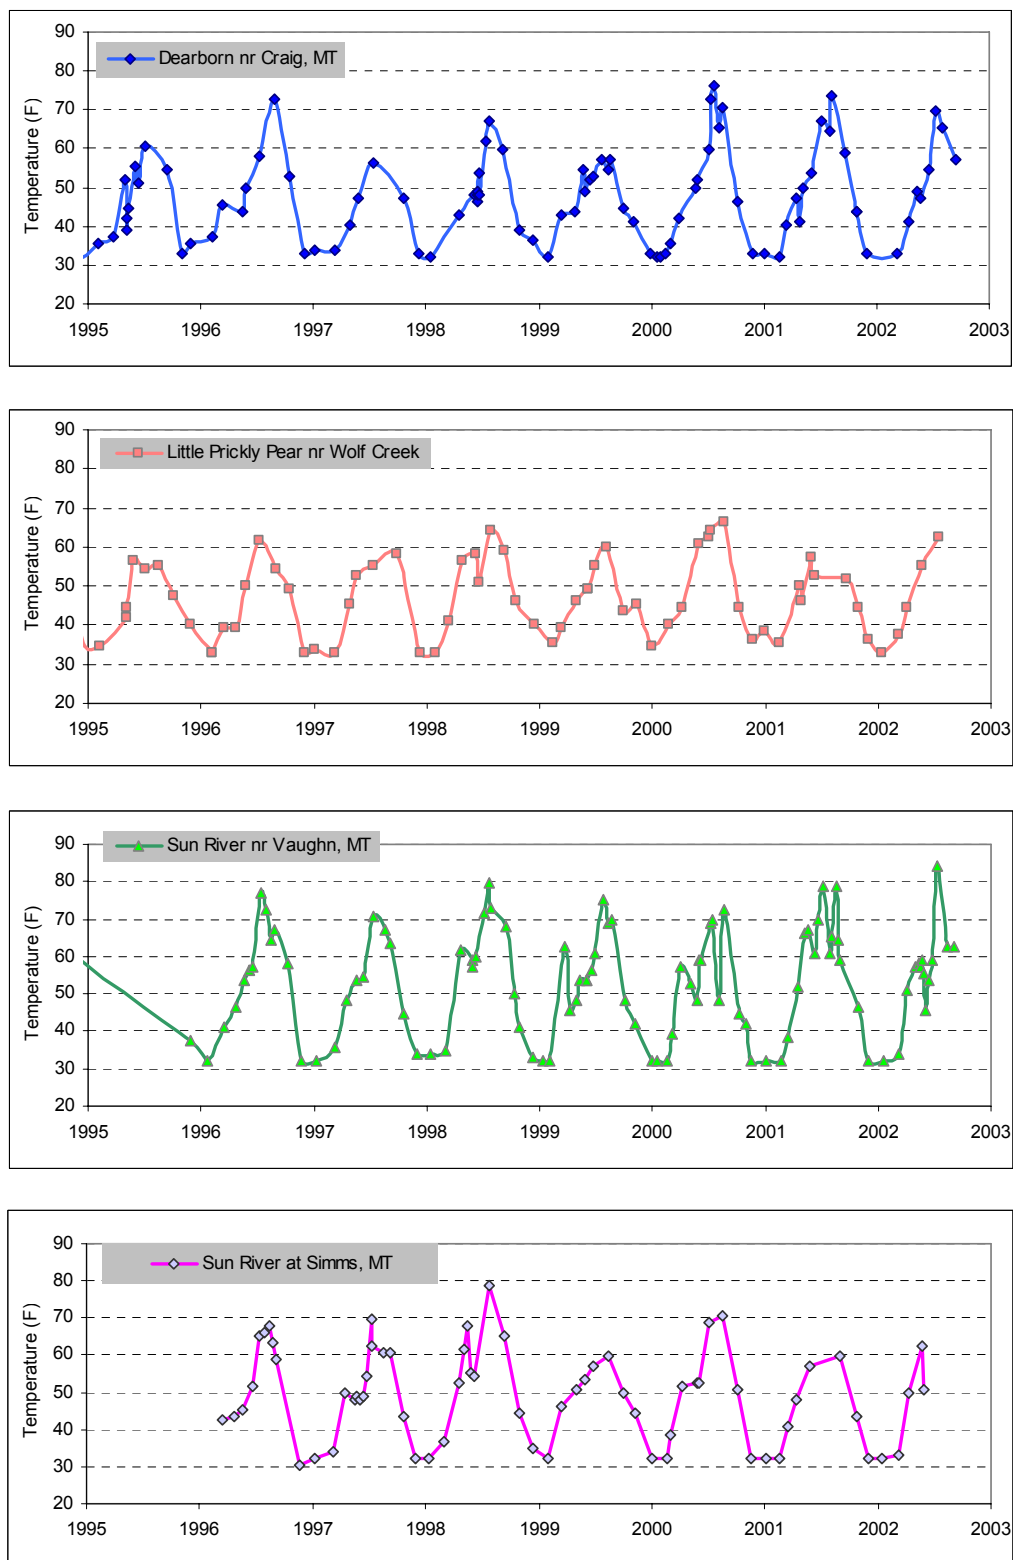
Figure 3-4. Comparison of Dearborn River temperature data to the Sun River and Little Prickly Pear Creek.

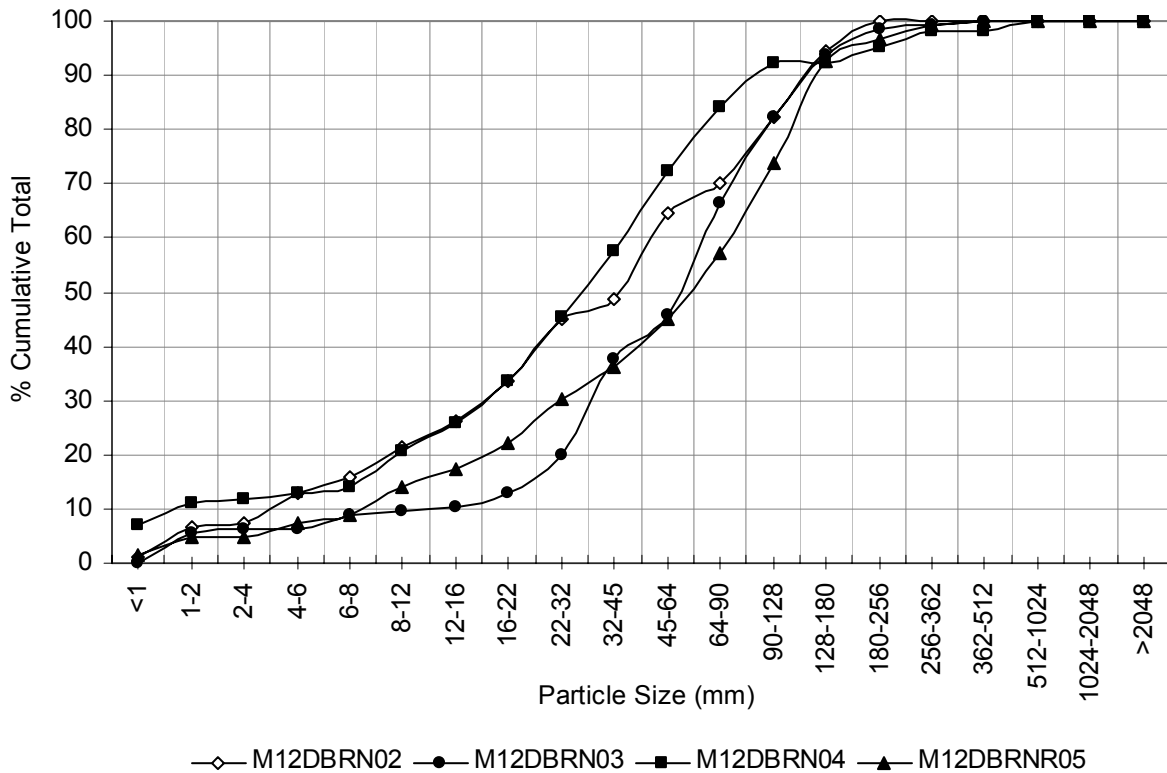
Figure 3-8. Cumulative stream bottom particle distribution for the Dearborn River.

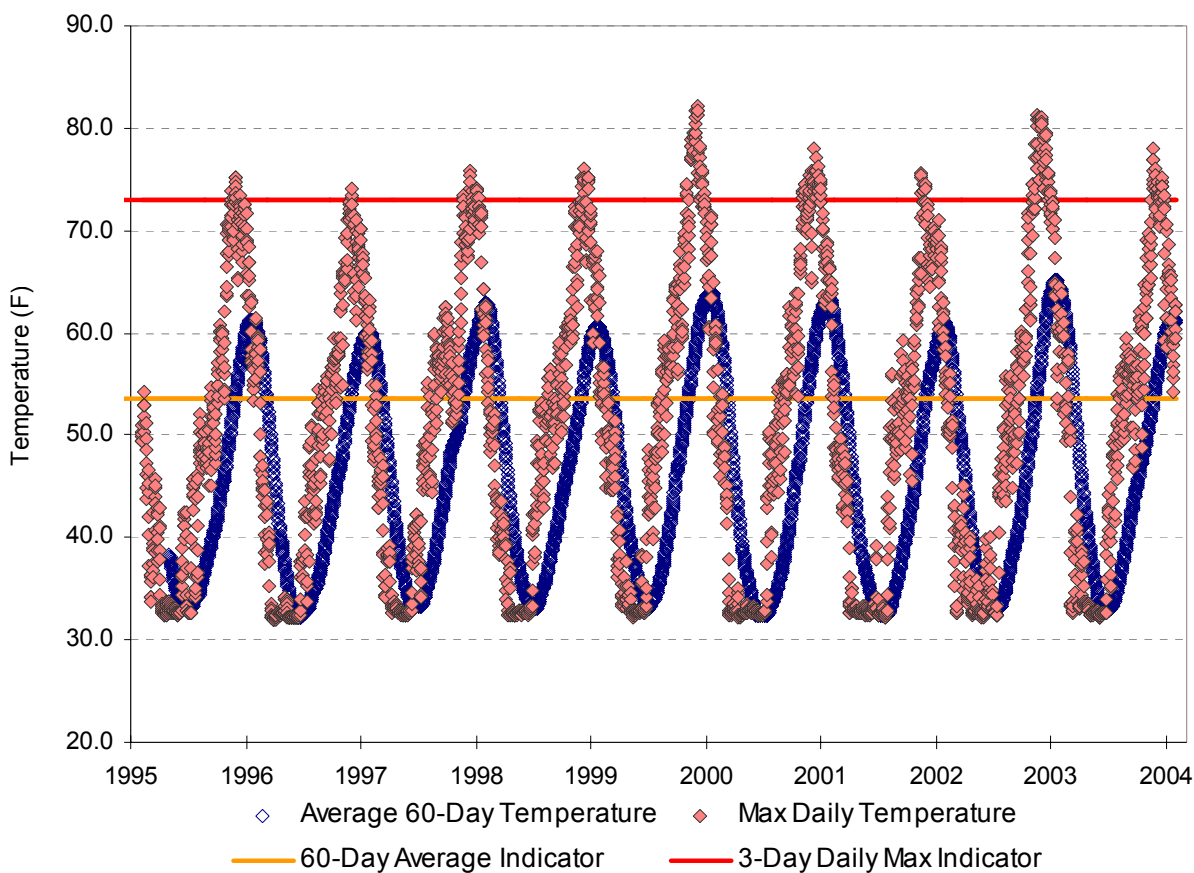
Figure 3-9. Evaluation of continuous temperature data for the Dearborn River at Highway 287 (USGS gage 06073500).

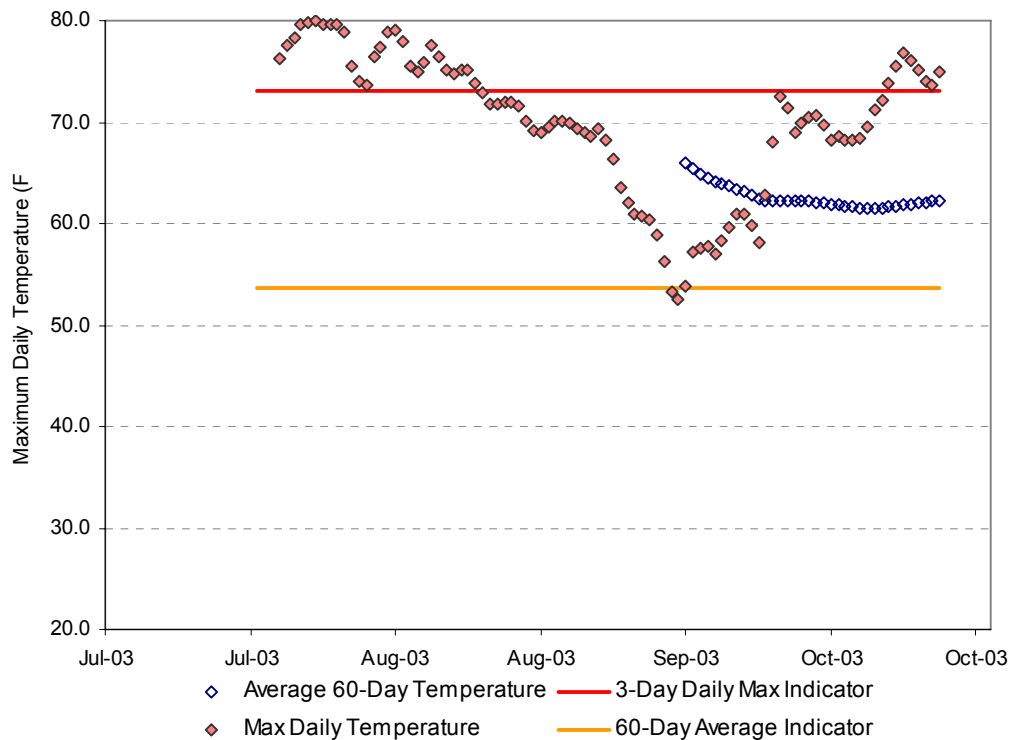
Figure 3-10. Continuous temperature evaluation for the Dearborn River downstream of Flat Creek.

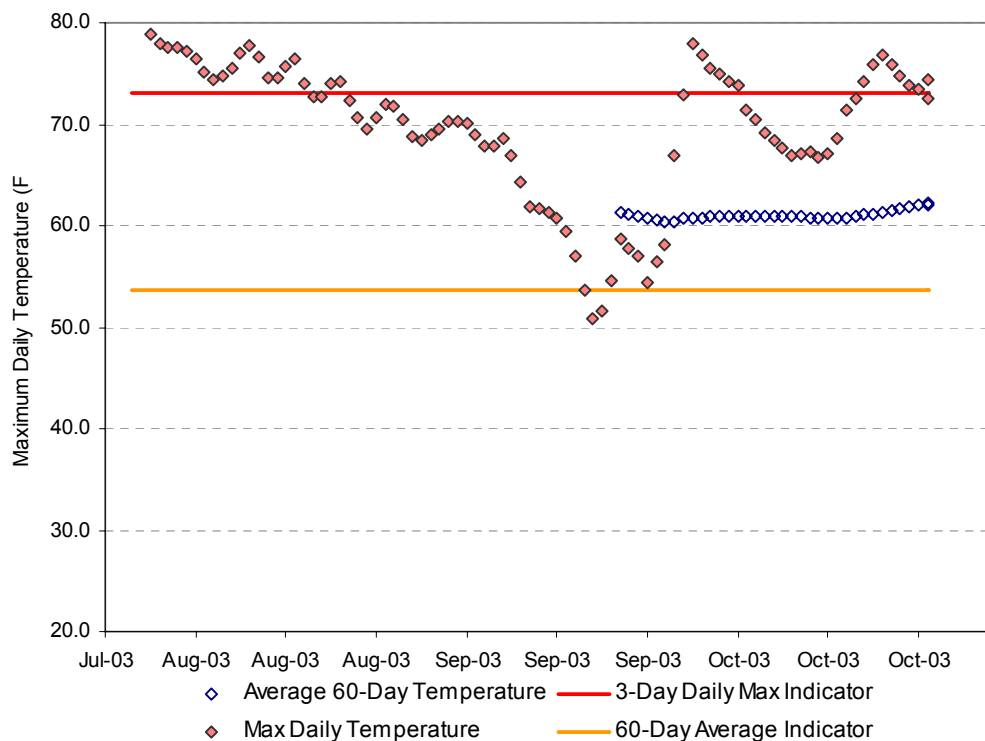
Figure 3-11. Continuous temperature evaluation for the Dearborn River at the Highway 200 Bridge.

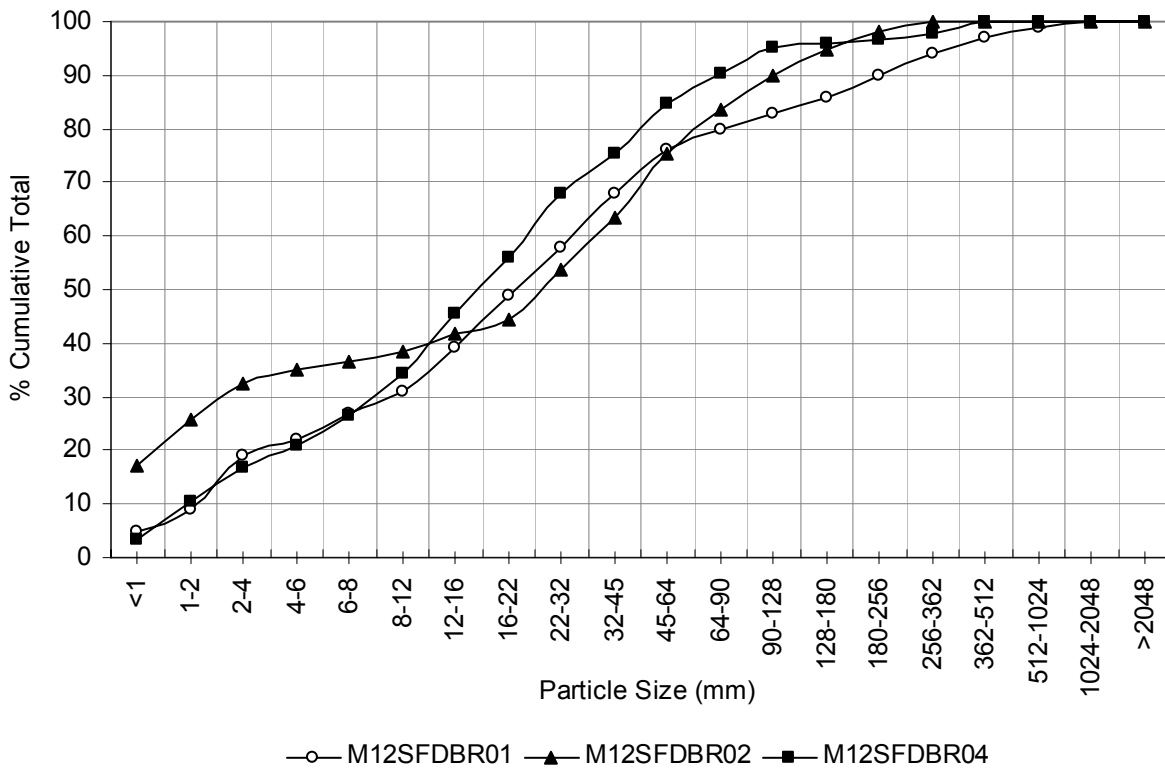
Figure 3-15. Cumulative stream bottom particle distribution for the South Fork of the Dearborn River.

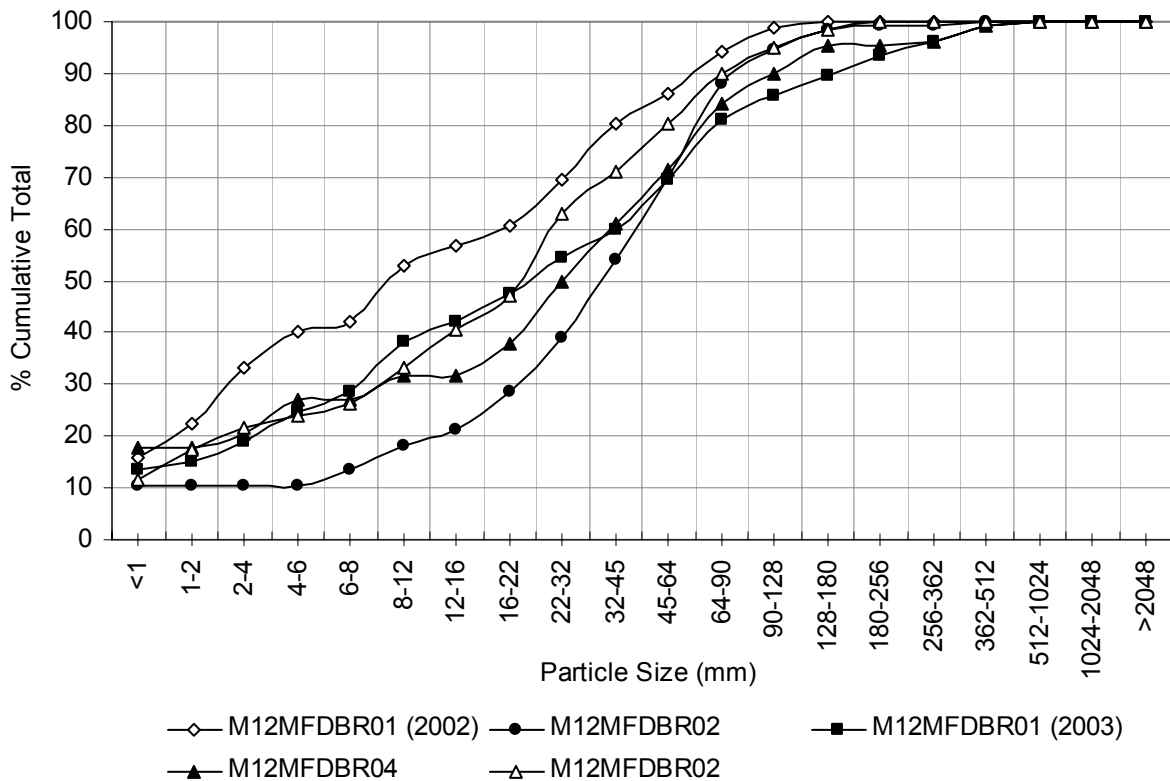
Figure 3-19. Cumulative stream bottom particle distribution for the Middle Fork of the Dearborn River.

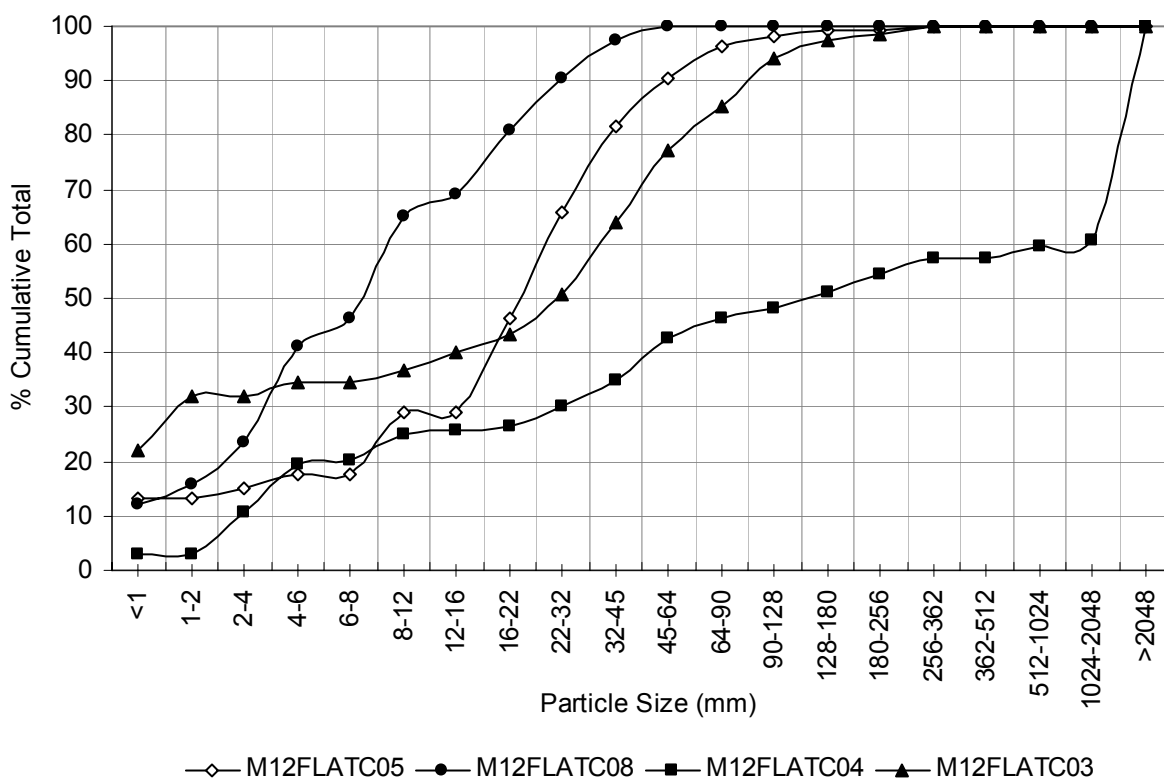
Figure 3-23. Cumulative stream bottom particle distribution for Flat Creek.

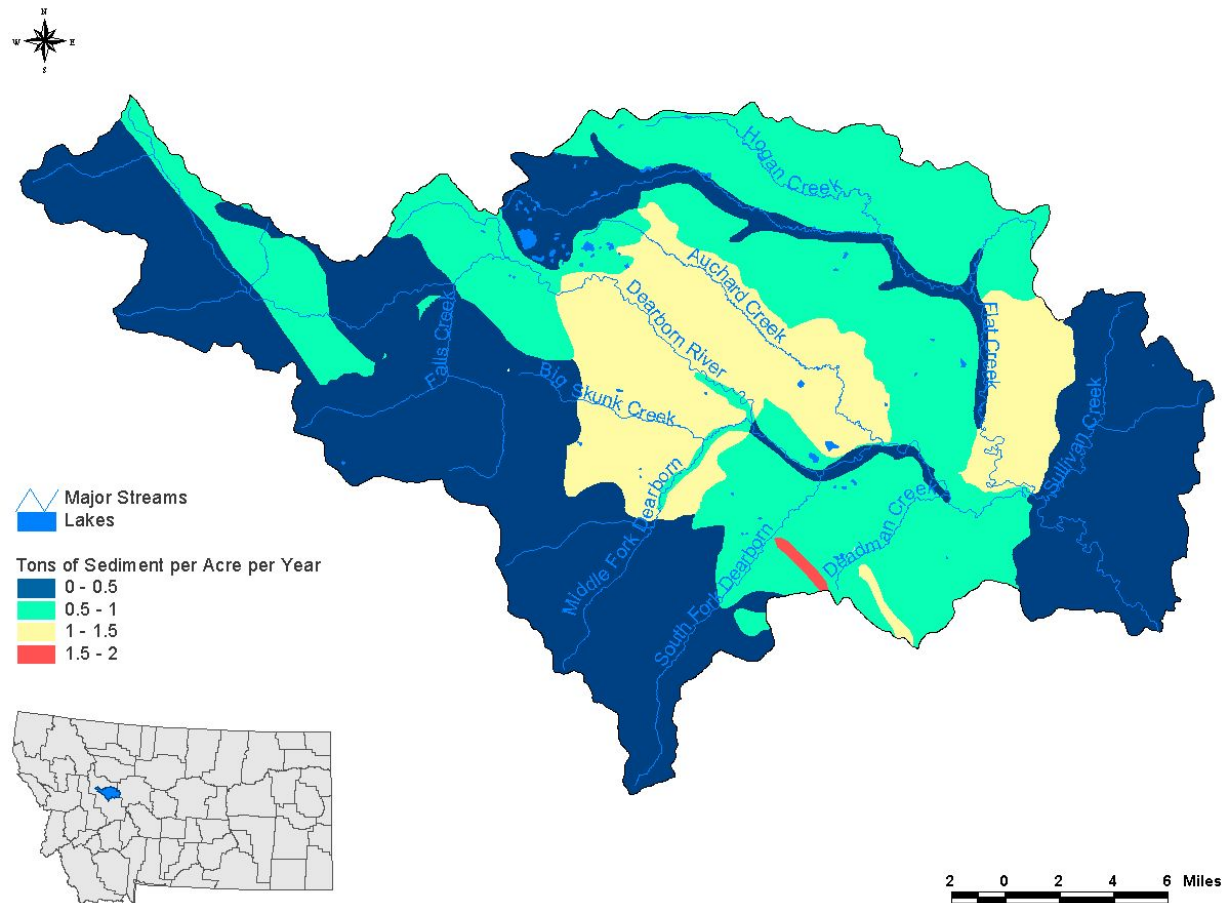
Figure 4-1. USLE soil loss in the Dearborn River watershed.

The six USLE soil factors were multiplied together for each unique polygon in the Dearborn River watershed. Annual loads and annual loads per acre were then calculated for each polygon. The results of the USLE analyses for the entire watershed are shown in Figure 4-1 and Table 4-1. The areas with the highest surface erosion were in the middle sections of the Dearborn River watershed near the Dearborn River, Auchard Creek, and Big Skunk Creek. The least amount of surface erosion was estimated to occur in the headwaters region and near the mouth of the Dearborn River near Sullivan Creek.

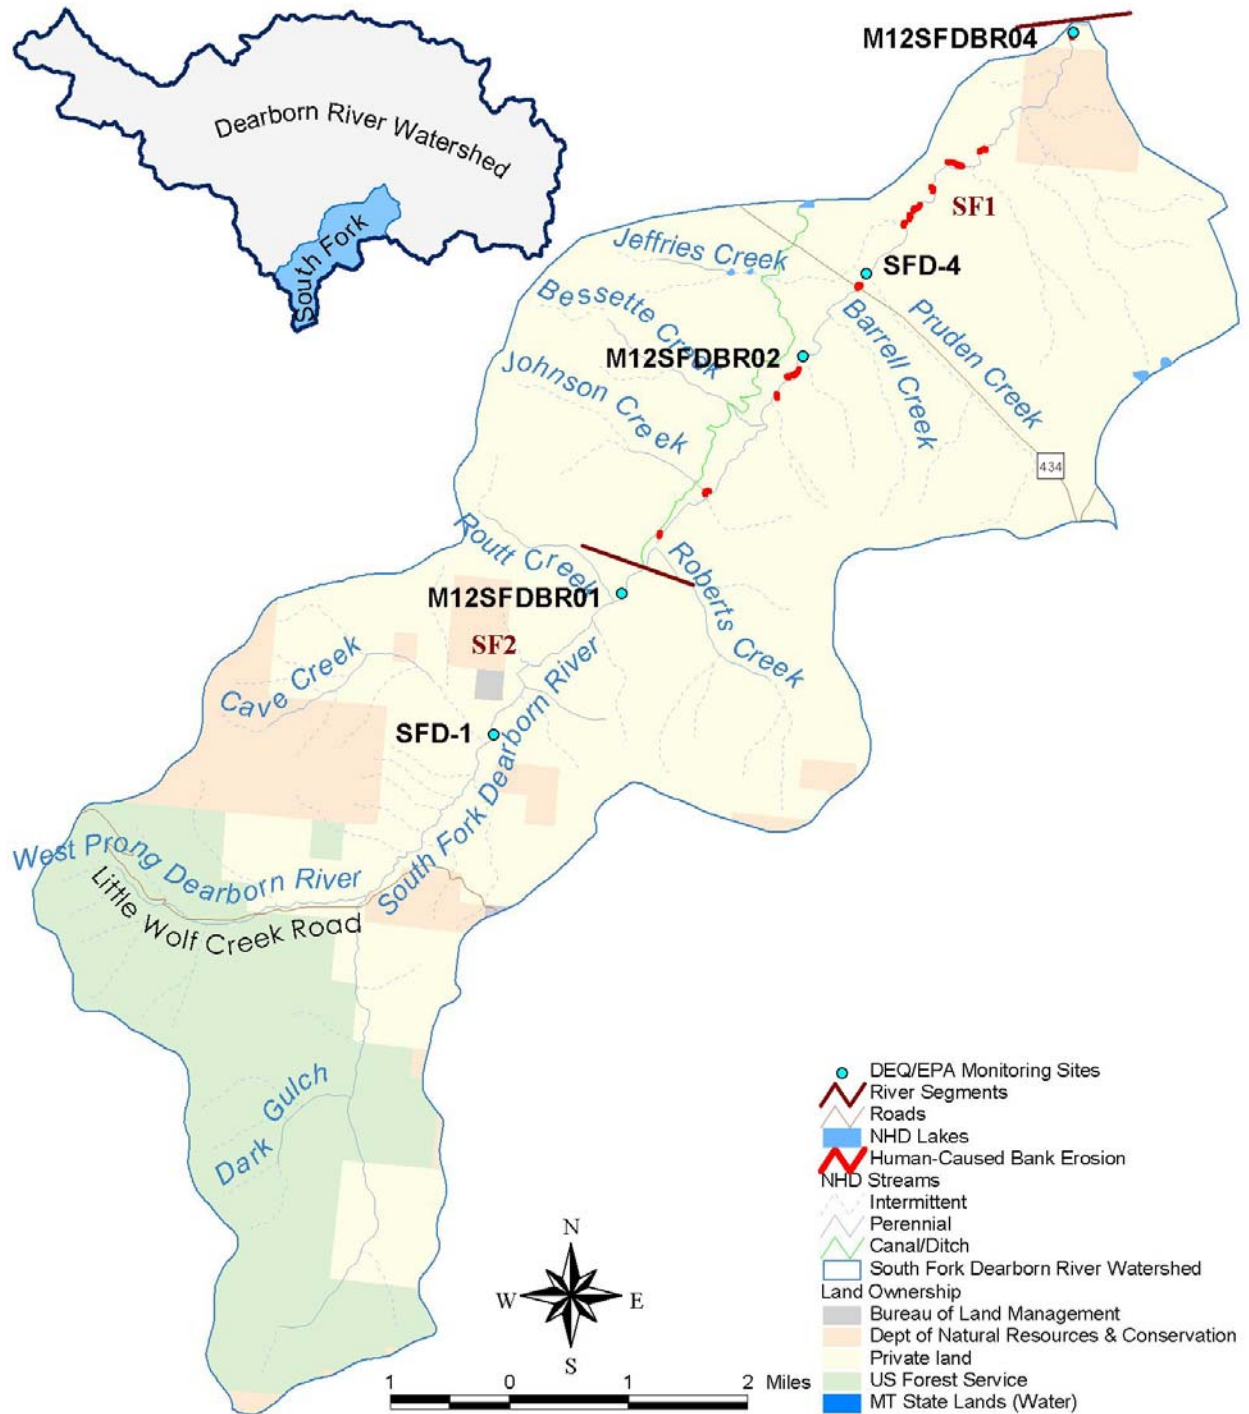
Figure 5-1. Human-caused sources of bank erosion along the South Fork Dearborn River.

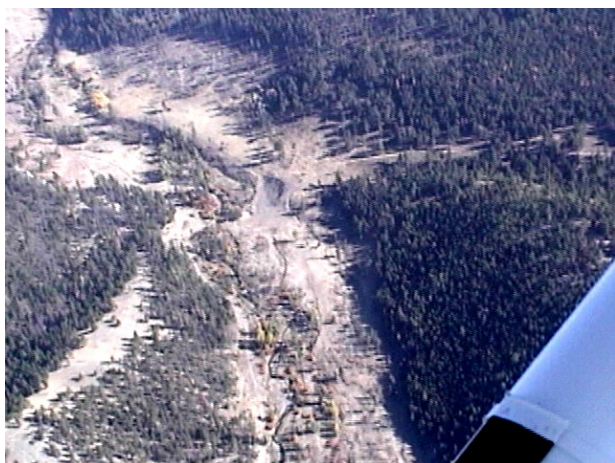
Figure 5-3. Extensive riparian clearing in the upstream section of the South Fork.

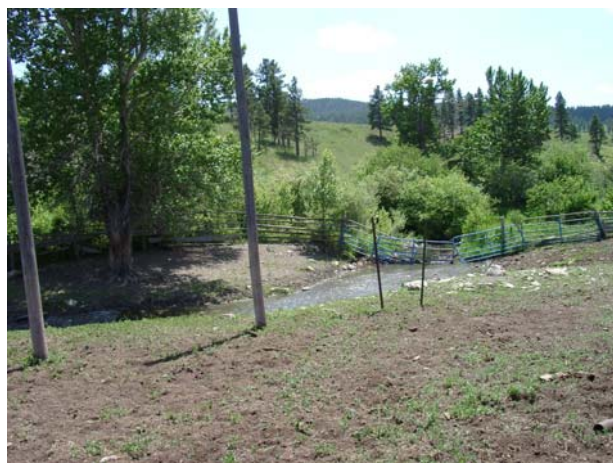
Figure 5-5. Livestock access to South Fork Dearborn River upstream of Highway 434.

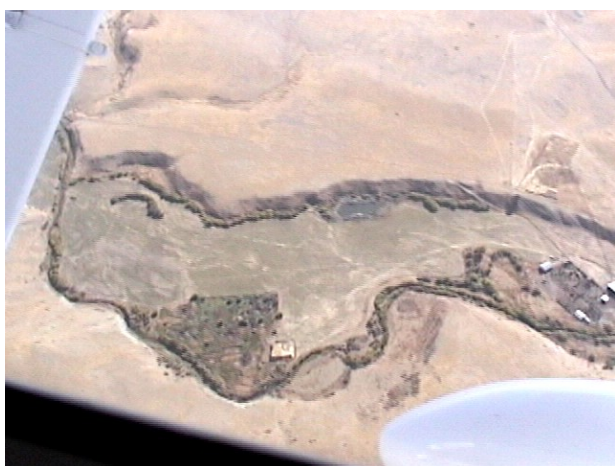
Figure 5-4. Extensive riparian clearing in the downstream section of the South Fork.

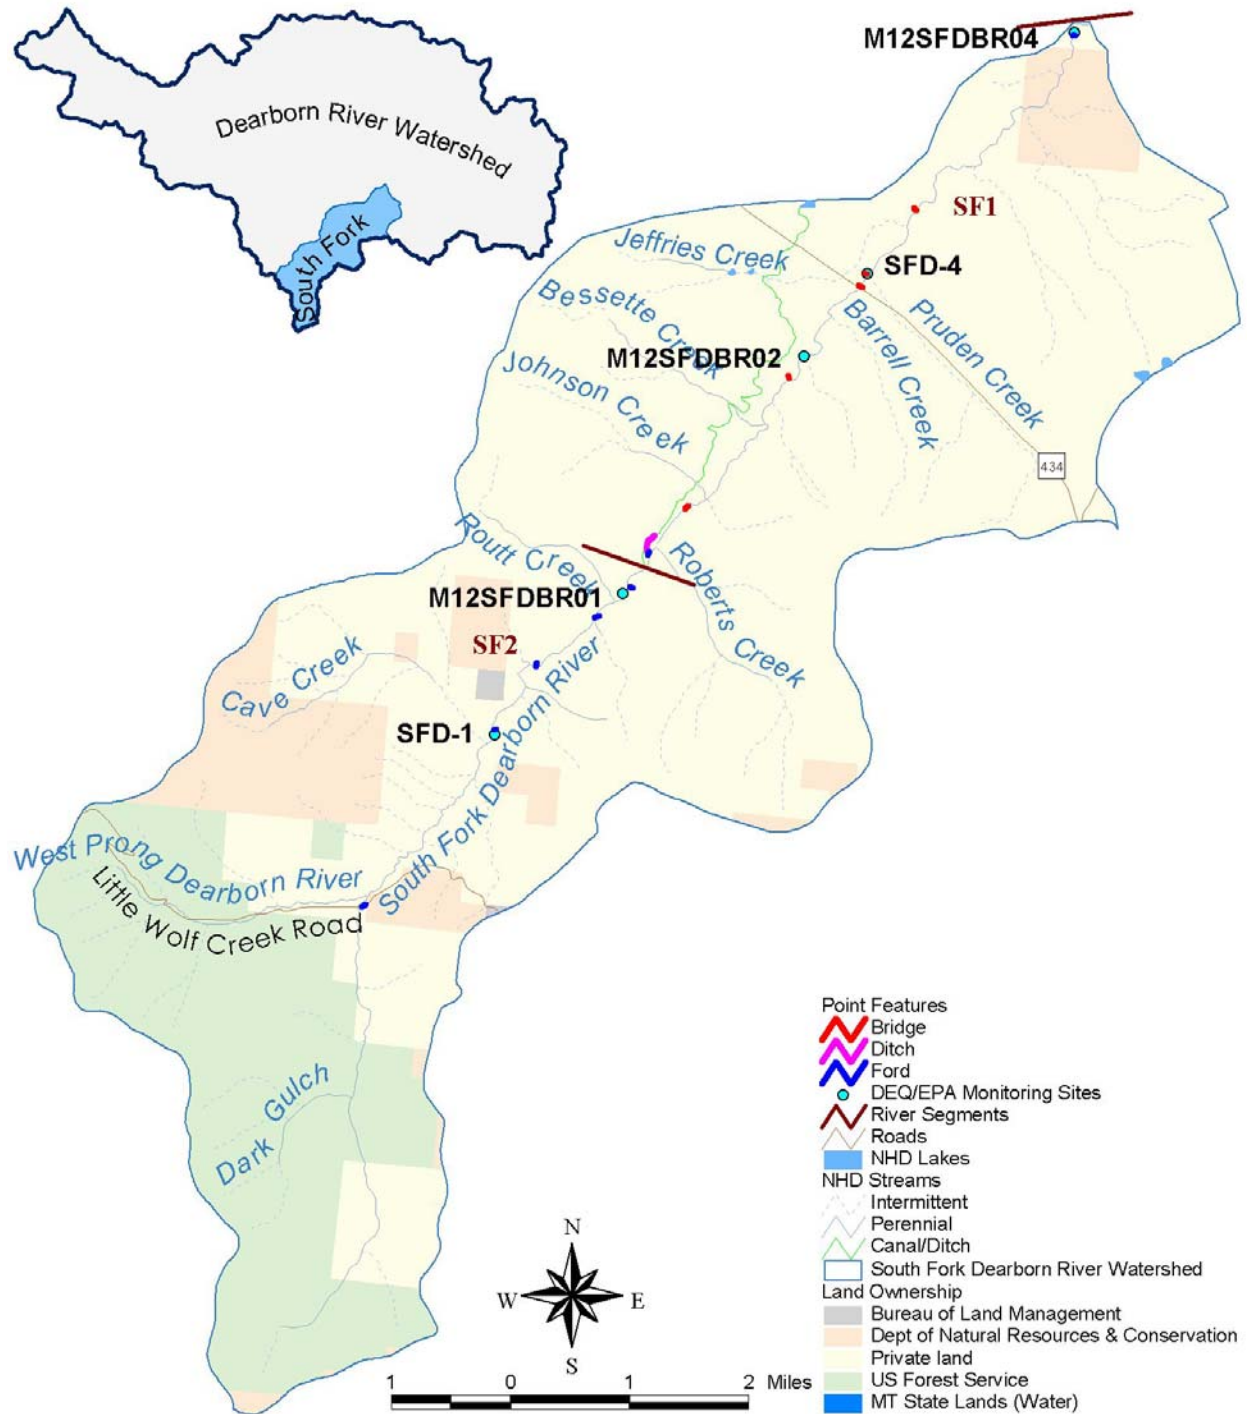
Figure 5-6. Point features along the South Fork Dearborn River.

Most other potential anthropogenic sources of sediment in the South Fork Dearborn River were not considered to be significant (Table 5-1 and Figure 5-6). Several bridges pose a potential risk of sediment loading and should be investigated during TMDL implementation (see Section 5.6). Appendix D includes detailed maps showing the locations of these bridges along with photos from the 2003 low-level aerial assessment. The maps are intended to facilitate additional investigations and the placement of best management practices by identifying precisely the locations of high priority sites.

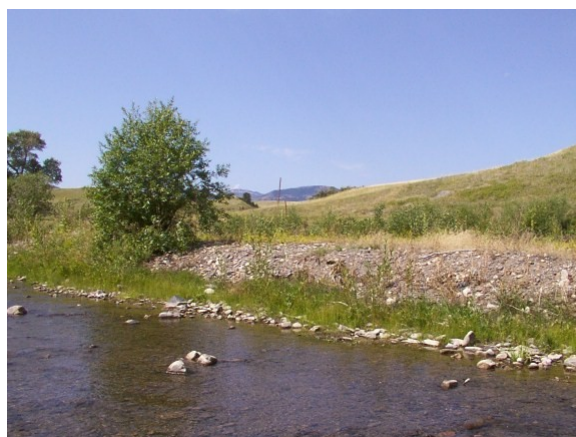
Figure 5-13. Lack of riparian vegetation along Middle Fork Dearborn River near confluence with Skunk Creek.

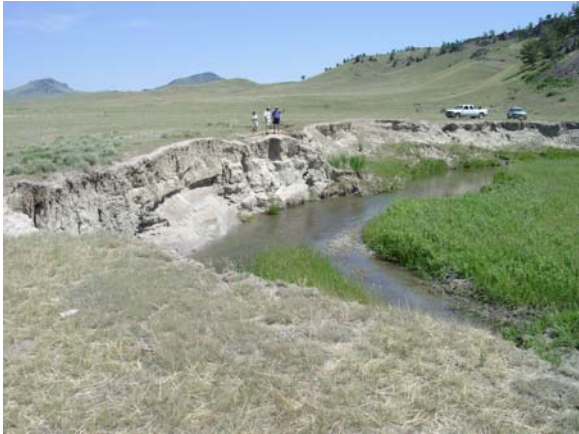
Figure 5-17. Bank erosion in lower Flat Creek.

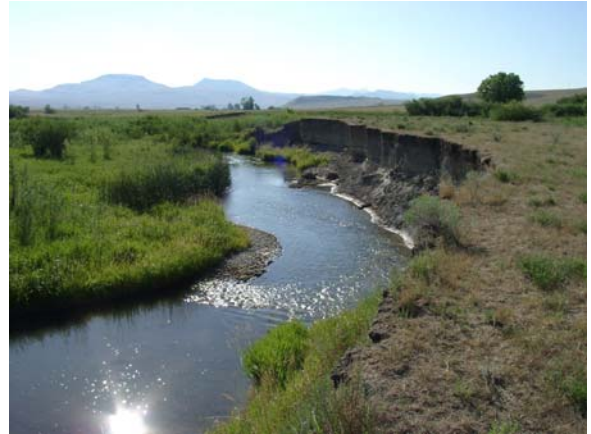
Figure 5-19. Bank erosion upstream of Highway 200.
