Grave Creek Watershed Water Quality and Habitat Restoration Plan and Sediment Total Maximum Daily Loads

March 2005

ERRATA SHEET FOR THE GRAVE CREEK WATERSHED WATER QUALITY AND HABITAT RESTORATION PLAN AND SEDIMENT TOTAL MAXIMUM DAILY LOADS

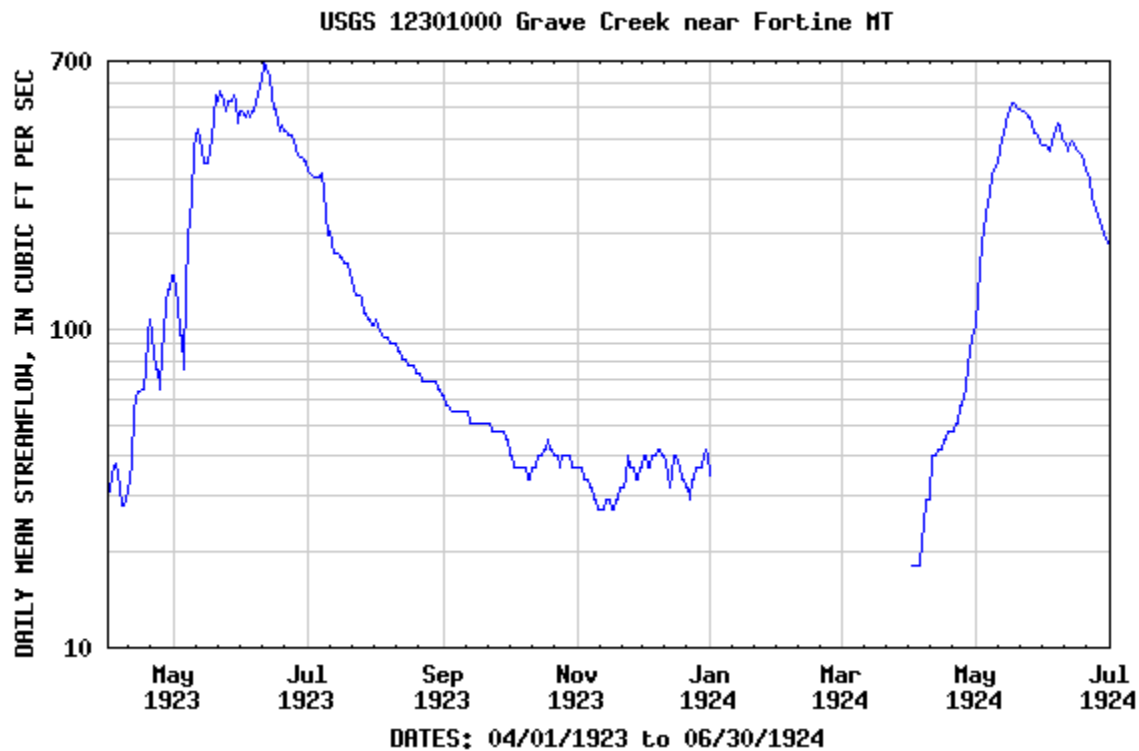
Figure 2-1: Grave Creek Hydrograph for April 1, 1923 through June 30, 1924 (Data Missing from January through April 1, 1924).

The United States Geological Survey (USGS) maintained a streamflow gaging station on Grave Creek from April 1, 1923 through June 30, 1924 (Figure 2-1). The limited period of records is not sufficient to conduct standard flood frequency analyses. The Montana Fish Wildlife and Parks (FWP) has also collected discrete flow data in lower Grave Creek, but this data is also insufficient for conducting a flood frequency analyses.

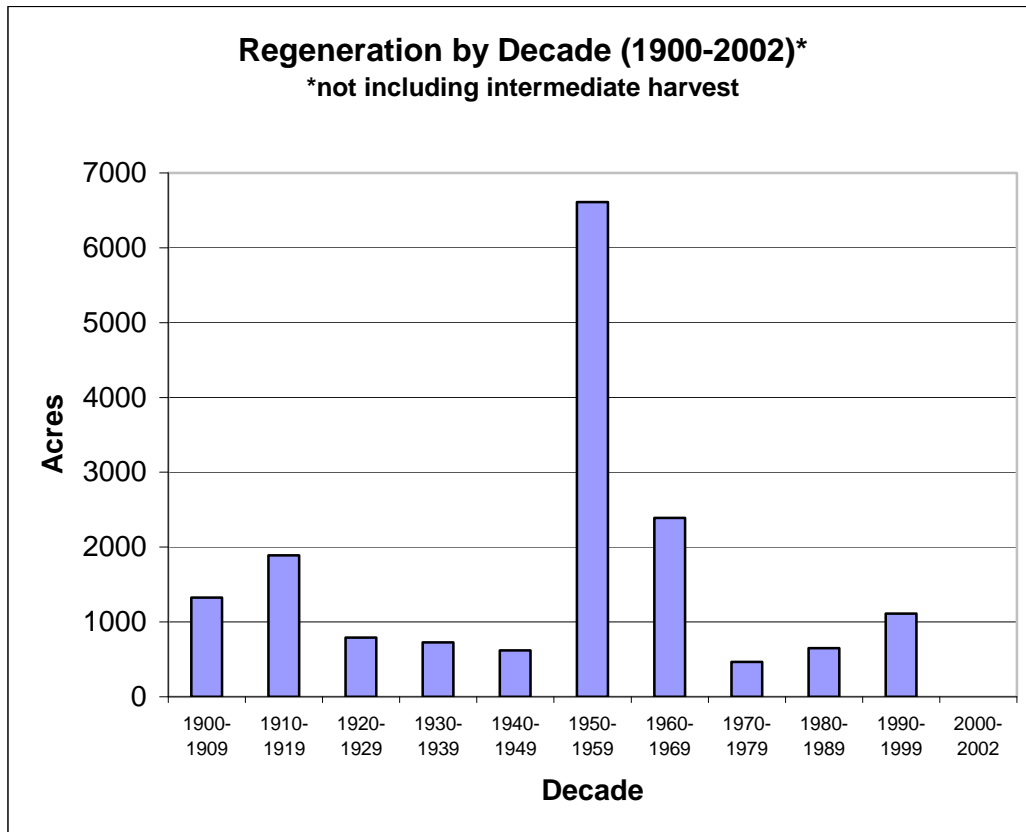
Figure 2-2: Acres of Regenerating Disturbance by Decade Over the 20th Century. The peak in the 1950s and 1960s is from spruce beetle logging; the higher figure from the 1990s is almost entirely attributable to the 1988 fire in Blue Sky drainage (1,040 acres burned). (Only US Forest Service ownership calculated, based on stand database query of year origin per decade) (USFS, 2002).

The management of the spruce bark beetle epidemic changed the character of the entire Grave Creek basin. In the 1950s and 1960s, large-scale logging was initiated in response to the spruce bark beetle infestation that affected northwestern Montana and Idaho. A timber salvage program was implemented to remove decaying trees and portions of the forest expected to succumb to the beetle infestation (USFS, 2002). Large (dominant trees 15 inch to 21 inch DBH) and very large (dominant trees >21 inch DBH) Engelmann spruce (*Picea engelmannii*) and alpine fir (*Abies lasiocarpa*) were removed from the headwaters of most of the primary tributaries in the watershed (Figure 2-2).

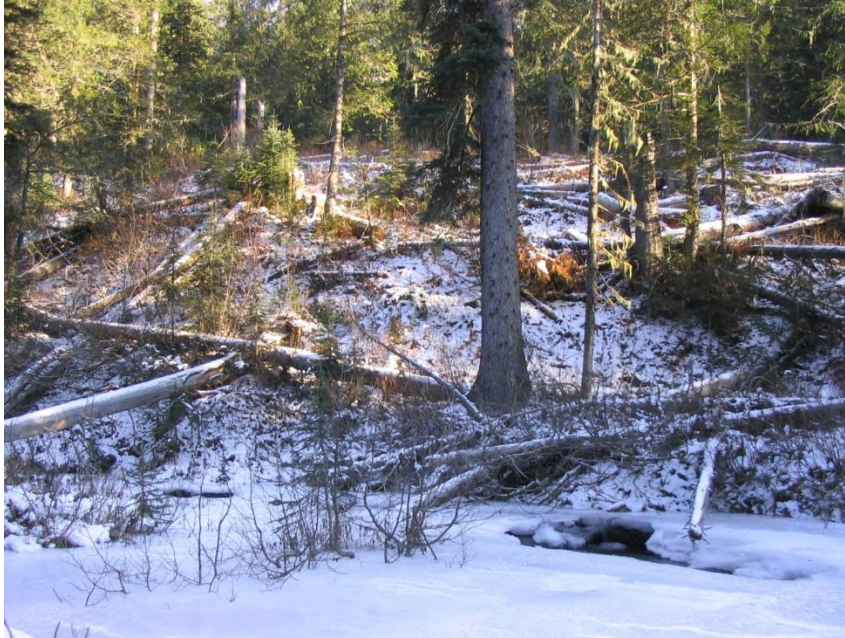
Photo 1: Clarence Creek – Riparian Harvest

may not have occurred in the portion of the stand that is within the riparian buffer as discussed in Appendix A. Nevertheless, harvest did occur in riparian areas as noted later in the assessment of mass wasting events in Section 6.0 and as shown by Photos 1 and 2.

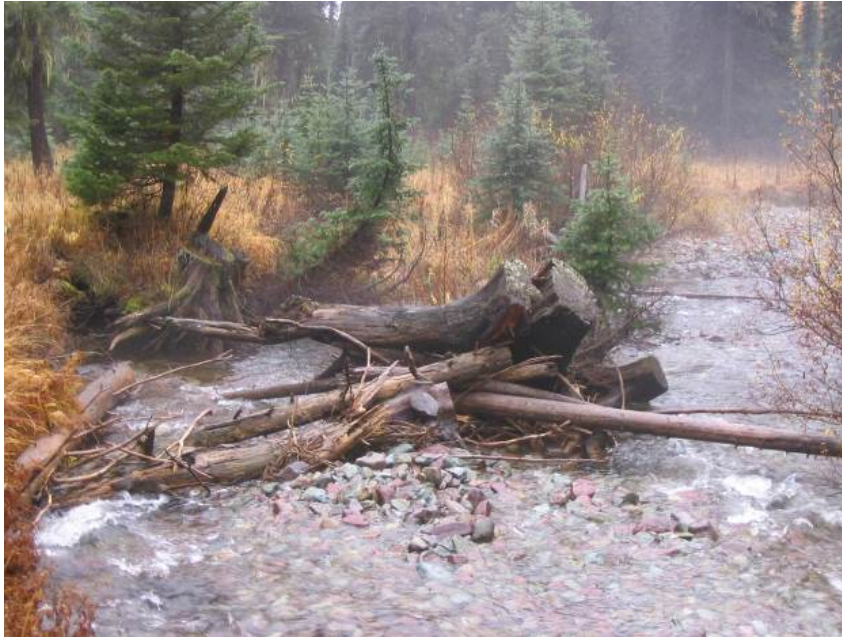
Photo 3: Main Stem Middle - Cut logs In-Stream - Marginal Habitat

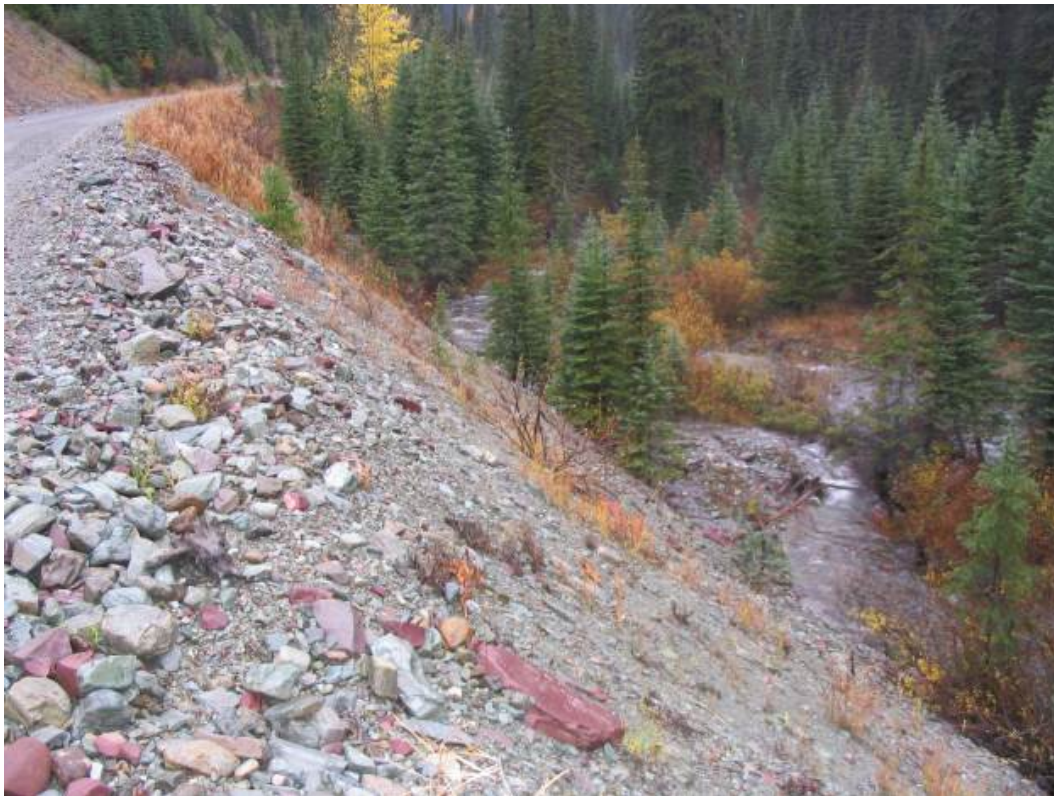
Photo 6: Main Stem Upper - Road Fill Road Encroachment

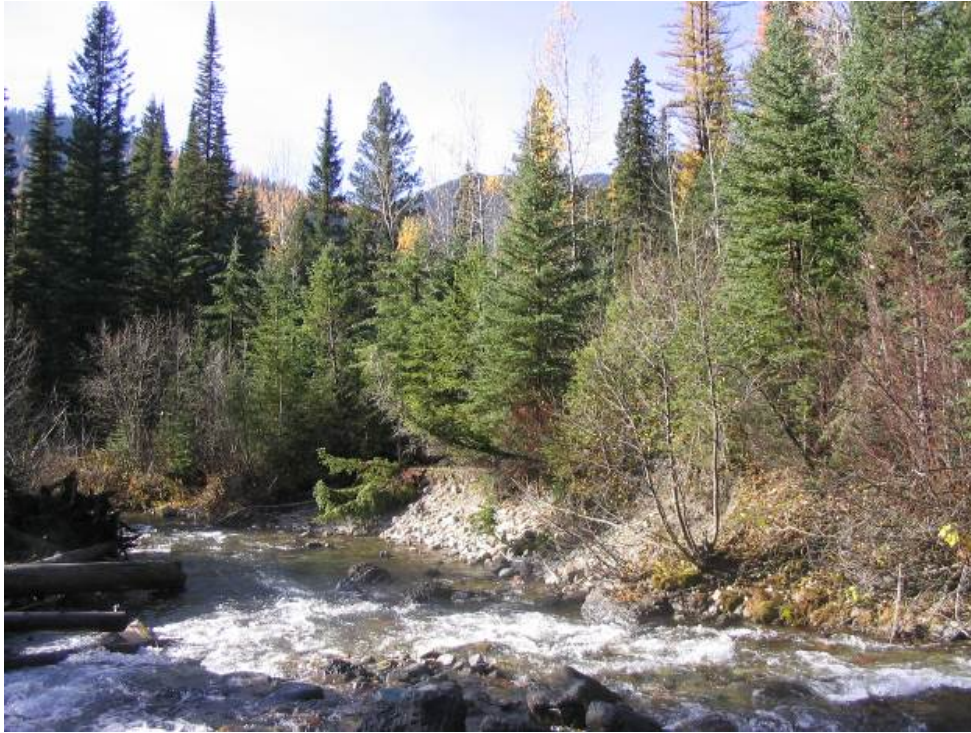
Photo 7: Main Stem Upper - Bank Erosion

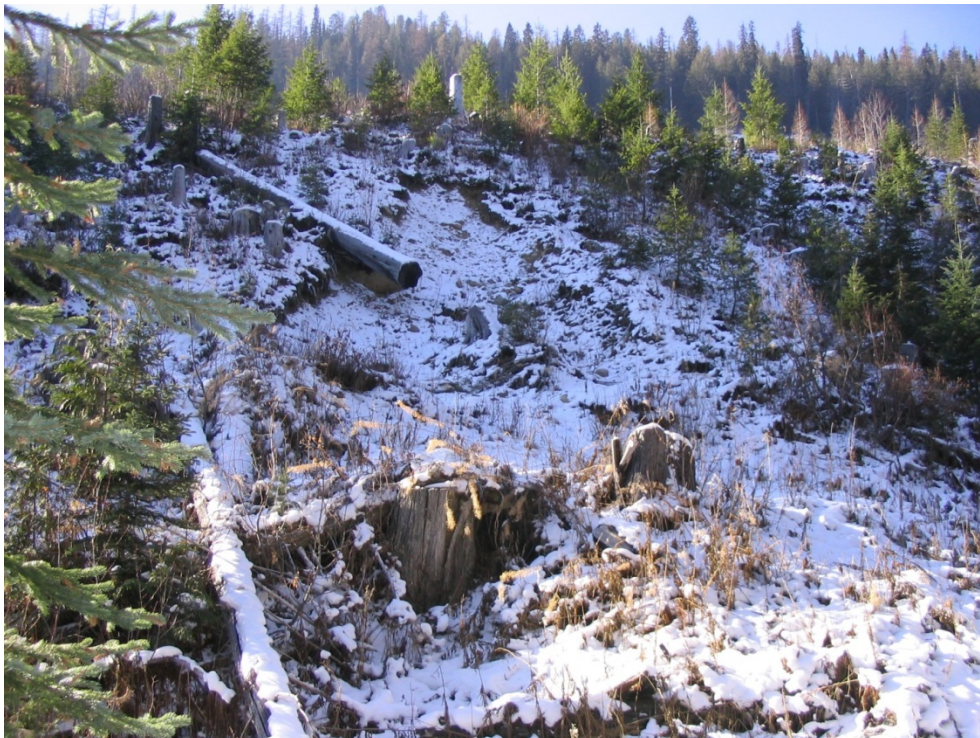
Photo 8: Stahl Creek - Riparian Harvest with No Buffer and with Mass Wasting

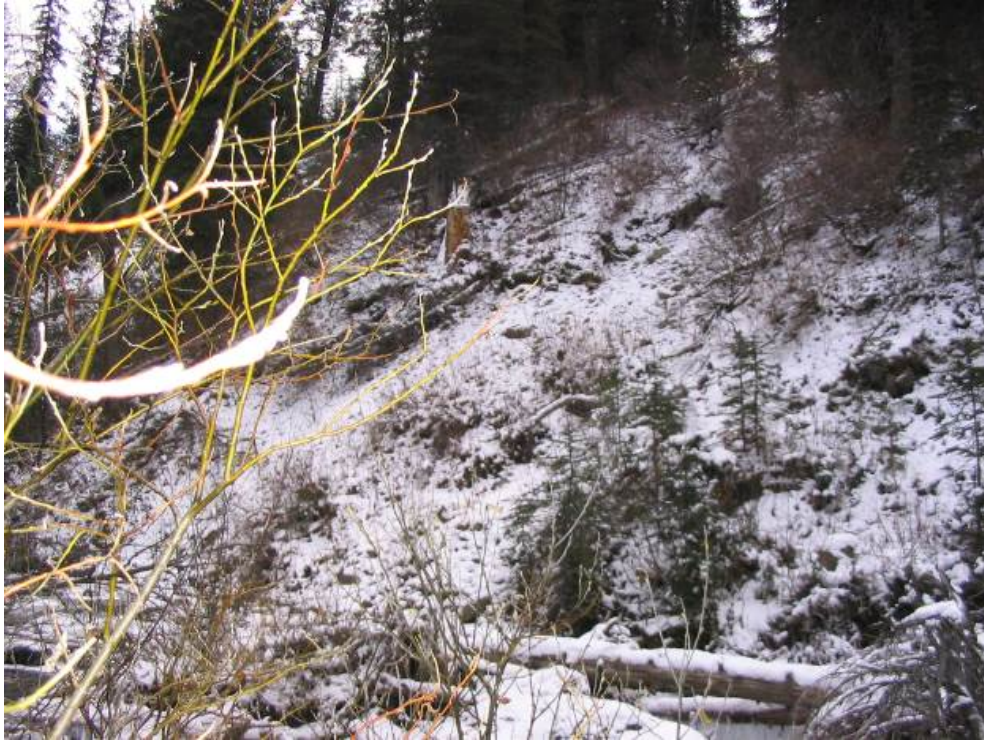
Photo 9: Blue Sky - Riparian Modification and Mass Wasting

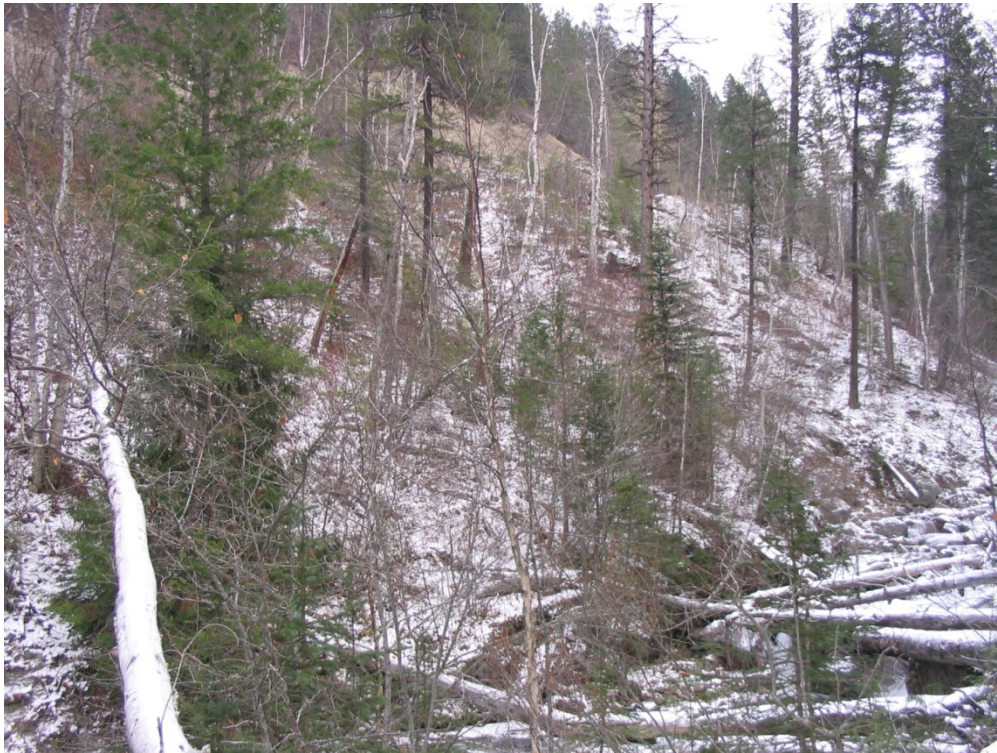
Photo 10: Williams - Road Encroachment and Riparian Harvest with Mass Wasting

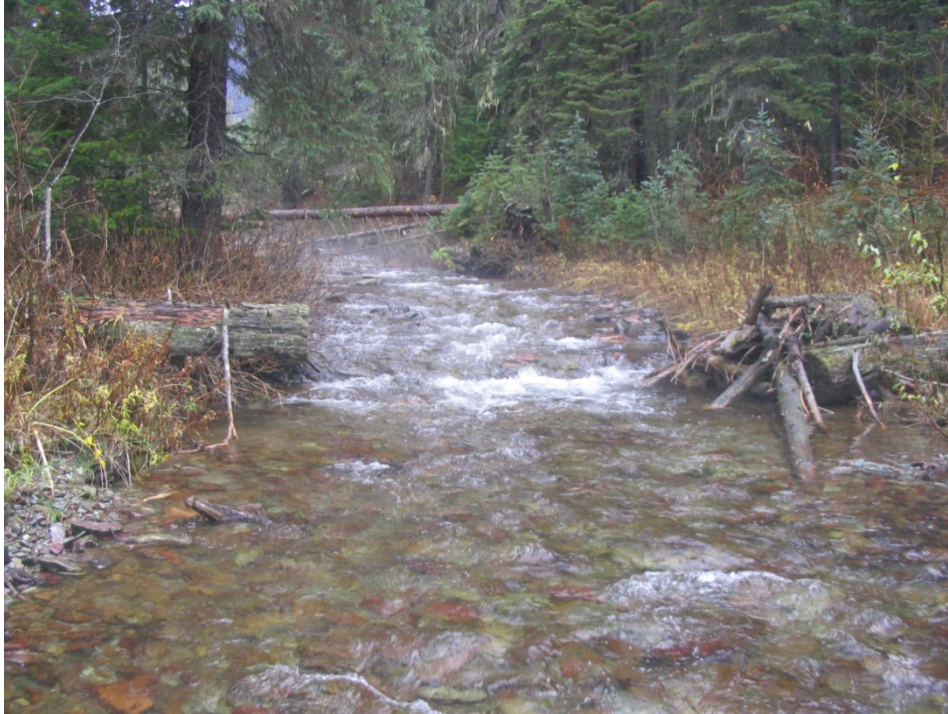
Photo 11: Main Stem Upper - Example of In-Stream LWD Removal

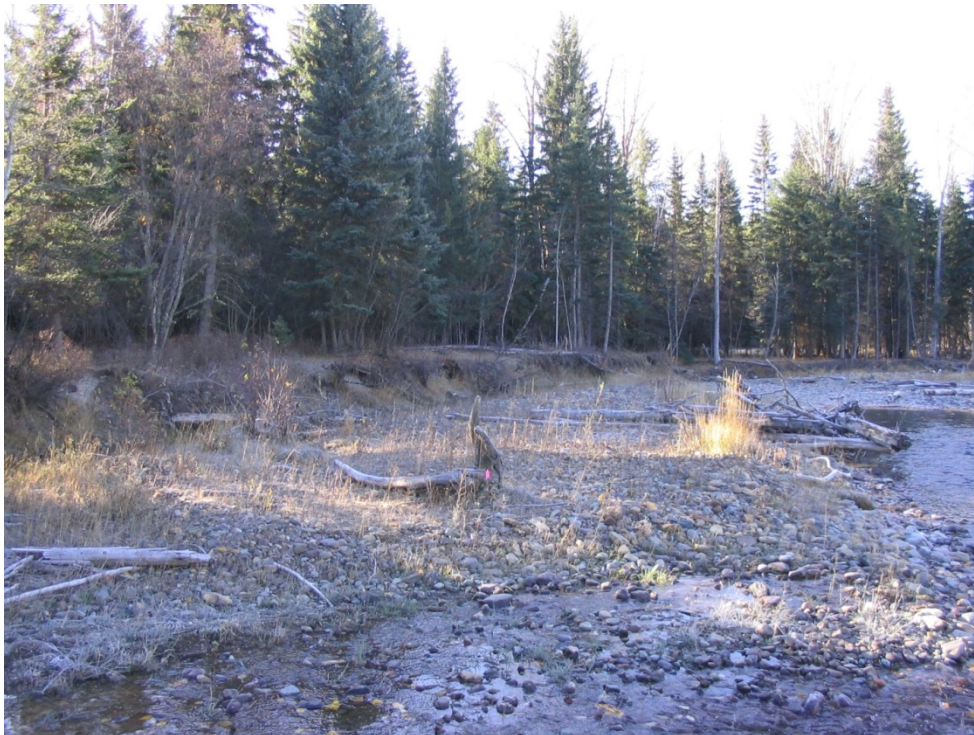
Photo 12: Main Stem Lower Below Canyon - Bank Erosion and Evidence of Aggradation

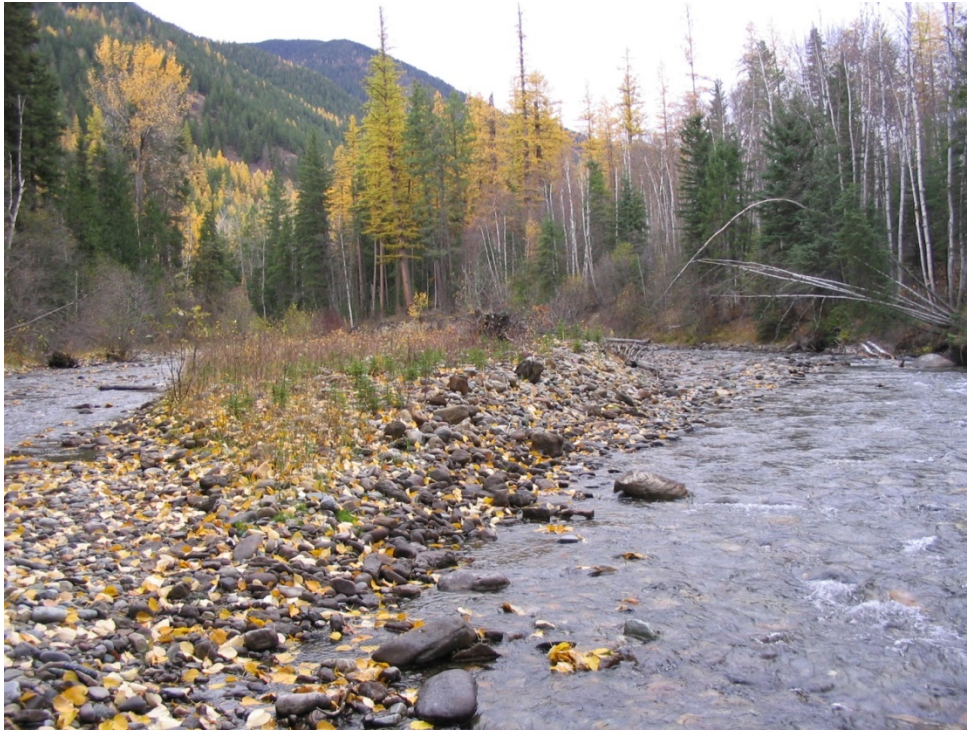
Photo 13: Main Stem Lower Above Canyon – Evidence of Aggradation

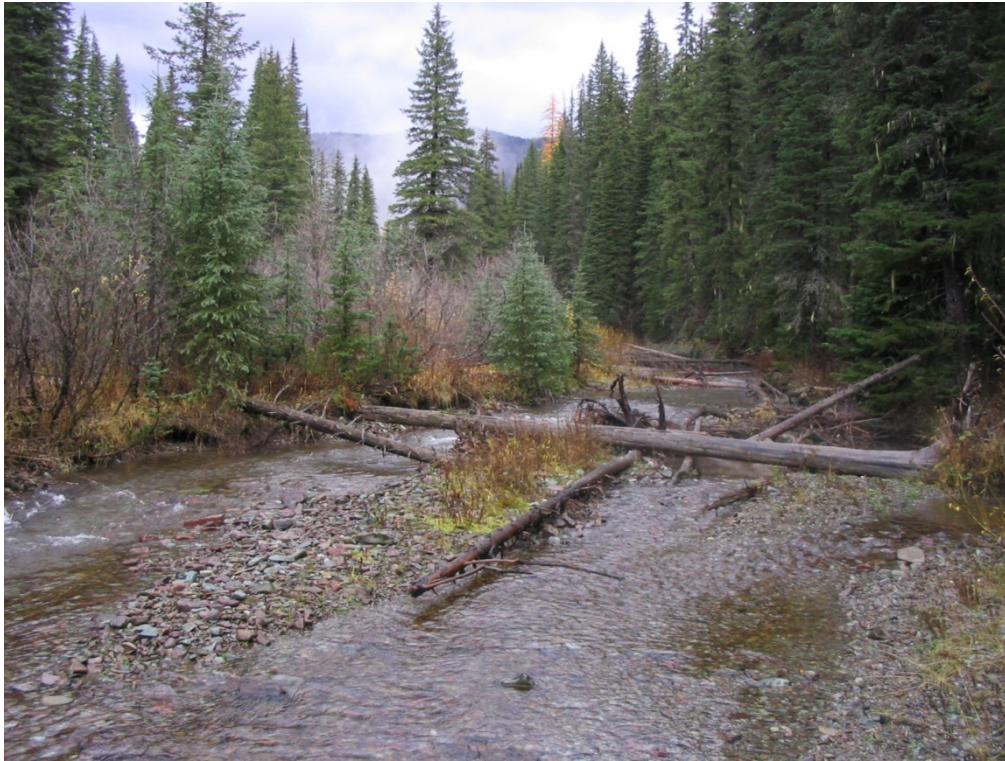
Photo 15: Main Stem Upper – Mid-Channel Bar, Evidence of Possible Aggradation

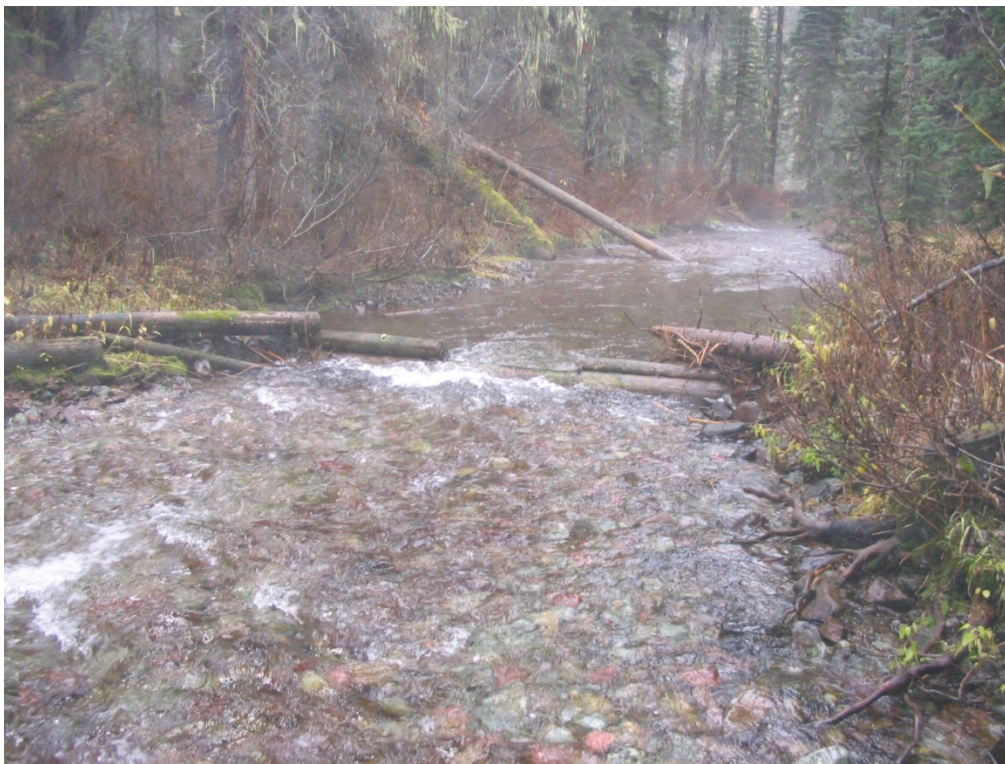
Photo 16: Main Stem Upper - Check Dam

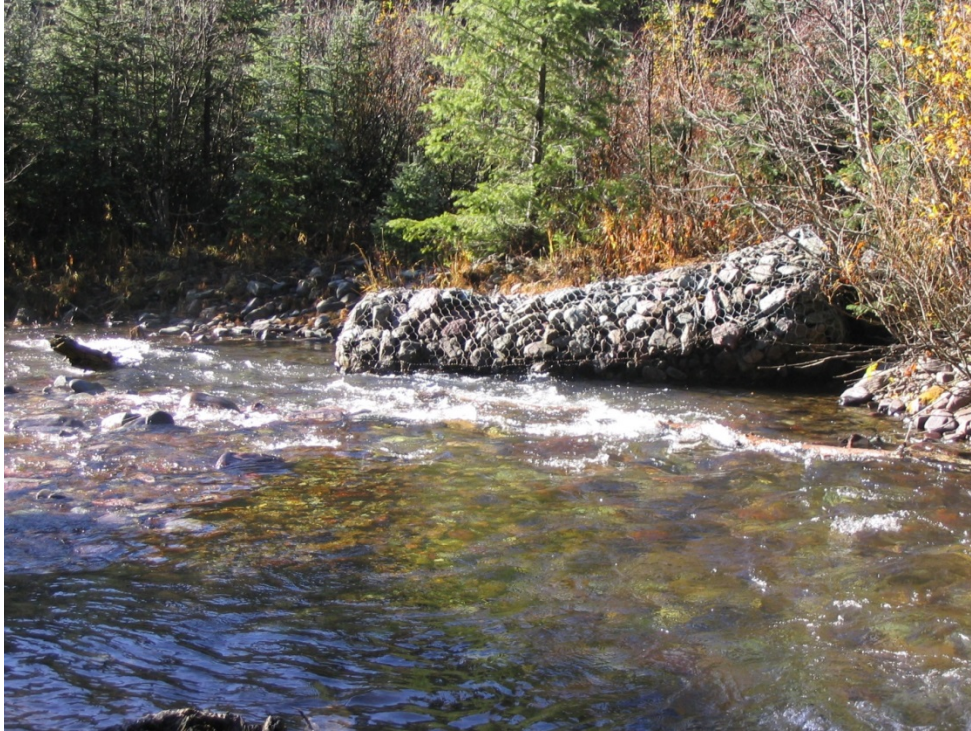
Photo 17: Main Stem Upper - Gabion for Fill Slope Protection

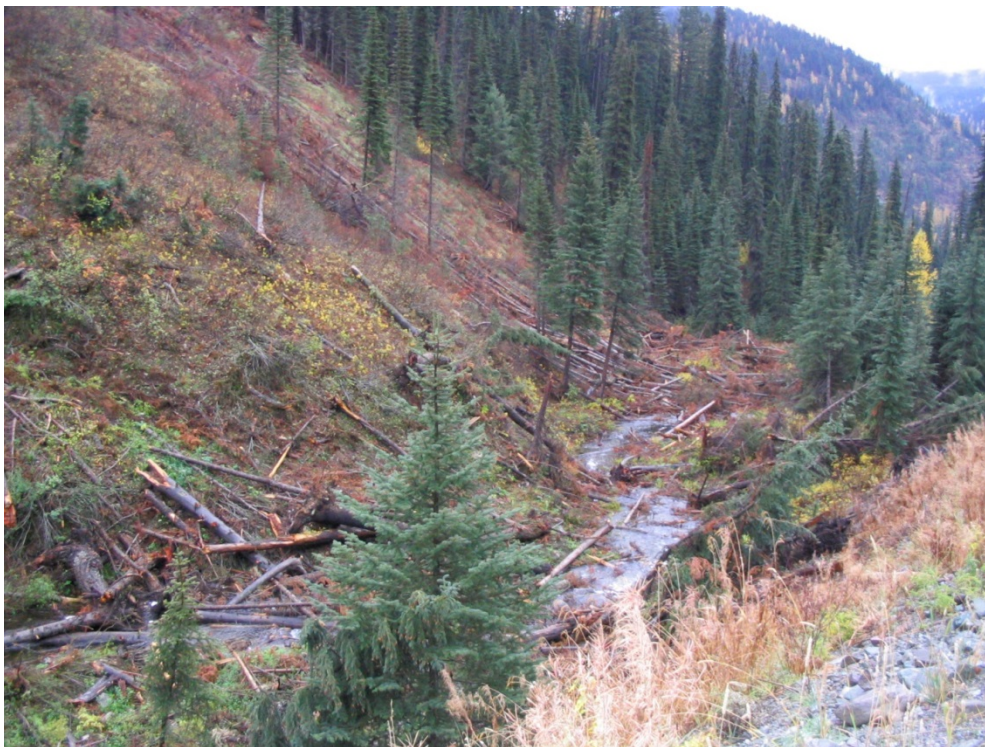
Photo 18: Main Stem Upper - Avalanche Slide - Woody Debris Contribution

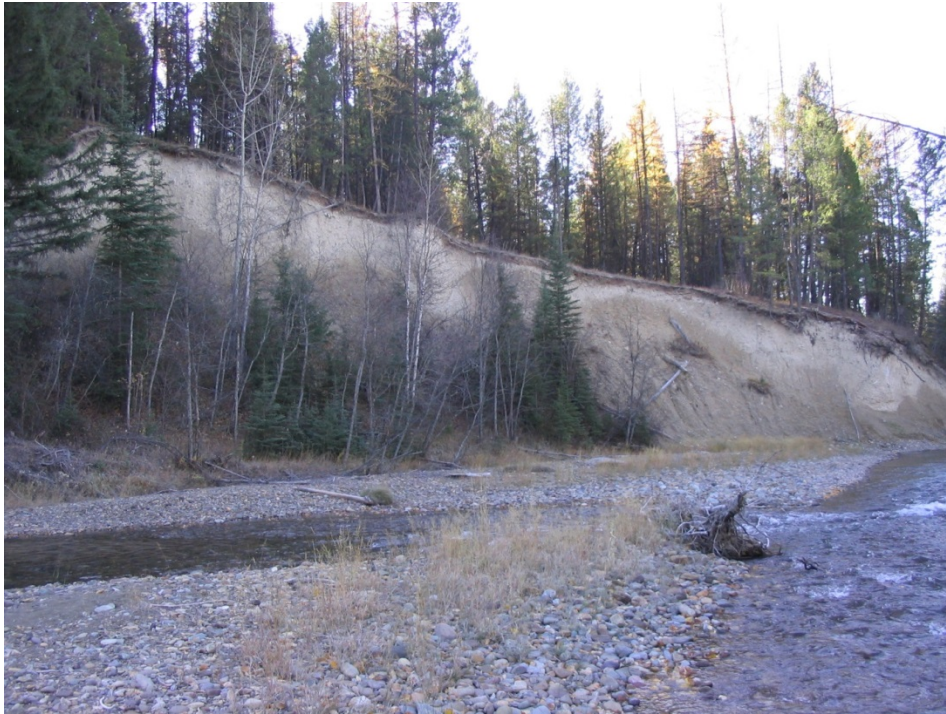
Photo 19: Main Stem Lower Below Canyon – Terrace Erosion

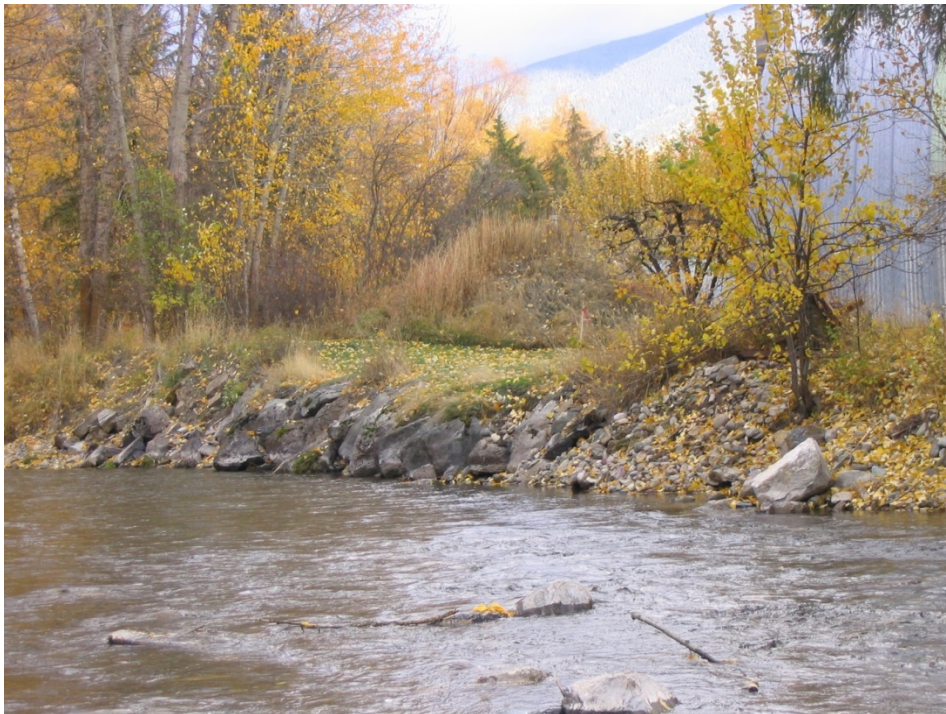
Photo 20: Main Stem Lower - Bank Armoring

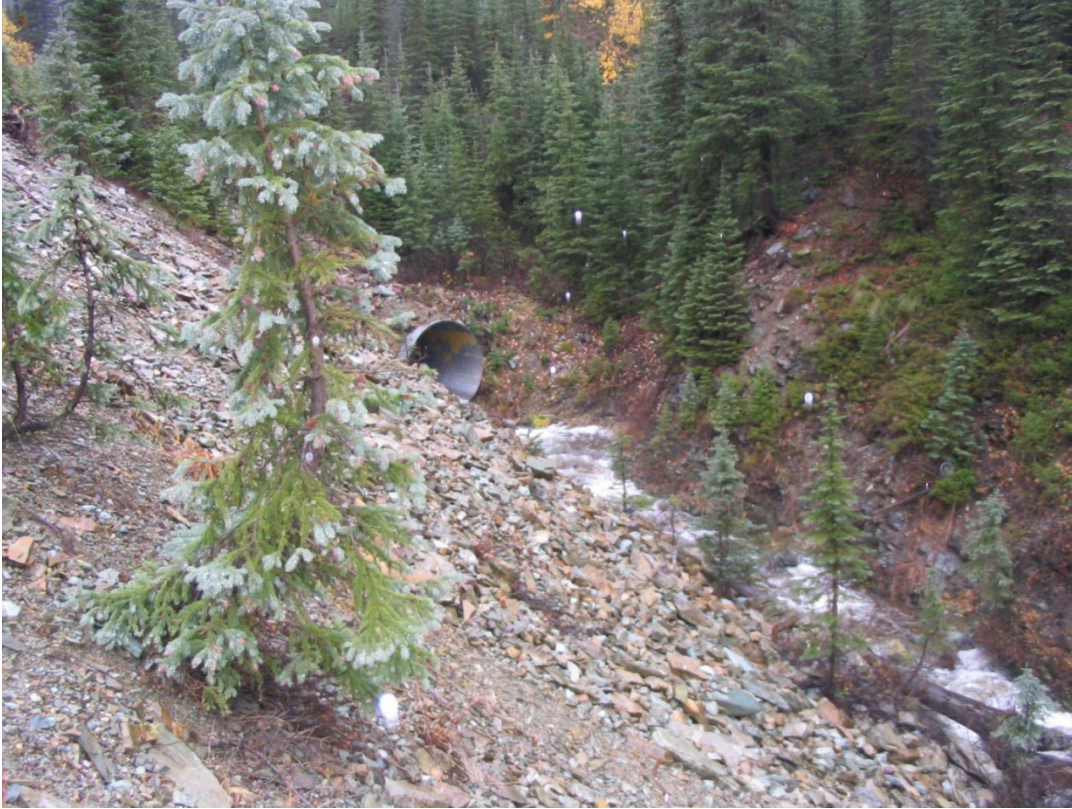
Photo 21: Fish Passage Barrier on Foundation Creek

Other Restoration Objectives	<ul style="list-style-type: none"> • Improve large woody debris recruitment potential through protection of riparian areas on all lands • Pursue cooperative approaches to improve flow conditions during low flow periods in lower Grave Creek • Evaluate and possibly address potential fish passage problem on Foundation Creek
