Red Rock Metals, Sediment, and *E. coli* TMDLs and Water Quality Improvement Plan

October 2021

Water Quality Planning Bureau
Watershed Protection Section

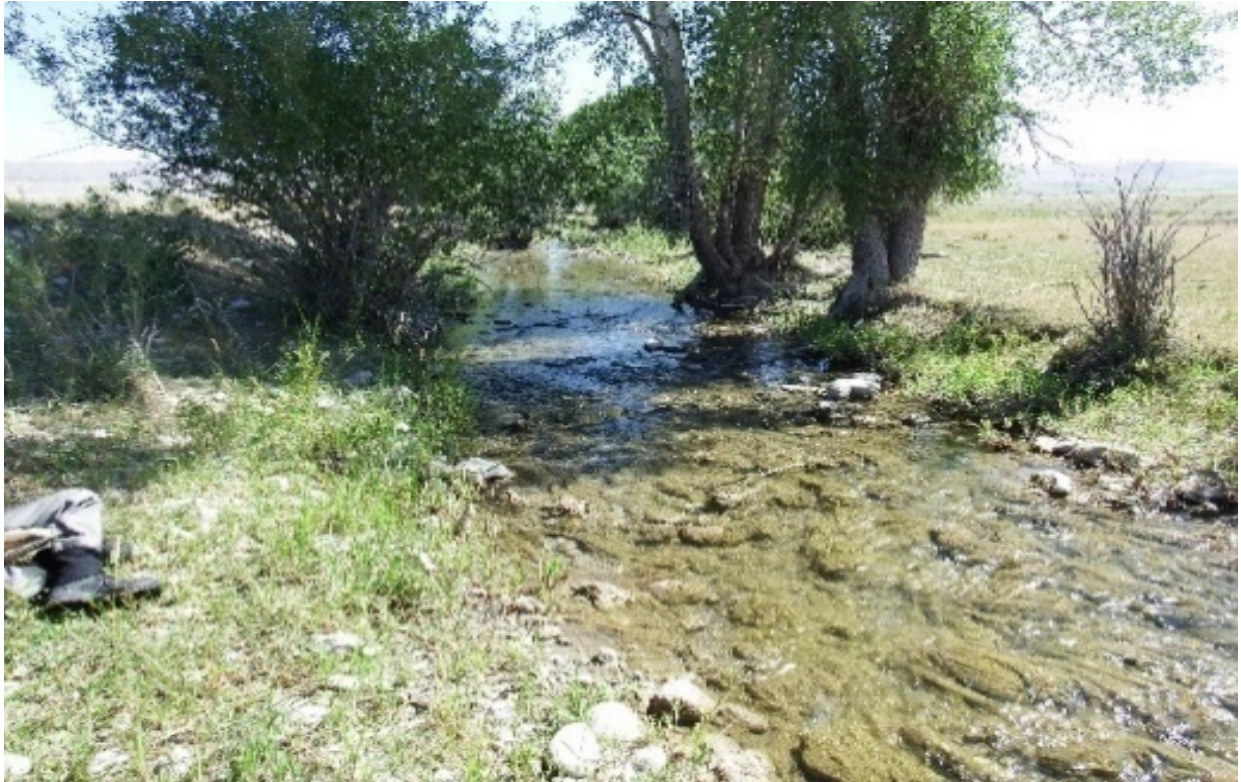
sedges and rushes although upland grasses are encroaching. For a long reach upstream, willows are nearly absent except a few, mature, isolated individuals, possibly due to historic removal. It appears the channel has widened. Although it is naturally straight and confined by the canyon, the road may be restricting sinuosity. Dense macrophyte beds are common, as well as moderate amounts of filamentous algae. The channel is quite stable in this canyon portion. However, immediately upstream above the canyon, the channel is experiencing lateral cutting, unstable banks, and meander cut-offs are forming.

Figure 6-2. Lack of riparian vegetation, sediment, and filamentous algae at BGS10-02a.

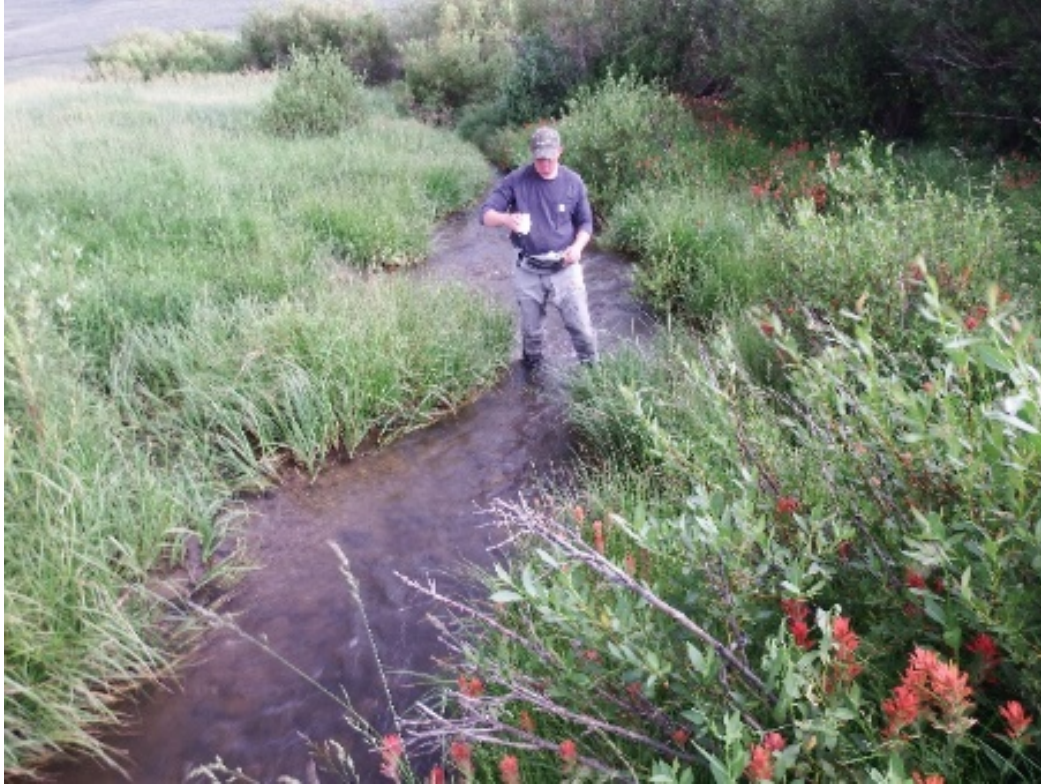
Figure 6-3. Gravel substrate and riparian vegetation at site ECLV07-01

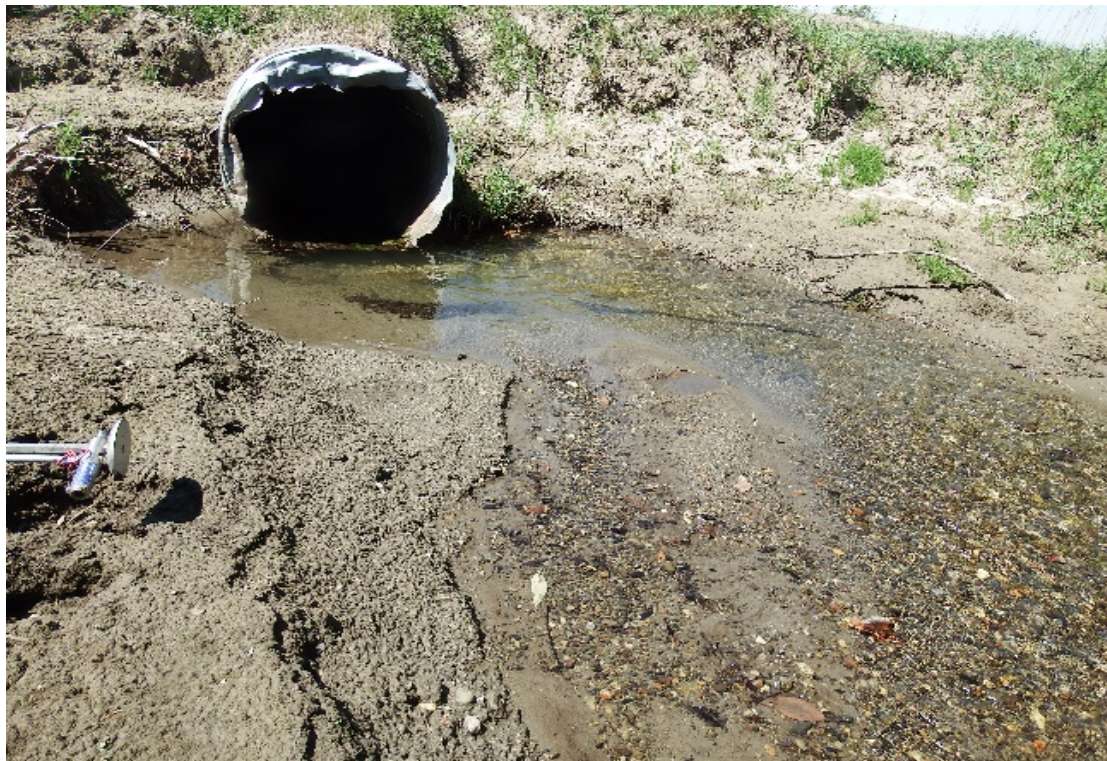
Visual observations and aerial images indicate that the channel is modified and impacted by human activities (grazing and flow modifications) and there is insufficient information to change the existing impairment listings. Jones Creek remains listed on the 2020 303(d) list for sediment/siltation, alteration of littoral and streamside vegetation, and flow modification.

Figure 6-4. Culvert and siltation in Jones Creek about two miles downstream of the South Valley Road crossing

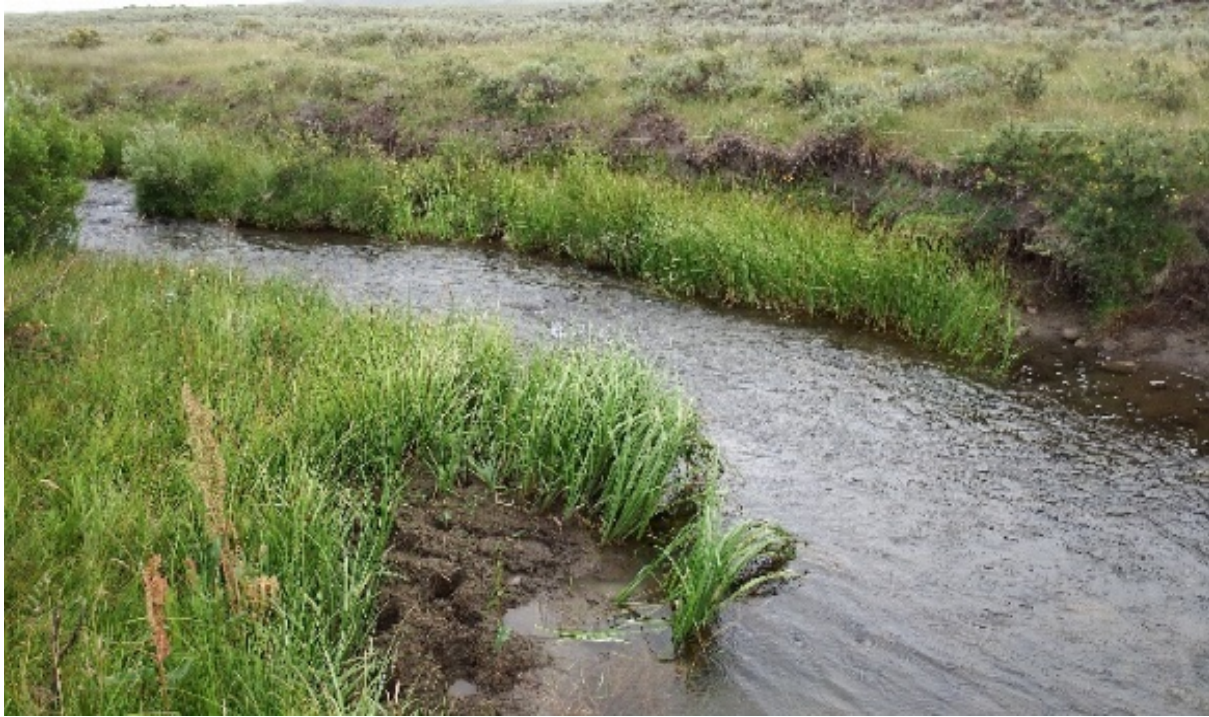
Figure 6-5. Condition of banks at LONG06-01a

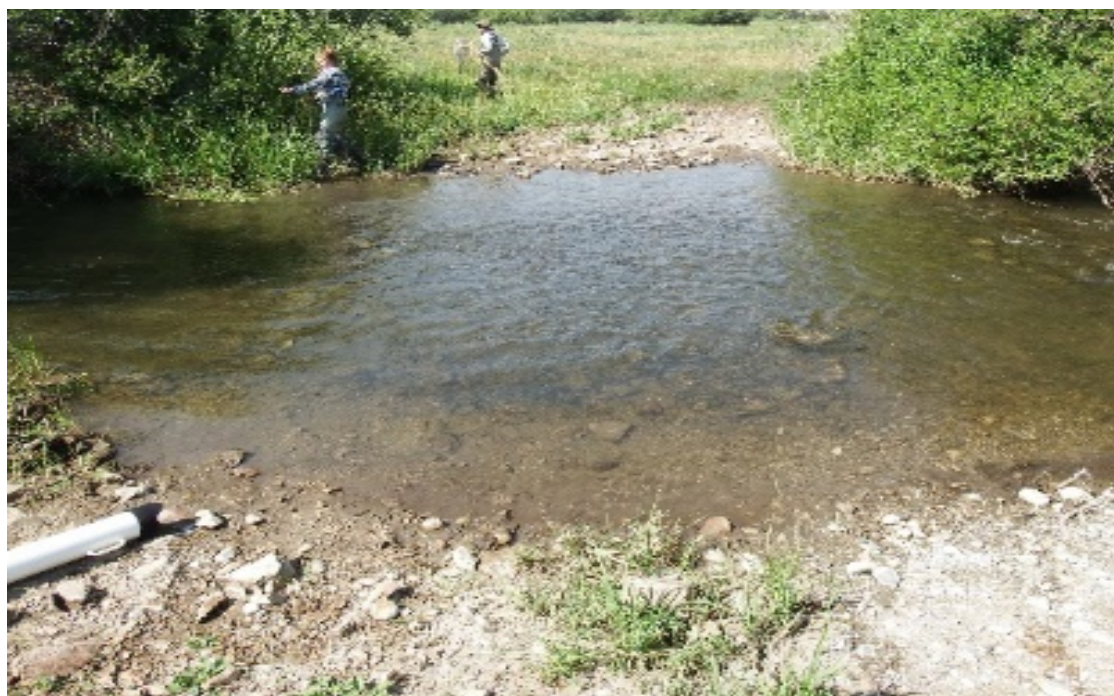
outside reference range, indicating the channel is getting wider and shallower and pool habitat is less common than desirable. For MDLG06-05a, width/depth ratio and residual pool depth is within reference range, but pool count is outside reference range (also indicating pool habitat is less common than desirable). For both sites, entrenchment ratio is within expected range given stream type.

Figure 6-6. Unpaved crossing at site MDLG06-05a

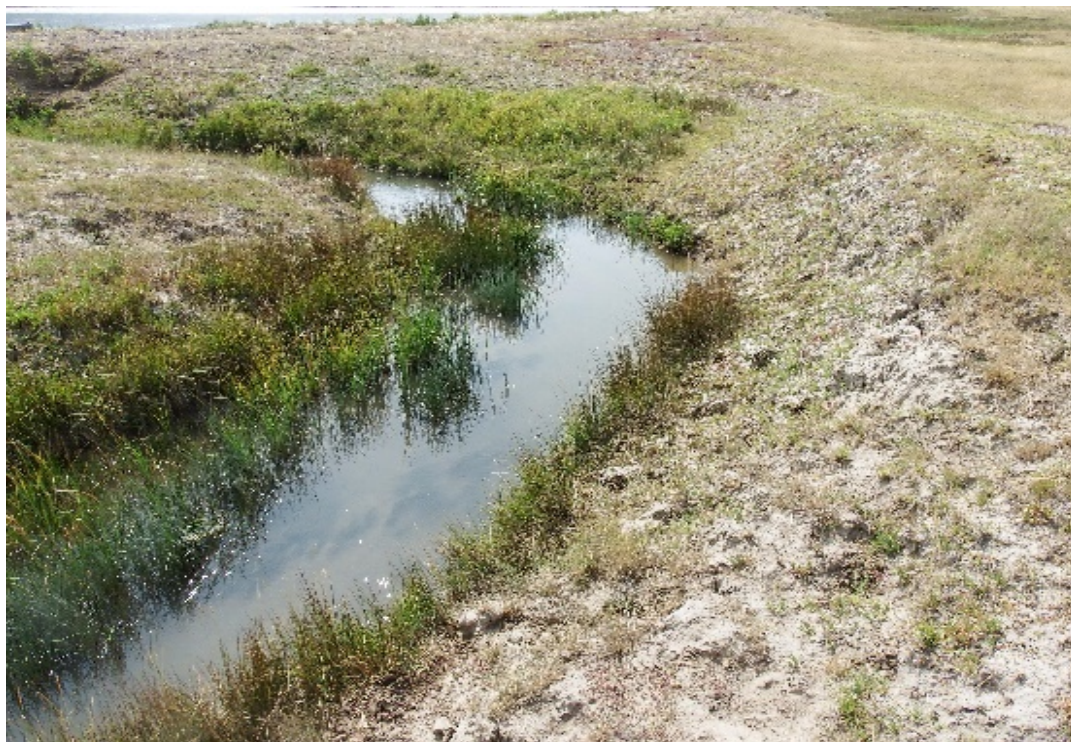
Figure 6-7. Trampling of banks on Peet Creek near the South Valley Road crossing

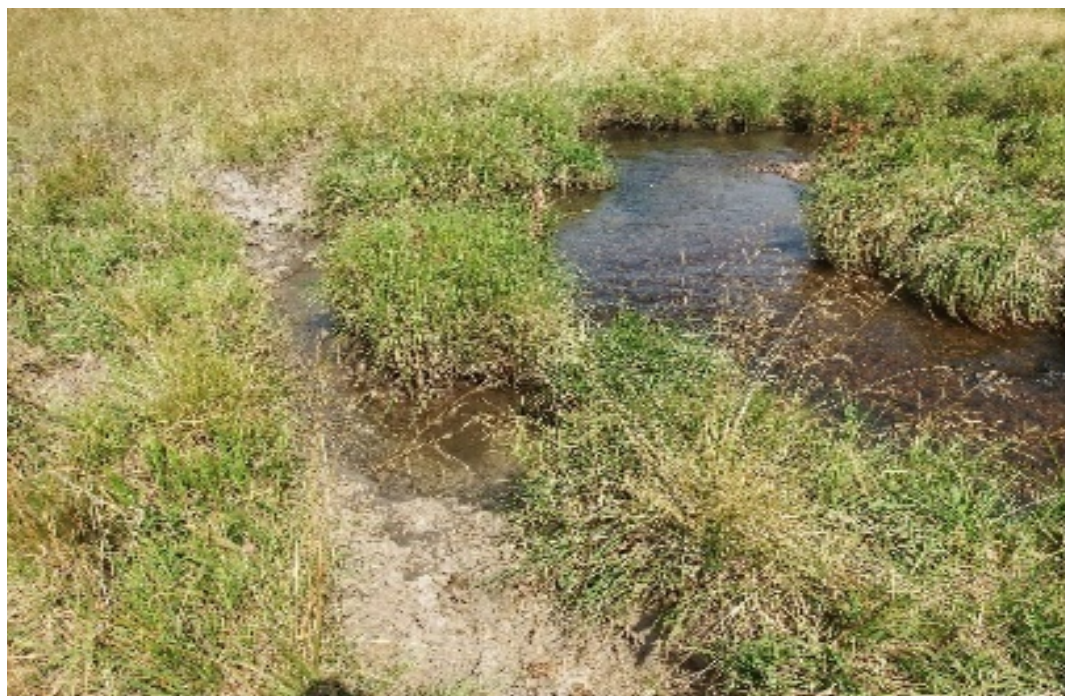
Figure 6-8. Heavily grazed area along site SELC06-01a
