Rock Creek Watershed Total Maximum Daily Loads and Water Quality Improvement Plans

September 2013

Water Quality Planning Bureau
Watershed Management Section

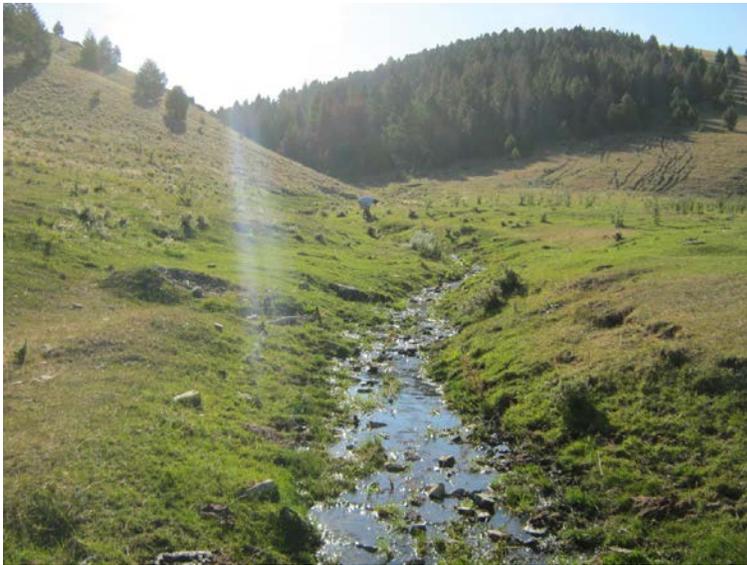
Stream channel measurements at the upper site resembled Rosgen type B4. Stream channel conditions at the site included B-type entrenchment, low width/depth ratios, poor riffle/pool development, and a gravel bottom with fines in low gradient areas. No LWD existed within the bankfull margin of the channel. Pool tails had spawning sized gravels, but the entire stream was trampled and not suitable for spawning. Silt accumulated in slow areas and on aquatic vegetation. No wetland species were found on banks; only grass species. The site had minimal understory with some cinquefoil and sage, but most were browsed. No overstory existed within the site. Many noxious weeds were noted above bankfull including mullein, thistle, and dock-leaved smartweed.

Figure 5-2. Riparian stubble and hummocky banks in ANTE 07-01

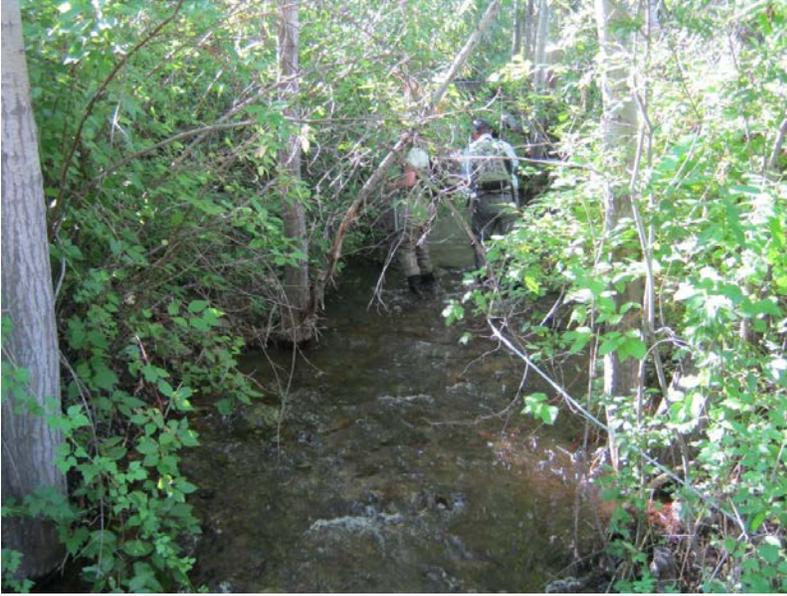
The upstream site resembled a B4 type stream, but was similar to an F4b in areas with entrenchment. Stream had a gravel bed with poor riffle development, and long runs and drops created by LWD. Several split channels existed with obvious aggradation. One split channel occurred below a large wood jam. Few fines existed throughout the channel. Pool tails had good spawning sized gravels. Pools were formed by LWD and lateral scour. Eroding banks were well vegetated and undercut with a lot of cobble; and were located on outside meander bends. Erosion was possibly influenced by road encroachment in places, but most erosion appeared to be natural. The site had a very dense understory of birch, currants and raspberry bushes. Some grasses occurred on banks but were mostly forbs. Grass may have been shaded out by dense canopy of tall birch, ponderosa pine and spruce. Some wetland vegetation occurred in the lower part of site and a few weeds (thistle) were noted. Riparian vegetation appears lush and in good health (**Figure 5-4**).

Figure 5-4. Healthy riparian area on Brewster Creek
