APPENDIX D – ROCK TPA BIOLOGICAL SAMPLING 2011: MACROINVERTEBRATE AND PERIPHYTON RESULTS

Appendix D is based report prepared for the DEQ by Watershed Consulting, LLC, Dec. 2011.

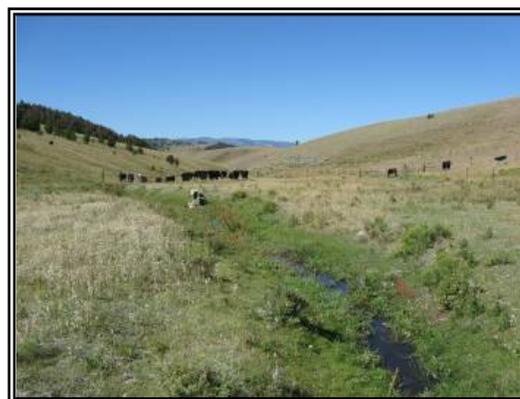
D3.1 ANTE 08-01

This stream reach is little more than a slow trickle, flowing through a heavily used cattle pasture just downstream from a corral. The channel was poorly defined due to trampling. Judging from non-riparian vegetation growing almost in the center of the stream (curly dock, pasture grasses), it is likely dry in many years. A mat of sediment and worm castings were common on “streambanks” and sometimes coated the entire channel. A cow pie was noted in the stream at transect A.

There was inadequate flow in this reach for a kick net; substrate was collected by hand and hand-washed in the net for 30 seconds. We avoided highly trampled areas and sampled where channel was most well-defined. There was no visible sign of periphyton at the time of sampling. Laboratory results confirm our visual assessments of the stream as impaired, likely due to sediment inputs. An impairment summary is provided in **Table D-4** and summary results of the Fish Cover/Other form are presented in **Table D-5**.

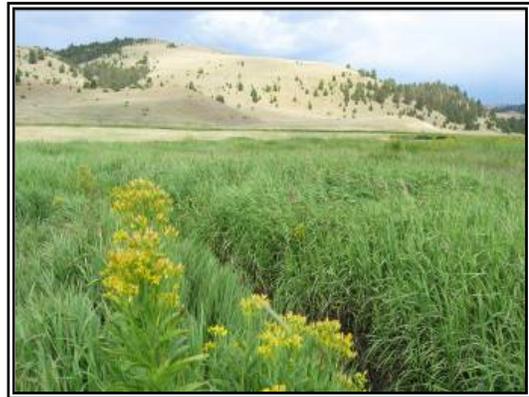
D3.2 ANTE 21-03

This reach is only an active channel from its upstream end to an irrigation ditch halfway down the reach. Head gates divert water in two directions above the lower field (which from aerial photographs may appear to contain a stream). The stream at time of sampling was cloudy, deeply incised and buffered by dense mats of grasses.

The stream substrate was small gravels (4-32mm) or clay. Thick grass creates a small undercut. Stream remains cool due to riparian cover but rocks have no "slime" to them. This reach showed a severe impairment class for macroinvertebrates and impairment for periphyton. An impairment summary is provided in **Table D-6** and summary results of the Fish Cover/Other form are presented in **Table D-7**.

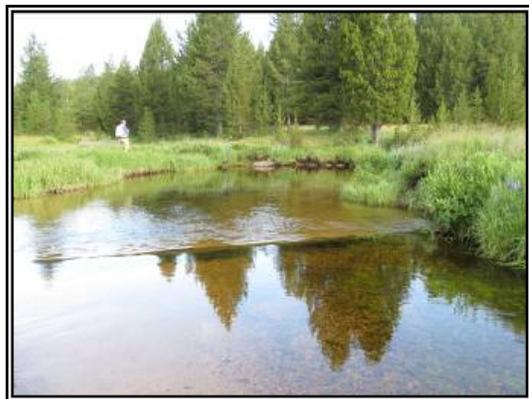
D3.3 WFRK 14-03

This wide and sinuous stream segment flows through an open meadow. An old fence crosses the stream just upstream of K and pieces of an old bridge and other structures were seen in the stream in several locations. Substrate varied from deep sediment deposits, deep pools, and gravels. The only visible current influence here would be a fishing campsite near A. About 20 cutthroat trout were seen by the remains of an old structure in the stream. Macroinvertebrate results showed a severe impairment class from the RIVPACS scoring. Periphyton was shown to be unimpaired. An impairment summary is provided in **Table D-8** and summary results of the Fish Cover/Other form are presented in **Table D-9**.

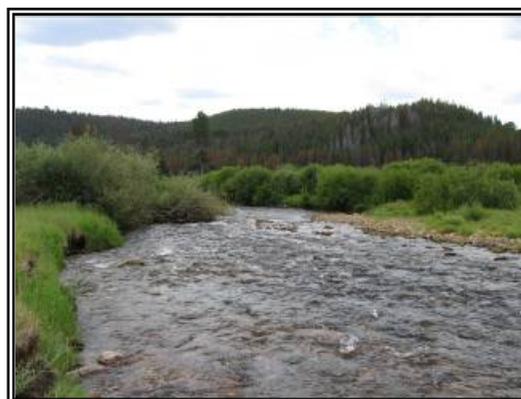
D3.4 WFRK 30-02

The downstream end of this reach is just upstream of a bridge. With a 1400 foot length, our sampling reach encompassed almost the entire stream segment. The upper reaches (G-K) are in a straightened section adjacent to highway 38. Riparian vegetation is reduced on river left in this straight section. Much moss was seen throughout the reach, which had large riffle sections divided by deeper sandy deposits.

As with its upstream reach, impairment for macroinvertebrates was just barely in the severe impairment class while periphyton impairment probability was low. An impairment summary is provided in **Table D-10** and summary results of the Fish Cover/Other form are presented in **Table D-11**.

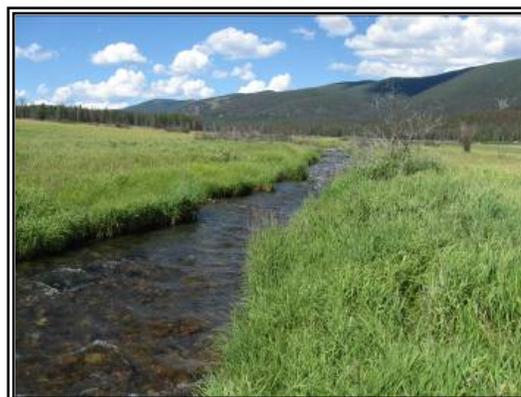
D3.5 UWIL 11-05

Haying dominates land uses throughout this reach. Willow and other shrubs are infrequent along banks, with several decadent representatives. Overhanging grasses provide some shade habitat. The reaches above and below this one have more vigorous riparian shrub growth. Stream has low sinuosity, with current and past land uses as the primary influences on the stream. Cobble substrate and riffles were common. Both periphyton and macroinvertebrates scored as impaired. An impairment summary is provided in **Table D-12** and summary results of the Fish Cover/Other form are presented in **Table D-13**.

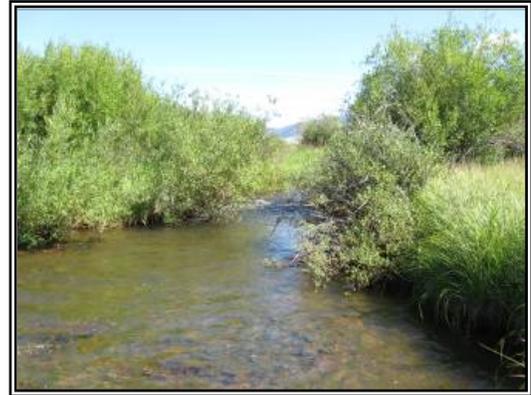
D3.6 UWIL 15-01

Agricultural land use surrounds the creek and grazing is evident close to the reach. The reach supports a mature riparian vegetation community in healthy condition. All ages of willow were present, providing good cover along much of the reach. Thick grass cover has impeded weeds. Cobble substrate was dominant in this mostly run/glide system.

Moderate impairment was determined for macroinvertebrates while periphyton results fell in the unimpaired class. An impairment summary is provided in **Table D-14** and summary results of the Fish Cover/Other form are presented in **Table D-15**.

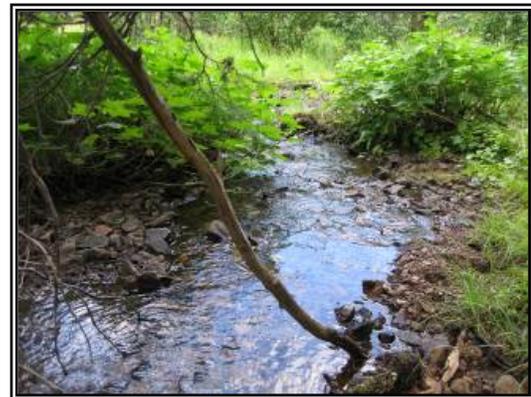
D3.7 QUTZ 08-01 (U.S)

Past activity in this gulch includes logging and mining. It appears mitigation work was also done here, evidenced by erosion control fabric placed on streambanks and within the channel at a gradient change. A pond was created further downstream possibly for sediment catchment. Despite this activity, this reach appears to be in a natural condition, just below the forested area in a transitional meadow. This channel likely has a very flashy character. Mosses and macrophytes appear to do well while microalgae are rarely present and usually in the form of dark and small colonies on some rocks.

At transect G some debris has created a small pool where macros and moss are growing more than usual, with minimal sign of microalgae. Both macroinvertebrates and periphyton showed impairment based on identified taxa. An impairment summary is provided in **Table D-16** and summary results of the Fish Cover/Other form are presented in **Table D-17**.

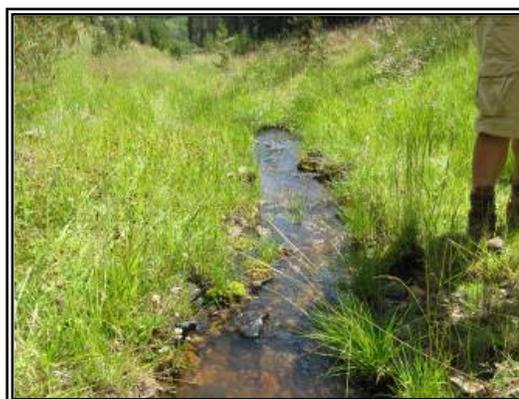
D3.8 QUTZ 08-01 (D.S)

This reach is below a sharp slope break mentioned in the previous reach, where the creek temporarily subs under a pile of rocks, and just upstream of a constructed pond. The stream is narrow and cobble-dominated with little periphyton growth observed except for one filamentous algae specimen at transect E. This site is best accessed from an old logging road not clearly visible from the Forest Service road. Periphyton were found to be impaired, while macroinvertebrates were determined to be unimpaired based on collected taxa. An impairment summary is provided in **Table D-18** and summary results of the Fish Cover/Other form are presented in **Table D-19**.
