Ruby River Watershed TMDL Implementation Evaluation

May 2020

Water Quality Planning Bureau
Watershed Protection Section

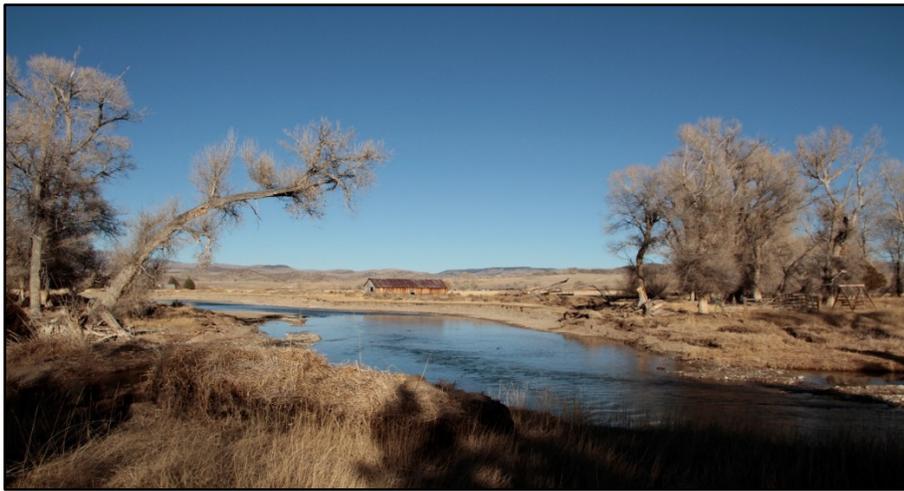
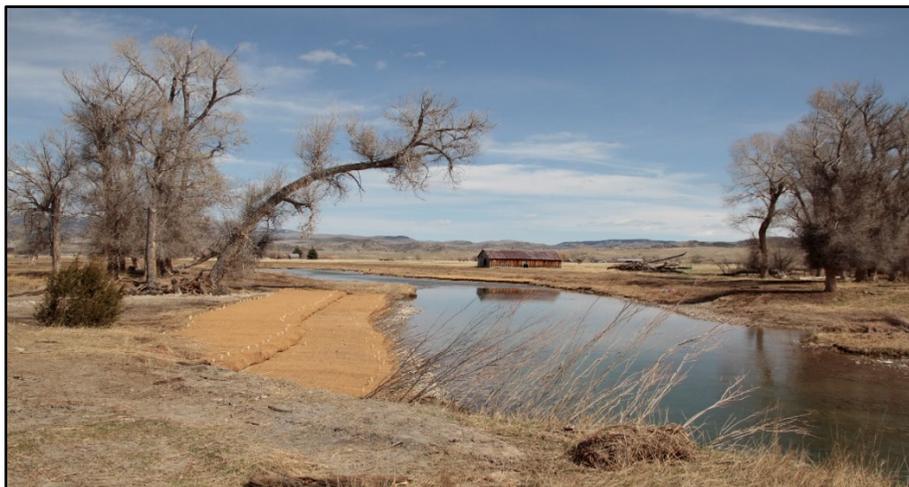
Cover photos:

Before and after photos of restoration efforts on the Miller Ranch
Photos by: Montana Dept. of Environmental Quality, Watershed Protection Section
