APPENDIX F

UNPAVED ROAD SEDIMENT ASSESSMENT

The West Fork Gallatin River Watershed Total Maximum Daily Loads (TMDLs) and Framework Watershed Water Quality Improvement Plan – Appendix F

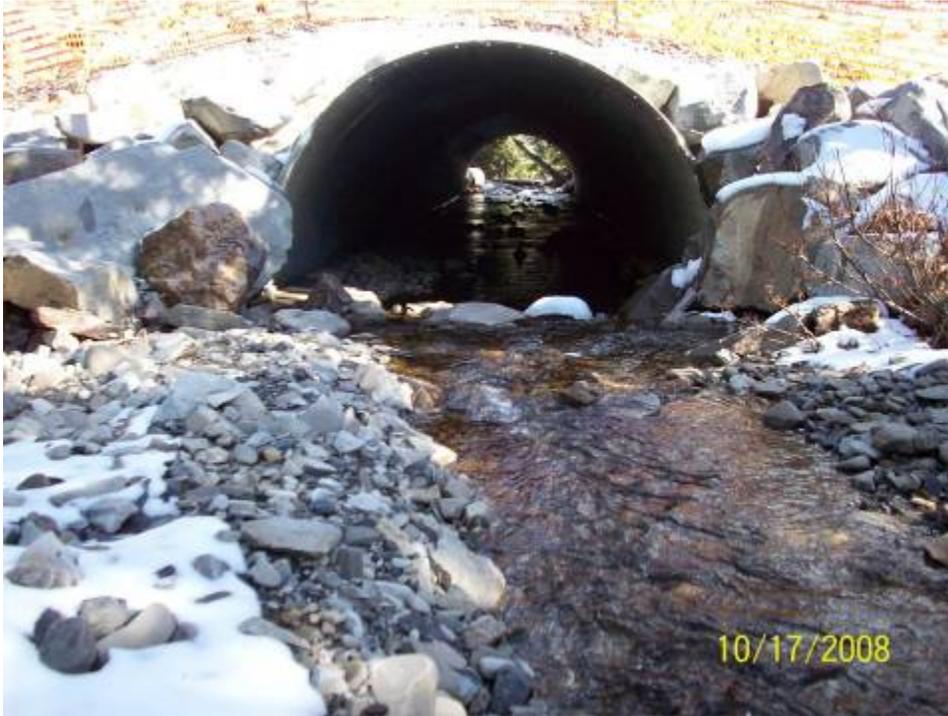
Bottomless corrugated steel culvert.

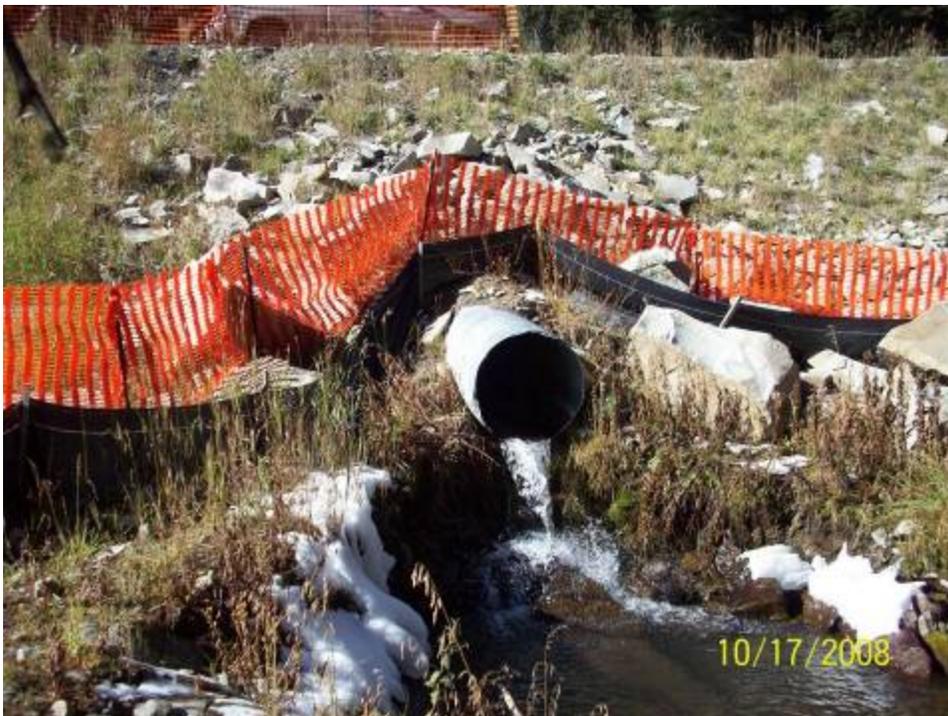
Perched corrugated steel culvert.

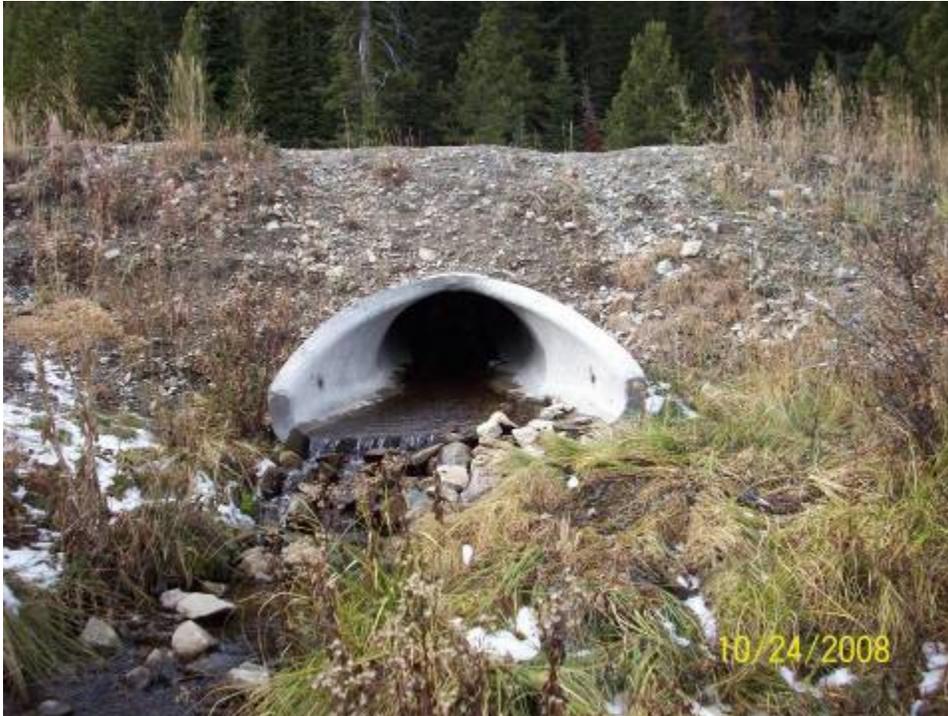
Example of concrete culvert.

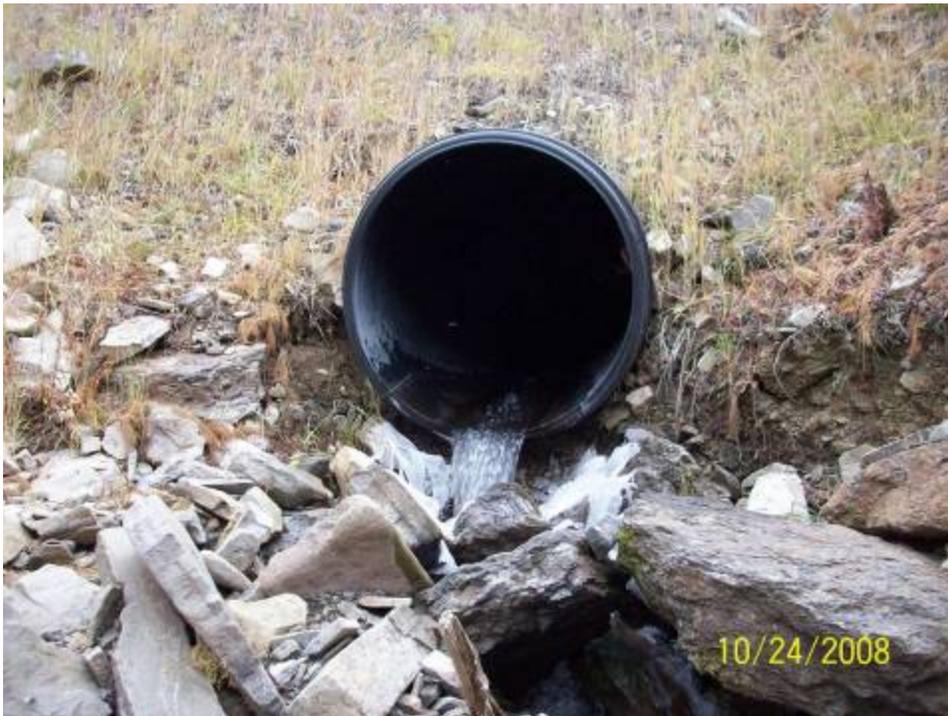
Corrugated plastic culvert, fish passage barrier.

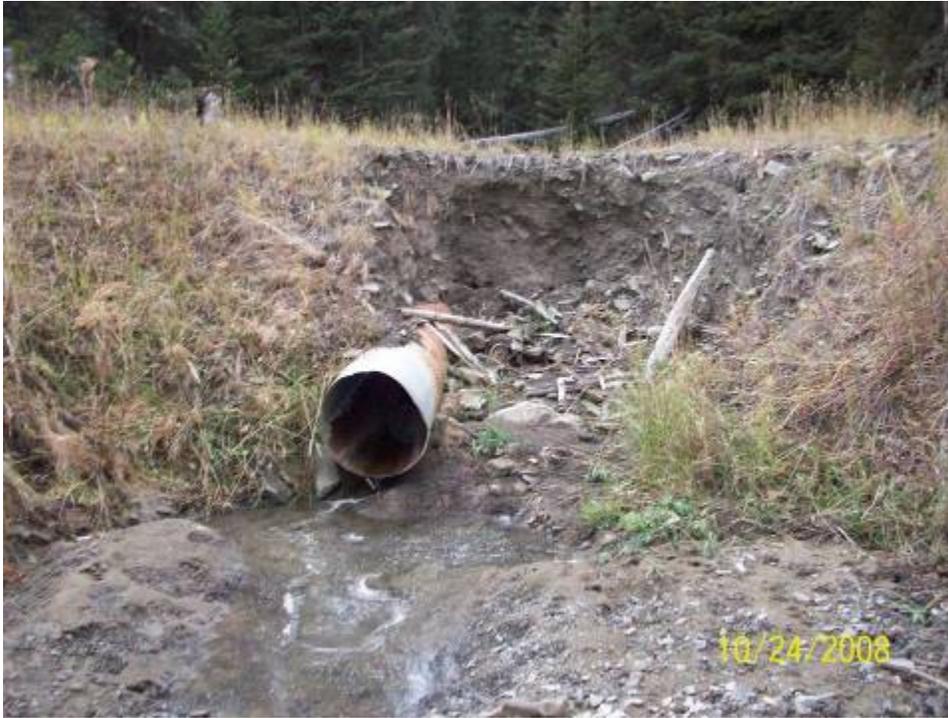
Erosion of road fill material adjacent to perched corrugated steel culvert.

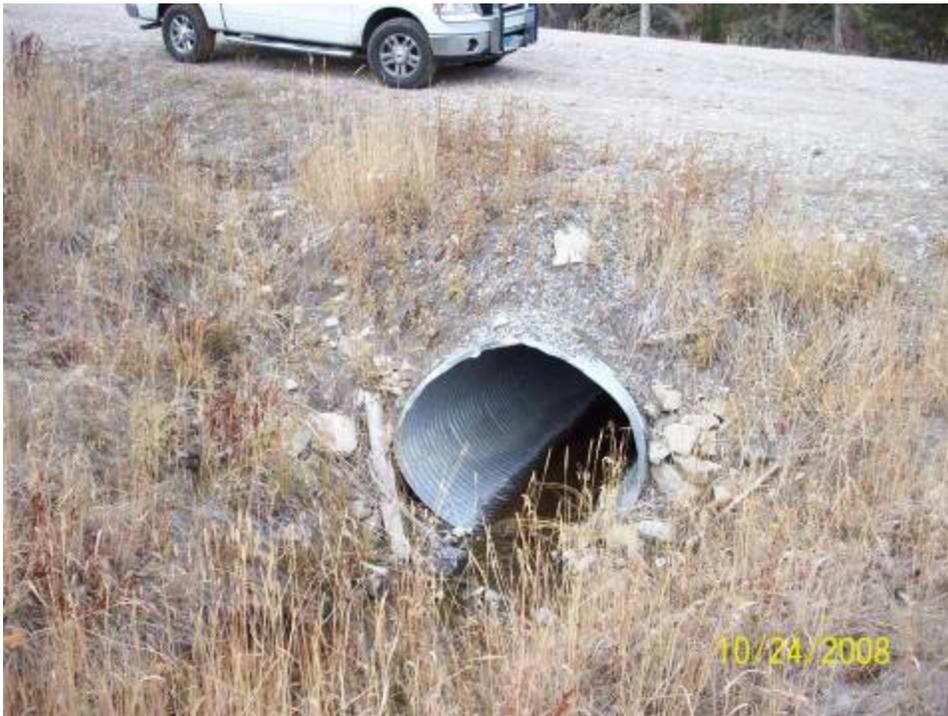
Correct culvert installation.

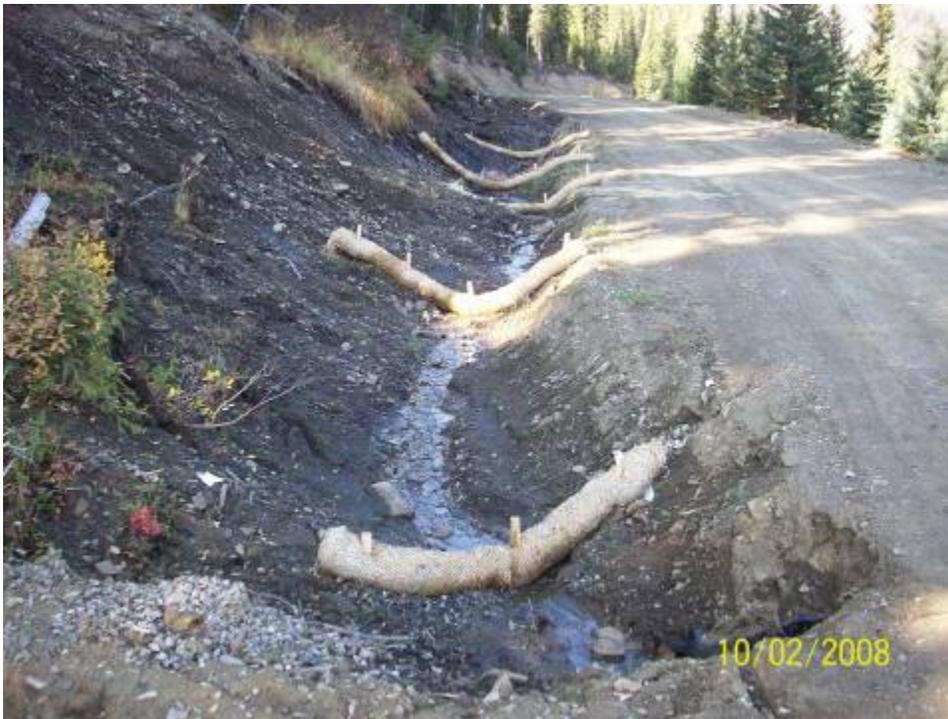
Fiber wattles used to control road ditch erosion.
