# Yaak River Watershed

## Sediment Total Maximum Daily Loads

*Montana Department of Environmental Quality*  
*September 10, 2008*

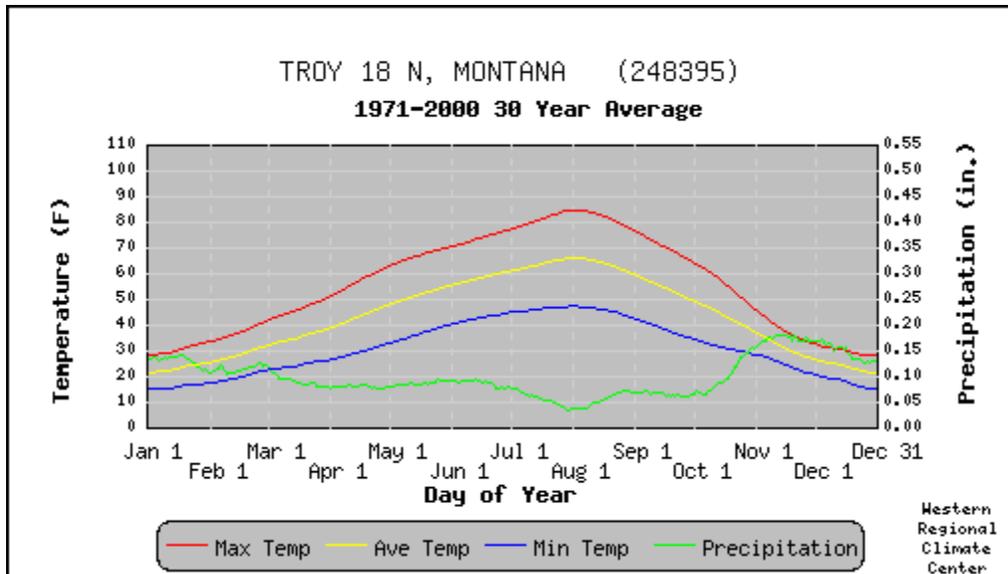
**Figure 2-1. Patterns in Average Precipitation and Temperature for Northwest of Troy, MT** (Western Regional Climate Center, 2001)

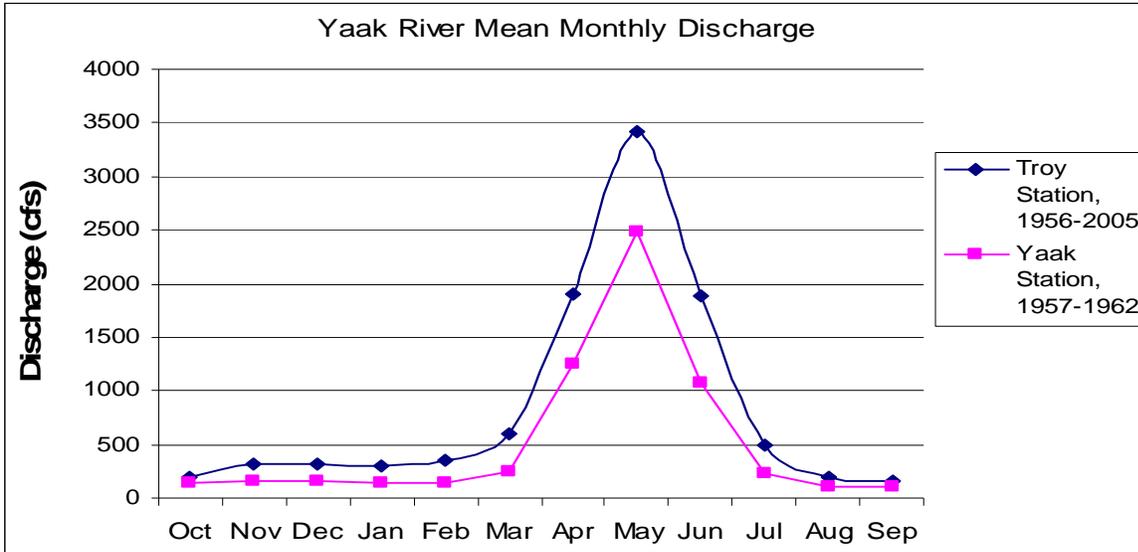
**Figure 2-2. Historical Flow Data from Yaak River near Troy and Yaak, MT (USGS, 2006)**

Historical stream gage data are available for two sites on the Yaak River. USGS gage 12304200 Yaak River near the town of Yaak; Montana, has data from only April 1957 – September 1962. The majority of the discharge information is from USGS gage station 12304500. This station has data from 1956 to present and is located at the mouth near Troy, Montana. Figure 2-2 is a hydrograph constructed from historical gauge station data.

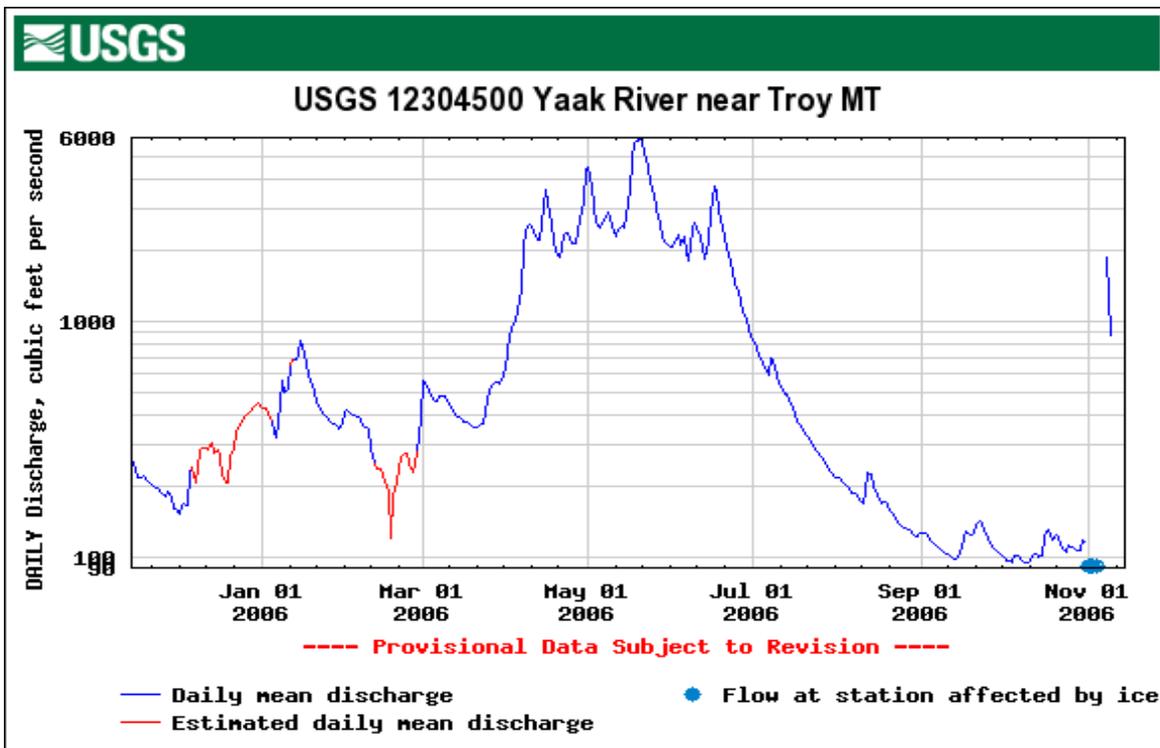
**Figure 2-3. Recent Streamflow data for Yaak River (USGS, 2006)**

On average, in the last 50 years, mean monthly discharge was below 500 cubic feet per second (cfs) for August through February. Historical data indicate an average peak flow at approximately 3,500 cfs in May (Figure 2-2). The mean historical flow does not reveal the magnitude of, or variation in, peak flows. As an example of the variability in flow, Figure 2-3 illustrates daily mean discharge for 2006, which reached a peak of nearly 6,000 cfs in June.

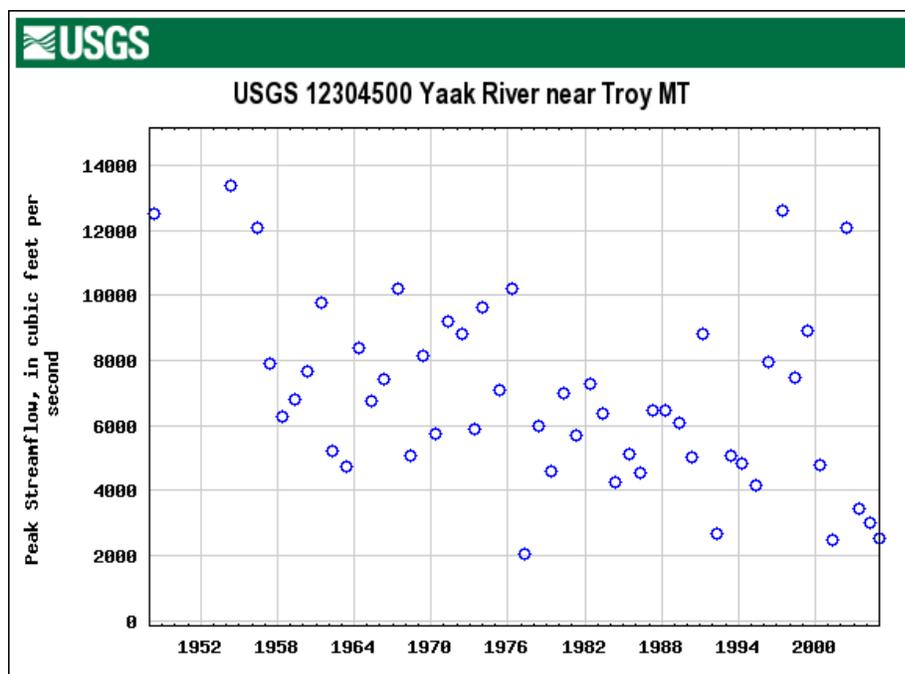
**Figure 2-4. Historical Peak Flow Yaak River** (USGS, 2006).

Figure 2-4 illustrates the range in historical peak flows on the Yaak River at USGS gage station 12304500.

These data demonstrate that the peak flow was over 10,000 cfs seven times in the period of record. The highest flow on record for the Yaak River was 13,400 cfs on May 20, 1954.

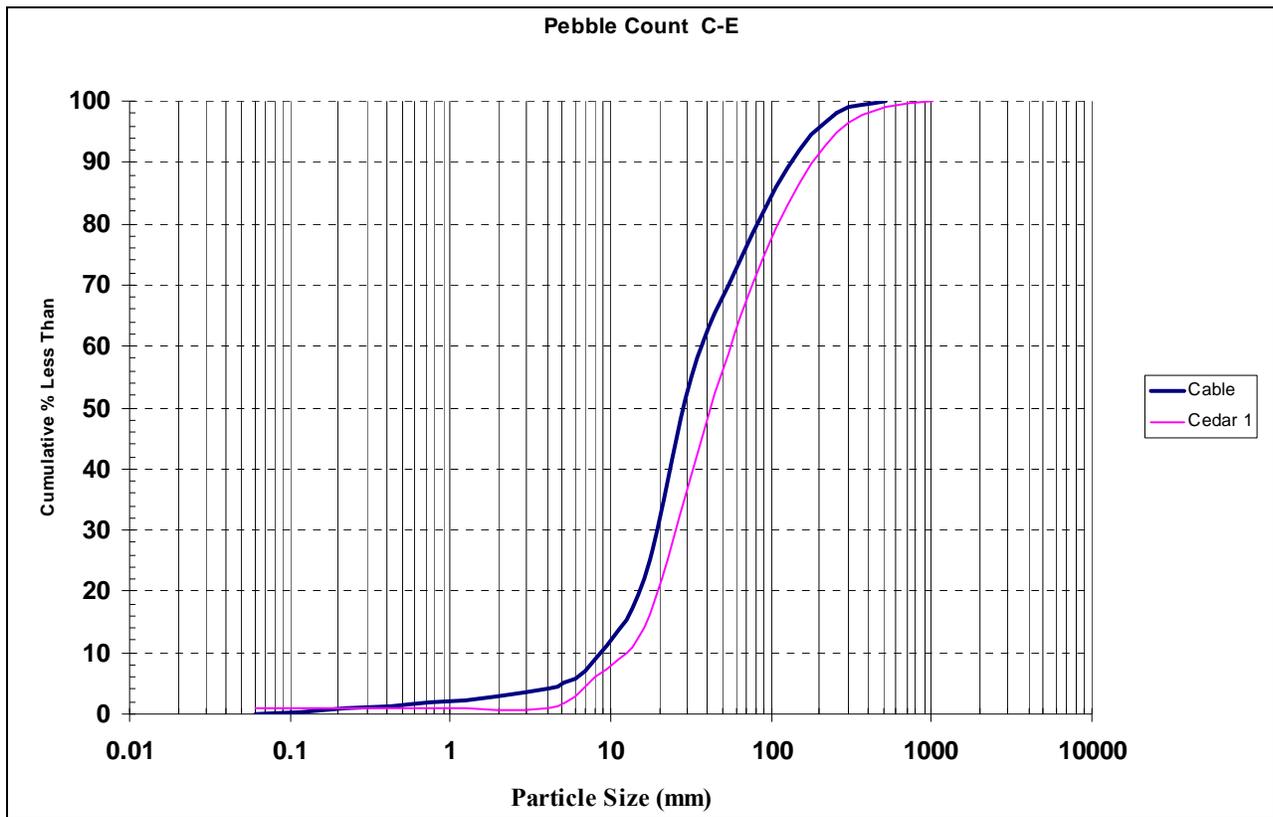
**Figure 4-1. Wolman Pebble Count Curves for Two Reference Reaches**

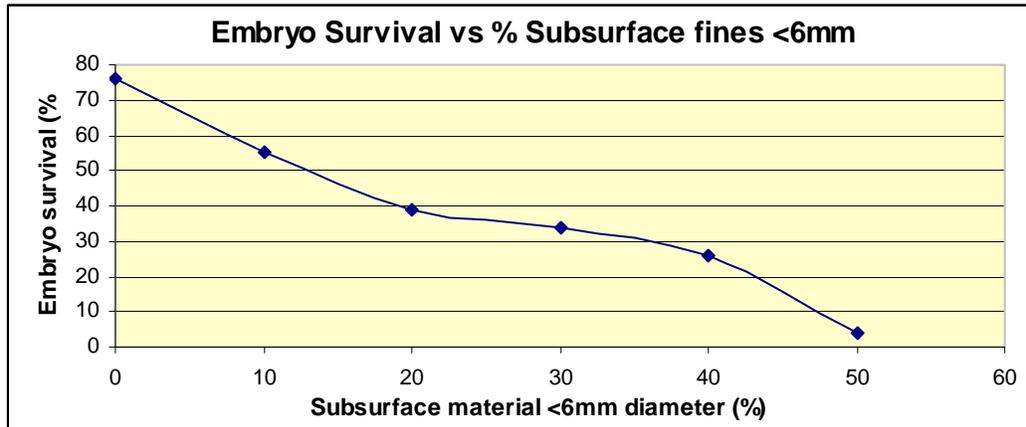
**Figure 4-2. Embryo Survival vs. % Subsurface Fines <6mm**  
(Weaver & Fraley, 1991)

Weaver and Fraley (1993) found a significant inverse relationship ( $r^2 = 0.72$ ,  $P < 0.005$ ,  $N = 17$ ) between fry emergence success and the percentage of substrate fines <6.35 mm in diameter in streams in the Flathead National Forest. Mean fry emergence success was 76, 55, 39, 34, 26, and 4%, respectively, in cells containing 0, 10, 20, 30, 40, and 50% substrate materials < 6.35 mm (Figure 4-2).

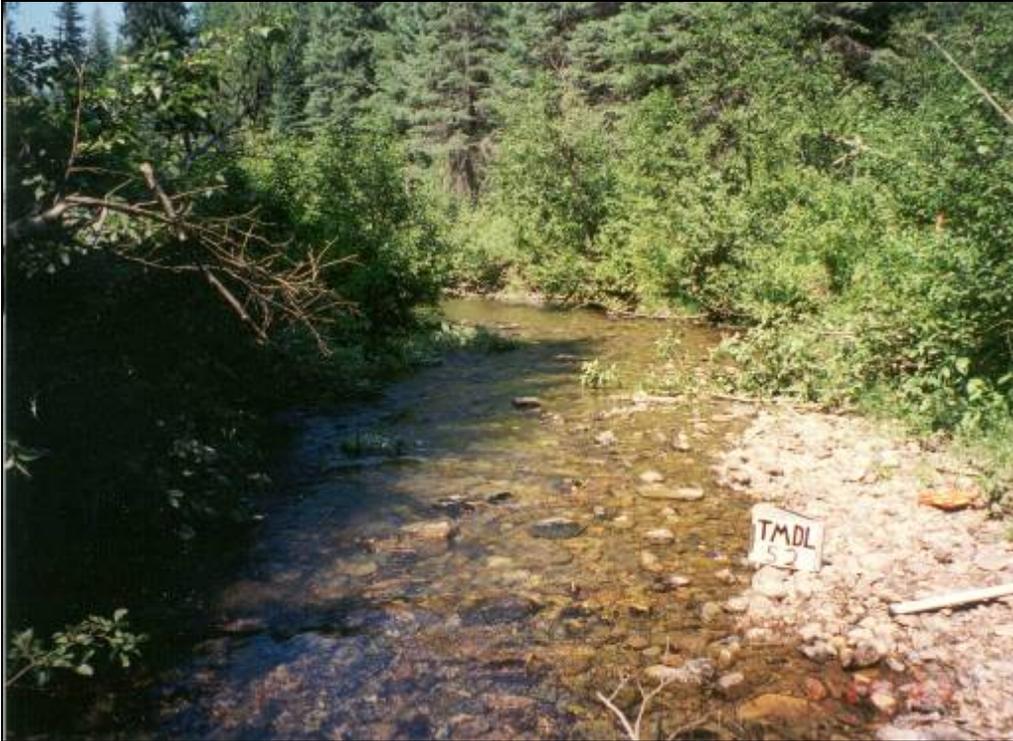
**Figure 4-4. Upper Seventeenmile Creek**  
(site 52 above Bridle Creek)

The main channel of Seventeenmile Creek flows through a Type II valley bottom. Typical of most Type II valleys, the Seventeenmile Creek channel is predominately a Rosgen “B” stream type with many Rosgen “C” reaches. There is little evidence of channel instability caused by natural processes, and the streambanks are stable and well-vegetated. Figures 4-5 through 4-8 display some of the stream and channel characteristics common to sites on Seventeenmile Creek.

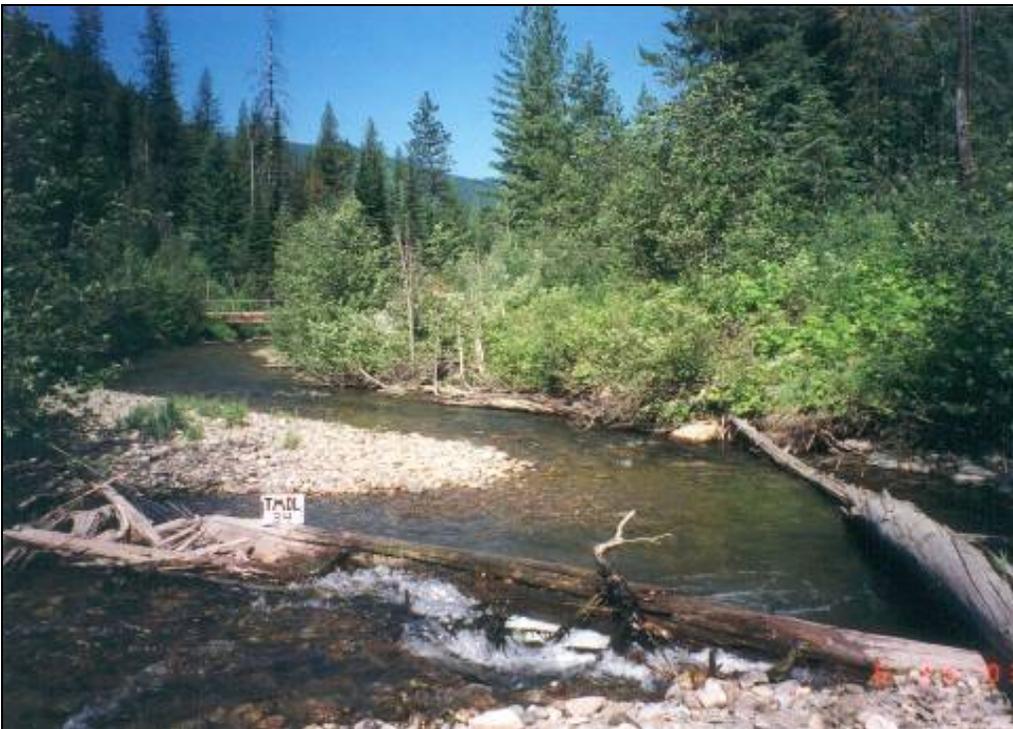
**Figure 4-5. Middle Seventeenmile Creek at Site 34, looking downstream**  
(site is above Hemlock Creek confluence)

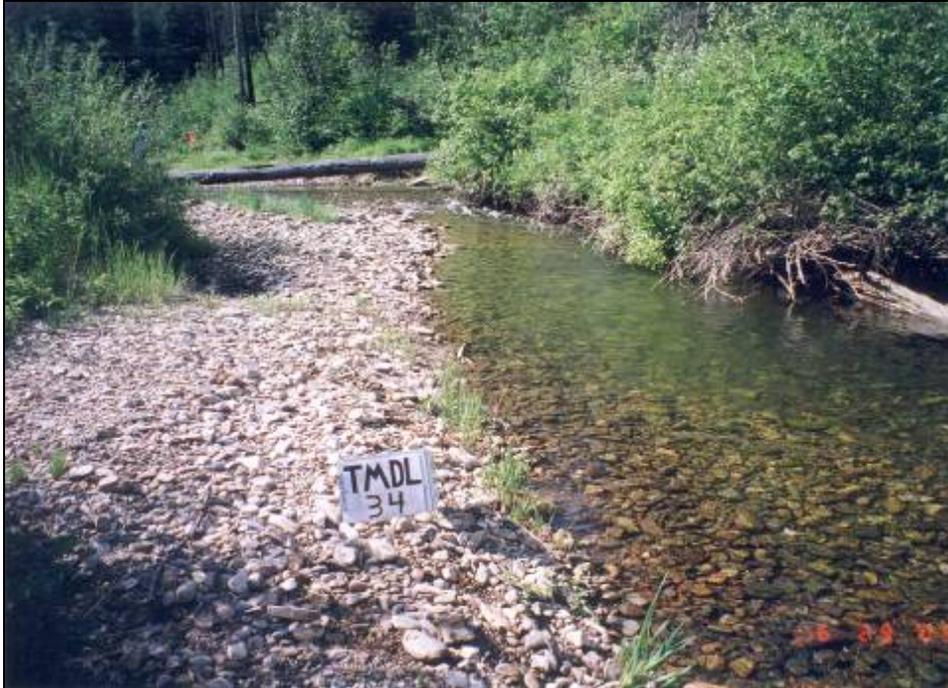
**Figure 4-6. Middle Seventeenmile Creek above Hemlock Creek**  
(site 34, upper reach looking upstream)

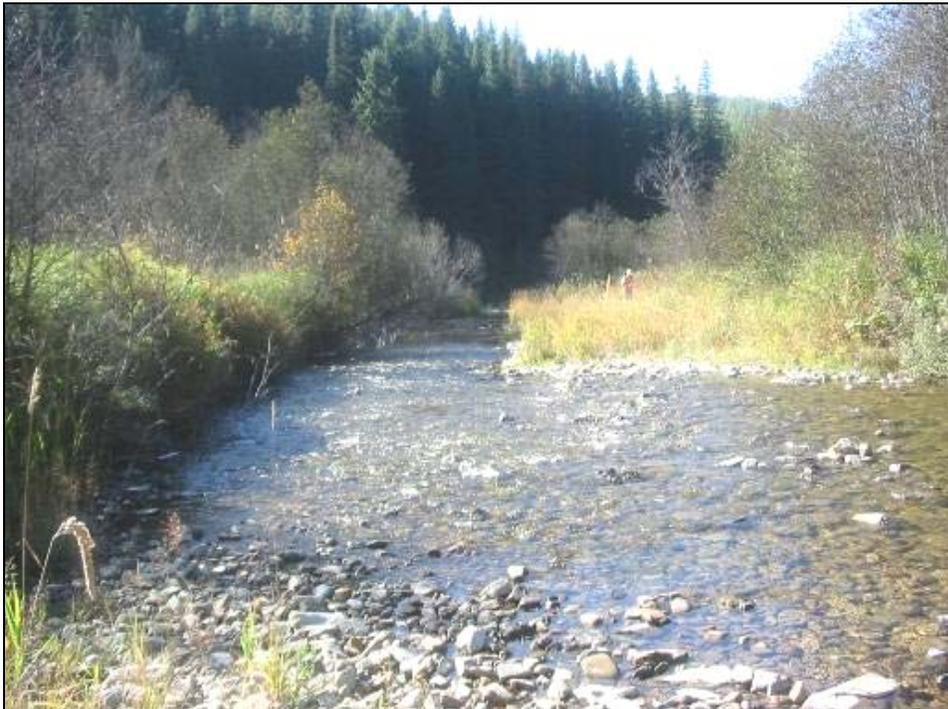
**Figure 4-7. Lower Seventeenmile Creek at Site 82 looking downstream**  
(site is above Bridle Creek)

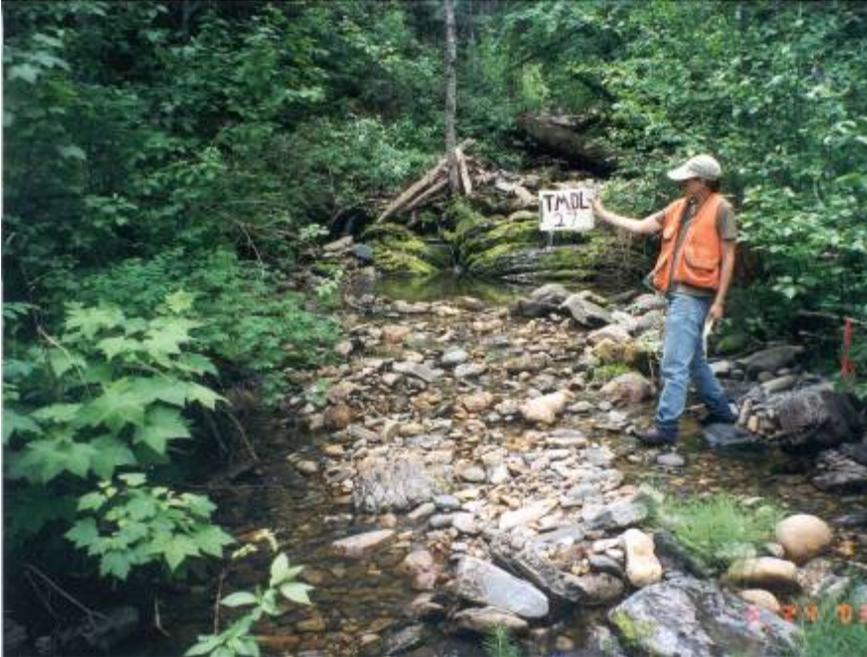
**Figure 4-9. Lap Creek, Lower Reach (Site 27) Looking upstream**

The main channel of Lap Creek flows through a Type II valley bottom. Typical of Type II Valleys, Lap Creek is predominately a Rosgen “B” stream type. There is little evidence of channel instability caused by natural processes. Stream banks are stable and well-vegetated. Figures 4-10 through 4-12 display some of the stream and channel characteristics common to sites on Lap Creek.

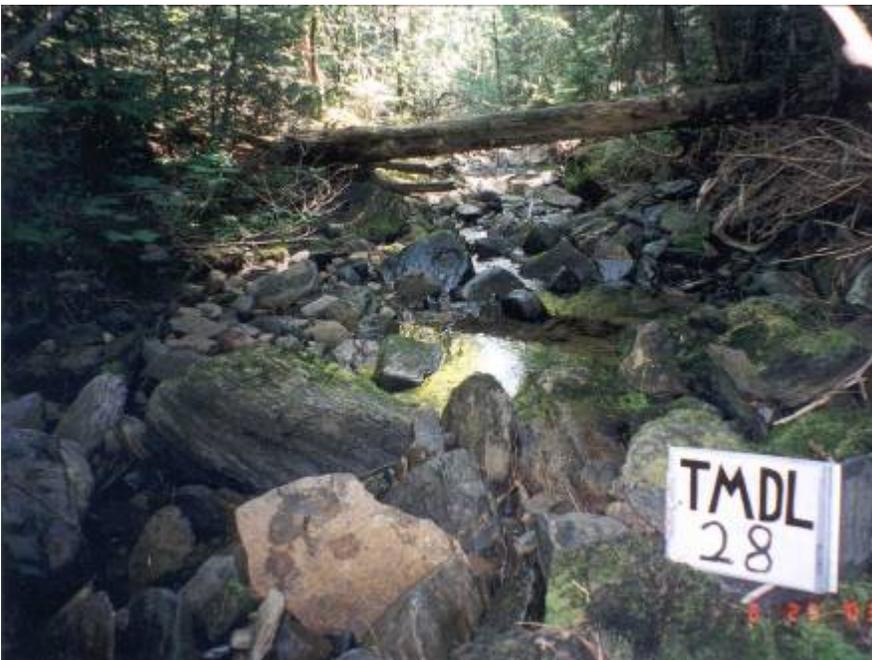
**Figure 4-10. Lap Creek, Lower Reach (Site 28) Looking downstream**

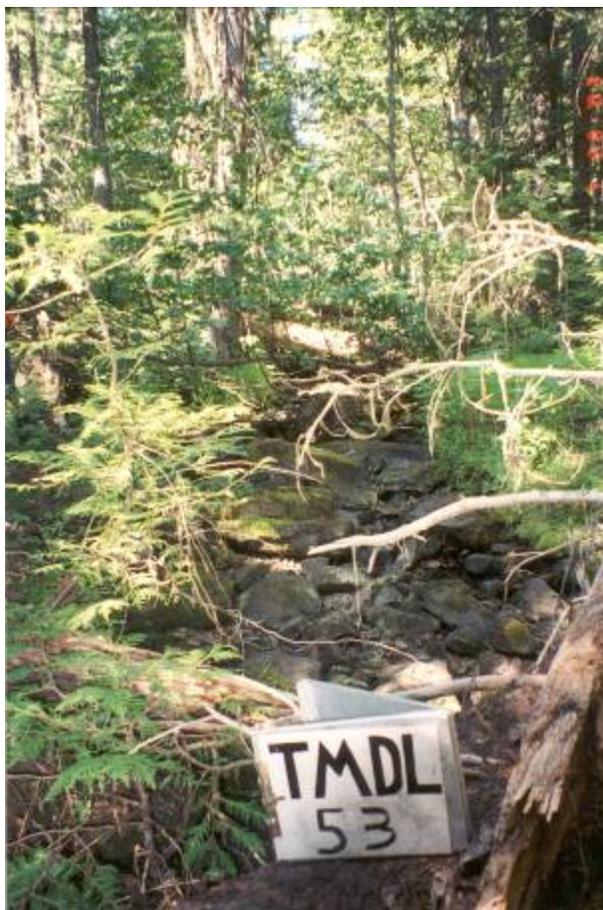
Figure 4-11. Lap Creek, Upper Reach (Site 53) Looking upstream

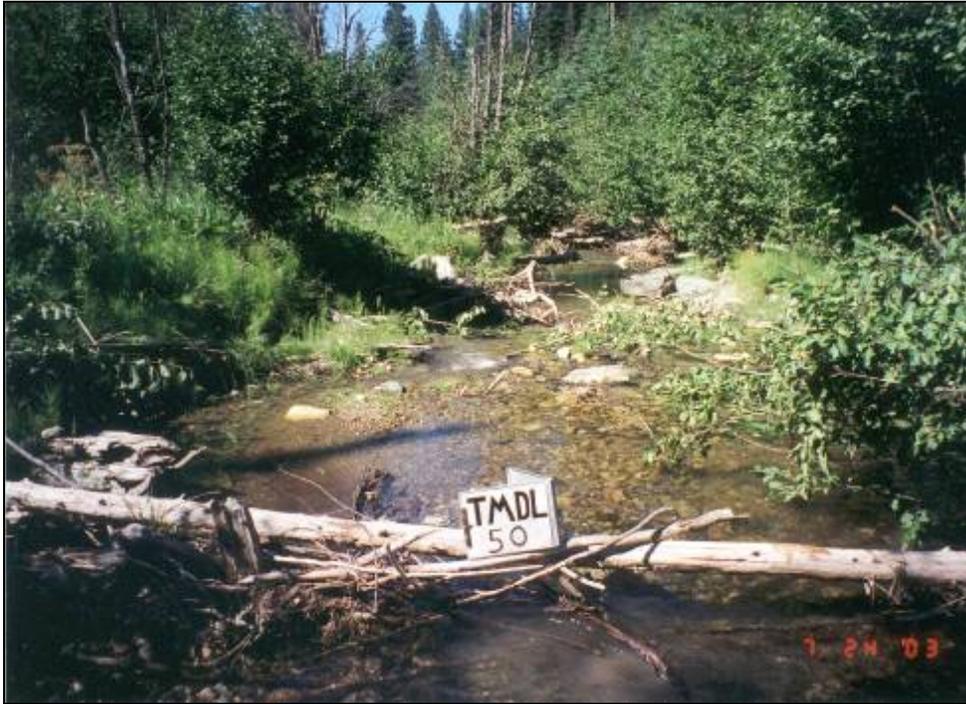
**Figure 4-13. South Fork Yaak River below Smoot Creek, site 50**

The main channel of the South Fork Yaak flows through a Type II valley bottom. Typical of Type II valleys, the South Fork Yaak channel is predominately a Rosgen “B” stream type with C inclusions. Figures 4-14 through 4-17 display channel conditions at the four sites established and evaluated on the South Fork Yaak River in 2003.

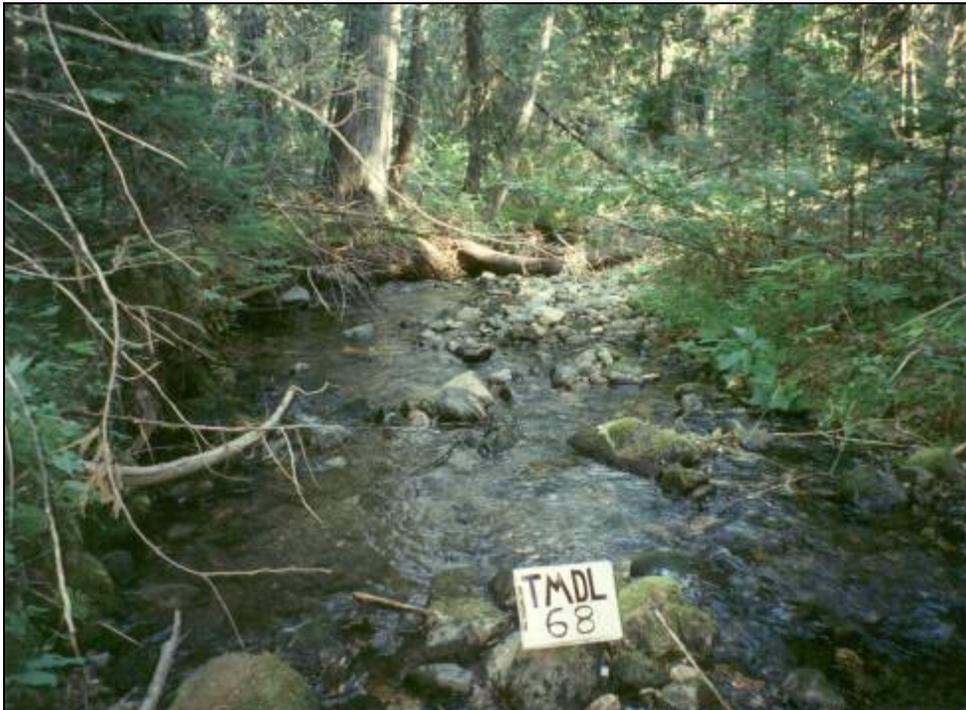
**Figure 4-14. South Fork Yaak River below Zulu Creek, site 68**

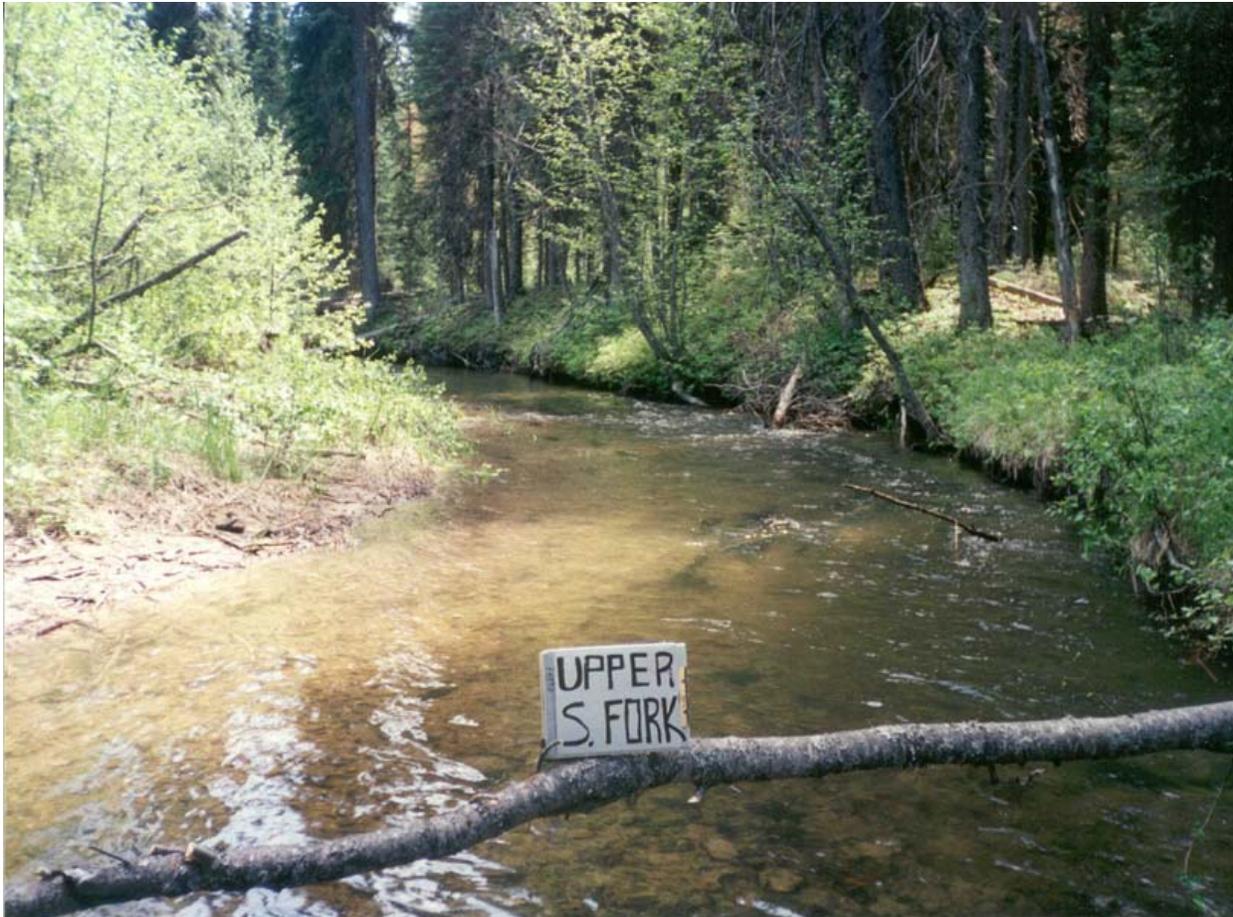
**Figure 4-15. South Fork Yaak River below Fowler Creek, site 18**

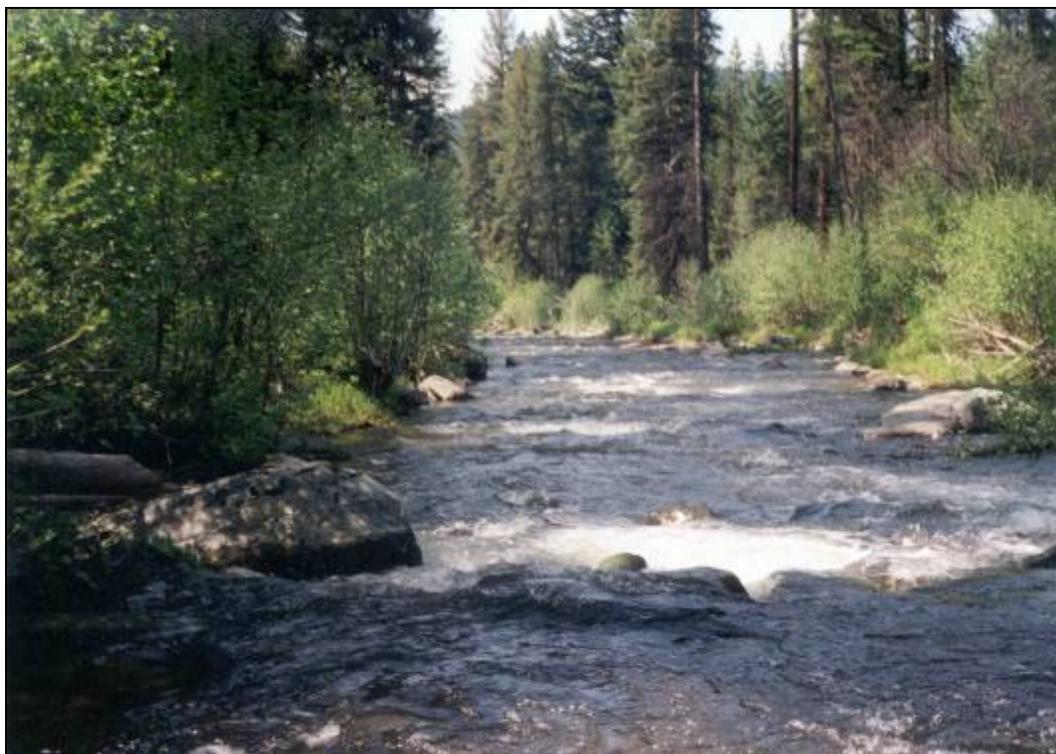
**Figure 4-16. South Fork Yaak River below Beaver Creek, site 16**

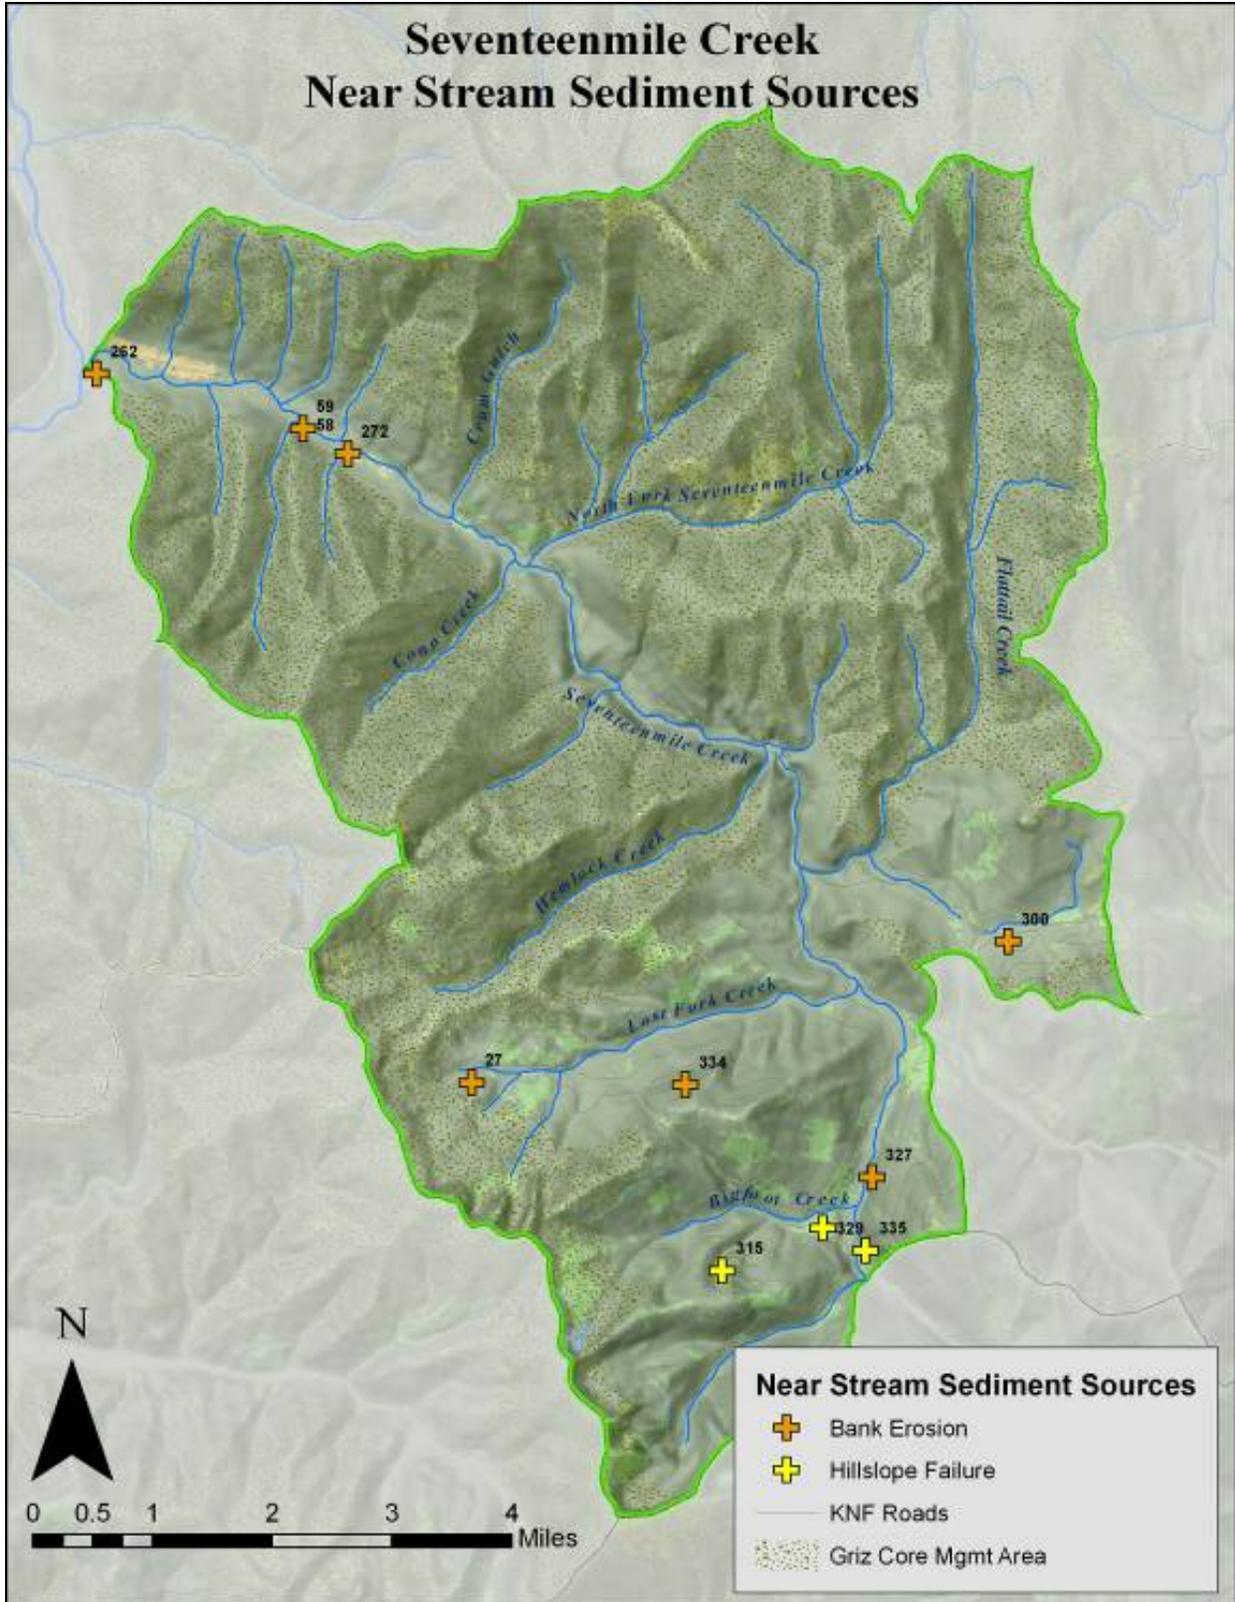
Figure 5-1. Seventeenmile Creek - Bank Erosion and Hillslope Failure Sites

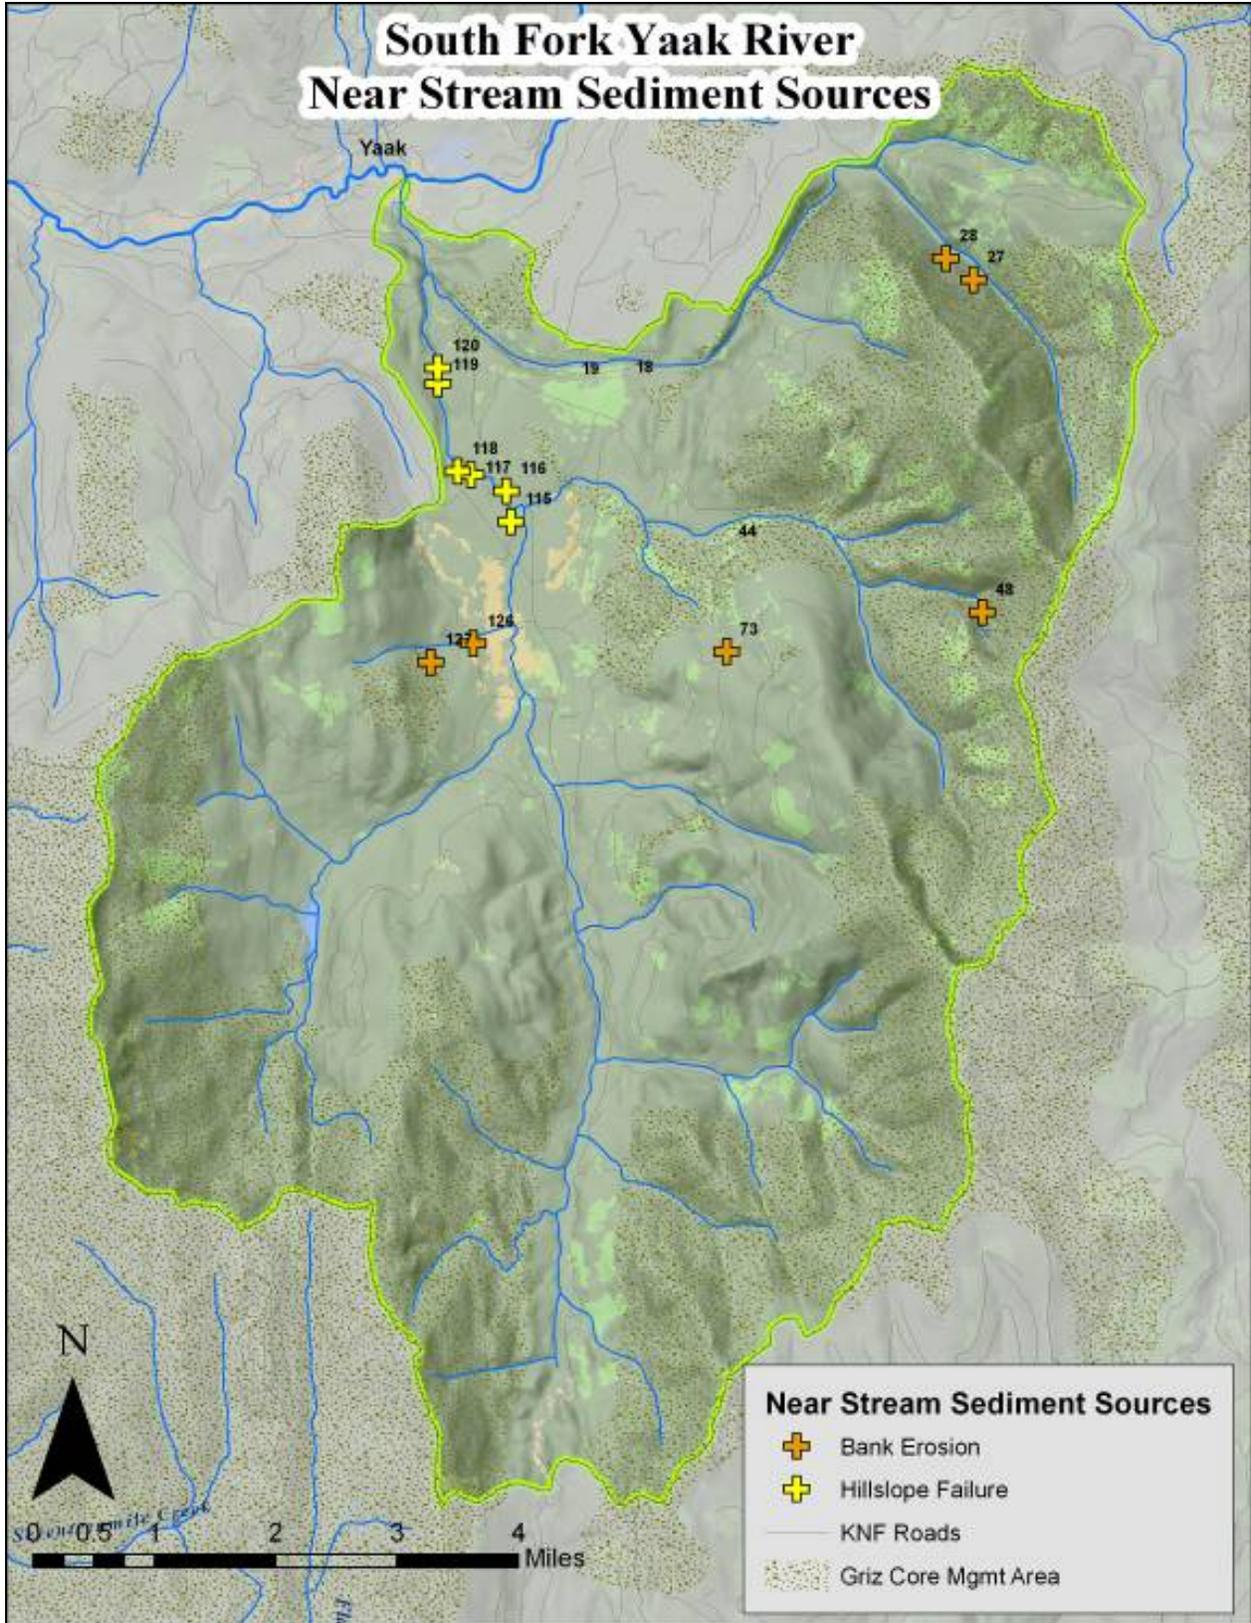
Figure 5-2. South Fork Yaak River - Bank Erosion and Hillslope Failure Sites

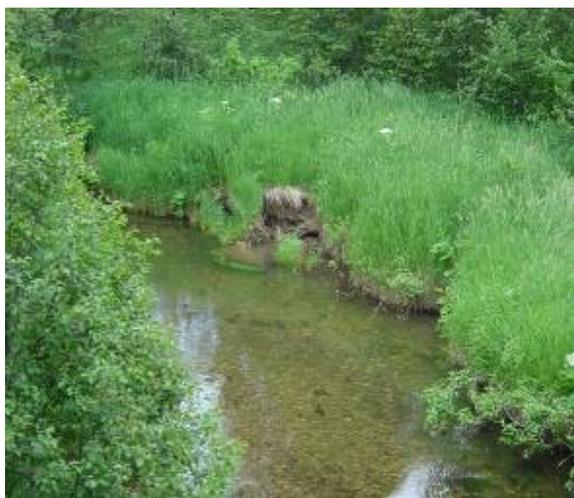
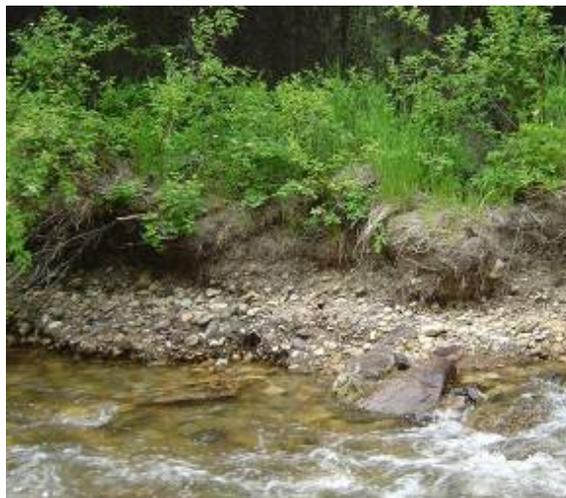
**Figure 5-3. Natural Bank Erosion**

**Figure 5-4. Natural Bank Erosion**

For this reason, it is assumed that the natural sediment load derived from hillslope and bank erosion observed in Seventeenmile Creek, Lap Creek, 13.26\*.06 and South Fork Yaak River is incorporated within the upland erosion estimates provided by the WATSED modeling results, and a specific sediment load estimate from bank erosion is not calculated.

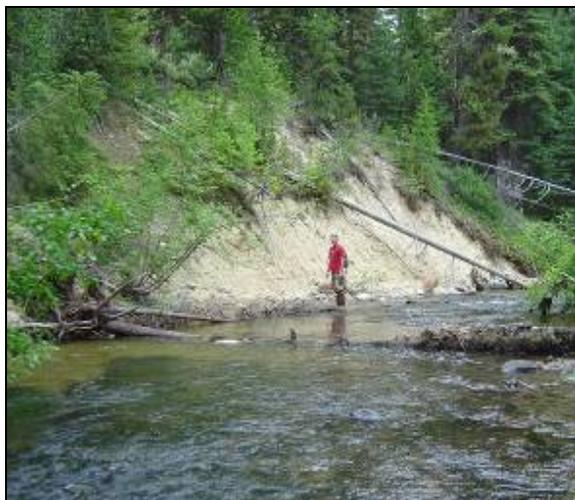
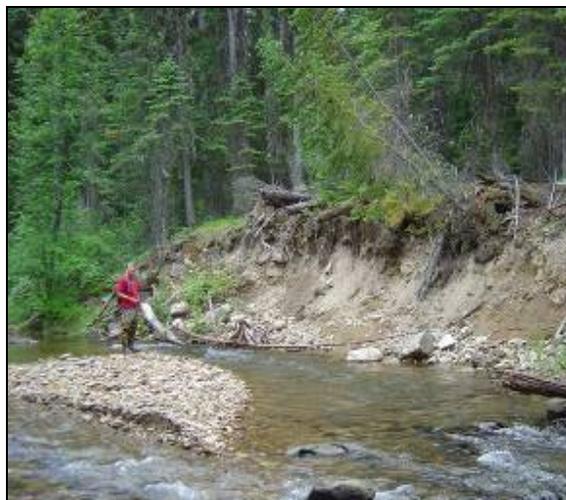
**Figure 5-5a. Hillslope Failure: Lower South Fork Yaak River**

**Figure 5-5b. Hillslope Failure: Lower South Fork Yaak River**

Agency personnel (USFS, EPA, DEQ) toured Seventeenmile Creek and South Fork Yaak River to ascertain the extent and degree of hillslope failure and mass wasting in the watershed, and, while agency personnel did not visit or verify all sites identified through Field Sediment Source Surveys, due to time constraints and difficulties accessing some sites, anthropogenic mass wasting and hillslope failure loads were not identified. Based on spatial extent of field data and professional judgment of agency resource managers, it is concluded that sediment loads to streams from hillslope failure or mass wasting events are not significantly elevated above

naturally occurring conditions, and specific numeric loads associated with this source category have not been calculated. WATSED modeling estimates presented in the following section include natural sediment loads from mass erosion (USFS, 1981).

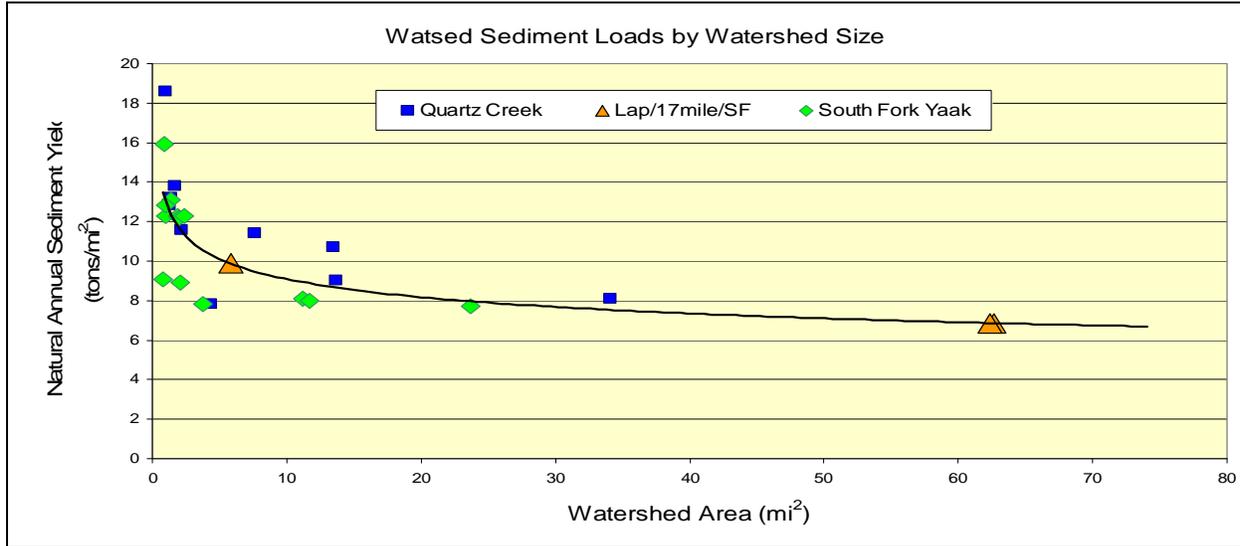
**Figure 5-6. Natural Annual Sediment Yield vs. Watershed Size: Yaak TPA**

As geology, topography and climactic regimes are similar among WATSED-modeled watersheds and watersheds of concern (Seventeenmile, South Fork Yaak, Lap), a regression equation was generated that related watershed size to estimated natural unit loading (tons/mi<sup>2</sup>/yr). Estimates of natural background unit loads for Seventeenmile Creek, South Fork Yaak River, and Lap Creek were generated from this regression equation (Figure 5-6, Table 5-3). ***Because modeling and validation of modeling results have not been conducted at a watershed scale for Seventeenmile Creek, Lap Creek, and South Fork Yaak River, values presented in Tables 5-2 and 5-3 should be considered only as relative estimates, and not actual loading values.*** As stated in previous sections, WATSED loading estimates have not separated out sediment loads from mass wasting and hillslope processes, but rather include them in the total estimate of natural sediment loading.

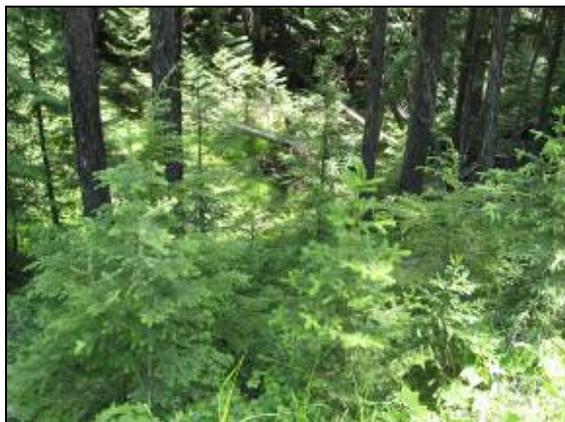
**Figure 5-13. Parallel Segment SFY-4A-P – Average Buffer Distance 70 feet**

In the field, parallel road segments were selected based on best professional judgment while traveling roads on which specific crossings were selected for evaluation. Parallel segments were selected in a manner where road segments would not be duplicated in both the crossing and parallel sediment load calculations. It was determined in the field that parallel road segments were not a significant source of sediment loading unless the stream buffer was very small (less than 20 feet) due to the extremely dense forest vegetation and stream buffers. As a result, parallel segments were only assessed if located very near a stream and if evidence of sediment delivery was noted. Only two parallel segments were identified and assessed in the Yaak TPA, one in the South Fork of the Yaak River (Figure 5-13) and one in Upper Seventeenmile Creek (Figure 5-14). One parallel segment representative of the dense vegetation conditions and low sediment delivery was measured (SFY-4A-P). As well, one segment where the road was located very near the stream and delivery was comparatively high (USC-2A-P). The majority of parallel sites observed in the field contained buffer distances greater than 50 feet and were heavily vegetated with no evidence of sediment delivery to the stream. USC-2AP was the only parallel site where evidence of sediment loading was noted. Figures 5-13 and 5-15 are included to show differences in the typical buffer conditions of the two parallel segments.

Field observations indicated that the vast majority of parallel road segments do not contribute sediment to streams, and buffer distances must be very small for sediment to reach adjacent stream channels. This conclusion was drawn based on observations in the three assessed subwatersheds only, the fact that nearly the entire road network (open roads) within these areas was traveled during fieldwork, and site USC-2A-P was the only site where evidence of delivery was noted. Also, a large portion of parallel road distance calculated in the GIS layers is present at road crossing locations and is accounted for in the crossing load calculations. As a result, parallel road segments are likely an insignificant contributor to overall sediment loading from the unpaved road network with isolated locations where roads are very close to streams. Because of the observed non-significance of sediment loading from parallel road segments, loads from parallel road segments were not calculated.

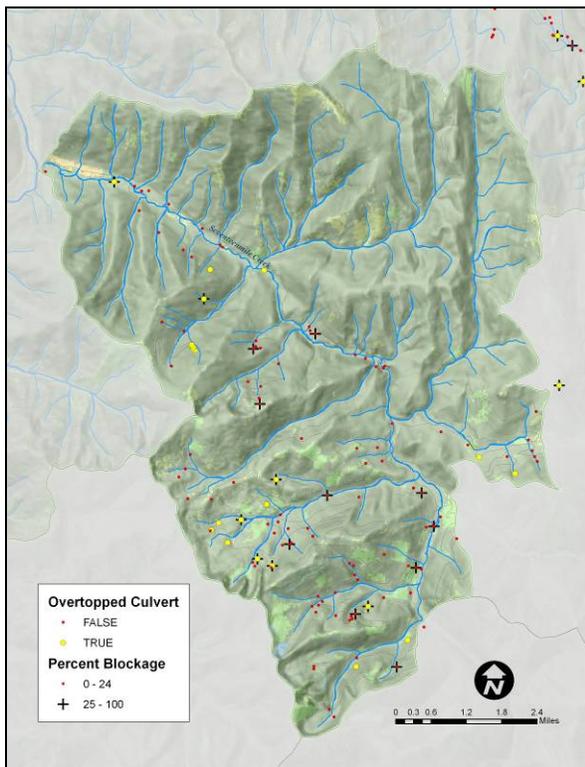
**Figure 5-15. Seventeenmile Creek – Overtopped and Blocked Culverts**

Constriction ratio (the ratio of culvert width to channel width) is used to evaluate the capabilities of culverts to pass high flows and associated debris. Culverts with widths less than bankfull stream widths were considered undersized and pose a potential risk of acute and chronic sediment delivery, channel scour, and debris accumulation, particularly under high flow conditions. Of the more than 180 culverts assessed for constriction, 67% had constriction ratios <0.7 and 24% had constriction ratios of <0.4.

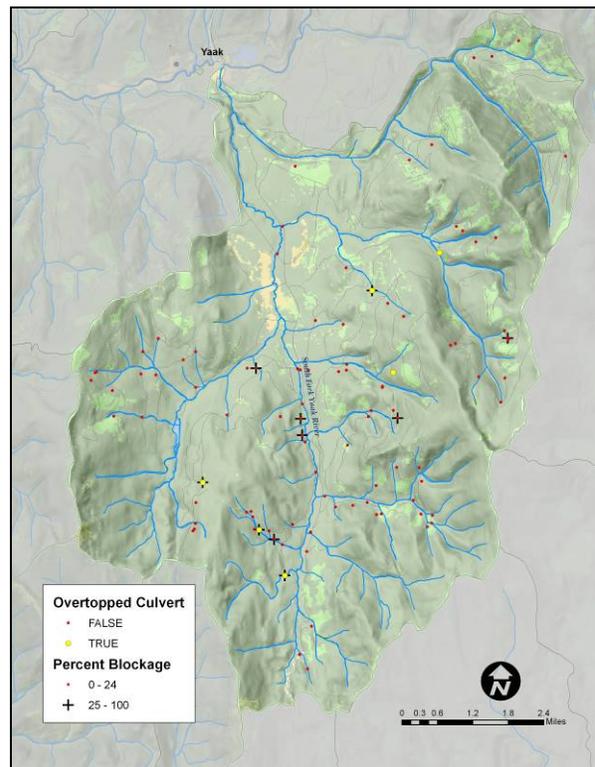
**Figure 5-16. South Fork Yaak River - Overtopped and Blocked Culverts**

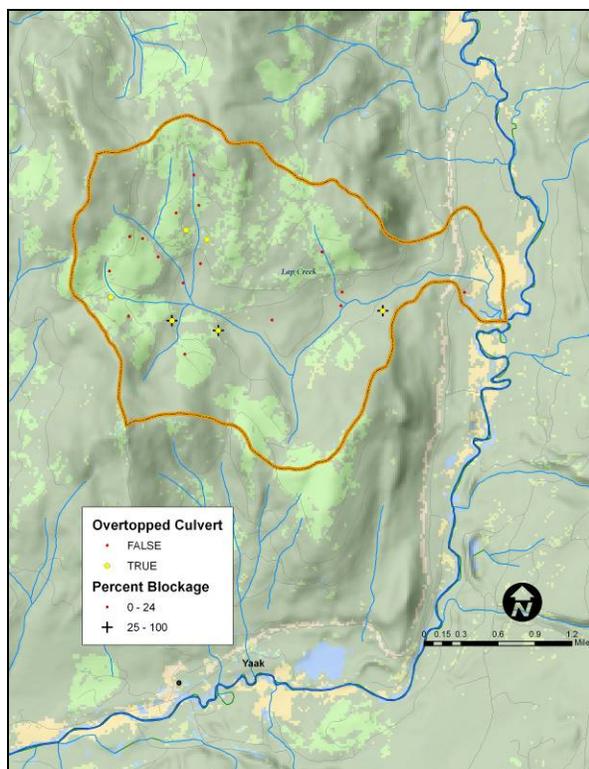
**Figure 5-17. Lap Creek - Overtopped and Blocked Culverts**
