MIDDLE BLACKFOOT-NEVADA CREEK TOTAL MAXIMUM DAILY LOADS AND WATER QUALITY IMPROVEMENT PLAN

Sediment, Nutrient, Trace Metal and Temperature TMDLs

September 22, 2008

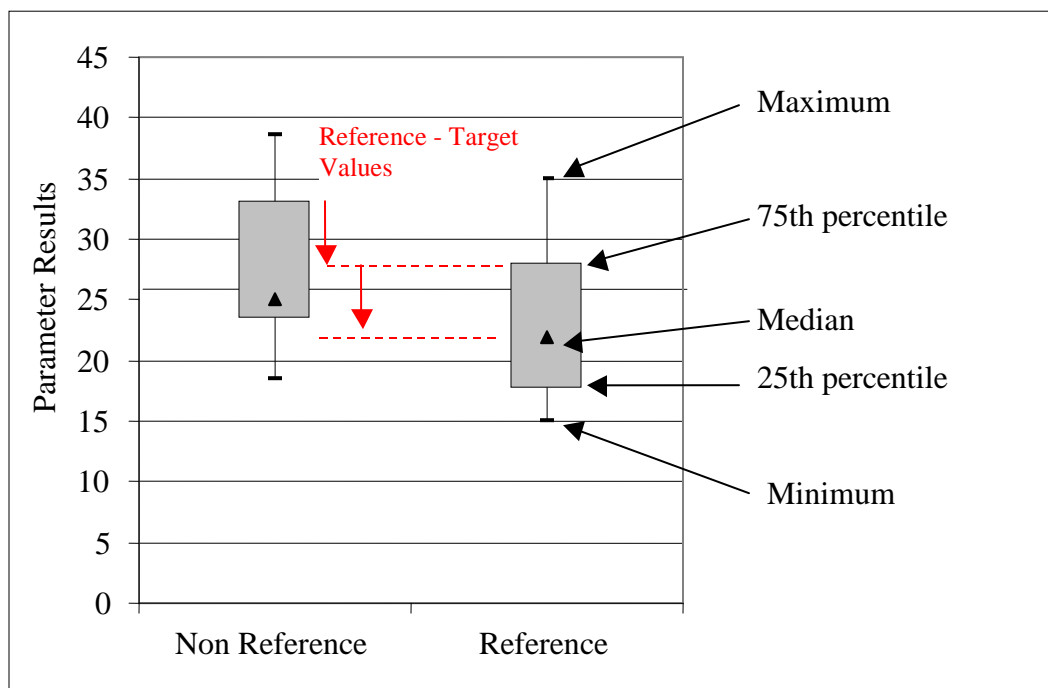
When the data set from the non-reference water body of interest is small, the individual data points are compared to the appropriate quartile from a reference data set. When the data set from an unassessed water body is larger, its quartile values are calculated and compared to those of the reference data set for determining impairment status. This approach is illustrated in **Figure 2-2**.

Figure 2-2. Comparison of Non-Reference to Reference Distributions Using a Target 75th Percentile (Lower Values More Desirable)

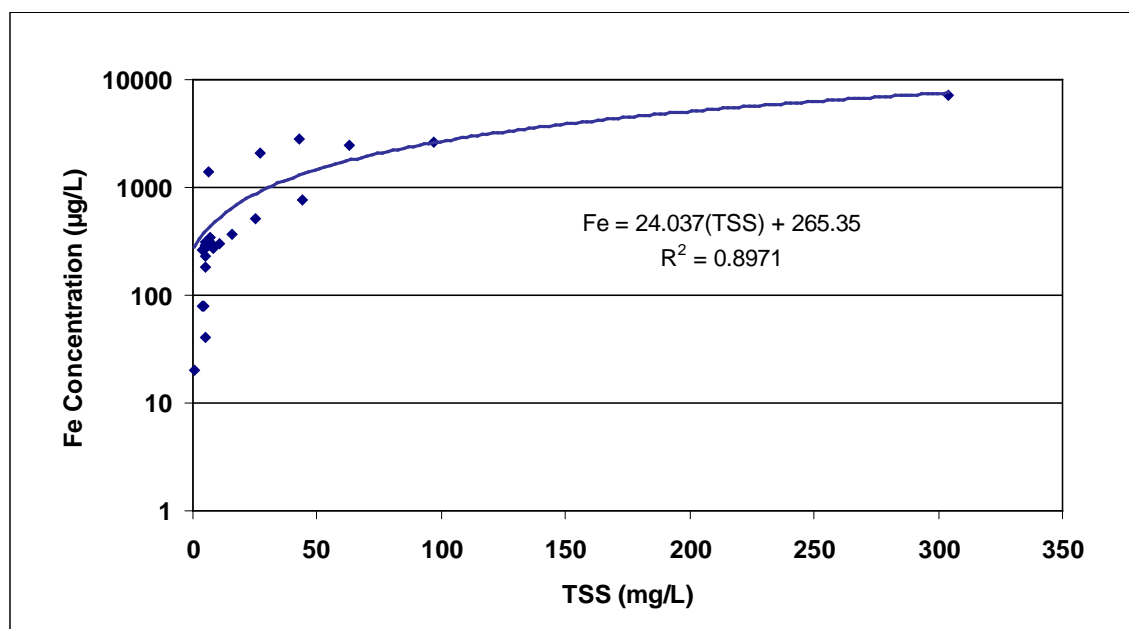
Figure 6-1 shows the graph of total recoverable iron concentrations as a function of total suspended solids (TSS) for data collected in upper Nevada Creek. The linear fit of the data suggests that suspended sediment concentration is a good predictor of total recoverable iron concentration, having an R^2 value of 0.90. The fitted curve in the figure depicts a linear relationship, but appears curved due to the logarithmic Y-axis. During the May 2005 monitoring, dissolved and total recoverable iron concentrations were measured in Washington and Jefferson creeks. Greater than 95% of the iron was present as a particulate in these streams, indicating that water column iron concentrations are primarily derived from suspended sediments that vary with stream discharge. Therefore, control of sediment sources should, to a large extent, mitigate iron water quality exceedences throughout the drainages.

Figure 6-1. Linear Regression of Total Recoverable Iron Concentrations with Total Suspended Solids Concentrations for Upper Nevada Creek

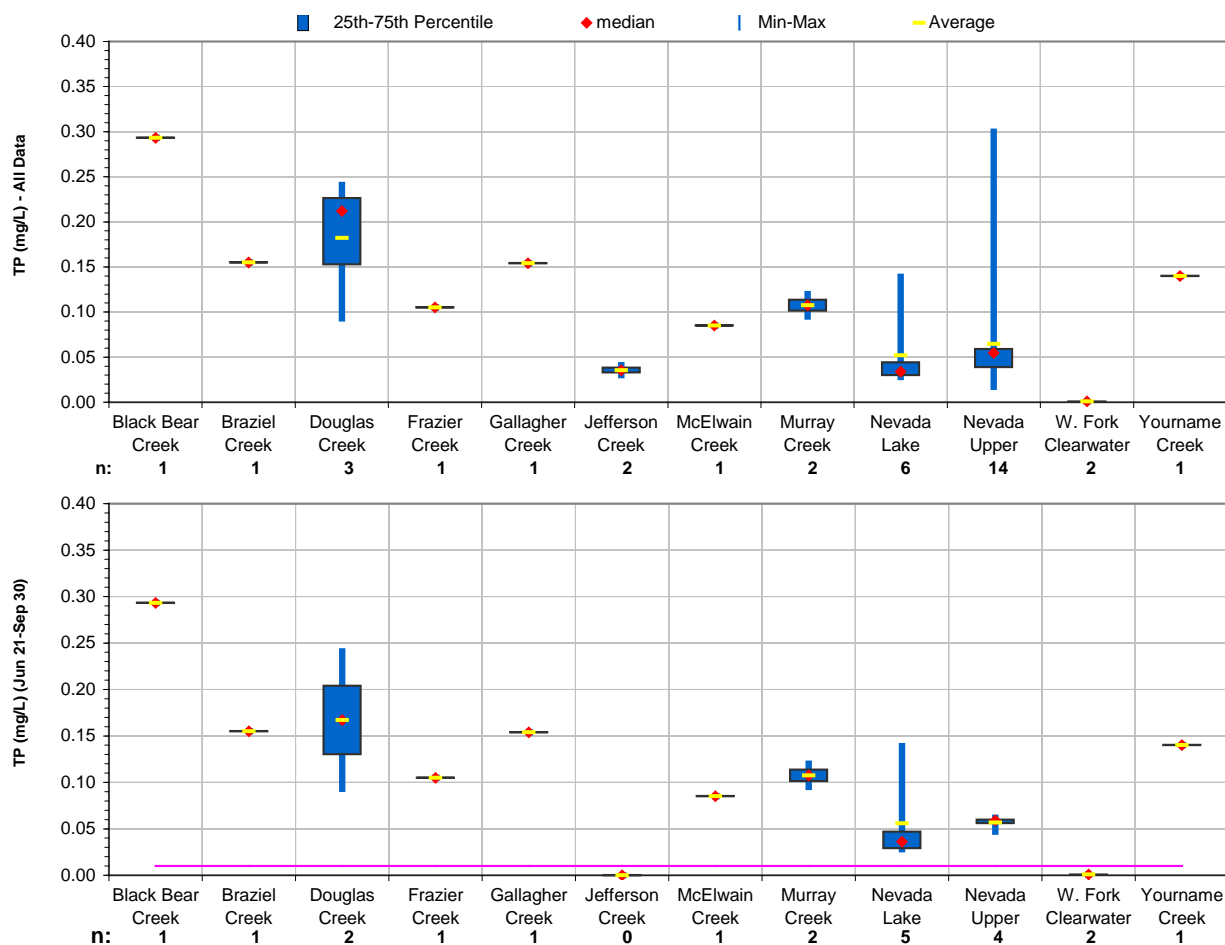
Figure 7-3. Summary of the Available Total Phosphorus Data in the Tributary Streams and Nevada Lake, 2001-2006

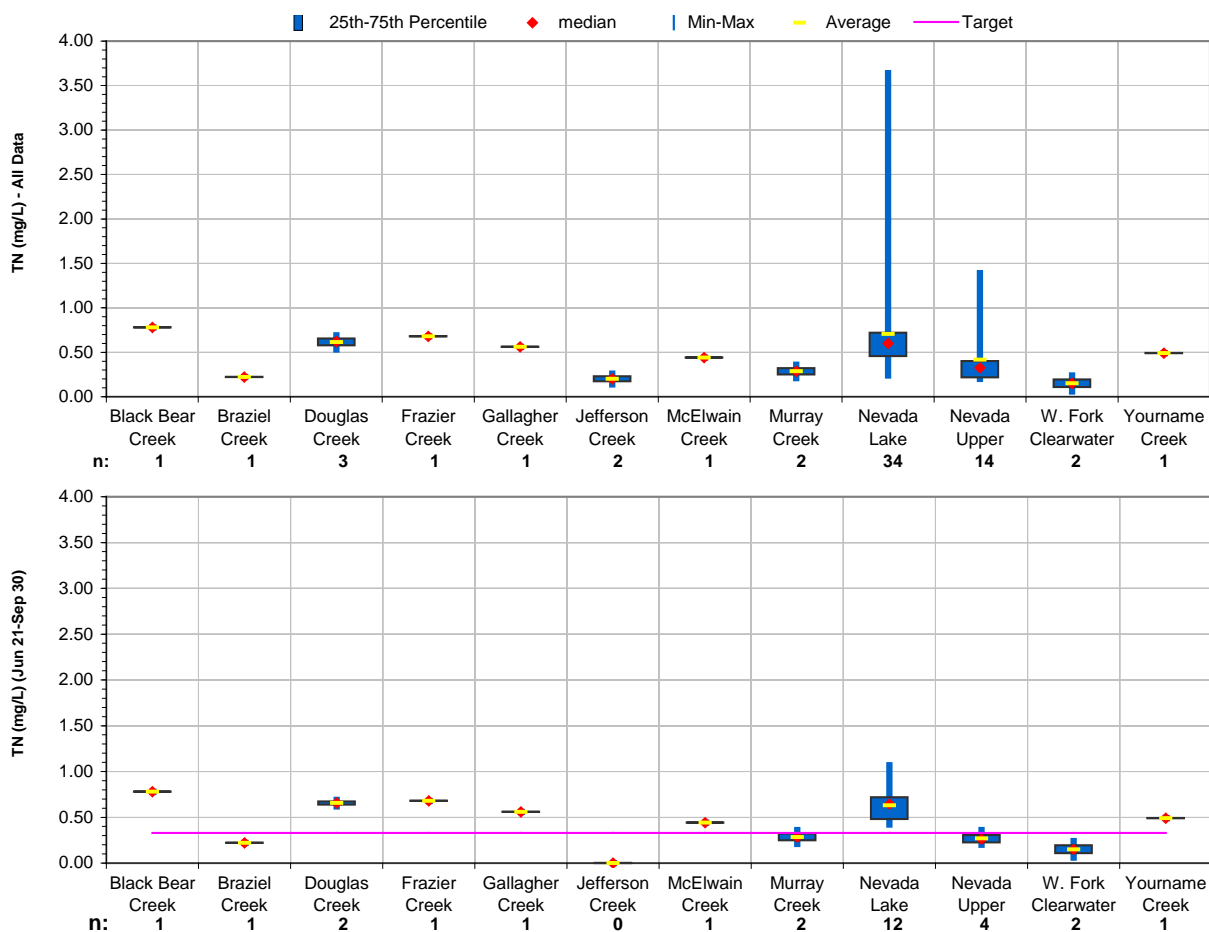
Figure 7-4. Summary of the Available Total Nitrogen Data for the Tributary Streams and Nevada Lake, 2001-2006

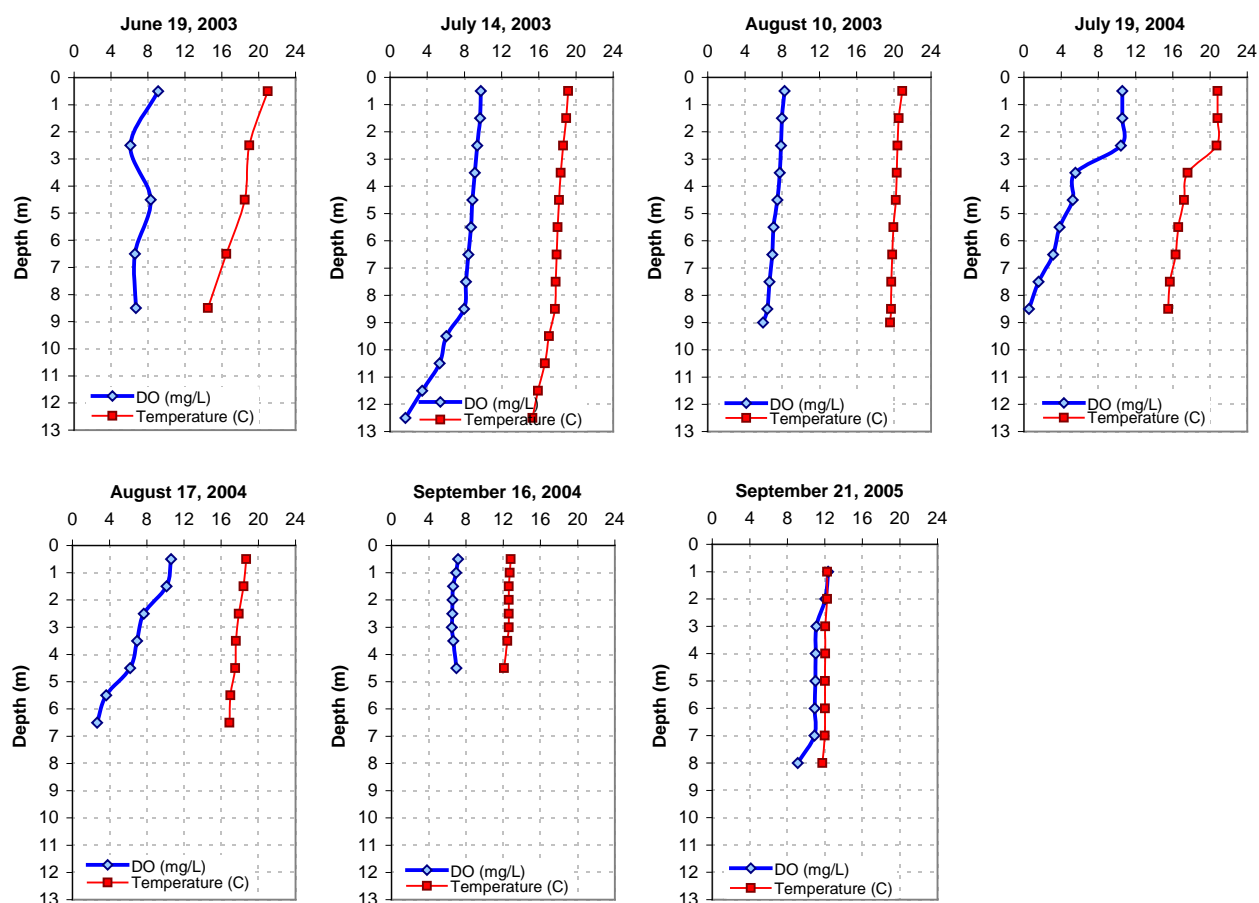
7-6). Three sampling events (July 14, 2003; July 19, 2004; and August 17, 2004) had dissolved oxygen concentrations at depth that were below the water quality standard of 5.0 mg/L.

Figure 7-6. Dissolved Oxygen and Temperature Profiles for Nevada Creek Reservoir (Station C03NVDRS01)

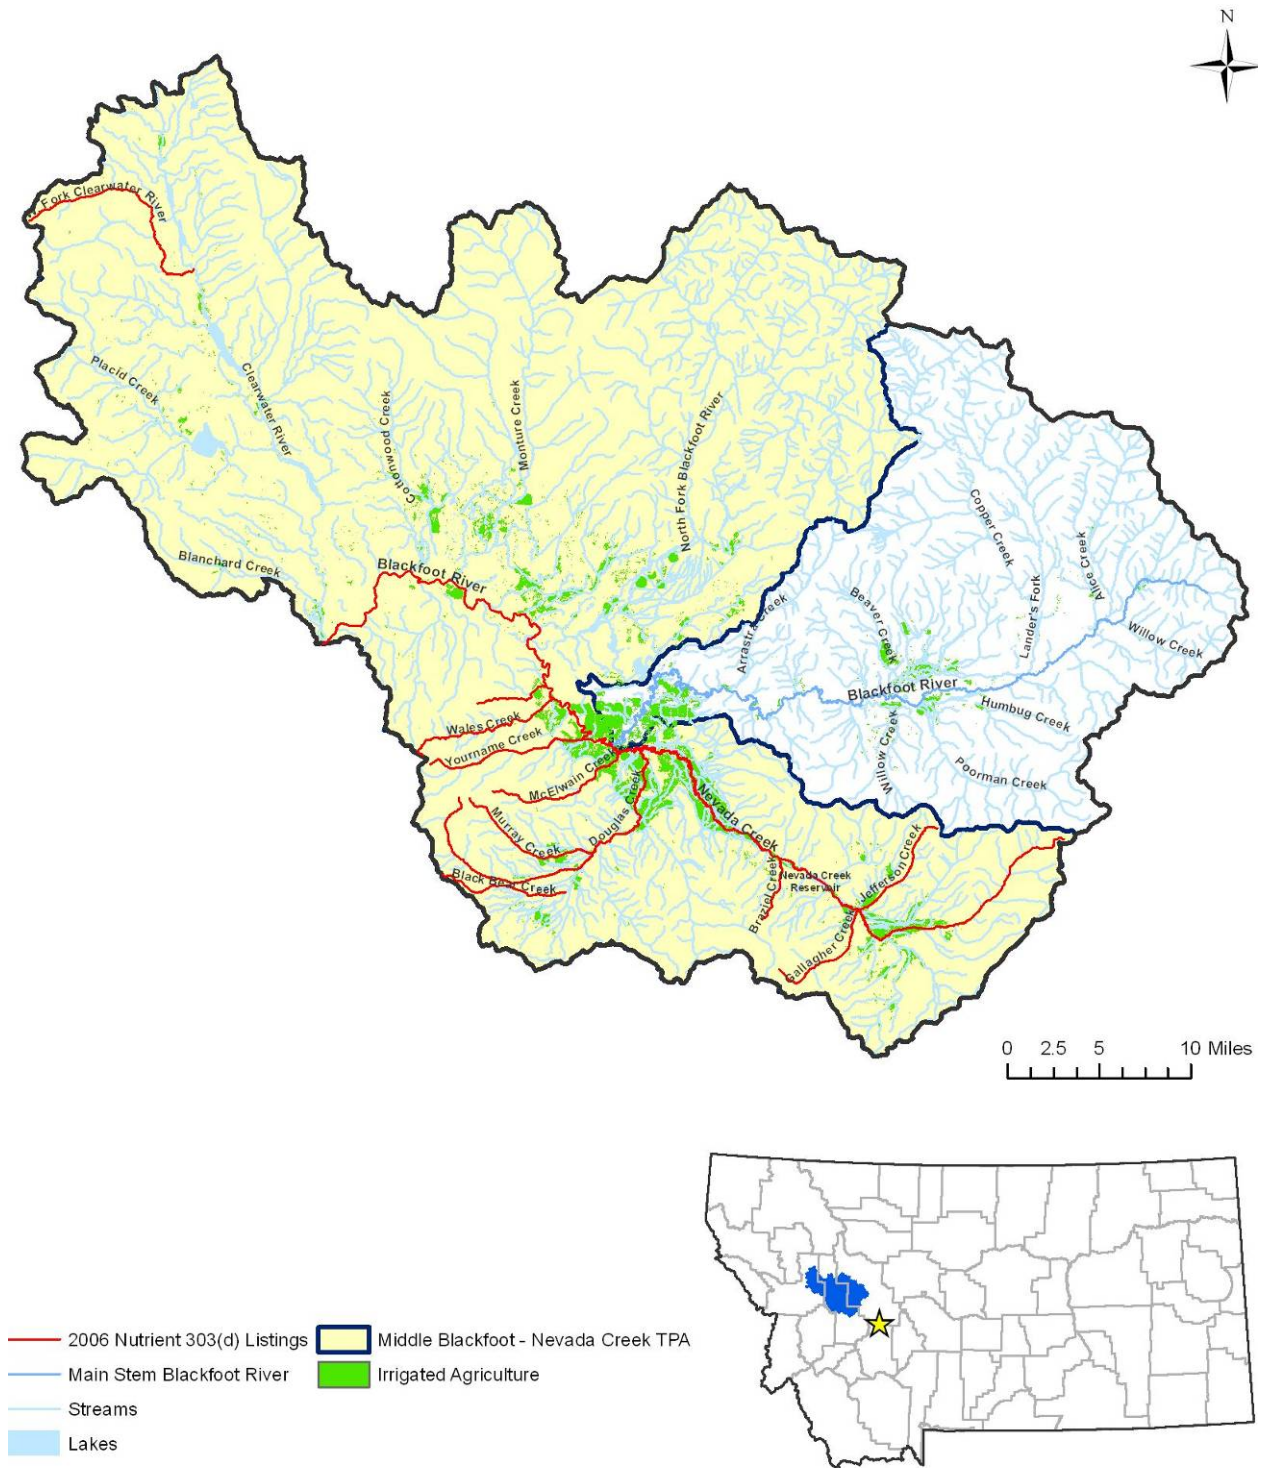
Figure 7-9. Irrigated Land in the Blackfoot River Watershed Upstream of the Confluence with the Clearwater River

Sources that occur at base flow conditions during the growing season are of principal concern. A simple GIS analysis was conducted to define the location and extent of the various sources. As shown in **Figure 7-7** and **Table 7-14**, agriculture is common throughout the watershed, and primarily consists of hay and pasture/grassland. Irrigated agriculture appears to be well represented by the NLCD land use classes “Hay/Pasture” and “Row Crops” (see **Figure 7-8**). From this analysis, the Blackfoot River Watershed (upstream of the confluence with the Clearwater River) has 40,692 acres of irrigated land which is primarily located in the Nevada Creek watershed (18,416 acres, 45 percent) and along the Blackfoot River valley near the confluence with Nevada Creek (**Figure 7-9**).

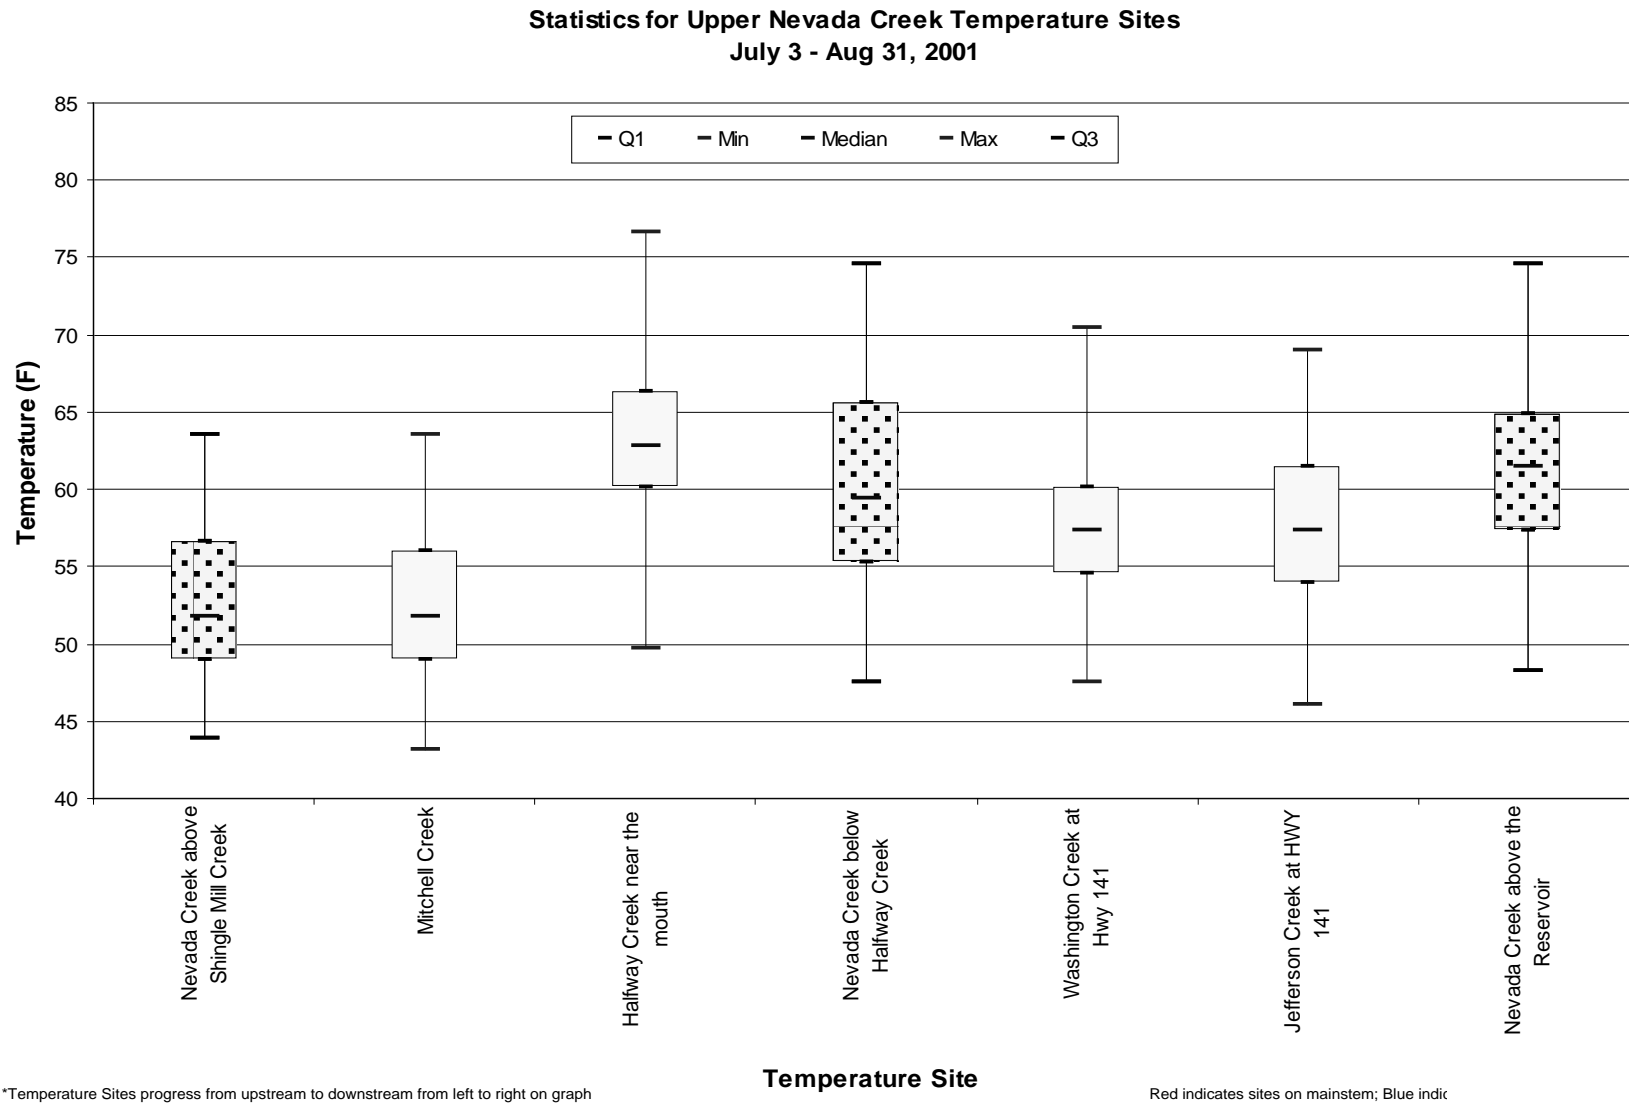
Figure 8-5. Upstream To Downstream Temperature Variation, Upper Nevada Creek, 2001

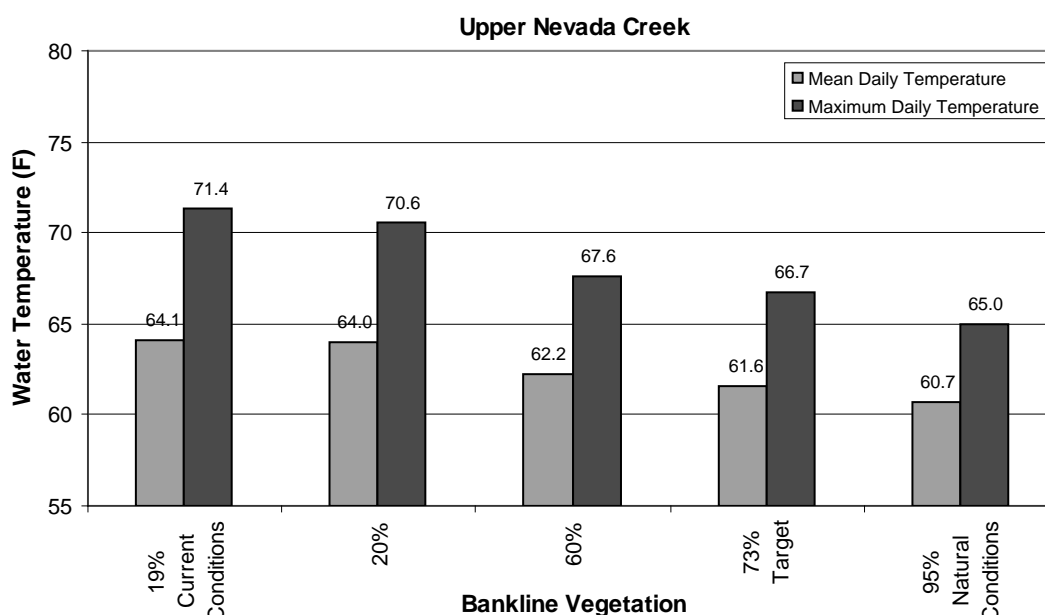
Figure 8-6. Simulated Mean and Maximum Temperature with Change in Bankline Vegetation for Upper Nevada Creek

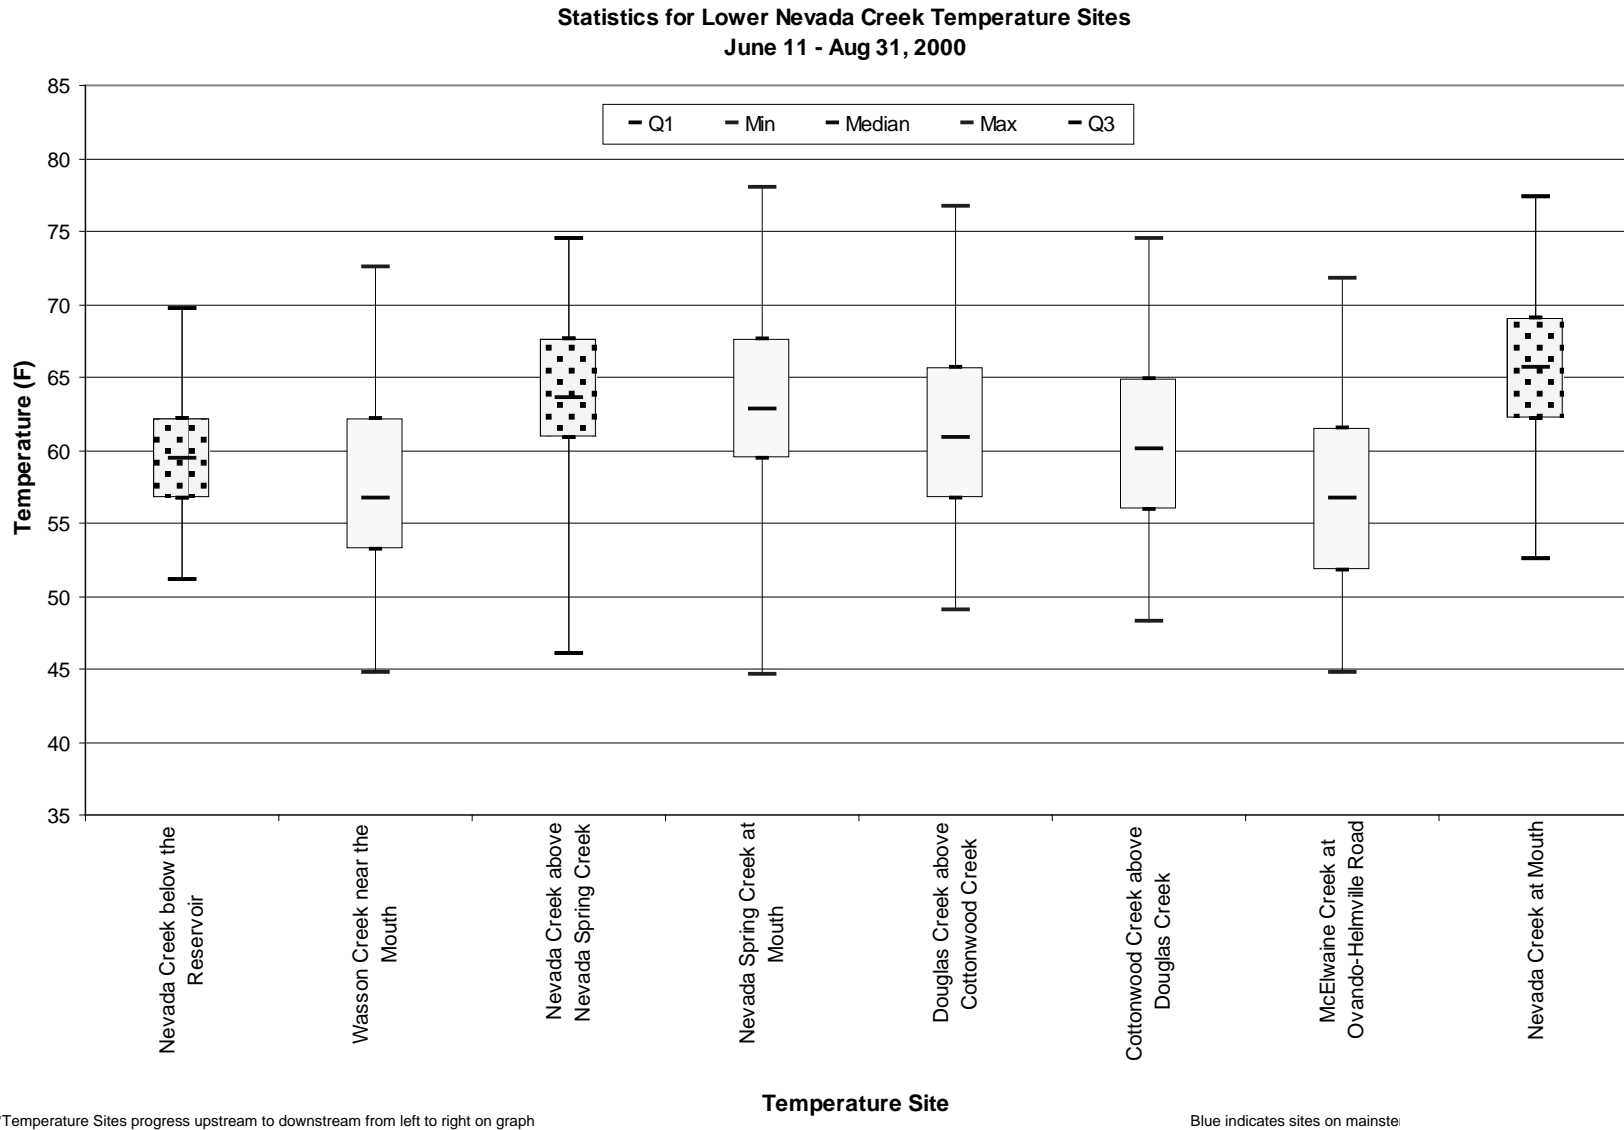
Figure 8-13. Upstream to Downstream Temperature Variation, Lower Nevada Creek, 2000

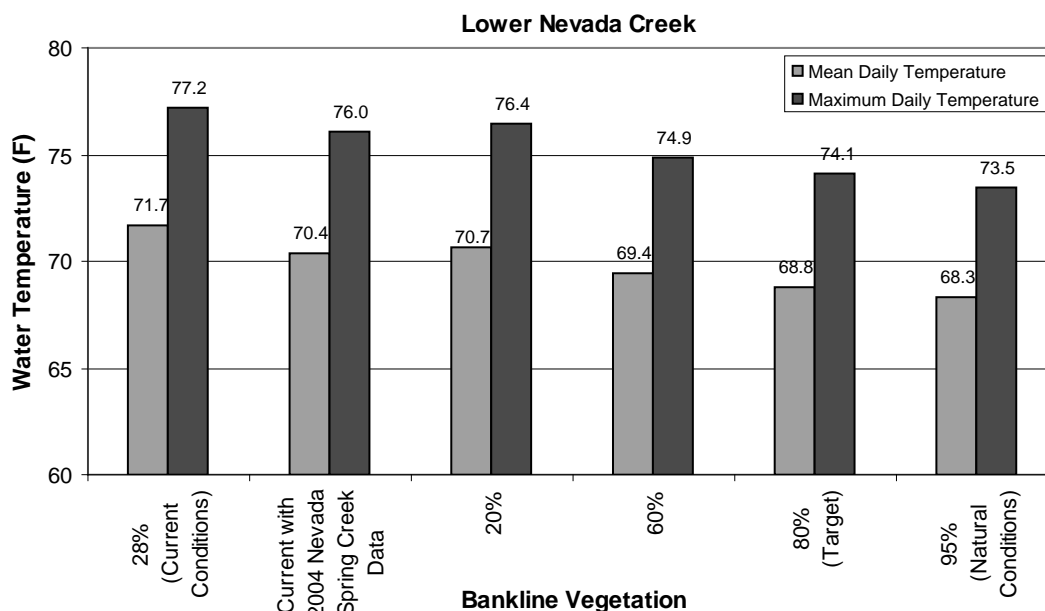
**Figure 8-15. Simulated Mean and Maximum Temperature with Change in Bankline Vegetation for Lower Nevada Creek****Lower Nevada Creek Impairment Status Summary**

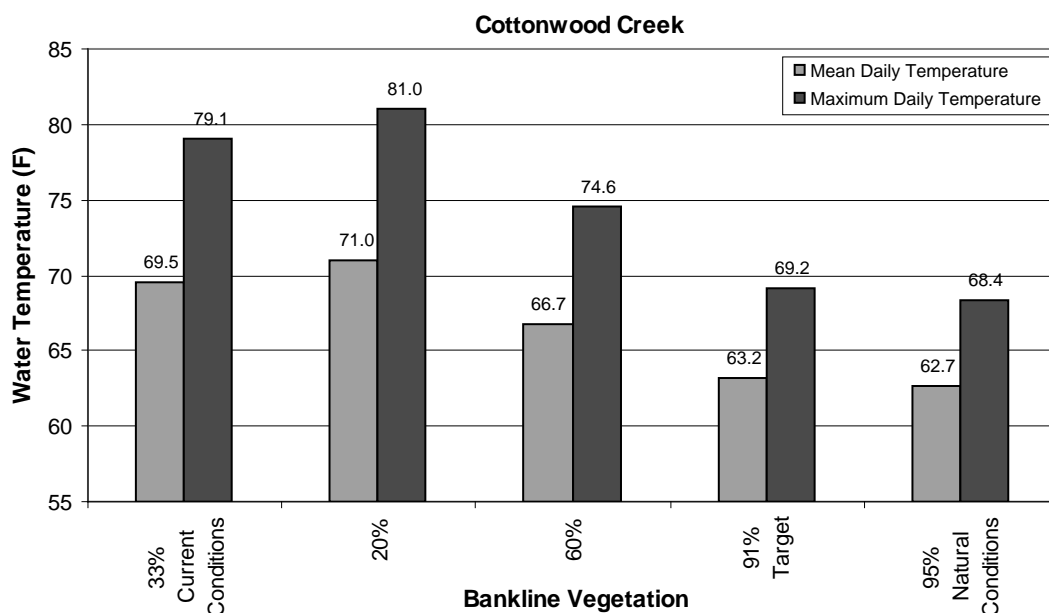
Figure 8-20. Simulated Mean and Maximum Temperature with Change in Bankline Vegetation for Cottonwood Creek

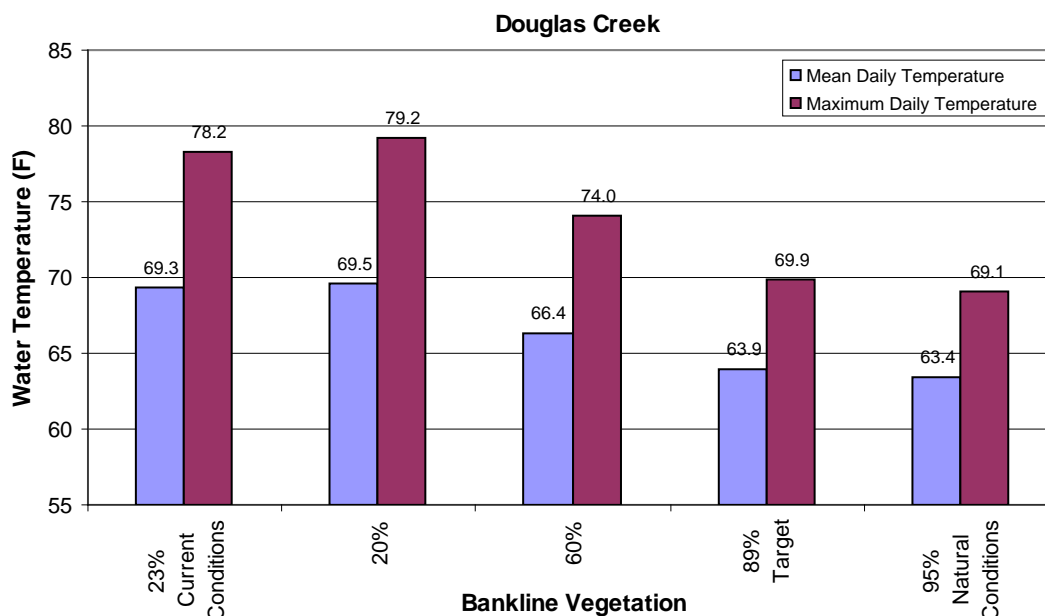
**Figure 8-27. Simulated Mean and Maximum Temperature with Change in Bankline Vegetation for Lower Douglas Creek****Lower Douglas Creek Impairment Status Summary**

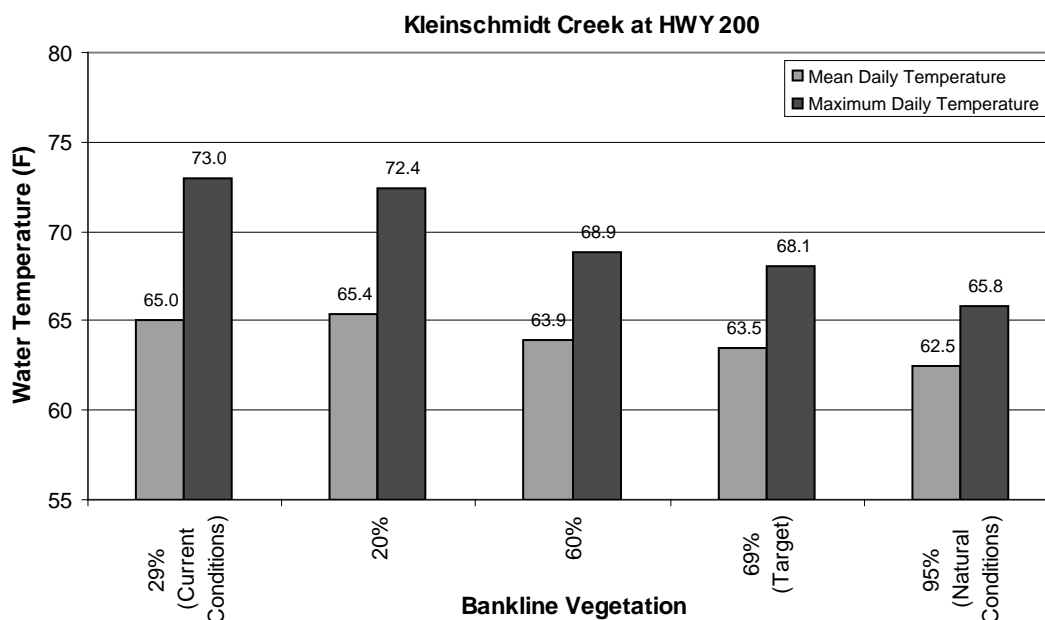
Figure 8-32. Simulated Mean and Maximum Temperature with Change in Stream Bank Vegetation, Kleinschmidt Creek above Highway 200

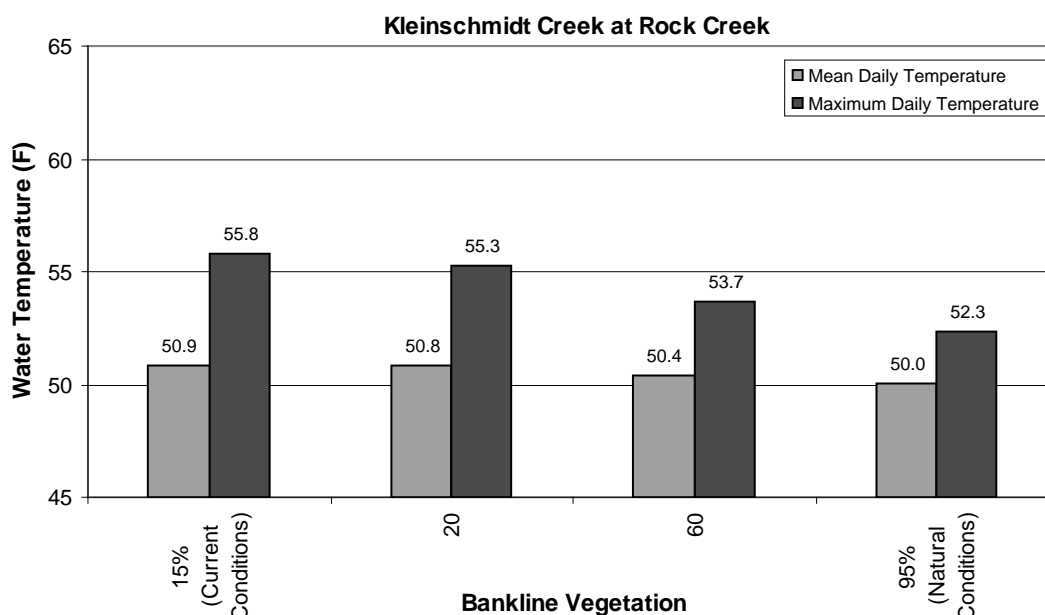
**Figure 8-33. Simulated Mean and Maximum Temperature with Change in Bankline Vegetation for Kleinschmidt Creek above Rock Creek**

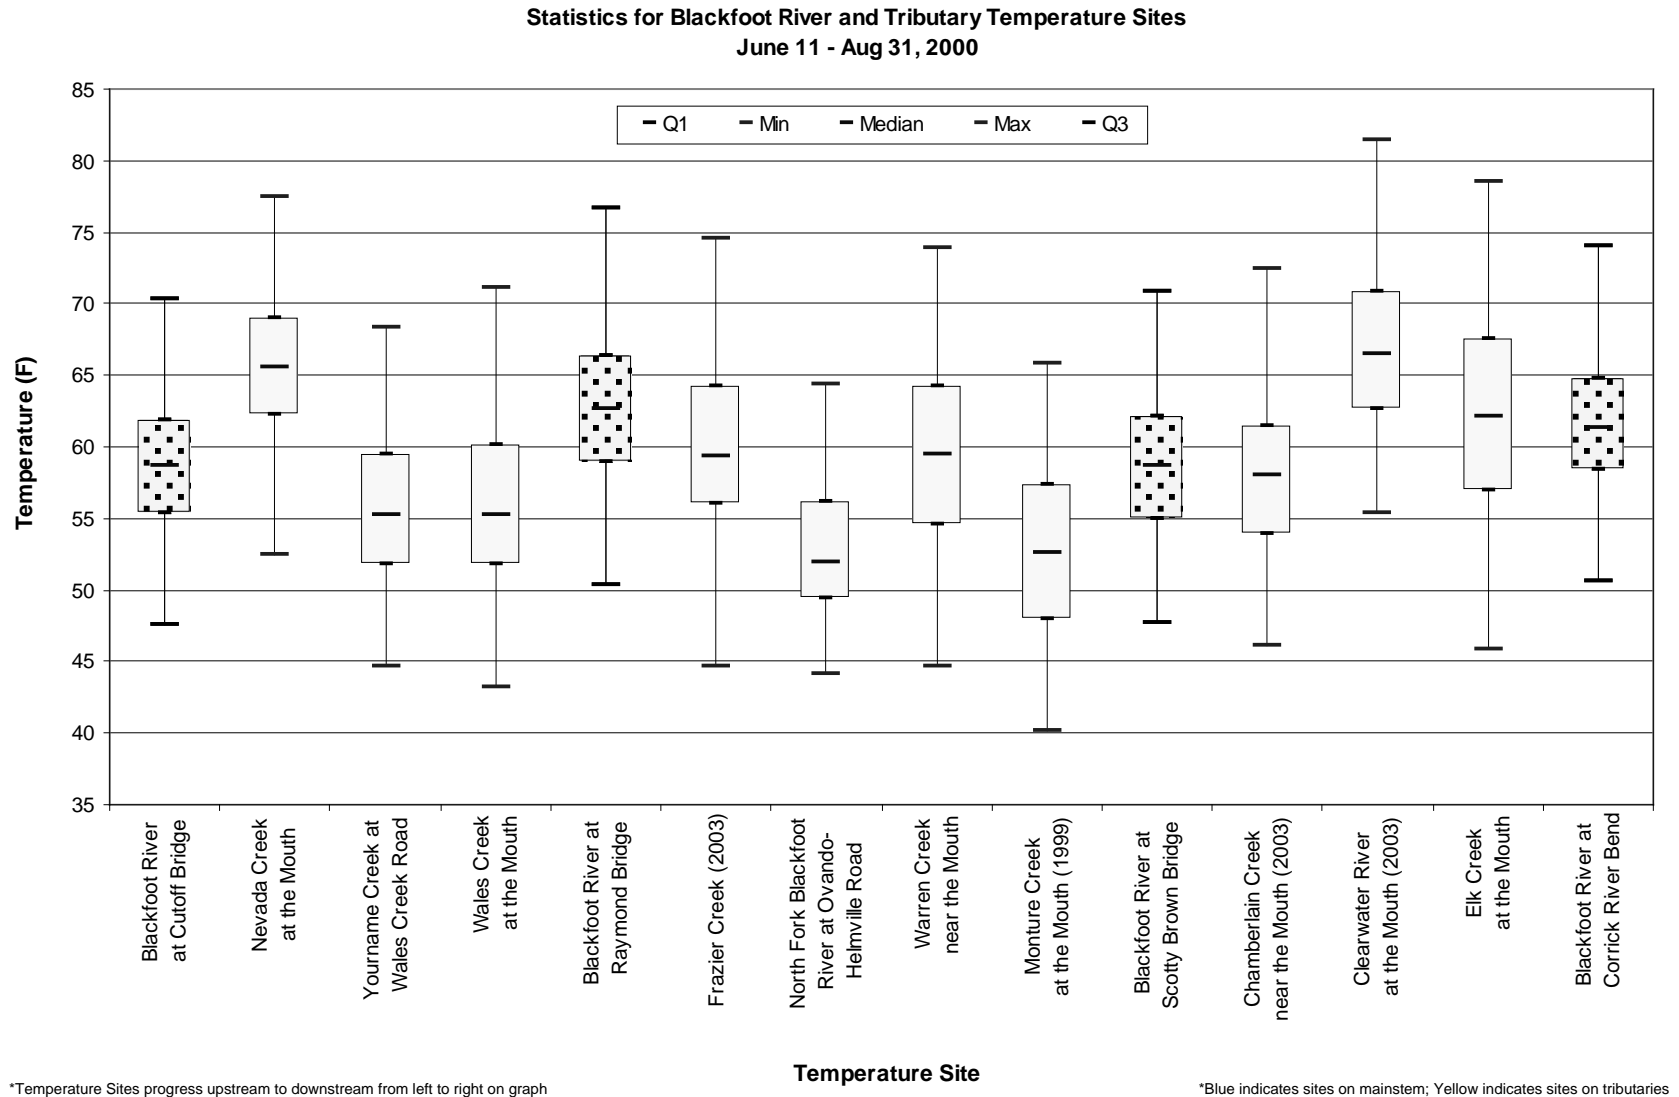
Figure 8-41. Upstream To Downstream Temperature Variation, Blackfoot River and Tributaries, 2000 and Other Years as Noted

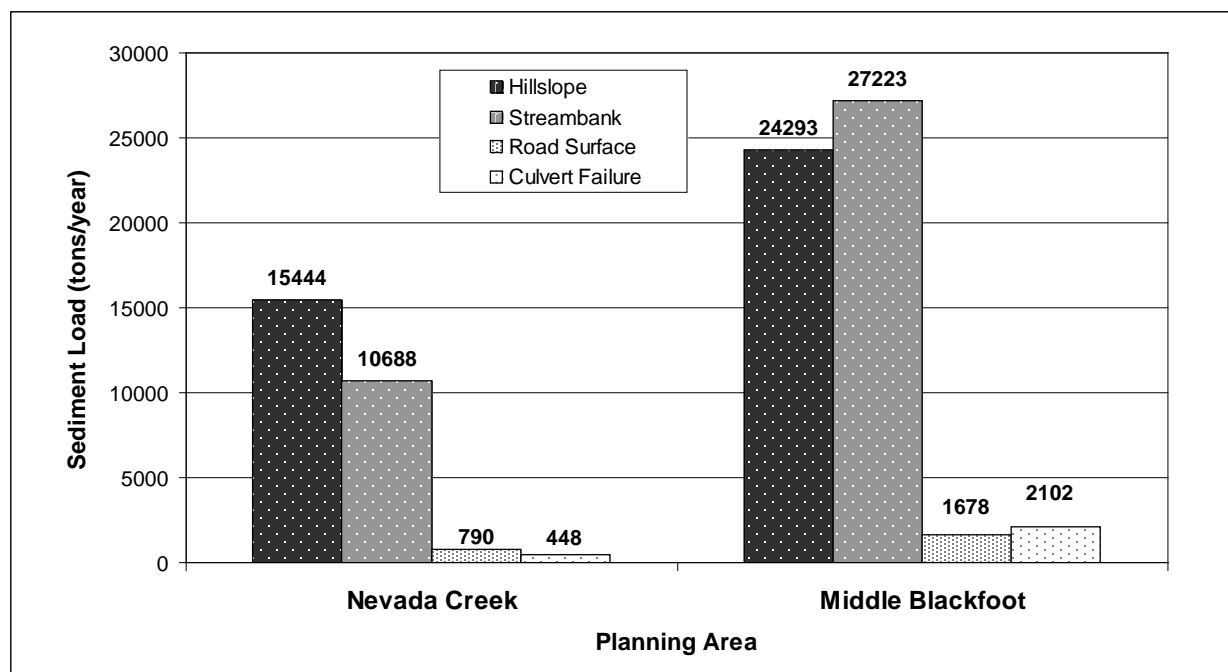
Figure 9-1 summarizes the existing sediment loading in the Nevada Creek and Middle Blackfoot planning areas from hillslope erosion, stream bank erosion, road surface erosion and culvert failure. Total loading to listed streams from the combined processes is estimated at 27,370 tons per year in Nevada Creek and 55,296 tons per year in the Middle Blackfoot.

Figure 9-1. Annual Sediment Loading From Principal Sources in the Nevada Creek and Middle Blackfoot Planning Areas

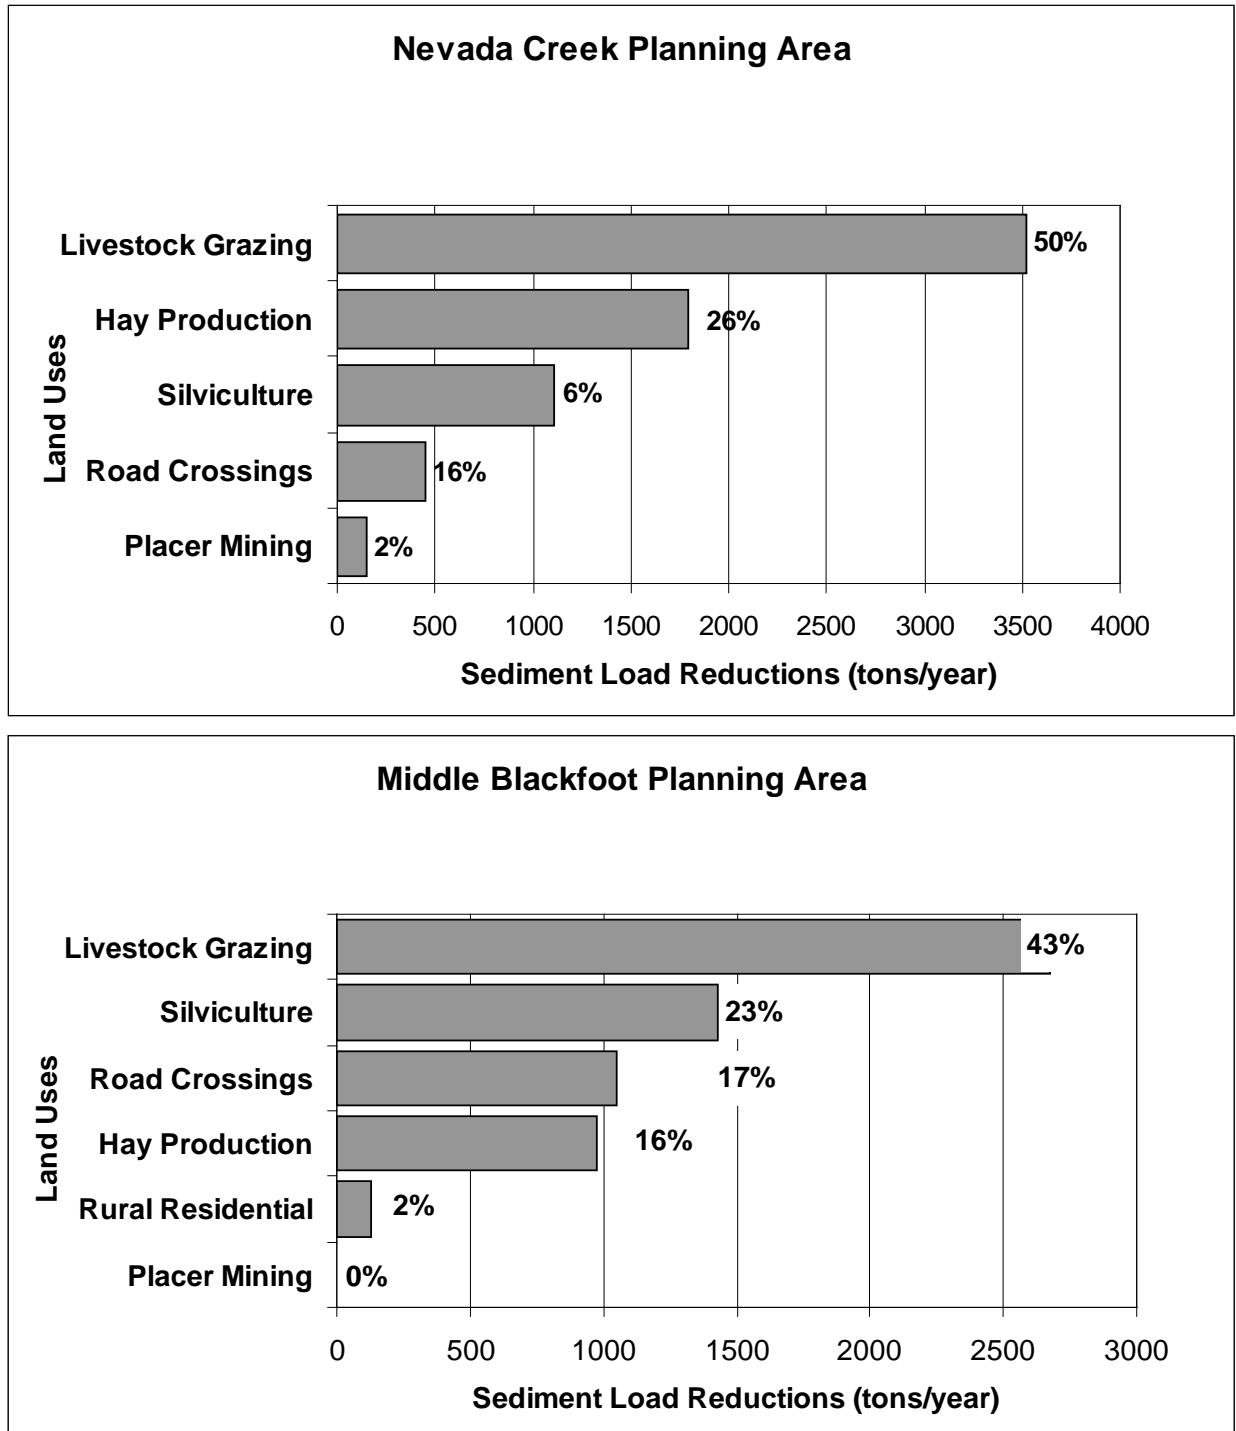
The reductions in road surface erosion and culvert failure are those possible with BMP implementation. **Figure 9-4** summarizes the total sediment load reduction allocations by contributing land use category for the Nevada Creek and Middle Blackfoot planning areas.

Figure 9-4. Sediment Reduction Allocations (Tons/Yr) by Contributing Land Use Category for the Nevada Creek and Middle Blackfoot Planning Areas

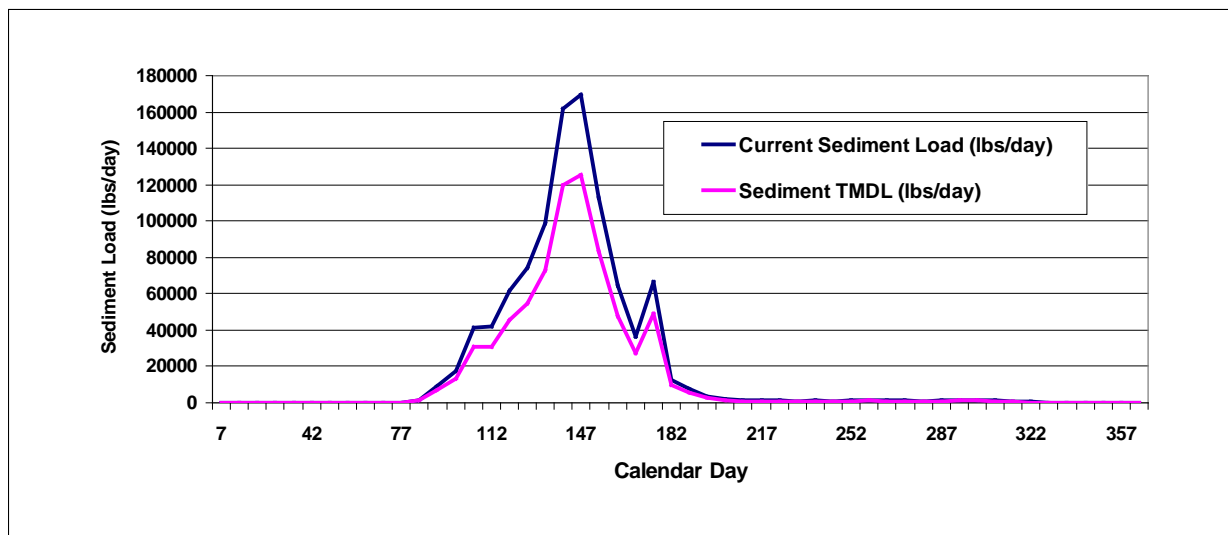
Upper Nevada Creek has a total annual sediment load estimate for of 3,501 tons per year (**Table 9-6**). The upper Nevada Creek reach file contains mean daily sediment loads. A daily loading fraction is calculated by dividing SWAT mean daily load by the total over 365 days (535 tons per the upper Nevada Creek reach file output). Current daily loading in upper Nevada Creek is 3,501 tons times the daily fraction. The allowable annual load of 2,592 tons ($3,501 - 909 = 2,592$) multiplied by the daily fraction gives an allowable daily load that represents the sediment TMDL. **Figure 9-5** illustrates the current daily loading and the allowable daily sediment loading remaining after a 26% reduction in upper Nevada Creek. Average weekly values were calculated in order to smooth the curve in the figure.

Figure 9-5. Current and Maximum Daily Sediment Loading for Upper Nevada Creek

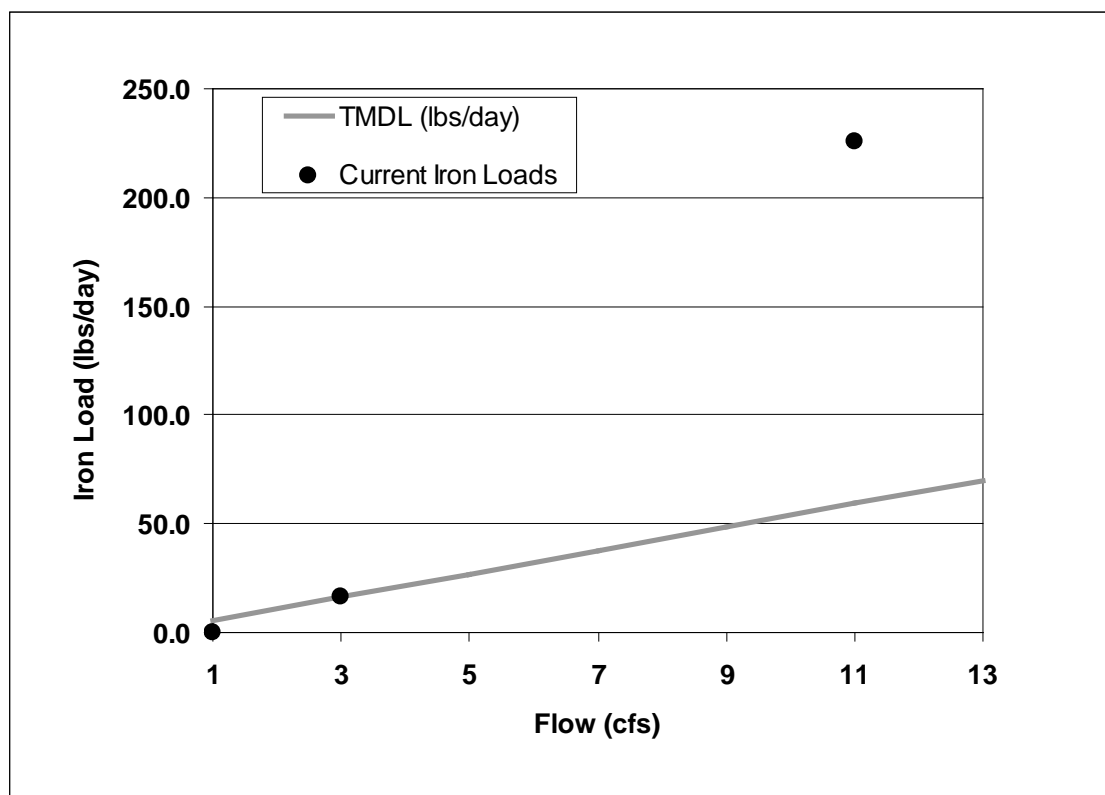
Note that the TMDL for any specific day is equal to the stream discharge in cubic feet per second multiplied by the numeric standard and the appropriate unit conversion factor. Future TMDLs calculated from flow conditions will necessarily differ from those in **Table 9-9** due to flow variability. **Figure 9-7** illustrates the line graph of the TMDL relative to the three measured loads in lower Washington Creek.

**Figure 9-7. The Graph of the Lower Washington Creek Iron TMDL with Current Loads Calculated from Analysis Results for Three Samples**

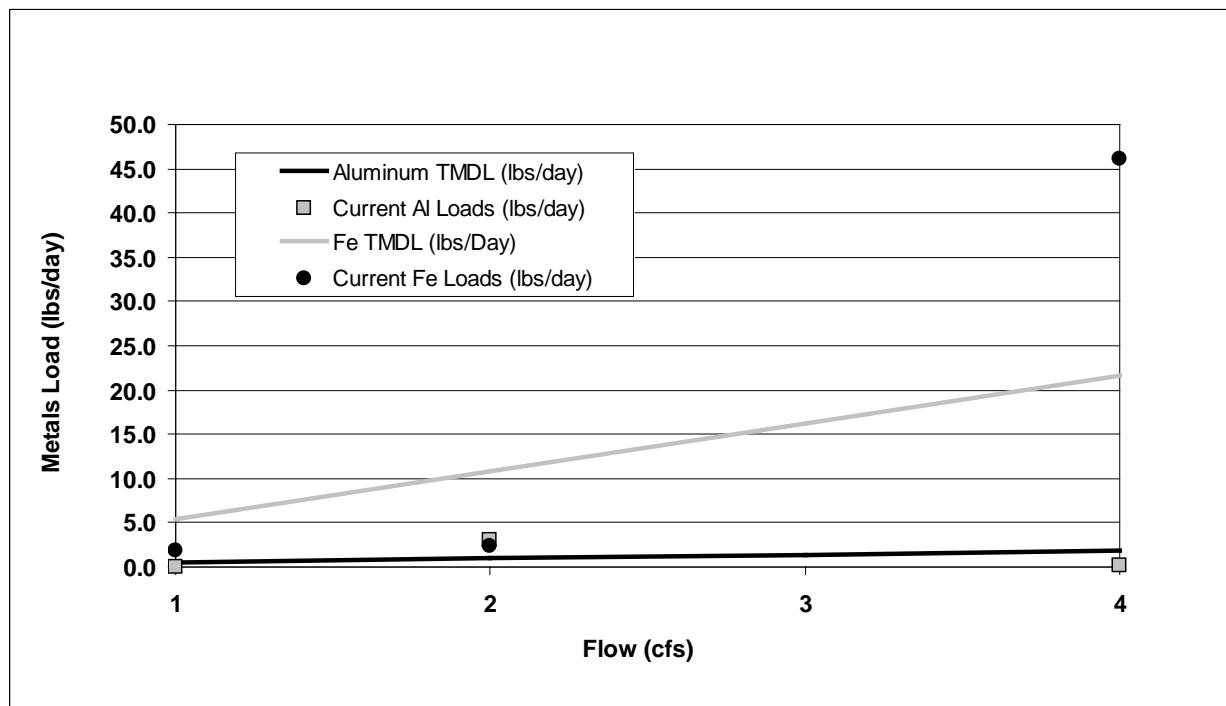
Figure 9-8. The Graphs of the Lower Jefferson Creek Iron and Aluminum TMDLs with the Respective Current Loads Calculated from Analysis Results for Three Samples
