MIDDLE BLACKFOOT-NEVADA CREEK TOTAL MAXIMUM DAILY LOADS AND WATER QUALITY IMPROVEMENT PLAN

Sediment, Nutrient, Trace Metal and Temperature TMDLs

September 22, 2008

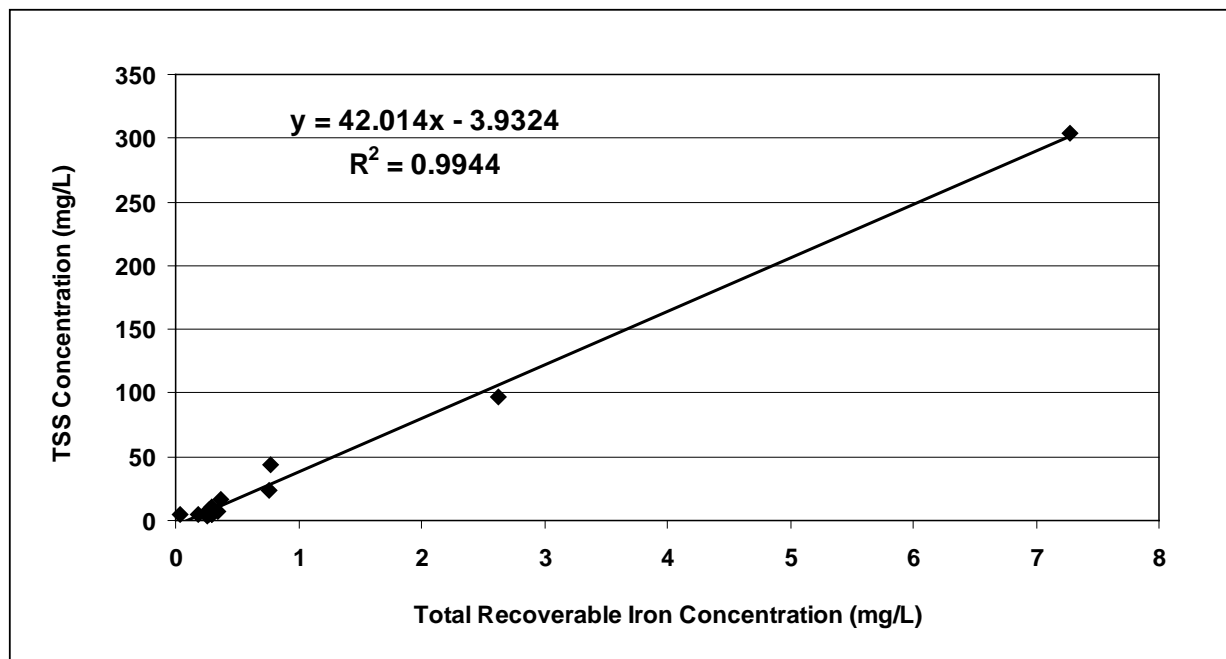
Figure 9-10. Graph of the Relationship between Total Recoverable Iron Concentration and TSS for Analysis Results from Upper Nevada Creek

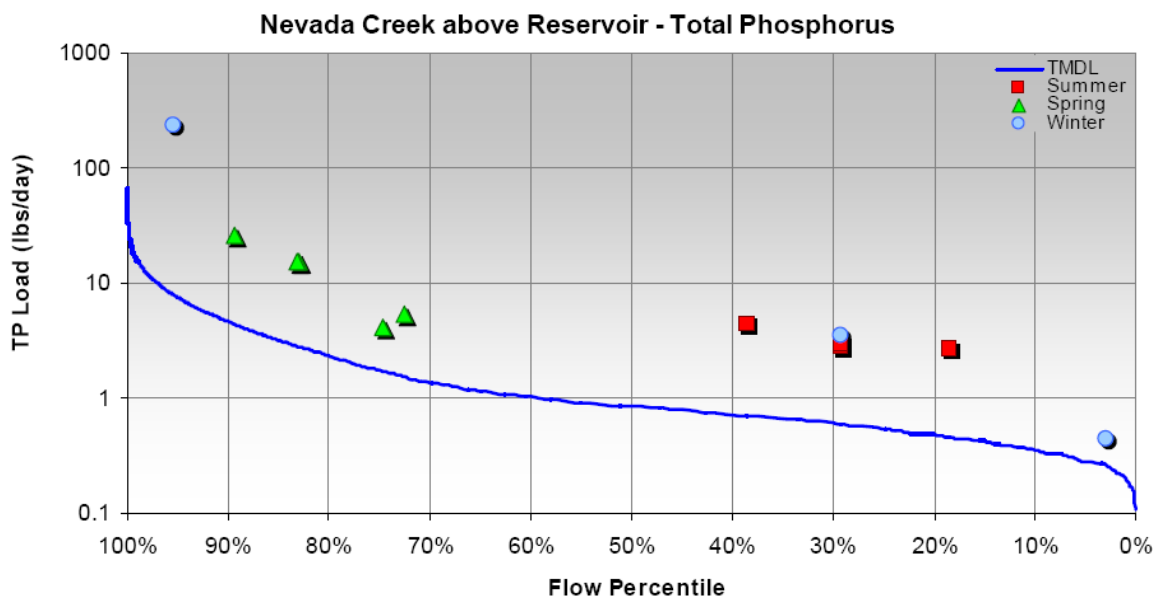
Figure 9-11. Comparison of the Allowable to the Observed Total Phosphorus Load for Nevada Creek Upstream of Nevada Creek Reservoir
USGS Station 12335500

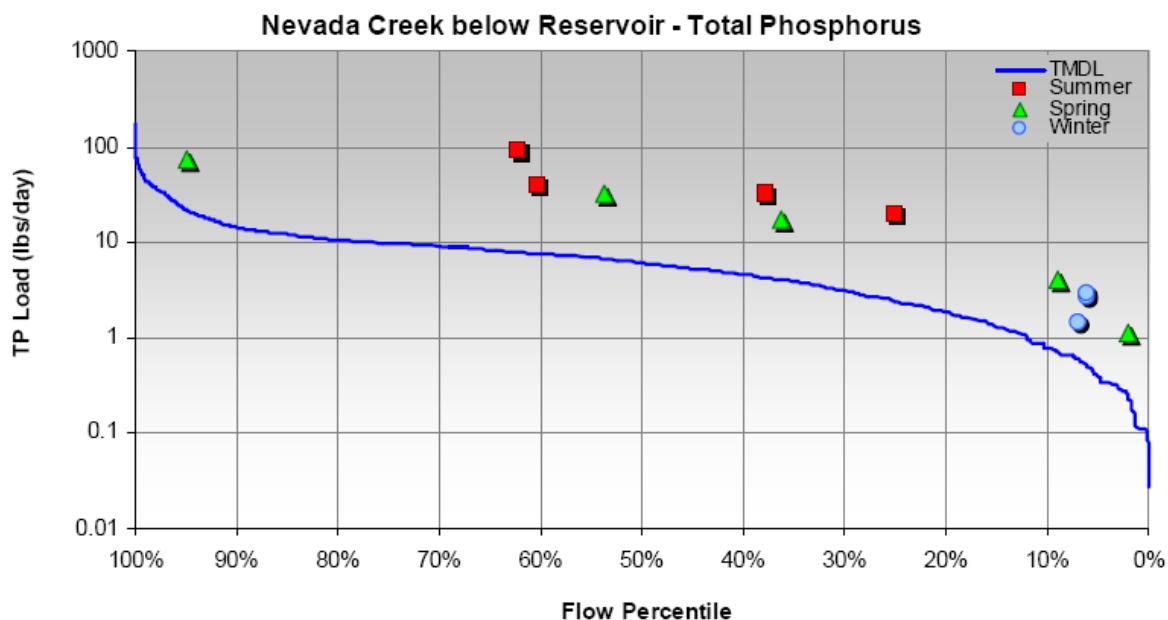
**Figure 9-12. Comparison of the Allowable to the Observed Total Phosphorus Load for Nevada Creek Downstream of Nevada Creek Reservoir**
USGS Station 12336600

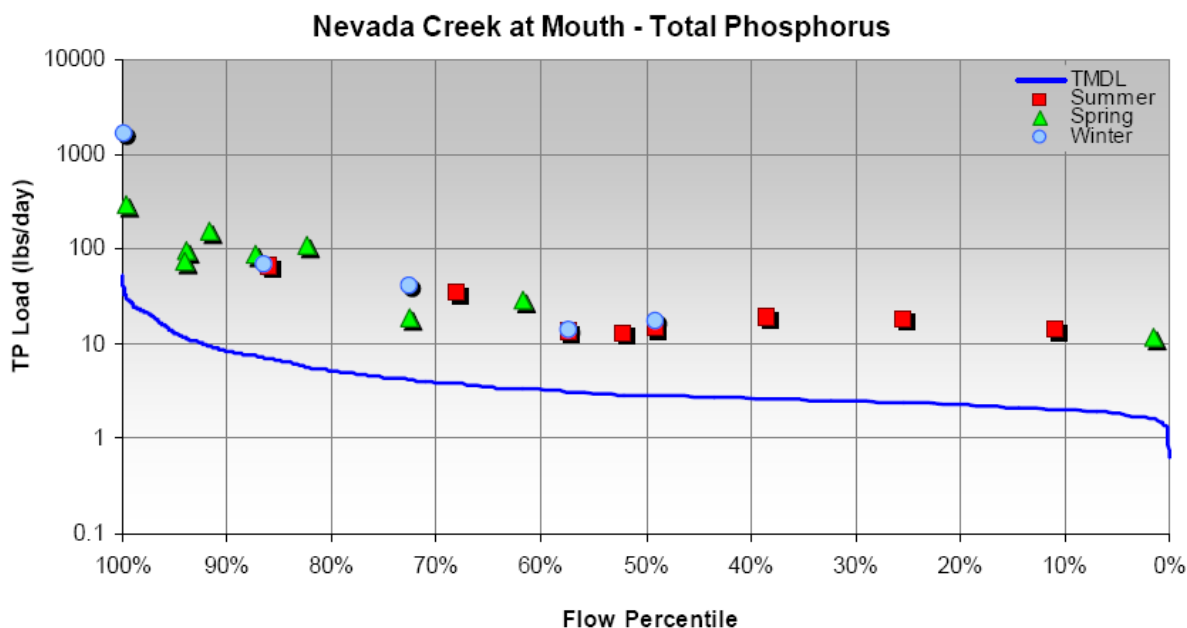
Figure 9-13. Comparison of the Allowable to the Observed Total Phosphorus Load for Nevada Creek at the Mouth

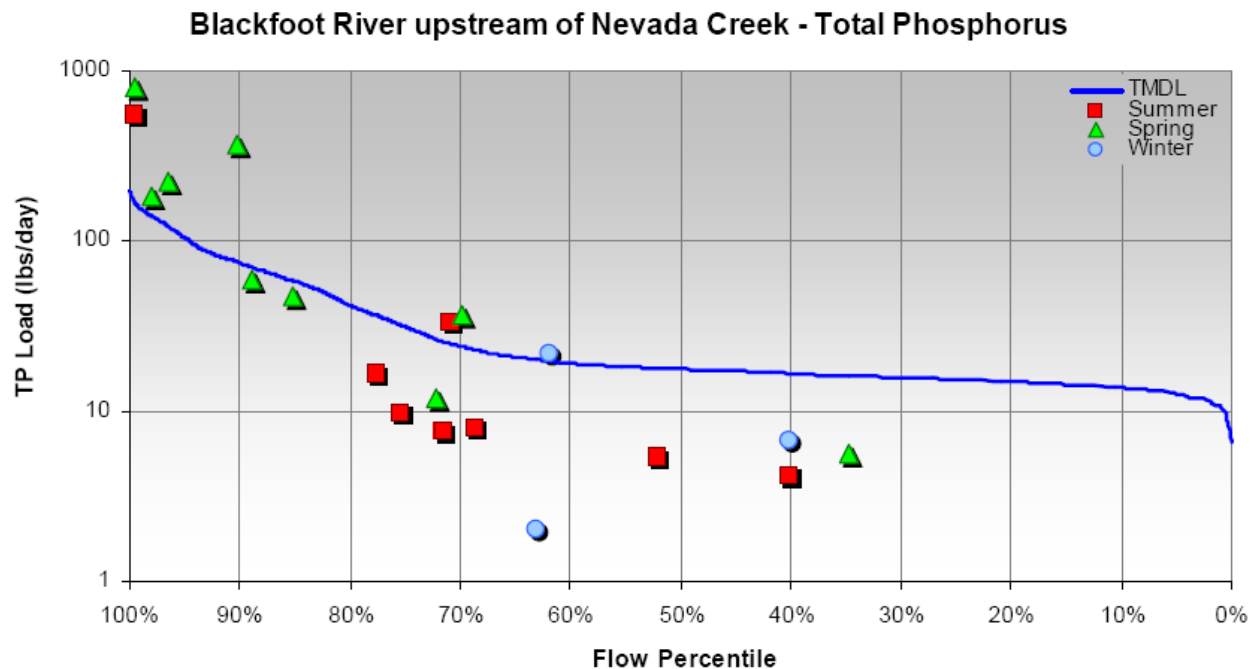
**Figure 9-14. Comparison of the Allowable to the Observed Total Phosphorus Load for Blackfoot River Upstream of Nevada Creek (USGS Station 12335100).**

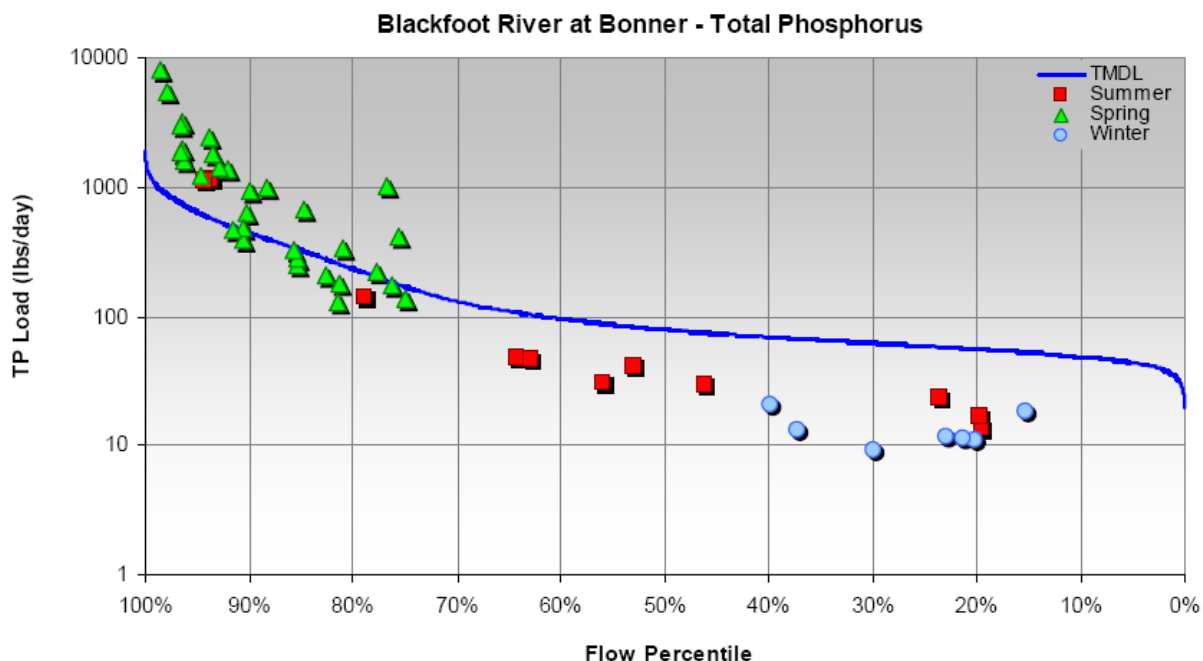
Figure 9-15. Comparison of the Allowable to the Observed Total Phosphorus Load for Blackfoot River at Bonner, MT (USGS Station 12340000).

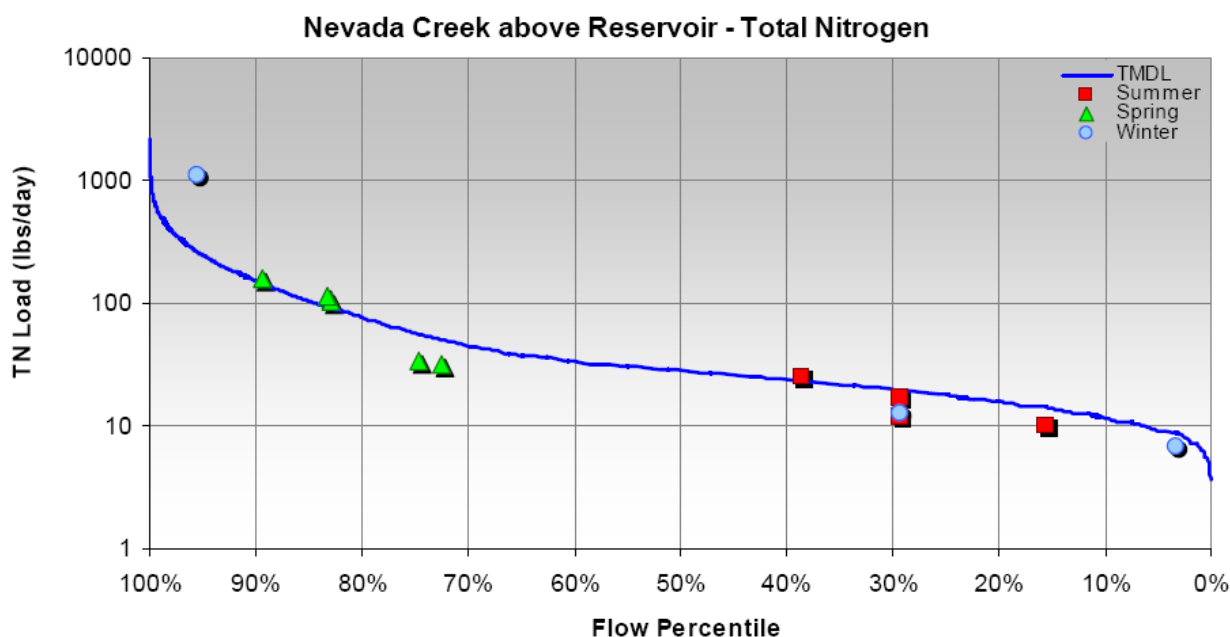
Figure 9-16. Comparison of the Allowable to the Observed Total Nitrogen Load for Nevada Creek Upstream of Nevada Creek Reservoir

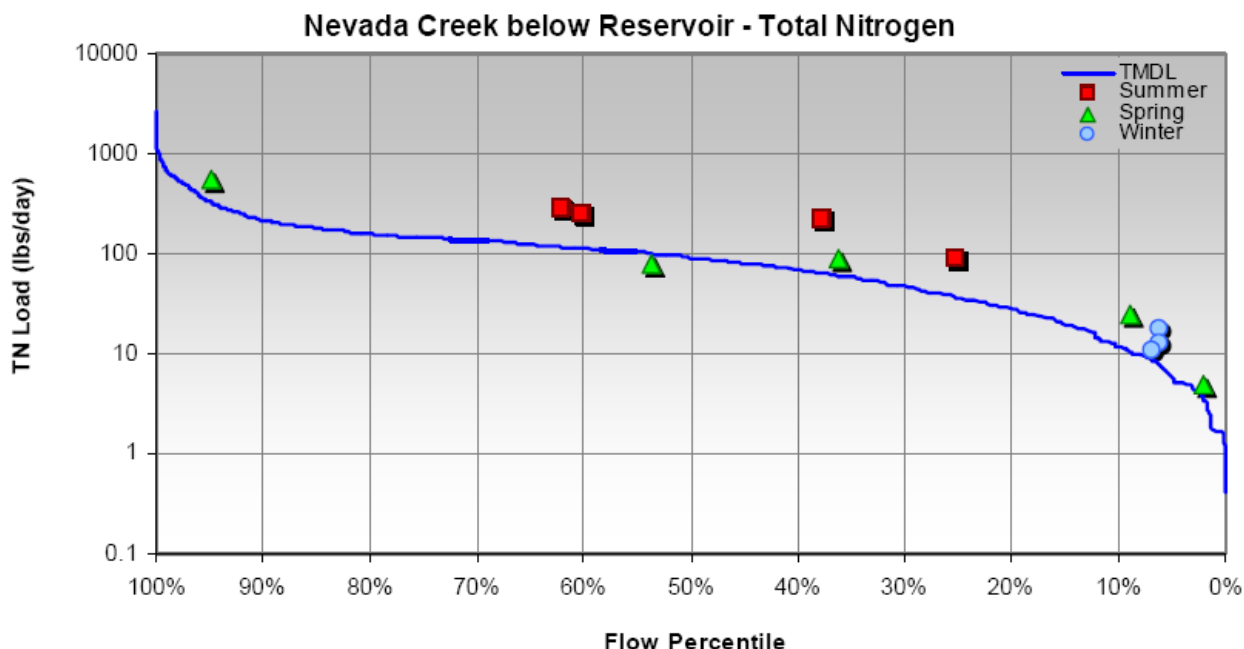
Figure 9-17. Comparison of the Allowable to the Observed Total Nitrogen Load for Nevada Creek Downstream of Nevada Creek Reservoir

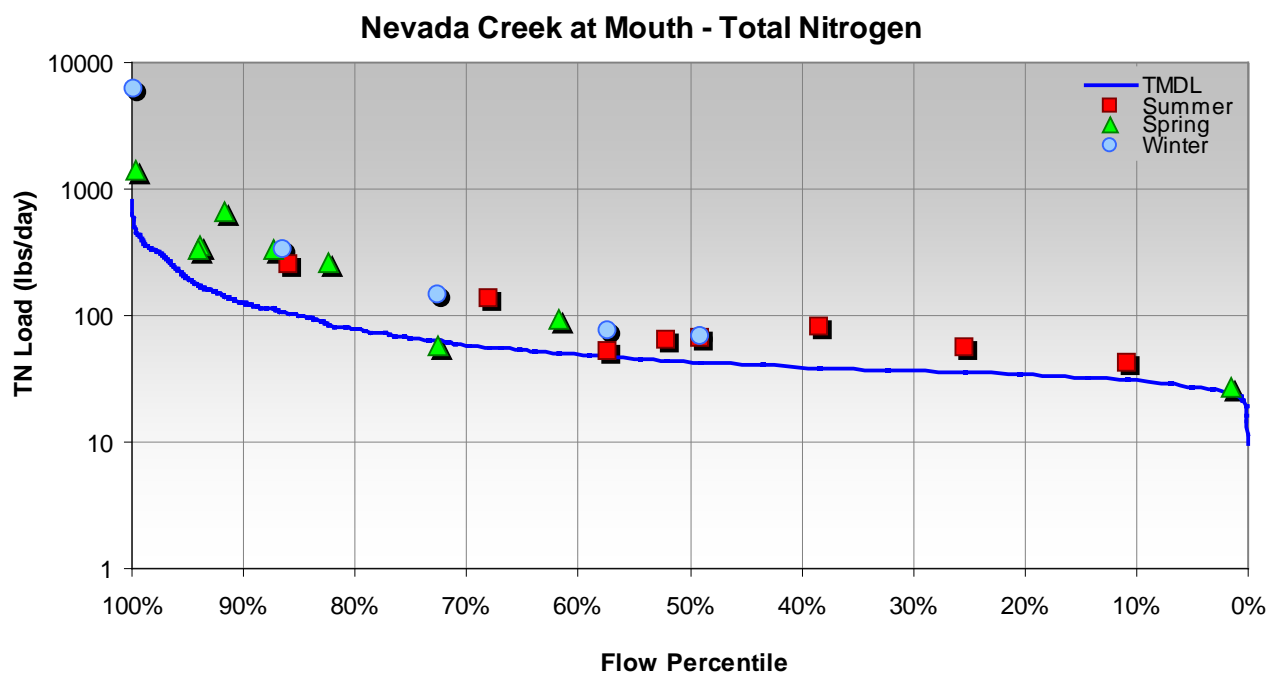
Figure 9-18. Comparison of the Allowable to the Observed Total Nitrogen Load for Nevada Creek at the Mouth

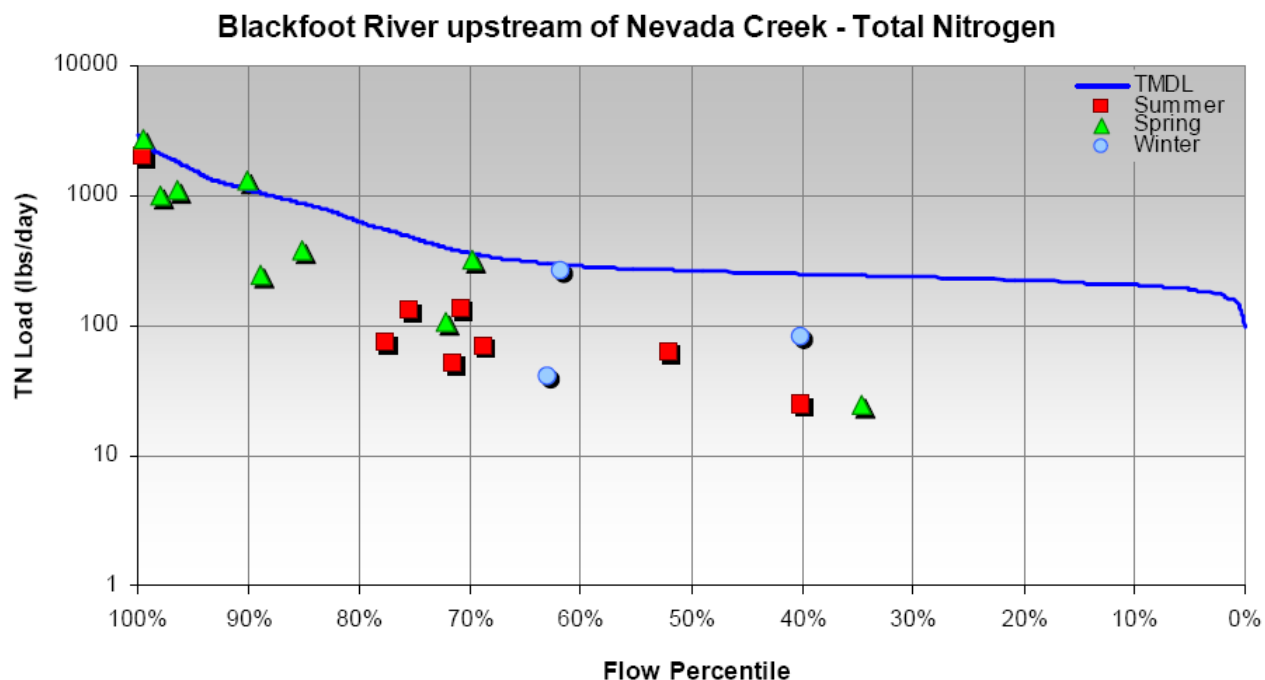
Figure 9-19. Comparison of the Allowable to the Observed Total Nitrogen Load for Blackfoot River Upstream of Nevada Creek

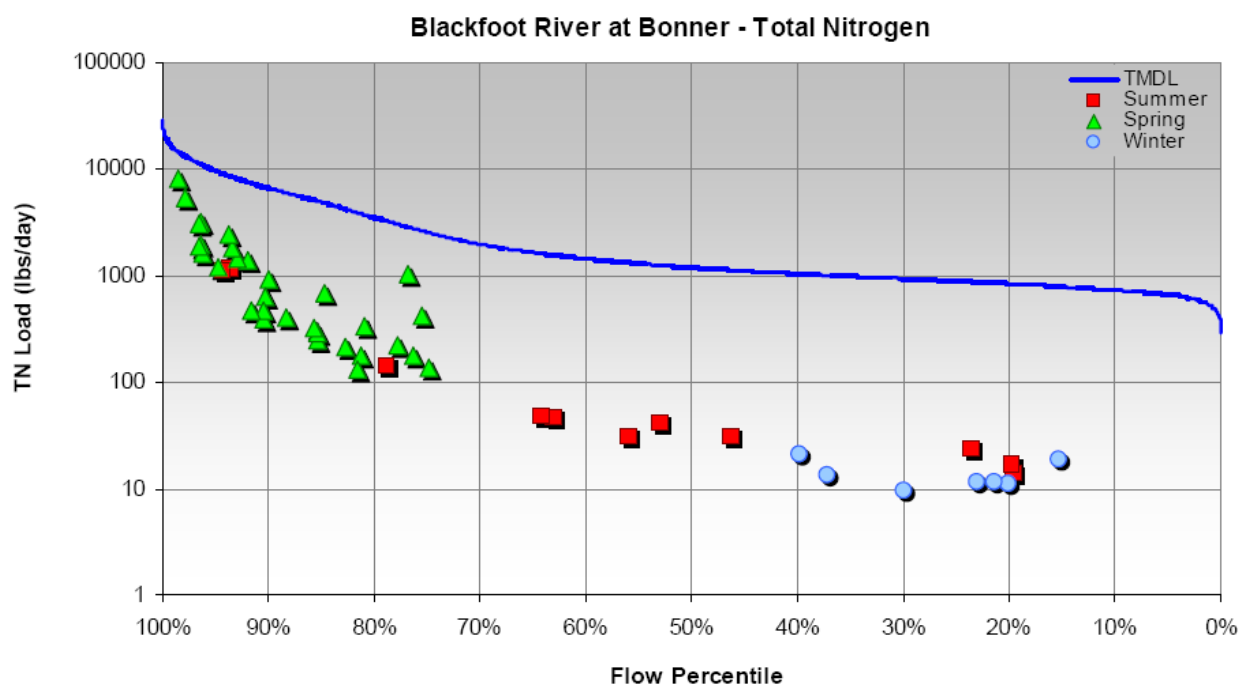
Figure 9-20. Comparison of the Allowable to the Observed Total Nitrogen Load for Blackfoot River at Bonner, MT

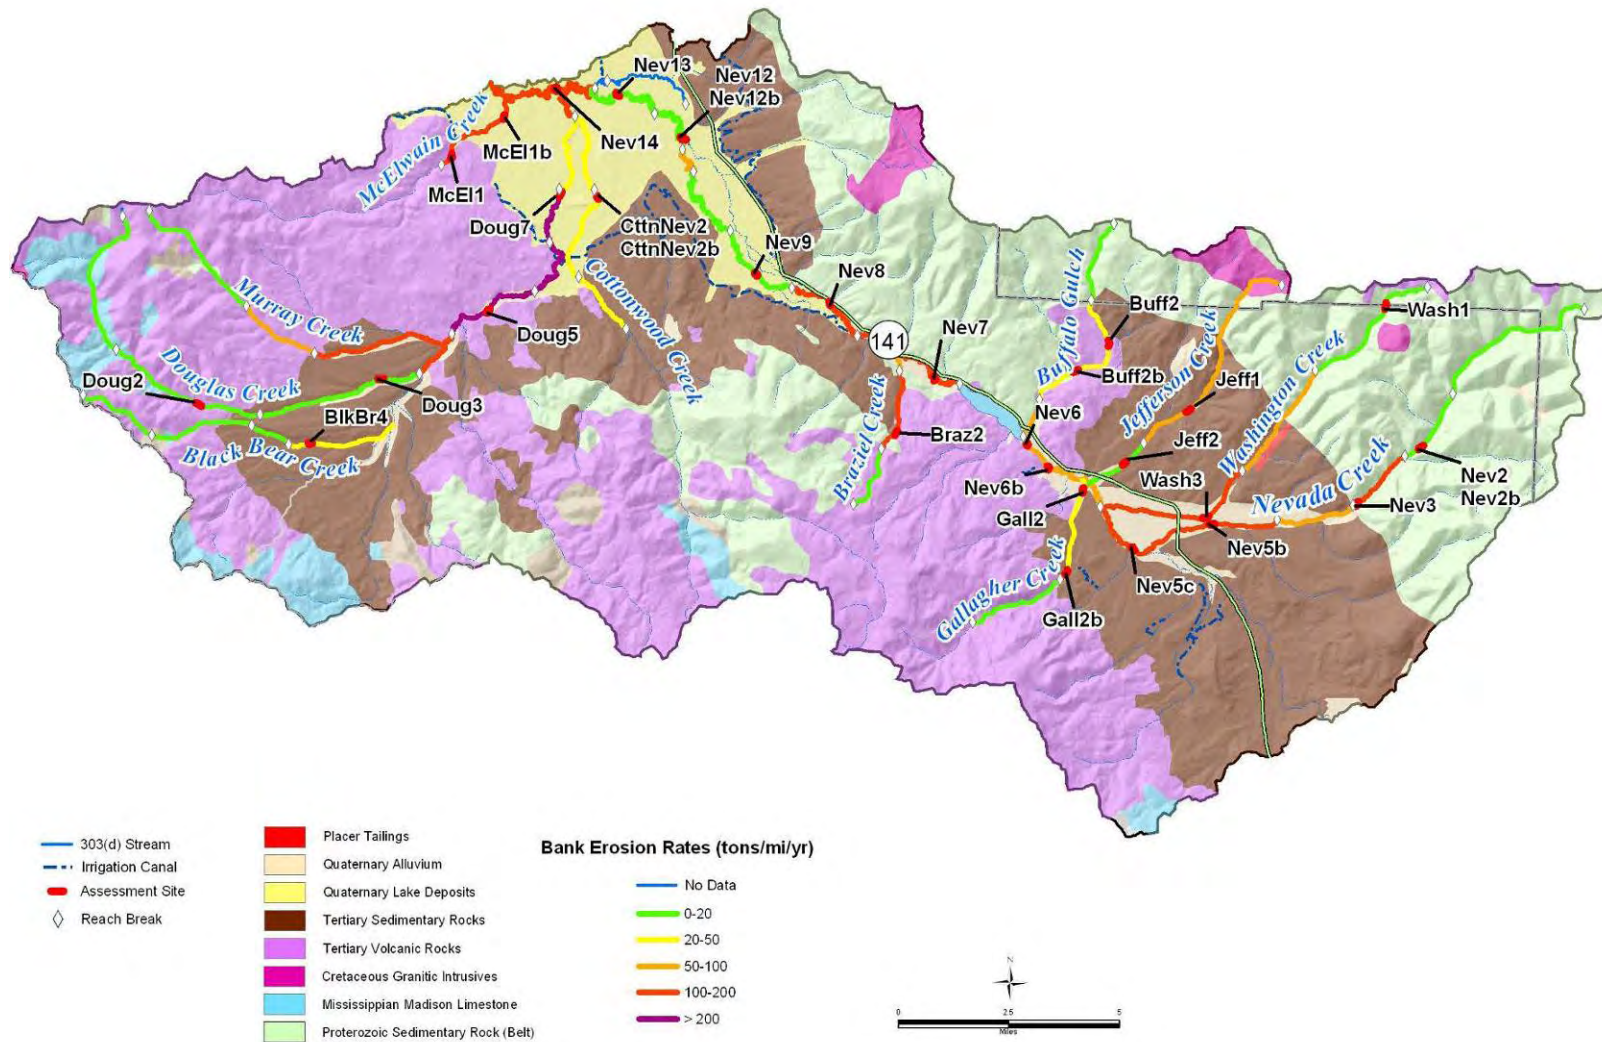
Figure A-31. Bank Erosion Rates by Reach in the Nevada Creek Planning Area

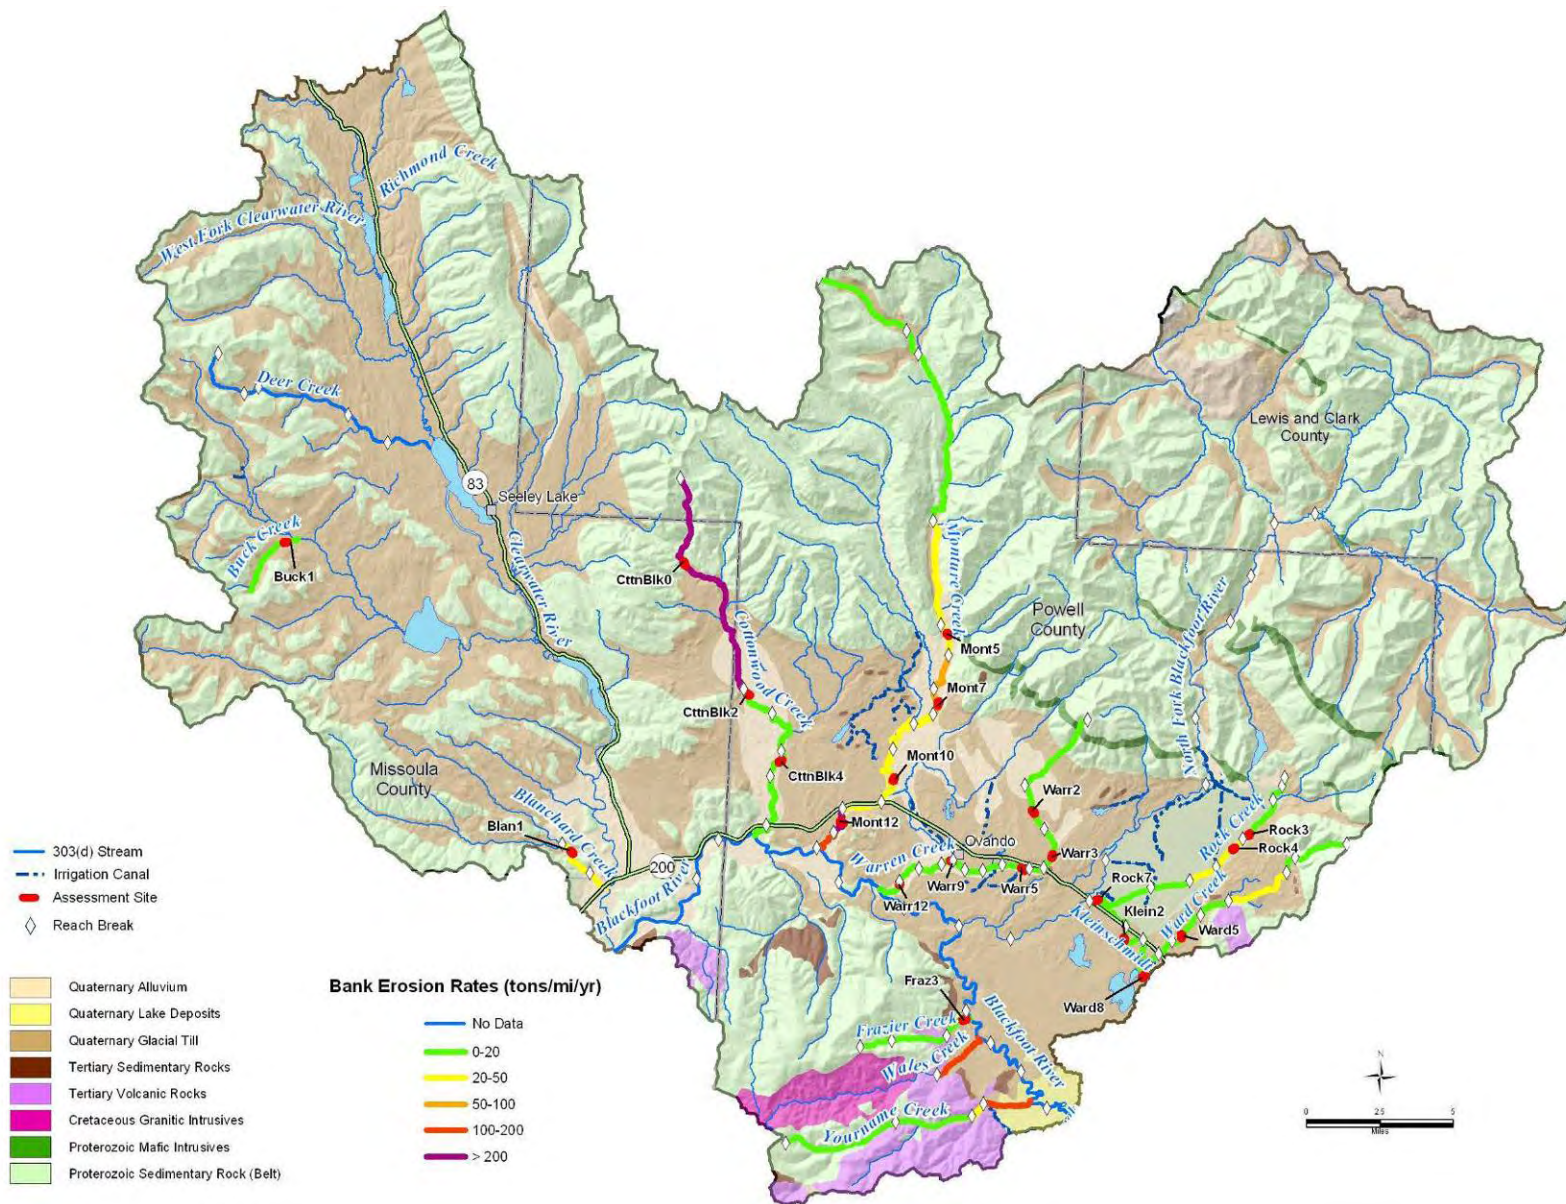
Figure A-32. Bank Erosion Rates by Reach in the Middle Blackfoot Planning Area

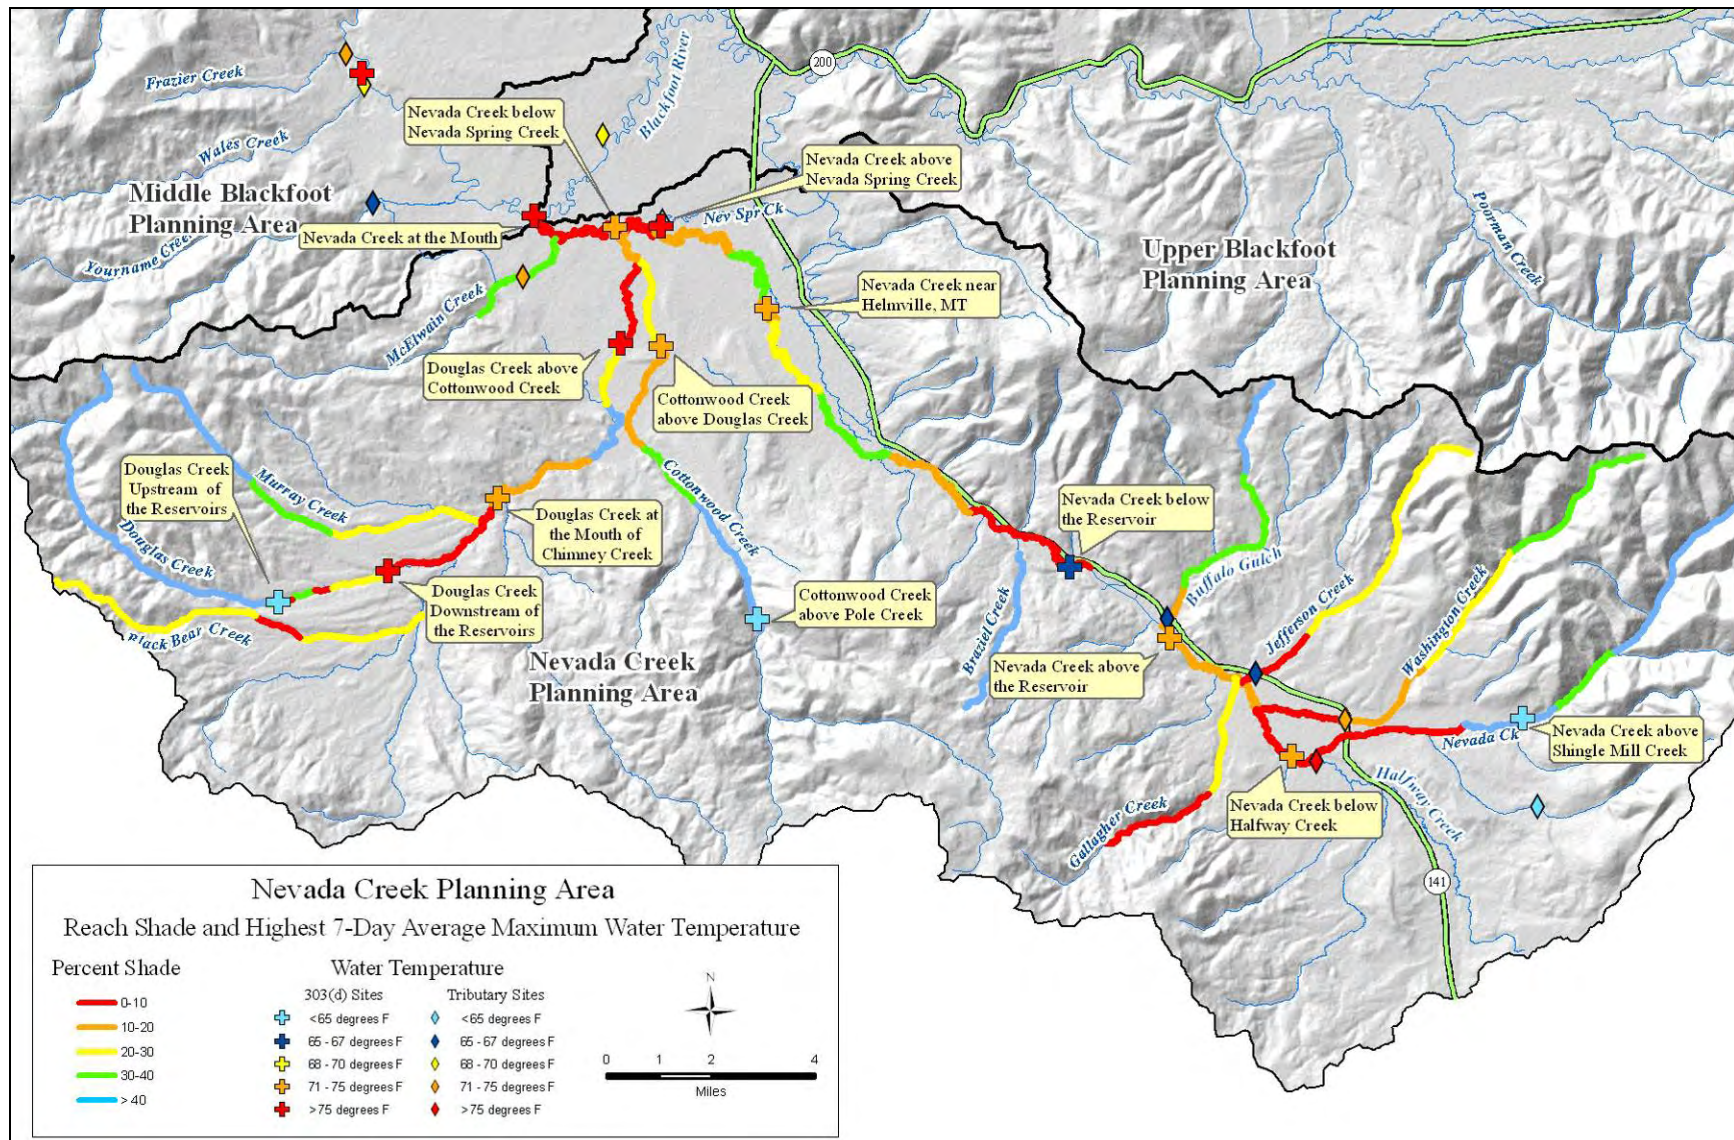
Figure A-36. Reach Shade and Highest 7-day Average Maximum Temperature, Nevada Creek Planning Area

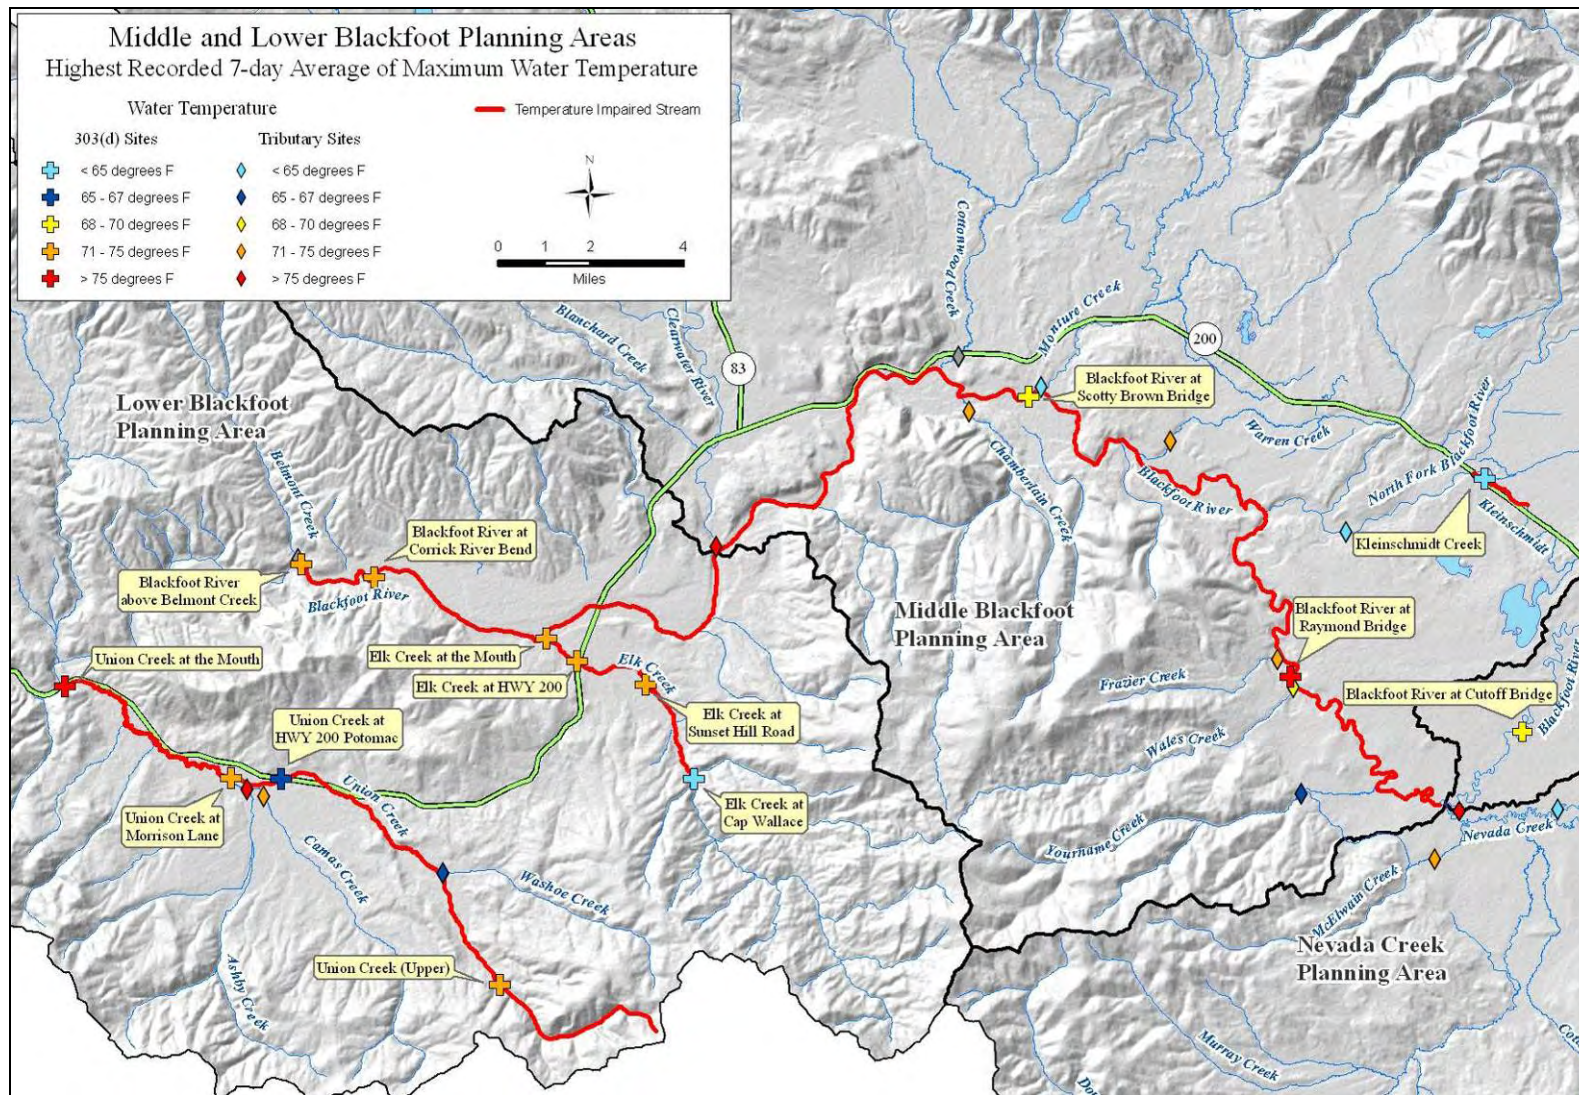
Figure A-40. Highest 7-day Average Maximum Temperature, Middle Blackfoot Planning Area

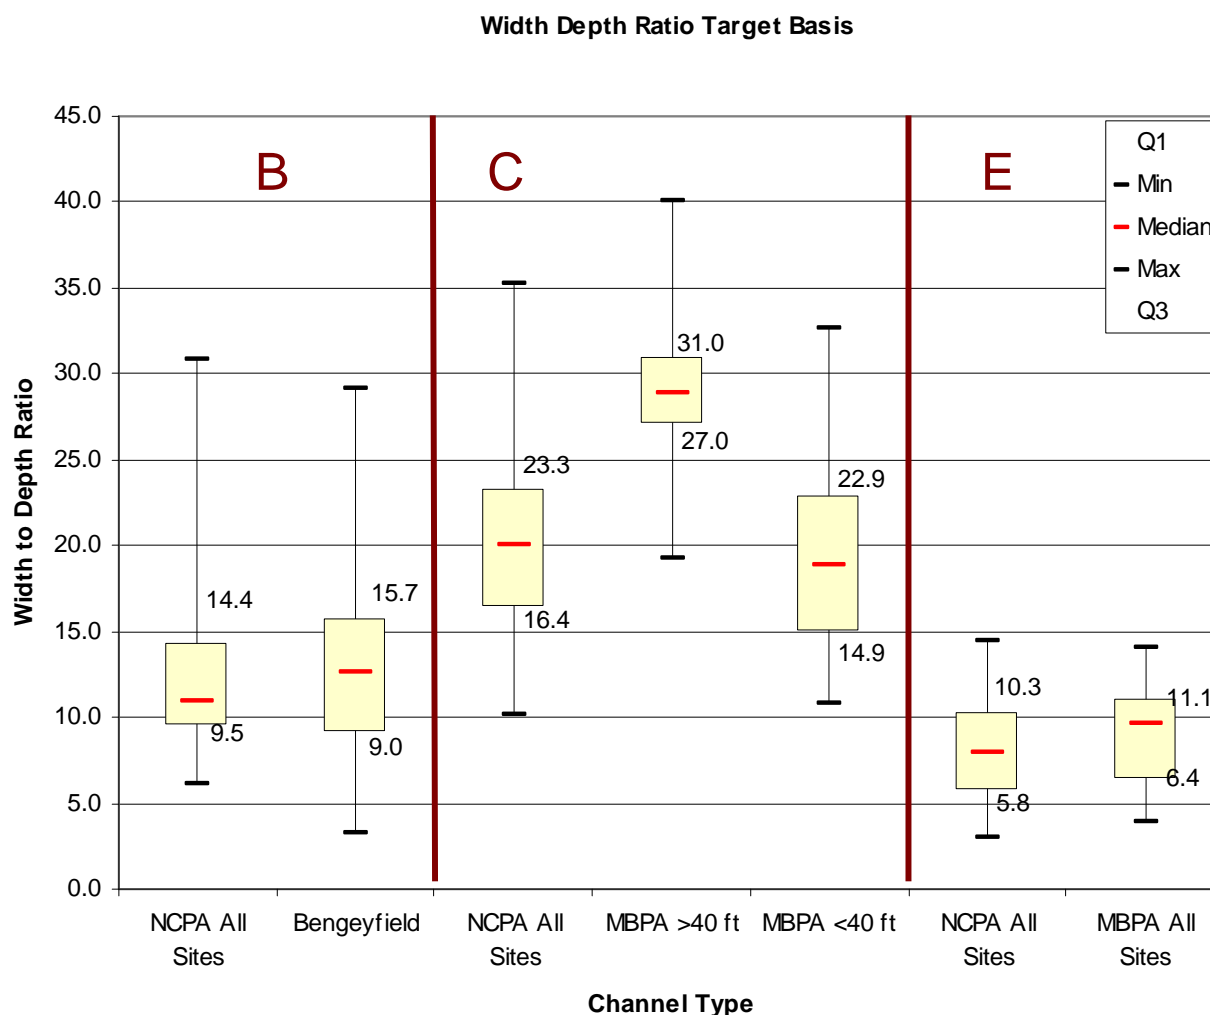
Figure D-6. Distributional Statistics for Width-To-Depth Ratio

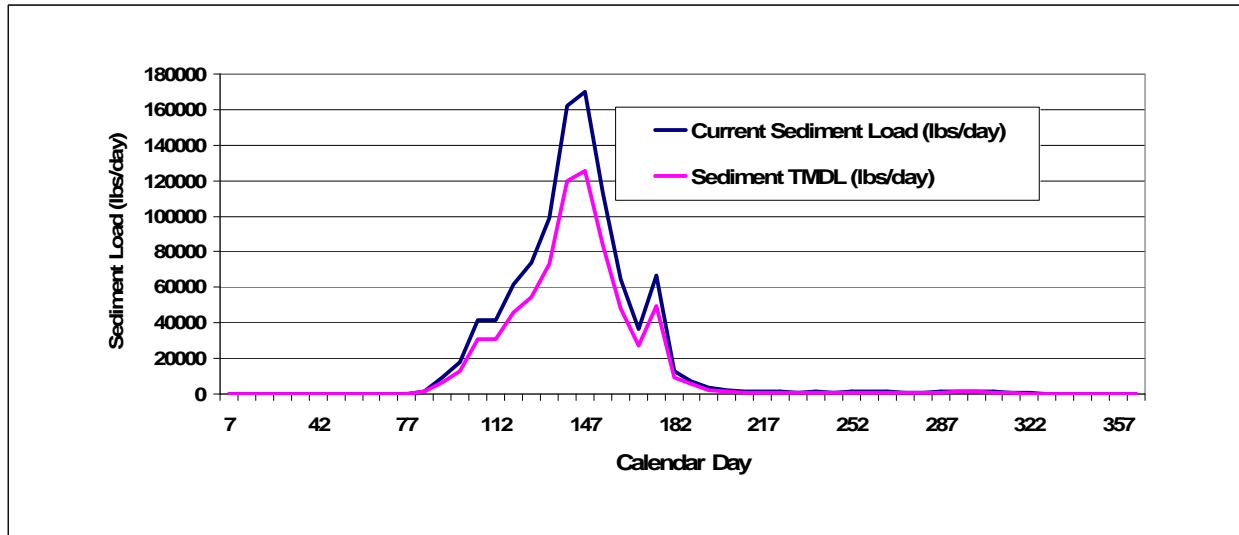
Figure E-1. Current and Maximum Daily Sediment Loading For Upper Nevada Creek

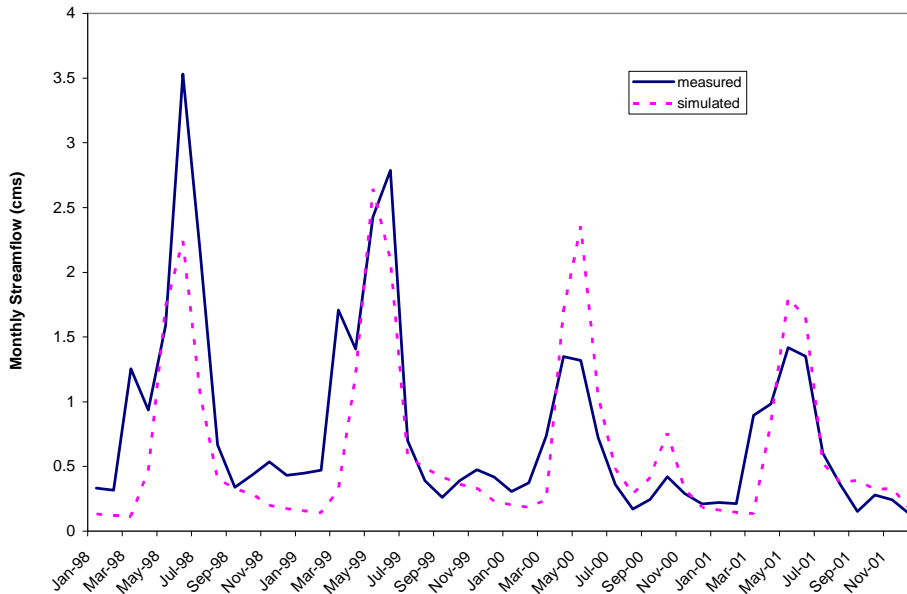
Figure I-6. Comparison of Measured Versus Simulated Monthly Discharge for Nevada Creek above the Reservoir during the 1998 To 2001 Validation Period

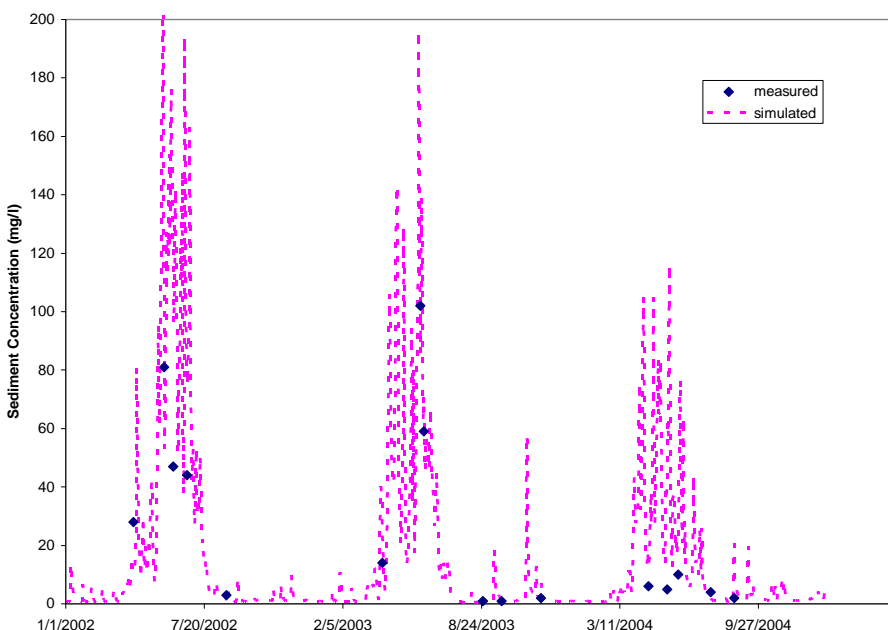
Figure I-16. Comparison of Measured Versus Simulated Sediment Concentration for the Blackfoot River at Bonner during the 2002 To 2004 Calibration Period

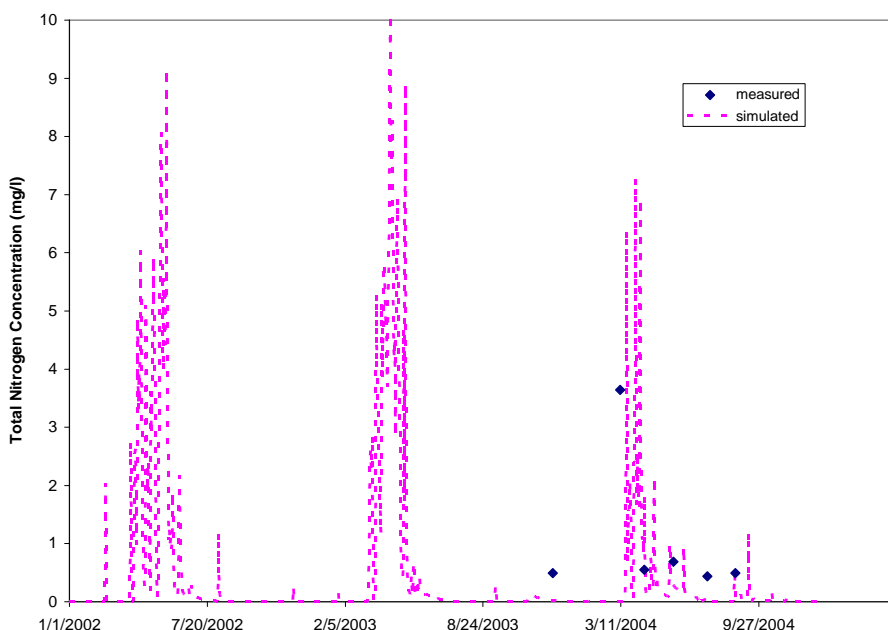
Figure I-17. Comparison of Measured Versus Simulated Total Nitrogen Concentration for Nevada Creek above the Reservoir during the 2002 To 2004 Calibration Period

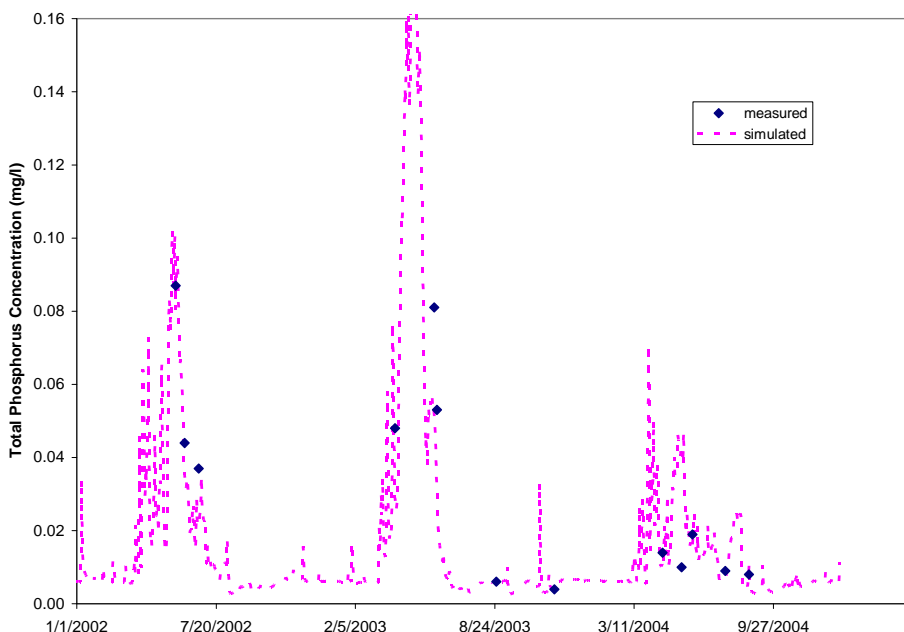
Figure I-26. Comparison of Measured Versus Simulated Total Phosphorus Concentration for the Blackfoot River at Bonner during the 2002 To 2004 Calibration Period

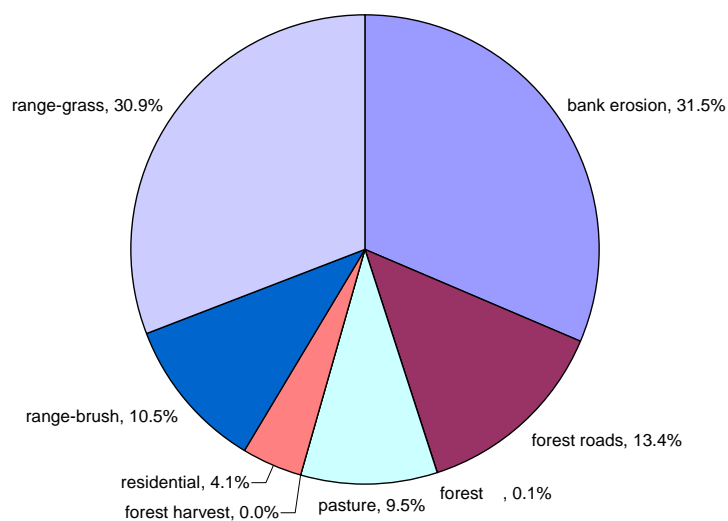
Figure I-27. Modeled Sources of Sediment for the Nevada Creek below the Reservoir Subwatershed
