Water Quality Protection Plan and TMDLs for the Swan Lake Watershed

June 9, 2004

Land & Water Consulting, Inc.

Montana Department of Environmental Quality

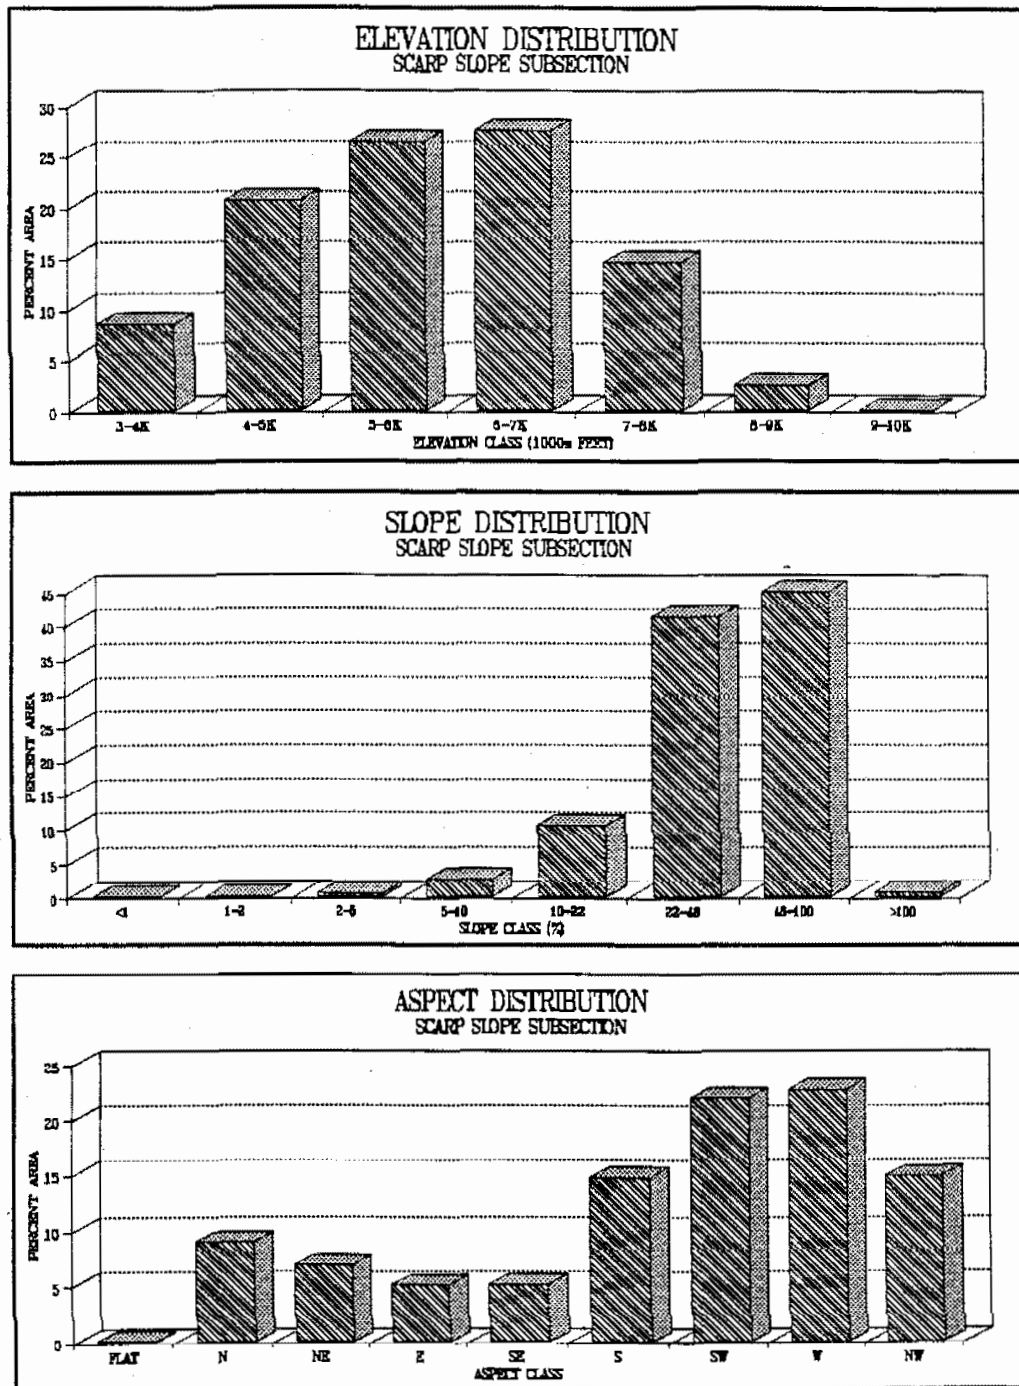
Figure 3.3.1-1. Elevation, slope and aspect distributions, scarp-slope subsection.
