Yaak River Watershed Sediment Total Maximum Daily Loads

Montana Department of Environmental Quality September 10, 2008

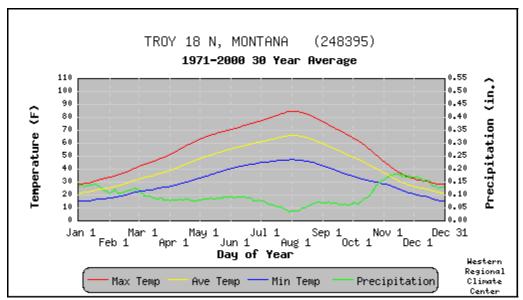
Figure 2-1. Patterns in Average Precipitation and Temperature for Northwest of Troy, MT (Western Regional Climate Center, 2001)

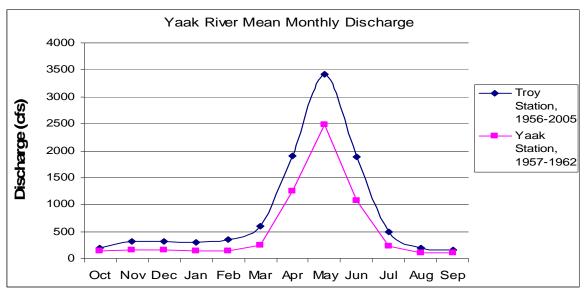
Figure 2-2. Historical Flow Data from Yaak River near Troy and Yaak, MT (USGS, 2006)

Historical stream gage data are available for two sites on the Yaak River. USGS gage 12304200 Yaak River near the town of Yaak; Montana, has data from only April 1957 – September 1962. The majority of the discharge information is from USGS gage station 12304500. This station has data from 1956 to present and is located at the mouth near Troy, Montana. Figure 2-2 is a hydrograph constructed from historical gauge station data.

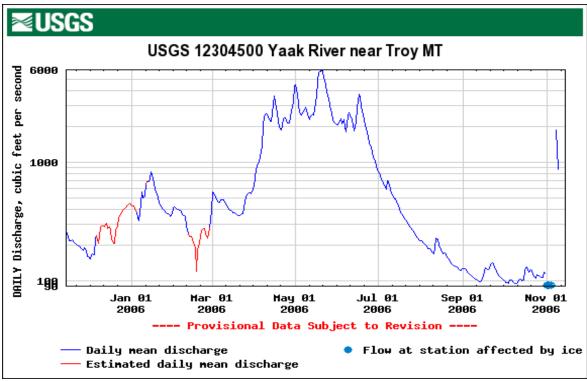
Figure 2-3. Recent Streamflow data for Yaak River (USGS, 2006)

On average, in the last 50 years, mean monthly discharge was below 500 cubic feet per second (cfs) for August through February. Historical data indicate an average peak flow at approximately 3,500 cfs in May (Figure 2-2). The mean historical flow does not reveal the magnitude of, or variation in, peak flows. As an example of the variability in flow, Figure 2-3 illustrates daily mean discharge for 2006, which reached a peak of nearly 6,000 cfs in June.

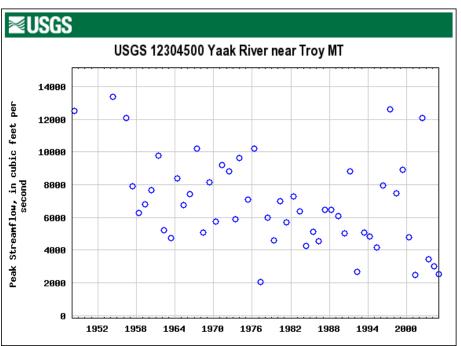
Figure 2-4. Historical Peak Flow Yaak River (USGS, 2006).

Figure 2-4 illustrates the range in historical peak flows on the Yaak River at USGS gage station 12304500.

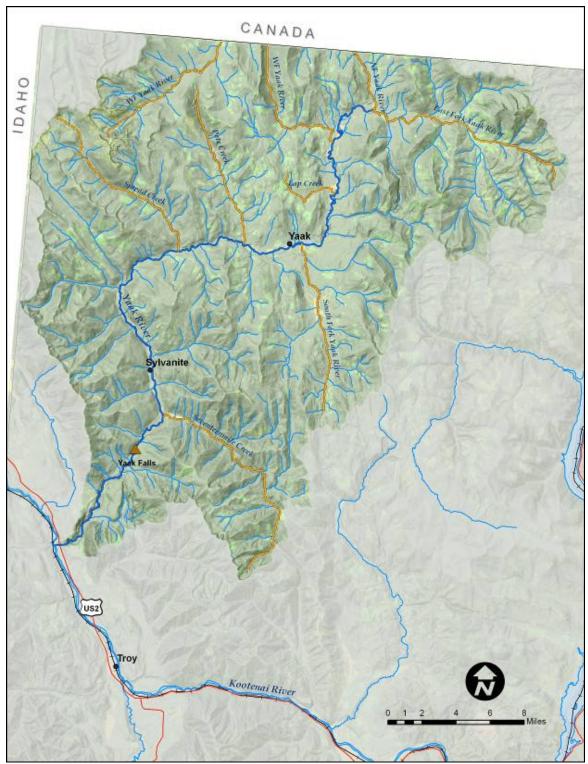
Figure 3-1. Water Body Segments in the Yaak TMDL Planning Area

Waterbodies reviewed by the state's SCD/BUD process fall into five categories. The level of beneficial use support for the listed waters can be as fully supporting all designated beneficial uses (F), threatened (T), partially support (P), not supporting (N) and lacking sufficient credible data (X). The beneficial use-support determination for the 303(d) Listed streams in the Yaak River TPA is provided in Table 3-1. The causes and sources of impairment for the 1996 303(d) List are shown in Table 3-2. The 2006 303(d) List is summarized in Table 3-3. A map of segment locations is given in Figure 3-1.

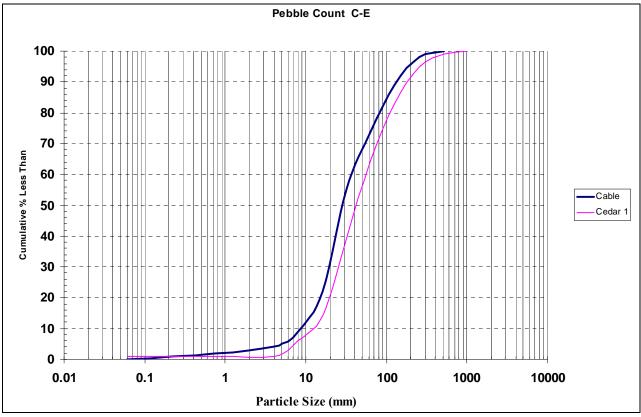
Figure 4-1. Wolman Pebble Count Curves for Two Reference Reaches

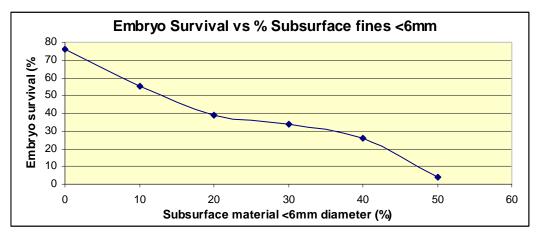
Figure 4-2. Embryo Survival vs. % Subsurface Fines <6mm (Weaver & Fraley, 1991)

Weaver and Fraley (1993) found a significant inverse relationship ($r^2 = 0.72$, P < 0.005, N = 17) between fry emergence success and the percentage of substrate fines <6.35 mm in diameter in streams in the Flathead National Forest. Mean fry emergence success was 76, 55, 39, 34, 26, and 4%, respectively, in cells containing 0, 10, 20, 30, 40, and 50% substrate materials < 6.35 mm (Figure 4-2).

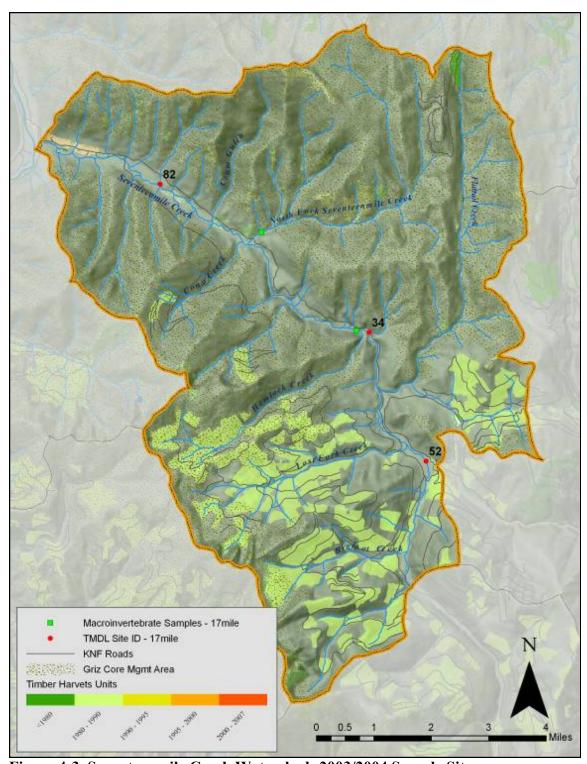
Figure 4-3. Seventeenmile Creek Watershed: 2003/2004 Sample Sites

Several survey sites were established and measured on Seventeenmile Creek in 2003 and 2004 as part of the Yaak TPA (Figure 4-4). Three sites were established on the mainstem and one each on the North Fork Seventeenmile, Flattail Creek, and Lost Fork Creek. In addition, information from several other sites on the mainstem and on tributaries was evaluated in the basin review, including some with data back to the 1990s.

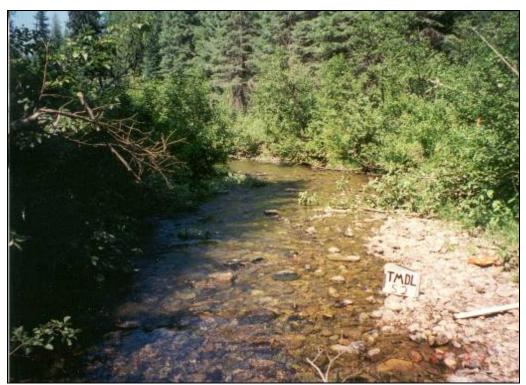
Figure 4-4. Upper Seventeenmile Creek (site 52 above Bridle Creek)

The main channel of Seventeenmile Creek flows through a Type II valley bottom. Typical of most Type II valleys, the Seventeenmile Creek channel is predominately a Rosgen "B" stream type with many Rosgen "C" reaches. There is little evidence of channel instability caused by natural processes, and the streambanks are stable and well-vegetated. Figures 4-5 through 4-8 display some of the stream and channel characteristics common to sites on Seventeenmile Creek.

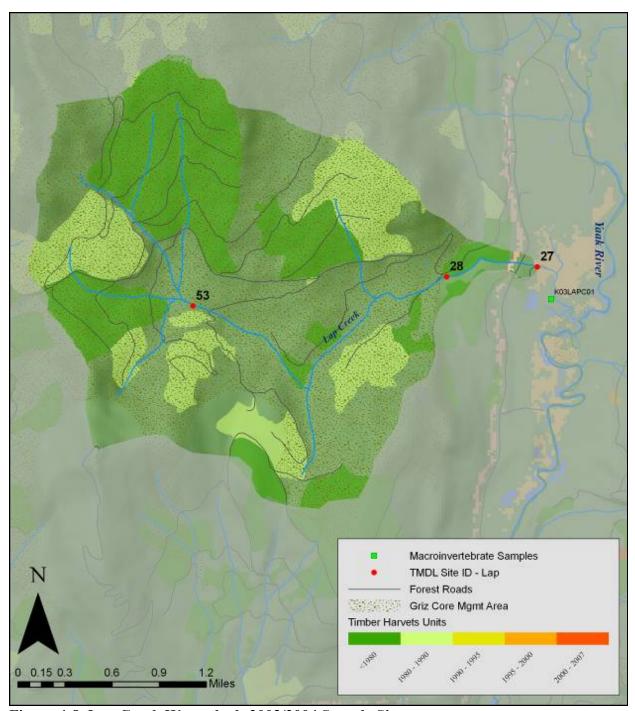
Figure 4-8. Lap Creek Watershed: 2003/2004 Sample Sites

Three monitoring sites were located on Lap Creek in 2003 for the Yaak TPA Process (Figure 4-9). The sampling locations included one site (28) very near a Forest Service Cumulative Effects (CE) site that had been established in 1991 (CE-21) in the middle portion of the watershed; and two additional sites above and below the CE site, sites 53 and 27, respectively.

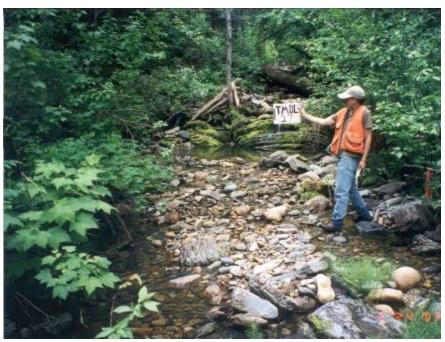
Figure 4-9. Lap Creek, Lower Reach (Site 27) Looking upstream

The main channel of Lap Creek flows through a Type II valley bottom. Typical of Type II Valleys, Lap Creek is predominately a Rosgen "B" stream type. There is little evidence of channel instability caused by natural processes. Stream banks are stable and well-vegetated. Figures 4-10 through 4-12 display some of the stream and channel characteristics common to sites on Lap Creek.

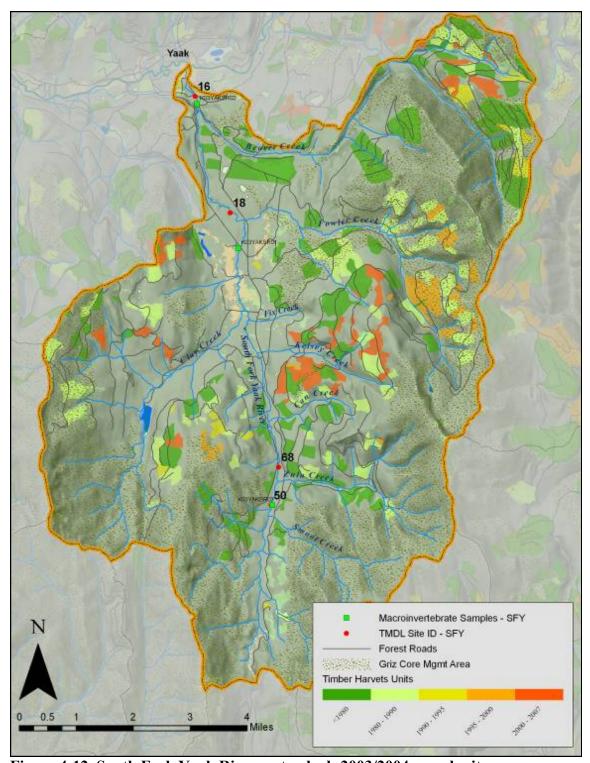
Figure 4-12. South Fork Yaak River watershed: 2003/2004 sample sites

Data was collected at four sampling locations on the South Fork Yaak in 2003 (Figure 4-13): South Fork River below Smoot Creek, site 50; South Fork River below Zulu Creek, site 68; South Fork River below Fowler Creek, site 18; and the South Fork River below Beaver Creek, site 16. Sites were also established on Smoot, Zulu, Clay, Fowler and Beaver Creeks. One of the sites, #16, South Fork below Beaver, had been sampled from 1991-1995 by the Forest Service as a Cumulative Effects Analysis Station (CE-11). Data from another FS site sampled in 1992 was also used in the analysis.

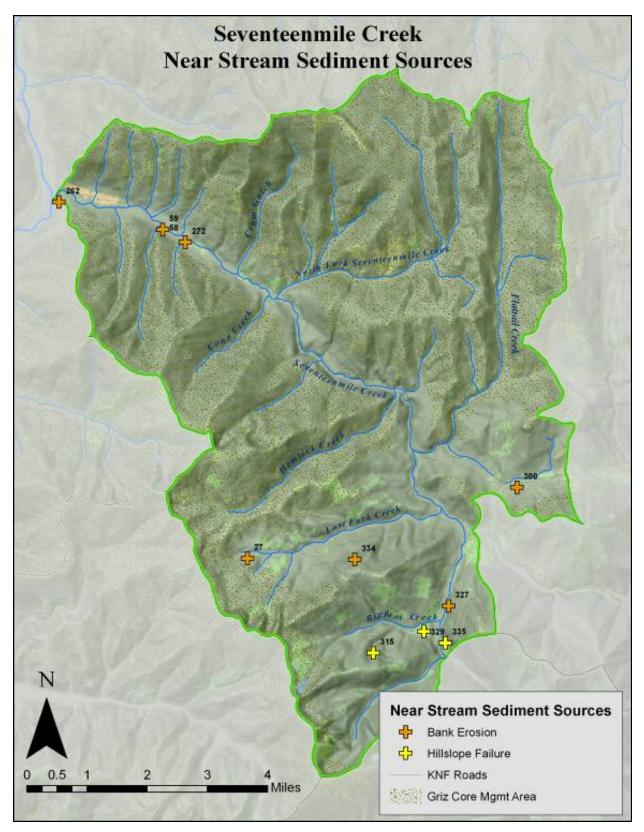
Figure 5-1. Seventeenmile Creek - Bank Erosion and Hillslope Failure Sites

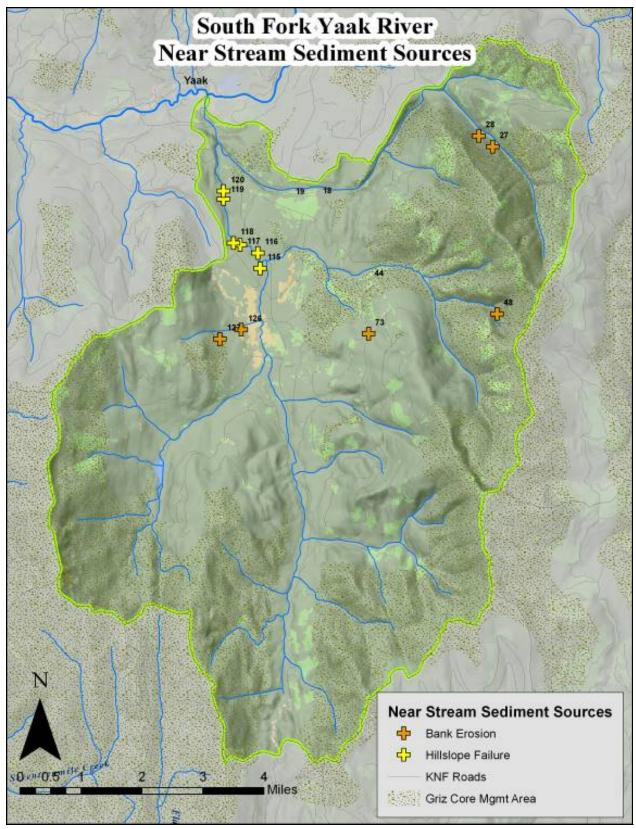
Figure 5-2. South Fork Yaak River - Bank Erosion and Hillslope Failure Sites

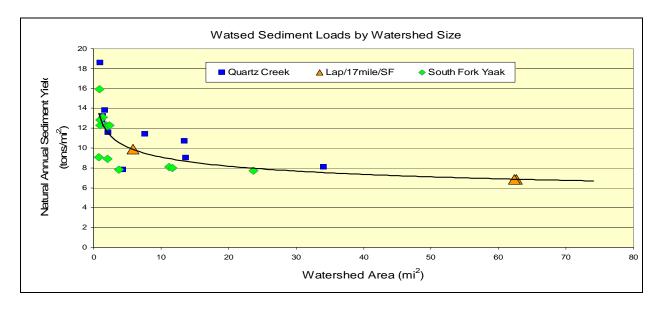
Figure 5-6. Natural Annual Sediment Yield vs. Watershed Size: Yaak TPA

As geology, topography and climactic regimes are similar among WATSED-modeled watersheds and watersheds of concern (Seventeenmile, South Fork Yaak, Lap), a regression equation was generated that related watershed size to estimated natural unit loading (tons/mi²/yr). Estimates of natural background unit loads for Seventeenmile Creek, South Fork Yaak River, and Lap Creek were generated from this regression equation (Figure 5-6, Table 5-3). Because modeling and validation of modeling results have not been conducted at a watershed scale for Seventeenmile Creek, Lap Creek, and South Fork Yaak River, values presented in Tables 5-2 and 5-3 should be considered only as relative estimates, and not actual loading values. As stated in previous sections, WATSED loading estimates have not separated out sediment loads from mass wasting and hillslope processes, but rather include them in the total estimate of natural sediment loading.

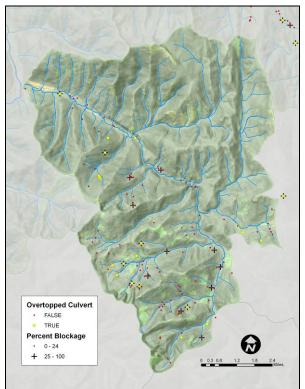
Figure 5-15. Seventeenmile Creek – Overtopped and Blocked Culverts

Constriction ratio (the ratio of culvert width to channel width) is used to evaluate the capabilities of culverts to pass high flows and associated debris. Culverts with widths less than bankfull stream widths were considered undersized and pose a potential risk of acute and chronic sediment delivery, channel scour, and debris accumulation, particularly under high flow conditions. Of the more than 180 culverts assessed for constriction, 67% had constriction ratios <0.7 and 24% had constriction ratios of <0.4.

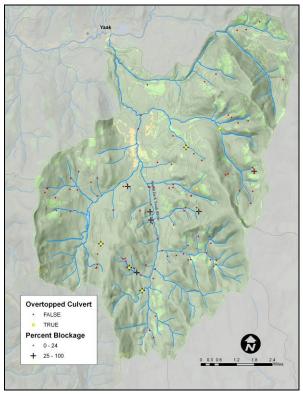
Figure 5-16. South Fork Yaak River - Overtopped and Blocked Culverts

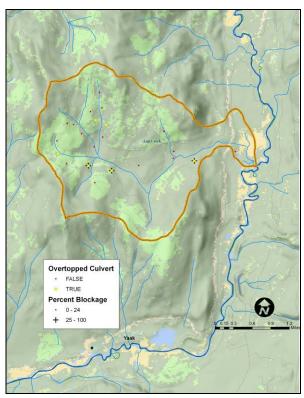
Figure 5-17. Lap Creek - Overtopped and Blocked Culverts

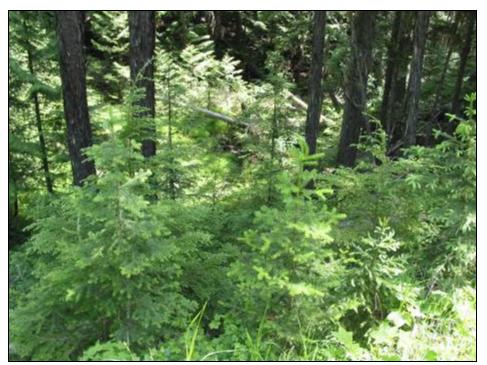
Figure B-1. Parallel Segment SFY-4A-P – Average Buffer Distance 70 feet

The two field-assessed parallel road segments in the Yaak TPA showed very different modeling results, with site SFY-4AP having a load of 0.02 tons/year and site USC-2AP having a load of 1.13 tons/year. Site SFY-4AP contained an average buffer distance of 70 feet and site USC-2AP had an average buffer distance of 10 feet. The majority of parallel sites observed in the field contained buffer distances greater than 50 feet and were heavily vegetated, with no evidence of sediment delivery to the stream. USC-2AP was the only parallel site where evidence of sediment loading was noted. Figures B-1 and B-2 are included to show differences in the typical buffer conditions of the two parallel segments assessed.

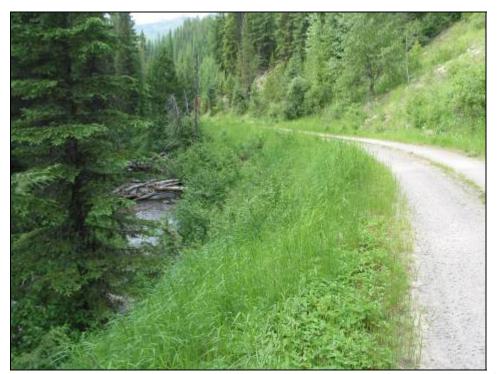
Figure B-2. Parallel Segment USC-2A-P – Average Buffer Distance 10 feet

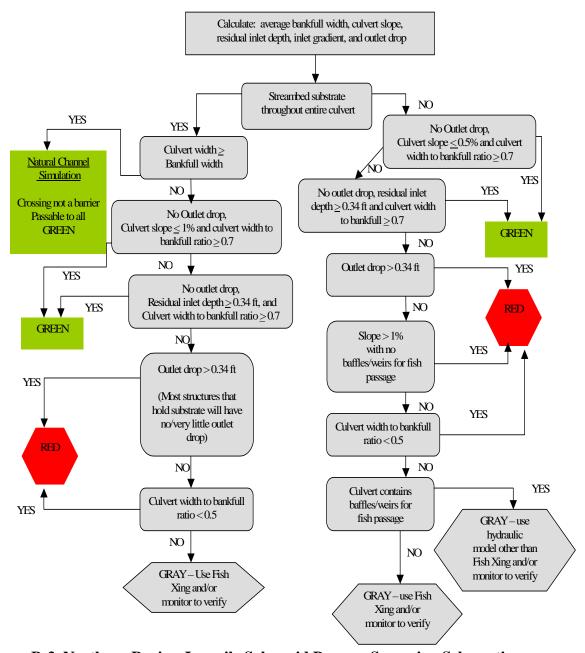
Juvenile salmonid fish passage evaluation criteria at flows less than bankfull flows for Region 1

Figure B-3. Northern Region Juvenile Salmonid Passage Screening Schematic

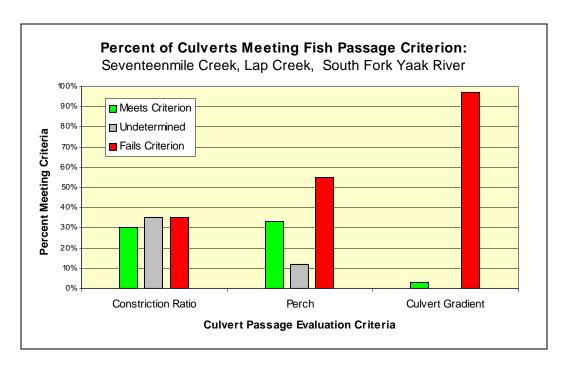
Figure B-4. Percent of Culverts Meeting Fish Passage Criterion

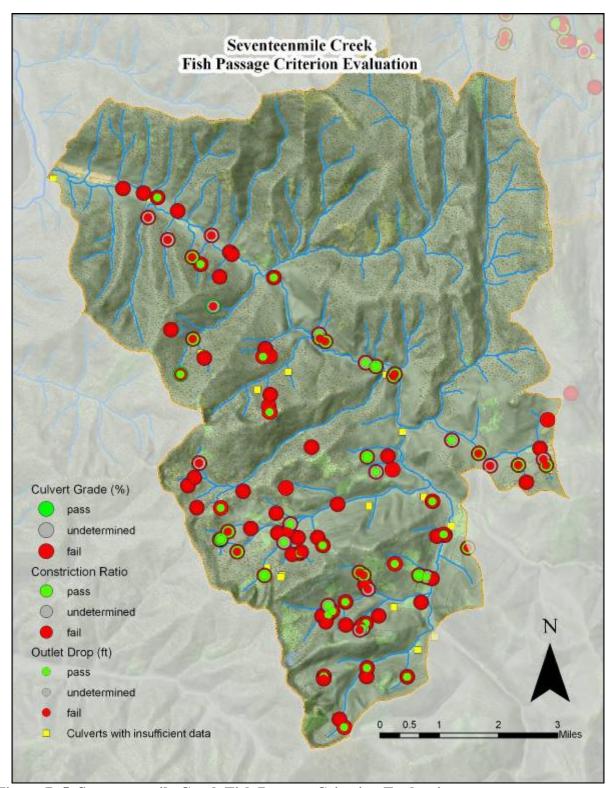
Figure B-5. Seventeenmile Creek Fish Passage Criterion Evaluation

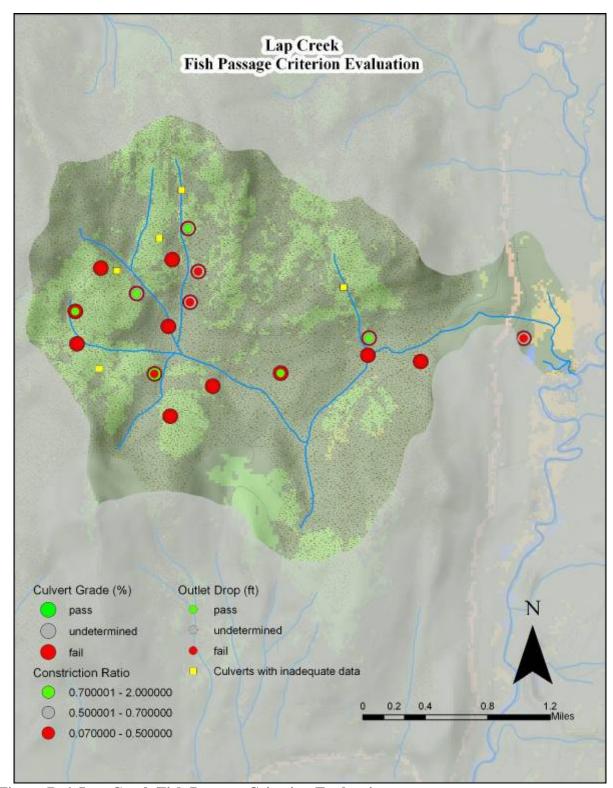
Figure B-6. Lap Creek Fish Passage Criterion Evaluation

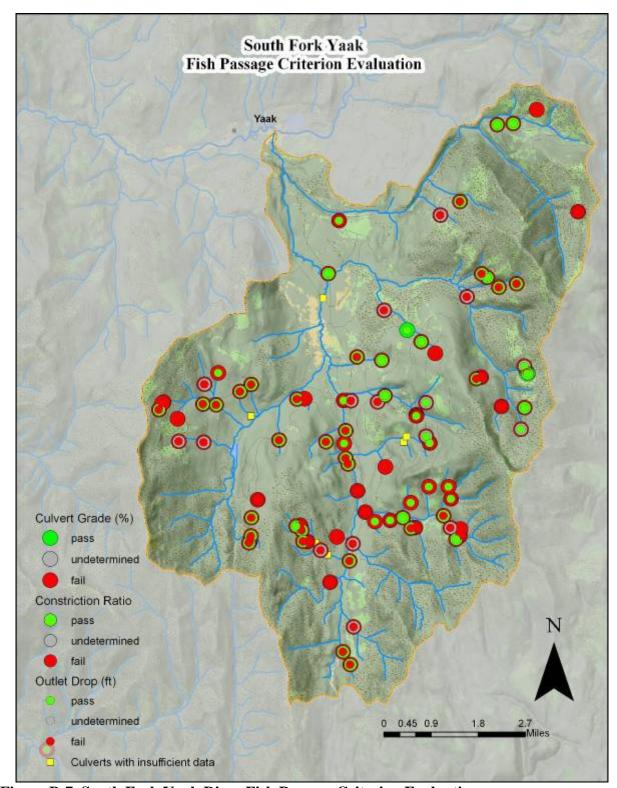
Figure B-7. South Fork Yaak River Fish Passage Criterion Evaluation

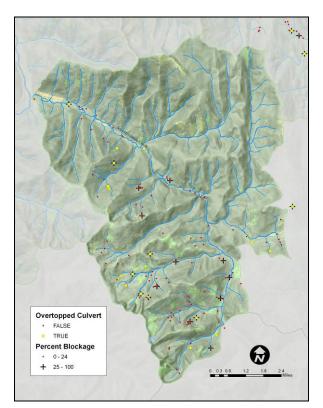
Figure B-8. Seventeenmile Creek – Overtopped and Blocked Culverts

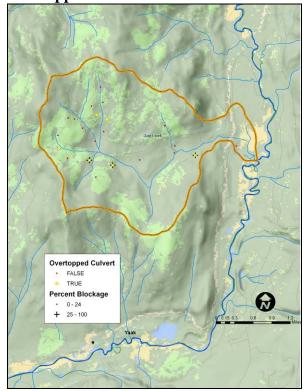
Figure B-10. Lap Creek - Overtopped and Blocked Culverts

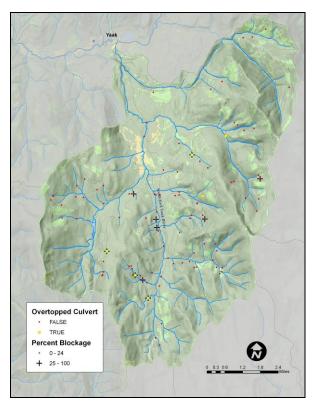
Figure B-9. South Fork Yaak River - Overtopped and Blocked Culverts

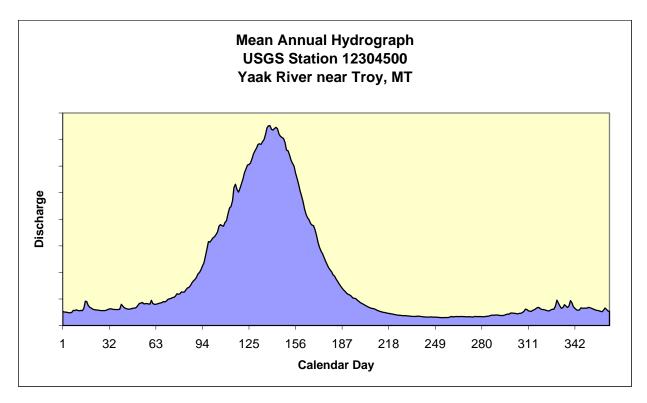
$\begin{tabular}{ll} Figure C-1. Mean Annual Hydrograph (relative discharge), Yaak River: USGS Station 12304500 \end{tabular}$

Annual allocations given in Section 6.0 provide a more practical operational loading analysis than does an allowable daily load limit, nonetheless allowable daily loading estimates are provided in Tables C-1, C-2, and C-3 in order to satisfy EPA's daily loading recommendations.
