Big Spring Creek Watershed Water Quality Restoration Plan and Total Maximum Daily Loads

March 2005
Version 1.1

Montana Department of Environmental Quality
Water Quality Planning Bureau

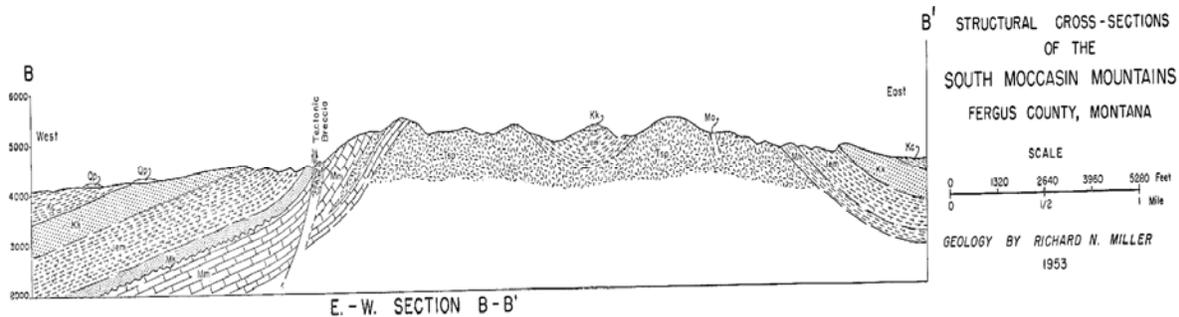
Paleozoic and Mesozoic strata that dip, generally, from 20 to 60 degrees, yet some areas exhibit nearly vertical to overturned bedding (Figure 2-2). The dip of these units gradually decreases away from the mountains until, after a few miles, they are nearly horizontal (Feltis, 1973).

Figure 2-2. Structural Cross-Section of the South Moccasin Mountains (Miller, 1959).

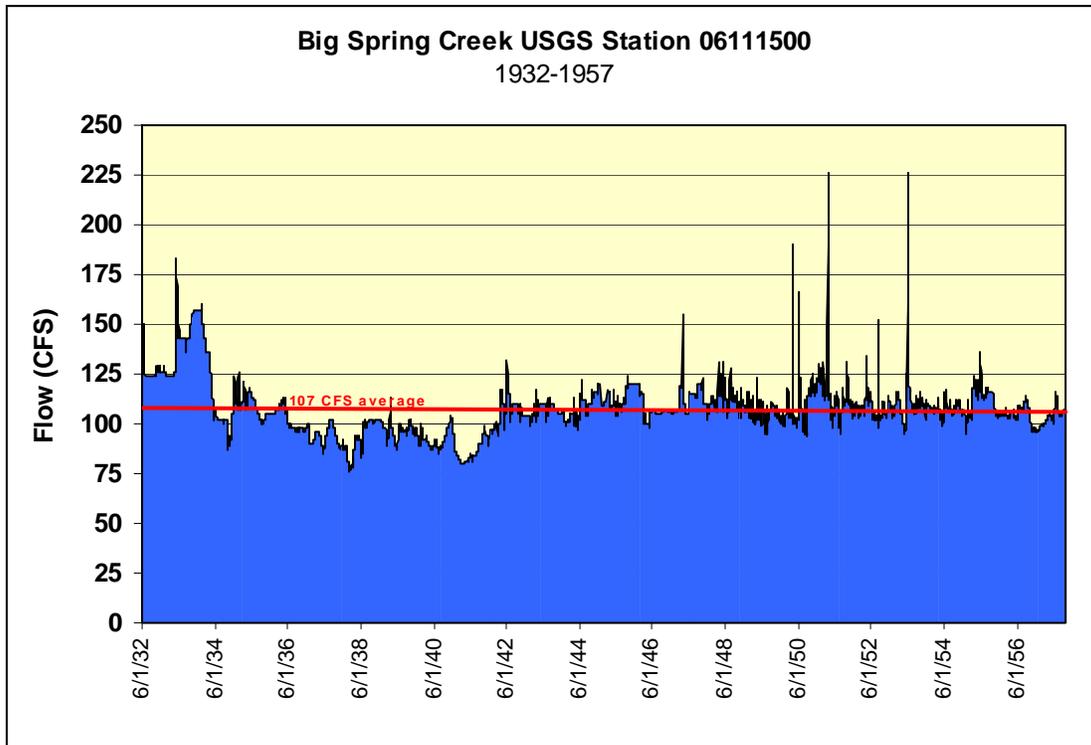
Feltis (1973) noted that, “discharge from the spring has gradually increased from about 109 cfs in February 1967 to 132 cfs in January 1969. This increase probably reflects the above-average precipitation during 1967 and 1968 following below-average precipitation in 1966.”

Figure 2-9. Daily Mean Stream Flow for USGS Station 06111500 from 6/1/1932 to 9/30/1957.

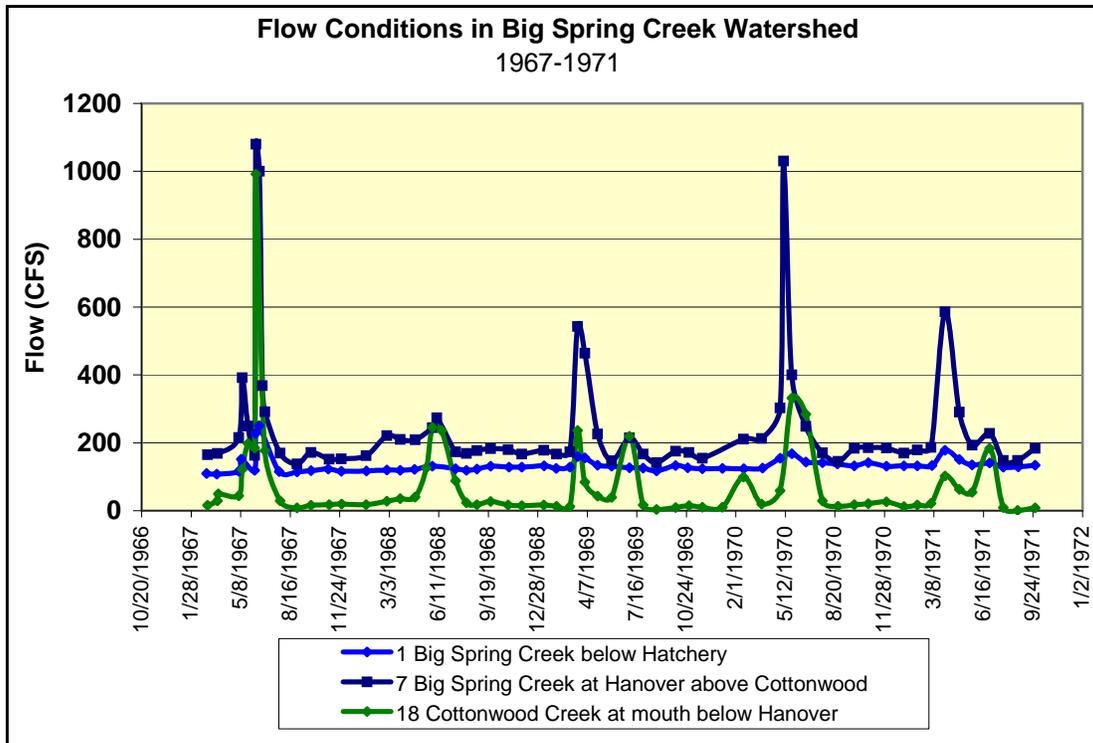
Below Lewistown, lower Big Spring Creek receives significant spring runoff input from Cottonwood Creek. While recorded discharge measurements on lower Big Spring Creek are limited, discharge at stations on Big Spring Creek recorded monthly from 1967-1971 (Figure 2-10) characterize the range of flow conditions typical of the lower watershed. Maximum and minimum recorded flows on Big Spring Creek at Hanover above Cottonwood Creek are 1,080 cfs on 6/8/1967 and 106 cfs on 8/25/1988, however, given the paucity of flow data on the lower watershed, these values should not be taken as true max and min values.

Figure 2-10. Big Spring Creek Monthly Flow, 1967-1971.

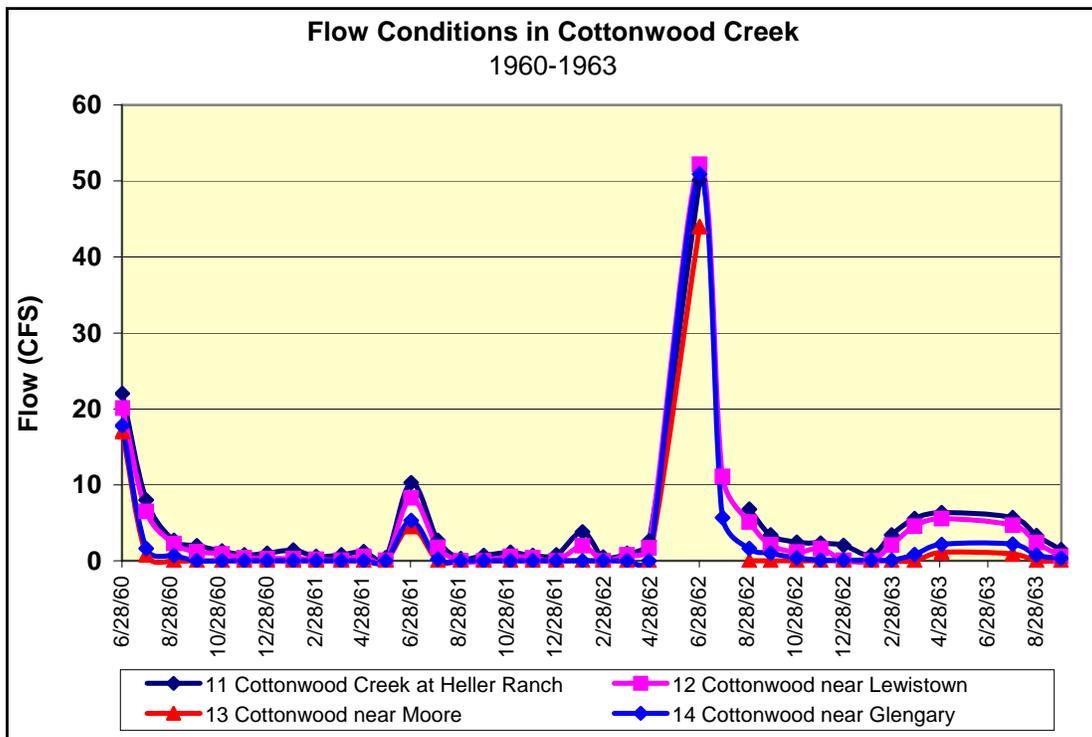
Figure 2-12. Monthly Flow Data for Four Locations on Cottonwood Creek.

Available data, as well as personal accounts from residents and landowners, demonstrate that middle Cottonwood, from above the foothill/basin boundary to near Glengary, is susceptible to regular dewatering and severe low flows in all times but snowmelt runoff and storm events. This is likely due to a combination of factors including: natural geology (infiltration into terrace gravels, loss of streamflow to the cavernous Madison limestone), drought, and irrigation withdrawals.

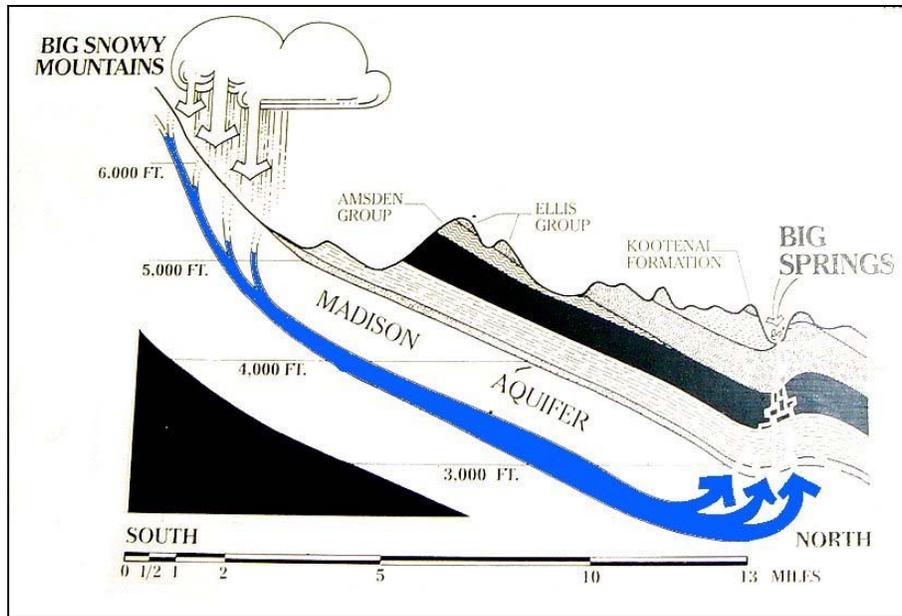
Artesian conditions exist where water in the subsurface is confined above by impermeable layers, and is best characterized by the bedrock aquifers that dip away from the Big Snowy Mountains and are overlain by impermeable shale's. By far, the most significant of these aquifers in the Big Springs Creek watershed is the Madison limestone. The Madison dips gently (8-10 degrees) away from the core of the Big Snowy Mountains and is topped by younger sandstones and shales, making it an ideal confined aquifer (Figure 2-13).

Figure 2-13. Generalized Cross Section of Water Flow Through the Madison Aquifer.

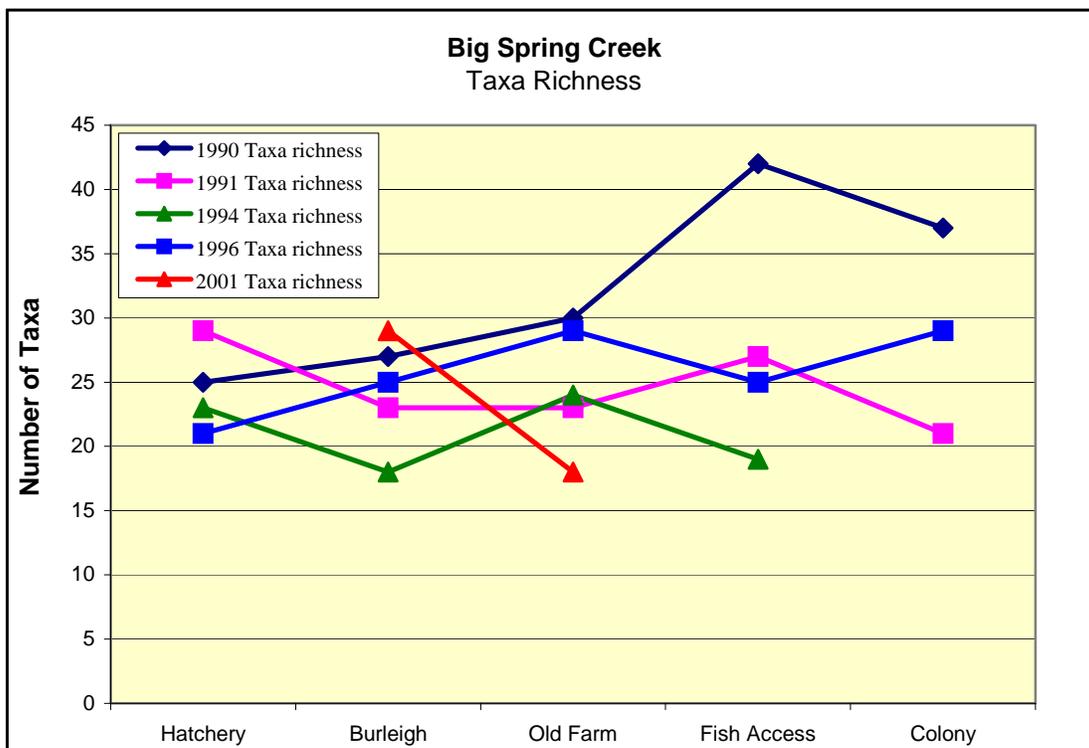
Taxa Richness (the number of unique taxa present in a sample) for five sites along Big Spring Creek is shown in Figure 2-14. Taxa Richness generally decreases with increasing degradation of riparian areas and water quality. However, slight increases in taxa richness can be observed where mild nutrient enrichment of previously nutrient-limited waters occurs. As waters become more enriched in nutrients downstream, more tolerant forms appear, elevating taxa richness. Wisseman (1992a) documented an increase in chironomid midge richness (tolerant form) from 4 taxa near the hatchery to 20 taxa at the Hruska fishing access north of town, indicating diminished water quality. Since 1990, however, downstream taxa richness has decreased substantially from 1990 levels, perhaps suggesting an improving trend in water quality.

Figure 2-14. Big Spring Creek Taxa Richness Trends Since 1990.

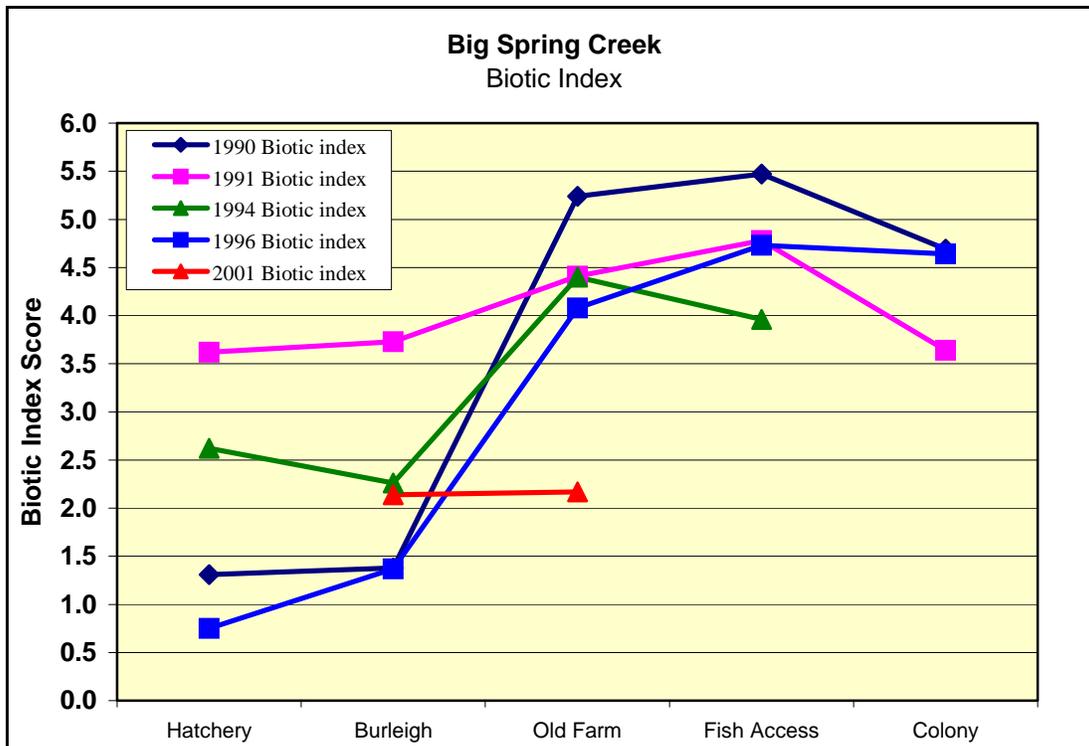
Generally, taxa tolerant to nutrient-enriched conditions are also tolerant to the aforementioned habitat conditions as well. Figure 2-15 shows Biotic Index values for sites along Big Spring Creek from 1990 to 2001. With the exception of the most recent sampling event (2001), data shows a marked increase in biotic index value downstream of Lewistown, indicating a change in substrate habitat and/or water quality conditions.

Figure 2-15. Big Spring Creek Biotic Index Trend Since 1990.

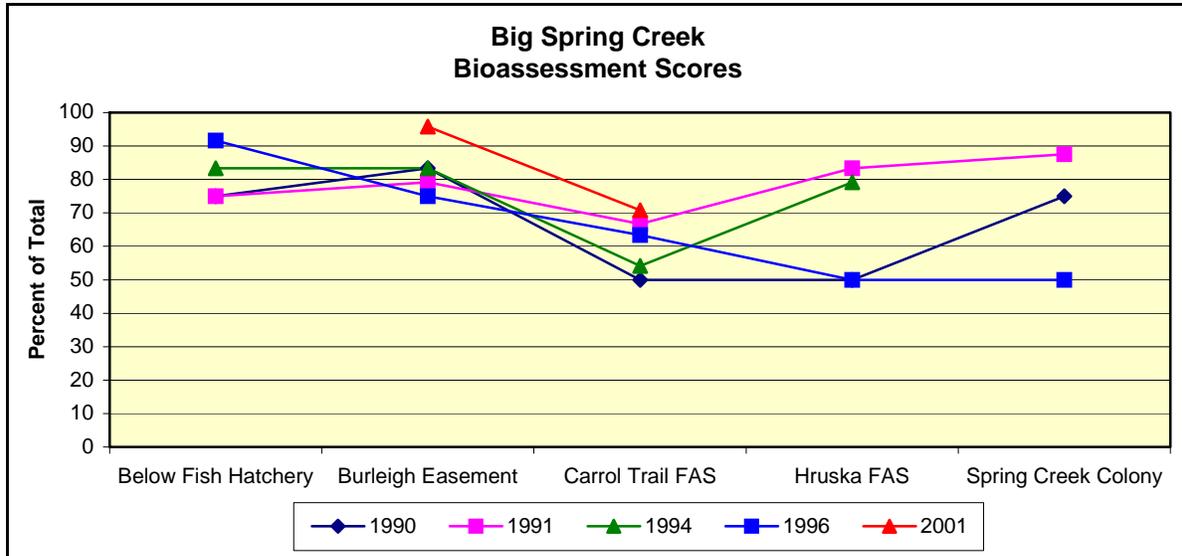
At the **Burleigh Easement** site, the percentage of clinger taxa (49%) collected in 2001 “suggests that benthic substrates were clean and unimpaired by fine sediment deposition” (Bollman, 2001b). Likewise, “functional components of the benthic invertebrate community seem to be well balanced, with adequate representation of grazers, scrapers, predators, and shredders” (Bollman, 2001b). EPT taxa richness was high (13) as was trichoptera richness (5). Multimetric bioassessment scores (Wisseman, 1992b) indicated unimpaired conditions (Figure 4-2). Macroinvertebrate habitat assessments scored in the optimal range in five of six years (Figure 4-3).

Figure 4-2. Big Spring Creek Macroinvertebrate Bioassessment Scores (1990-2001).

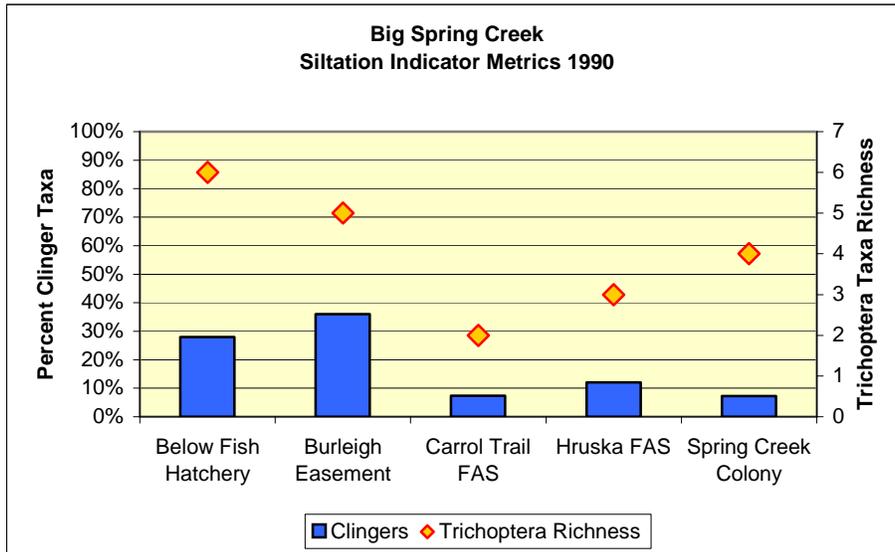
improve slightly. Compared to upstream sites, EPT Richness, percent clinger taxa and trichoptera richness all decrease at downstream sites implying degradation of water quality at both the Carroll Trail FAS and the Hruska FAS (Figures 4-4 thru 4-6). Also, specific reductions in the number of mayfly and stonefly taxa from sites upstream of Lewistown to sites downstream of Lewistown suggest reach-scale disturbances affect both Carroll Trail FAS and Hruska FAS (Bollman, 2001b).

Figure 4-4. Big Spring Creek Siltation Indicators 1990.

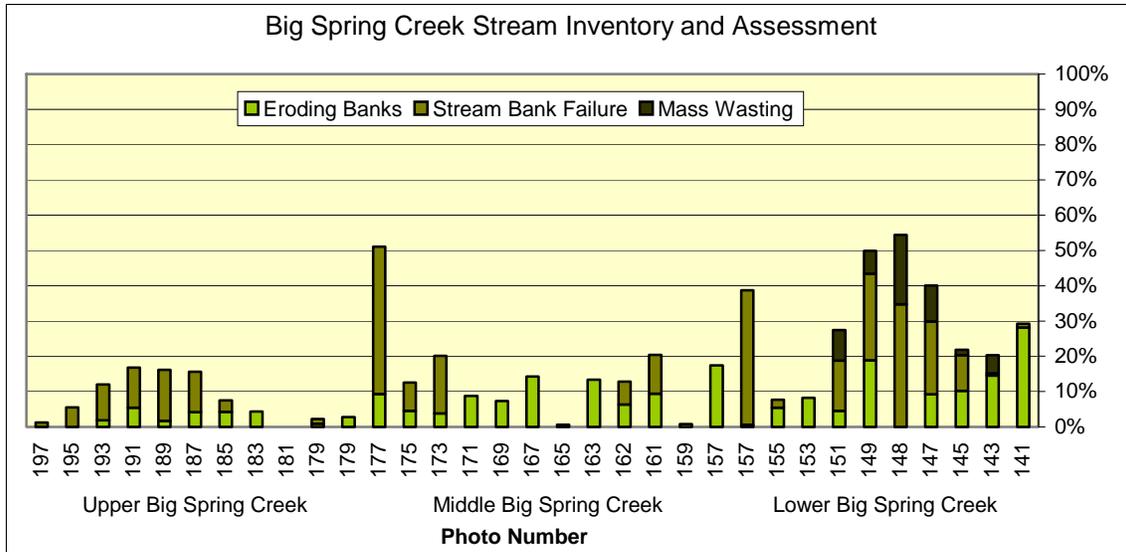
Overall, eroding banks and stream bank failure both increase in a downstream direction. While bank erosion and stream bank failure do not appear to be excessive on average, specific segments do exhibit erosion and failure levels much higher than the average (Figure 4-13). The majority of riprapped stream banks occur just above, through and below Lewistown (Figure 4-14). Mass Wasting occurs predominantly in the lower portion of Big Spring Creek (Figure 4-13).

Figure 4-13. Stream Bank Condition by Reach (Modified from Hawn, 1990).

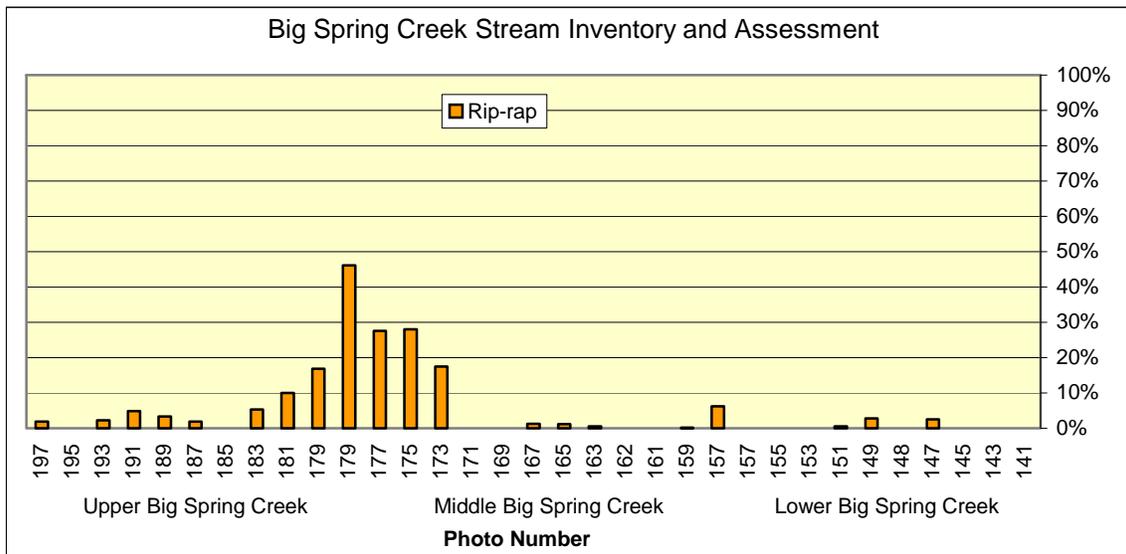
Figure 4-14. Riprap by Reach (Modified from Hawn, 1990).

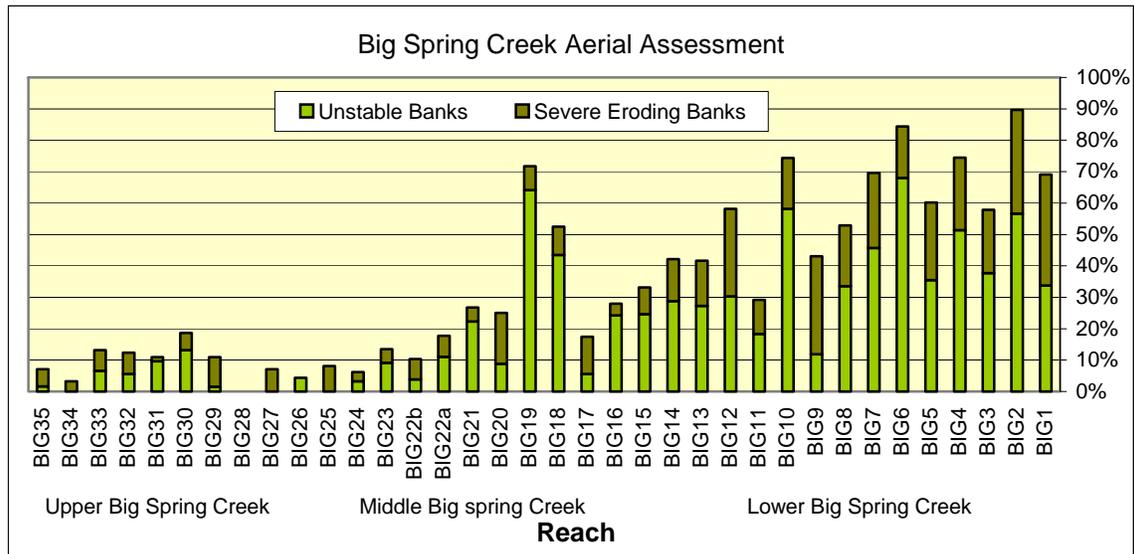
In general, bank erosion and bank instability increase in the downstream direction (Figure 4-15). Big Spring Creek upstream from Lewistown (Big28-Big35) exhibits low levels of bank instability and bank erosion. Bank instability and erosion levels increase noticeably downstream from Big20, just upstream from the Hruska Fishing Access Site. Channel riprap levels (Figure 4-16) are similar to those identified by Hawn in the 1990 Stream Inventory and Assessment.

Figure 4-15. Big Spring Creek Channel Condition (Modified from Land & Water Consulting, 2003).

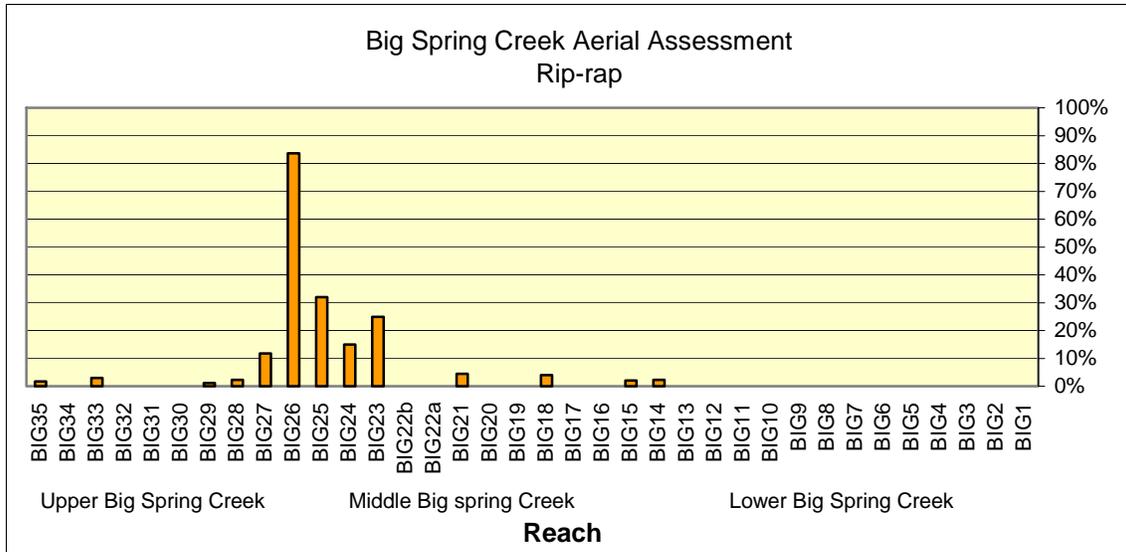
Figure 4-16. Big Spring Creek Channel Riprap (Modified from Land & Water Consulting, 2003).

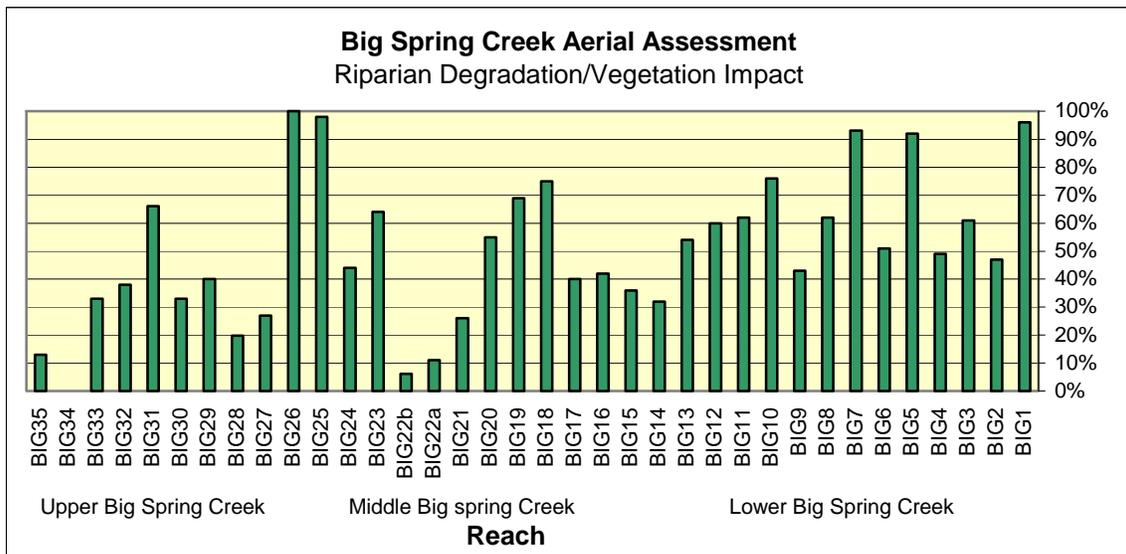
Paralleling channel condition, riparian degradation generally increases in a downstream direction (Figure 4-17). Riparian composition along upper and middle Big Spring Creek is characterized by a higher percentage of trees and woody shrubs than lower Big Spring Creek. Riparian composition along lower Big Spring Creek is predominantly grass/sedge communities (Figure 4-18).

Figure 4-17. Big Spring Creek Degraded Riparian Vegetation (Modified from Land & Water Consulting, 2003).

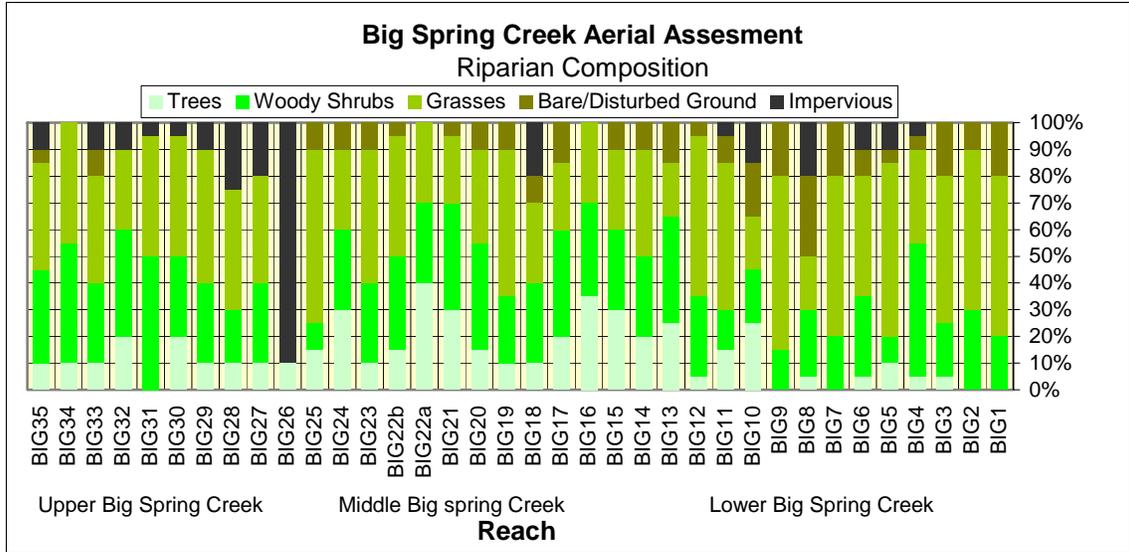
Figure 4-18. Big Spring Creek Riparian Composition (Modified from Land & Water Consulting, 2003).

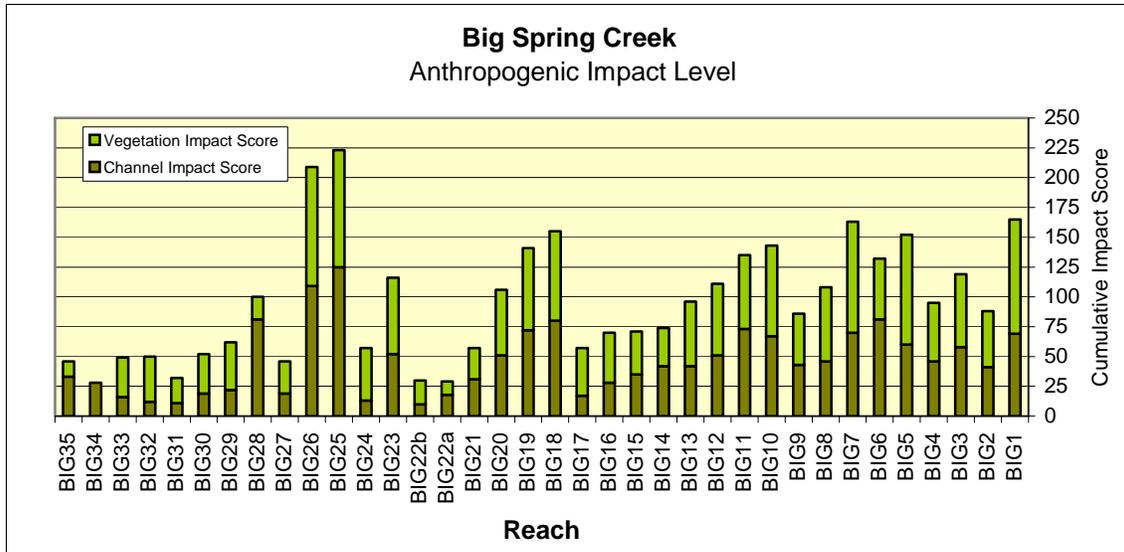
Information obtained on vegetation condition and channel condition was used to develop overall ratings named *Vegetation Impact Category* and *Channel Impact Category* (Appendix B) *Vegetation Impact Category* is a rating of *lightly impacted*, *moderately impacted* or *highly impacted*, and relies on the amount of degraded riparian vegetation determined from aerial assessment. *Channel Impact Category* is a rating of *lightly impacted*, *moderately impacted* or *highly impacted* based on the cumulative score of the percentages of riprap, channelization, unstable banks and severely eroding banks. A general rating of anthropogenic impact level that sums both vegetation impact and channel impact scores is given in Figure 4-19. Impact levels are rather low (generally below 50) upstream from Lewistown (Big26), providing support for low levels of biological impacts (Section 4.1.1.1). Relatively high impact levels for reaches Big25 and Big26 are present immediately upstream from Carroll Trail FAS (Big 24) and likely influence water quality conditions at Carroll Trail (high siltation index, low percent clingers, high surface fines).

Figure 4-19. Big Spring Creek Anthropogenic Impact Level by Reach (Modified from Land & Water Consulting, 2003).

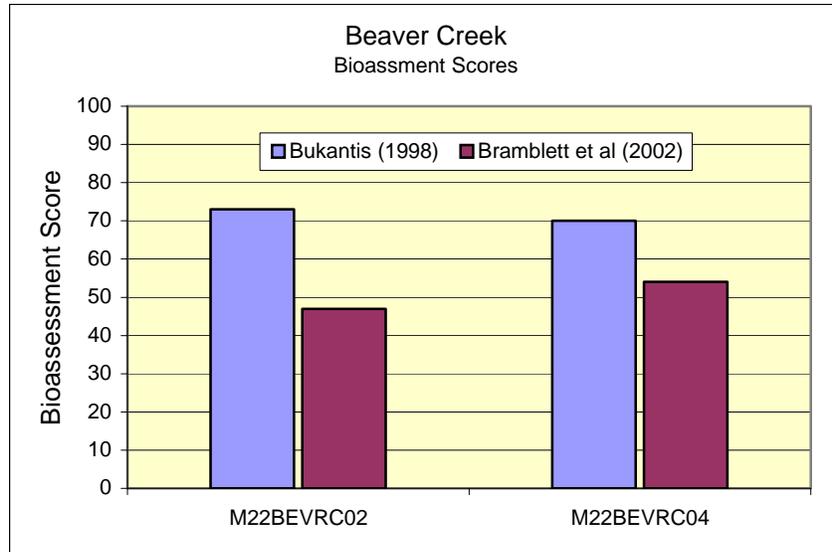
It is expected that sediment levels in plains streams are higher than in MVFP streams, and that macroinvertebrate assemblages reflect this natural change in substrate and habitat conditions. Consequently, it is expected that biotic assemblages downstream from M22BEVRC01 may reflect this environmental gradient. Beneficial use support at sites M22BEVRC02 and M22BEVRC04 was evaluated using both a Montana Plains ecoregion metric developed by Bukantis (1998), and another by Bramblett et al. (2004). Figure 4-21 shows Bioassessment scores based on these two metrics. While metric response varies, both metric scores are below 75%, indicating partial support of beneficial uses.

Figure 4-21. Plains Bioassessment Scores for Two Sites on Beaver Creek.

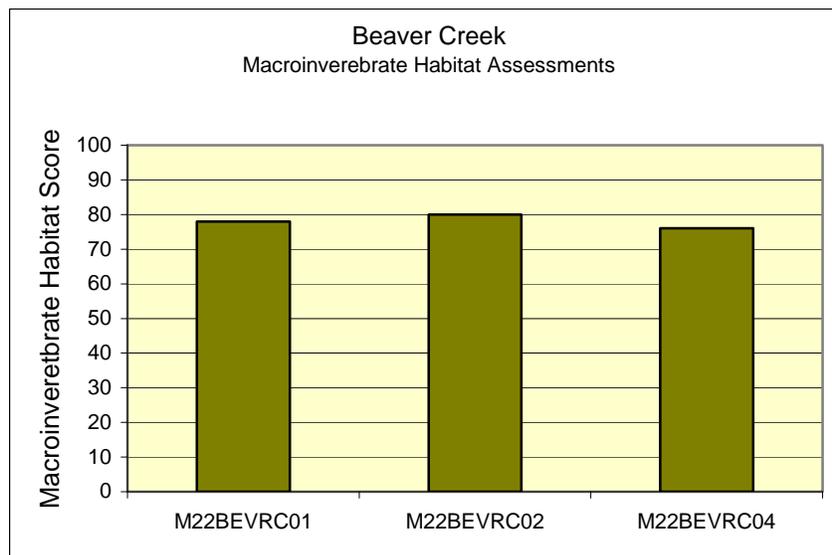
Macroinvertebrate habitat assessments were conducted at each sampling location on Beaver Creek (Figure 4-22).

Figure 4-22. Beaver Creek Macroinvertebrate Habitat Assessment Scores (2003).

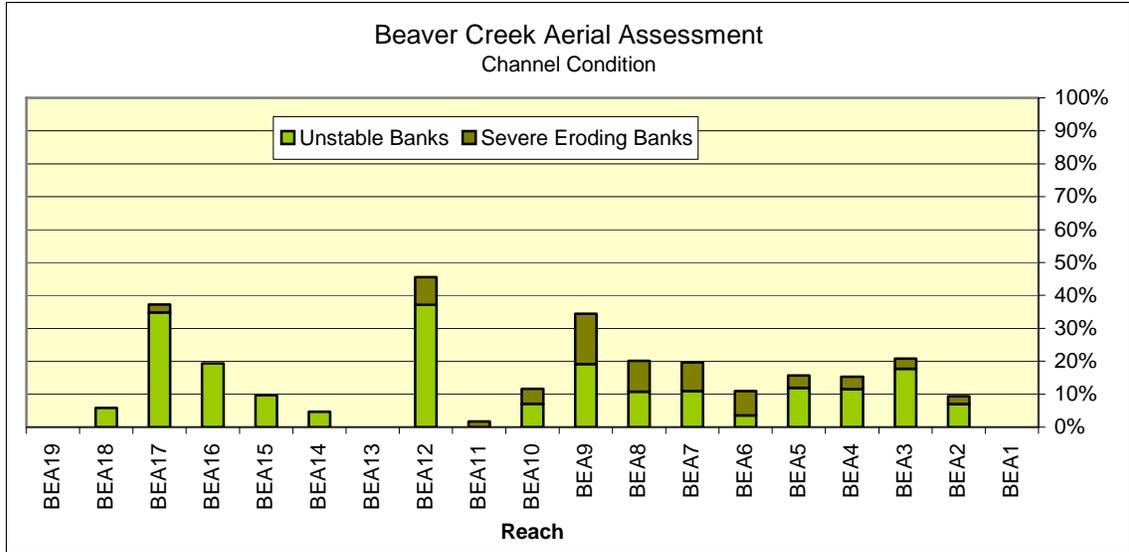
Figure 4-25. Beaver Creek Channel Condition (Modified from Land & Water Consulting, 2003).

Based on this assessment, combined bank erosion and bank instability are below 20% in all but 3 of 19 reaches. Several reaches had very low to negligible amounts of bank erosion. Riparian degradation ranged from 0% to 83% per reach with an average value of 41% for all of Beaver Creek. Riparian degradation, however, is not considered a cause of impairment in itself, nor does it necessarily correspond to higher levels of sediment input, especially in more stable E-channel systems. For instance, in the case of Beaver Creek, many reaches with a high percentage of riparian degradation also had relatively low levels of bank erosion and instability. Riparian vegetation composition is dominated by trees and woody shrubs and make up over 63% of the riparian cover on Beaver Creek. In many reaches, streamside vegetation is very lush, even though buffer zones may be limited. Figure 4-28 illustrates a typical segment of Beaver Creek. Note that even though riparian degradation is evident, there is very little bank erosion.

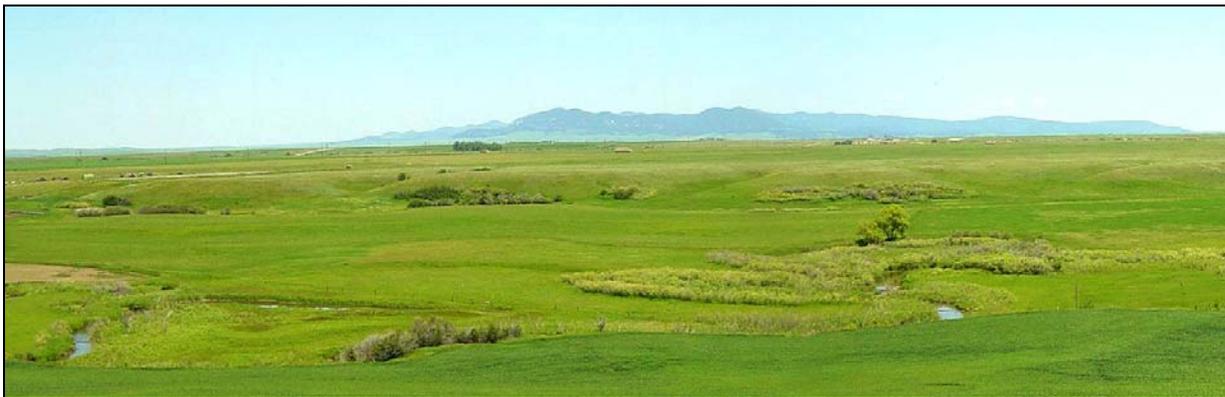
Figure 4-28. Typical Riparian Condition of Beaver Creek (BEA5).

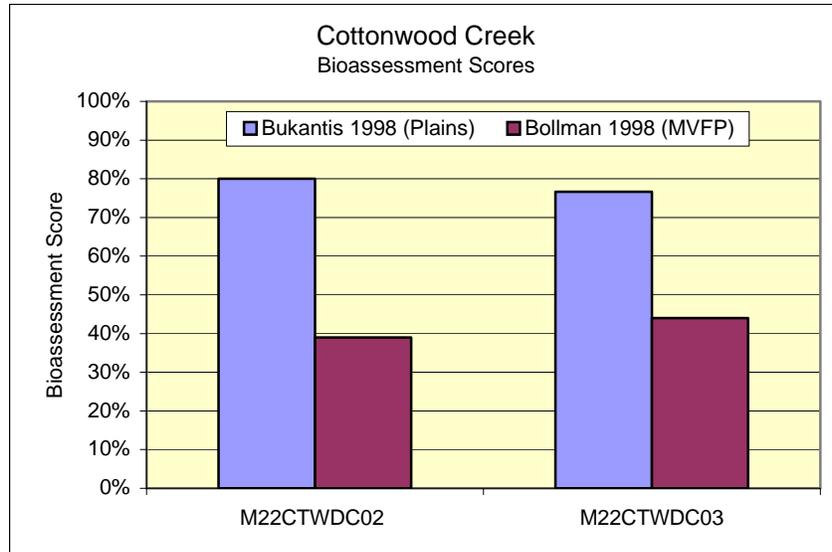
Beneficial use support at sites M22CTWDC02 and M22CTWDC03 was evaluated using both a Montana Plains ecoregion metric developed by Bukantis (1998), and the MVFP ecoregion metric developed by Bollman (1998). Figure 4-30 shows bioassessment scores based on these two metrics.

Figure 4-30. Bioassessment Score Comparisons for Two Sites on Cottonwood Creek.

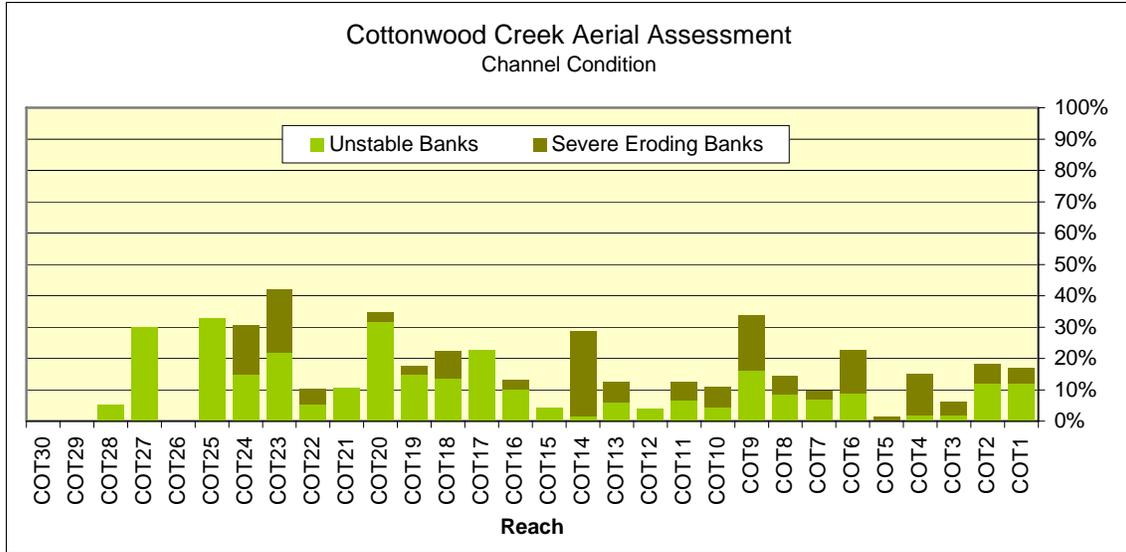
condition information included: *stream bank length, Rosgen Level I channel type, riprap, channel alteration, unstable banks, and severely eroding banks*. Riparian vegetation condition included: *percent composition of trees, woody shrubs, grasses, bare/disturbed ground and impervious cover, feet of degraded riparian vegetation, and average buffer width per subreach*. In addition to channel and vegetation information, adjacent land use information was obtained from the aerial photography. No ground-truthing of the aerial assessment was conducted. The resultant data and methods utilized to derive these values are shown in Appendix D. A summary of channel and vegetation condition is given in Figures 4-33 thru 4-35.

Figure 4-33. Cottonwood Creek Channel Condition (Modified from Land & Water Consulting, 2003).

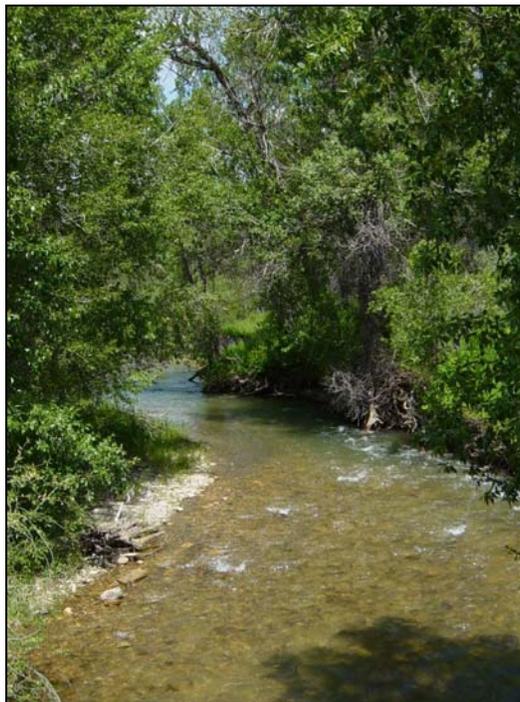
Based on this assessment, the percentage unstable banks and severe bank erosion on upper Cottonwood Creek, MT41S004_051, was 12.9% and 3.9%, respectively. Riparian degradation ranged from 0% to 69% per reach with an average value of 25% for segment MT41S004_051. Riparian vegetation composition is dominated by trees and woody shrubs and make up over 77% of the riparian cover on Upper Cottonwood Creek. Figure 4-36 illustrates a typical segment of Upper Cottonwood Creek, MT41S004_051.

Figure 4-36. Typical Riparian Condition of Upper Cottonwood Creek (COT18).

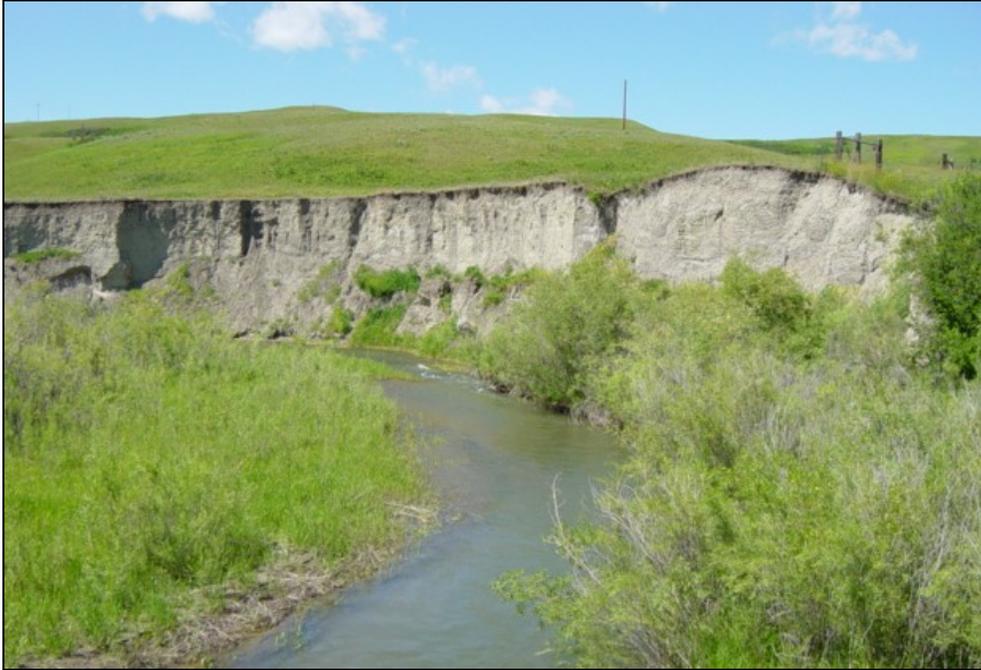
The percentage unstable banks and severe bank erosion on lower Cottonwood Creek, MT41S004_052, was 6.5% and 6.7%, respectively. Riparian degradation ranged from 0% to 37% per reach with an average value of 20% for segment MT41S004_052. Riparian vegetation composition is dominated by trees and woody shrubs and make up 75% of the riparian cover on lower Cottonwood Creek. Figure 4-37 illustrates a typical segment of lower Cottonwood Creek, MT41S004_052 during spring flow conditions (June 21, 2003).

Figure 4-37. Condition of Lower Cottonwood Creek (COT4).

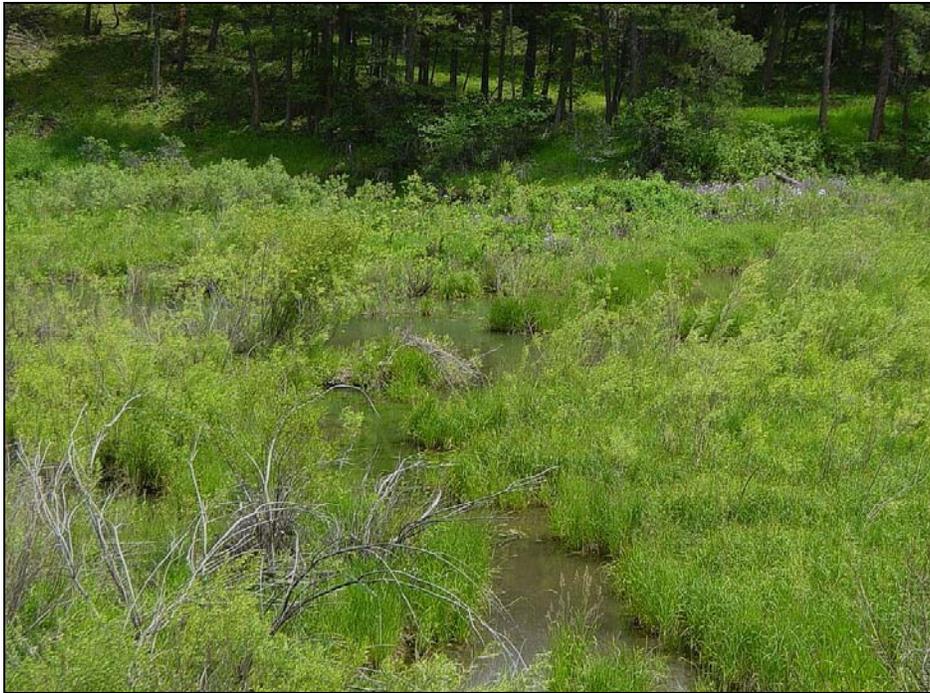
Figure 4-44. Turbid water associated with beaver complexes (Casino Creek, 2003).

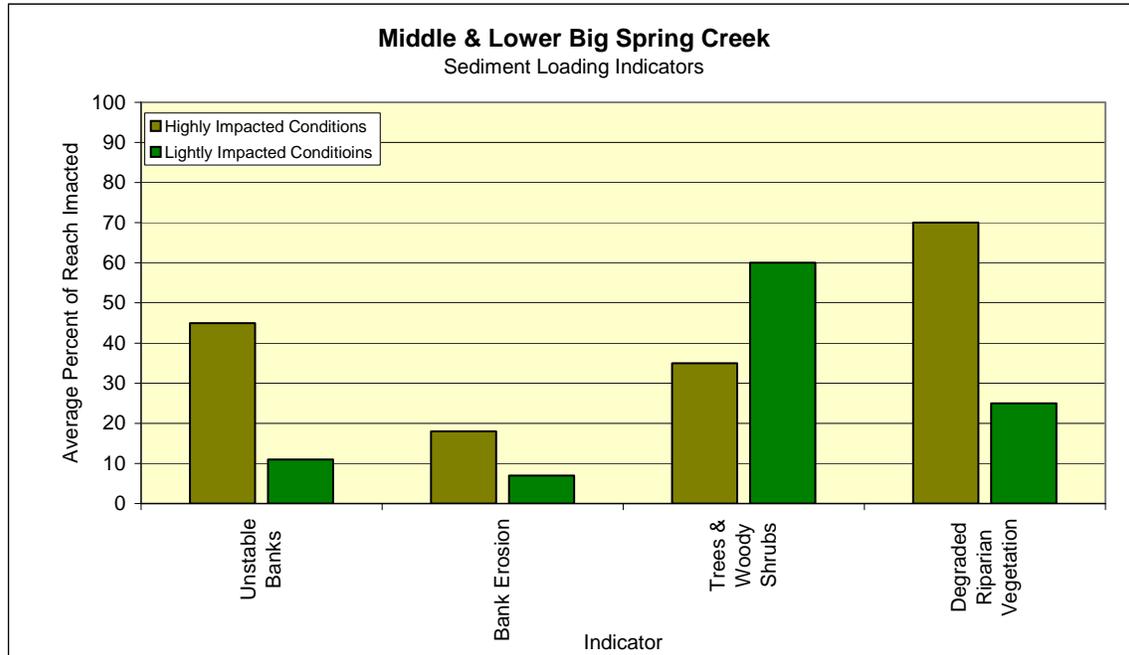
Figure 5-6. Comparison of ‘Highly Impacted’ and ‘Lightly Impacted’ Reaches on Middle and Lower Big Spring Creek.

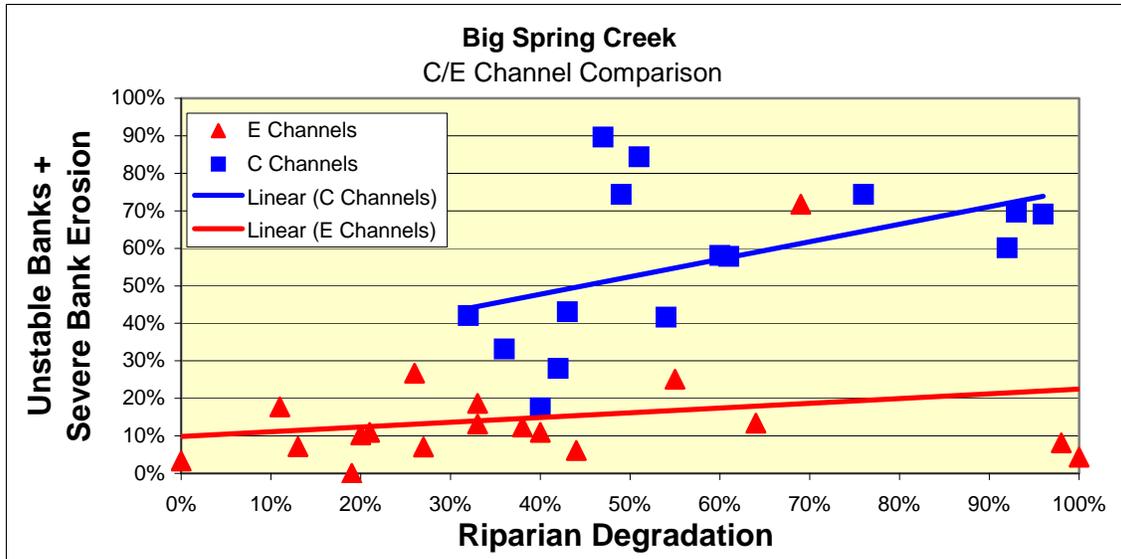
Figure 5-7. Comparison Between C and E Channel Types in Big Spring Creek.

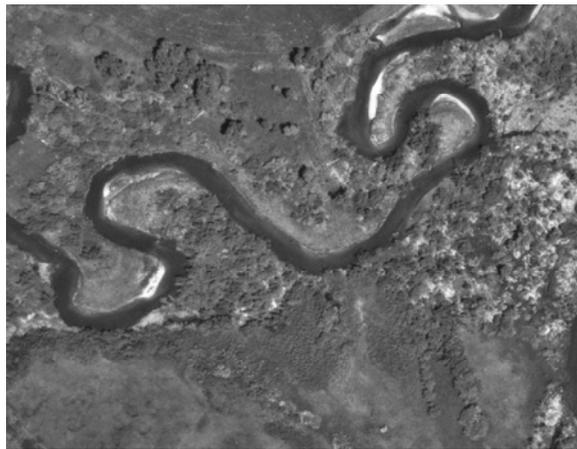
Figure 5-10. Bank Stabilization with Native Vegetation.

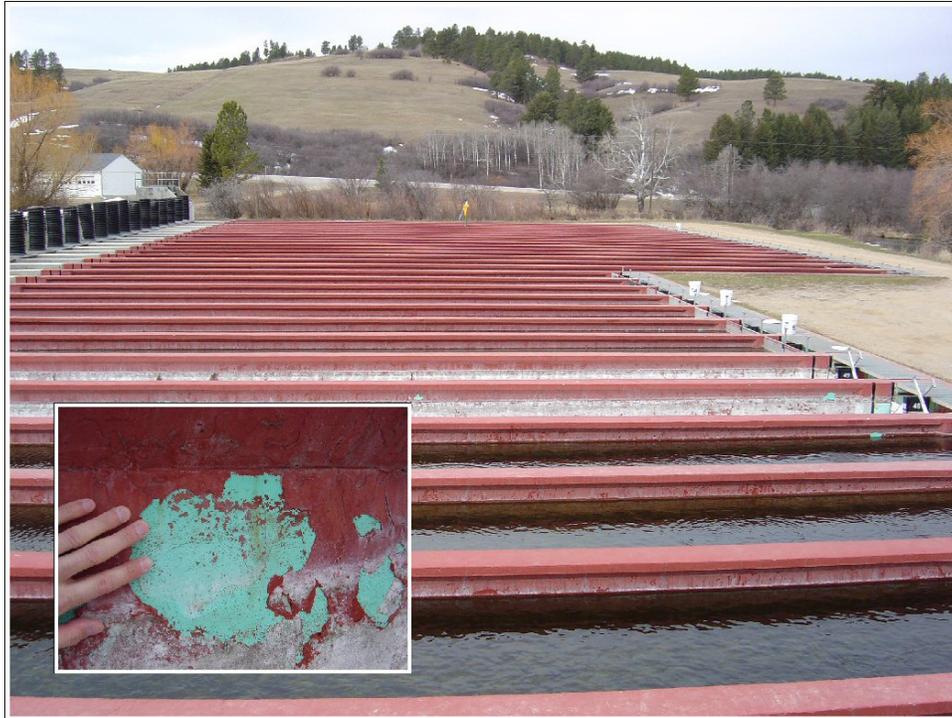
Figure 6-7. Paint containing PCBs at the Big Springs Trout Hatchery – Lower Raceways.

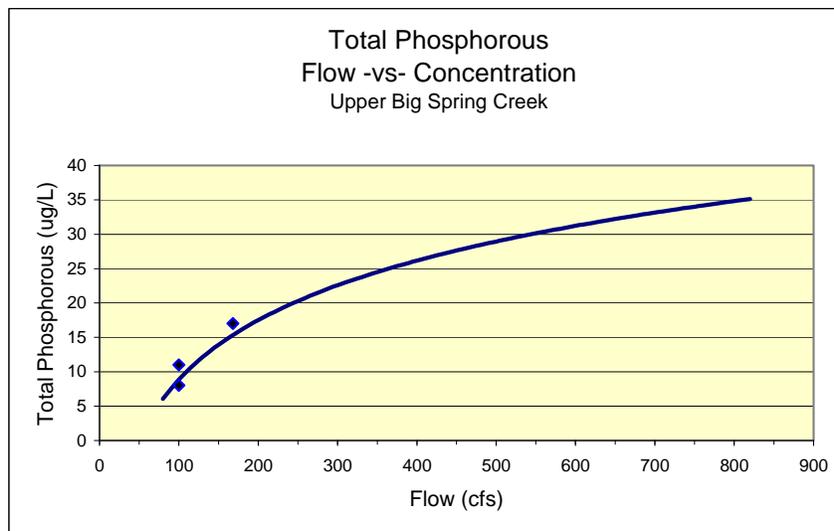
Figure 8-3. Total phosphorous concentration/Flow curve for upper Big Spring Creek.

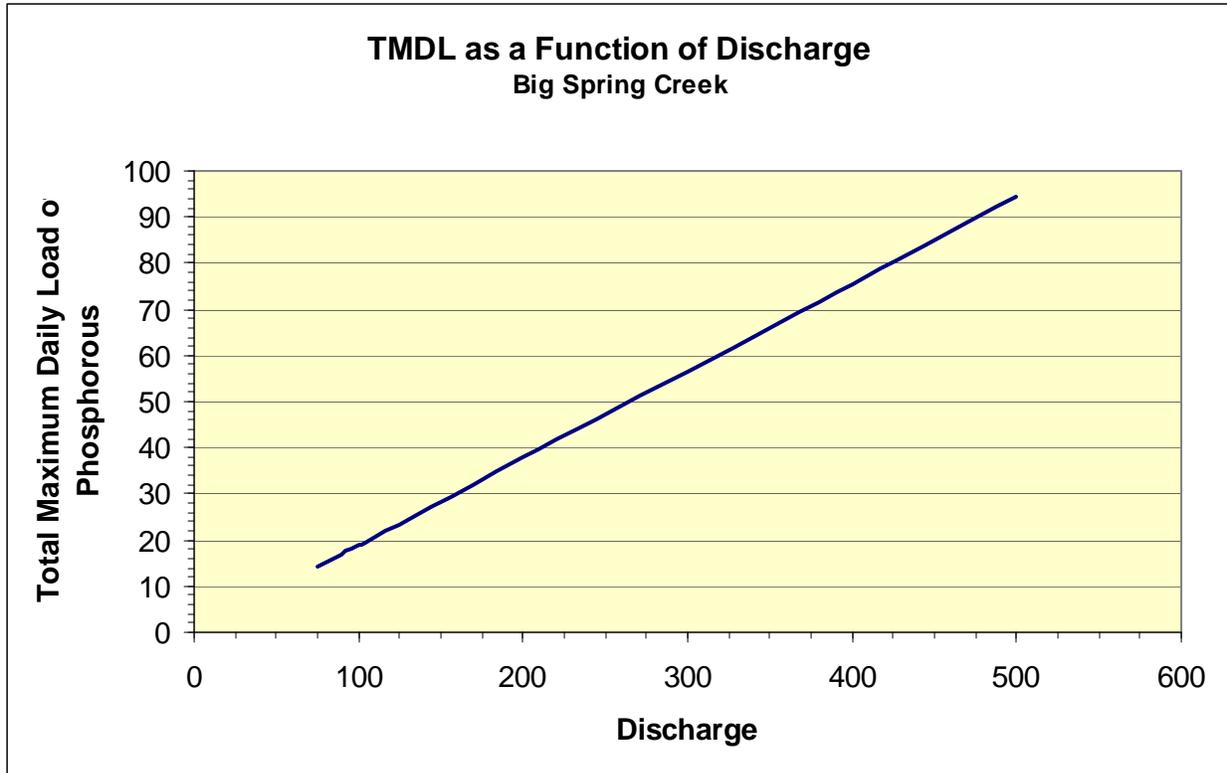
Figure 8-5. Allowable total maximum daily loads as a function of discharge for Big Spring Creek.

Total Nitrogen targets are presently being met in Big Spring Creek. Total phosphorous targets are exceeded; therefore a TMDL of phosphorous is calculated. Because allowable phosphorous concentrations are a function of flow, the **TMDL is dependent on flow conditions**. Table E-2 presents the TMDL of phosphorous under different flow conditions, and shows the necessary load reduction required to meet the TMDL.
