**SCAT Area Transition Report
for A02**

Silvertip Pipeline Incident
Laurel, Montana

October 18, 2011

Our Ref.:
B0085883.1103

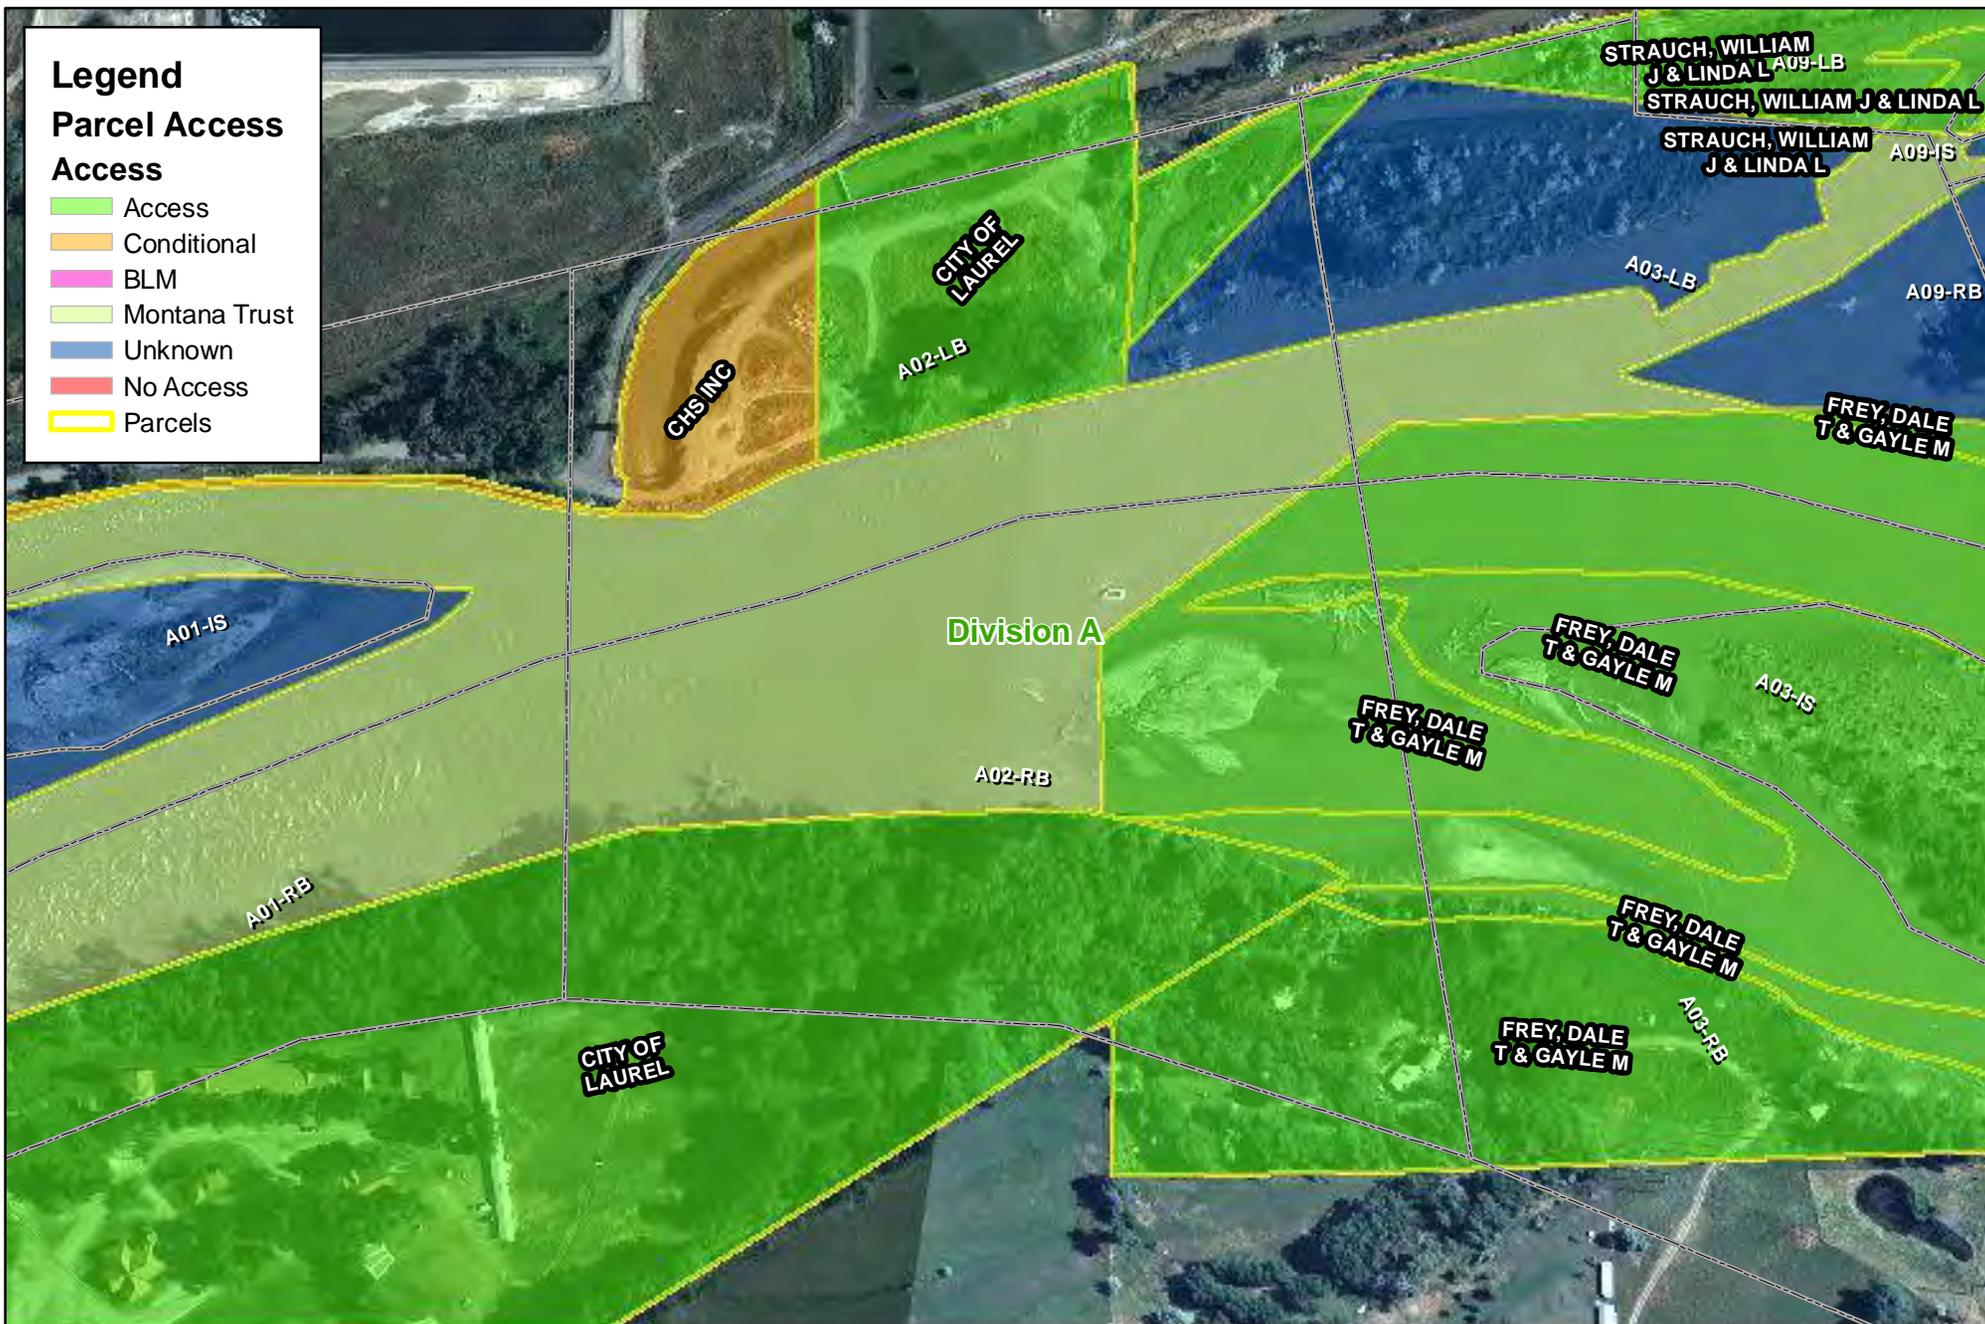
Figure 1 provides an aerial map of SCAT Area A02, along with the (a) SCAT Area boundary, (b) parcel boundaries and respective property owners, and (c) access constraints identified during the oil cleanup process. The acreage surveyed in Area A02 is 12.8. There were no access issues for this area.

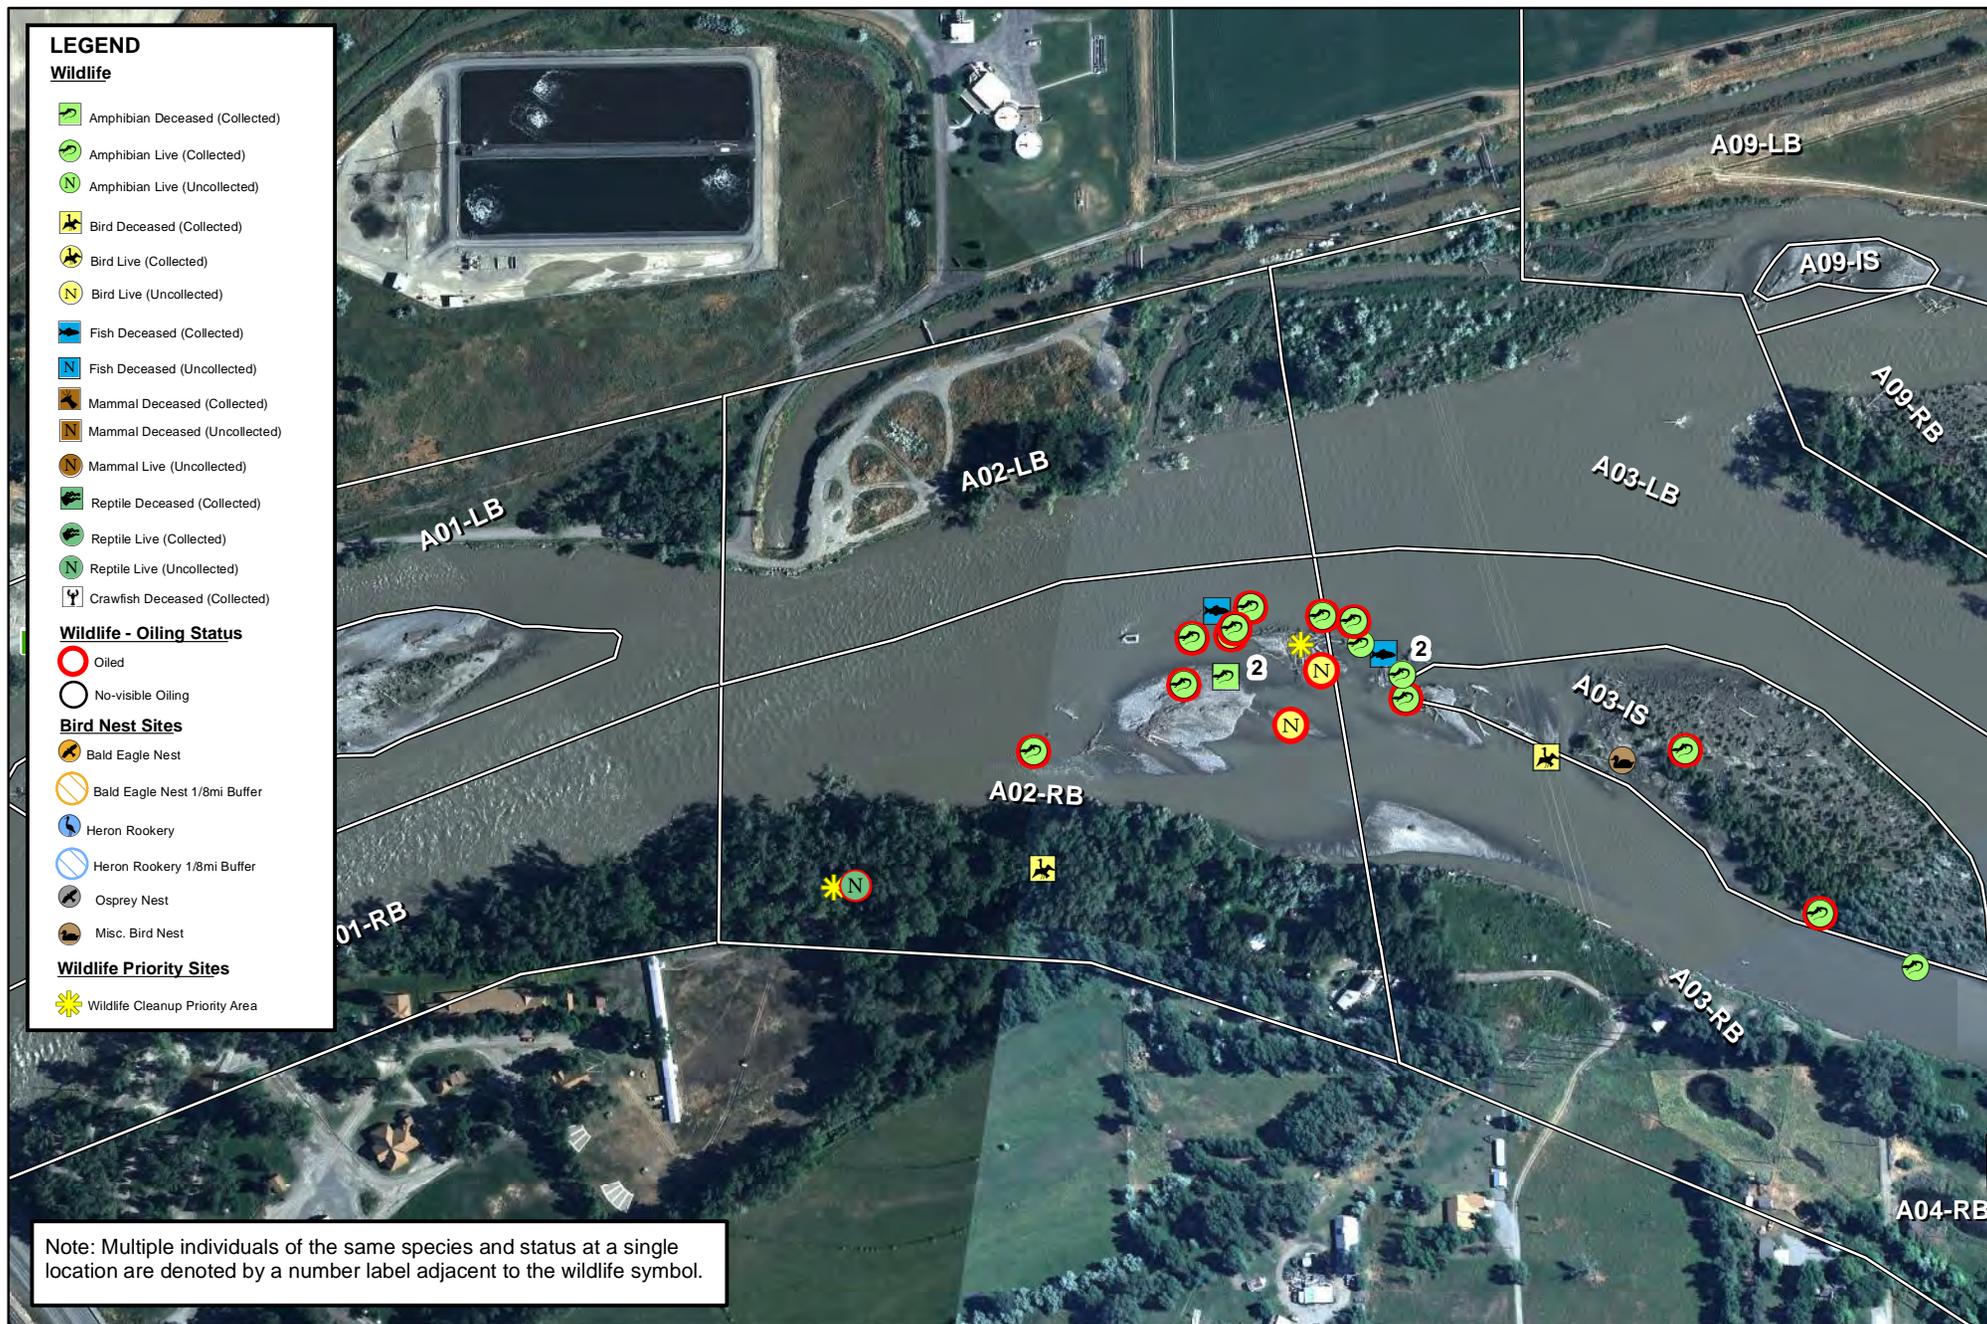
Figure 2
Wildlife Resources

Figure 2 summarizes the natural resources identified in this segment. International Bird Rescue and Resource Advisors from U.S. Fish and Wildlife Service conducted regular inspections of Area A02. Seven oiled Woodhouse's toads (*Bufo woodhousii*) were captured, cleaned, and released. Two lightly oiled spotted sandpipers (*Actitis macularius*) were located on the A02 portion of the 'A03-Island' and their condition was monitored; it was determined that the birds did not need to be captured and cleaned. One oiled painted turtle (*Chrysemys picta*) was observed at the 'turtle pond'; however, it could not be captured despite repeated efforts. Three deceased animals with no visible oiling were recovered; one grey catbird (*Dumetella carolinensis*), one Woodhouse's toad, and one black bullhead (*Ameiurus melas*). Two Wildlife Priority Cleanup Areas were identified. The 'turtle pond' was identified as a Wildlife Priority Area due to persistent sheen. Water and sediment was removed from the turtle pond, which diminished the amount of sheen. Sheen has not been noted recently in the turtle pond; however, water levels have fallen and water may no longer be in contact with oil-impacted soils in the upper bank. The turtle pond is scheduled to be checked for sheen after the next substantial rain event. Prior to and during cleanup, the turtle pond was regularly monitored for oiled wildlife, and Mylar streamers were installed to

haze birds from the area and prevent oiling. The second Wildlife Priority Cleanup Area was a debris pile on the tip of the 'A03- Island' that had a pool of oiled water associated with it. The debris pile and associated oiled water was a wildlife attractant that resulted in several oiled toads and two lightly oiled spotted sandpipers. The debris pile and underlying depression were treated to reduce the potential for wildlife oiling and are no longer considered a hazard. No active migratory bird nests were identified in Area A02.

Two Wildlife Priority Cleanup Areas were identified and remediated in A02. To mitigate the persistent sheen found in the 'turtle pond,' water and sediment were removed from the pond. The turtle pond was subsequently checked after a rain event and no evidence of sheen was noted on the water. The debris pile on the tip of 'A-3 Island' was taken apart by heavy machinery, oily material was removed and disposed of offsite, sand and gravel material from adjacent areas was used to fill in the depressed area beneath the pile, and the pile was reconstructed with the remaining clean debris. 'Sign-off ' on the debris pile is found in Appendix G; the exception memo, which was written and signed on August 30, 2011, was signed again on September 23, 2011 upon completion of the work. Appendix G includes an email from the MDEQ that documents the work was completed to their satisfaction.

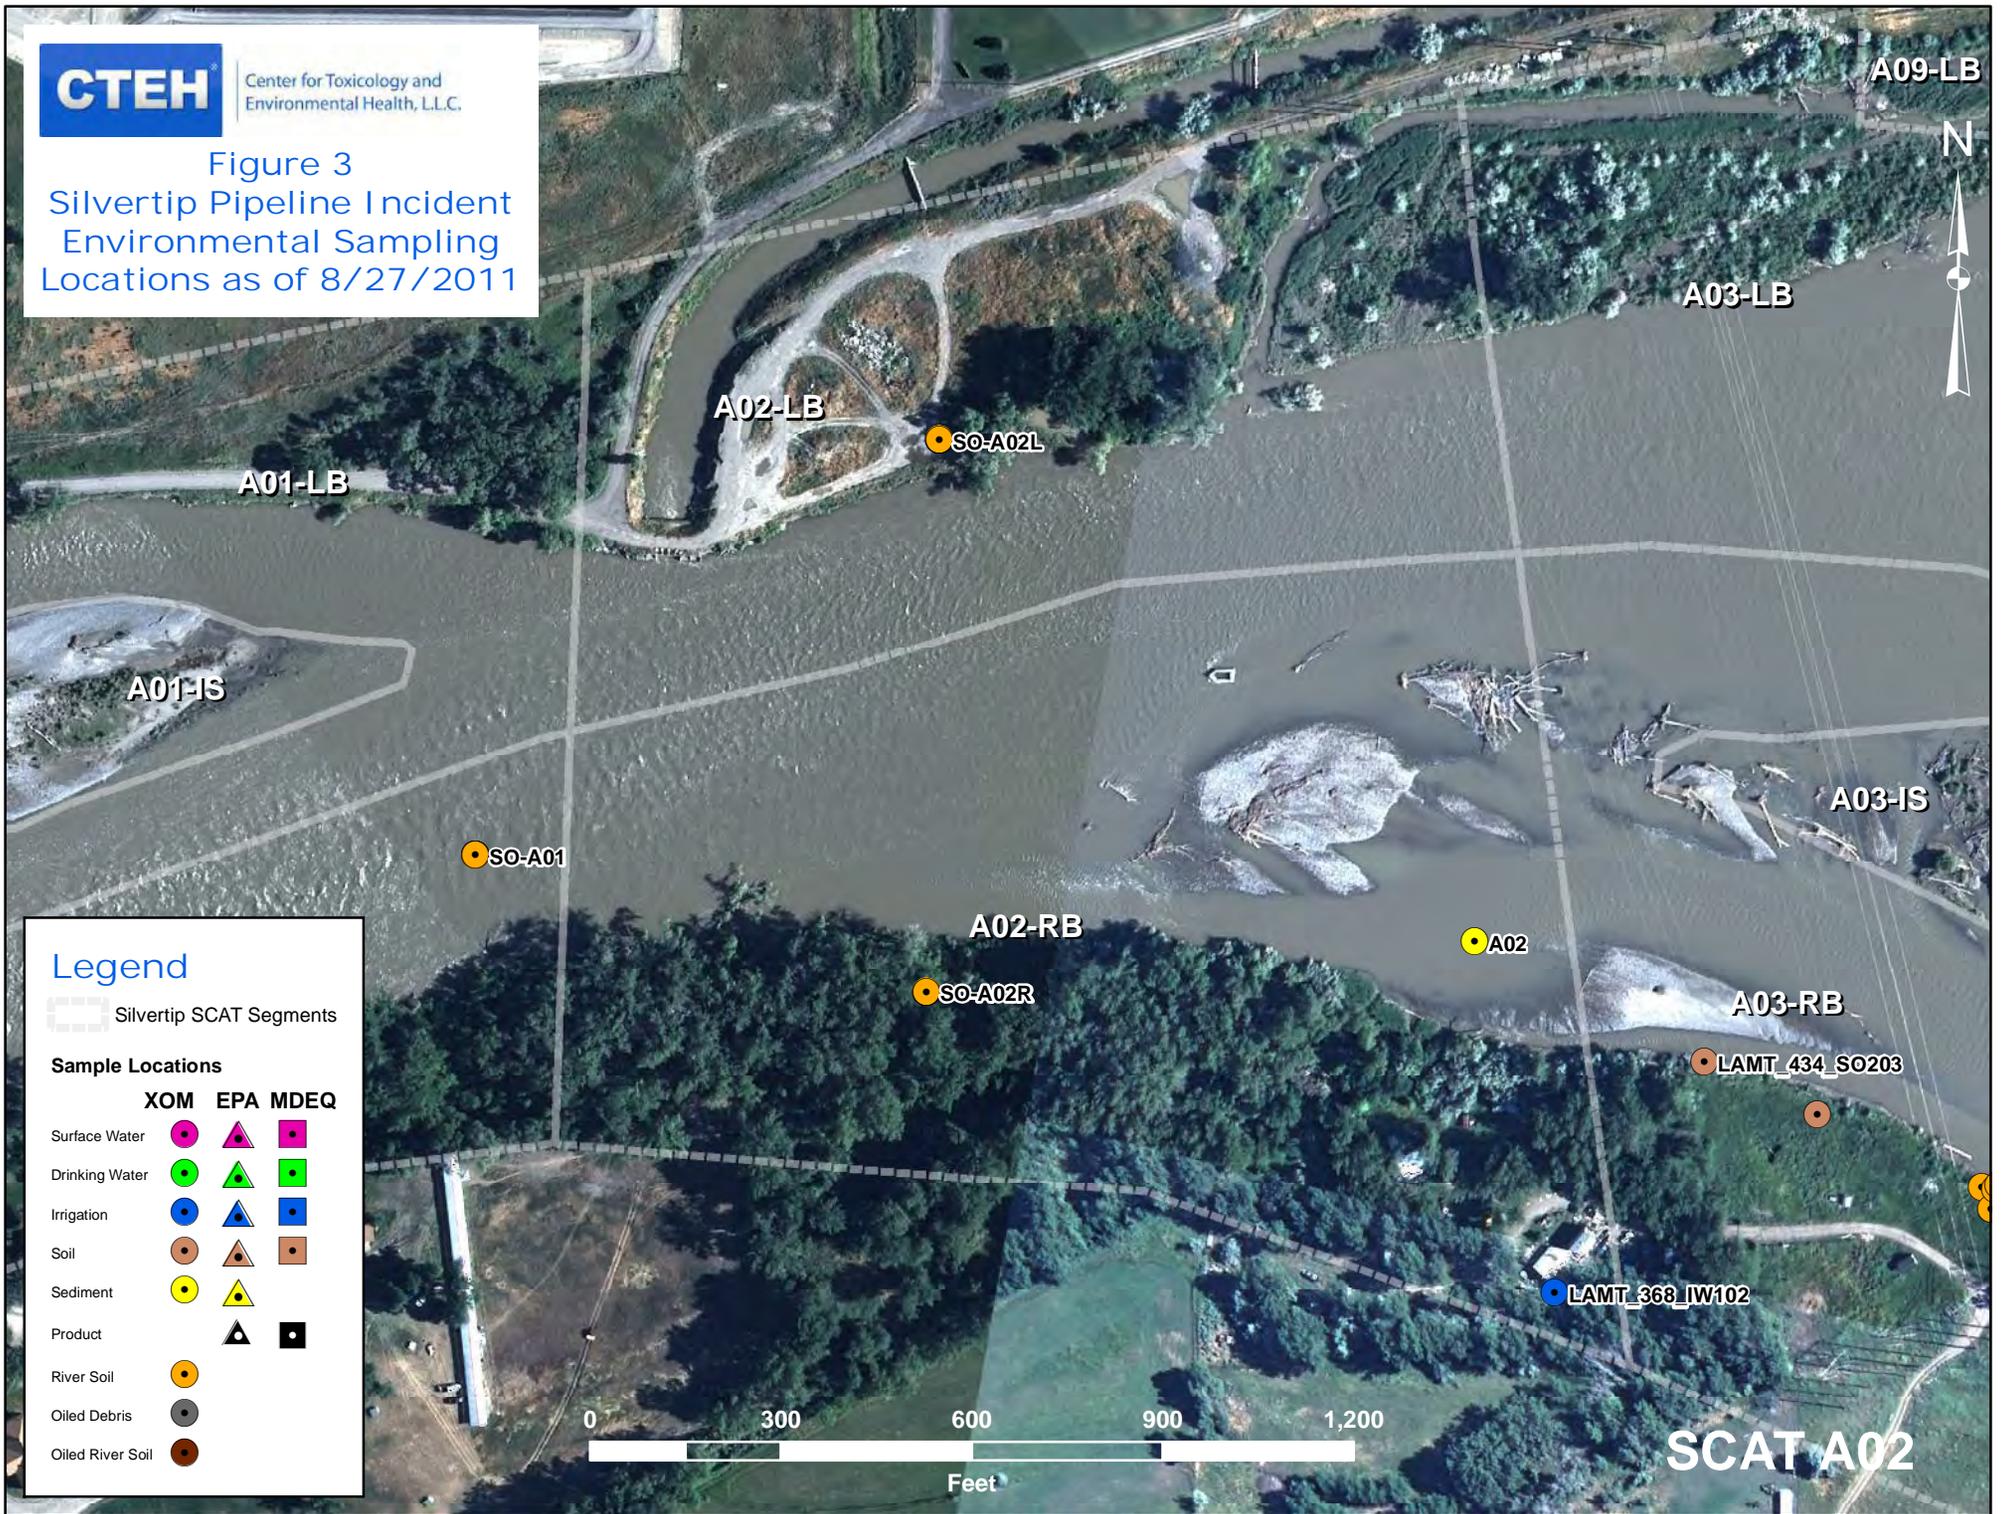
Figure 3
Silvertip Pipeline Incident
Environmental Sampling
Locations as of 8/27/2011

Table 1 (below) summarizes samples collected within Area A02. The analytical results for the samples collected can be accessed through a publicly accessible database on the United States Environmental Protection Agency's (USEPA's) website. The approximate locations of samples collected within Area A02 are provided on Figure 3.

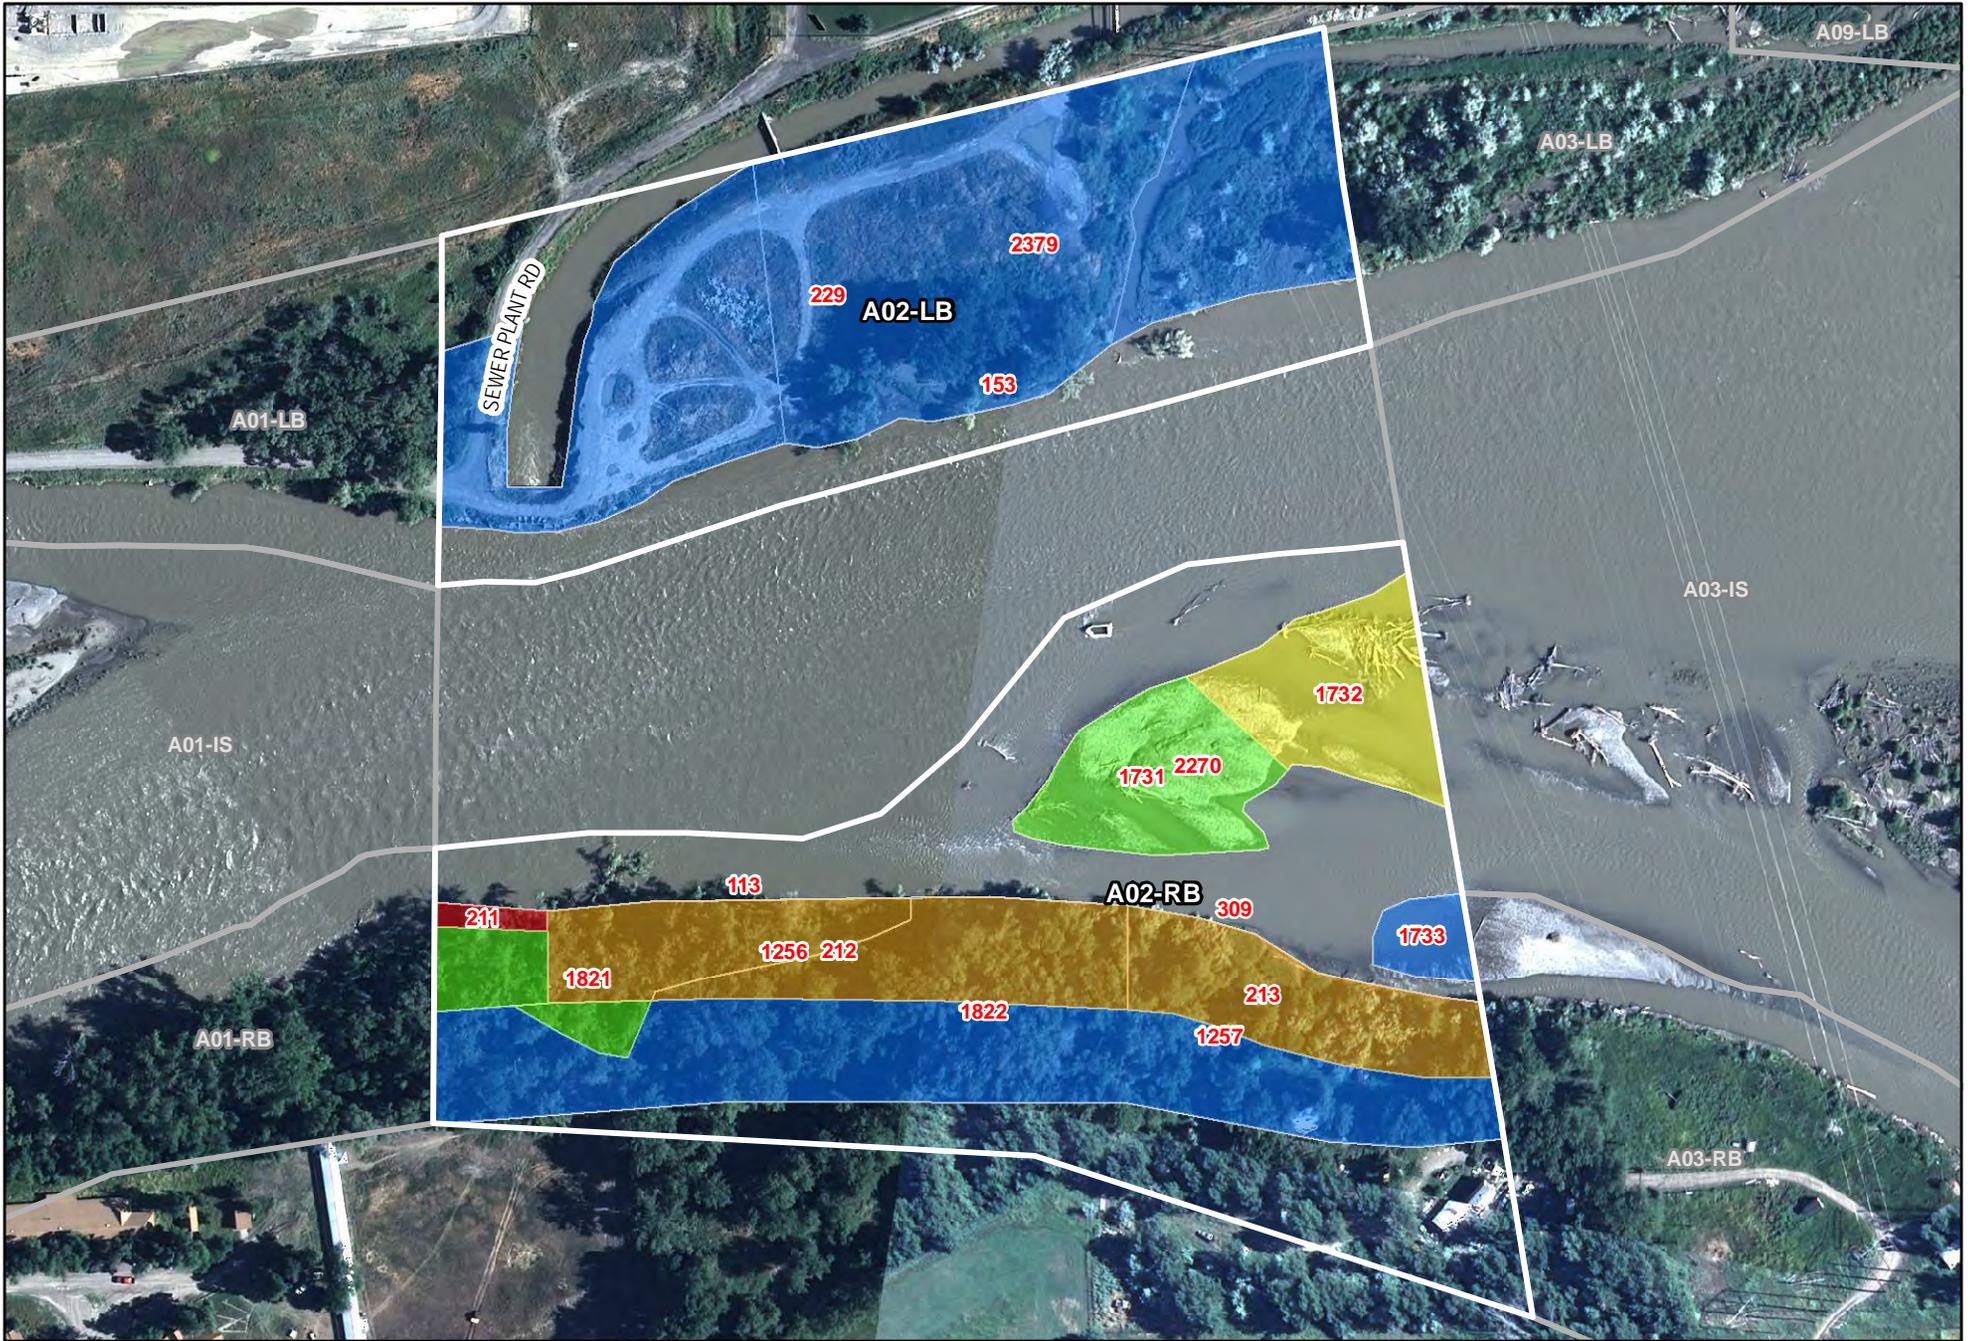
The SCAT teams used systematic evaluation criteria and treatment method tables approved by the National Oceanic and Atmospheric Administration to provide a standard approach for data collection and conducting field surveys. The forms and sketches from the initial SCAT surveys performed along the river bank (water edge) and floodplain within Area A02 are included in Appendix B. Figure 4 provides the maximum oiling zones observed by the SCAT team during the initial surveys of Area A02.

<p>9999 Oiling Zone ID Red Heavy Oiling Orange Moderate Oiling</p>	<p>Yellow Light Oiling Green Very Light Oiling Blue No Oil Observed</p>	<p>Figure 4 - Maximum SCAT Observations For SCAT Area: A02</p> <p>160 0 160 320 Feet</p>

The SCAT team developed compiled treatment recommendations (CTRs) providing approved treatment methods (ATMs) for each oiling zone identified during the initial SCAT surveys ([CTR No. 3](#) and [CTR No. 17](#)).

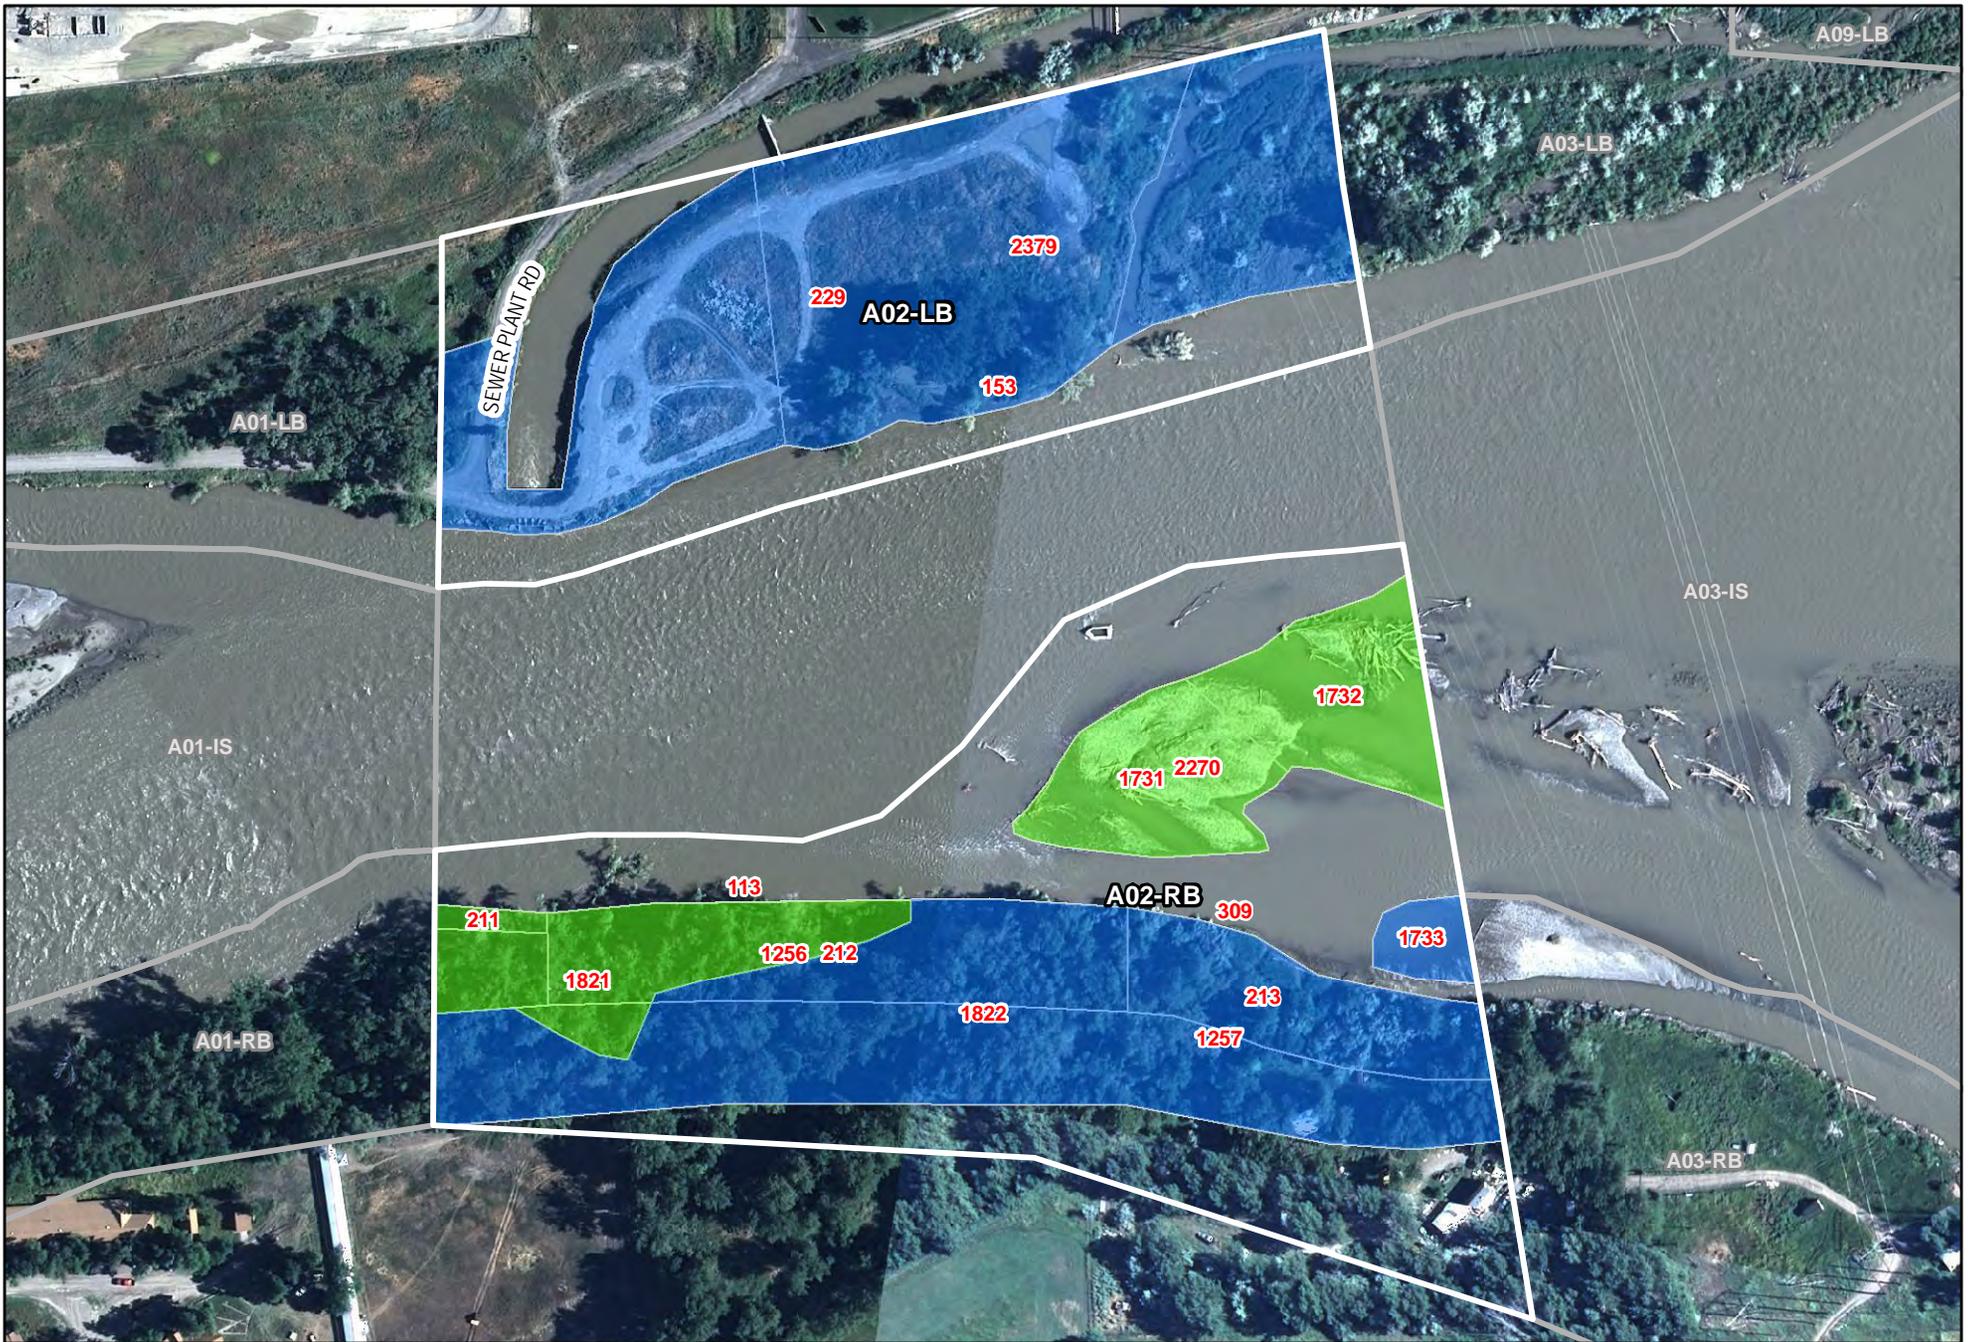
Figure 5 - Final SCAT Observations
For SCAT Area: A02

Figure 5 shows the oiling conditions within Area A02 following completion of oil removal activities. The SCAT team performed final surveys of the left and right banks within SCAT Area A02 to confirm the agreed-upon cleanup endpoints identified in the

applicable CTRs had been achieved. The final SCAT survey documentation is presented in Appendix E.

Based on the final SCAT surveys performed on the left and right banks within Area A02, no further treatment is recommended for these segments. SCAT Segment Sign-Off Forms are included as Appendix F.

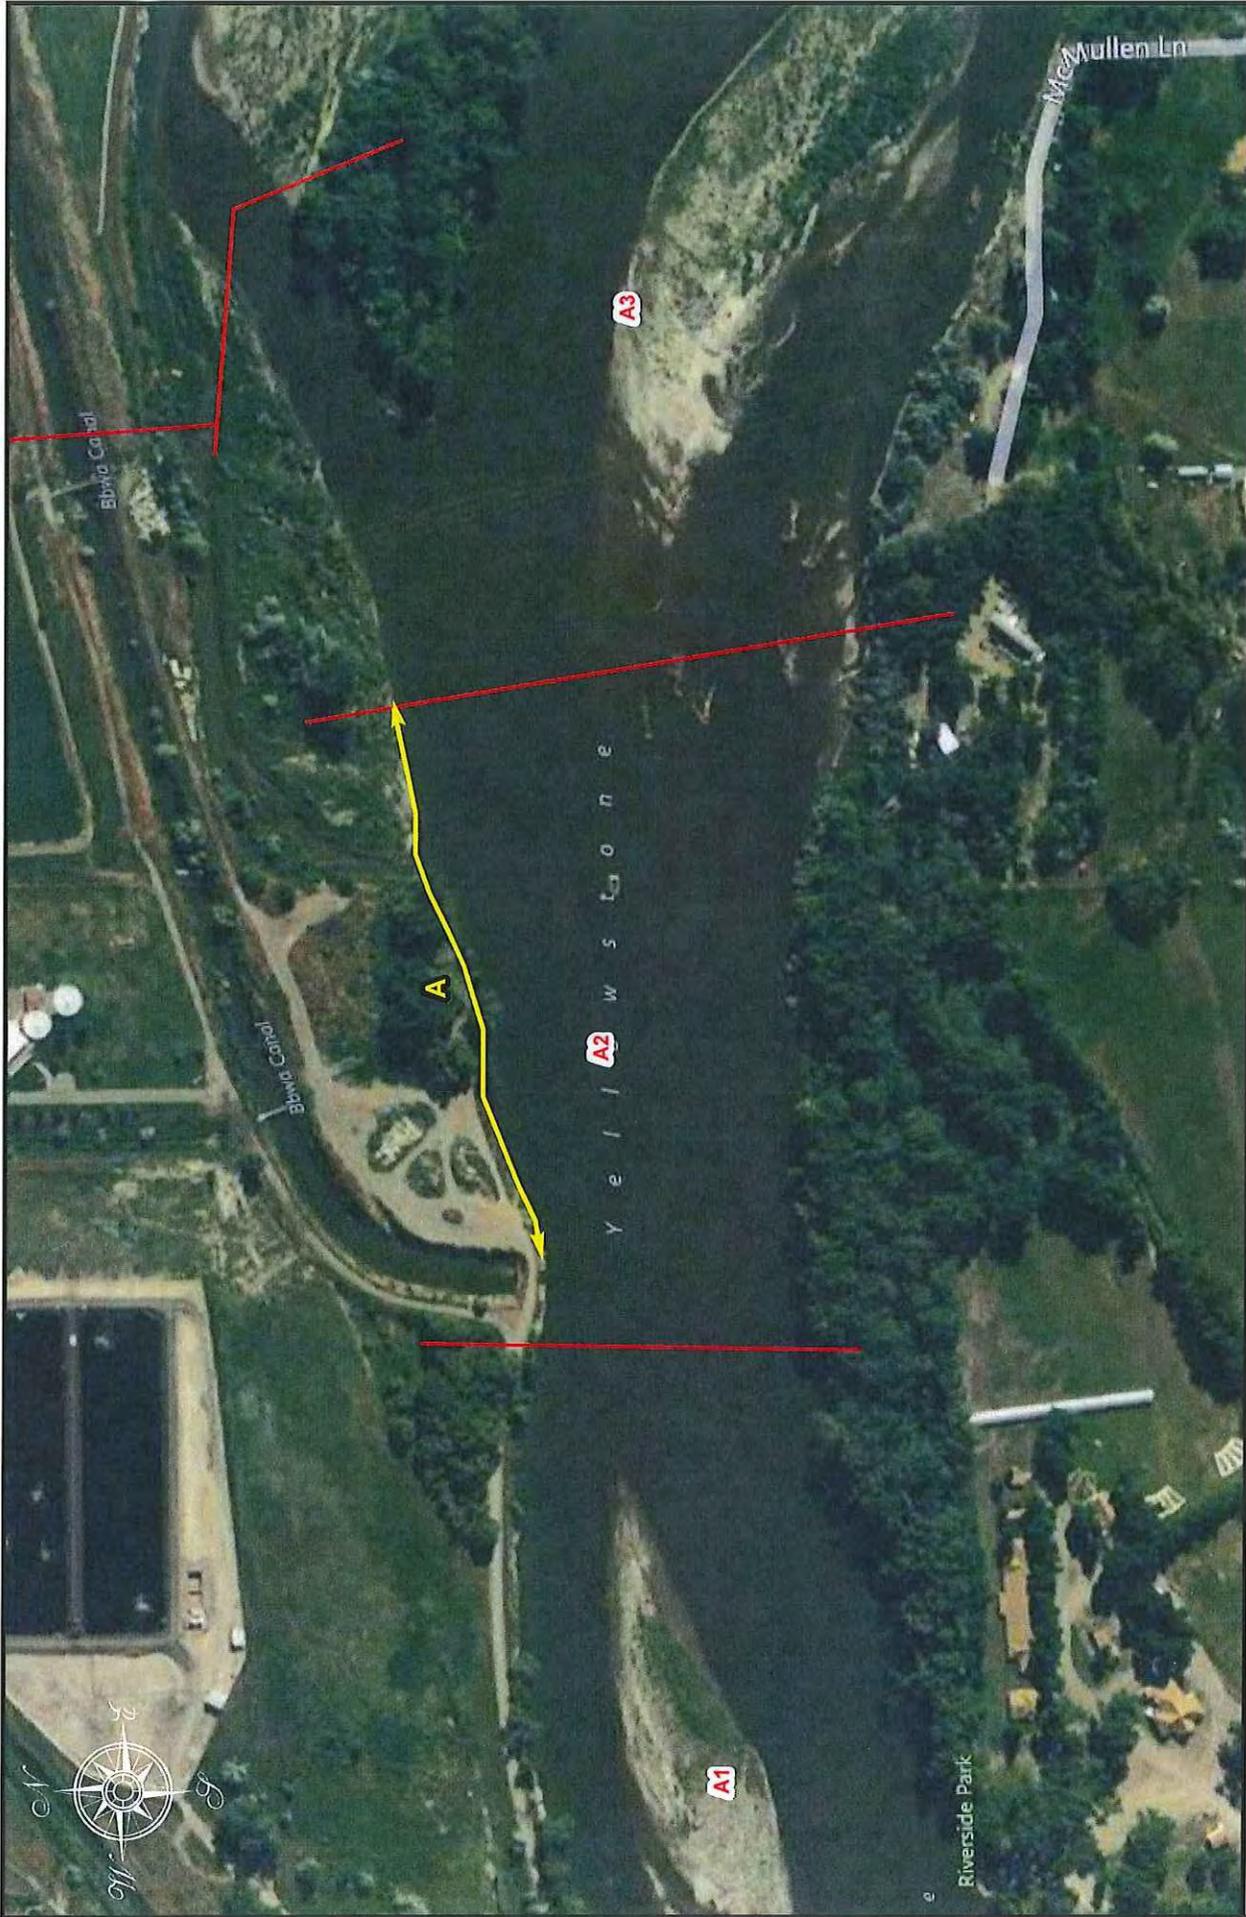
SCAT Teams 2 & 4 Survey
 Segment A2 Left Bank
 11-Jul-2011

Cleanup Recommendations: No oil observed along river channel margin

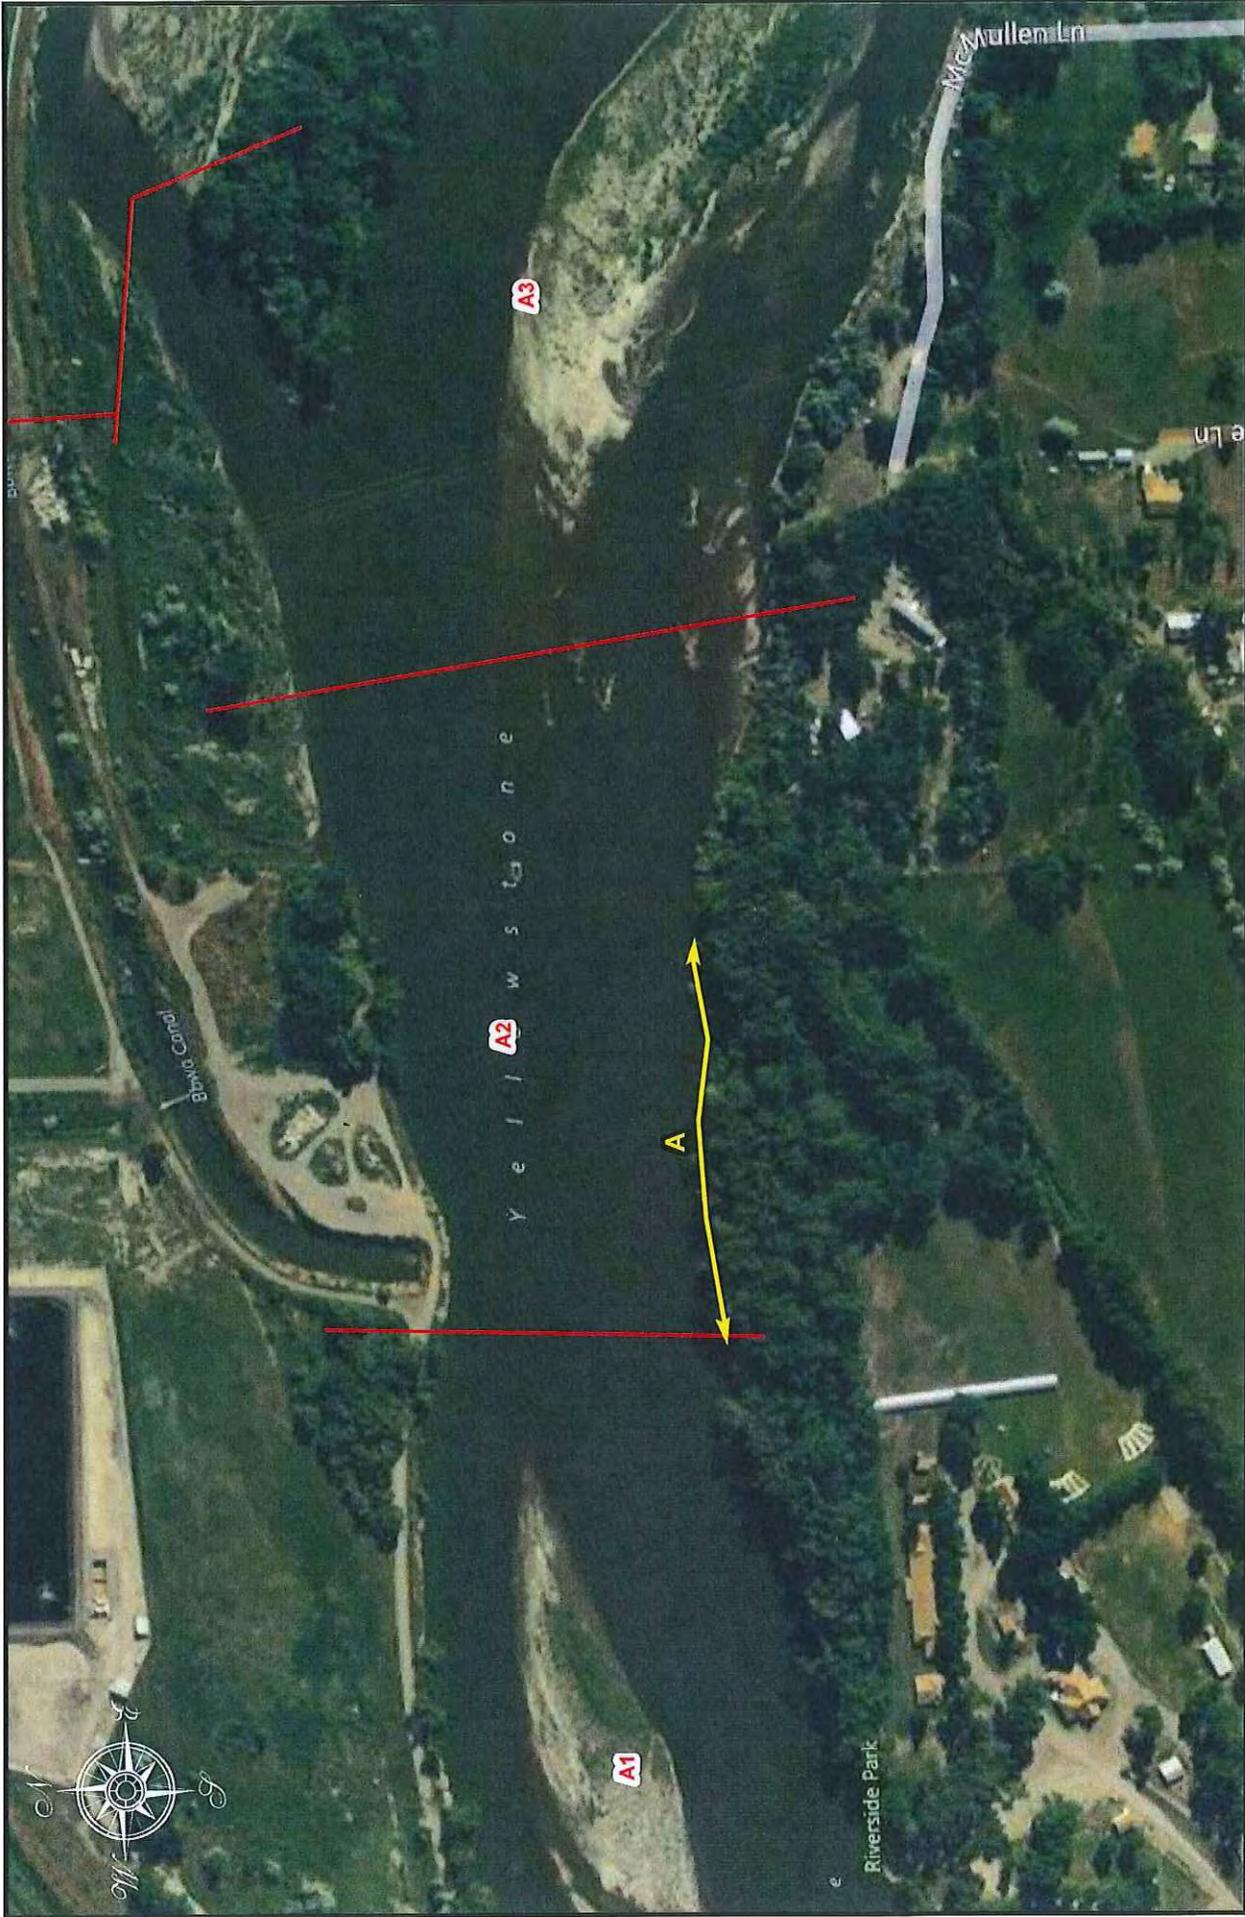
SCAT Teams 2 & 4 Survey

Segment A2 Right Bank

Cleanup Recommendations: Trim oiled vegetation; wipe large oiled debris; remove small oiled debris; wipe oiled trees;

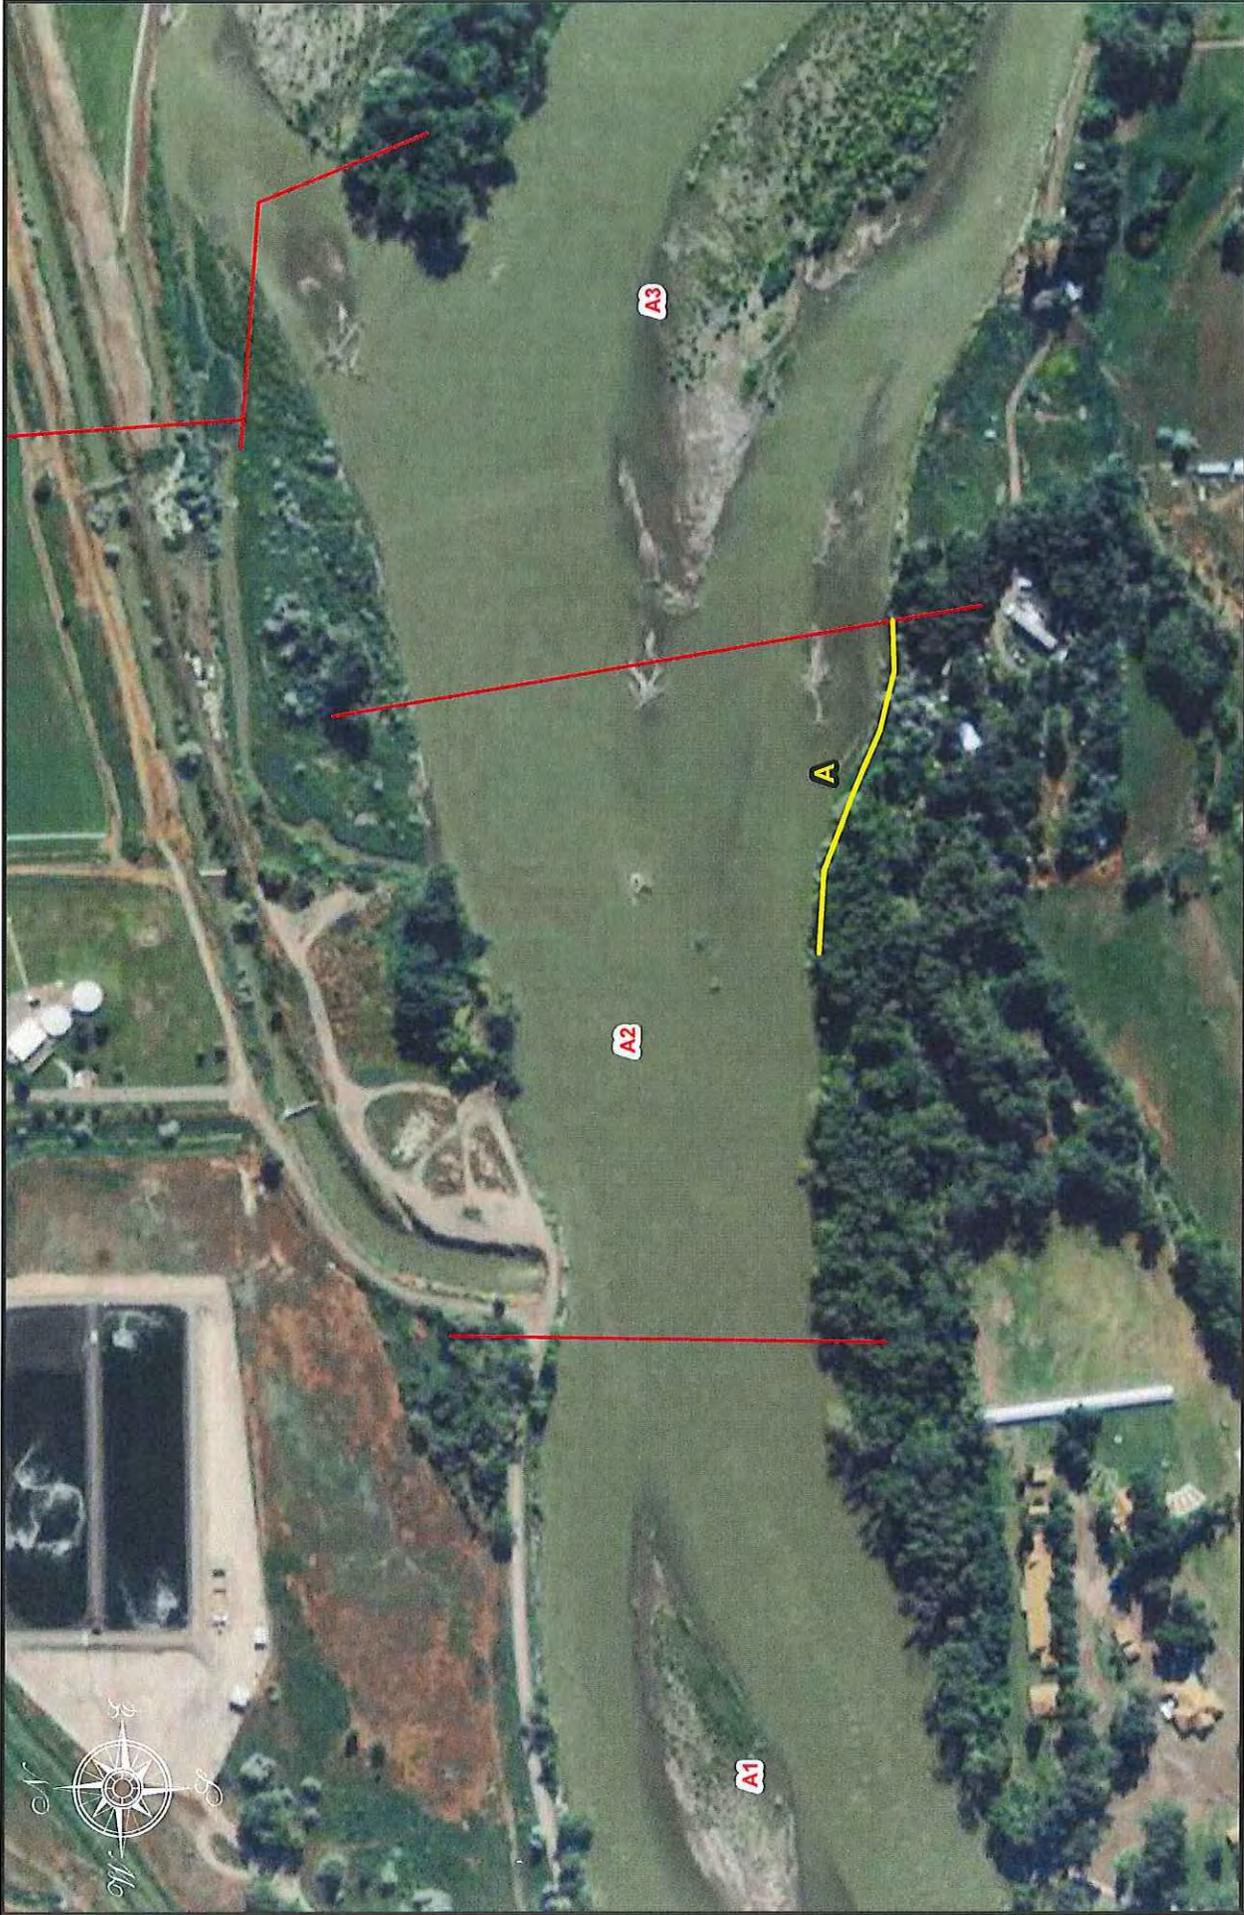
SCAT Teams 1 & 2 Survey

Segment A02 - Right Bank

Dead, but unoiled bird was found and reported to Wildlife Hotline (800-259-0596). Zone A and Zone B parallel each other and thus combined lengths are longer than segment length (see sketch map).
