**SCAT Area Transition Report
for A02**

Silvertip Pipeline Incident
Laurel, Montana

October 18, 2011

Our Ref.:
B0085883.1103

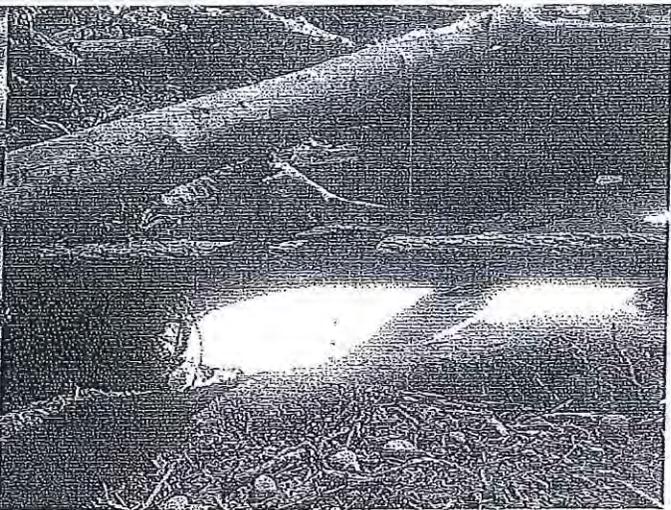
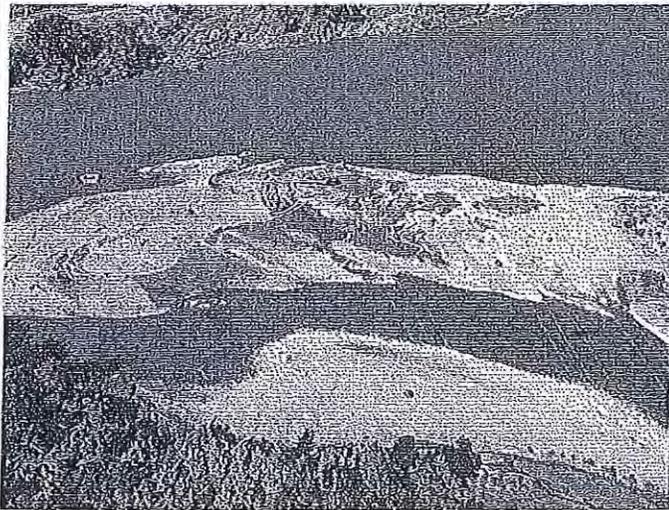
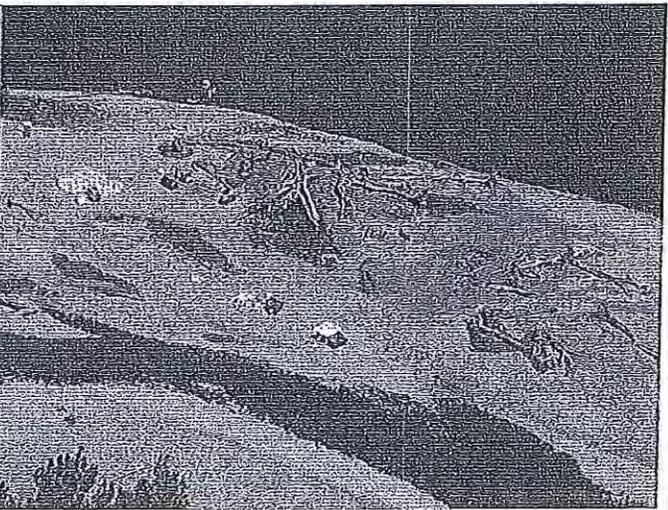
MESSAGE: In consultation with the U.S. Fish and Wildlife Service, International Bird Rescue, and the USCG Strike Team, the EPA visited A3 Island, just downstream of the spill site. Previously, EPA and USCG had given direction to clean-up crews to continue limited high-volume, low pressure flushing for a period of time around two areas of embedded cottonwood roots and trunks that are on the west side of the island and a known source area. The flushing was insufficient to mobilize residual oil in these areas and the groundwater level is creating pools in the scoured topography beneath the trunks and oil from within the root balls has created sheen within these pools. The light excavator and skid-steer loader that have been airlifted to the island are incapable of removing this debris from the ground to get at the source of the sheen. Due to repeated wildlife oiling issues at this site and the proximity to the spill site, this area was recommended for partial burial with locally available substrate and clean debris to deter birds and other wildlife from being attracted to the pool as a source of food (small minnows) and shelter. Crews have created an earthen berm with several yards of clean sand taken from adjacent areas of the island to isolate the base of the cottonwood trunks nearest the root balls and to serve as a sand filter and absorbent for any oil released from the residual source, which should allow the sheen on the pool to dissipate and weather completely. Crews also took clean un-oiled debris and covered the pools to deter wildlife access and comply with USFWS guidance. There is still source material that may need to be monitored or removed depending upon future observations.

The Unified Command is aware of this area within SCAT Segment A3IS and that operations within these segments are nearing completion with the exception of this area by the Pre-Inspection Survey Teams and Re-SCAT efforts. We agree with the recommended treatment proposed above for this area, but request that water-based operations crews or wildlife branch personnel continue to monitor these areas from the river to ensure that sheen is not released from saturated substrates, as pictured above. ExxonMobil will coordinate any future remediation activities at this site with MTDEQ. In the meantime, this segment will be flagged and excised within GIS maps from the Re-SCAT report that will be produced to close-out the segment. This document will be included as an attachment to the Area Transition Report to document the need for additional work within this segment.

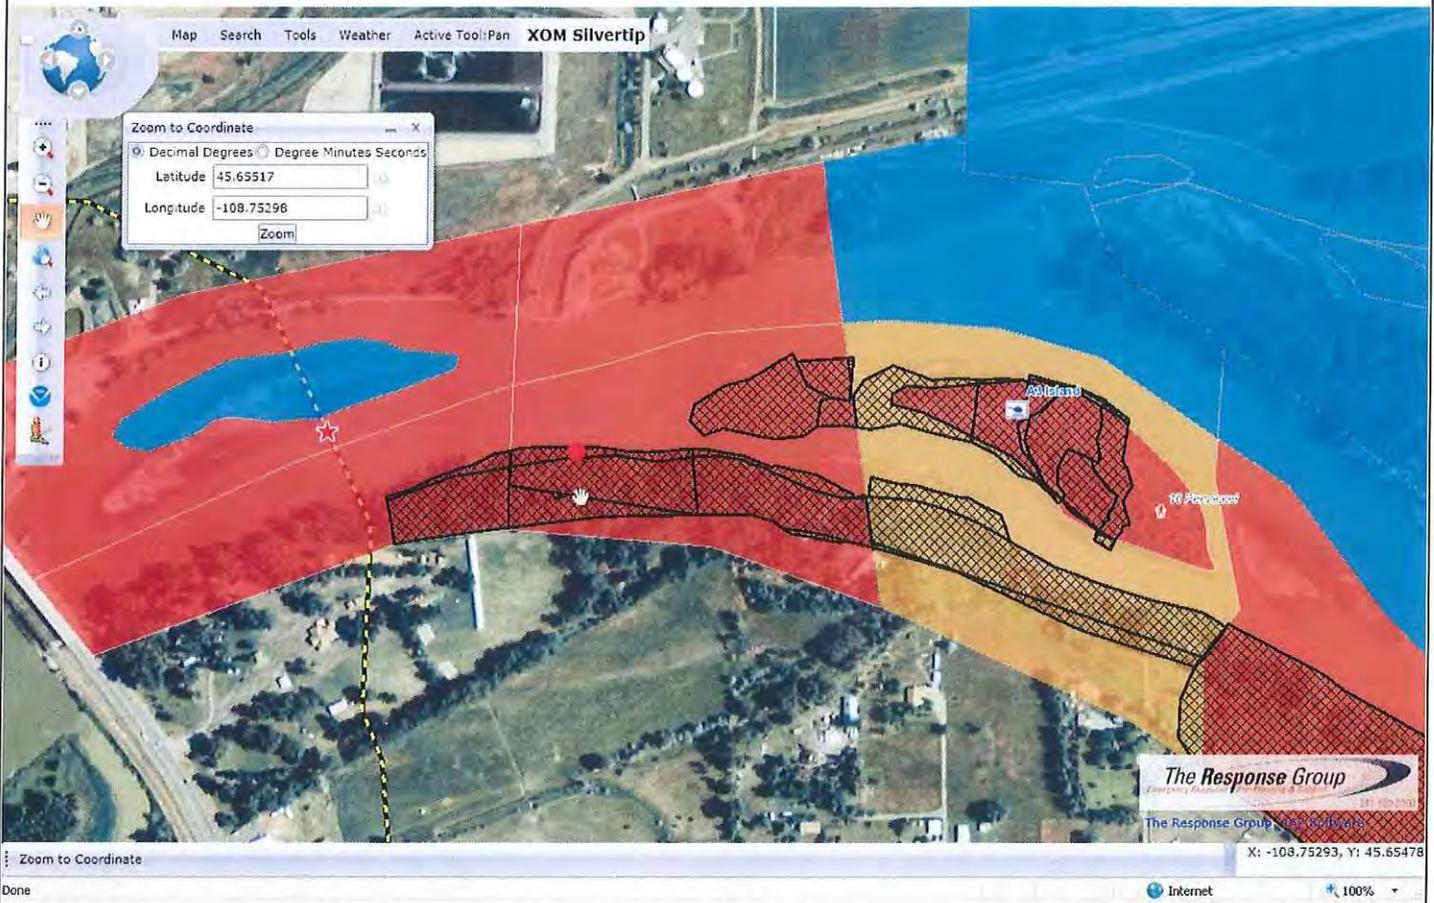
MESSAGE: International Bird Rescue and Resource Advisors with the USFWS identified a pool with sheen in scat sector A2. This segment has passed SCAT but requires further response to reduce wildlife exposure risks. The pool is located downstream from an oiled stump that had boom around it. It is approximately 3 ft by 9 ft in size. Spotted sandpiper tracks were seen going into the pool. Sorbent pads were placed in the pool. The area is identified on the map below.

The Unified Command is aware of this area within SCAT Segments A2 and understands that operations within these segments have been completed by operations and passed by Re-SCAT efforts. We agree with the recommended treatment proposed above for this area. ExxonMobil will coordinate any future remediation activities at this site with MTDEQ. In the meantime, this segment will be flagged as a "Wildlife Exception" and excised within GIS maps from the Re-SCAT report that will be produced to close-out the segment. This document will be included as an attachment to the Area Transition Report to document the need for additional work within this segment beyond Re-SCAT and a POST should be used to re-close the segment once these wildlife concerns are addressed by operations teams.

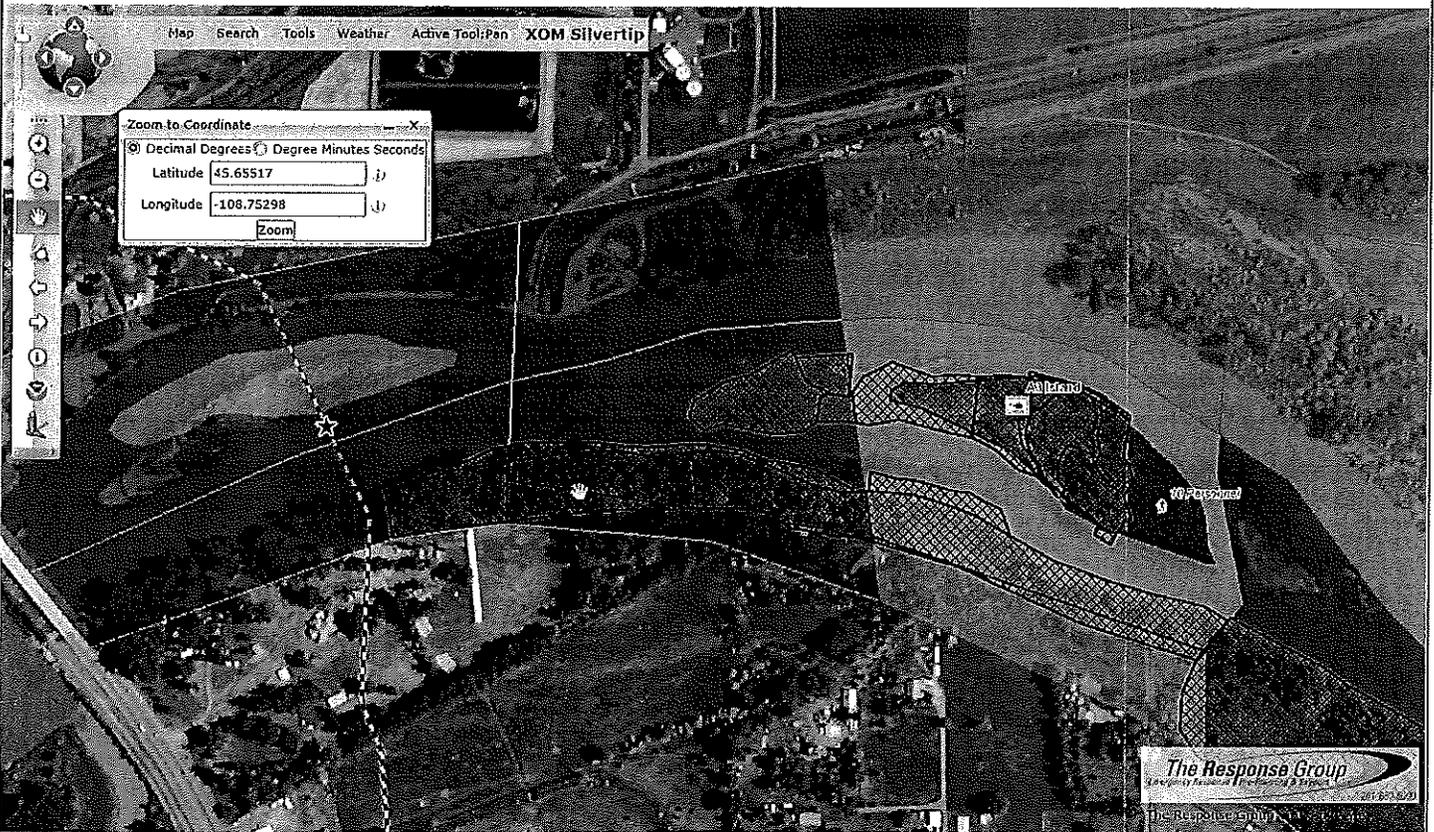
MESSAGE: International Bird Rescue and Resource Advisors with the USFWS Identified a pool with sheen in scat sector A2. This segment has passed SCAT but requires further response to reduce wildlife exposure risks. The pool is located downstream from an oiled stump that had boom around it. It is approximately 3 ft by 9 ft in size. Spotted sandpiper tracks were seen going into the pool. Sorbent pads were placed in the pool. The area is identified on the map below.

The Unified Command is aware of this area within SCAT Segments A2 and understands that operations within these segments have been completed by operations and passed by Re-SCAT efforts. We agree with the recommended treatment proposed above for this area. ExxonMobil will coordinate any future remediation activities at this site with MIDEQ. In the meantime, this segment will be flagged as a "Wildlife Exception" and excised within GIS maps from the Re-SCAT report that will be produced to close-out the segment. This document will be included as an attachment to the Area Transition Report to document the need for additional work within this segment beyond Re-SCAT and a POST should be used to re-close the segment once these wildlife concerns are addressed by operations teams.
