**SCAT Area Transition Report
for A08**

Silvertip Pipeline Incident
Laurel, Montana

October 25, 2011

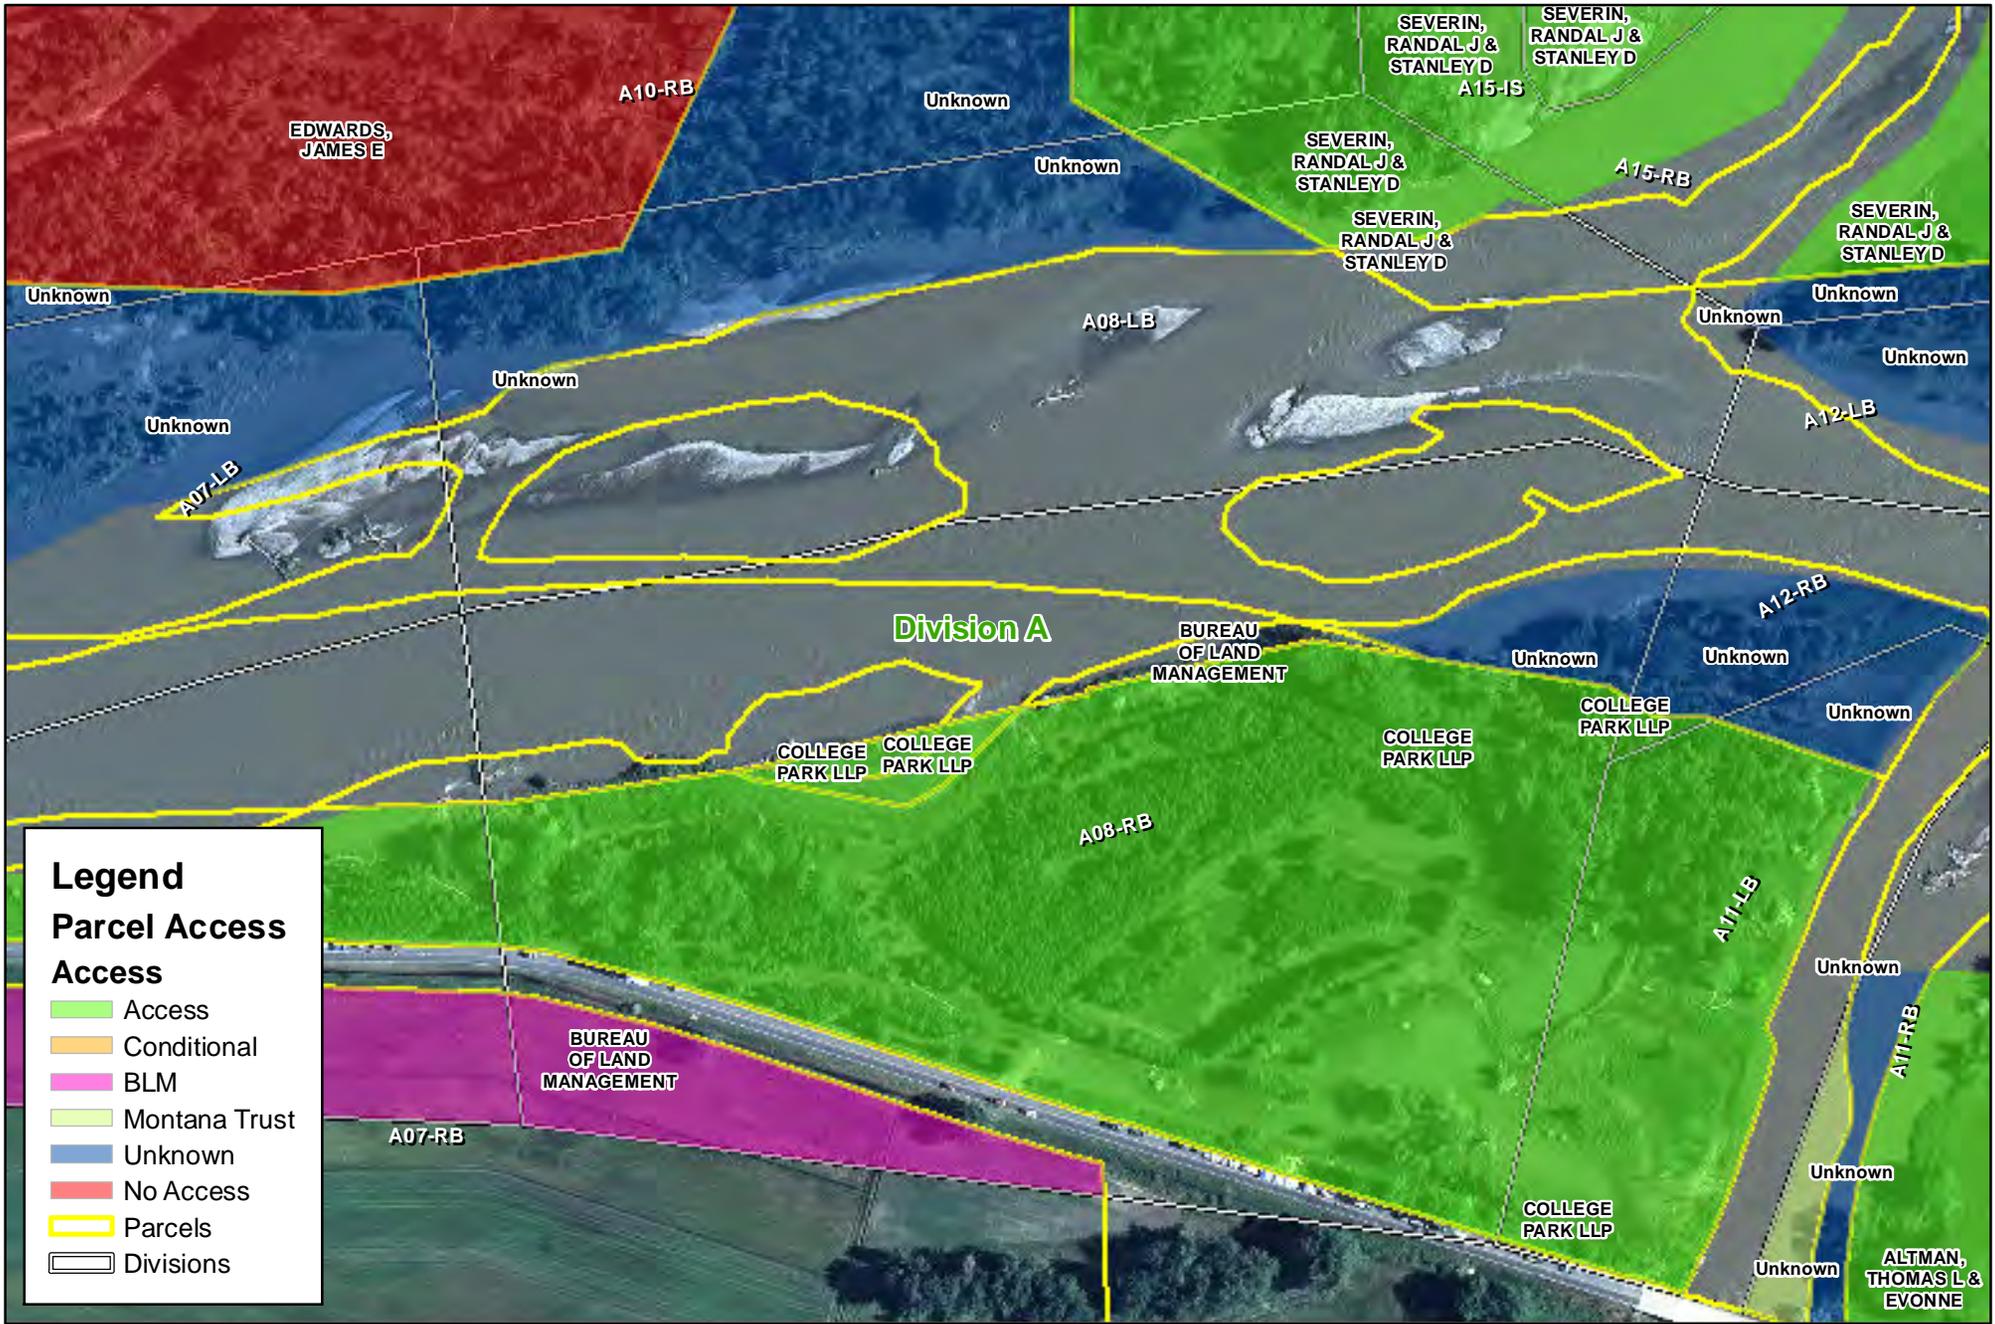
Figure 1 provides an aerial map of SCAT Area A08, along with the (a) SCAT Area boundary, (b) parcel boundaries and respective property owners, and (c) access constraints identified during the oil cleanup process. The acreage surveyed in Area A08 is 17.9. There was one access issue for the western part of the left bank.

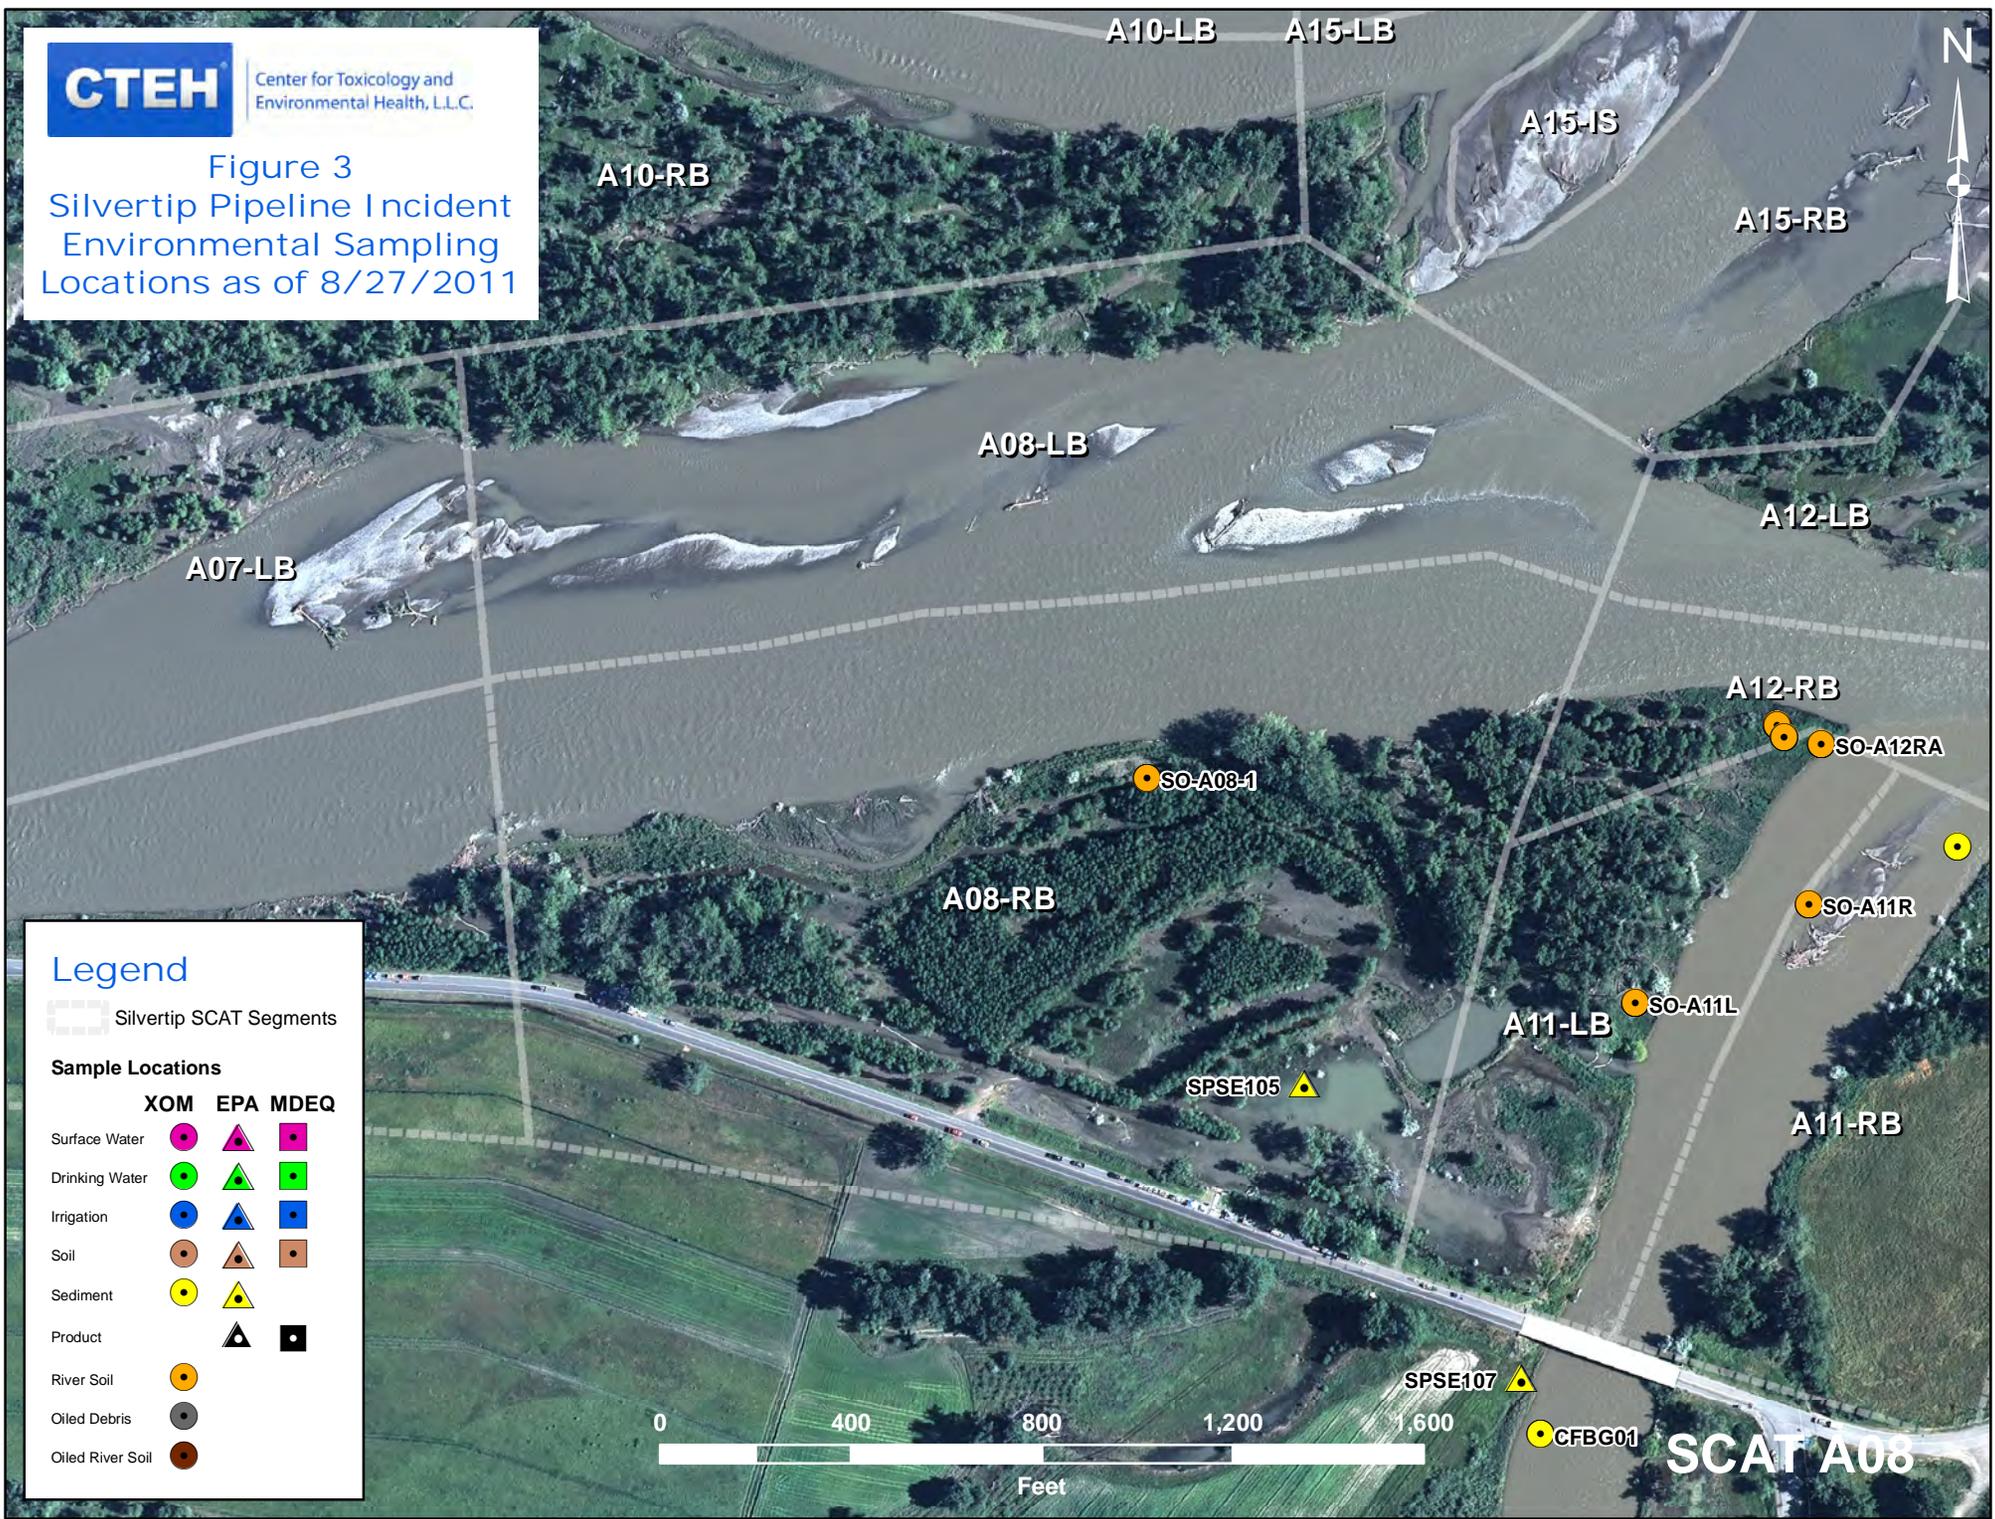
Figure 3
Silvertip Pipeline Incident
Environmental Sampling
Locations as of 8/27/2011

Table 1 (below) summarizes samples collected within Area A08. The analytical results for the samples collected can be accessed through a publicly accessible database on the United States Environmental Protection Agency's (USEPA's) website. The approximate locations of samples collected within Area A08 are provided on Figure 3.

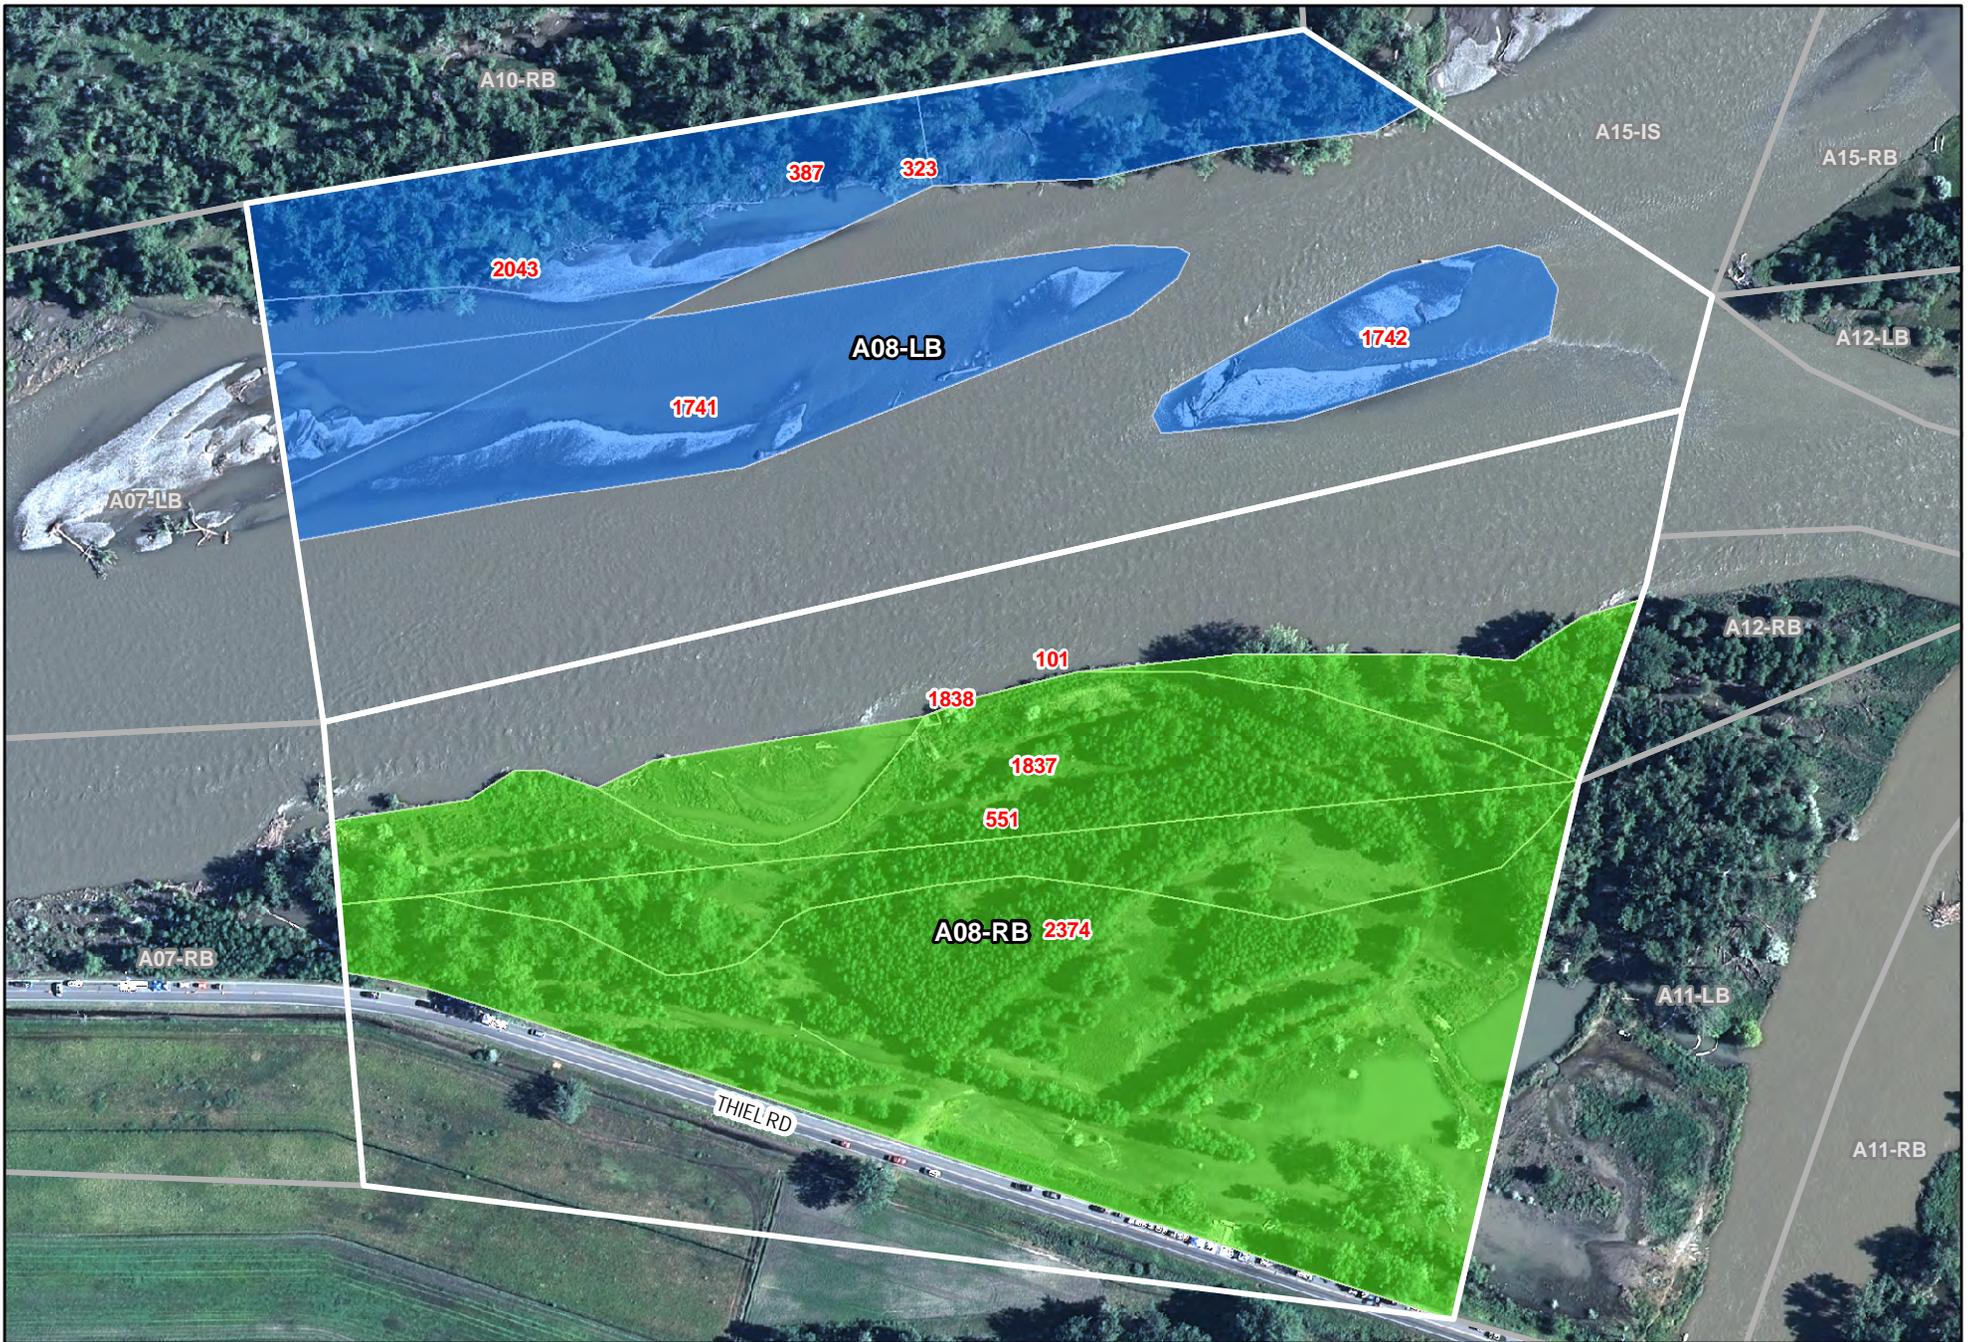
**Figure 5 - Final SCAT Observations
For SCAT Area: A08**

Figure 5 shows the oiling conditions within Area A08 following completion of oil removal activities. The SCAT team performed final surveys of the right bank within SCAT Area A08 to confirm the agreed-upon cleanup endpoints identified in the applicable CTRs had been achieved. The final SCAT survey documentation is presented in Appendix E.

Based on the initial SCAT surveys performed on the left bank within Area A08, no oiling was observed. Based on the final SCAT surveys performed on the right bank within Area A08, no further treatment is recommended for this segment. SCAT Segment Sign-Off Forms are included as Appendix F. However additional monitoring is recommended for this area due to persistent sheen at several log depressions. The approved treatment plan for these areas is described in the Exception Memos, included as Appendix G, which are generated to track the treatment and monitoring of this area.

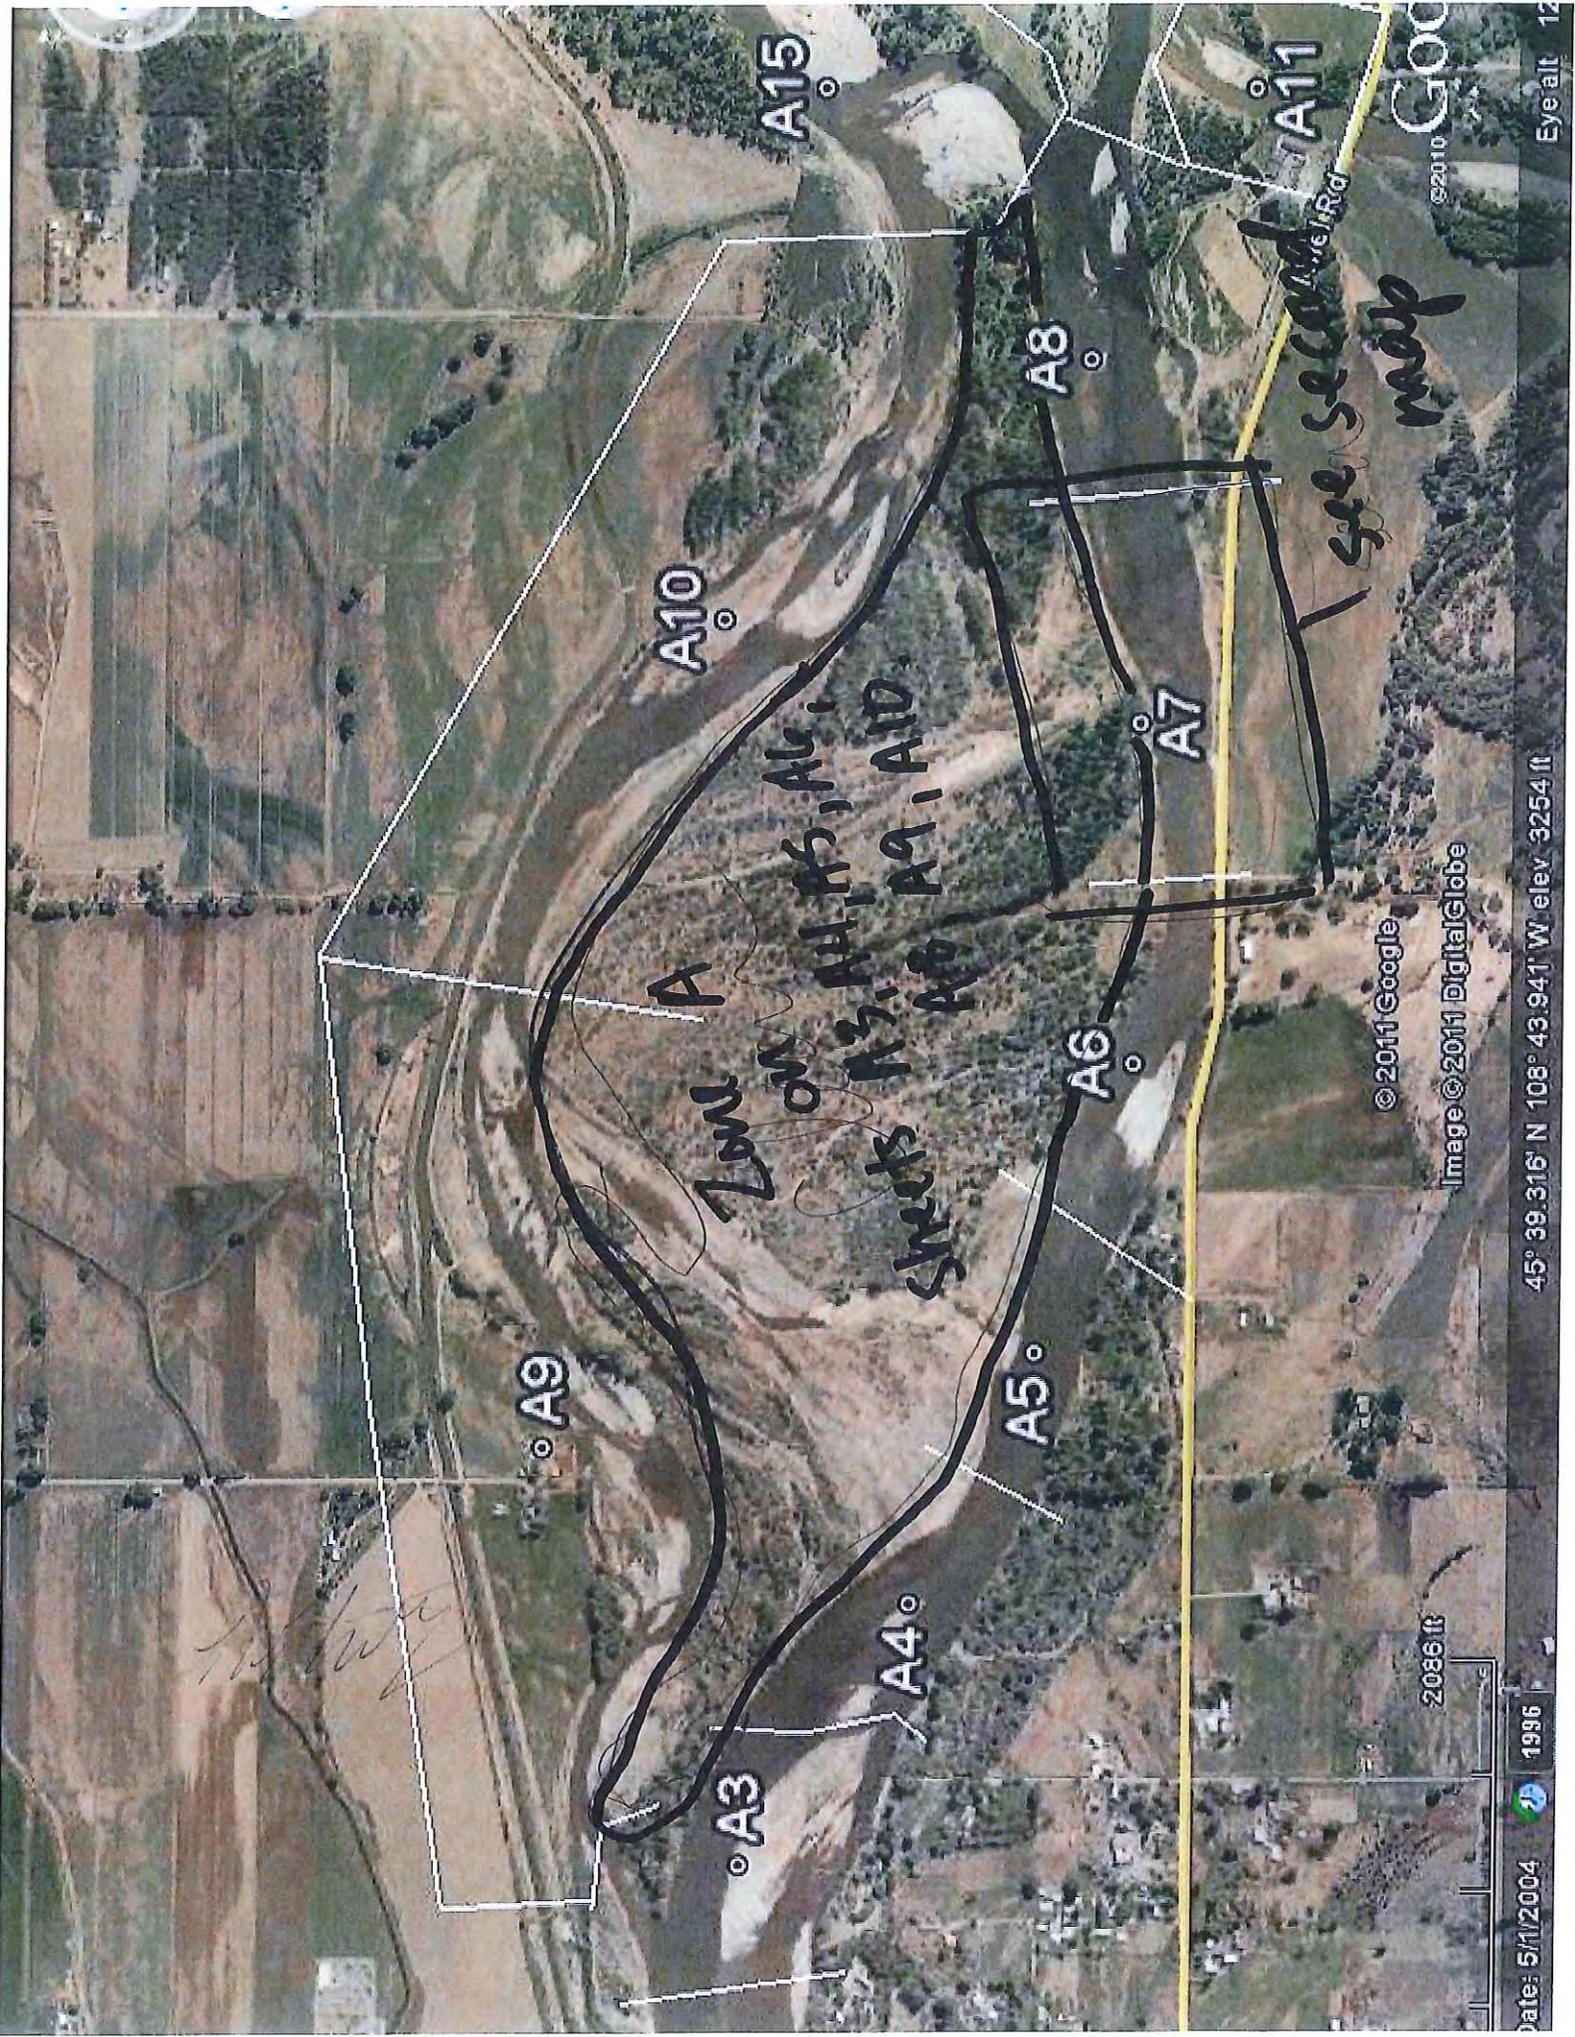
Left bank
AA 9/29/11

Low on A
Low on A4, A5, A6,
A7, A8, A9, A10

Zone A - NOO . NPT

Zone B - NOO . NPT

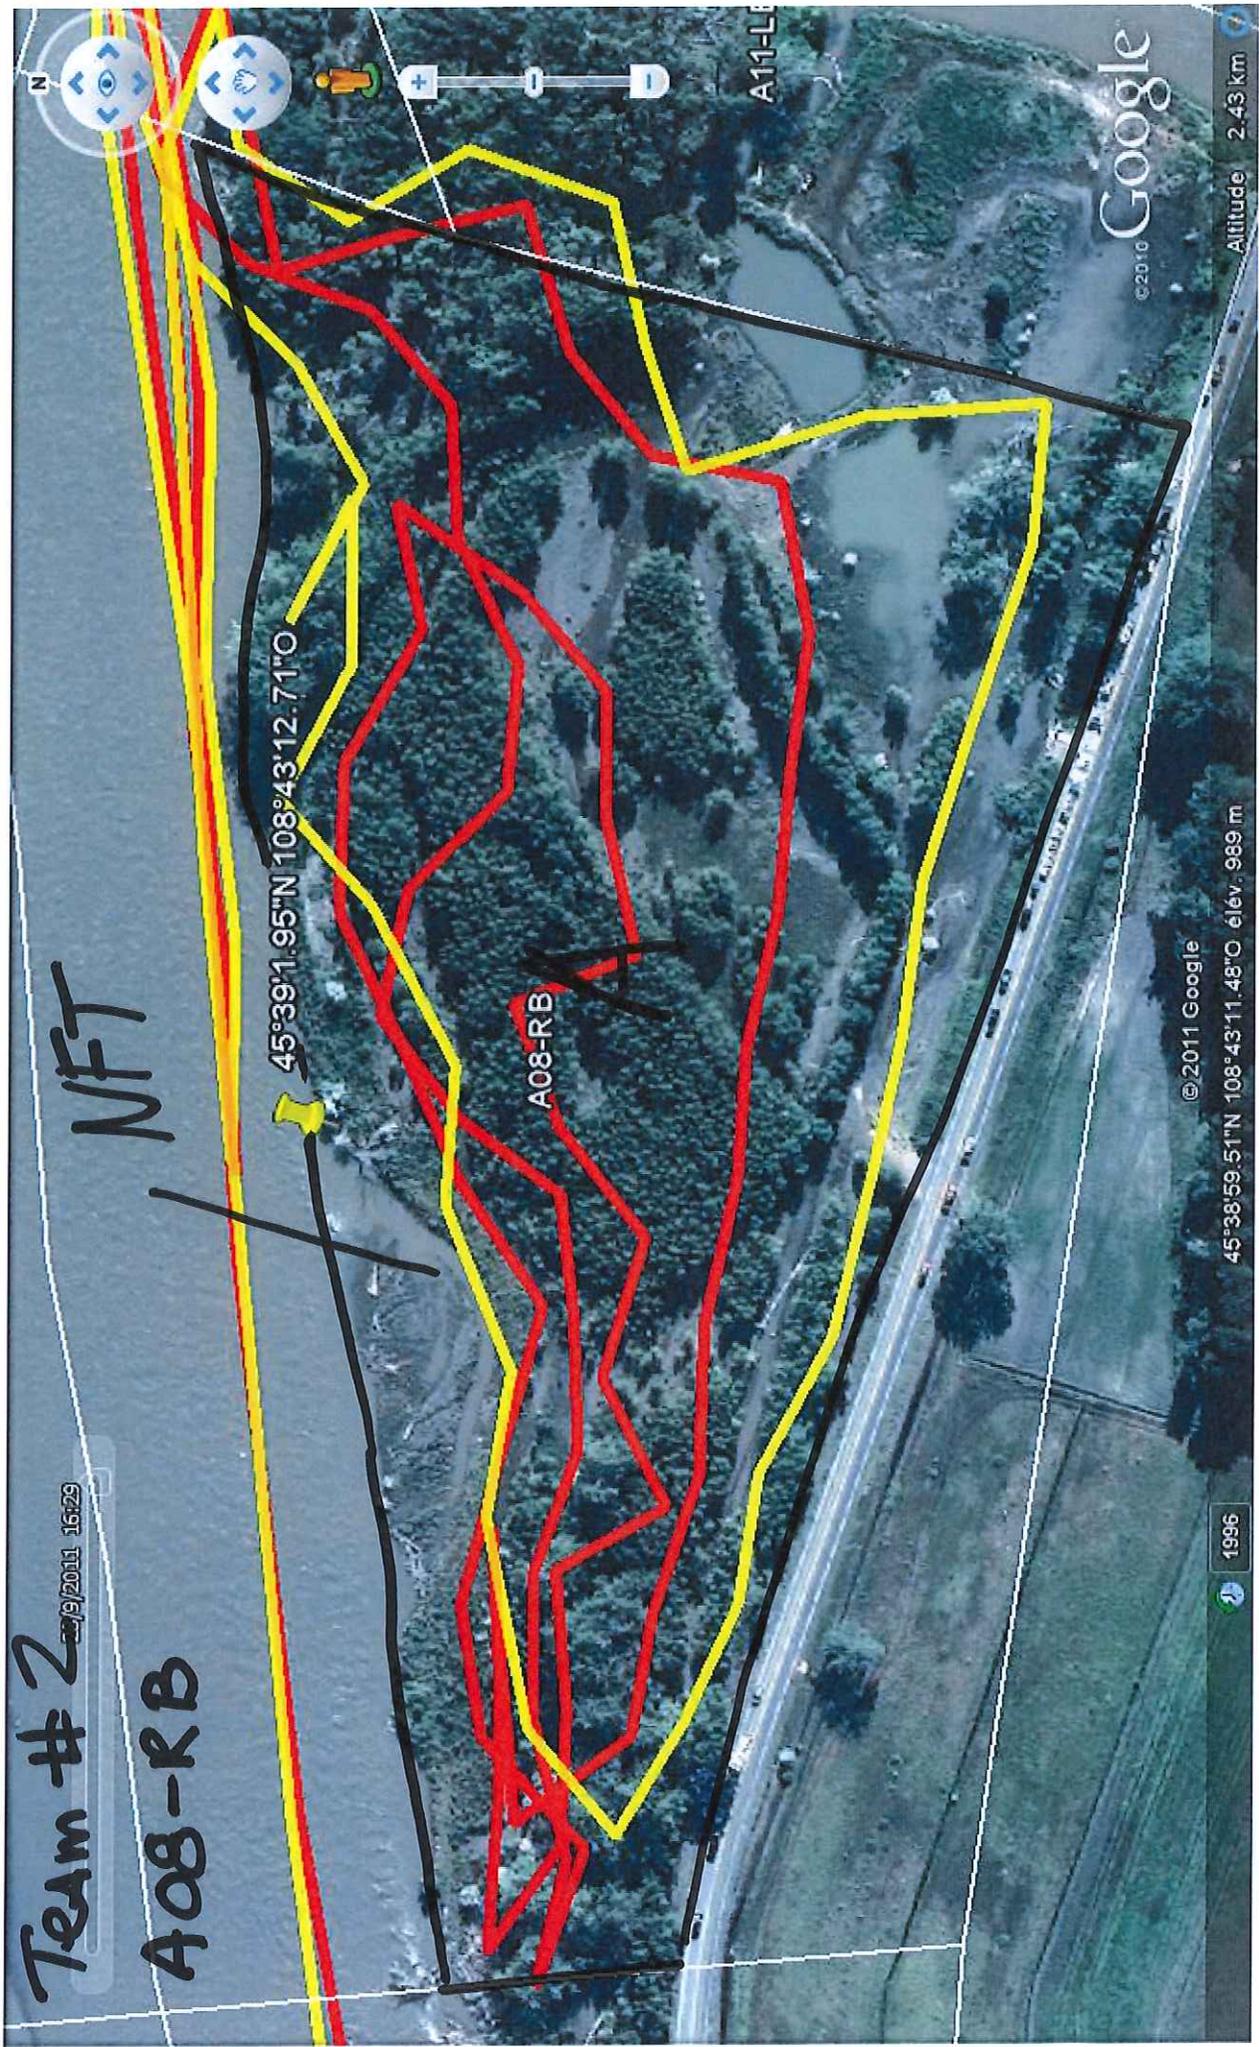
A08-RB

A: ReSCAT with Ops Hot Shots
 - stain and tag debris, stain and coat on large debris tree. The Hot Shots cleaned the segment, 3 bags
 Meet the condition of the CTR, NFT
 • WP sorbent booms on site need to be removed (see sketch)

NFT

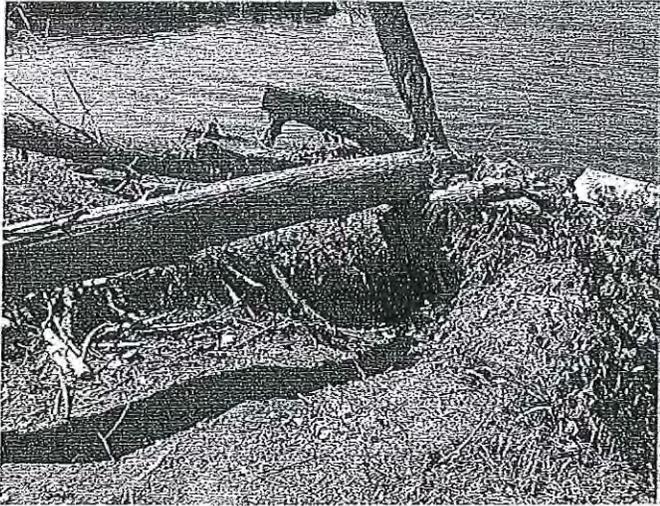
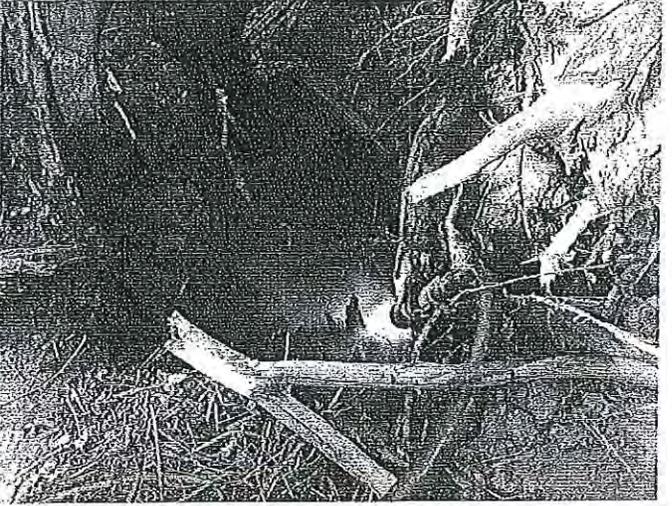
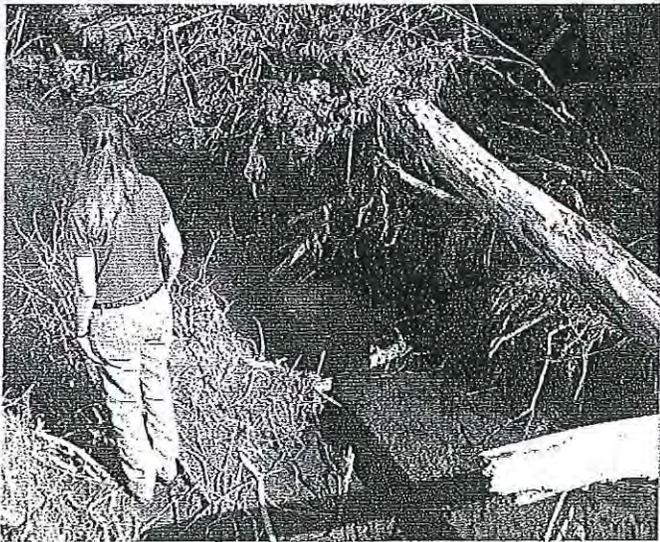
The Unified Command is aware of this area within SCAT Segments A7RB and A8RB and that operations within these segments are now complete with the exception of this area by the Pre-Inspection Survey Teams and Re-SCAT efforts. We agree with the recommended treatment proposed above for this area, but request that water-based operations crews or wildlife branch personnel continue to monitor these areas from the river to ensure that sheen is not released from saturated substrates, as pictured above. ExxonMobil will coordinate any future remediation activities at this site with MTDEQ. In the meantime, this segment will be flagged and excised within GIS maps from the Re-SCAT report that will be produced to close-out the segment. This document will be included as an attachment to the Area Transition Report to document the need for additional work and monitoring within this segment.

We recommend that at A-7 the flushing operations be stopped and it be allowed to sheen naturally if it does so. The boom should be maintained, but at a distance away from the depression to allow any sheen that may emanate from the depression to disperse and degrade from sun exposure. Once flushing is stopped, locally obtained dirt should be used to immediately dust the depression area and exposed roots while still damp to minimize possibility of oil being transferred to any wildlife that may enter the depressions.

As recommended for A-7, we also recommend that the sorbents at both A-8 depressions be removed to facilitate natural evaporation and drying of sediment and wood in the depression. If possible, oiled roots that can be safely reached should be trimmed to extent possible. The sorbent boom should be maintained at a distance from the depressions to allow sheen to disperse and degrade from sun exposure, but to also ensure sheen does not escape from site and into the river.
