**SCAT Area Transition Report for
A18**

Silvertip Pipeline Incident
Laurel, Montana

October 18, 2011

Our Ref.:
B0085883.1103

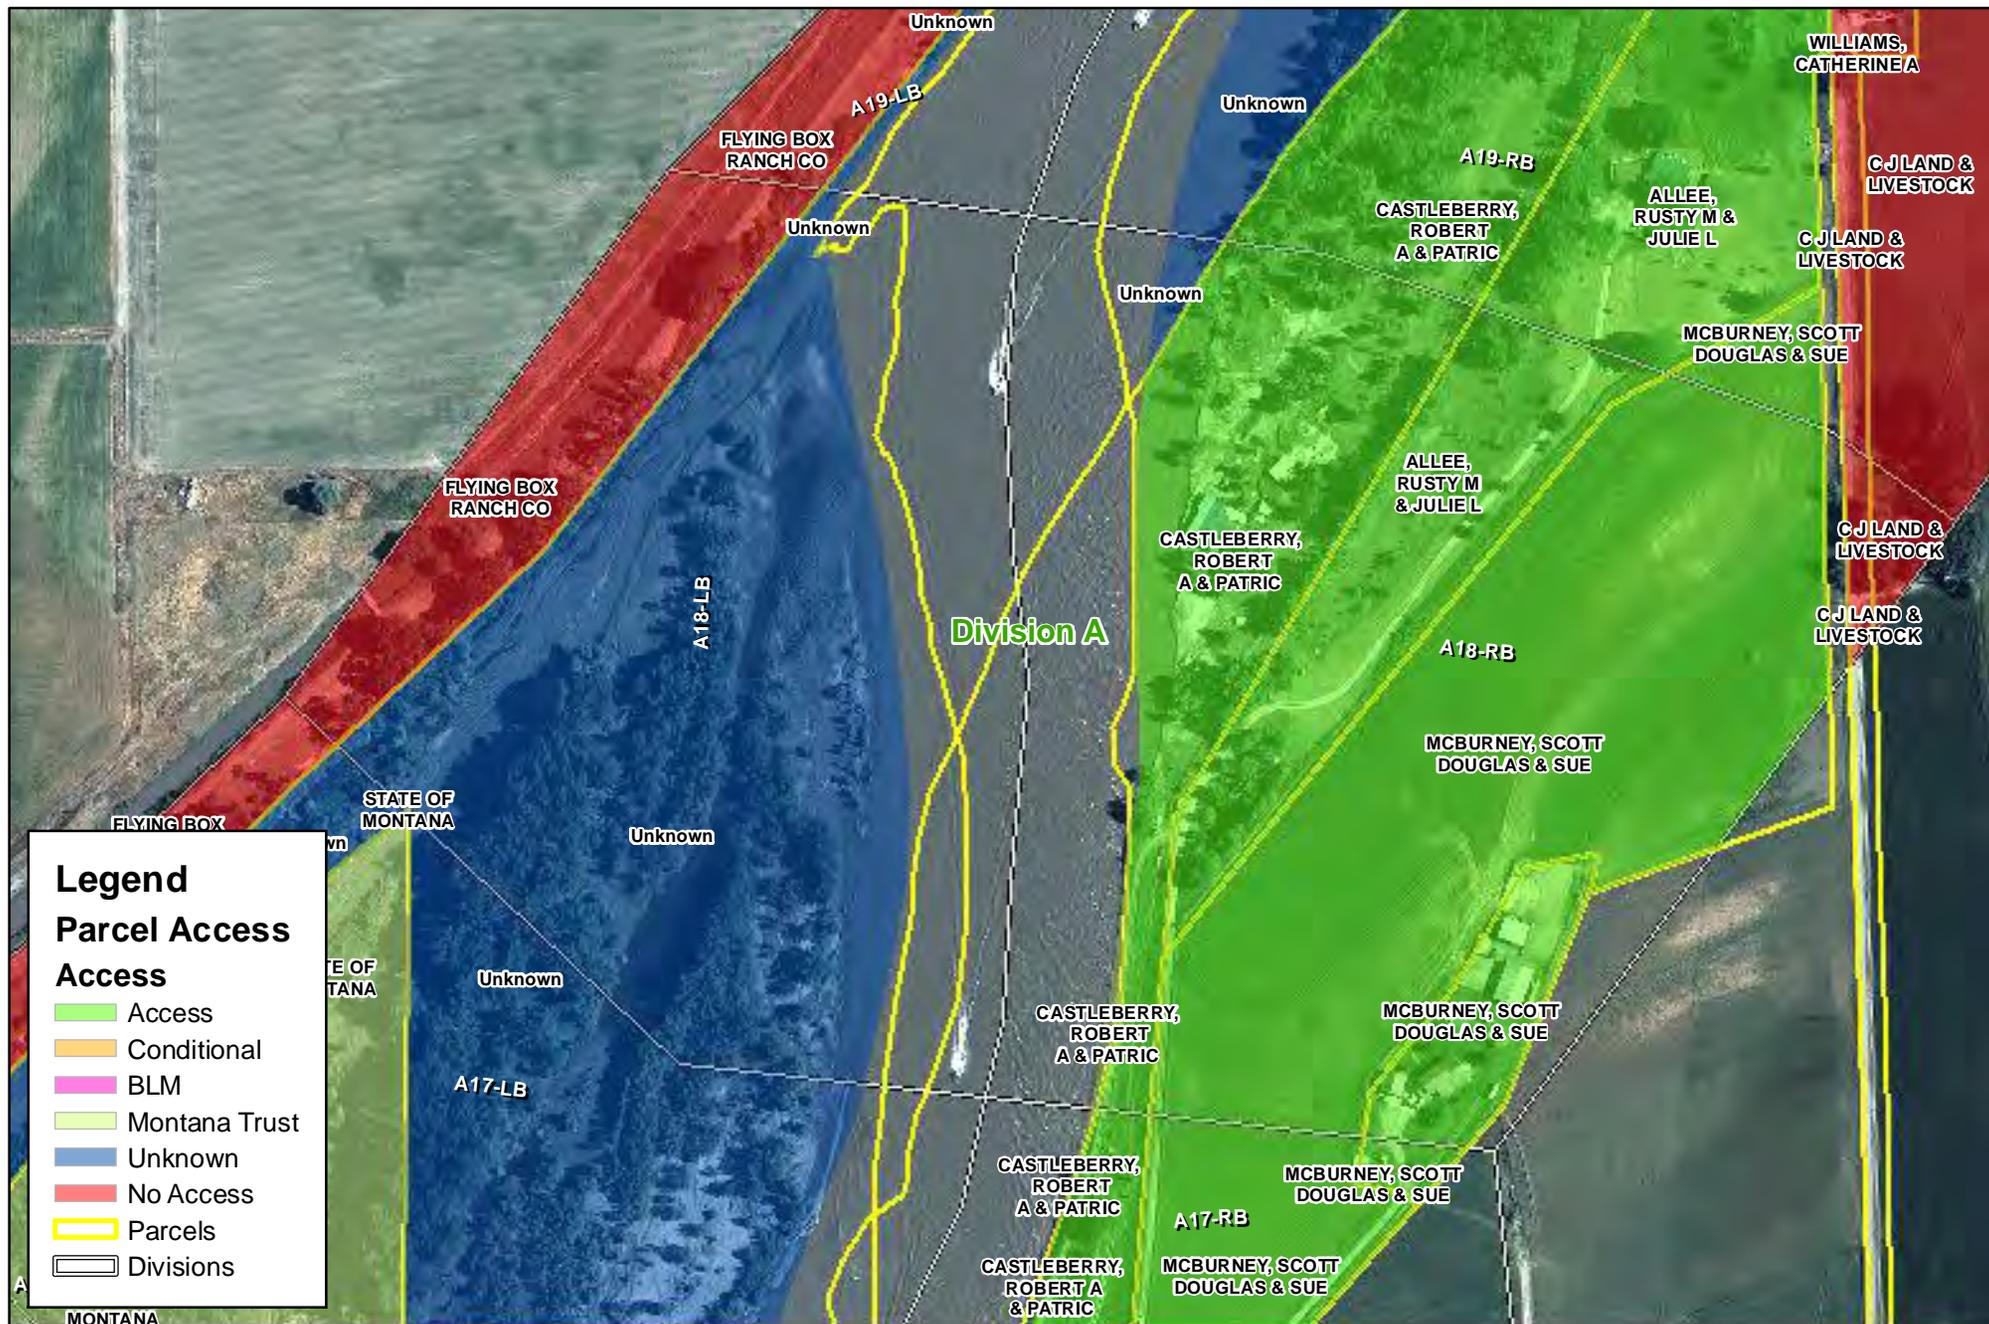
Figure 1 provides an aerial map of SCAT Area A18, along with the (a) SCAT Area boundary, (b) parcel boundaries and respective property owners, and (c) access constraints identified during the oil cleanup process. The acreage surveyed in Area A18 is 19.5. There were access issues for an upland portion of the left bank and a small upland portion of the right bank of Area A18.

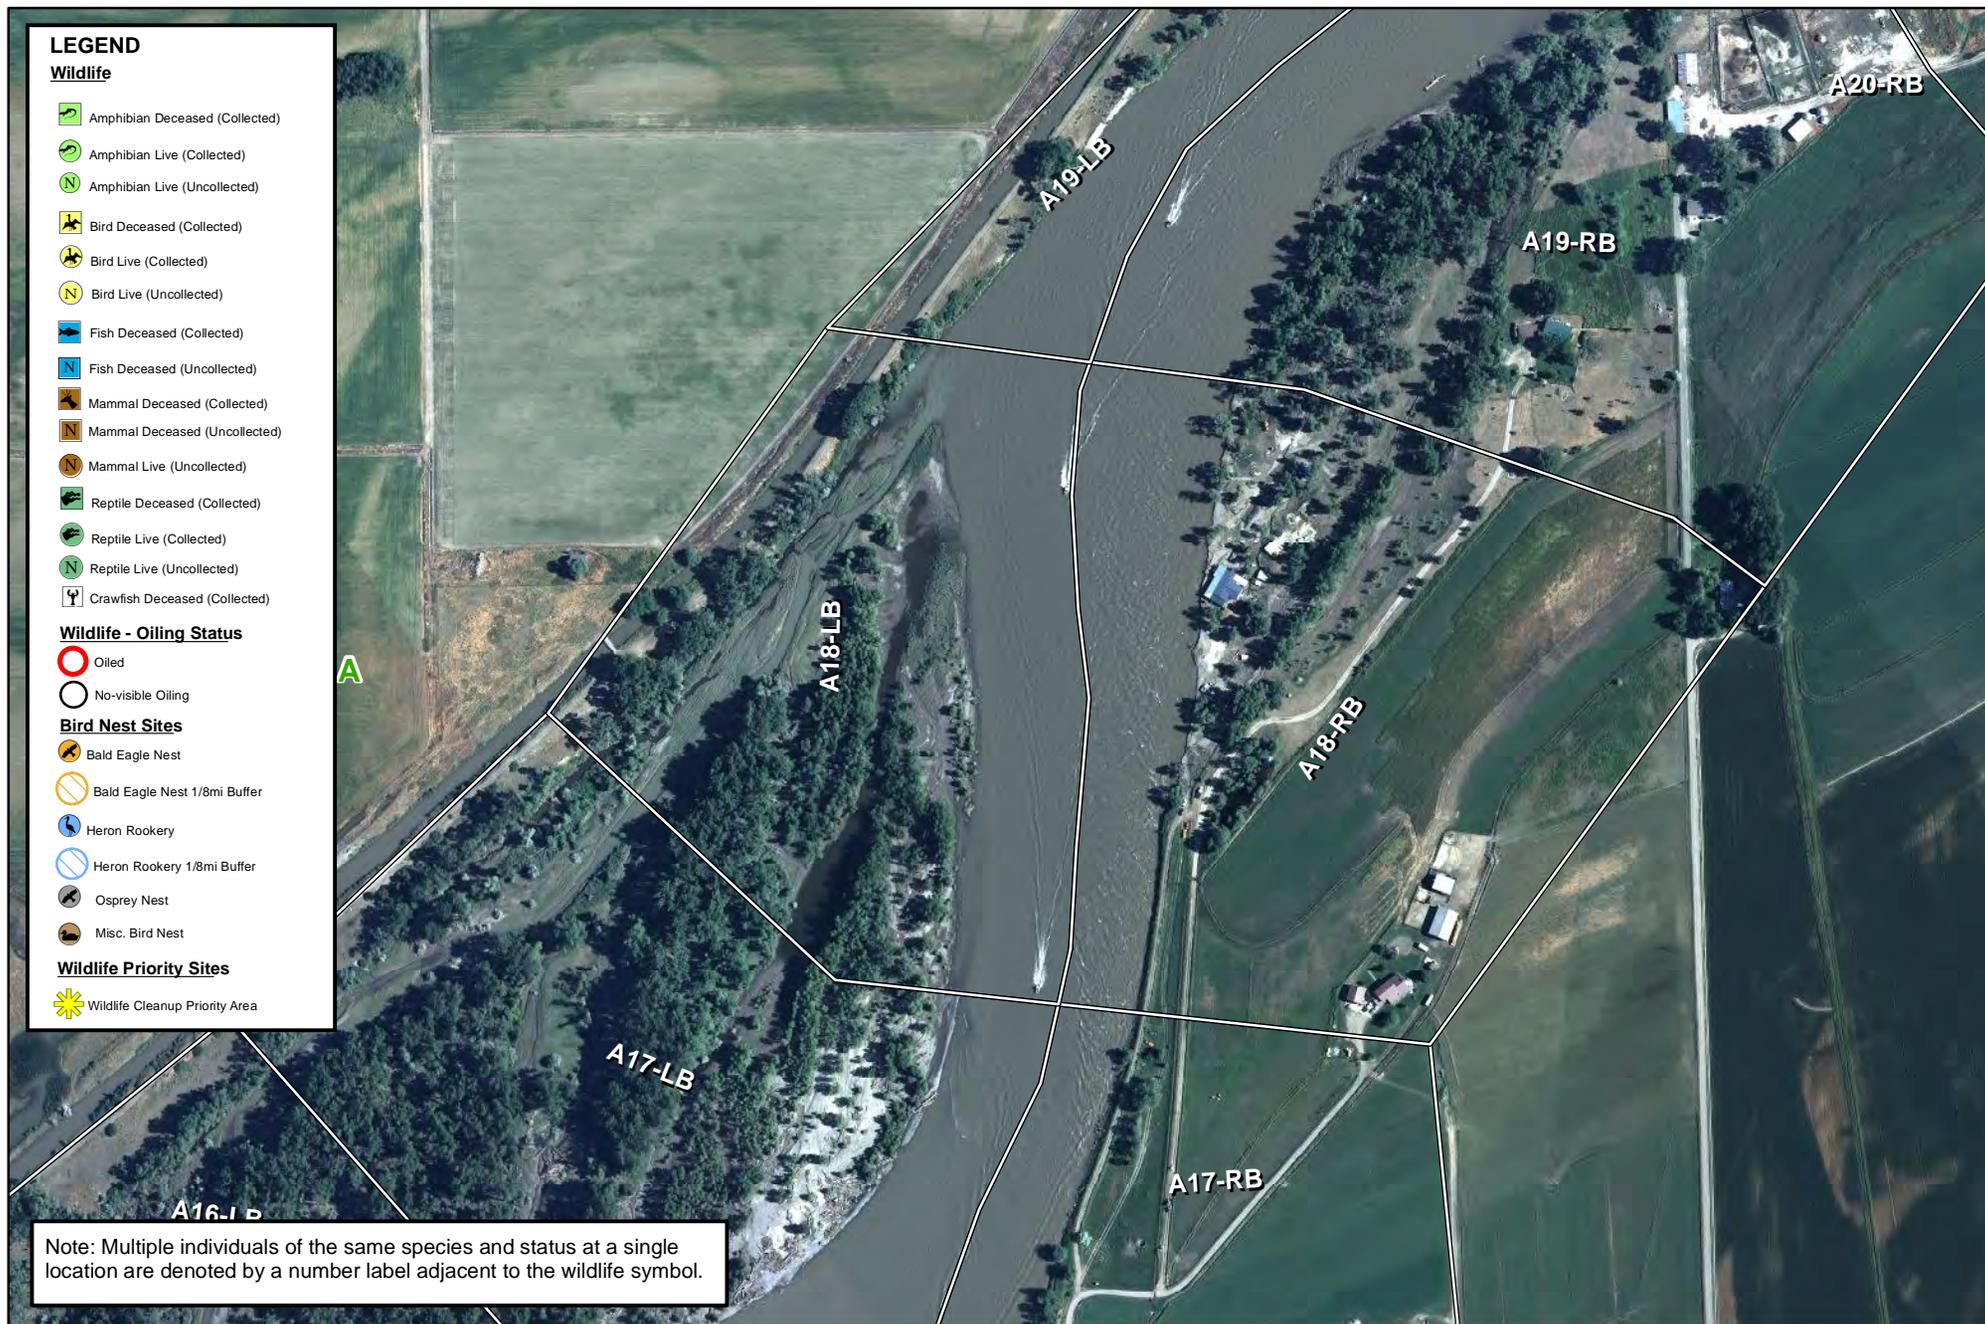
Figure 2
Wildlife Resources

Figure 2 summarizes the natural resources identified in this segment. International Bird Rescue and Resource Advisors from U.S. Fish and Wildlife Service conducted regular inspections of the areas in A18 that did not have access issues. No oiled wildlife was observed or recovered. No Wildlife Priority Cleanup Areas were identified. No active migratory bird nests were identified in Area A18.

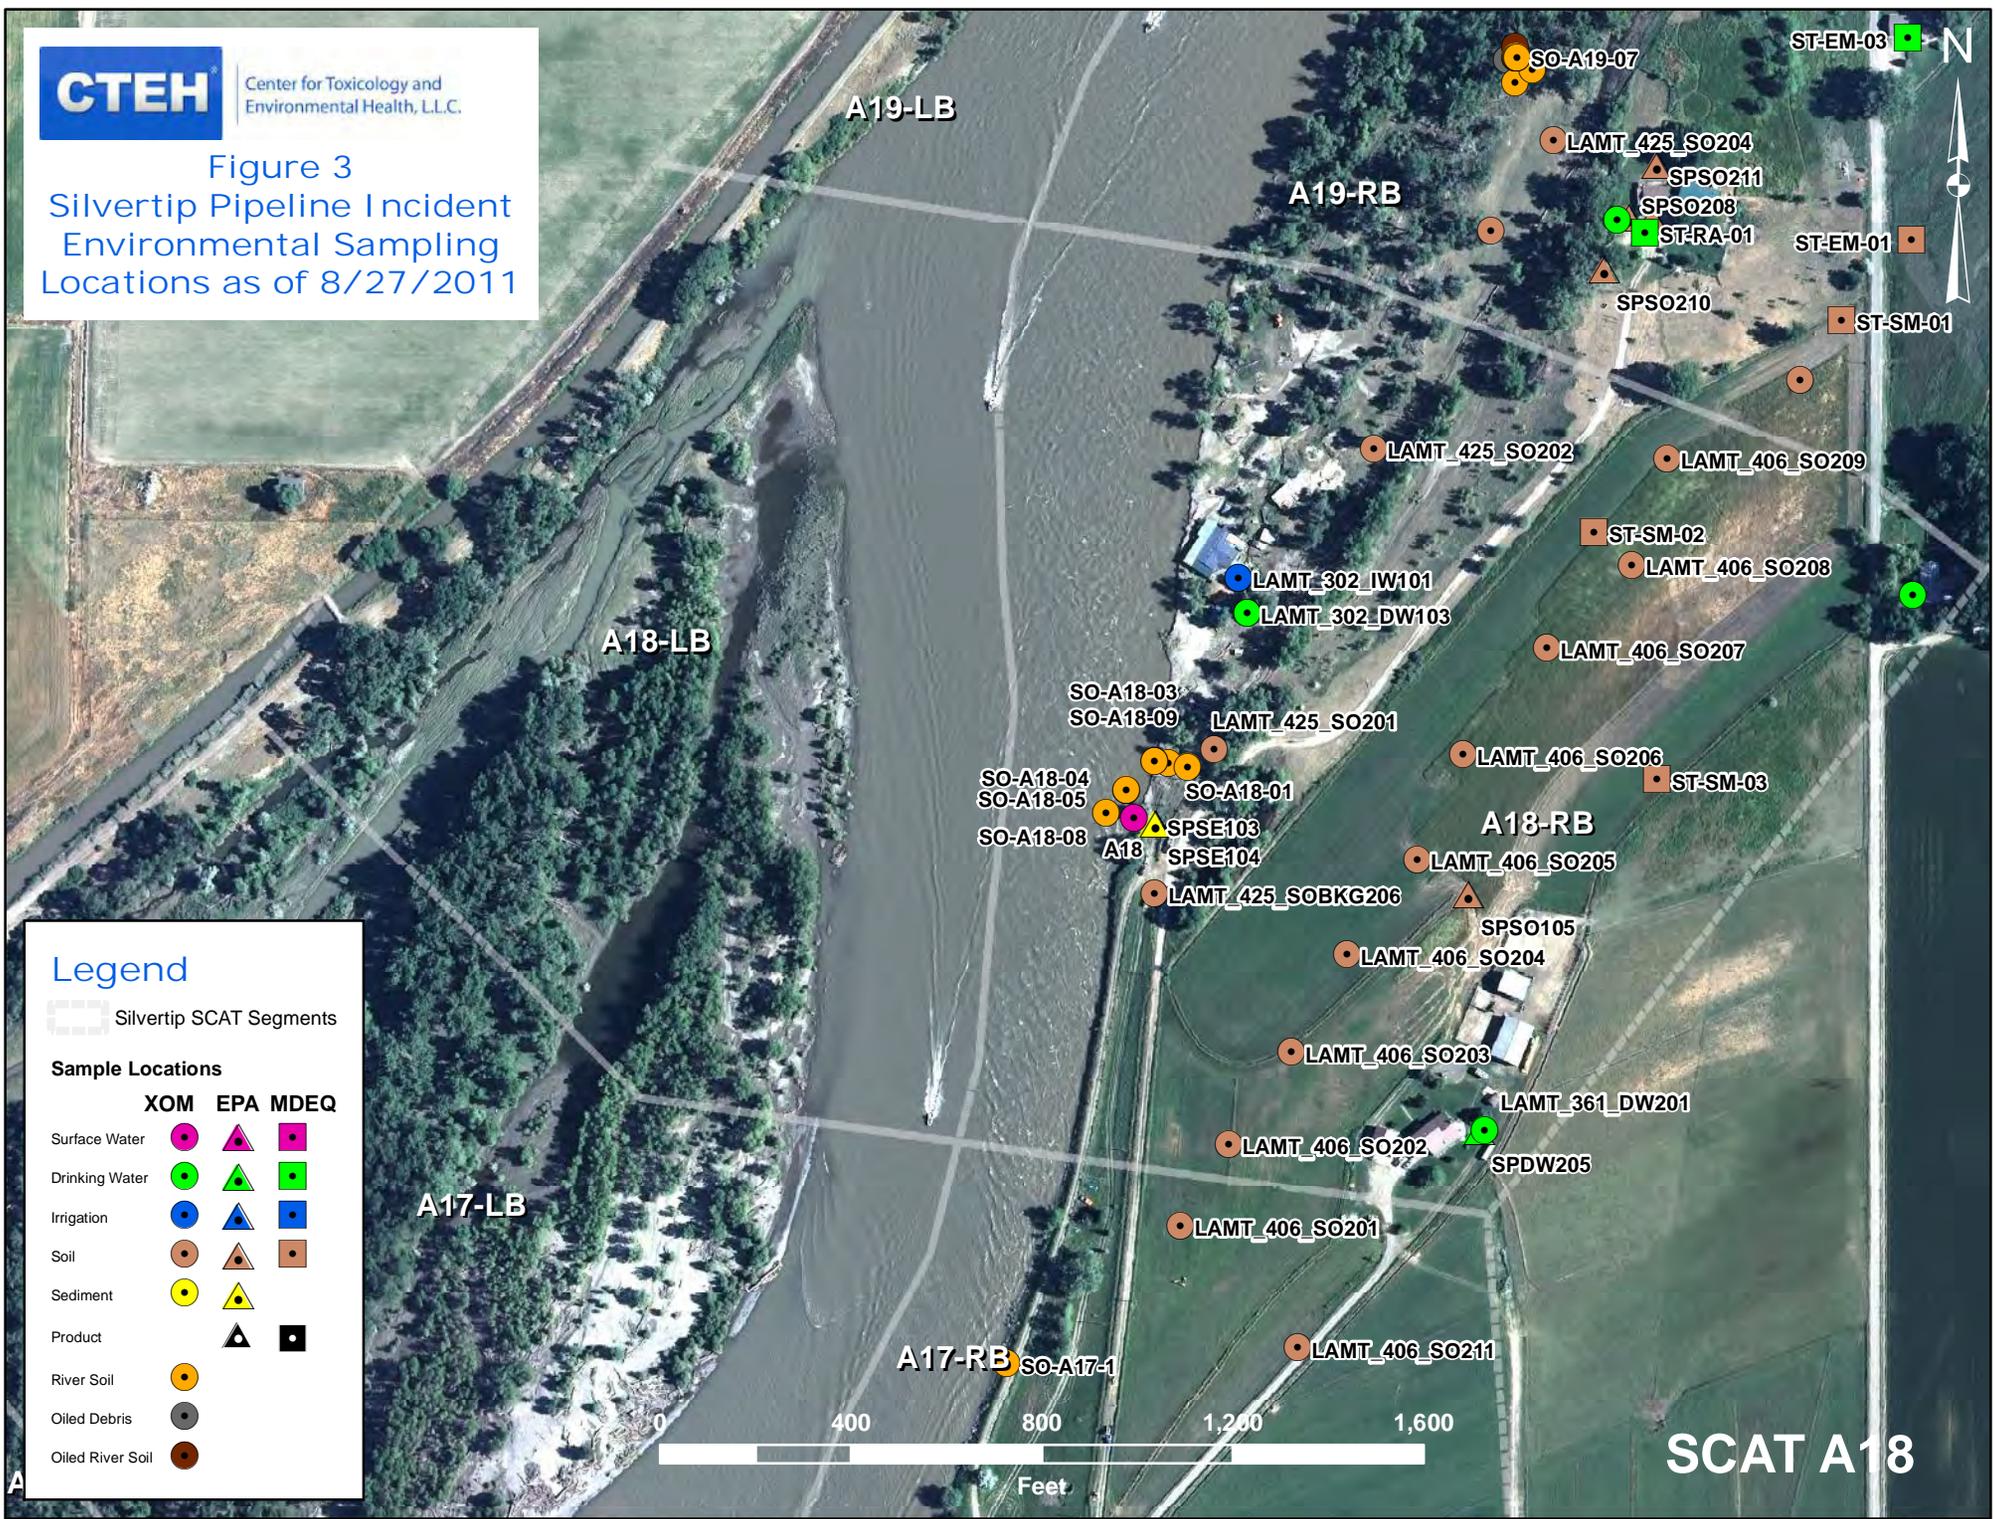
Figure 3
Silvertip Pipeline Incident
Environmental Sampling
Locations as of 8/27/2011

Table 1 (below) summarizes samples collected within Area A18. The analytical results for the samples collected can be accessed through a publicly accessible database on the United States Environmental Protection Agency's (USEPA's) website. The approximate locations of samples collected within Area A18 are provided on Figure 3.

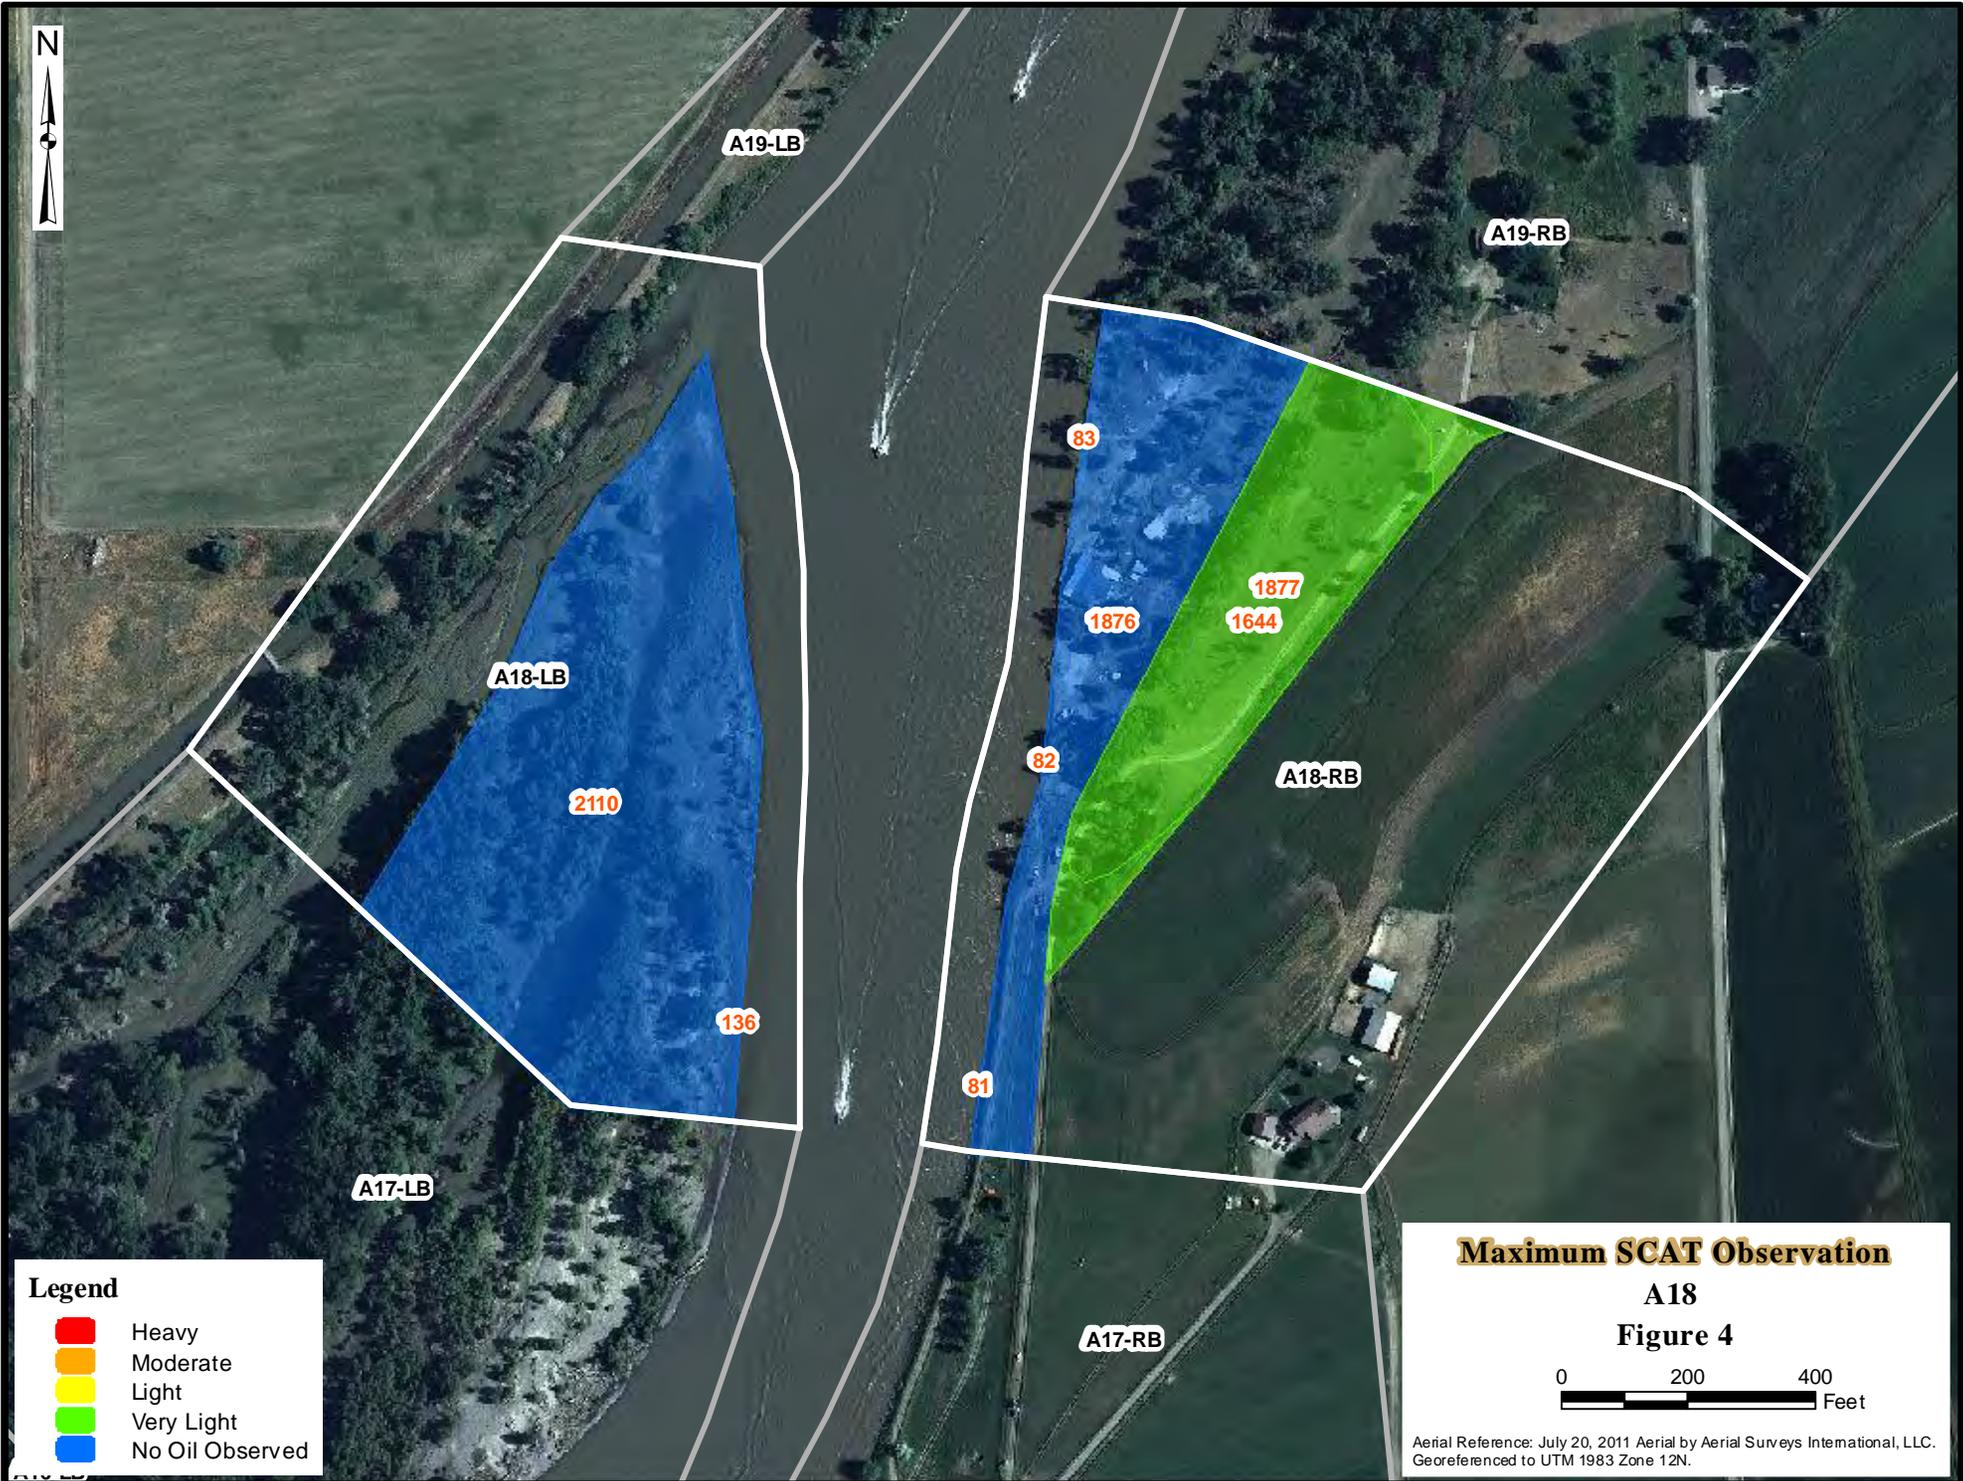
The SCAT teams used systematic evaluation criteria and treatment method tables approved by the National Oceanic and Atmospheric Administration to provide a standard approach for data collection and conducting field surveys. The forms and sketches from the initial SCAT surveys performed along the river bank (water edge) and floodplain within Area A18 are included in Appendix B. Figure 4 provides the maximum oiling zones observed by the SCAT team during the initial surveys of Area A18.

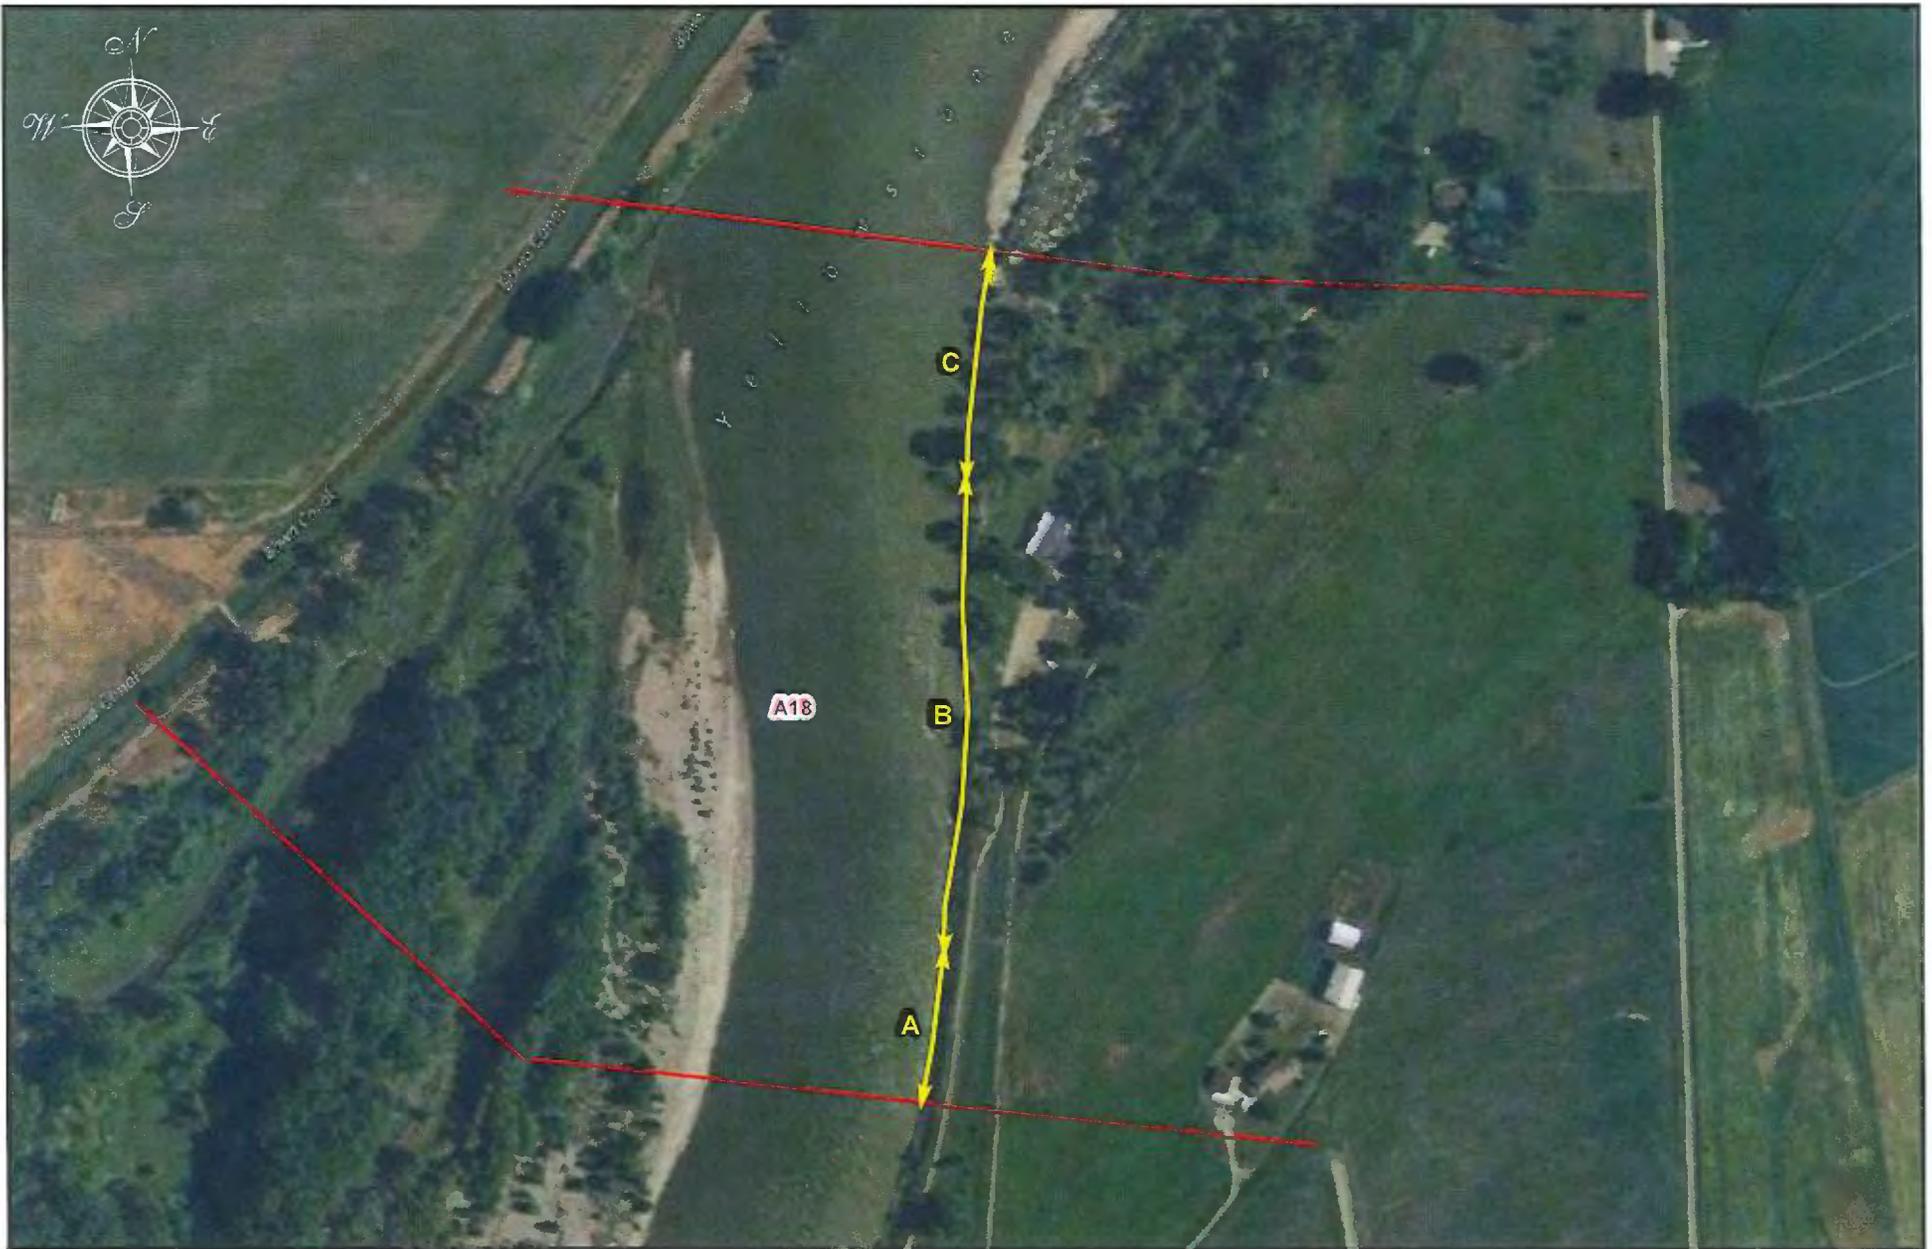
Segment A18 Right Bank

Zone A & C Oiled Band Height: 40cm

Due to survey platform (jet-drive boat) oil band width and heights are estimates. Unable to verify by foot.

Cleanup Recommendations: Trim oiled vegetation; wipe large oiled debris; remove small oiled debris; wipe oiled trees;

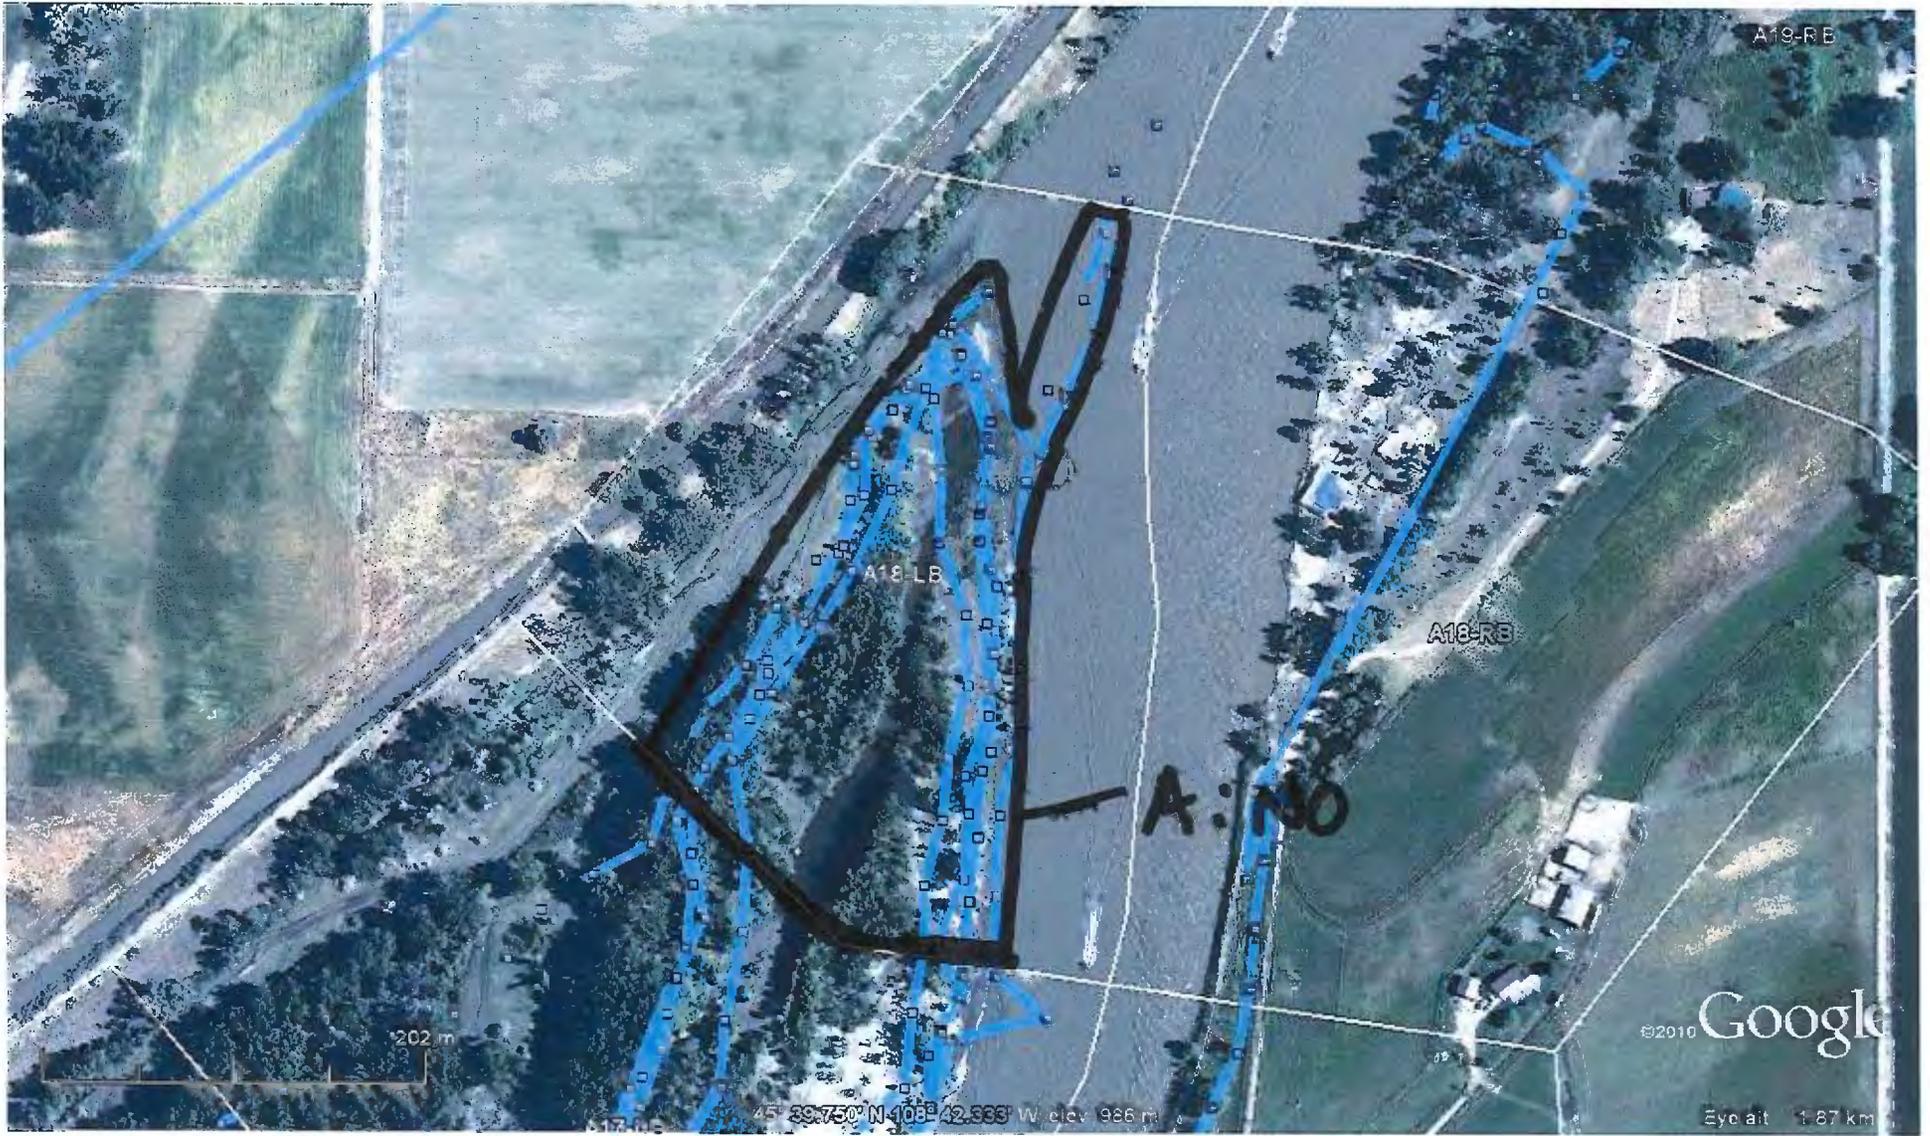
A18 LB
T2 9/5/11

Zone A : No oil ; no treatment required

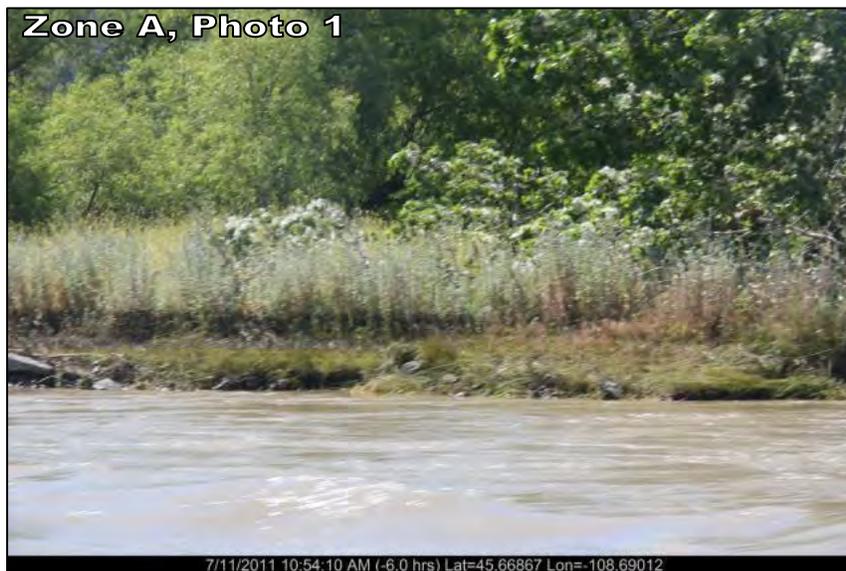
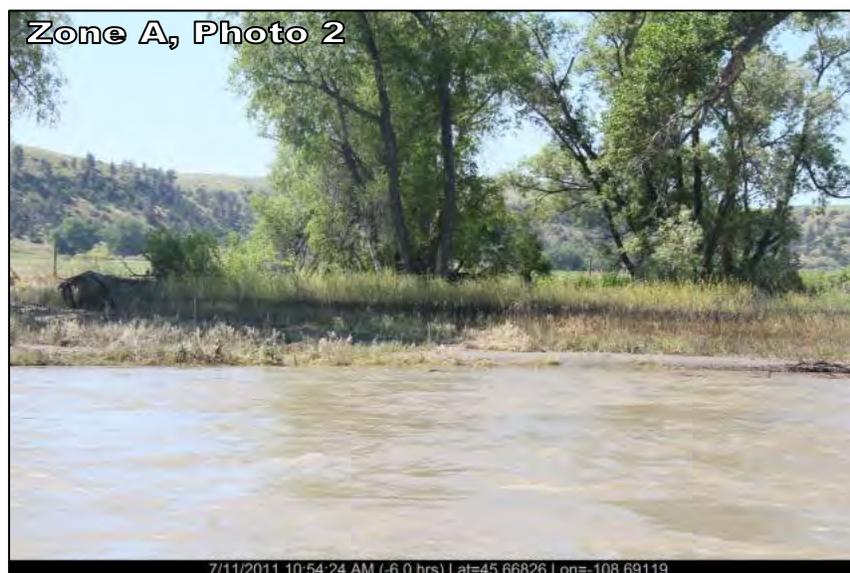
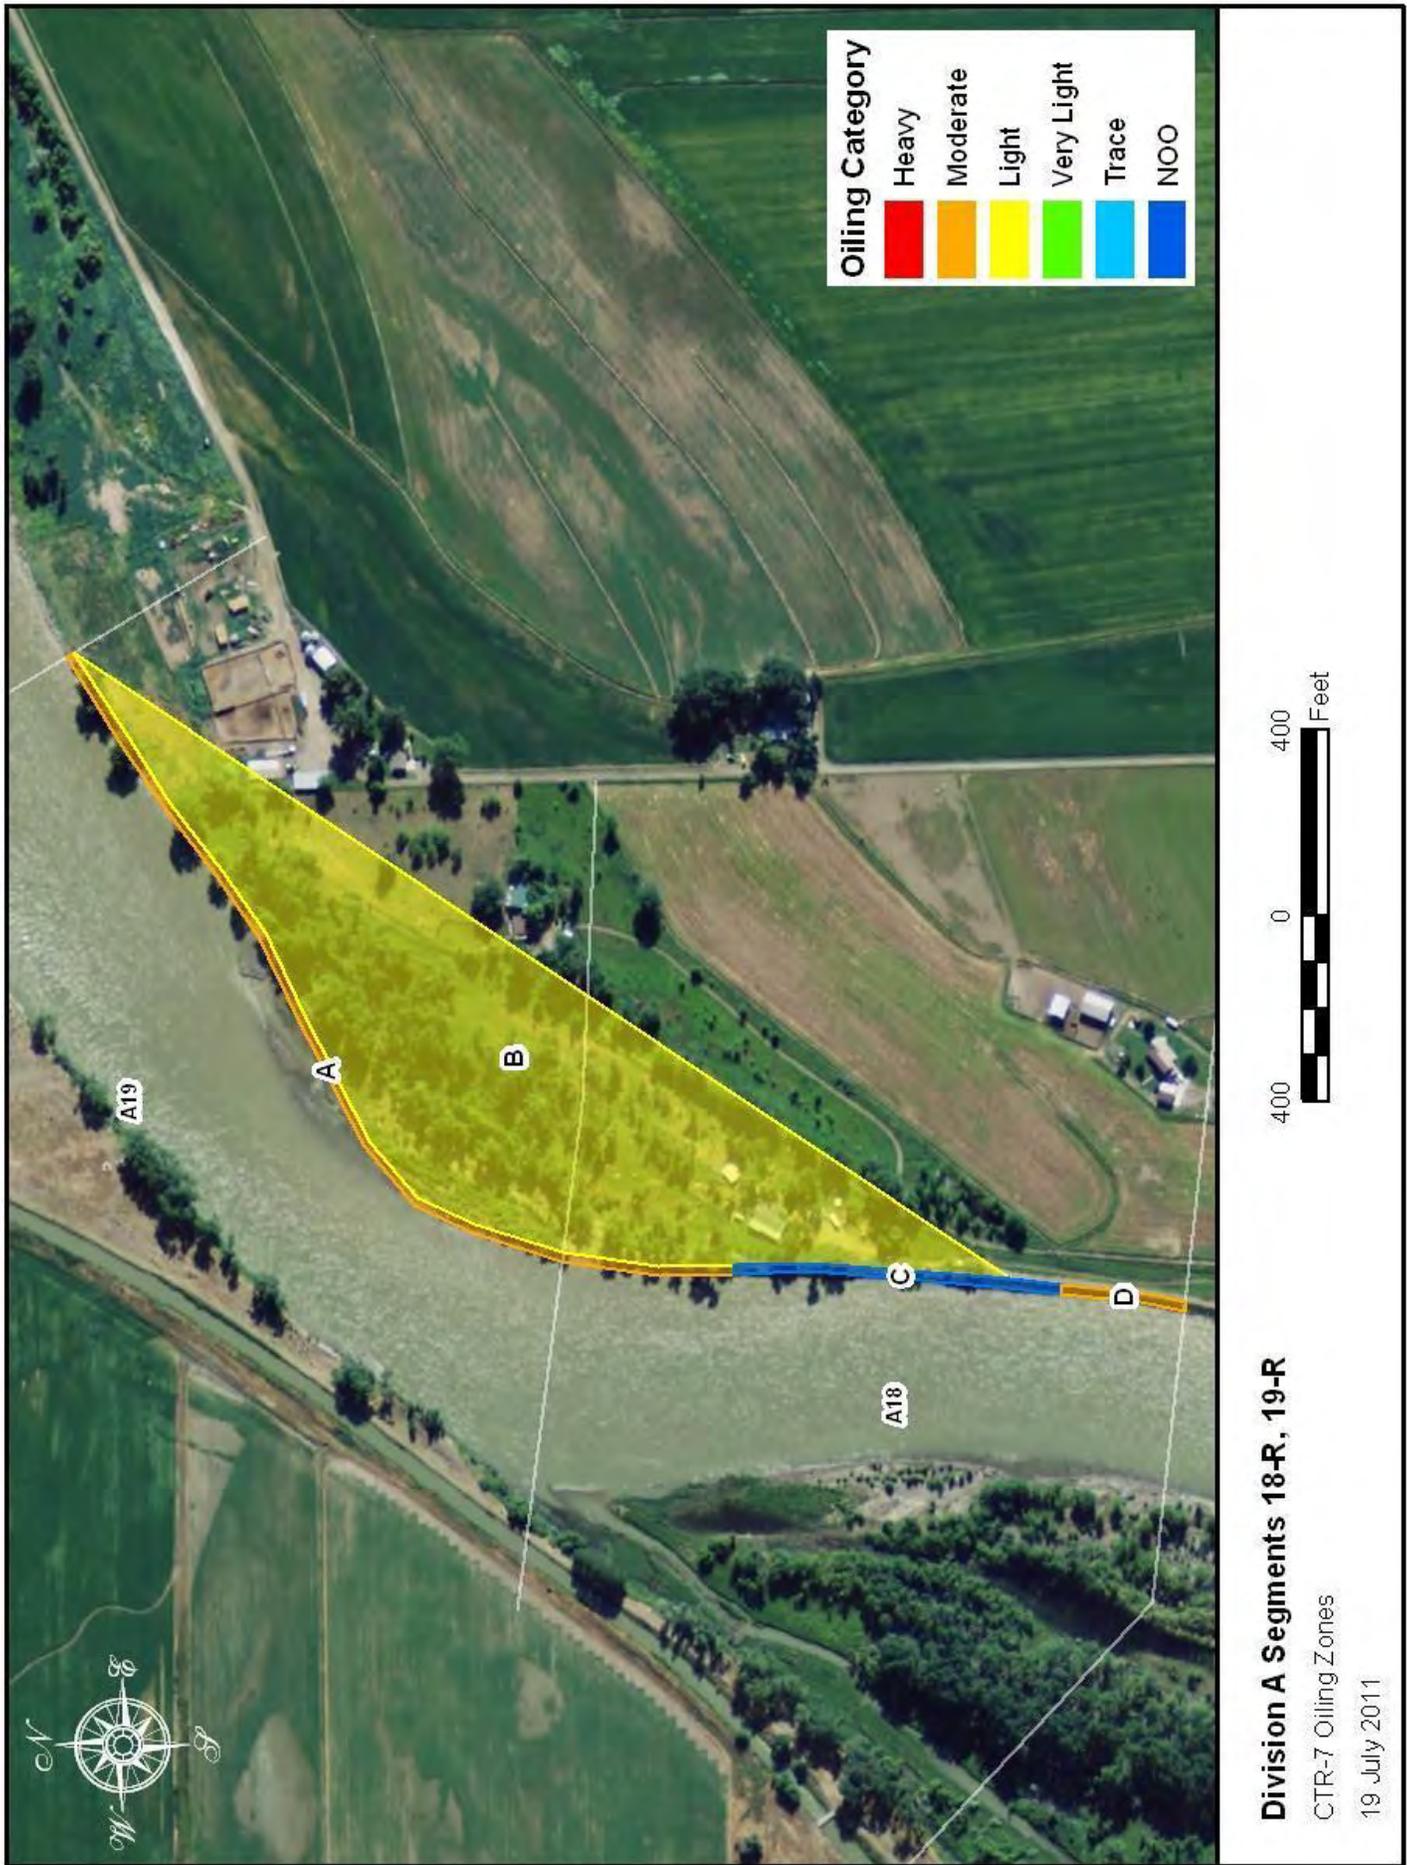
Zone A and D:

Primary Oiling Conditions: ~95% distribution of oiled debris (coat), oil coat/stain on vegetation within 5 meters of the bank.

Cleanup Recommendations: Cut and remove oil-coated vegetation smaller than 1" diameter. Remove oil-coated debris smaller than 4" diameter. Do not cut grass shorter than 2" from the ground. Wipe larger oil-coated vegetation and debris. **Pending further authorization, the size and quantity of oil coated debris in this zone may warrant alternative cleanup methods such as burning or removal.**

Do not cut grass shorter than 2" from the ground.
