**SCAT Area Transition Report for
A18**

Silvertip Pipeline Incident
Laurel, Montana

October 18, 2011

Our Ref.:
B0085883.1103

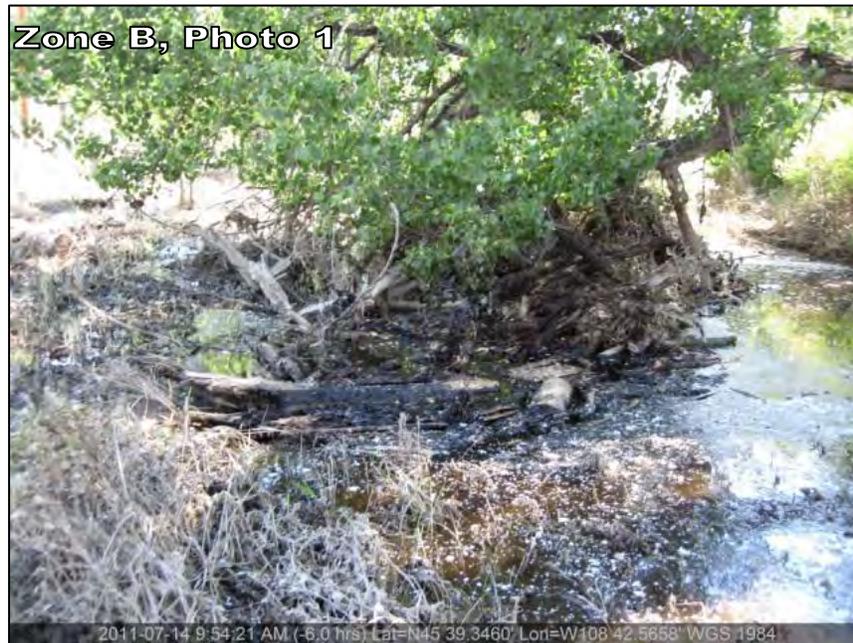
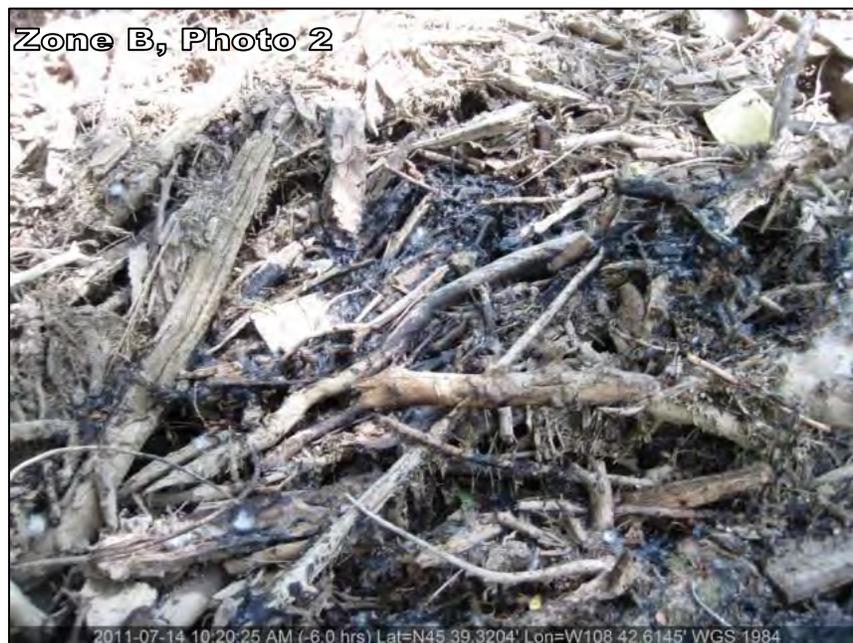
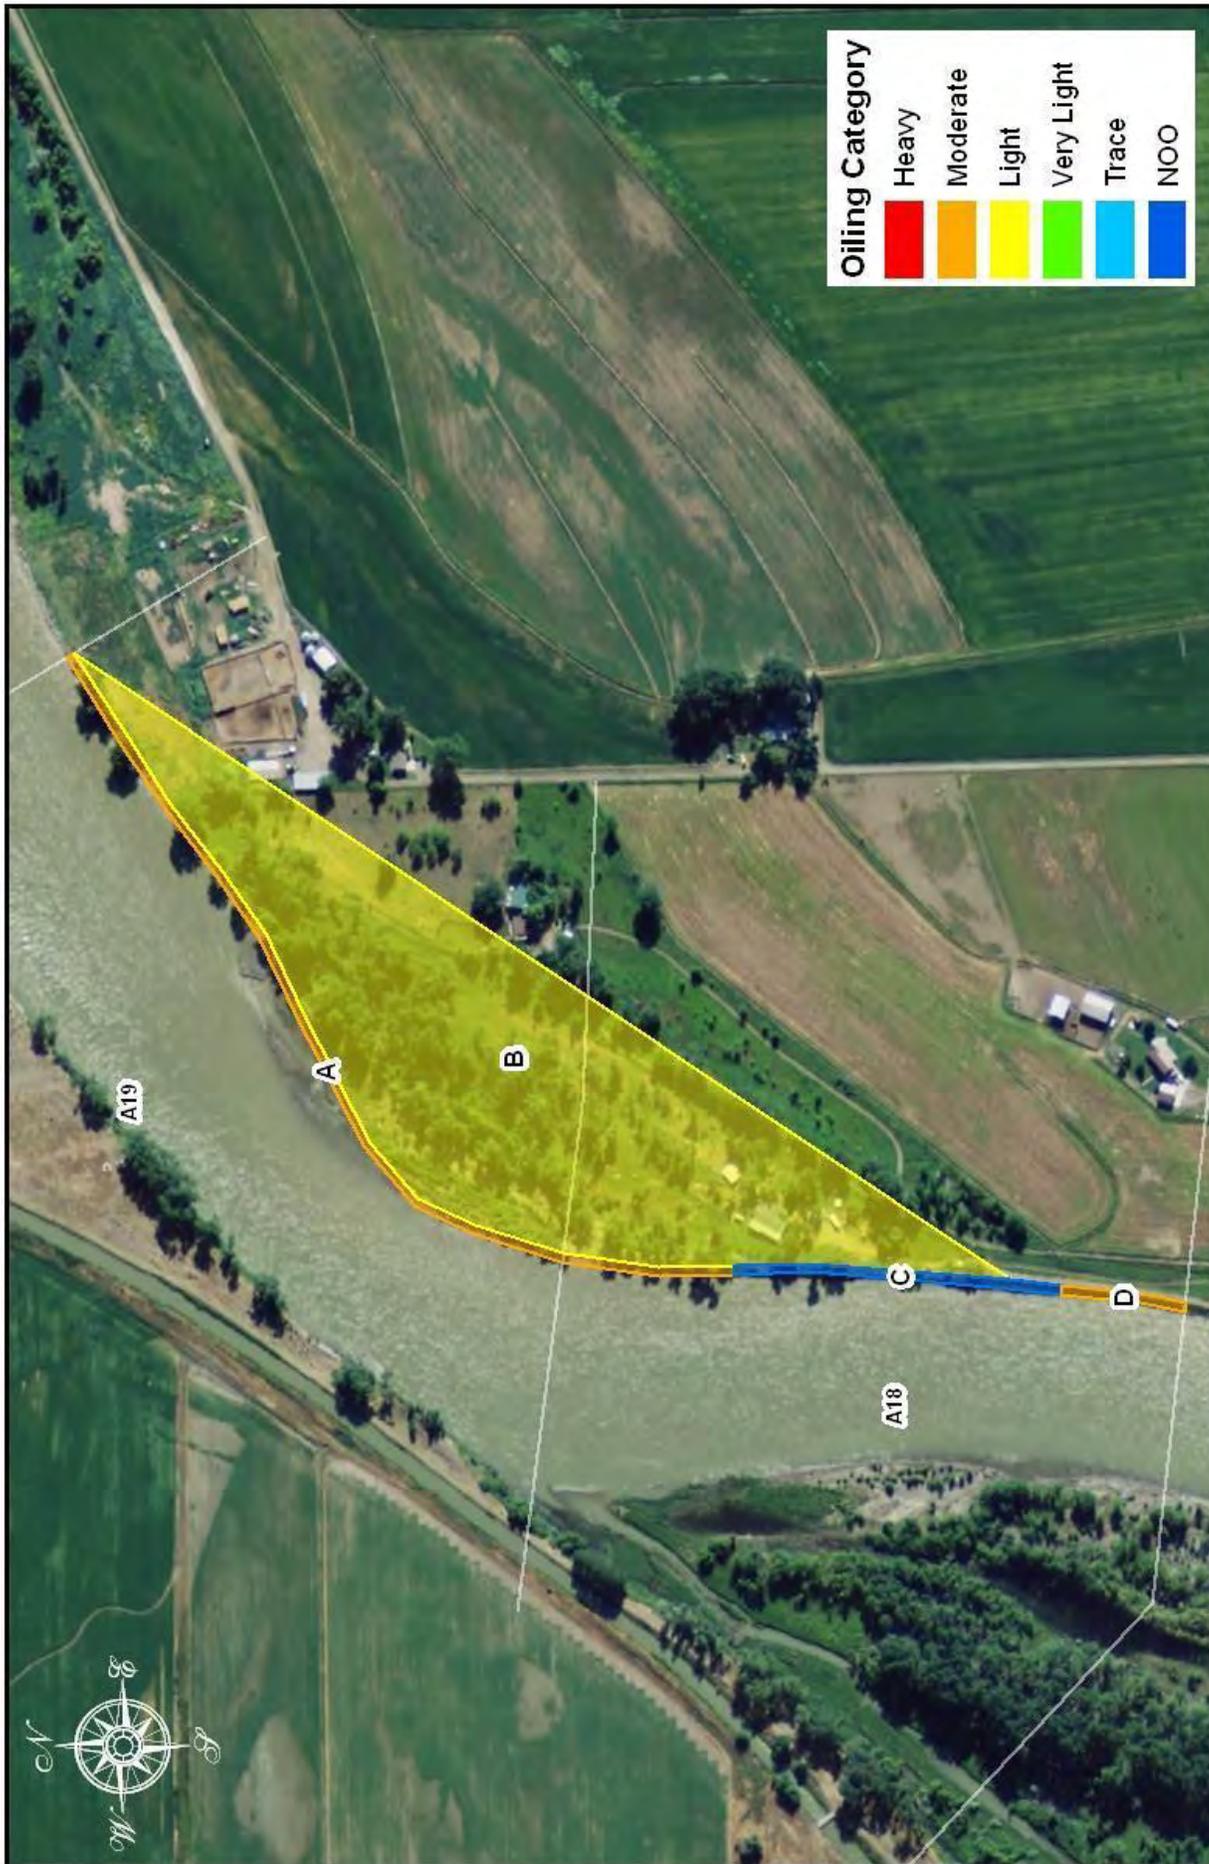
CTR-7 Oiling Zones

Zone B:

Primary Oiling Conditions: ~10% distribution of oiled debris (cover and coat) and oil cover on vegetation within 5 meters of the bank.

Cleanup Recommendations: Cut and remove oil-coated vegetation smaller than 1" diameter. Do not cut grass shorter than 2" from the ground. Wipe oil-coated vegetation larger than 1" diameter. Only remove oil-coated debris smaller than 4" diameter. Wipe oil-coated debris larger than 4" diameter.

Do not cut grass shorter than 2" of the ground.

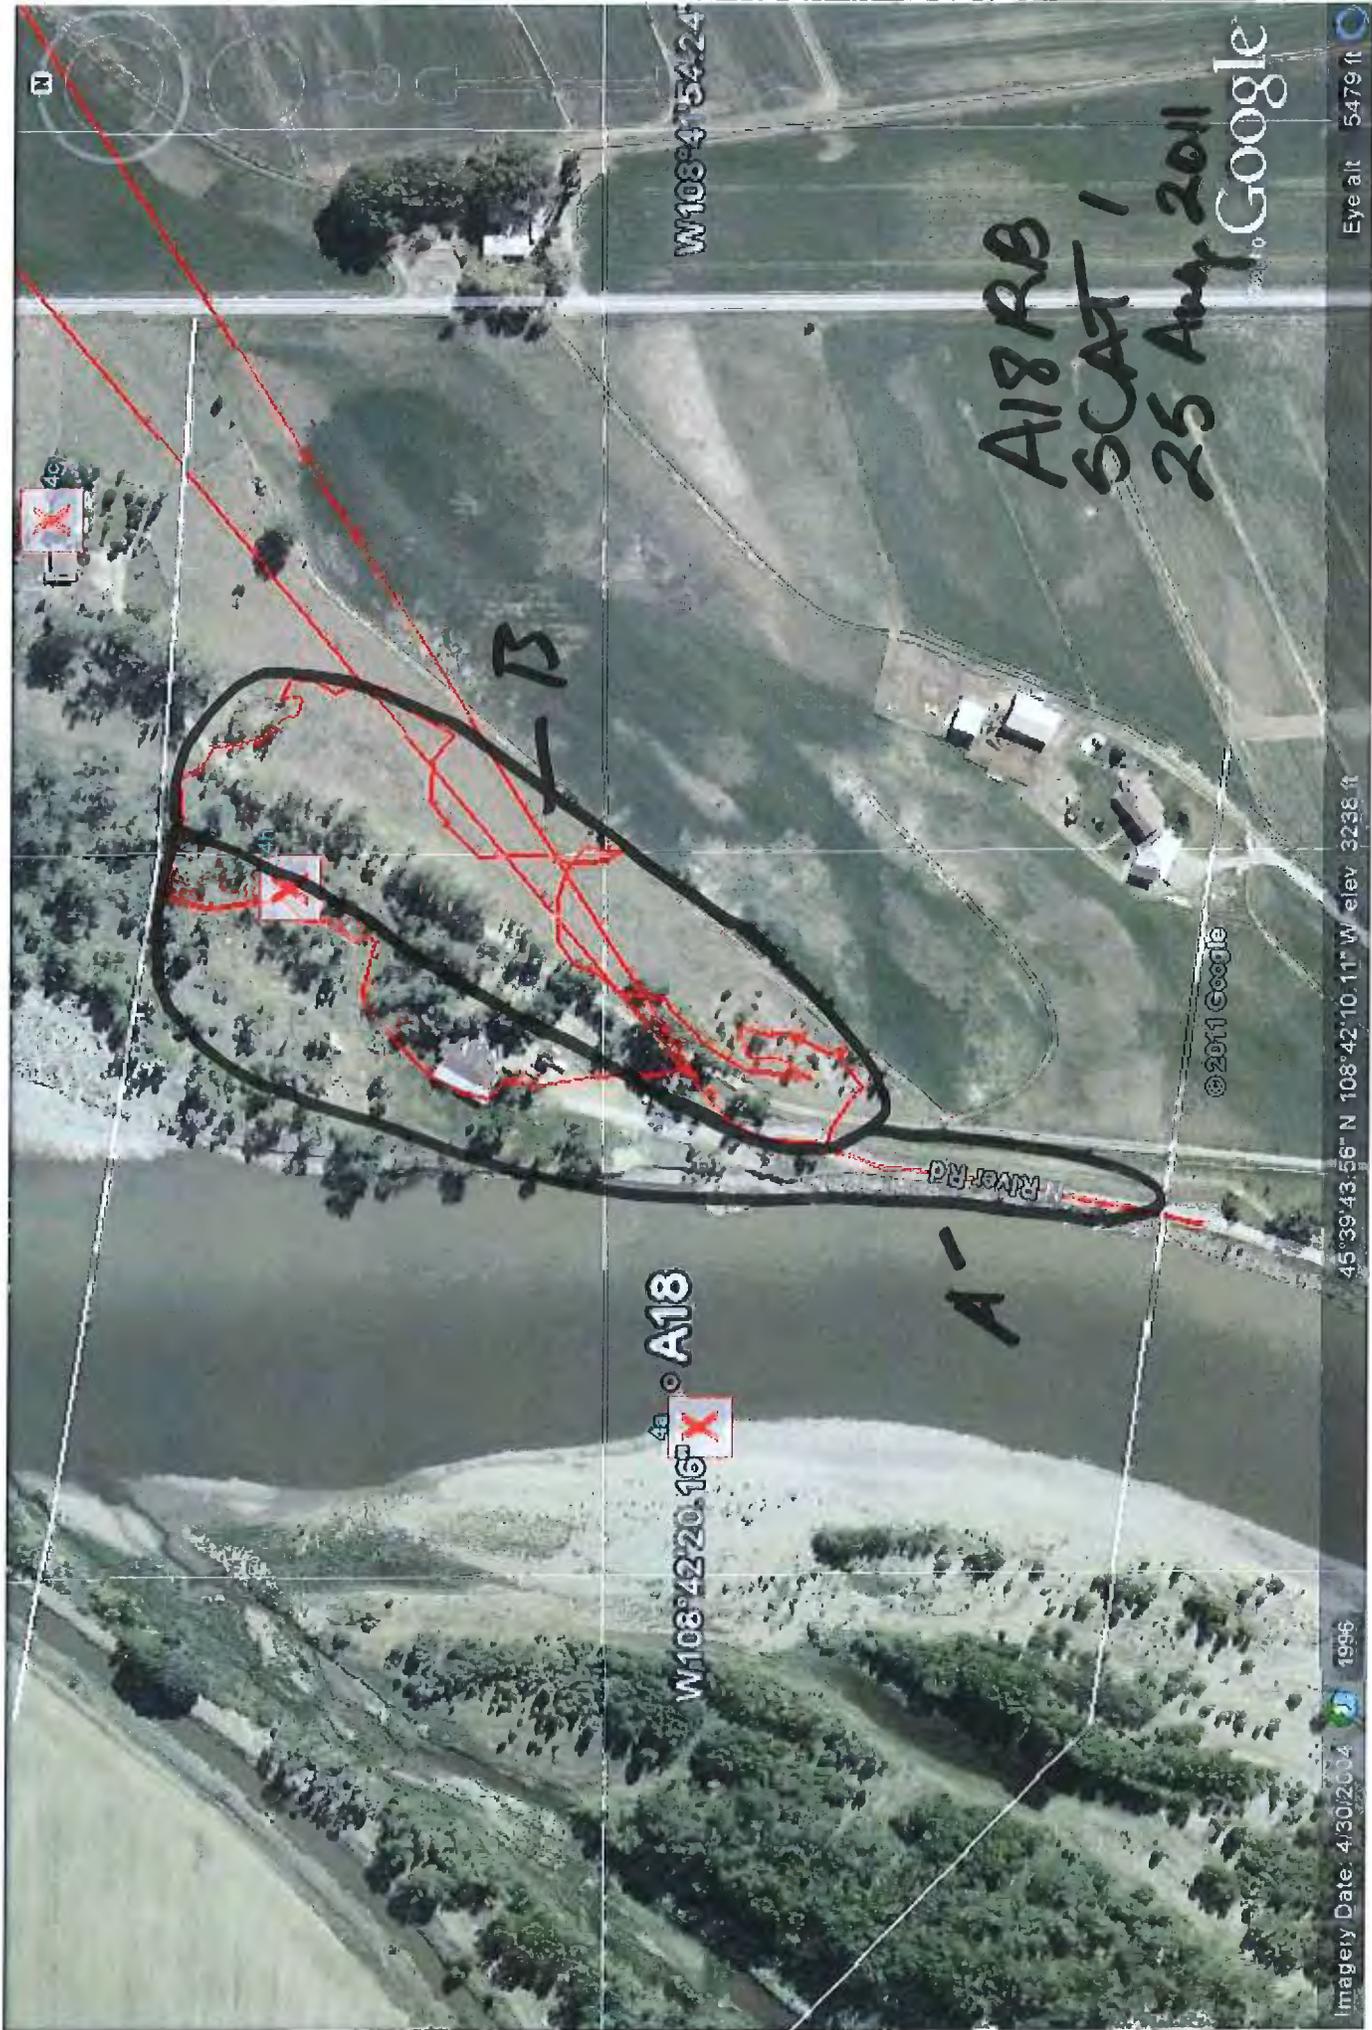
A18 RB
SCAT 1
25 Aug 2011

Zone A - No oil observed

Zone B - sporadic stain + coat partly leak on trees

No further action

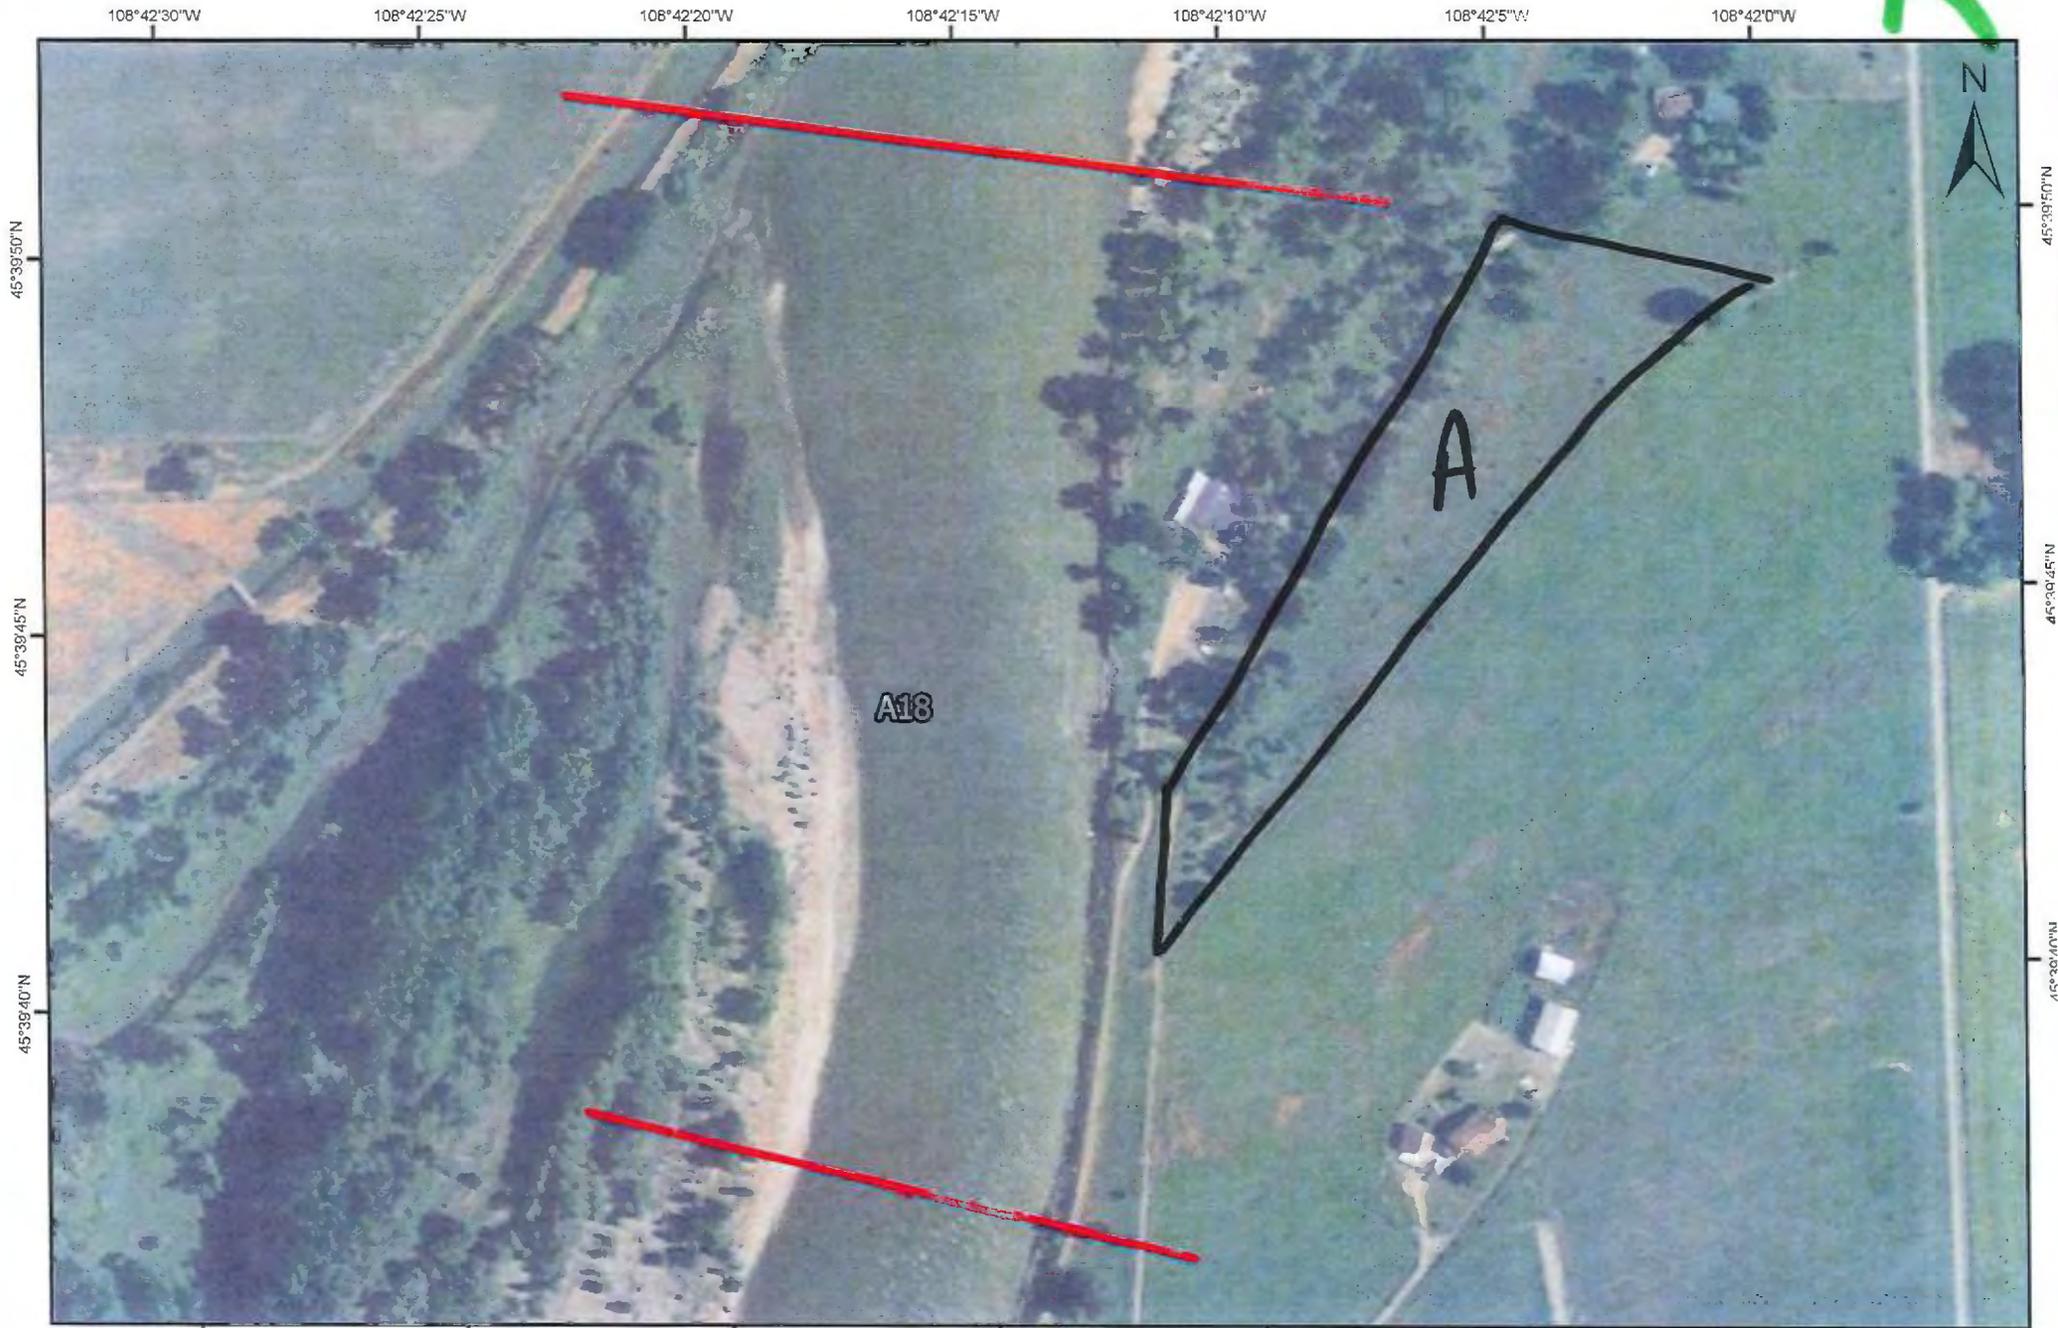
A18 -
(LR)??

Zone A: This zone was treated in accordance with the CTR and meets its objectives. No further treatment recommended.
