**SCAT Area Transition Report for
A20**

Silvertip Pipeline Incident
Laurel, Montana

October 18, 2011

Prepared by:
ARCADIS G&M of North Carolina, Inc.
11000 Regency Parkway
West Tower, Suite 205
Cary, North Carolina 27518-8518
Tel 919.469.1952
Fax 919.469.5676

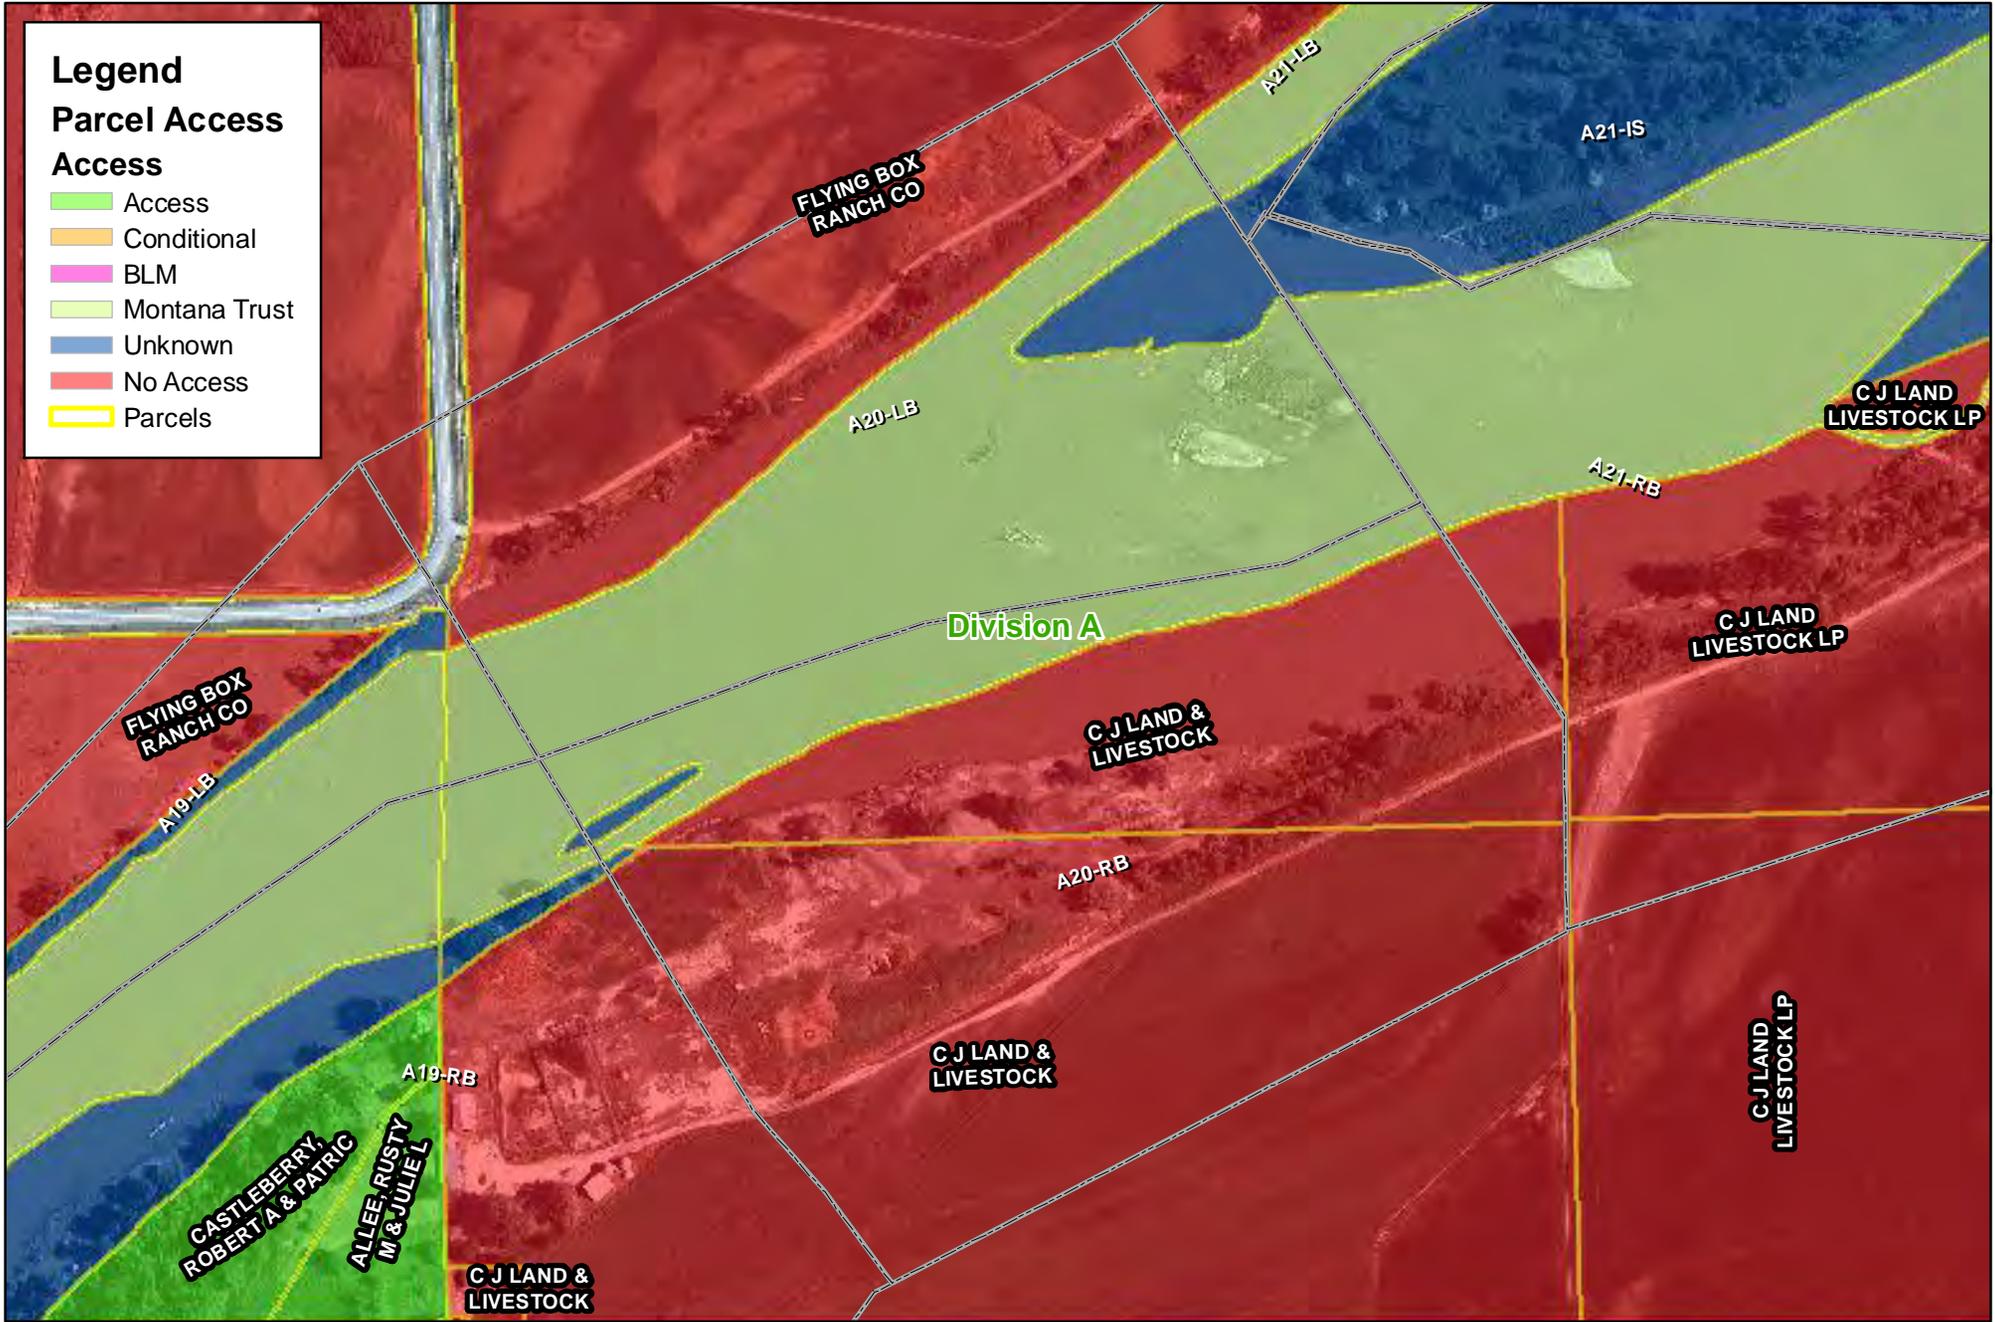
Figure 1 provides an aerial map of SCAT Area A20, along with the (a) SCAT Area boundary, (b) parcel boundaries and respective property owners, and (c) access constraints identified during the oil cleanup process. The acreage surveyed in Area A20 is 17.7. There were access issues for the right bank and no access was granted for the left bank.

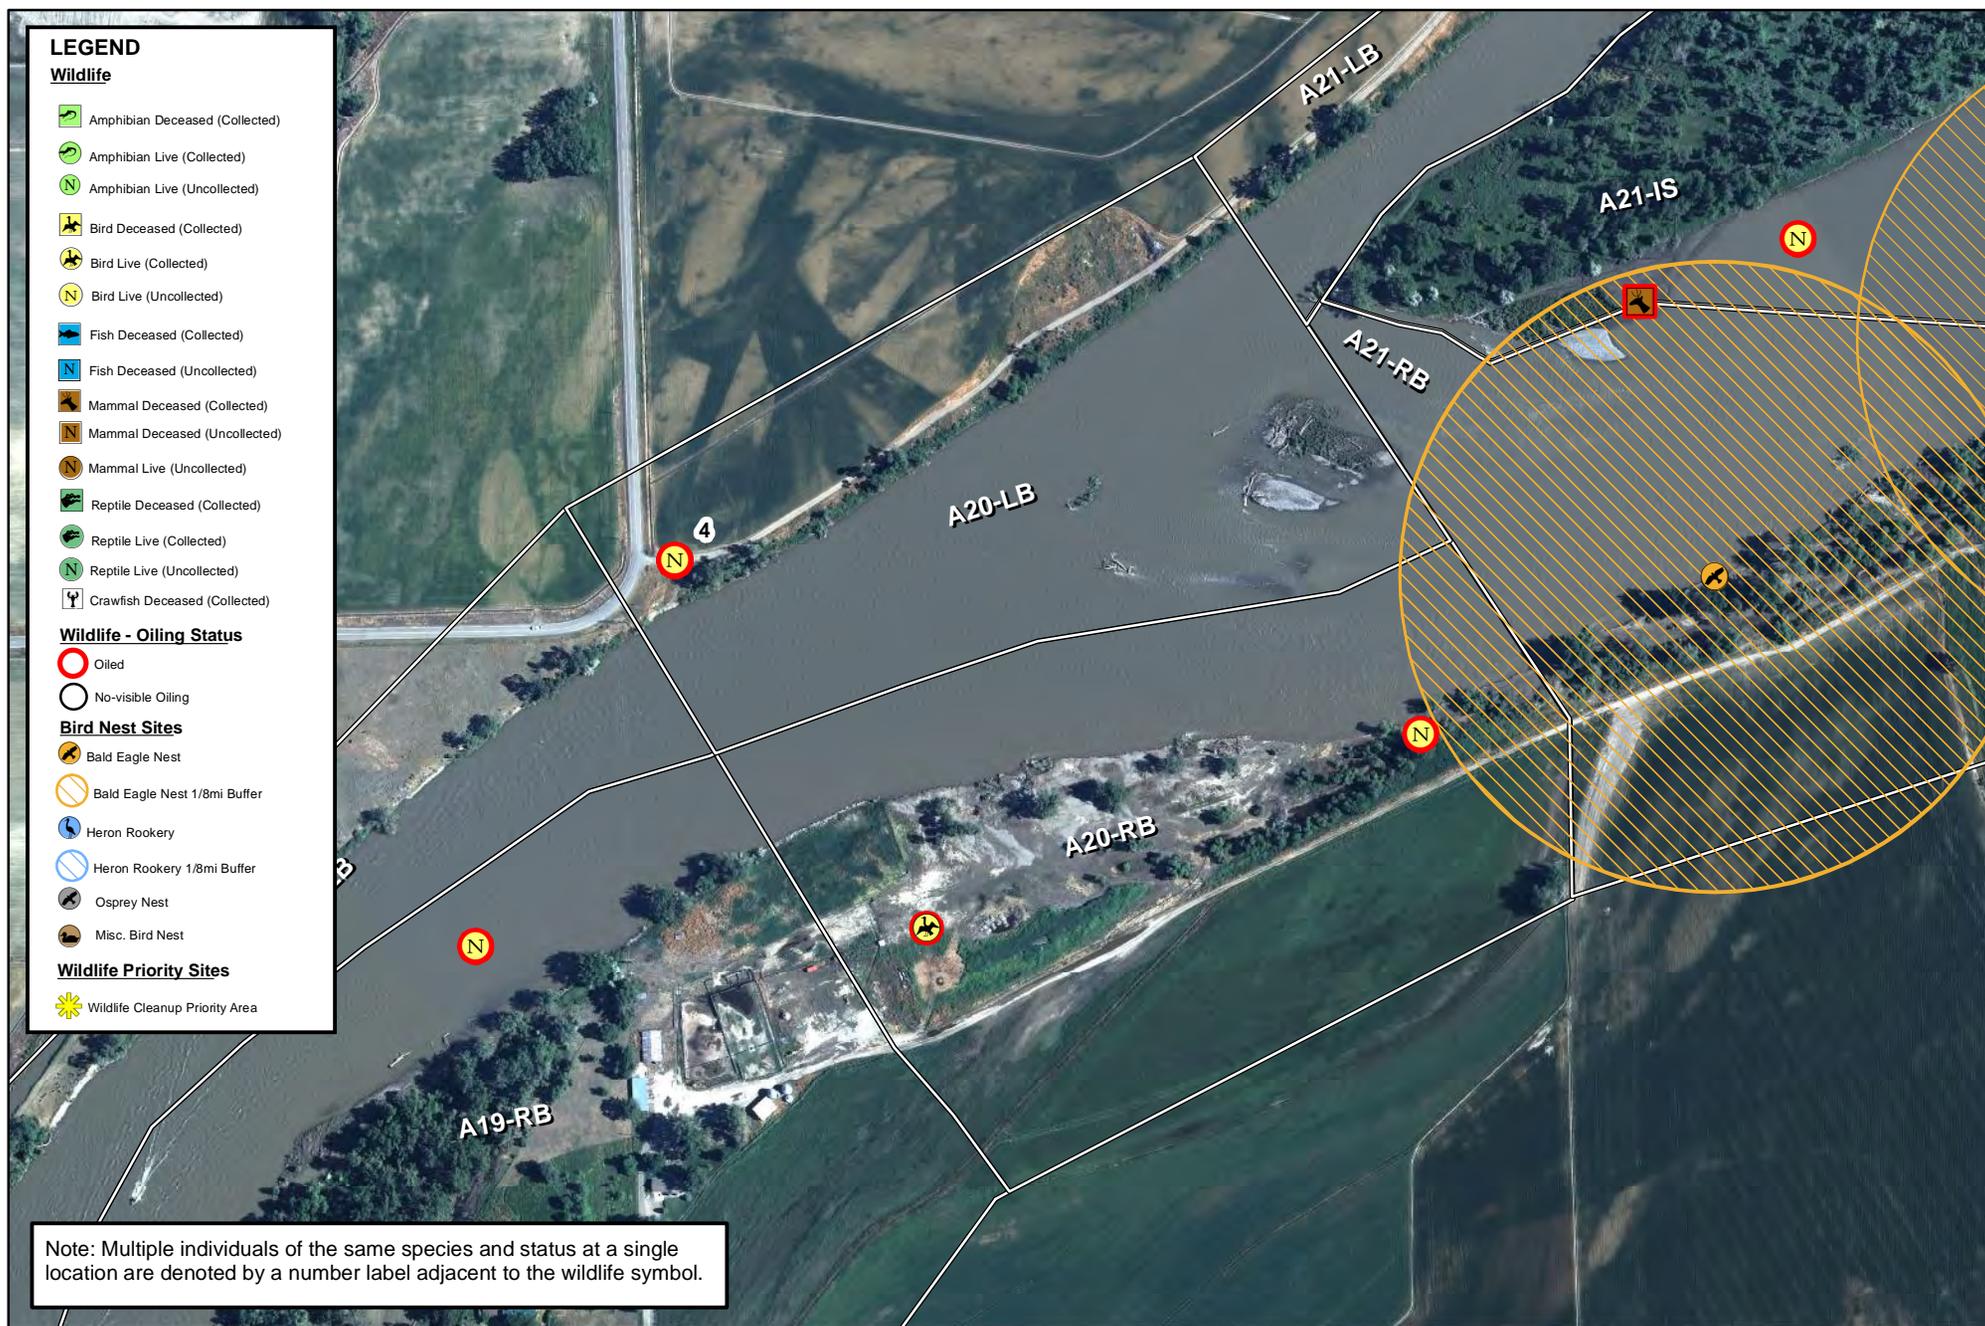
Figure 2
Wildlife Resources

Figure 2 summarizes the natural resources identified in this segment. International Bird Rescue and Resource Advisors from U.S. Fish and Wildlife Service conducted regular inspections of Area A20. Four Canada geese (*Branta canadensis*) with heavy oiling were observed. One heavily oiled Canada goose was captured, cleaned, and released; this was likely one of the four previously noted oiled geese. The other geese could not be captured. One black capped chickadee (*Poecile atricapillus*) with light to medium oiling was observed, but could not be captured for cleaning. No Wildlife Priority Cleanup Areas were identified. No active migratory bird nests were identified in Area A20. However, a portion of a bald eagle (*Haliaeetus leucocephalus*) nesting buffer zone extended into Area A20. Buffer zones protecting the nest were provided to Operations.

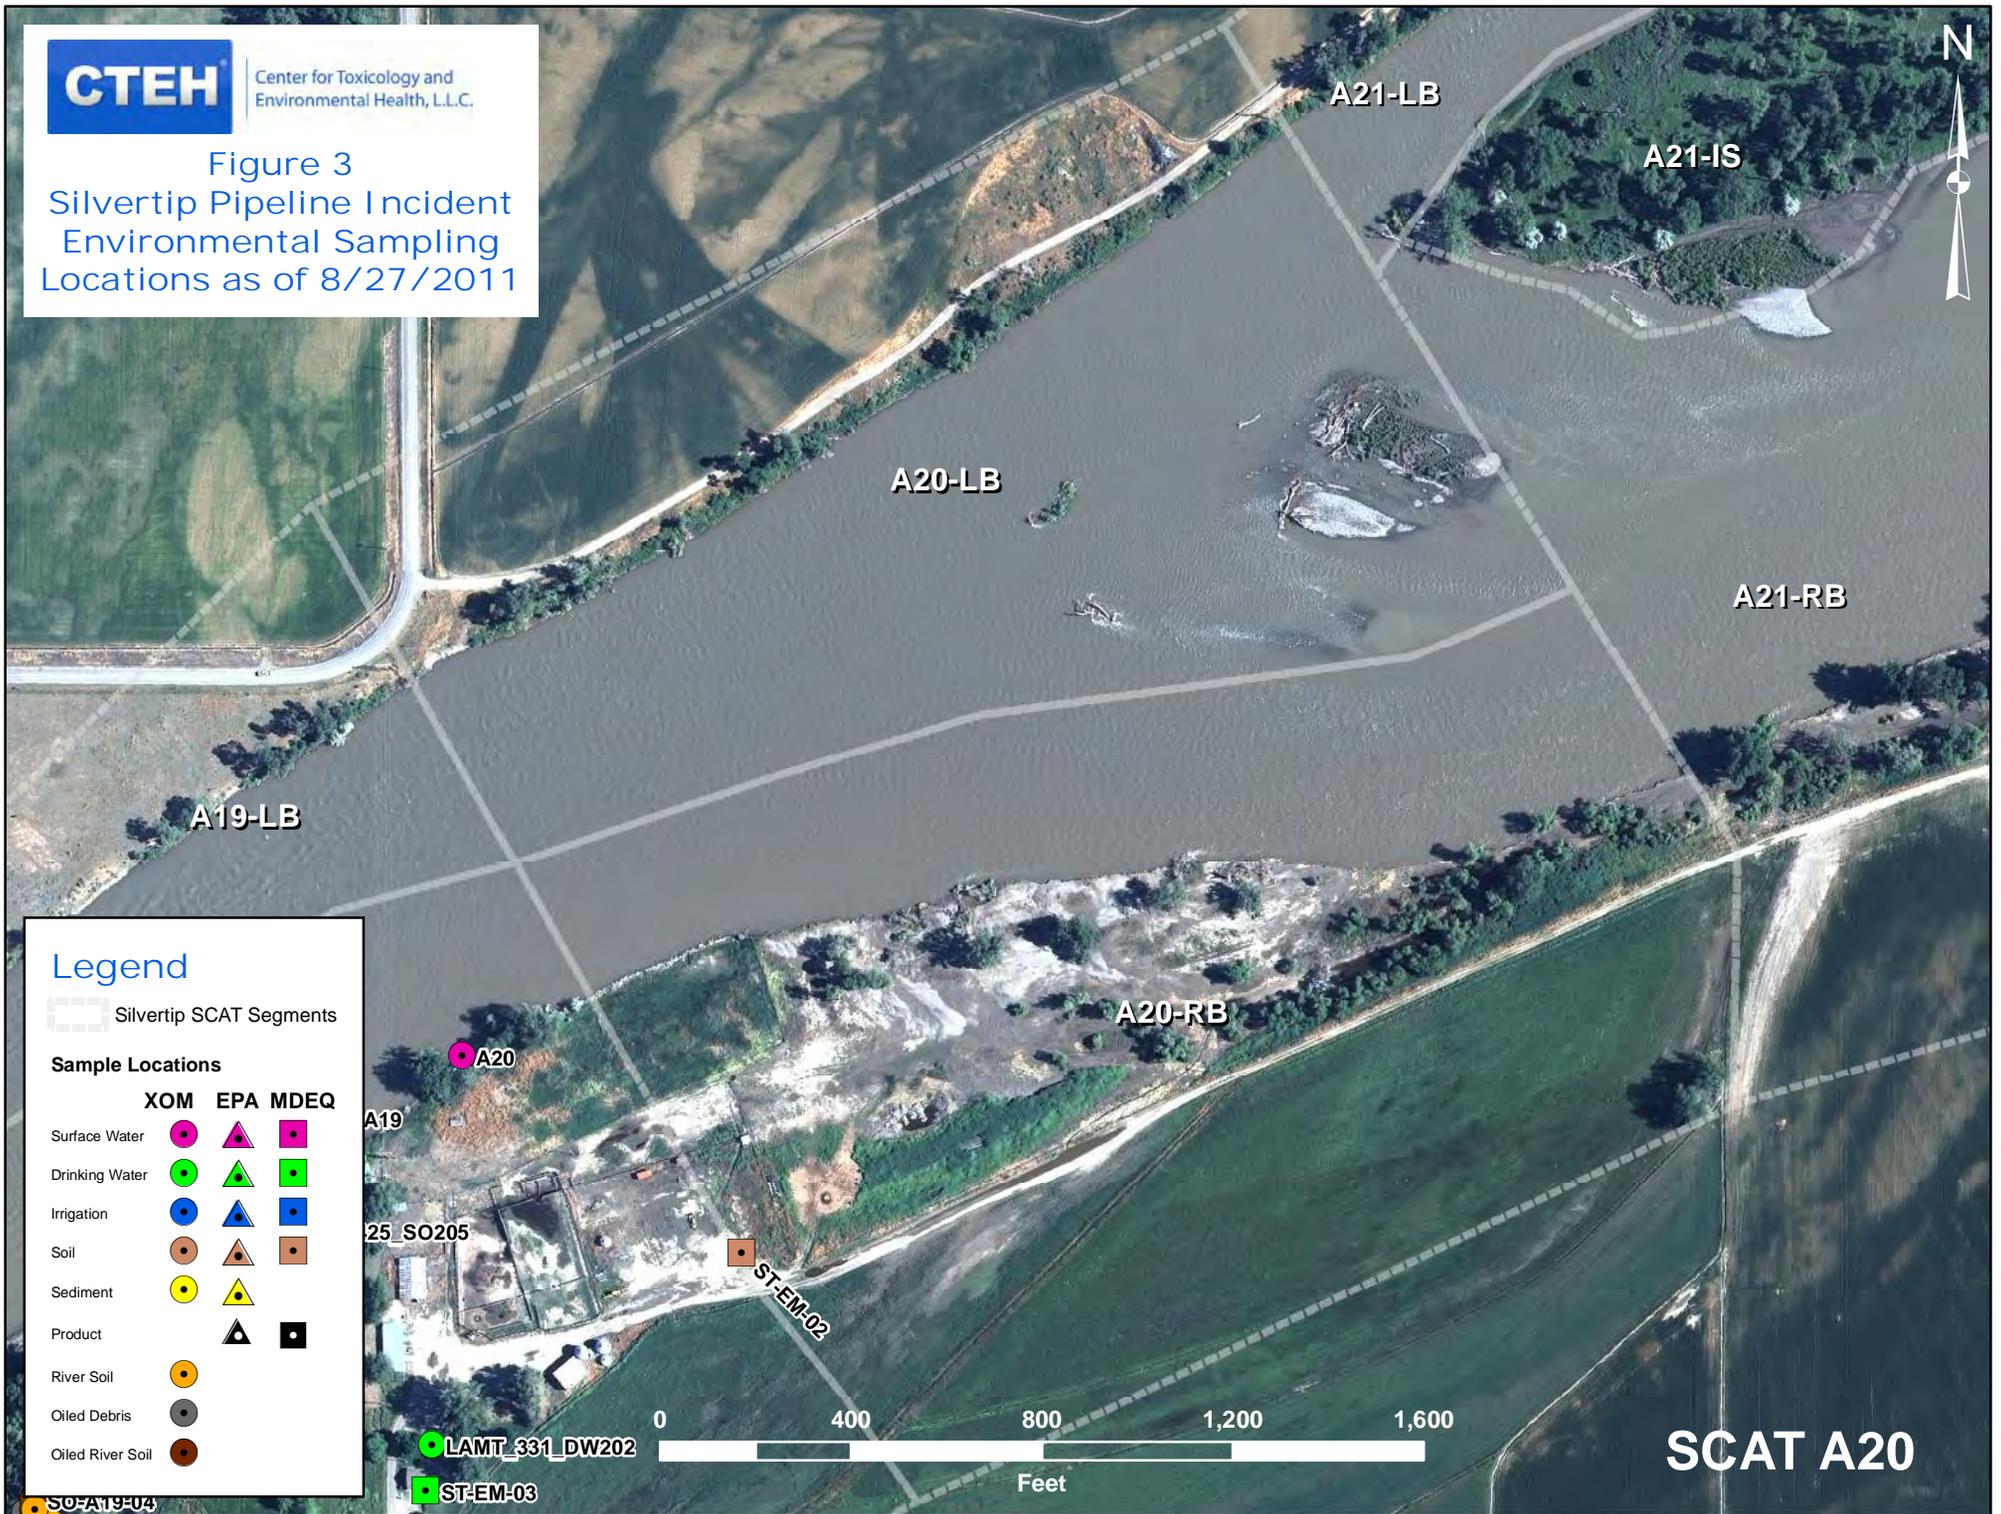
Figure 3
Silvertip Pipeline Incident
Environmental Sampling
Locations as of 8/27/2011

the United States Environmental Protection Agency's (USEPA's) website. The approximate locations of samples collected within Area A20 are provided on Figure 3.

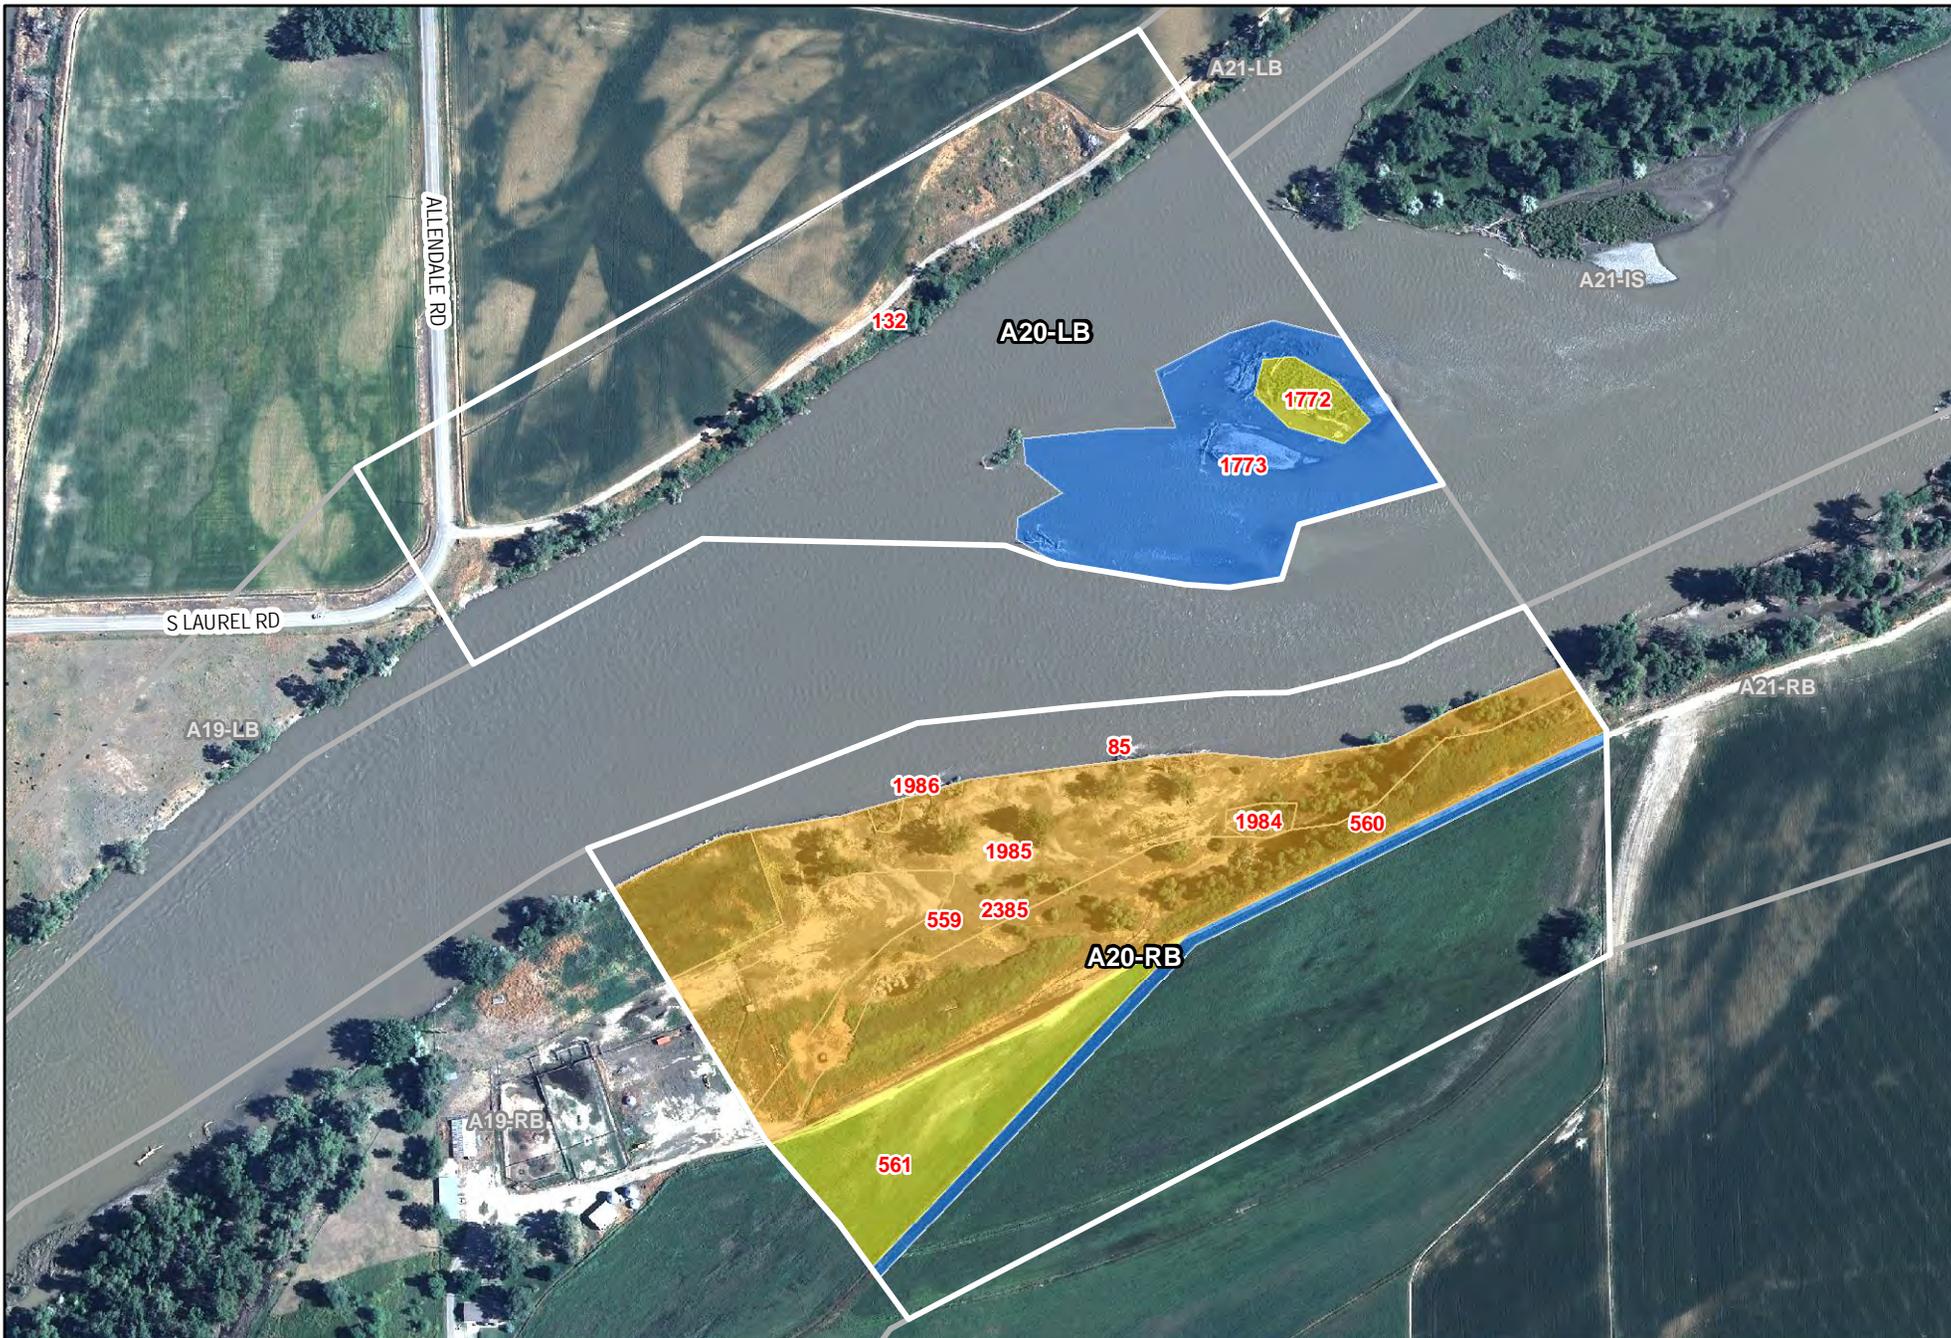
Figure 4 - Maximum SCAT Observations For SCAT Area: A20

The SCAT teams used systematic evaluation criteria and treatment method tables approved by the National Oceanic and Atmospheric Administration to provide a standard approach for data collection and conducting field surveys. The forms and sketches from the initial SCAT surveys performed along the river bank (water edge) and floodplain within Area A20 are included in Appendix B. Figure 4 provides the maximum oiling zones observed by the SCAT team during the initial surveys of Area A20.

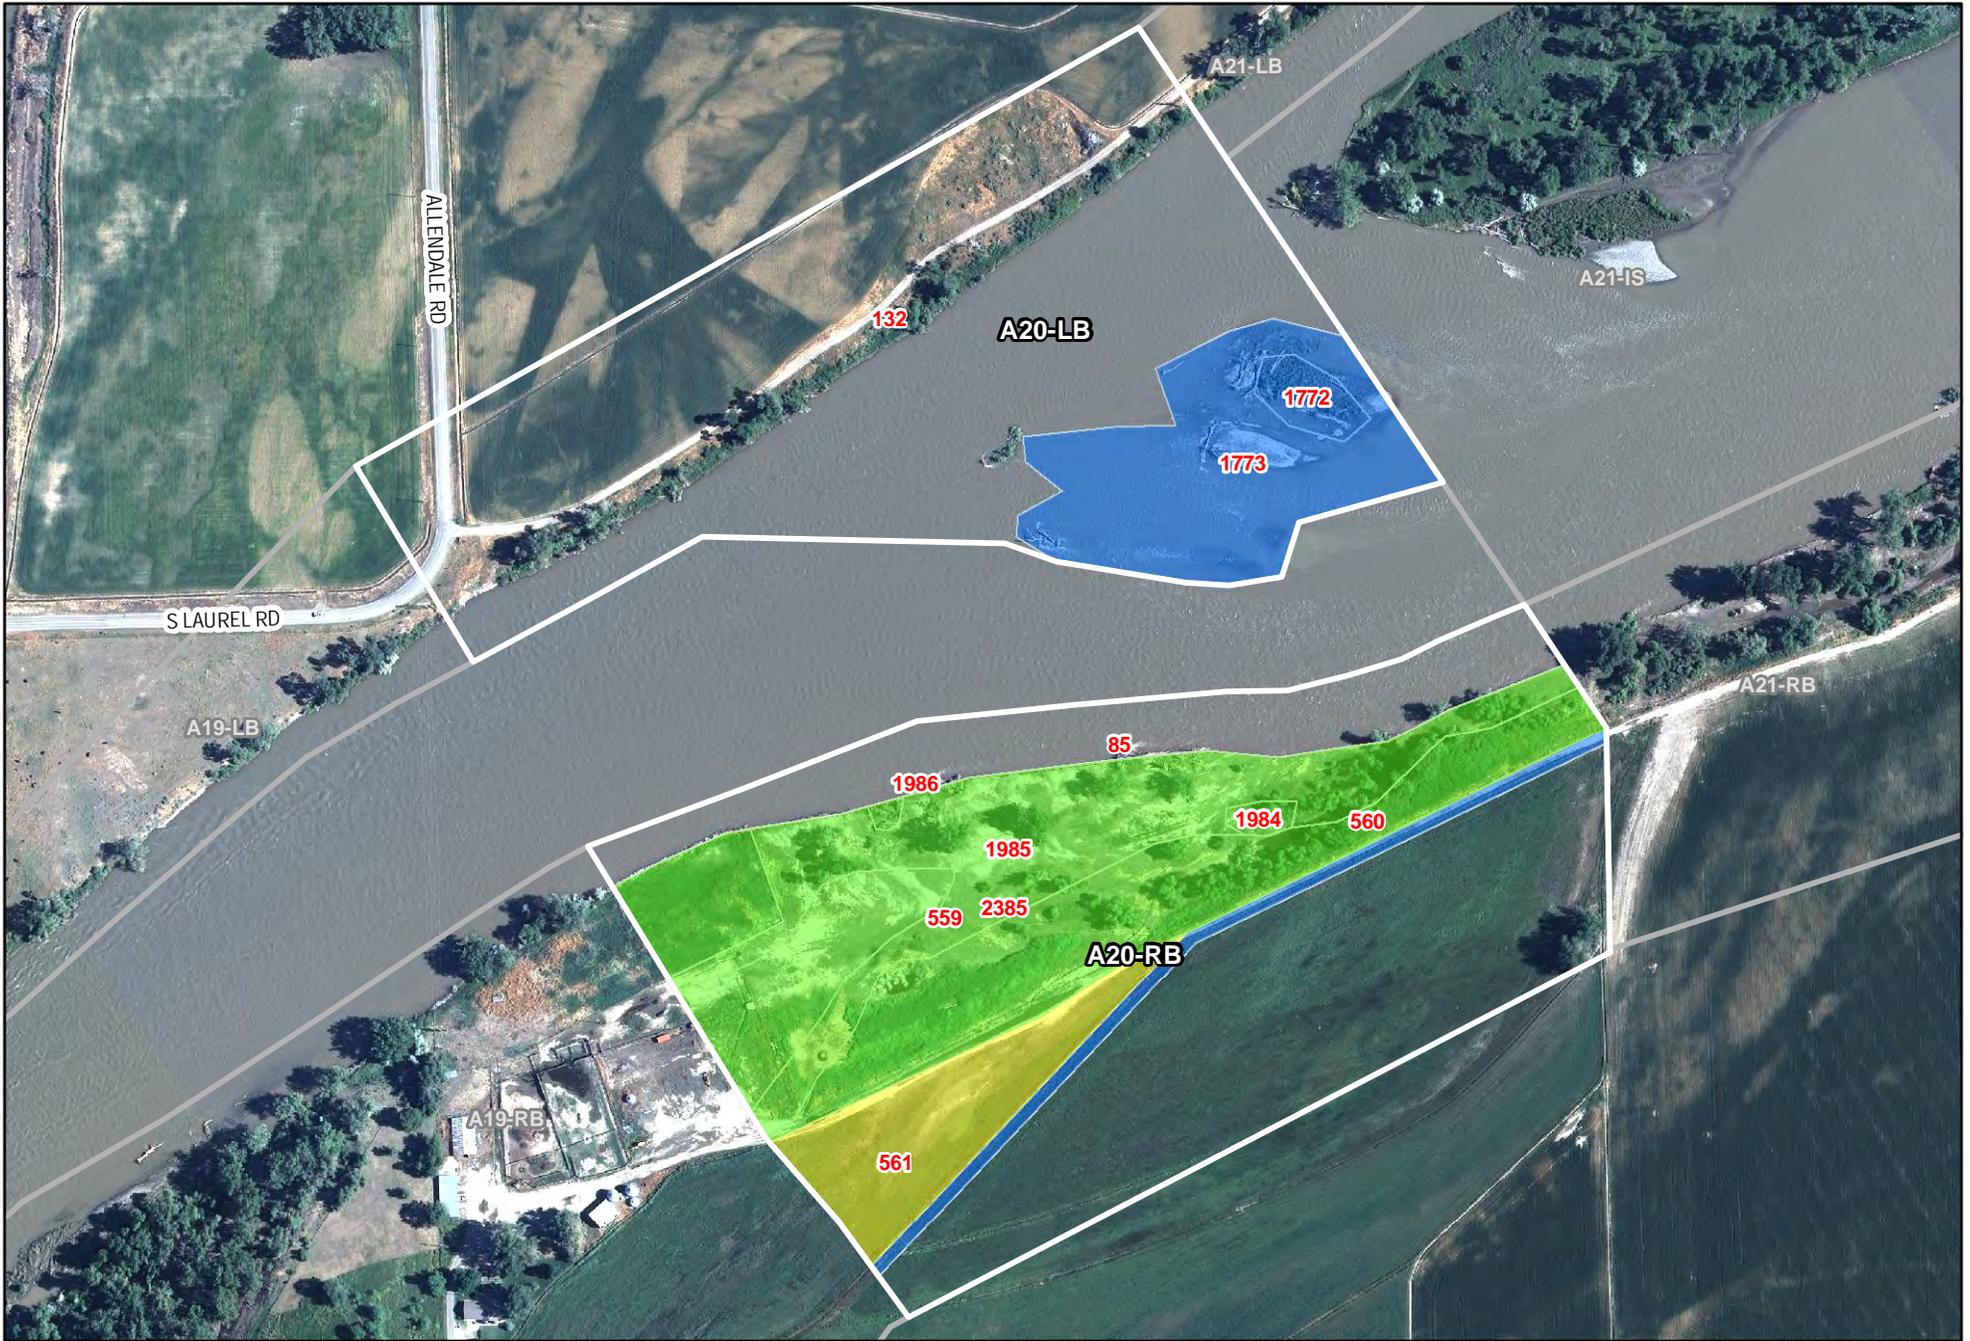
<p>9999 Oiling Zone ID</p> <p>Red Heavy Oiling</p> <p>Yellow Moderate Oiling</p>	<p>Light Green Light Oiling</p> <p>Very Light Green Very Light Oiling</p> <p>Blue No Oil Observed</p>	<p>Figure 5 - Final SCAT Observations</p> <p>For SCAT Area: A20</p>

Figure 5 shows the oiling conditions within Area A20 following completion of oil removal activities. The SCAT team performed final surveys of the right bank within SCAT Area A20 to confirm the agreed-upon cleanup endpoints identified in the applicable CTRs had been achieved. The final SCAT survey documentation is presented in Appendix E.

Based on the final SCAT surveys performed on the right bank within Area A20, no further treatment is recommended for this segment. SCAT Segment Sign-Off Forms are included as Appendix F.

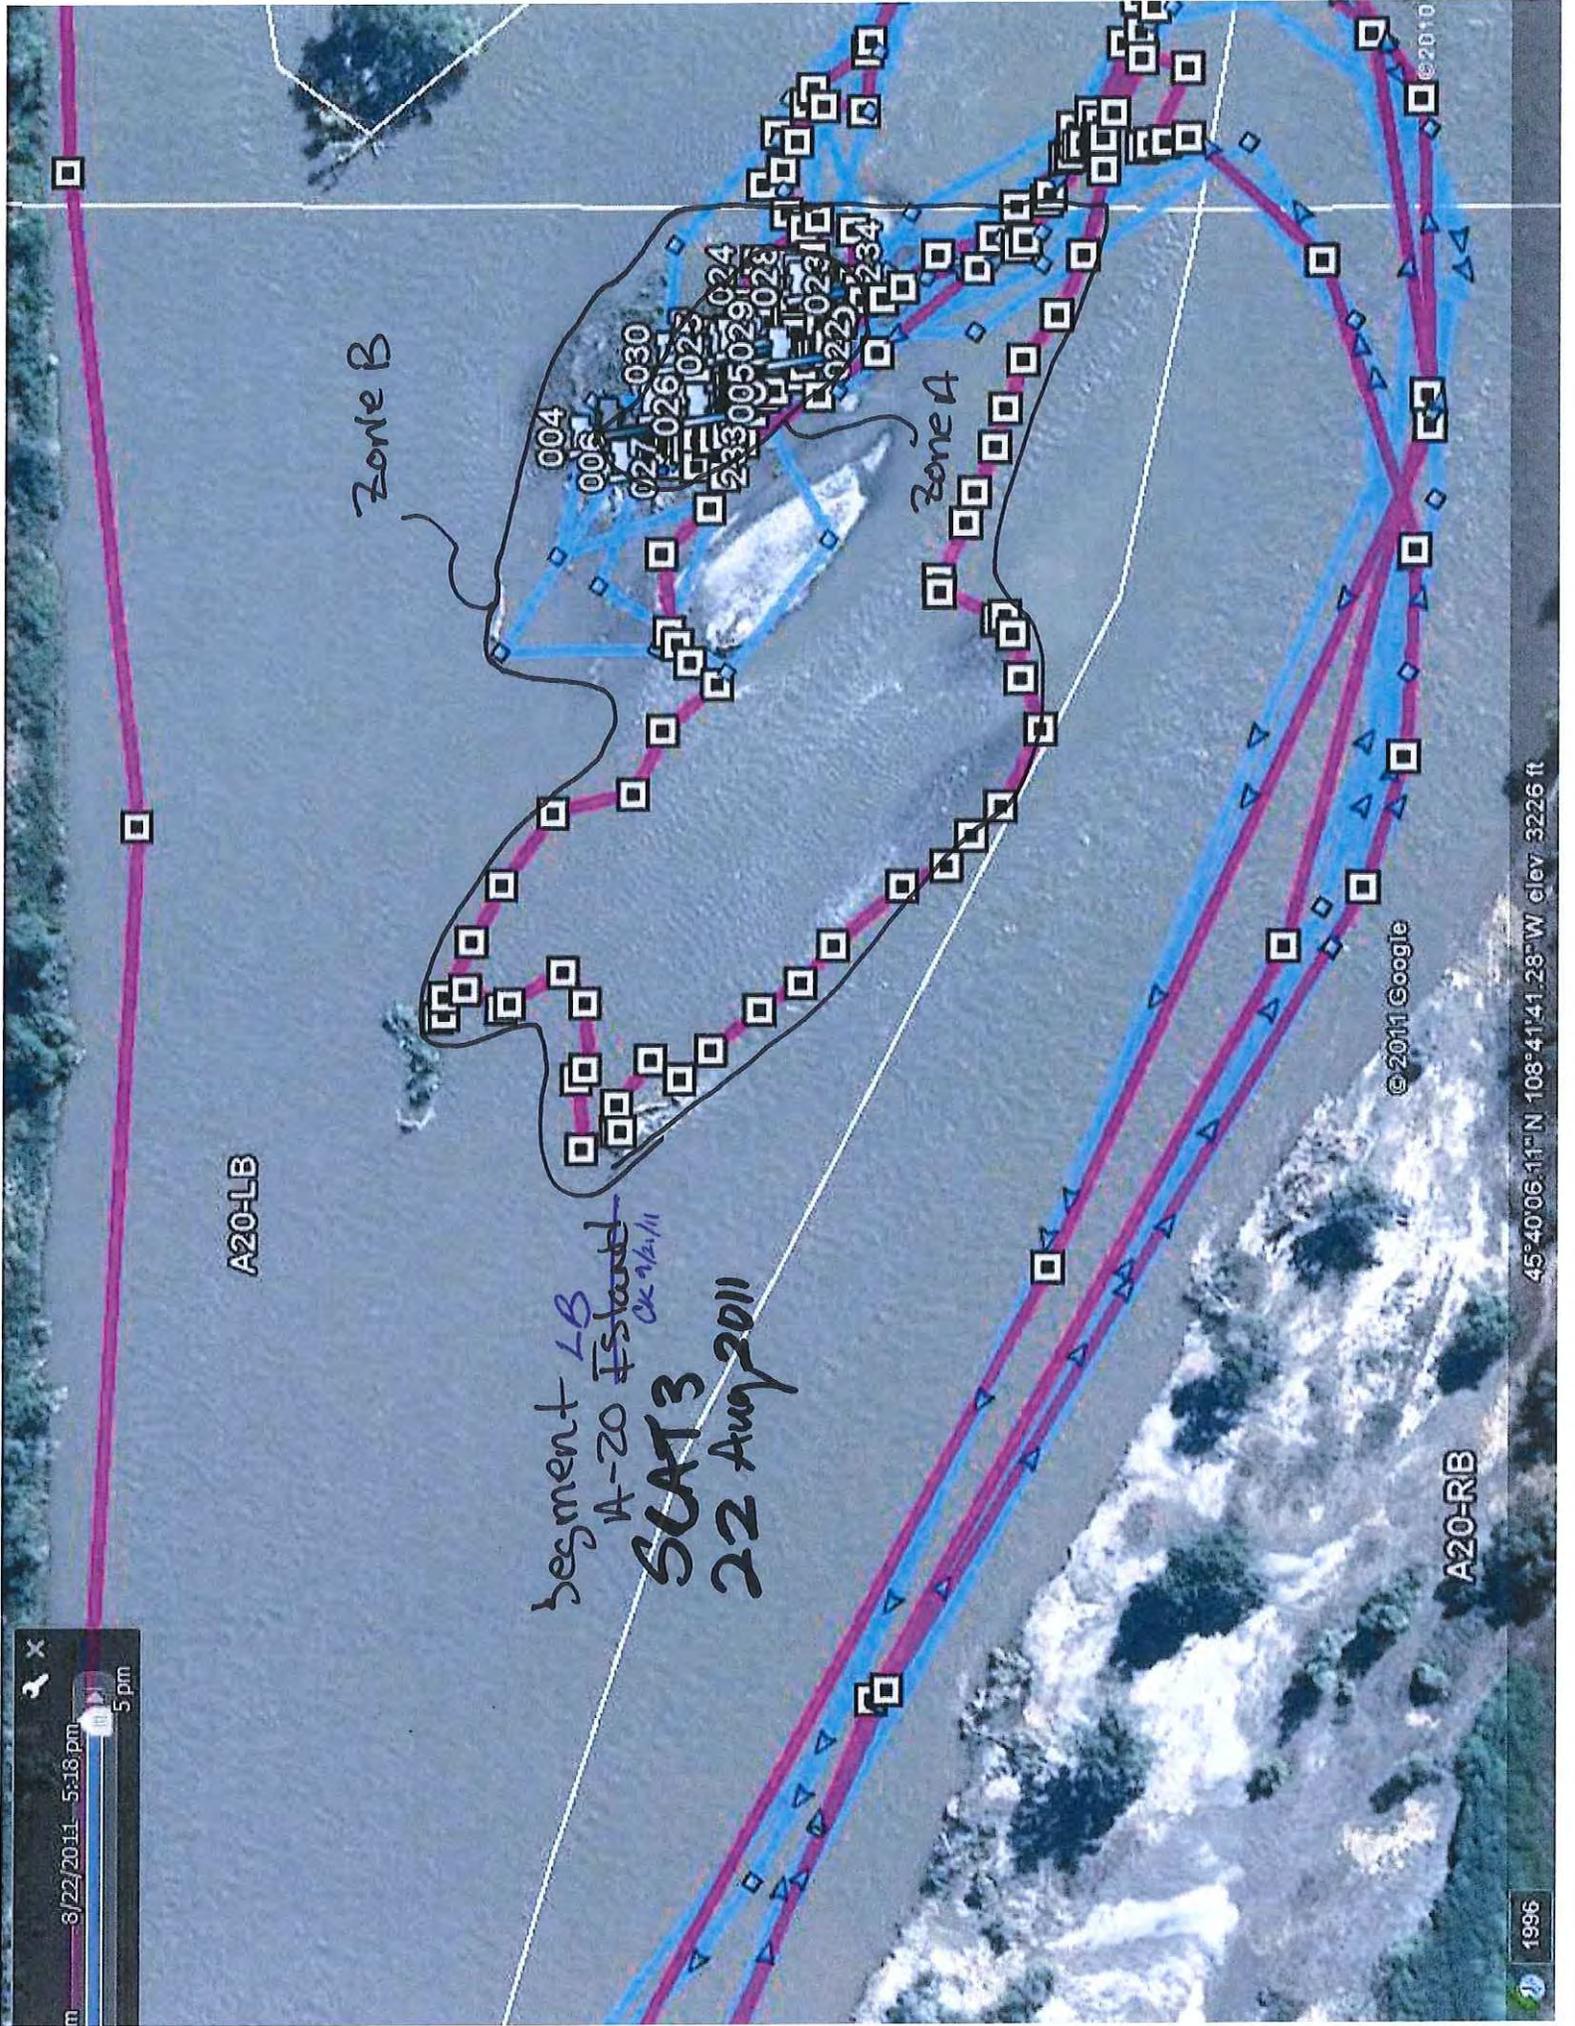
Segment LB
A-20 Estuary
OK 8/21/11
SCAT3
22 Aug 2011

Zone A - COAT oiling on shrubs - we had A Hotshot
 Sporadic
 ops Team who removed ~~the~~ oiled vegetation -
 No further Treatment Required

Zone B - Rest of segment - No oiling observed

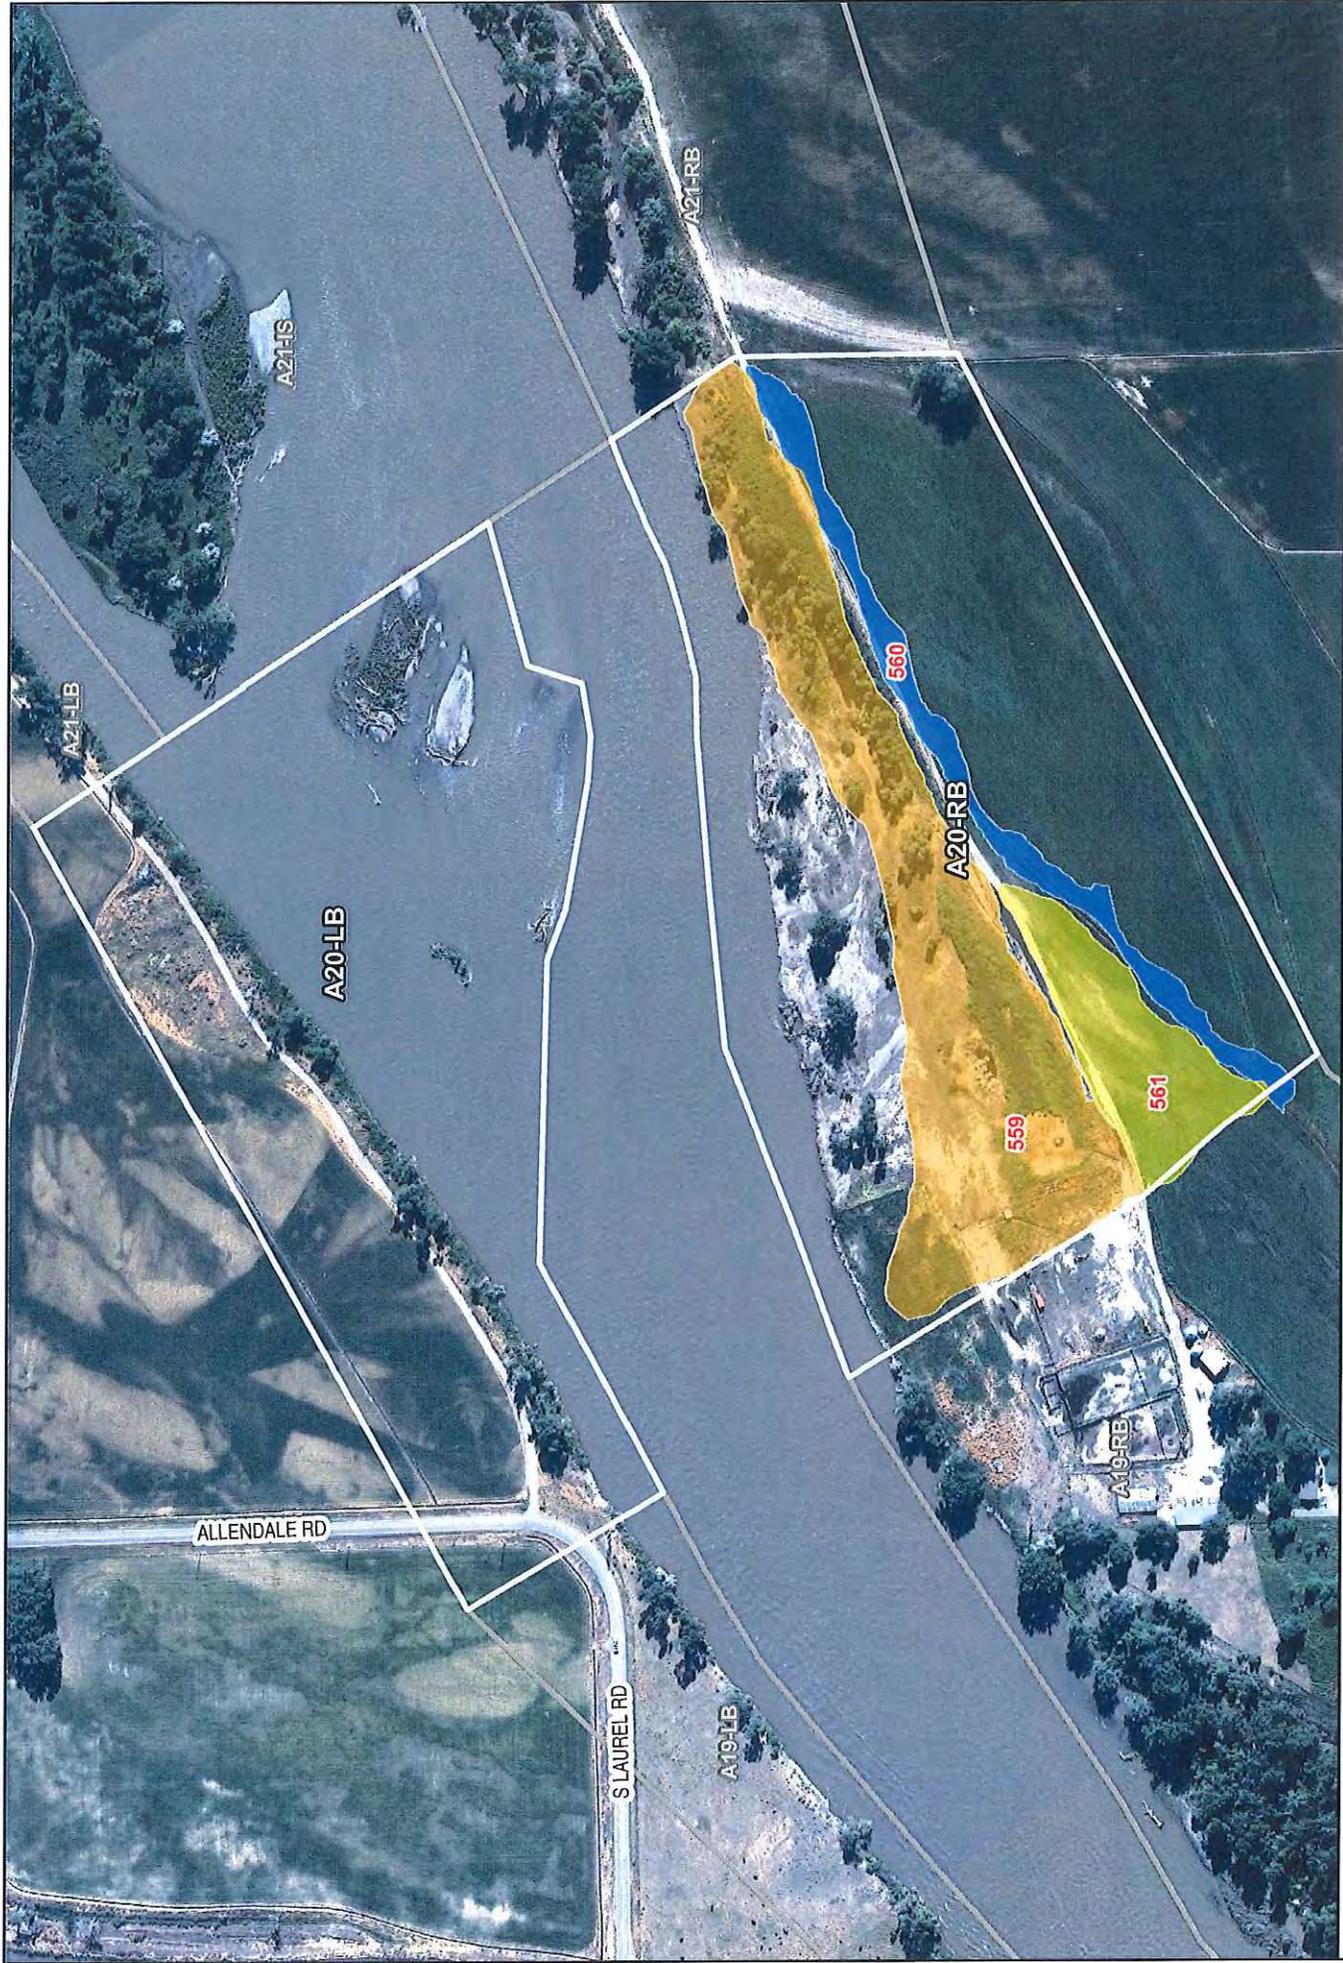
Figure 4 - Maximum SCAT Observations For SCAT Area: A20

Zone A - varied from 187m to 40m wide. Recommend removal of needed vegetation and debris piles

Zone B - No oil

Zone C - Hay field - Recommend cut and Removal of all affected Hay grasses and vegetation

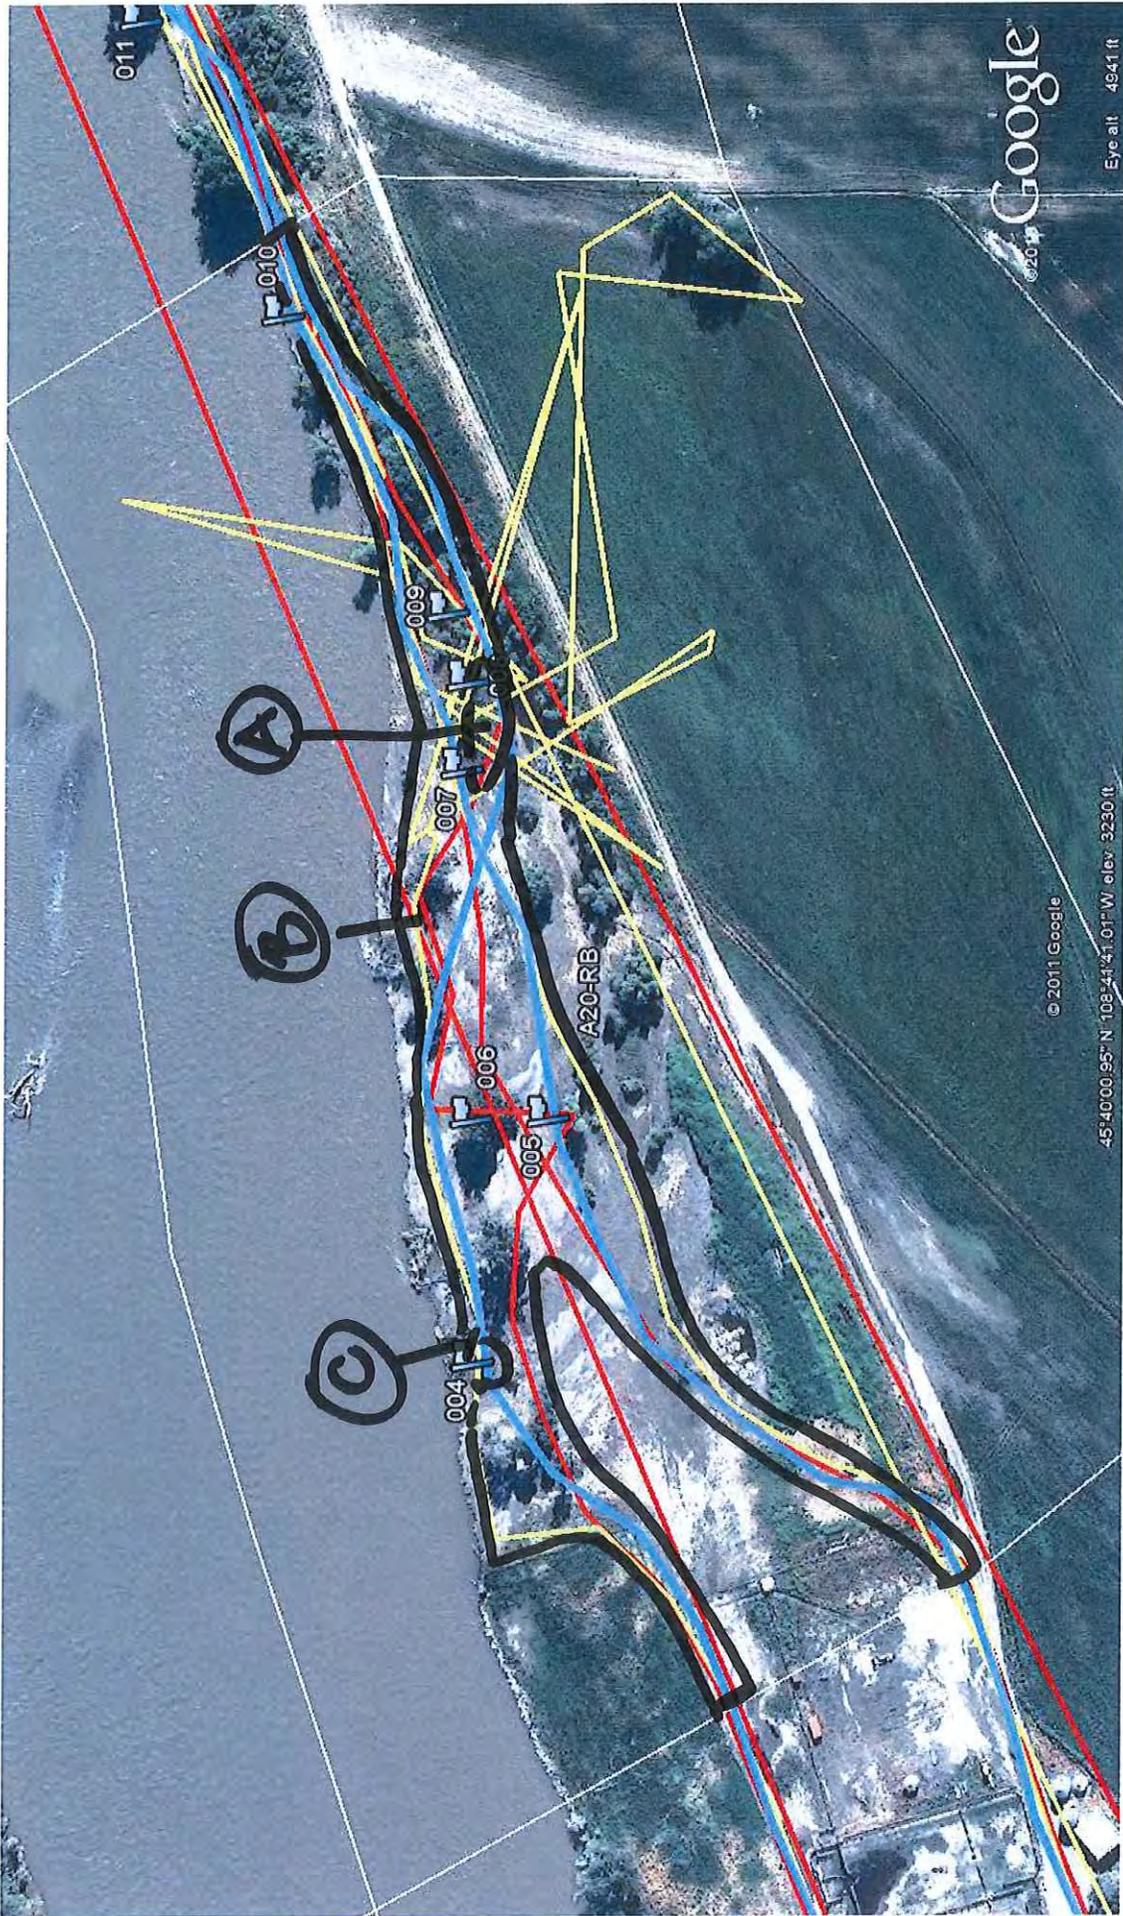
A20-RB
SCAT 4
1 Sept 2011

OILING BAND HEIGHTS (BATH TUB RING)
 OILED HEIGHT: 0.05m - 2.0m

TREATMENT RECOMMENDATIONS:
 ZONES A & C: ATM #1 & ATM #2. ZONE C DEAD VEGETATION. ZONE A INNER, N SIDE OF DRY CREEK

ZONE B: NO FURTHER TREATMENT
