**SCAT Area Transition Report for
A20**

Silvertip Pipeline Incident
Laurel, Montana

October 18, 2011

Prepared by:
ARCADIS G&M of North Carolina, Inc.
11000 Regency Parkway
West Tower, Suite 205
Cary, North Carolina 27518-8518
Tel 919.469.1952
Fax 919.469.5676

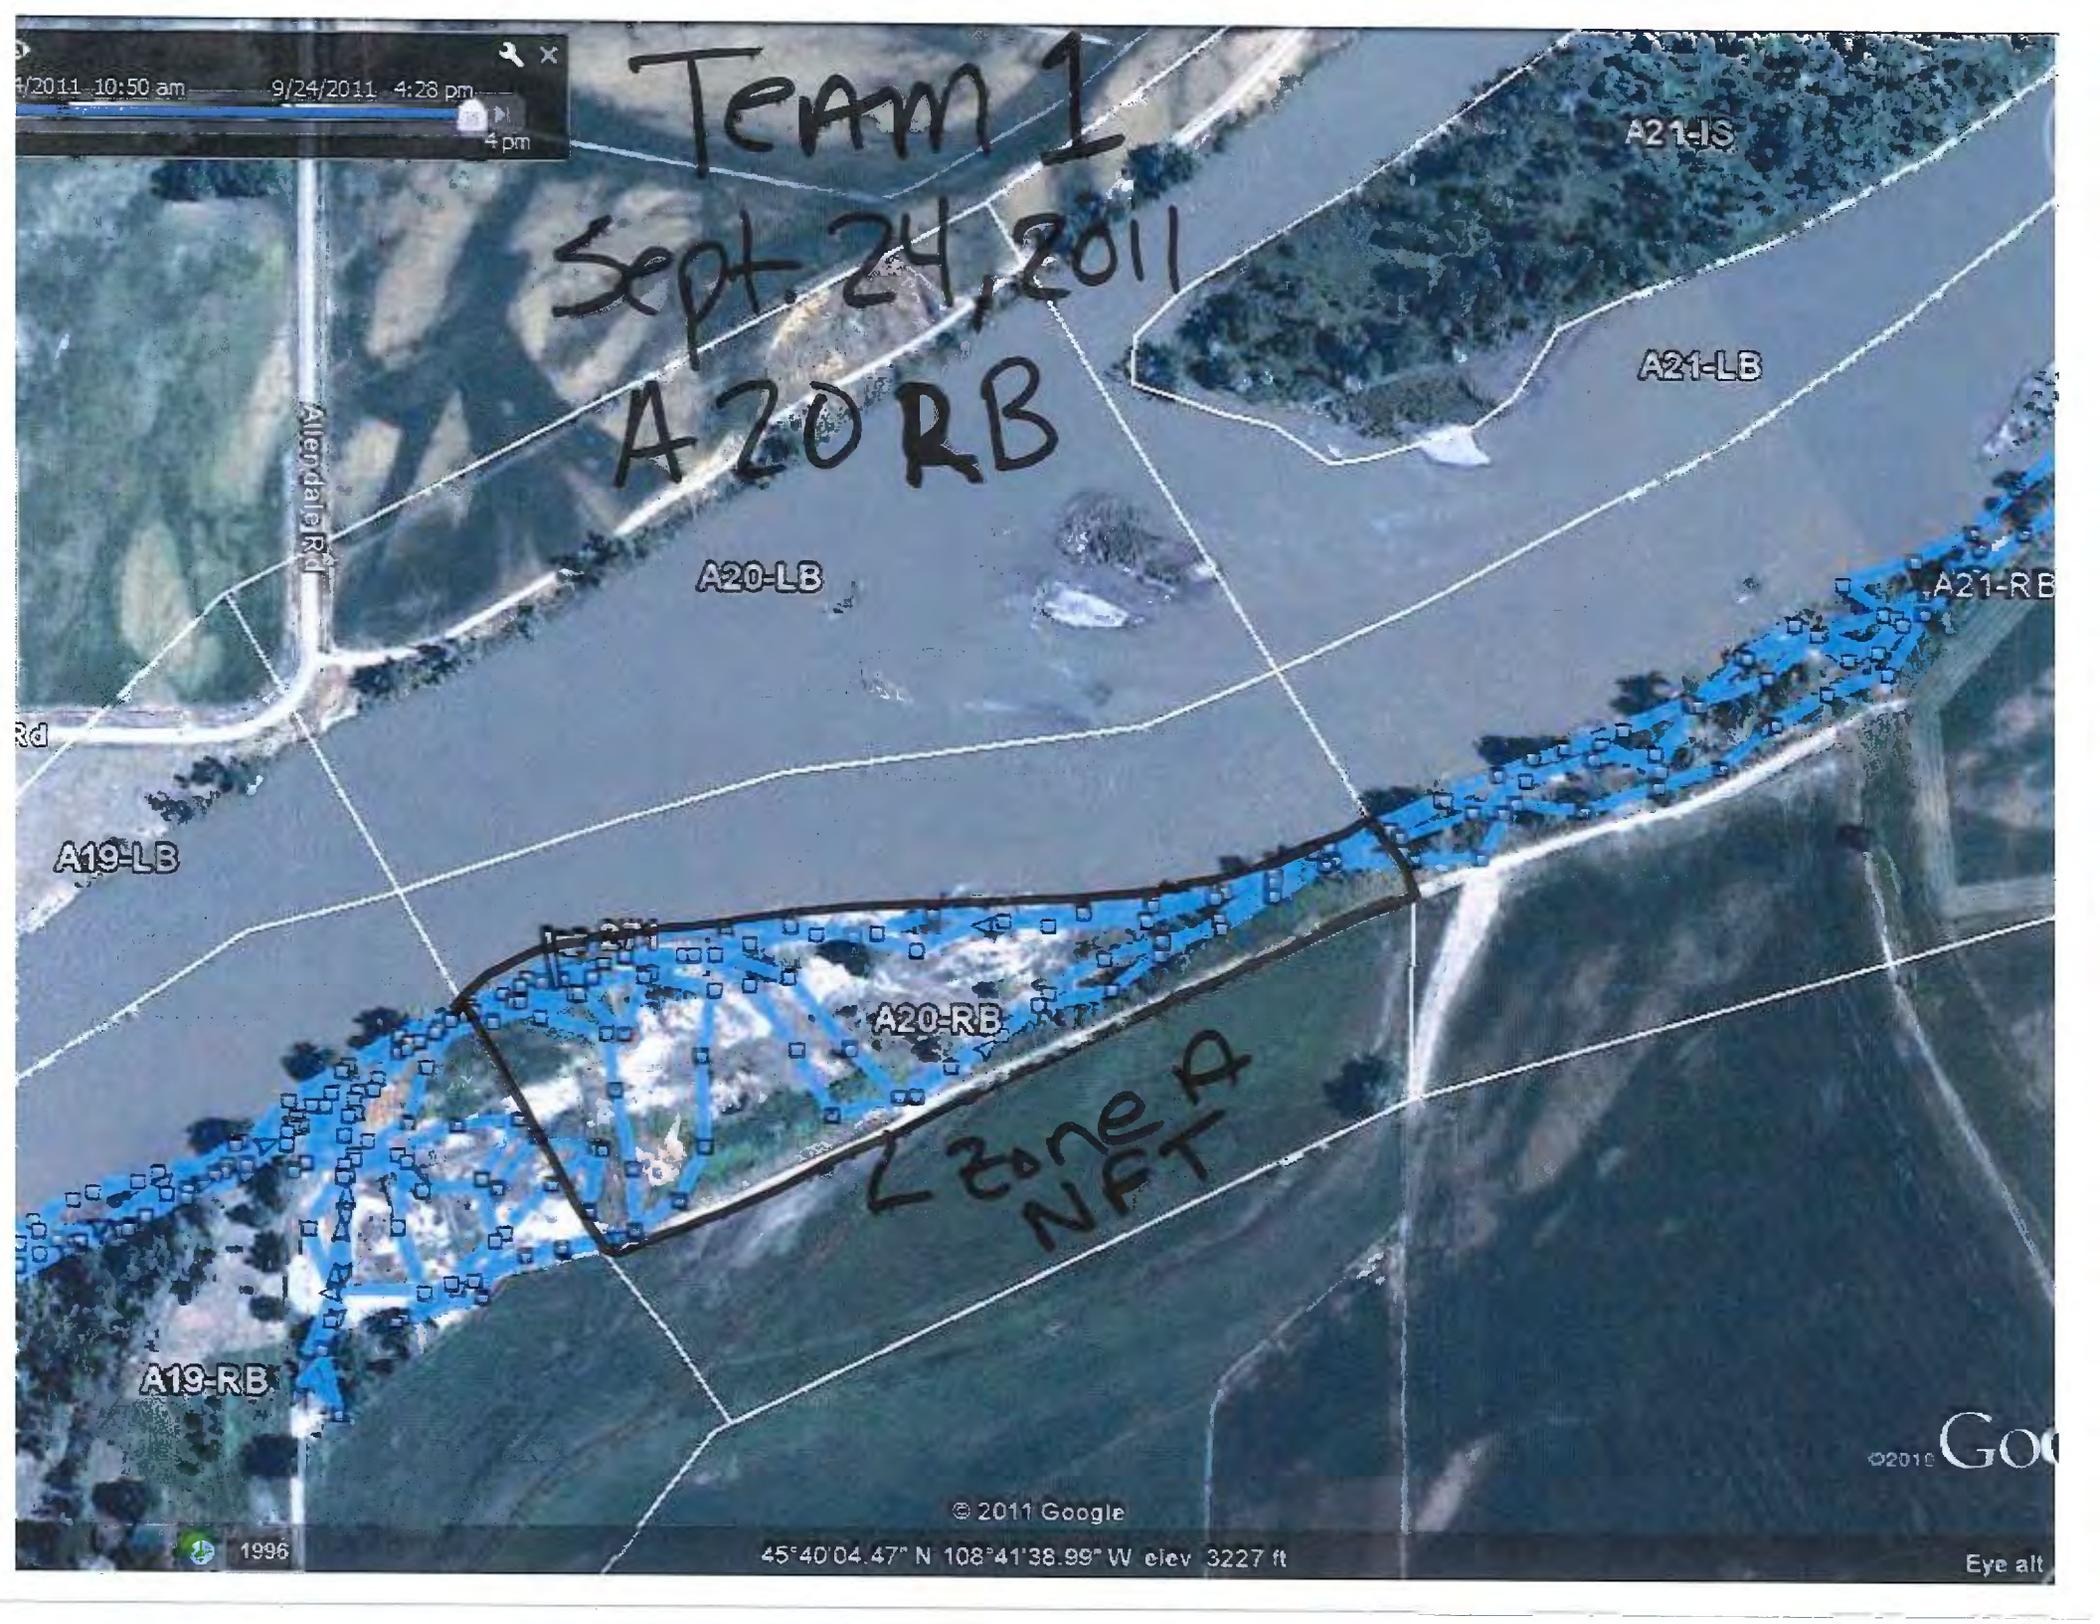
Located sporadic cont a stain on vegetation & debris. Hot shot crew removed or treated oiled material. No further Treatment Required (NFT).
