**SCAT Area Transition Report for
B22**

Silvertip Pipeline Incident
Laurel, Montana

October 21, 2011

Our Ref.:
B0085883.1103

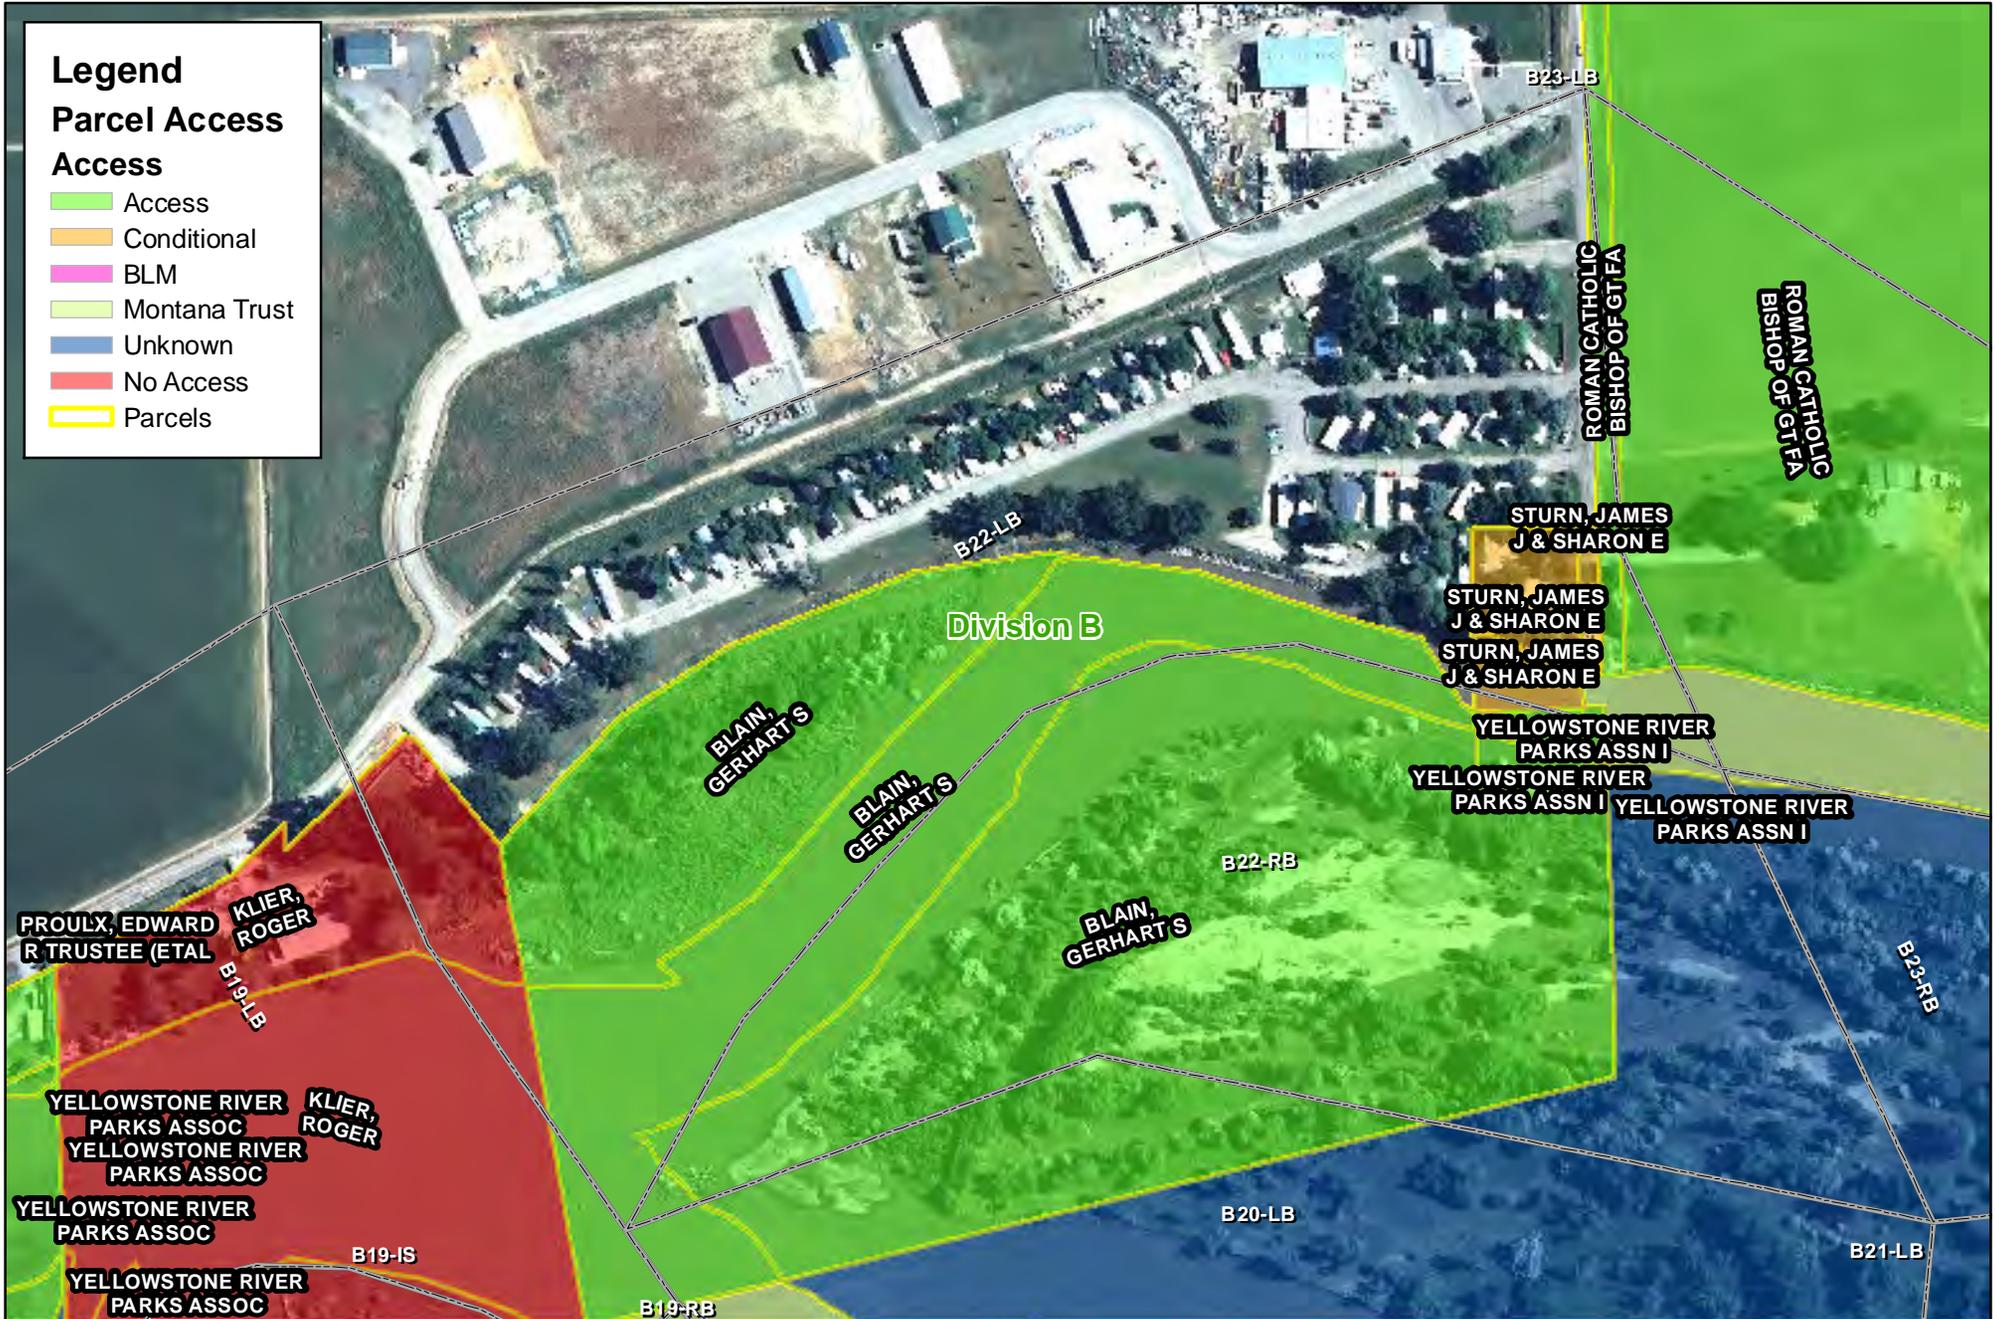
Figure 1 provides an aerial map of SCAT Area B22, along with the (a) SCAT Area boundary, (b) parcel boundaries and respective property owners, and (c) access constraints identified during the oil cleanup process. The acreage surveyed in Area B22 is 17.3. There was a partial access issue for the left bank.

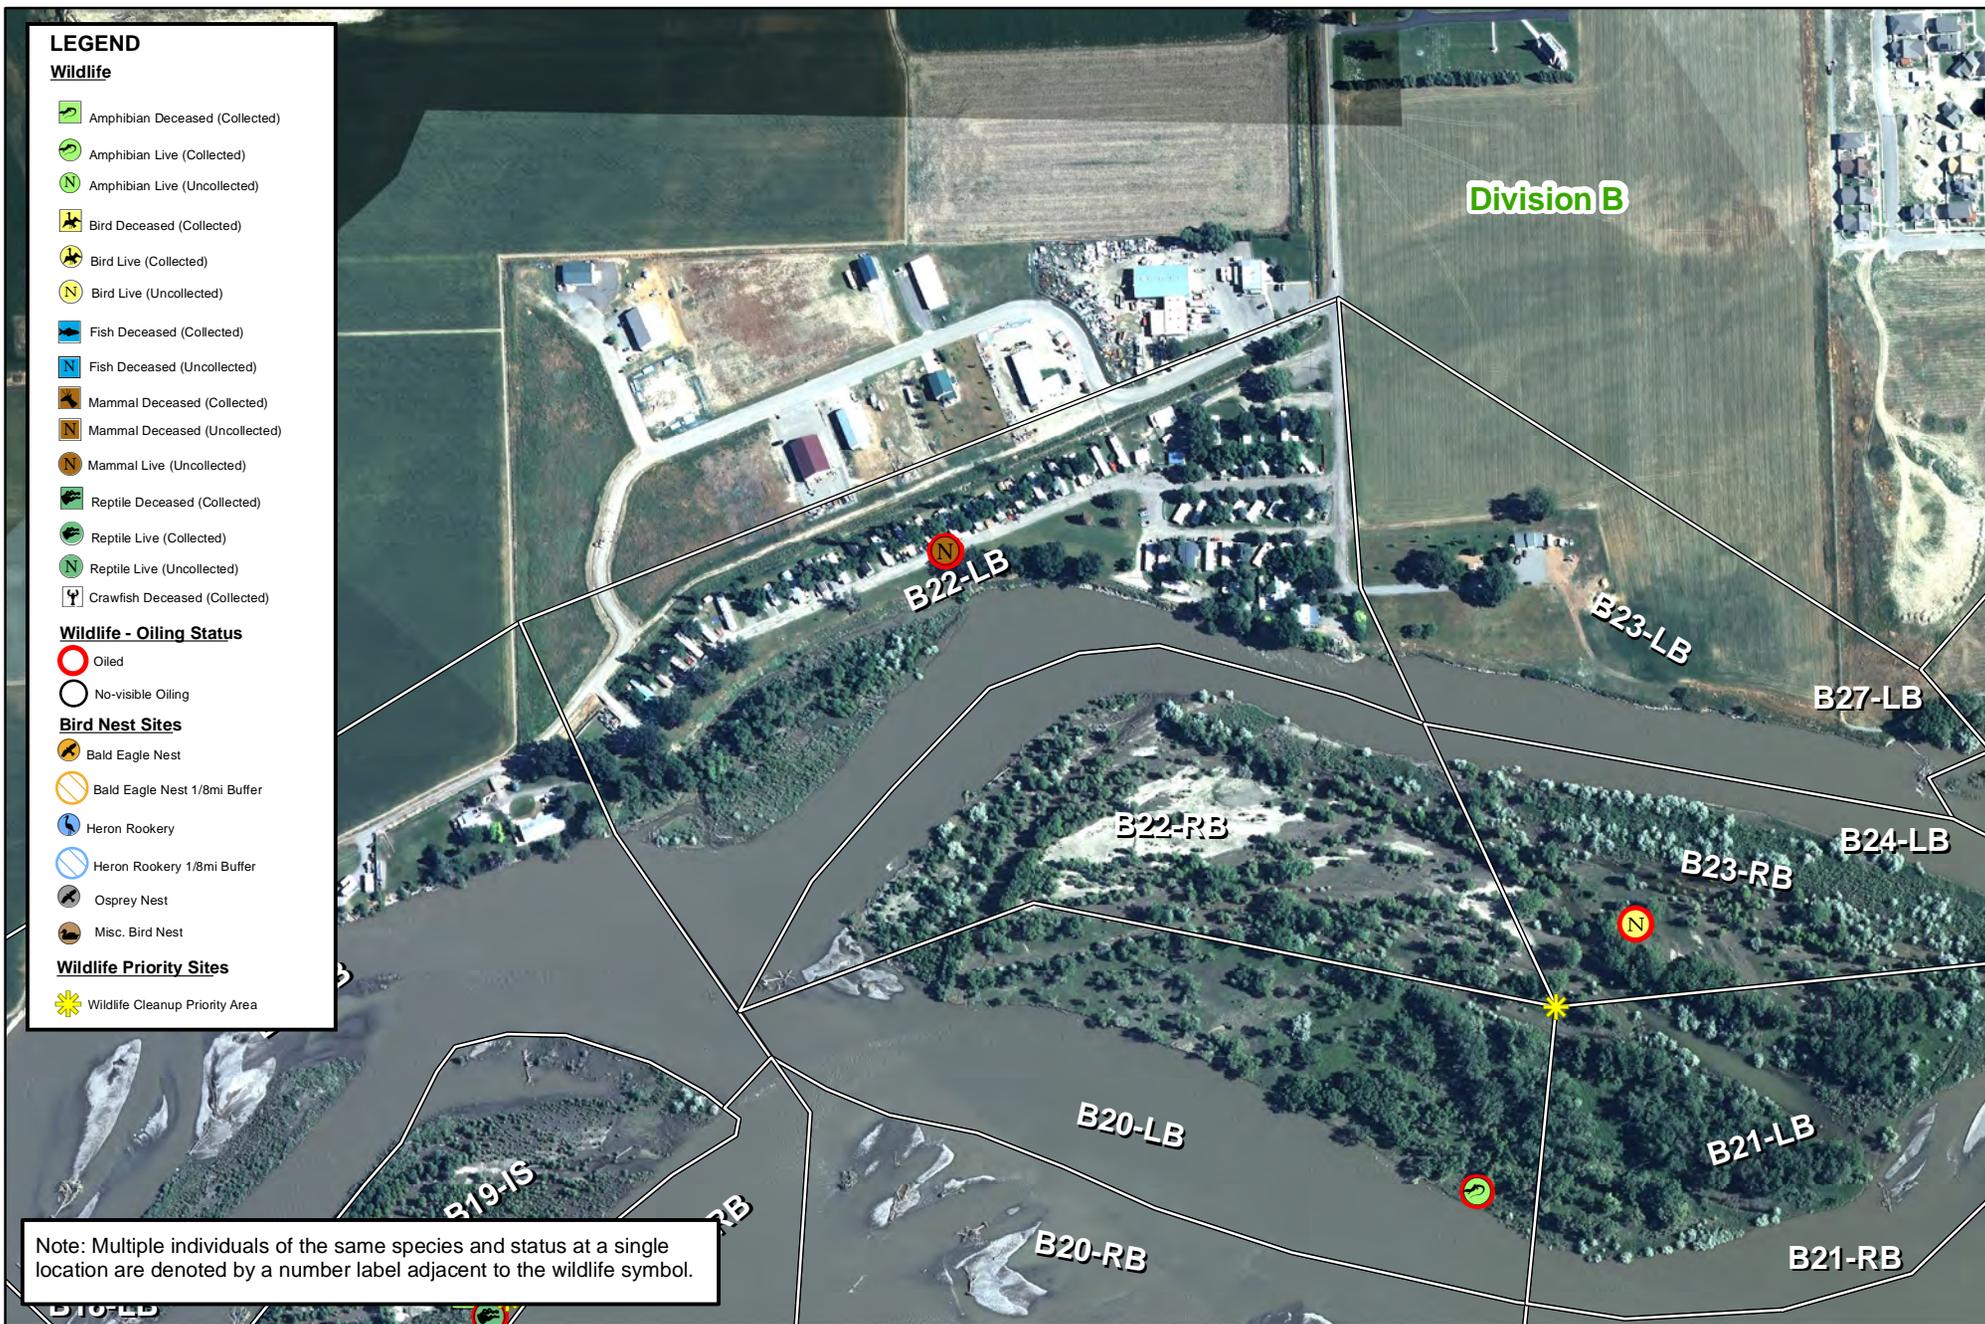
Figure 2
Wildlife Resources

Figure 2 summarizes the natural resources identified in this segment. International Bird Rescue and Resource Advisors from U.S. Fish and Wildlife Service conducted regular inspections of Area B22. One possibly oiled otter (*Lontra canadensis*) was reported by the public; this animal was not subsequently observed by incident response biological staff. A Wildlife Priority Cleanup Area (WPCA) was identified that encompassed the four segments that make up the B20 Island (B20-LB, B21-LB, B22-RB, and B23-RB). The WPCA consisted of several areas of transferable oil located across the B20 Island. The WPCA was treated to reduce the potential for wildlife oiling and is no longer considered a wildlife hazard. No active migratory bird nests were identified in Area B22.

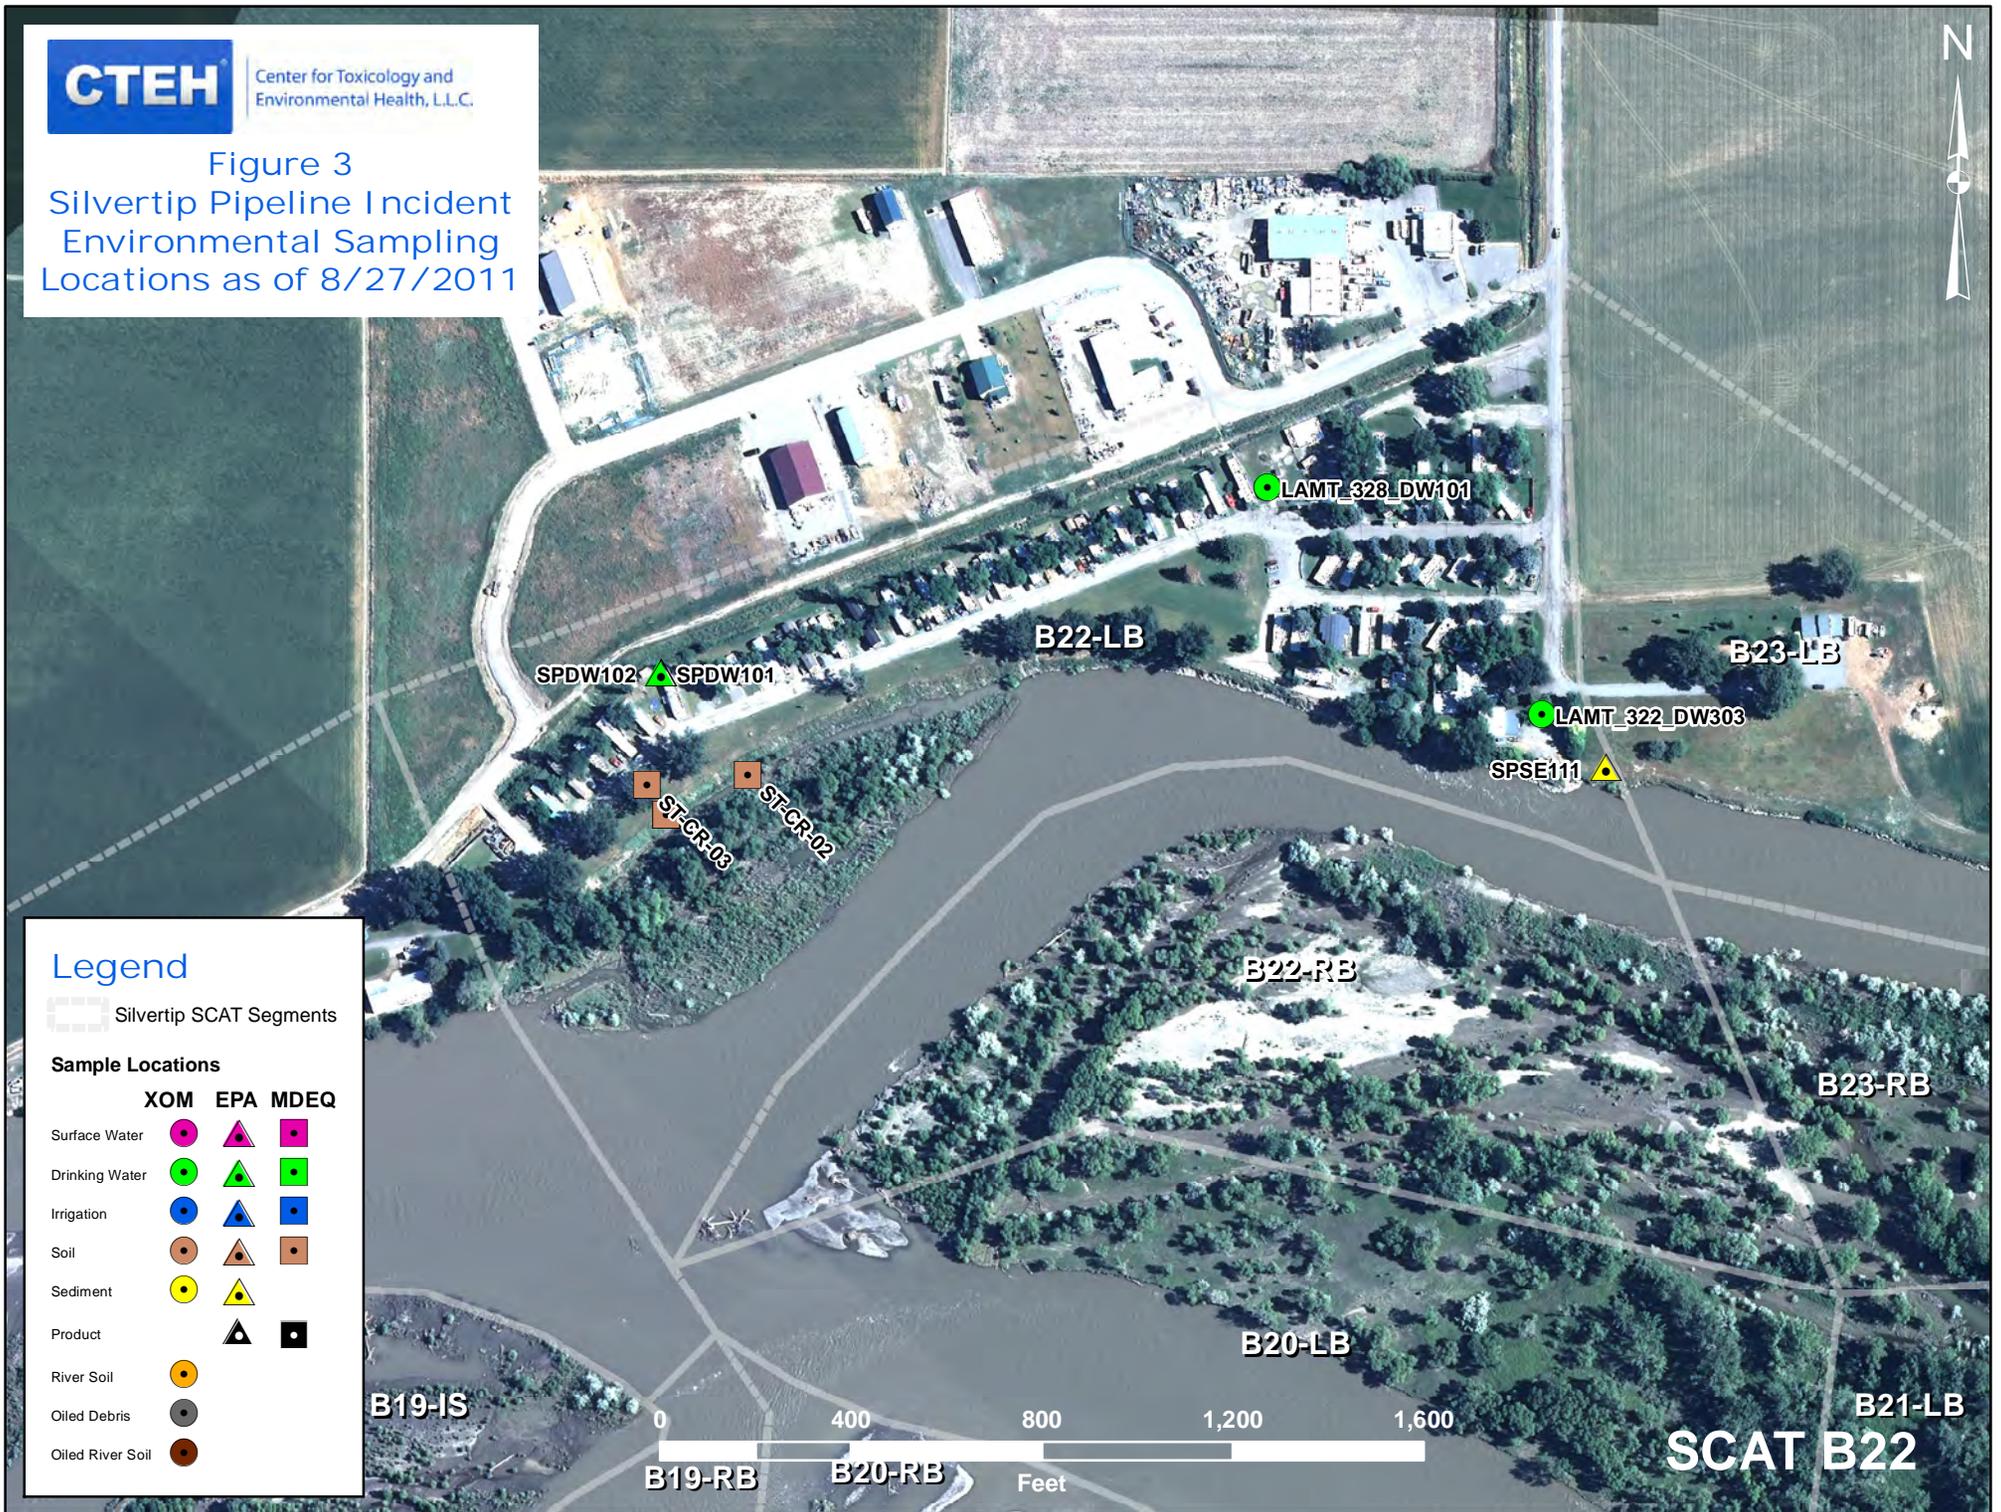
Figure 3
Silvertip Pipeline Incident
Environmental Sampling
Locations as of 8/27/2011

Table 1 (below) summarizes samples collected within Area B22. The analytical results for the samples collected can be accessed through a publicly accessible database on the United States Environmental Protection Agency's (USEPA's) website. The approximate locations of samples collected within Area B22 are provided on Figure 3.

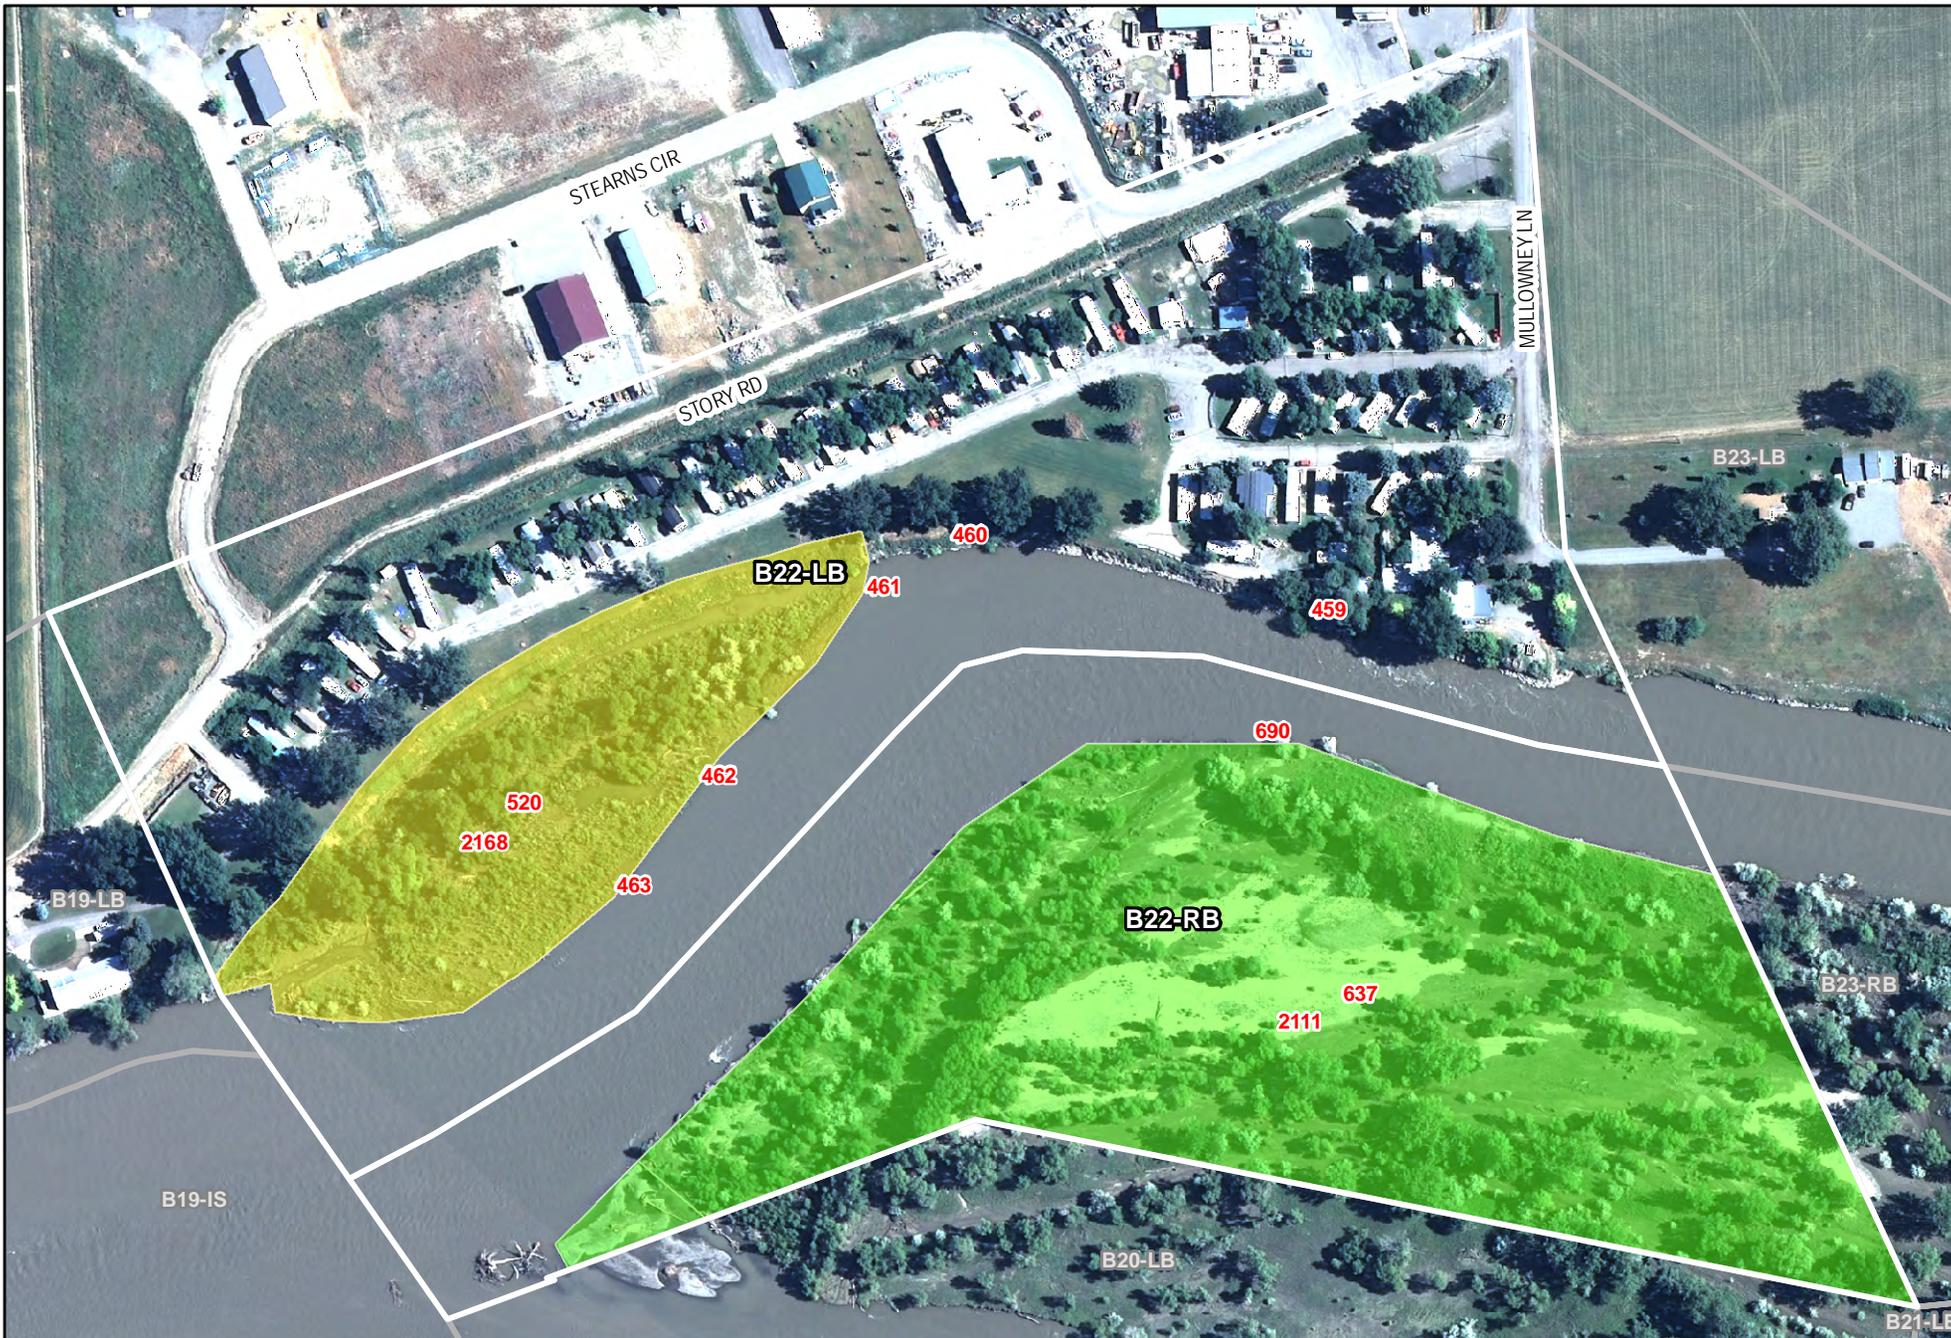
Figure 4 - Maximum SCAT Observations For SCAT Area: B22

The SCAT teams used systematic evaluation criteria and treatment method tables approved by the National Oceanic and Atmospheric Administration to provide a standard approach for data collection and conducting field surveys. The forms and sketches from the initial SCAT surveys performed along the river bank (water edge) and floodplain within Area B22 are included in Appendix B. Figure 4 provides the maximum oiling zones observed by the SCAT team during the initial surveys of Area B22.

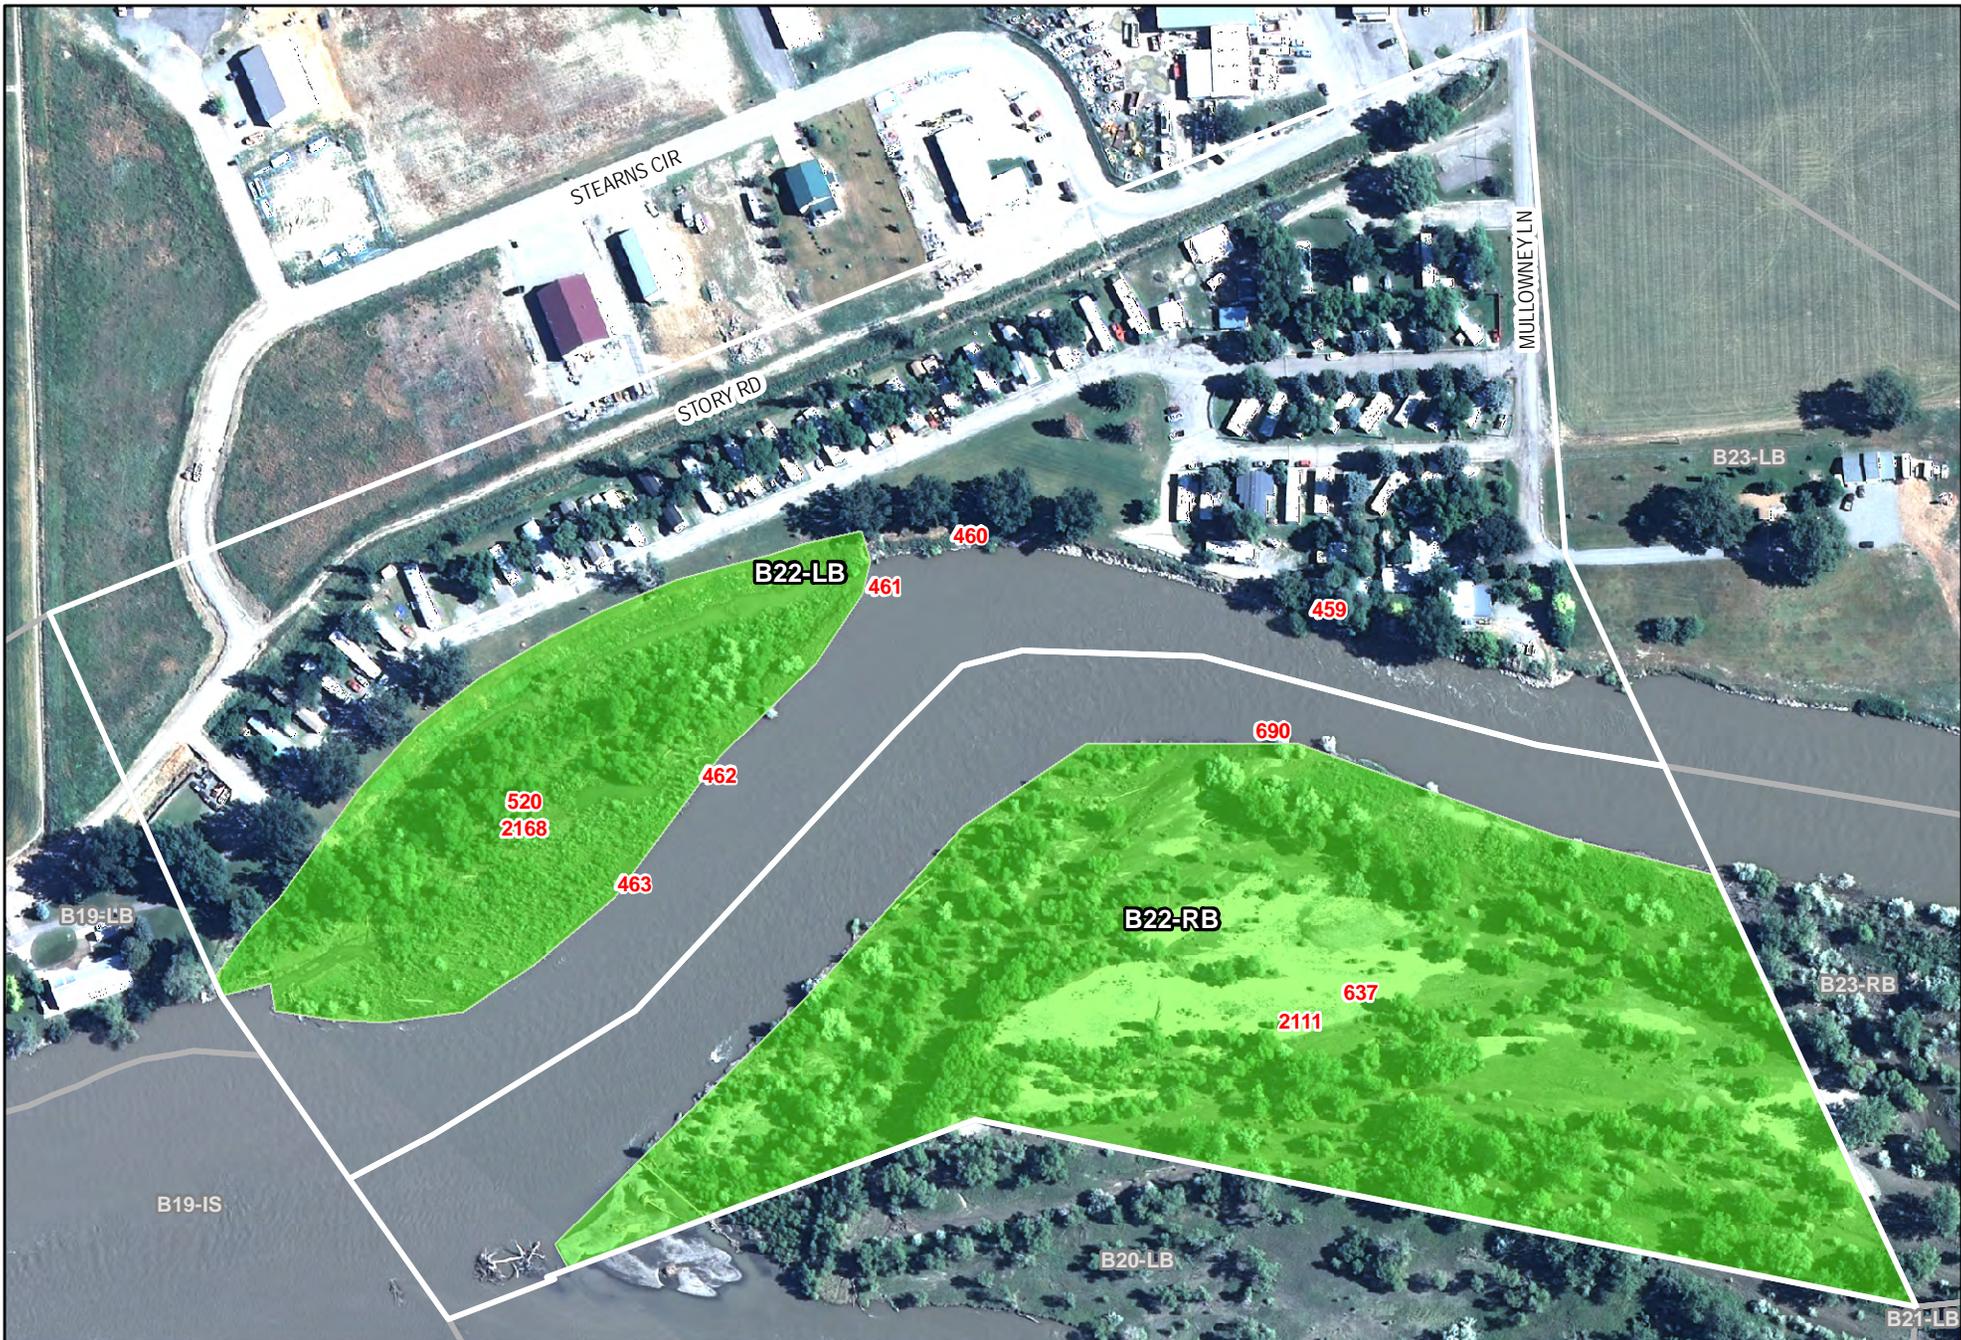
**Figure 5 - Final SCAT Observations
For SCAT Area:**

Figure 5 shows the oiling conditions within Area B22 following completion of oil removal activities. The SCAT team performed final surveys of the left and right banks within SCAT Area B22 to confirm the agreed-upon cleanup endpoints identified in the applicable CTRs had been achieved. The final SCAT survey documentation is presented in Appendix E.

Based on the final SCAT surveys performed on the left and right banks within Area B22, no further treatment is recommended for these segments. SCAT Segment Sign-Off Forms are included as Appendix F.

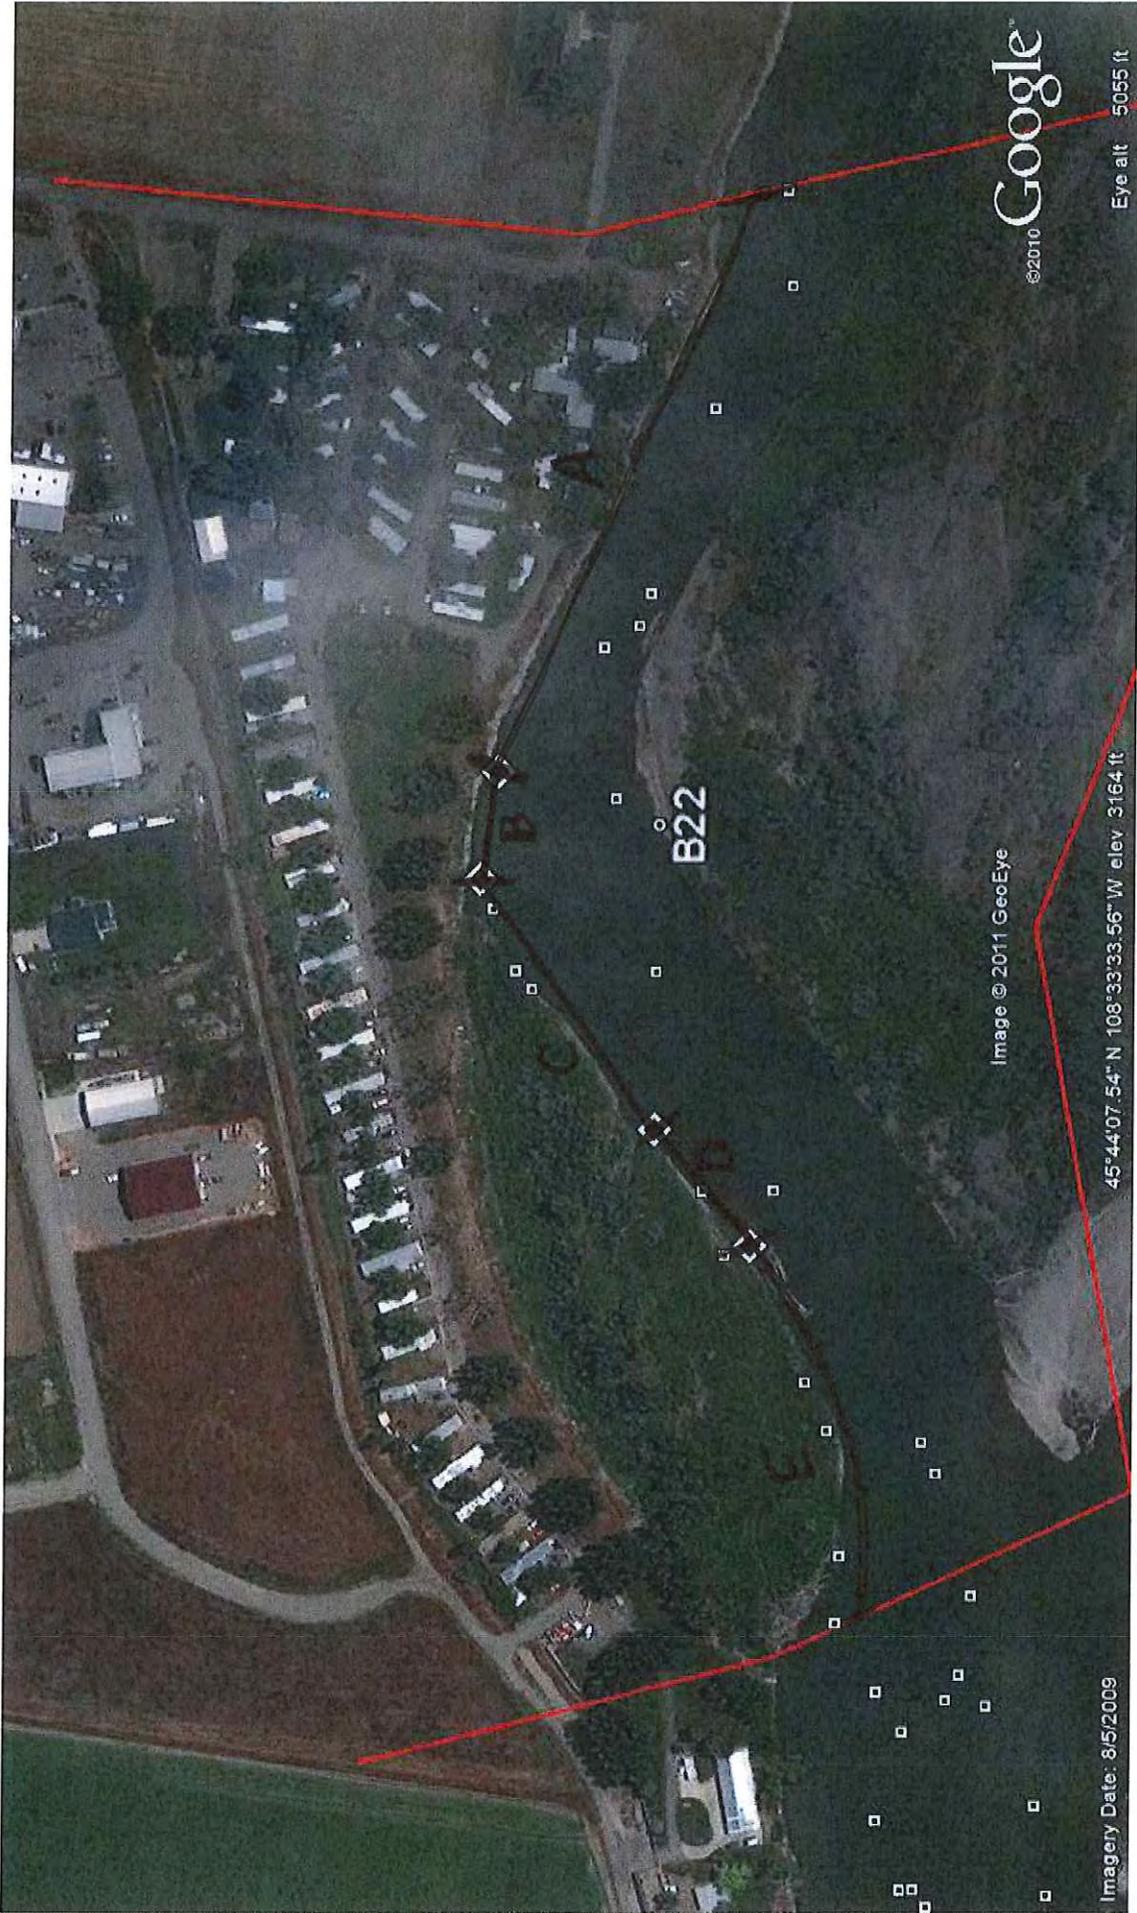
B22

Oil band heights: Zone B, D - 30cm

Oil band heights: Zone B - 30cm

Treatment Recommendations:
 Zone A, C, E: No oil observed; no treatment required.
 Zone B, D: Cut & remove oil coated vegetation smaller than 1" diameter. Wipe larger oil coated vegetation.

Zone A, C: Cut & remove oil coated vegetation smaller than 1" diameter. Wipe larger oil coated vegetation.

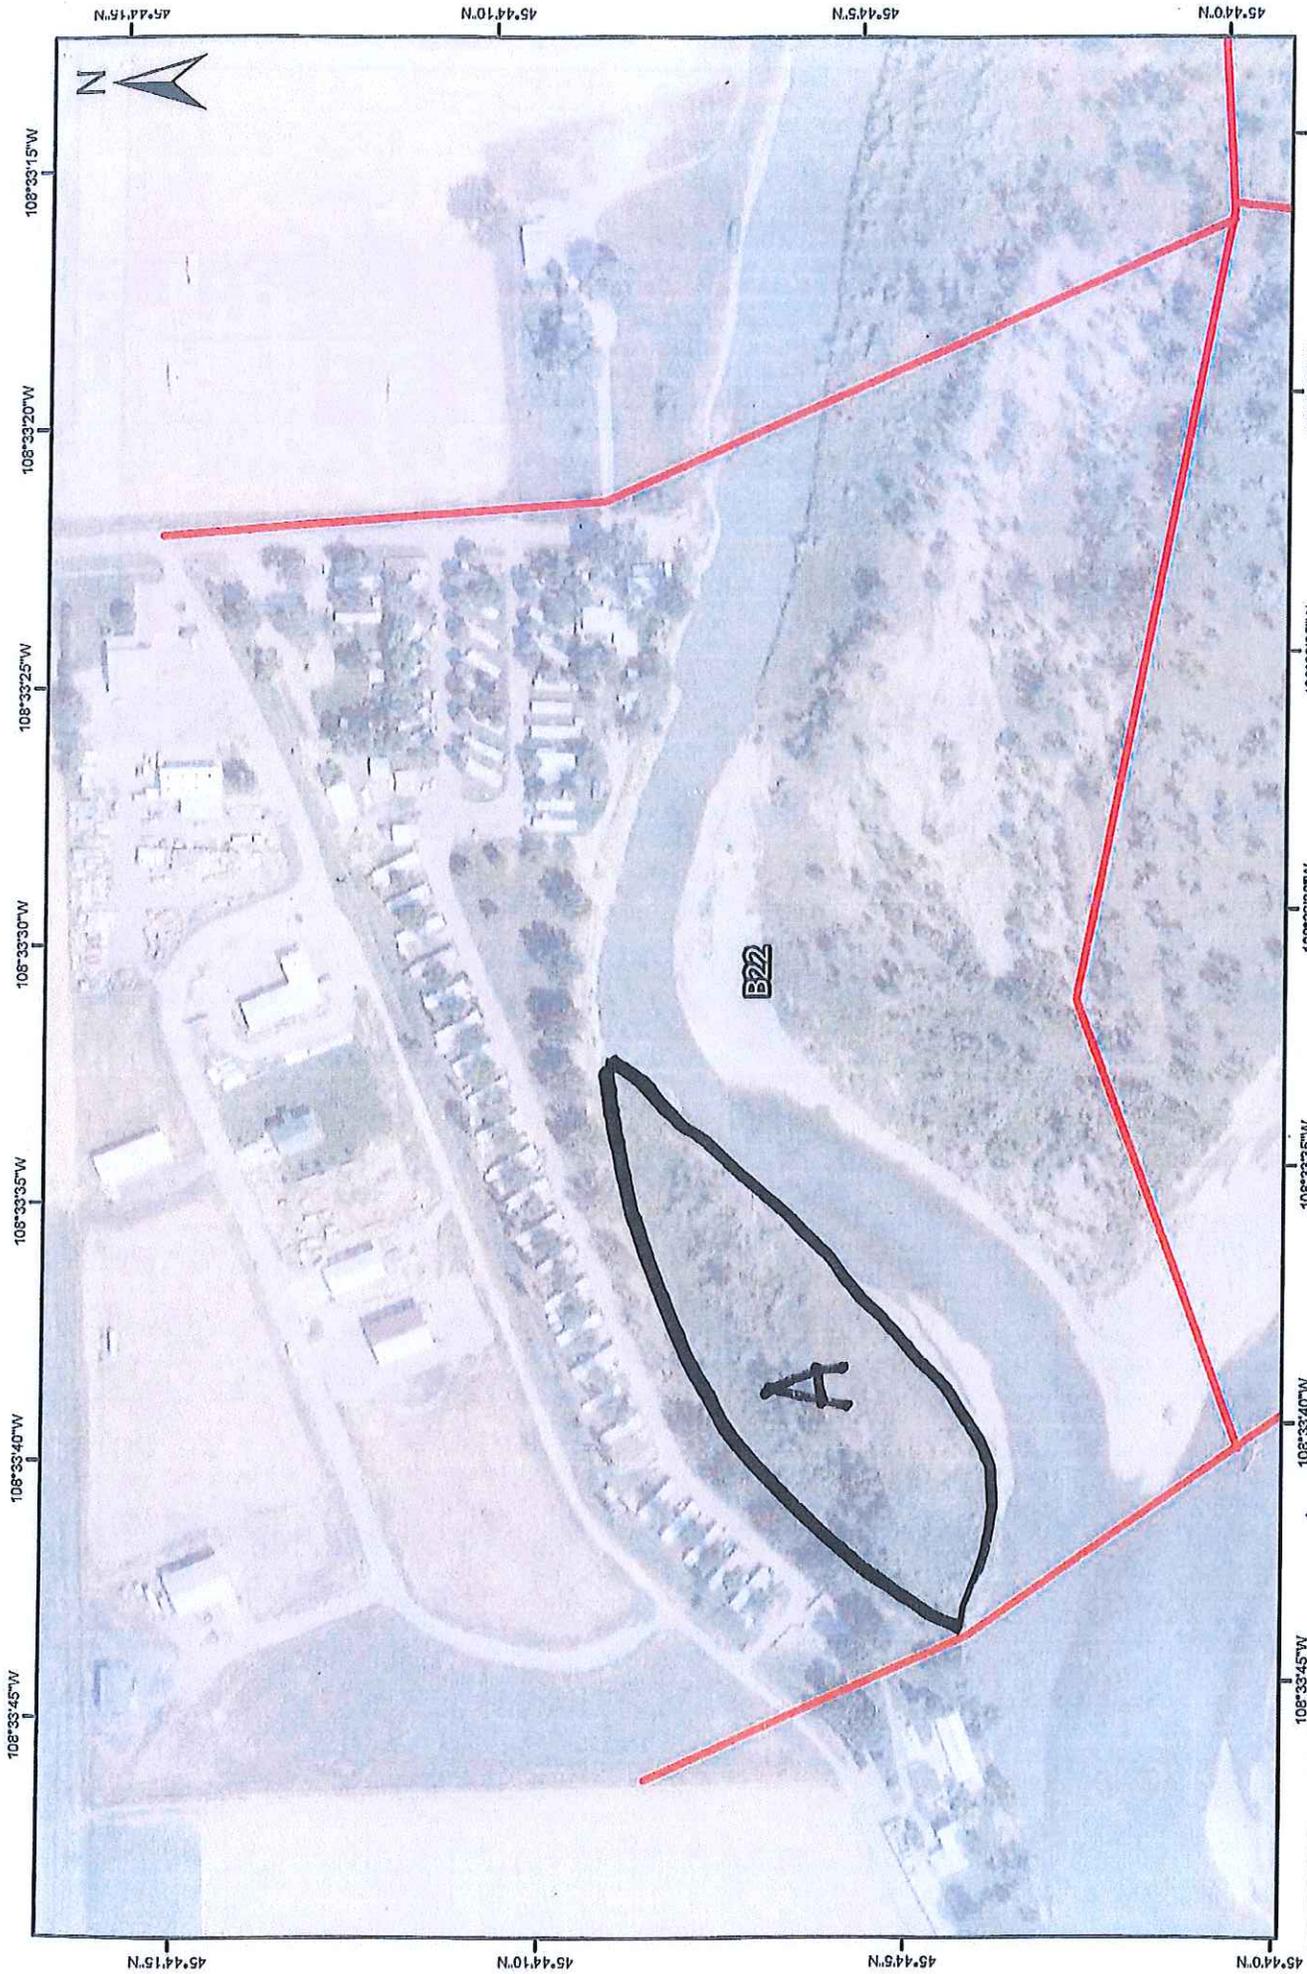
B22 -
 (L/R/I)??

Oil Zone A: Recommend low priority coated debris pile removal at N 45° 44.123' N 108° 33.624' W. Marked with pink tape.

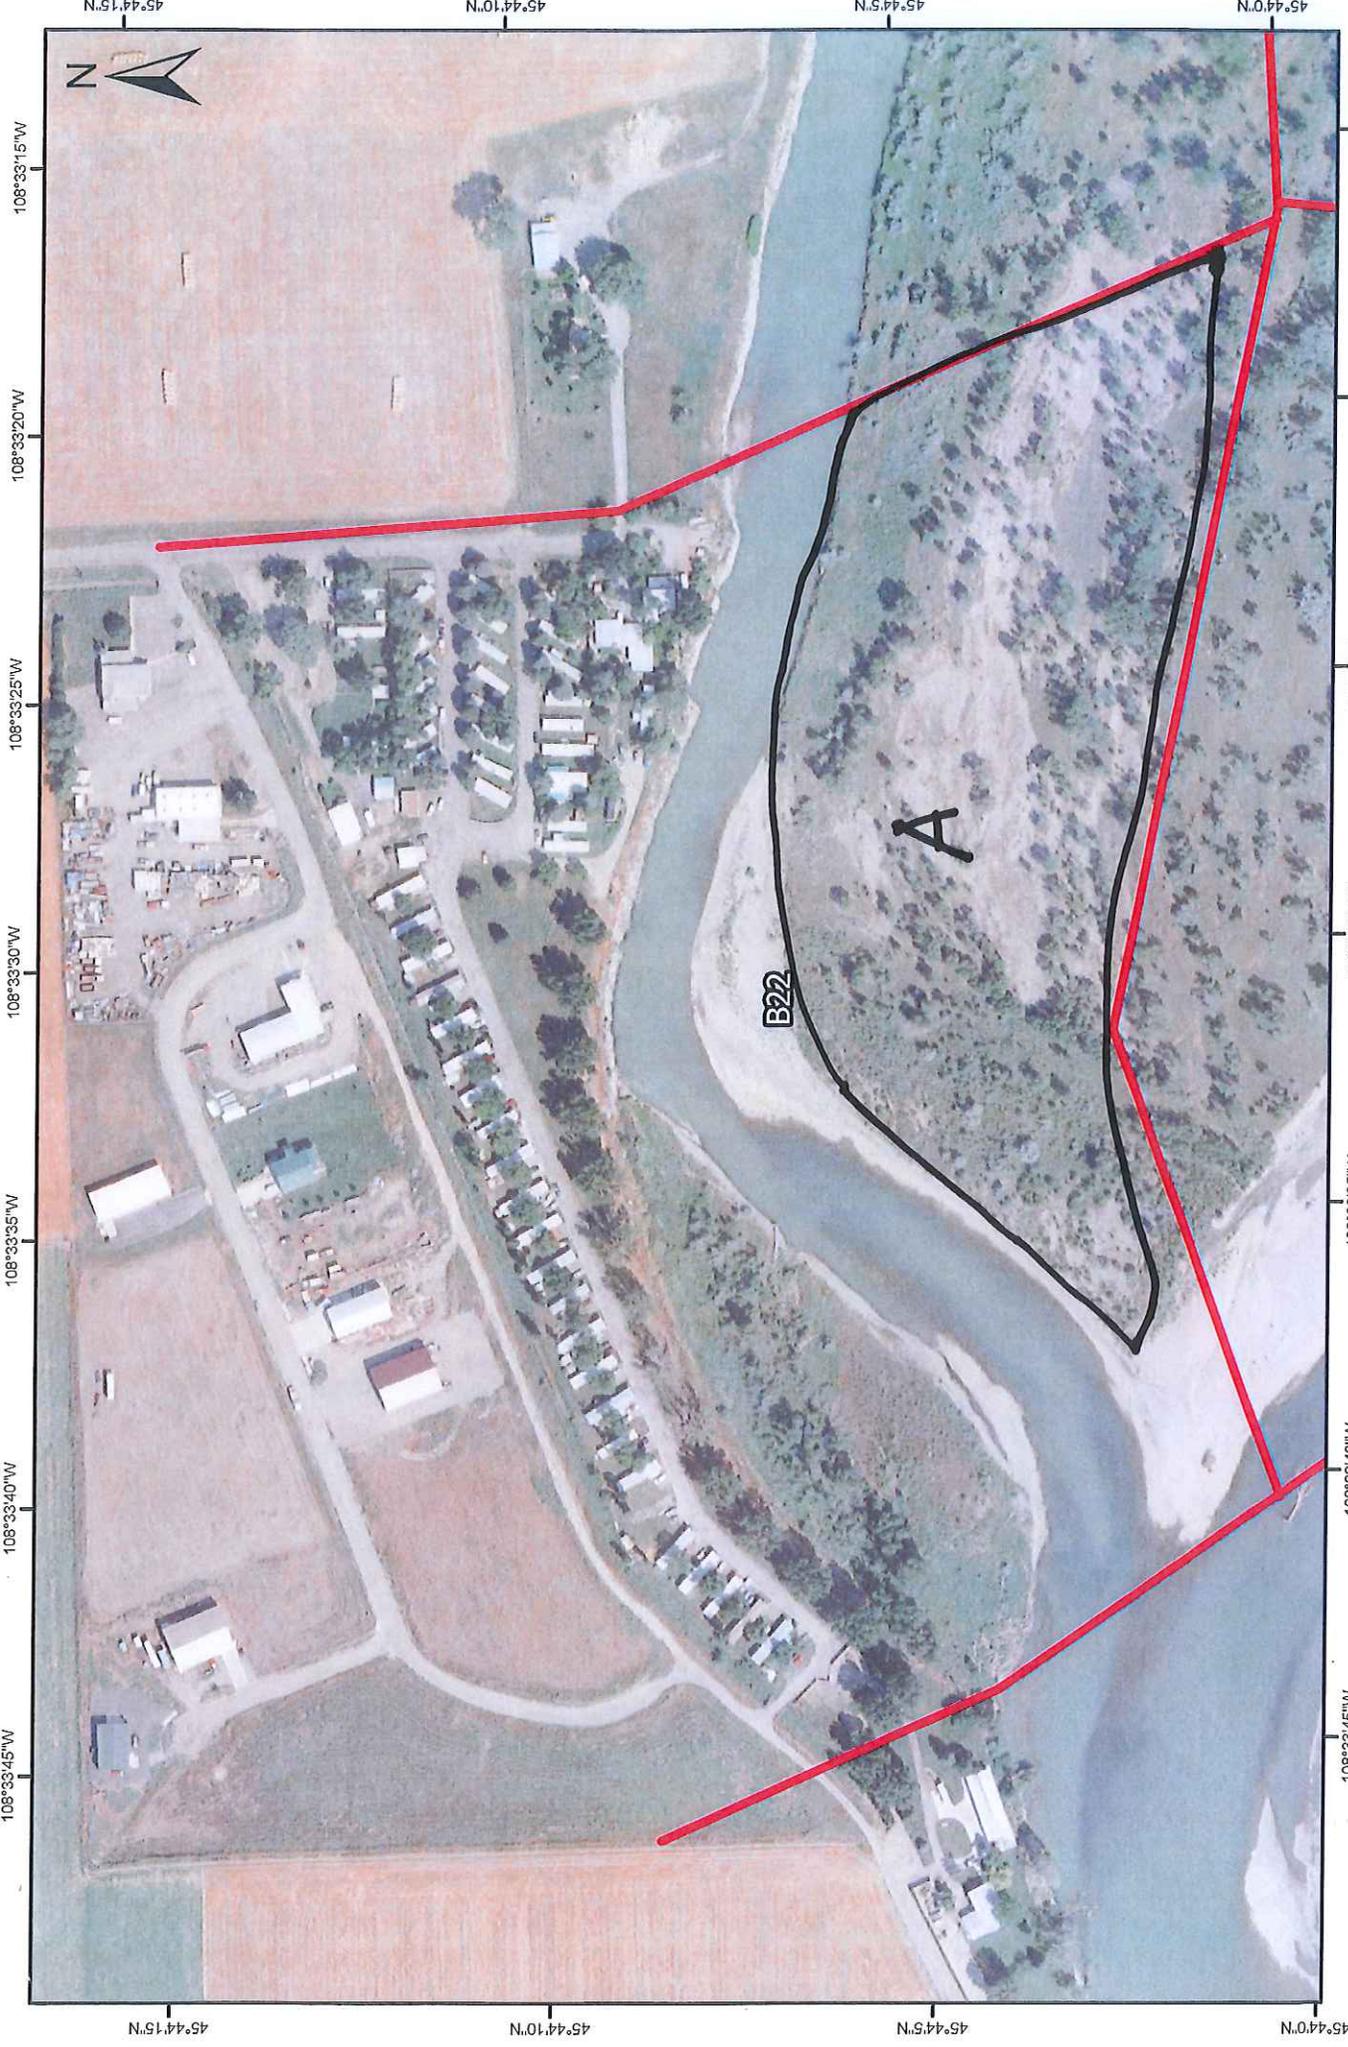
Zone A had isolated area of stained and coated debris and veg including grass and shrubs

Debris needs to be manually bagged and removed.

Veg needs to be cut and/or trampled and removed where applicable
